Report of Work under Archaeological Supervision and Control

St Andrew's Church, Thursford, Norfolk; installation of lavatory and kitchenette

NHER ENF 145651

**Sarah Bates, Report no. 56
December 2020**

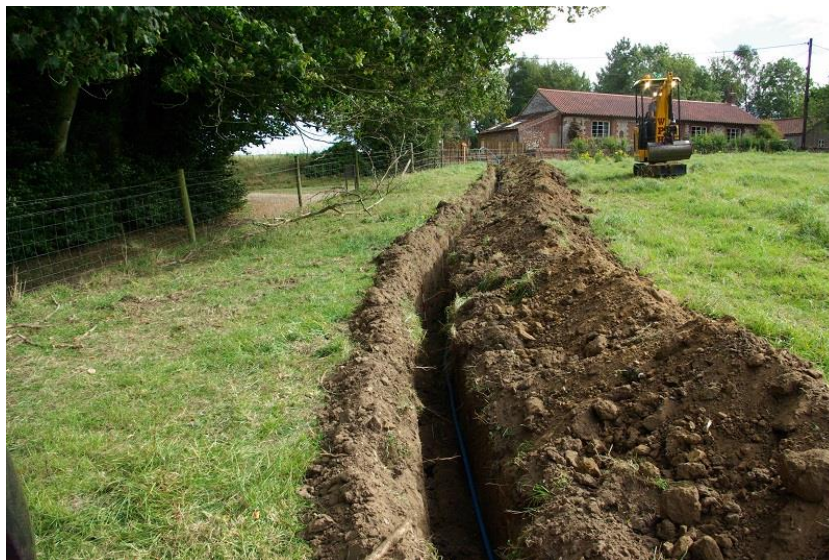
Trench 6 was between 0.75m and 0.90m deep (slightly shallower, 0.65m, near the western end of the field) (Plates 1 and 2). Fine, slightly gritty, orange brown sandy silt subsoil included rare to occasional small and medium sized flints and a very rare fragment of brick or tile [15] (Plate 3). Eastwards from about mid-way across the field the lower subsoil included patches of orangey grey clay reflecting the natural geology. Topsoil was brown silty loam with a slightly stonier lower horizon in some places. [16]. At the time of the work, the topsoil was quite dry and quite hard. Approximately 55m from the west end of the trench an area of more flint-rich spoil (with moderate amounts of flints) and a few fragments of brick was observed over a distance of about five metres. Finds recovered from the spoil from Trench 6 include a sherd of possible Middle Saxon pottery from near the west end of the field and post-medieval pottery (a small number of sherds) from along its length. A fragment of post-medieval roof tile may have been used as a spacer in a pottery kiln. A crudely retouched thermal fragment of flint was also found.

Plate 1: Trench 6, looking WSW

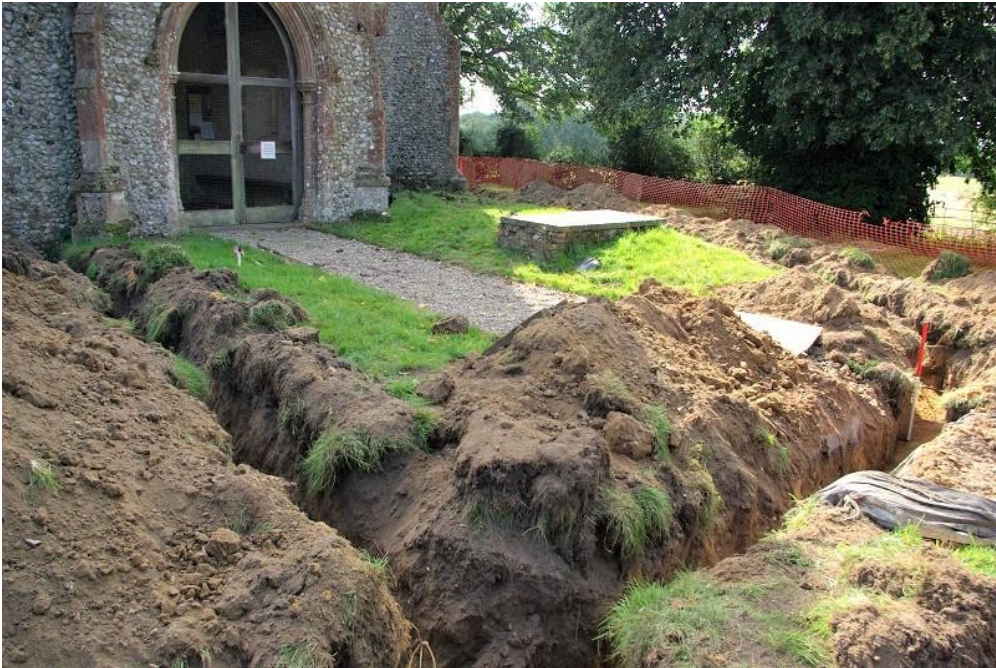
Trench 3 ran from the north-west corner of the churchyard to just east of the north path, then turning southwards to serve the kitchenette in the north aisle (Fig. 2, Plates 4 and 5). It was between 0.65m and 0.75m deep, being shallowest to the east of the church. Churchyard soil [13] was overlaid by 0.30m of topsoil [14]. At the church wall, the footings of the north aisle and porch's north-east buttresses were exposed.

Plate 4: Trench 3, looking E, 1m scale

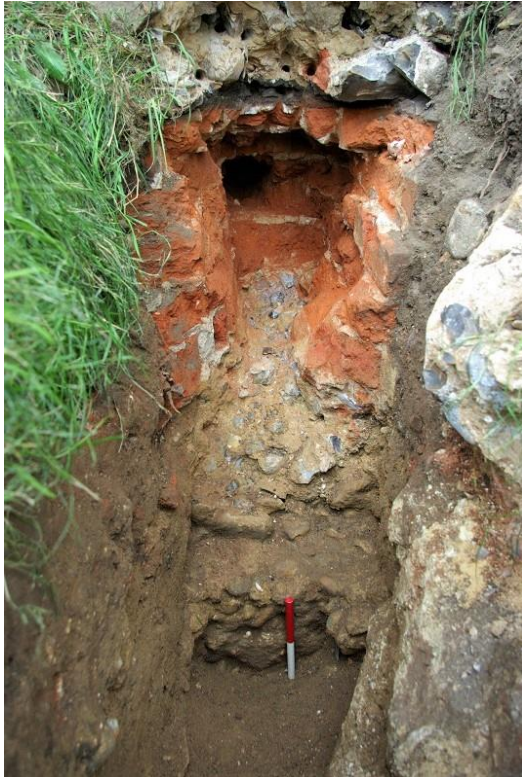
Plate 5: Trenches 1 and 3, looking NW, 1m scale

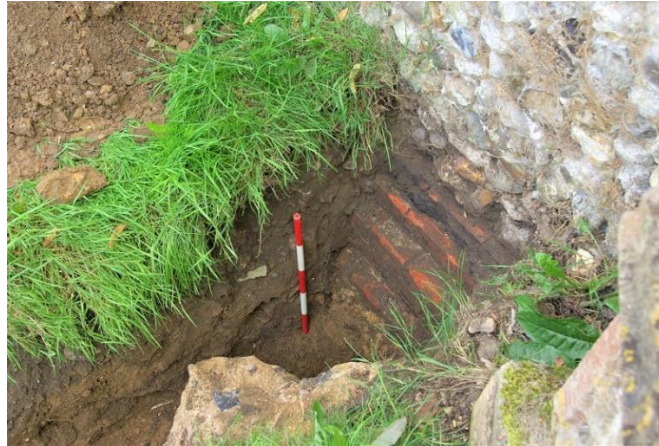
lower steps of flint in cream mortar with chalk flecks [9] (Plate 6). The lowest step extended 0.30m from the face of the aisle wall and its bottom was reached at a depth of 0.95m below the existing ground level (1.86m below the bottom of the stone window sill to the east). Above the solid flint footing were three steps of red brick with greyish white hard mortar [4] and [5] (Figs 2 and 3, Plate 7). Soil deposits recorded immediately to the north of the aisle footings included a lower layer of yellowish brown soft silty sand with very few flecks of mortar [19] overlain by a thin spread of cream sandy mortar [23] which was roughly level with the top of the lowest step of footing [9] and probably related to the subsequent construction (Fig. 3). Above [23] was deposit [18] which was very similar to [19] but with slightly more mortar flecks. The upper horizon of layer [18] coincided with change in the stepped footing from flint [9] to brick [4] and deposit [18] lapped into the interface between the two different parts of the footing (Plate 8) although on its removal the north faces of the footings [9] and [4] were seen to be flush to each other (Fig. 3). Above this level was deposit [17]; a darker yellowish brown sandy silt with moderate amounts of crushed mortar and very rare fragments of brick. This merged with the 'churchyard soil' described elsewhere but, here, clearly post-dated the construction of the north aisle.

Small parts of the church footings were observed during the work. The upper, brick, footings exposed at the north aisle wall clearly related to the 19th-century construction. The lower part of the footing (flints in a cream lime mortar), was very different in fabric and mortar type and there was a distinction in the soil layers abutting the footings with silty sand deposits possibly pre-dating the construction of the upper, brick, footing. These facts might point to an earlier date for the lower part of the footing with it then being utilised during the construction of the 19th-century north aisle. The very exact overlaying of the brick footing upon the mortared flints,

with the vertical north face flush between the two parts, might, however, suggest that they are of the same date and the overall stepped nature of the footing seems consistent with a 19th-century date (Richmond pers. com. August 2019).

Plate 6: N aisle stepped footing [9], brick footing [4] partly removed, looking S, 0.5m and 0.2m scales

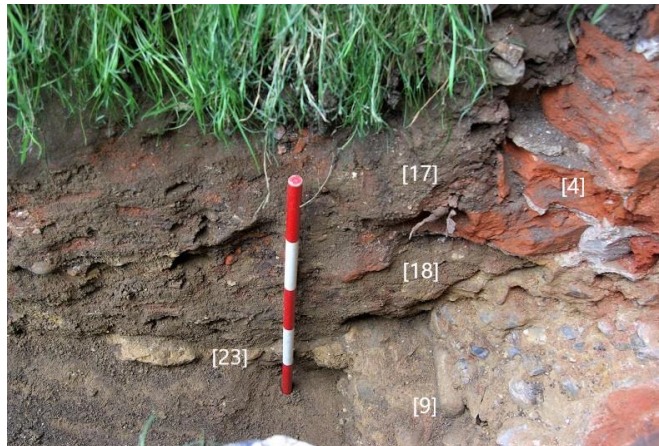
Plate 7: N aisle stepped brick footing [4], looking SE, 0.5m scale

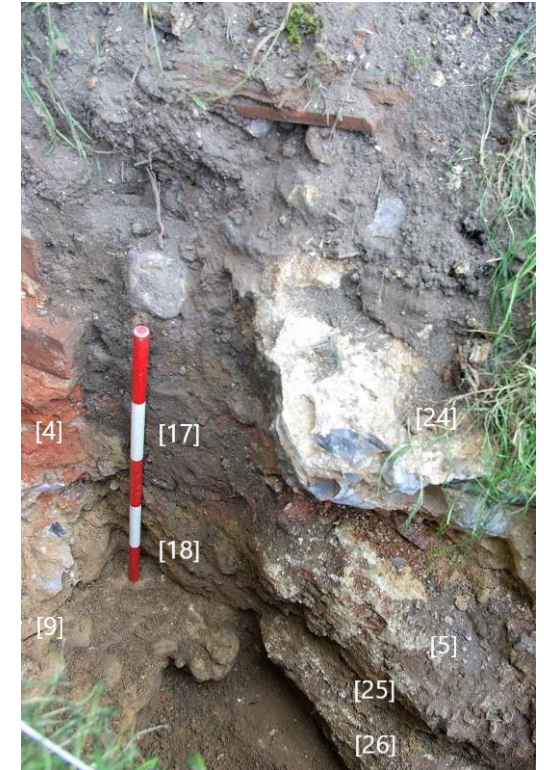
Plate 8: Deposit [18] before its removal from above top of footing [9], looking E from above, 0.5m scale

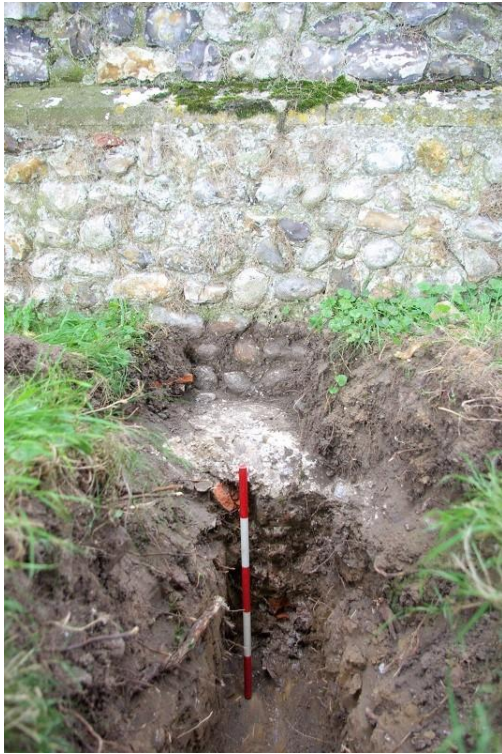
The north-east corner of the porch's north-eastern buttress footing was seen in the side of Trench 3. (Plates 6, 7 and 9). The lowest exposed deposit, its bottom not reached, was compacted crushed chalky mortar [26] which appeared to have an overlying layer of yellowish brown silty sand [25] running between it and an upper, very similar chalky mortar [5] (Plate 9 – red brick dust visible on part of the buttress footing resulted from cutting through aisle wall). Above the compacted mortar foundation layers, the north-east corner of the solid mortared flint footing [24] protruded into the excavated trench extending 0.55m from the end of the buttress and 0.15m from its south-east side. Its upper surface was 0.40m below the bottom of the chamfer on the buttress plinth.

It was difficult to clarify any relationship between the recorded aisle and porch buttress footings due to the small area and awkward angle between them exposed in the trench (see Plate 9). Richmond considers it most likely that the porch was rebuilt as part of the first phase of 19th-century restoration with the construction of the north aisle a few years later. The date of an original porch is uncertain but it seems quite likely that its footings would have been utilised and the porch rebuilt in the same position. The position of the porch in relation to the north aisle is unusual and suggests that it predated the existence of a north aisle.

Plate 9: Porch buttress footings [26]/[25]/ [5]/[24], N aisle footing [9]/[4], looking SW, 0.5m scale

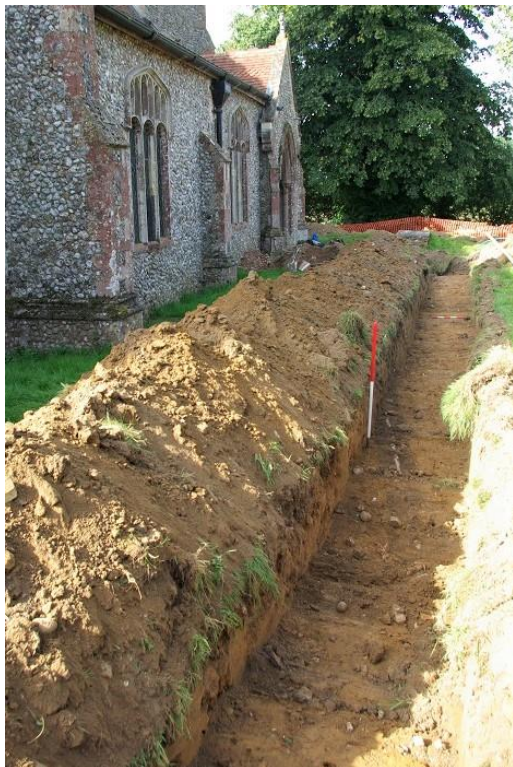
Trench 10 was positioned in the open area of churchyard approximately 3.50m north of the north aisle (Fig. 2, Plates 11-13). It was 14.30m in length and 1.20m wide. The base of the trench sloped down from a depth of 0.20m at the west end to 0.60m about five metres to the east and to a maximum depth of 0.75m along the central length. The easternmost two metre length sloped up to ground level (as per the design specification). Churchyard soil [13] was overlaid by 0.30m of topsoil [14]. In the eastern part of the trench some *in situ* lower leg and foot bones were exposed (Plate 13) (but were actually below the depth required for the trench arch drain so were re-covered with soil). Just to the north of these bones, the drain from the church to a soakaway in the north-east part of the churchyard was partly exposed running from WSW to ENE.

Plate 11: Trenches 10 and 3 (to left);
looking E, 0.5m scale

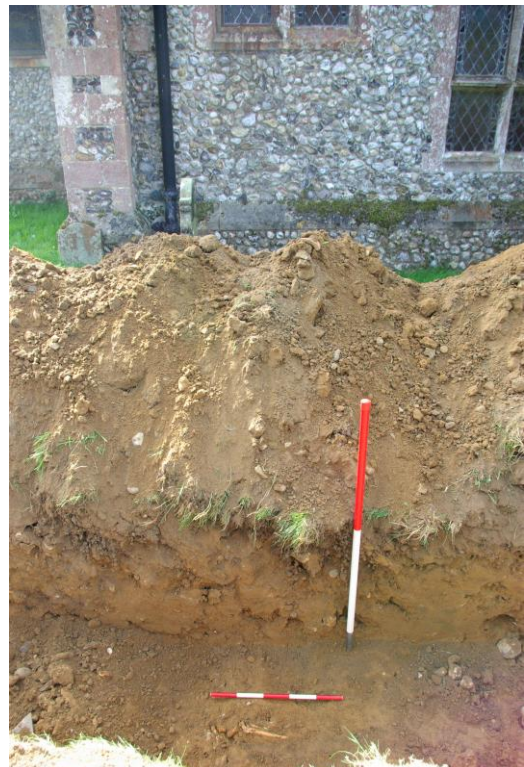
Plate 12: Trench 10;
looking W, 1m and 0.5m scales

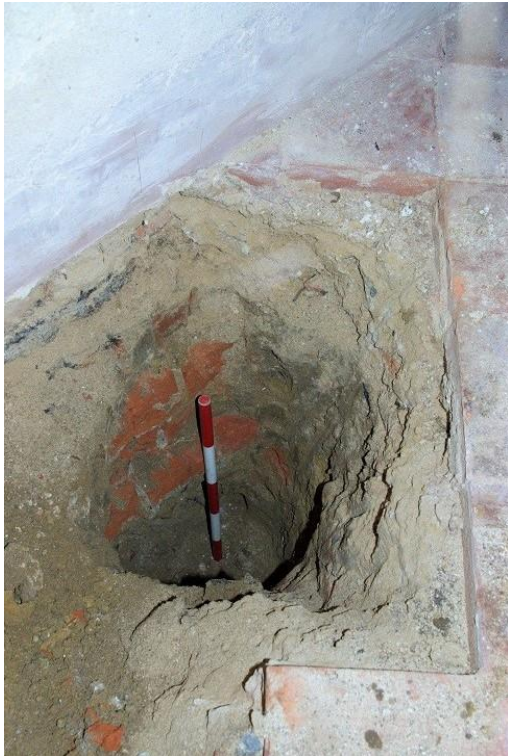
The internal wall footings were exposed by the removal of the floor and under-lying deposits (Plates 15-17). Three courses of red bricks were seen at the west and south walls above which were the plastered wall faces. The bricks were just below the external ground level (measurements were taken at the west window). At the north side of the vestry a small area of flints was exposed at the bottom of the tower stair turret wall but most of that area, and the surface exposed at the tower's south wall remained partly covered in render. To the east, flints were exposed at the base of the nave's west wall and, at the vestry doorway, the stone threshold slab (the top of which was flush with the former floor of the vestry) was removed. Loose mortar

rubble was seen below it and the heavily disturbed areas of the south aisle wall were exposed at each side, partly supported by bricks - presumably from when the doorway was inserted in the 19th century (Plate 17). The original wall base or footing was not seen below/within the doorway.

Plate 17: Vestry; floor level lowered and threshold removed, looking E, 0.5m scale

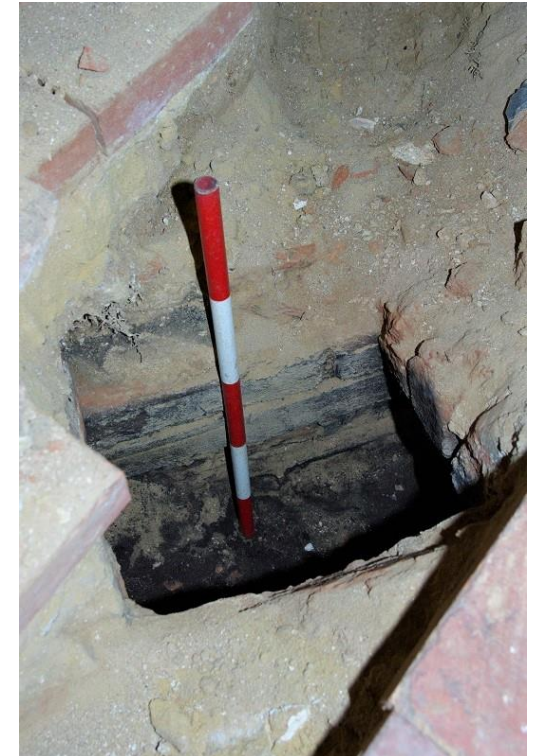
In July 2020 a narrow 'trench' was dug from the vestry doorway across the nave and north aisle to lay an electricity cable to the new kitchenette (Fig. 2, Plate 19). This was approximately 0.20m wide and deep and along almost all of its length only the crushed sandy mortar subfloor make-up material [21] was seen and very little of it was excavated from below the tiled floor. Centrally within the nave the brick channel for a former heating duct was exposed, its uppermost bricks only 0.10m below the floor surface (Fig. 2, Plate 20). Its inner faces were sooted black and there was a thick layer of soot in its base. It was 0.30m wide and 0.58m in depth from the nave floor surface to a flat surface at its base (presumably the brick base but not exposed due to the thick deposit of black soot (80mm) in the bottom). Existing electricity cables were exposed in two places (see Fig. 2).

Plate 19: Nave; area 12, looking SW
