**THE ARCHAEOLOGY CO.**

Old Market Hall, Bacup  
Historic Building Survey

April 2016

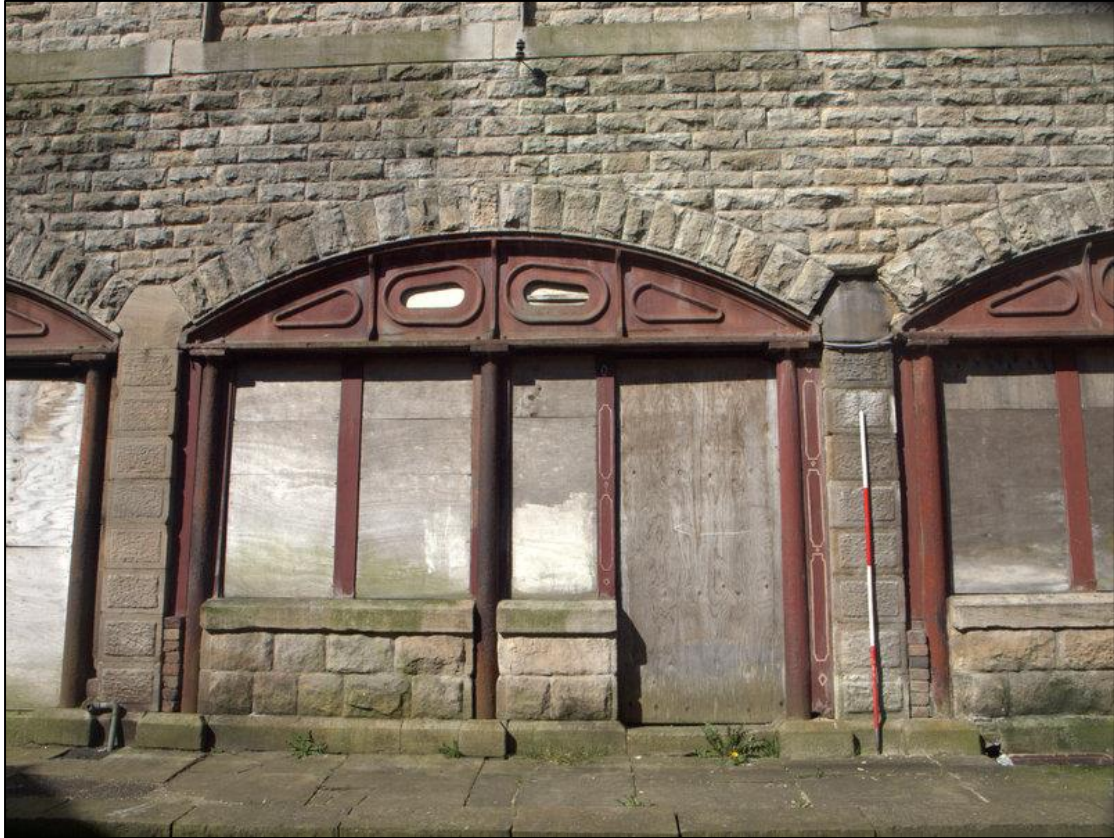
Plate 7: Detail of shop front on east elevation

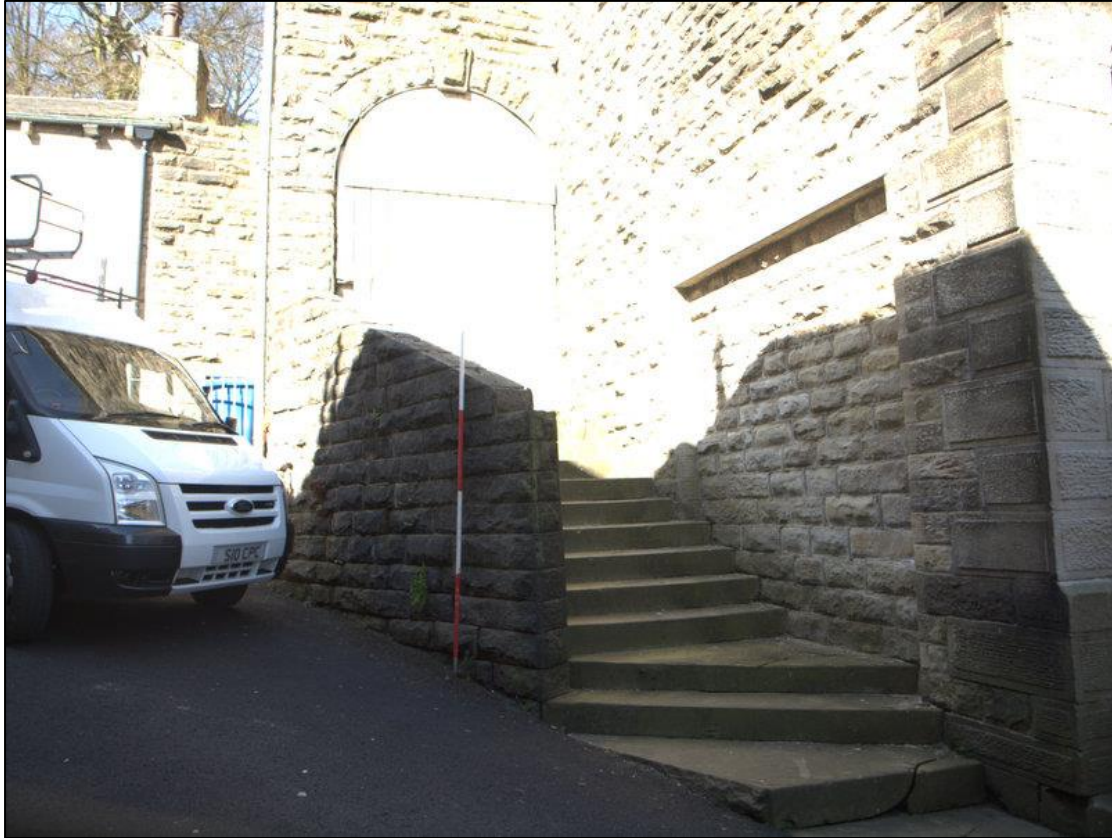
Plate 11: Stone steps leading up to blocked doorway in east elevation

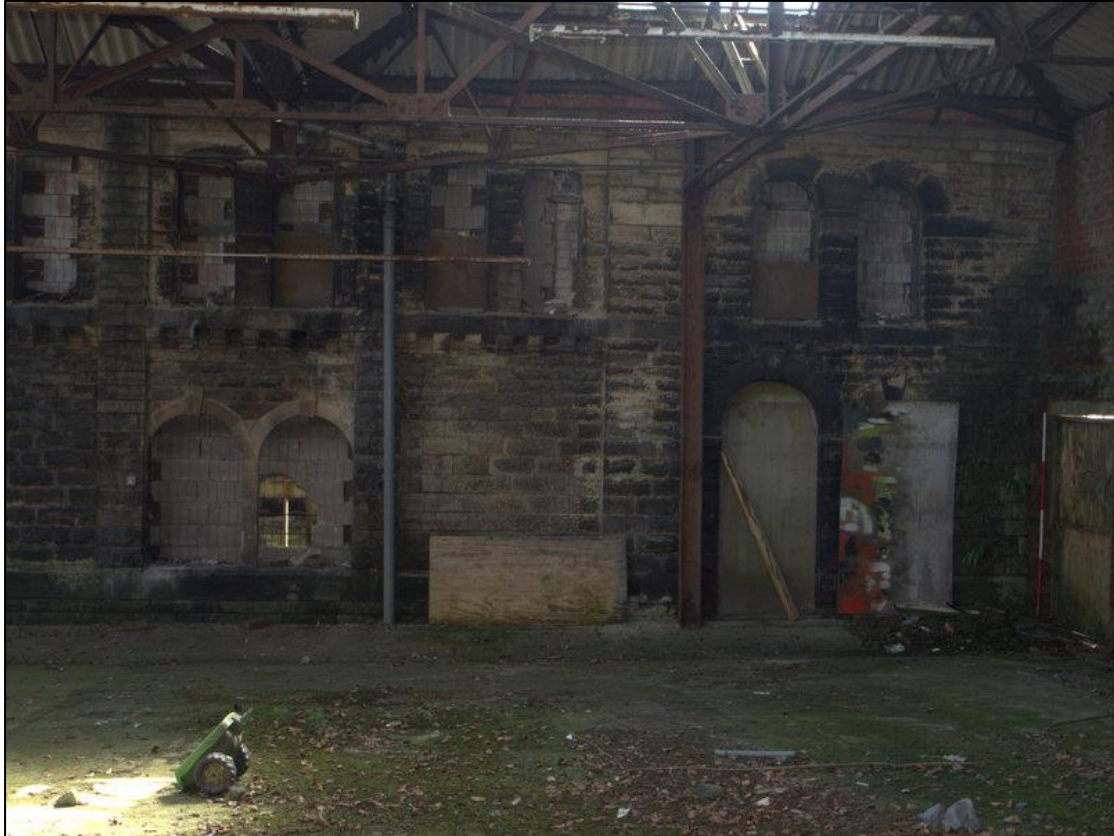
6.5 West elevation (Plates 17 - 22). The majority of this face lies within the later extension, with only the first two bays facing the street. This is much the same as the east elevation, without the lower ground shop fronts. The first bay contains a pair of portrait windows matching those on the east face, with the majority of the other bays containing two pairs of windows at first floor level and decorative recesses at ground floor level. One of the exceptions to this is bay 5, which contains a large doorway with rounded arch lintel and sandstone surround, matching that on the north elevation. The ninth bay also differs from the east elevation, as at ground floor level there is a doorway, next to a window, both having a rounded sandstone lintel with false keystone. All of the windows on this face have been blocked with brick.

Plate 22: Detail of blocked windows in southern end of west elevation

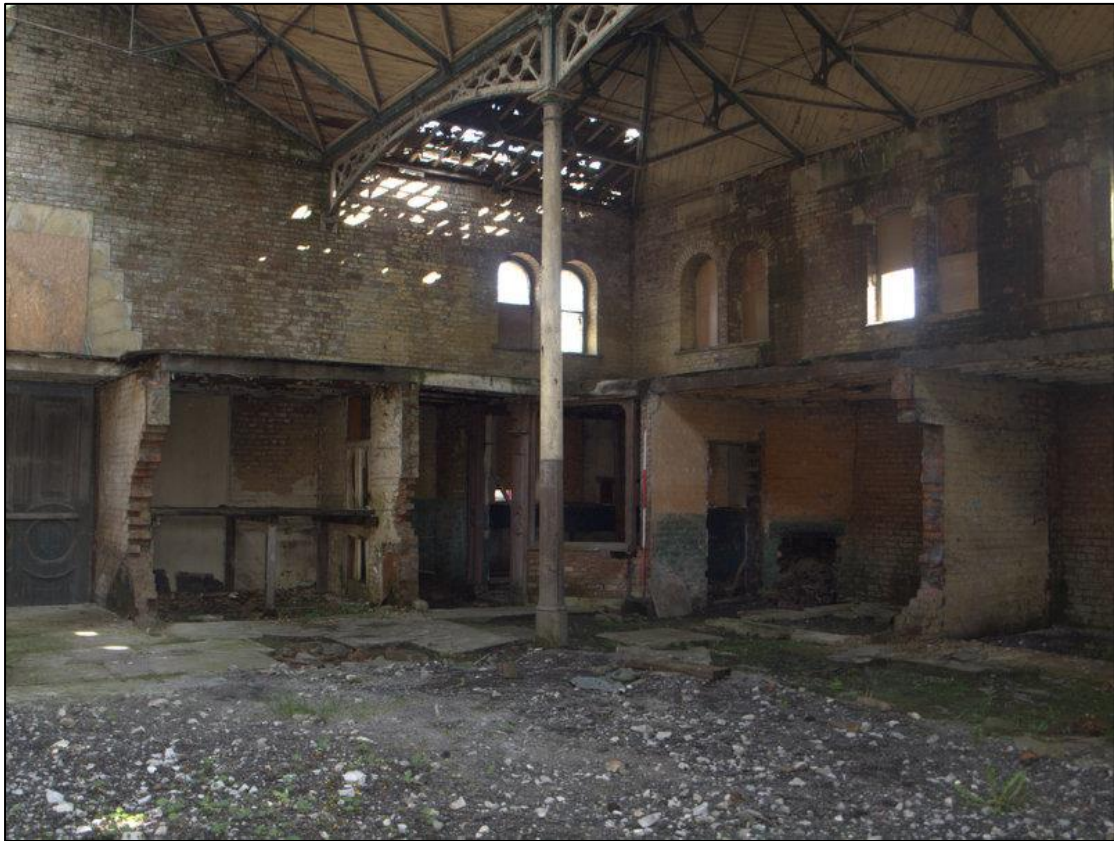
Plate 25: Remains of offices in northeast corner

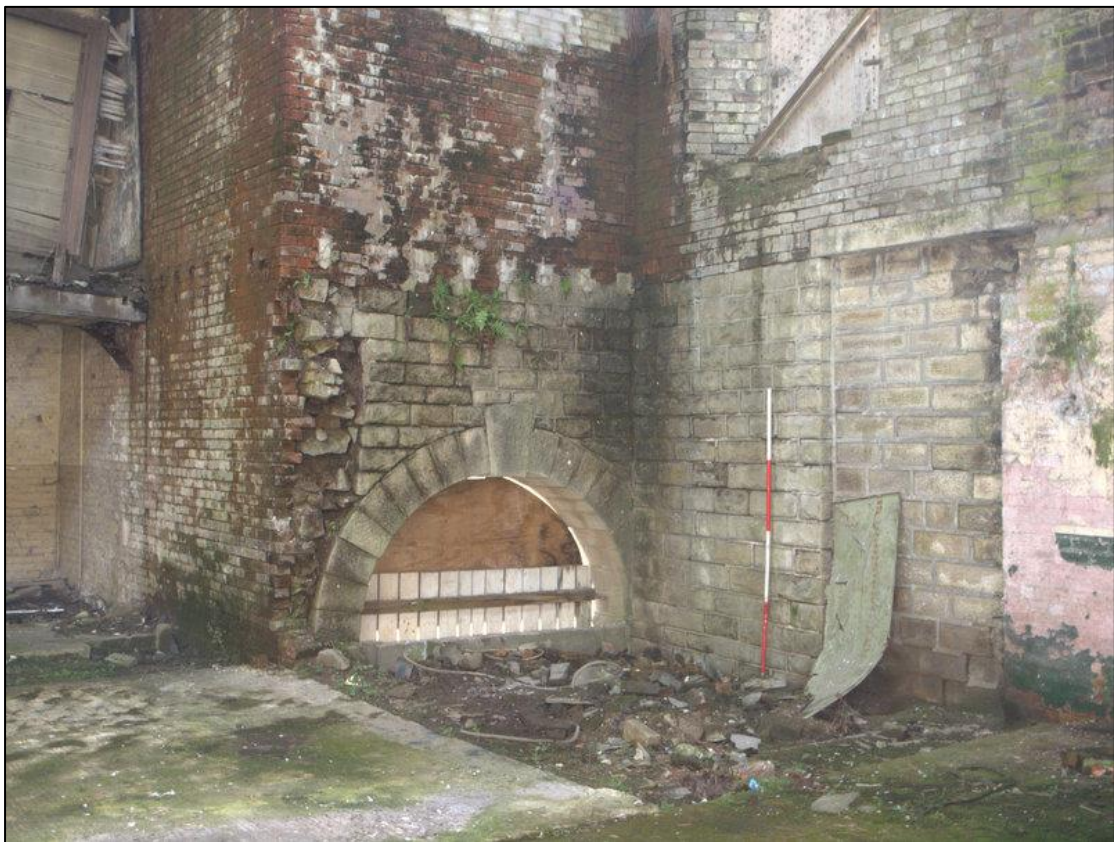
Plate 30: Blocked doorway and infilled staircase at southern end of east side.

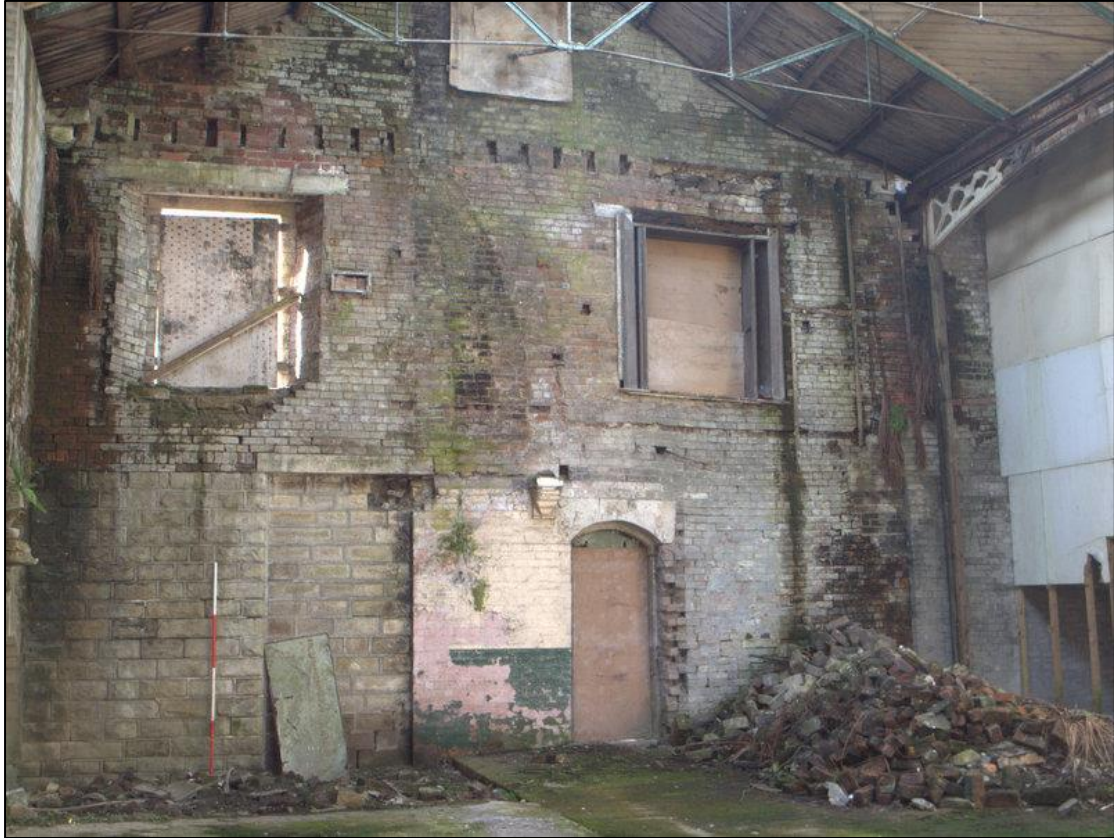
In the centre of the southern wall (Plate 31) are two blocked doorways. That to the east has a flat lintel and is set within a stone wall, rather than brick. To the west the smaller personnel doorway has an arched lintel. Both are blocked. Above are two blocked portrait windows, and above them are a series of joist holes. Finally, near the top of the gable is the circular window with stained glass, although this is boarded over. The western bay is featureless, except for a blocked doorway with arched sandstone lintel in the western corner (Plate 34). The western wall has more modern structures butting against it (Plate 32). At the southern end is the doorway and window, both blocked, and visible from the exterior (Plate 34). To the north of this is a pair of blocked windows with an RSJ lintel inserted above (Plate 33). Finally, in the centre of the face is a large entrance set within a sandstone surround, matching the northern doorway (Plate 35). A pair of straight joints run up the wall to the north of this, possibly marking a blocked doorway, although could also mark a removed wall (Plate 36).

Plate 31: Central bay of southern elevation

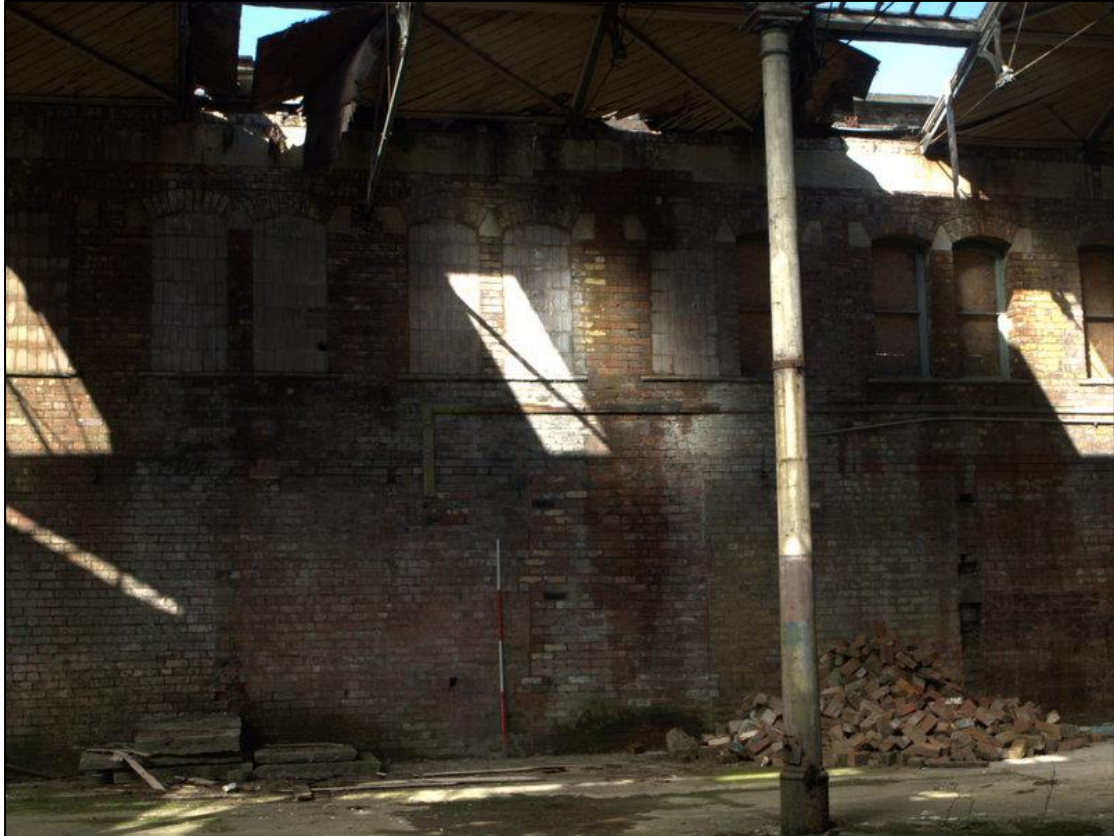
Plate 36: Section of western wall showing possible blocked doorway

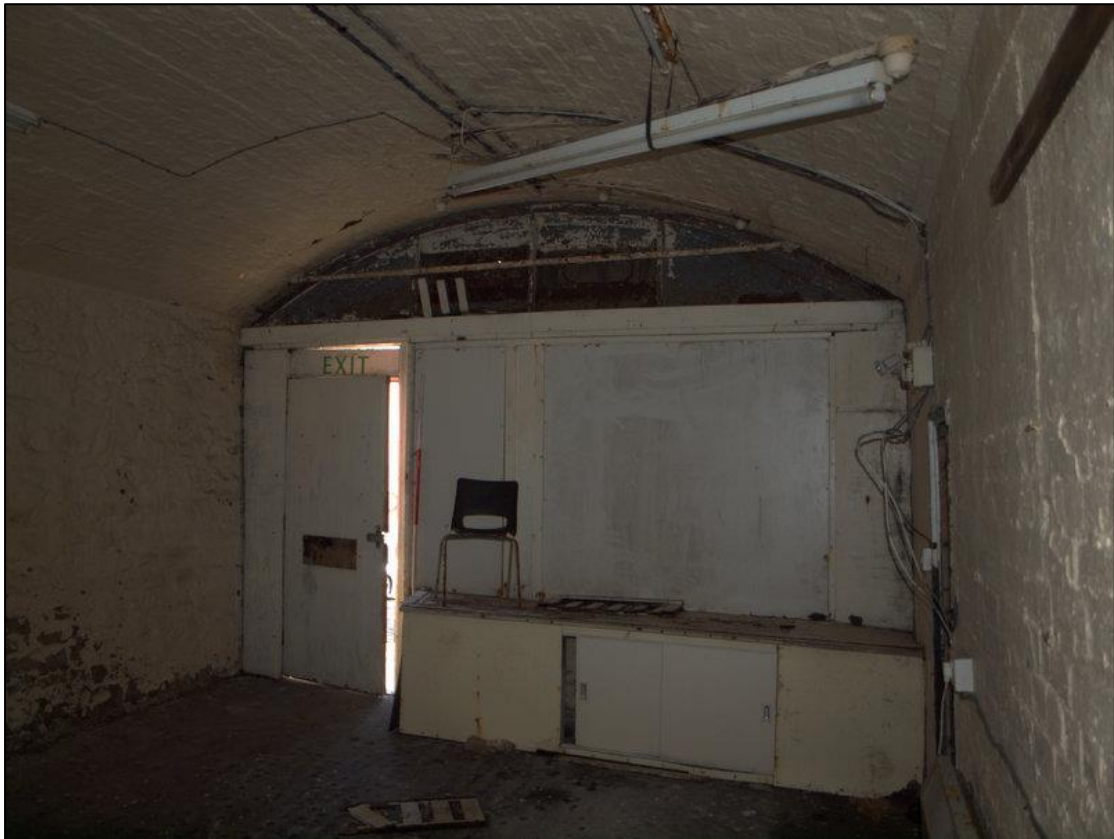
Plate 41: Northern unit in lower ground floor showing entrance and blocked windows

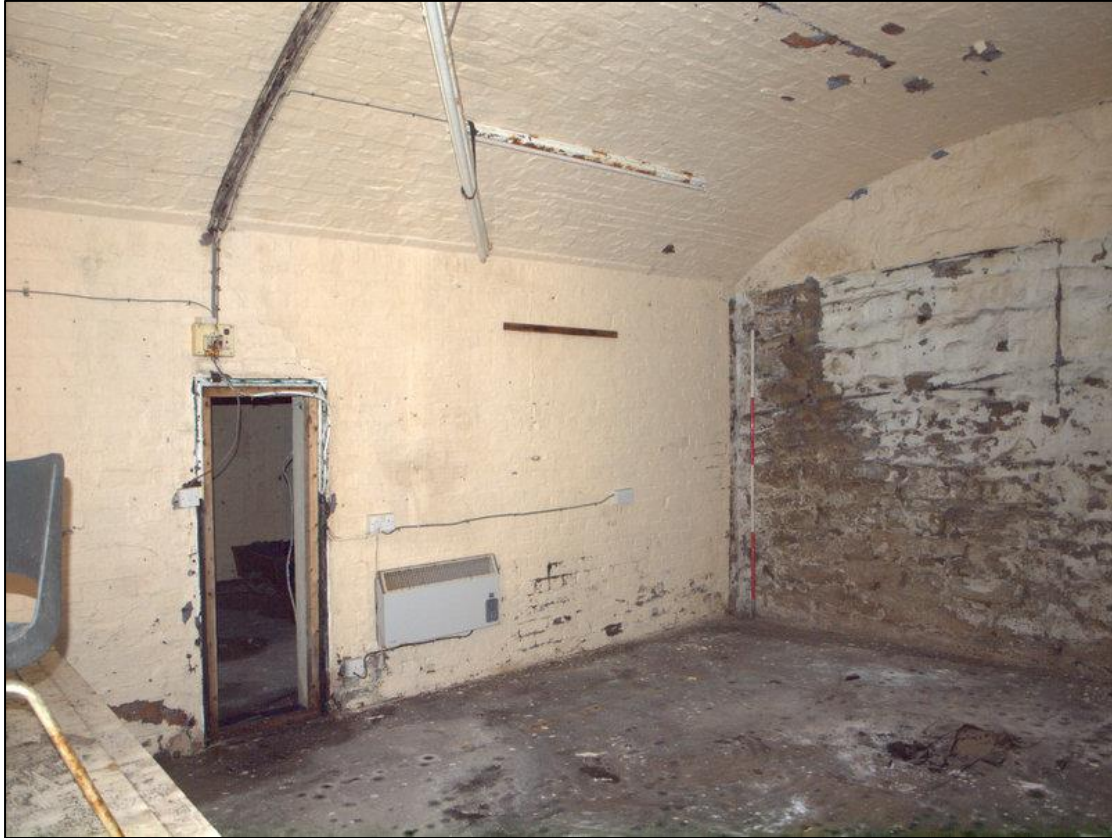
Plate 43: Southern wall of unit showing inserted doorway

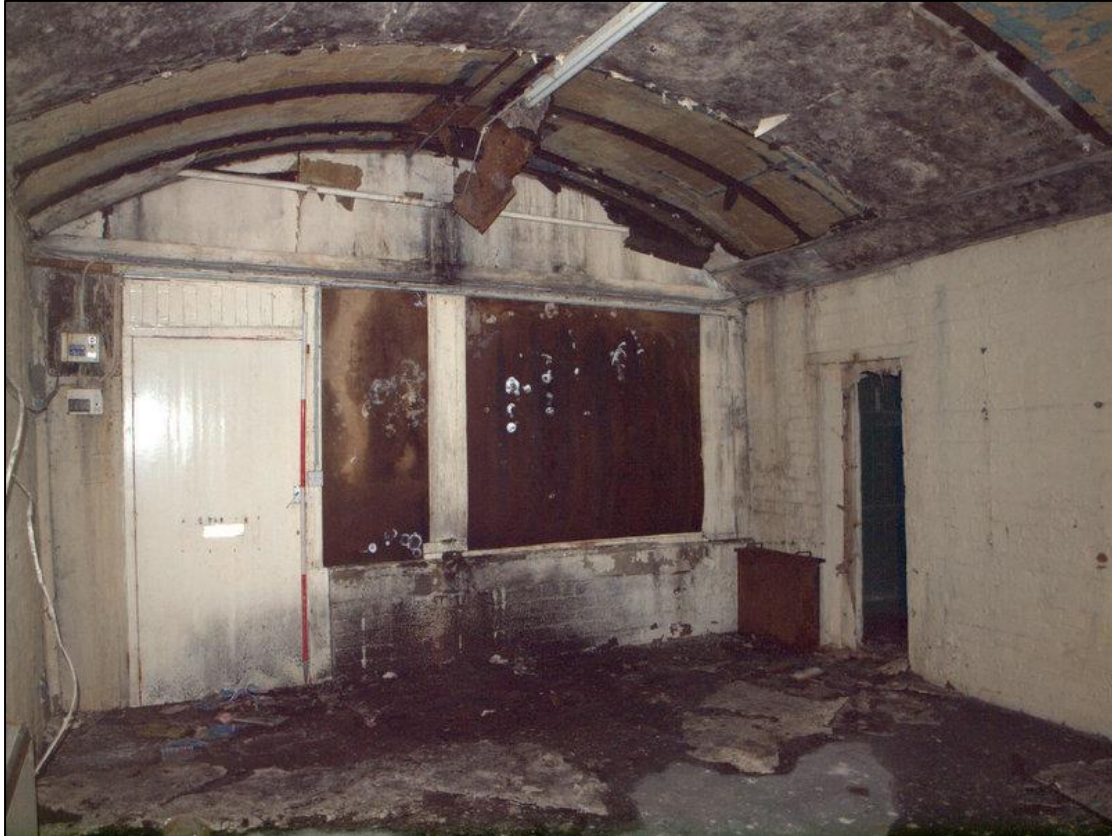
Plate 44: Second unit showing boarded frontage and further inserted doorway

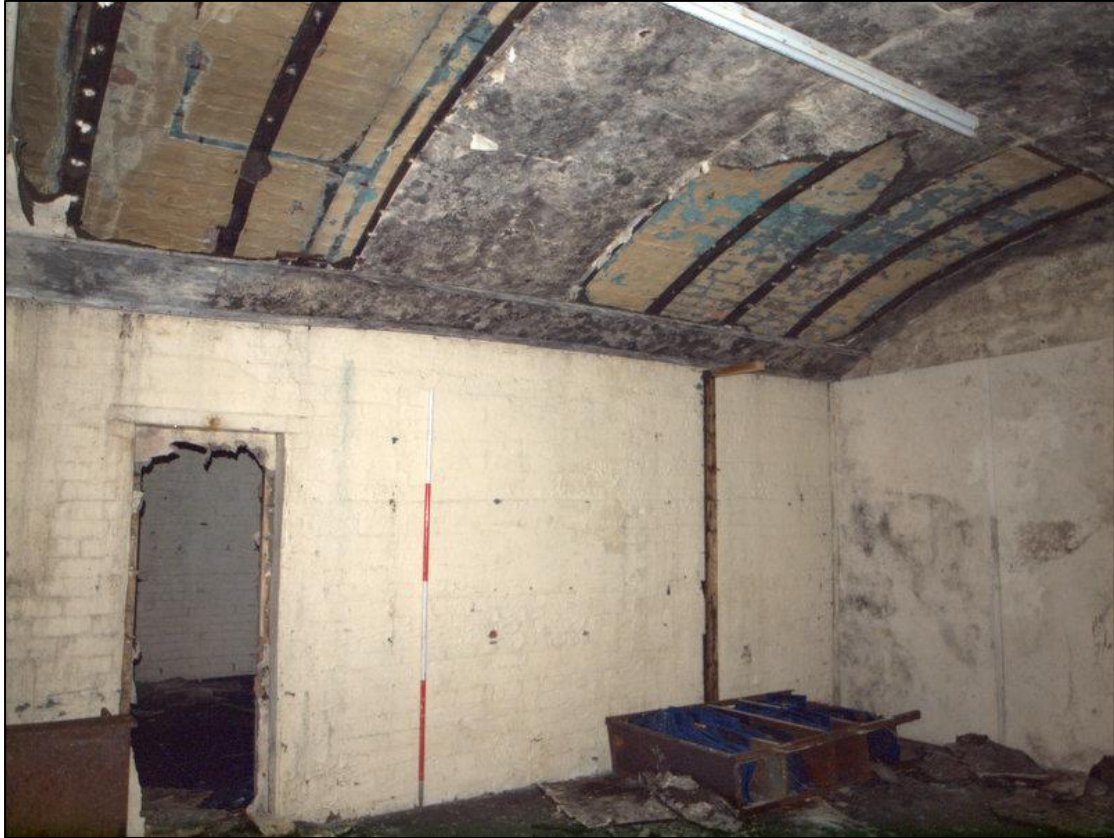
Plate 45: Second unit showing inserted doorway, rear wall and bricks of the vaulted roof

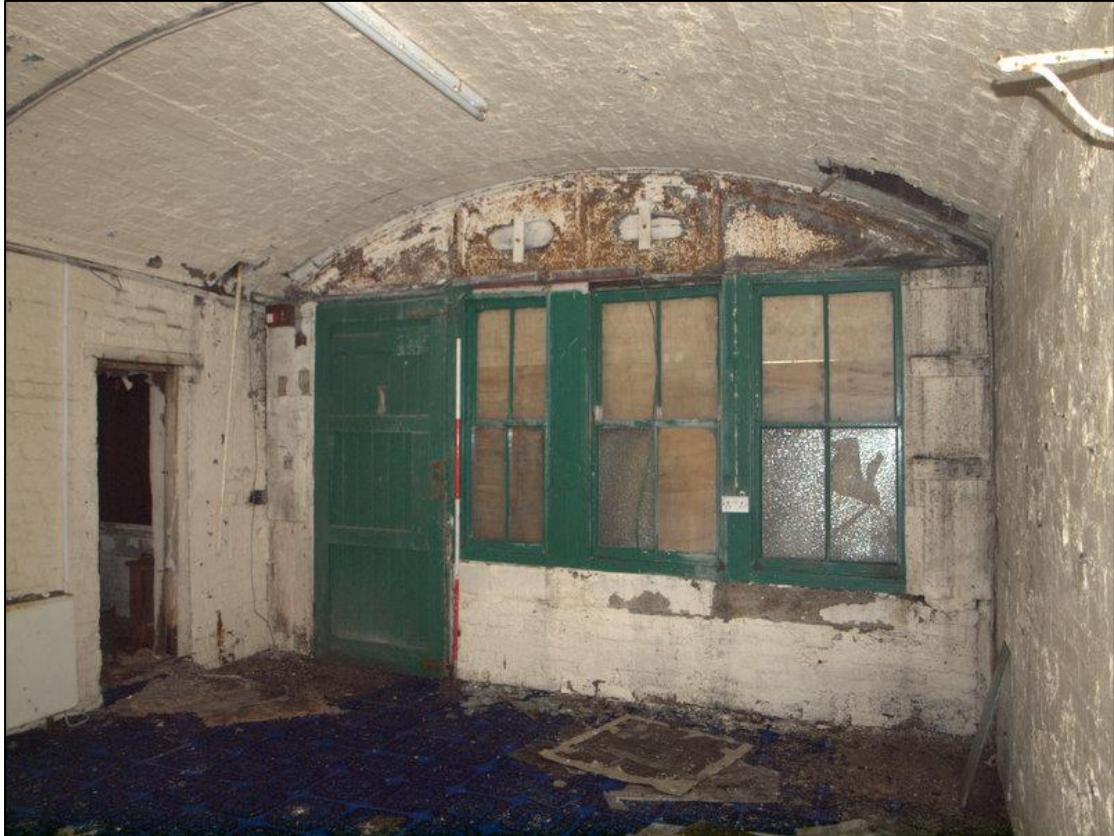
Plate 46: Boarded frontage of the third unit

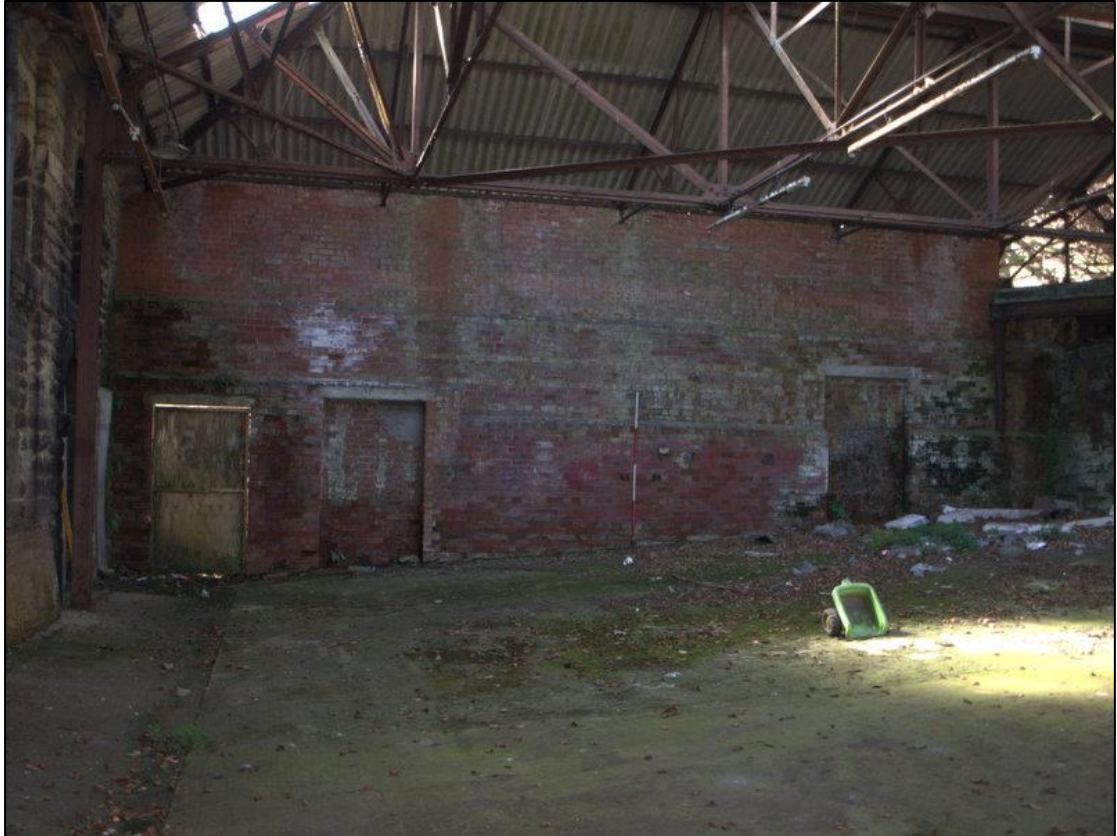
wall is brick and contains three blocked doorways (Plate 56). Two of these lie to the east and are both personnel doorways. The easternmost is blocked with ply, whereas the western is bricked up. To the west is a further blocked doorway. All have concrete lintels. To the north is the other brick face (Plates 59 & 60). As with the exterior it contains a loading doorway to the east and a personnel doorway to the west. The face steps in twice as the wall rises and a timber frame has been put in place along the central section. Between the two doorways a first floor office has been inserted (Plate 61), resting on RSJ beams and timber joists. A stud wall runs along the west side. No staircase remains.

Plate 56: Southern wall showing blocked doorways

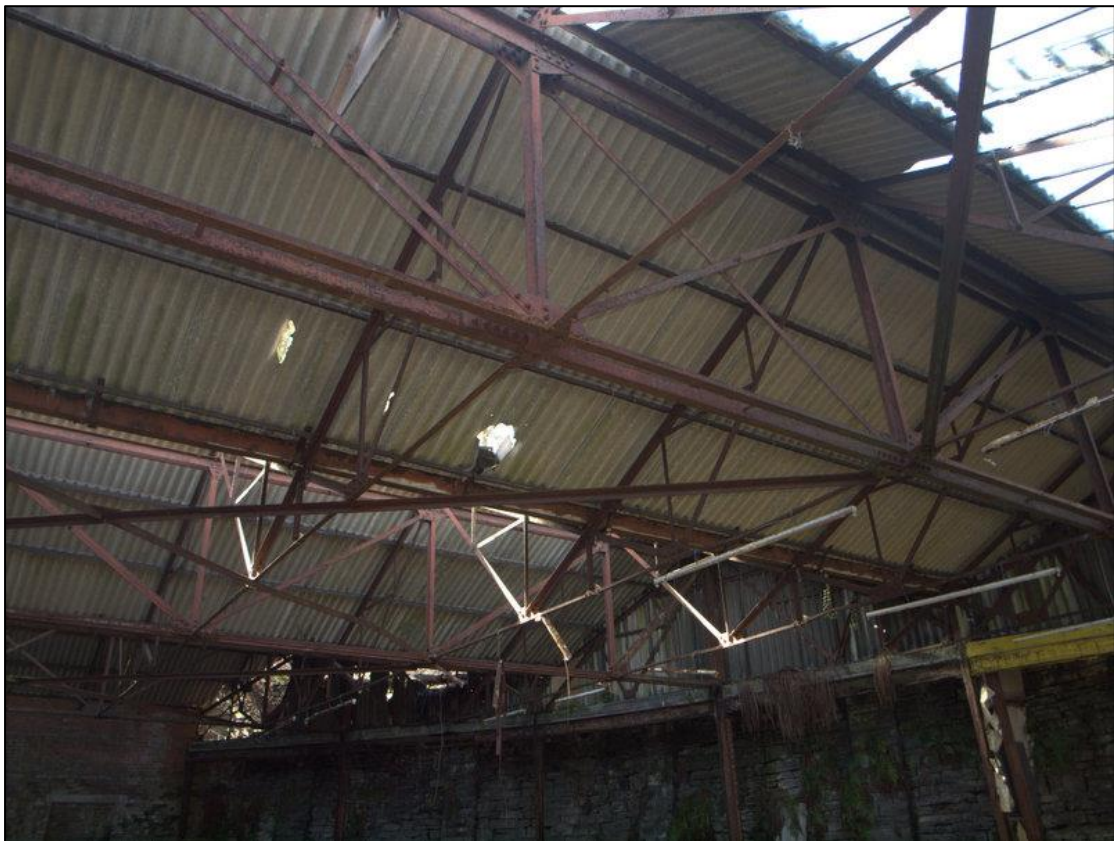
- 6.13 The roof structure (Plate 62) is supported on a series of RSJ columns running along the east and west walls. These in turn support Iron beams and a lattice work iron structure supports the asbestos covered roof.

Plate 62: Roof structure
