Duke of York, Burnley Historic Building Survey

June 2018

1.1 Steven Price of The Archaeology Co. has been commissioned to prepare a level 3 historic building survey of the Duke of York, Colne Rd, Burnley BB10 1DT. Planning condition 4 of application APP/2017/0140 states that:

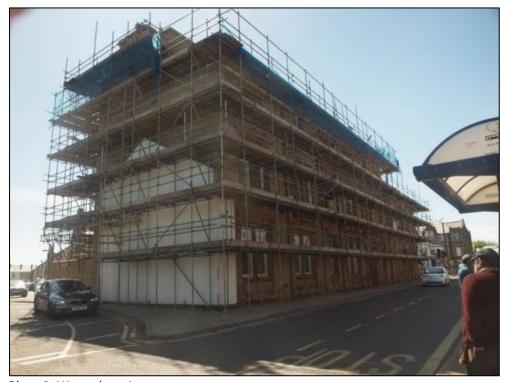
Plate 2: West elevation

West elevation (Plates 1 & 2). This forms the elevation forming Colne Road and is 6.2 10 bays across. Bay 1, to the north has a pair of two light timber framed sash windows (the upper lights boarded over) in a sandstone surround, separated by a sandstone mullion. The cill is likewise sandstone and the lintel is a projecting decorative sandstone feature. Above is a matching window, although the upper lights are present to the southern still retaining the stained glass. The cill is formed of the sandstone sting course running along the building face and the lintel is similar but more ornate than the window below it. A further sandstone sting course runs across the face at first floor level, cut by the window jambs. The lintel of the window extends up to meet the cill of the second floor window, which, although similar to those below it, is much smaller. A sandstone coping lies above and runs across the face. To the south, bay two is similar, although has a bay window at first floor level, each of the three casements retaining their stained glass. The second floor widow is a single timber framed portrait window. Bay 3 matches bay 1, except the ground and first floor windows are single portraits, rather than a pair. Bay 4 matches the first bay and a sign reading "DUKE OF YORK" lies above the ground floor window. Bay 5 contains the main entrance to the building. The timber panelled door is set within a sandstone surround with columns to each side with dog tooth capitals. The lintel above is a large sandstone block with the raised works "DUKE OF YORK HOTEL" within it. Above this the sandstone columns continue to rise, flanking the timber framed portrait windows

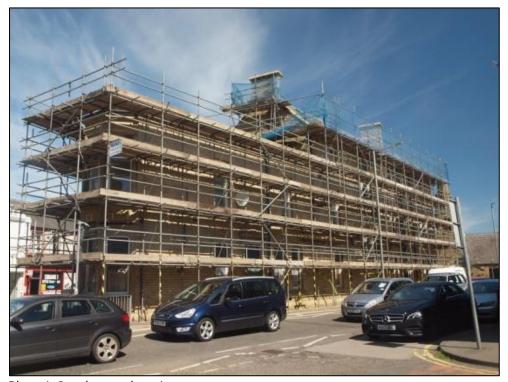
Plate 4: Southeast elevation

6.3 Southeast elevation (Plates 3 & 4). Bays 1 to 3 of this elevation, facing Briercliffe Road, constitute the two story section of the building. Bay 1 contains a timber framed sash window at both first and floor levels, each with a simple sandstone lintel. The ground floor also has a simple sandstone cill, whereas the cill for the first floor windows is formed by the sandstone string course. Bay 2 is featureless at first floor level but contains an entrance doorway at ground floor level. The timber panelled door is flanked by a pair of simple sandstone columns and matching lintel. Above this is a light, now blocked. The surround is similar to the doorway, although the base of the columns is scrolled and the lintel contains a sandstone pediment. Bay 3 matches bay 1, although has a pair of timber framed sash windows at ground floor level, rather than one, the single first floor window located centrally above them. Bay 4 marks the start of the three story section of the building. This matches bay 1, with the exception of having a small timber framed casement window at second floor level. Bay 5 contains the rear entrance to the staircase. The doorway is set within a moulded sandstone surround with projecting sandstone lintel with pediment above. Each level contains a pair of staggered timber framed sashes, marking the staircase location. An additional light lies to the south of the doorway, which lies partially below ground level and lights the steps to the basement. Bay 6 contains a pair of timber framed sash windows at

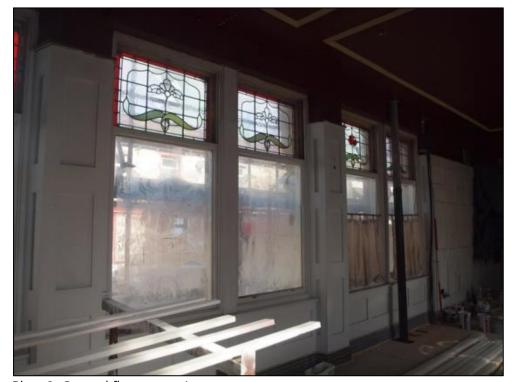
Plate 8; Ground floor room 1

- 6.5 The ground floor is divided into seven areas. At the southern end is room 1, a triangular room at the southern end of the building (plates 7 10). This has been completely refurbished in the early 200's, after the firebomb attack. The timber panelling along the walls hides the external door visible externally at the southern end of the Southeast elevation onto Briercliffe Road. The windows have likewise been replaced along with the floor and ceiling.

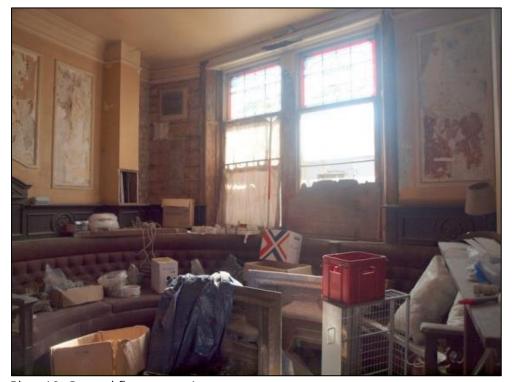
Plate 18: Ground floor room 4

- 6.11 Room 4 (plates 17 20) is the lounge, with a tiled fireplace with timber surround set in the southern wall, backing onto the fireplace or room 2. Built in seating lines the west, north and south walls, with decorative timber panelling above. The wall above this is plastered with moulded timber 'frames' across. A picture rail runs around the room at a high level, as a part of a cornice, which s different to the cornice found in the rest of the ground floor.

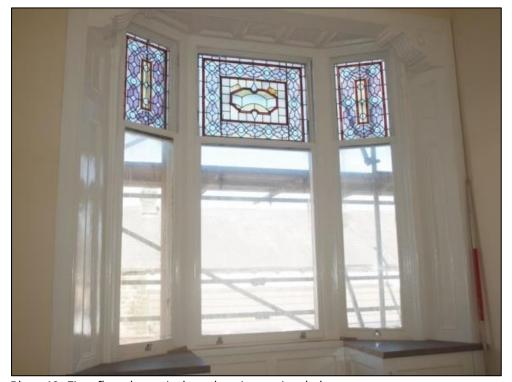
6.15 (Plates 25 – 65) Both of these have been extensively modified and altered to create a series of 4 flats at each floor. Little has been retained, with fireplaces blocked and any skirting, rails or cornicing having been removed. However, a few of the windows still retain the decorative moulded timber surround and panelling (Plates 42 – 43).

Plate 42: First floor bay window showing stained glass

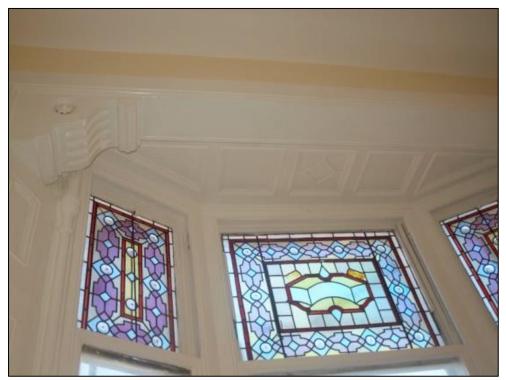
Plate 43: Detail of panelling of above

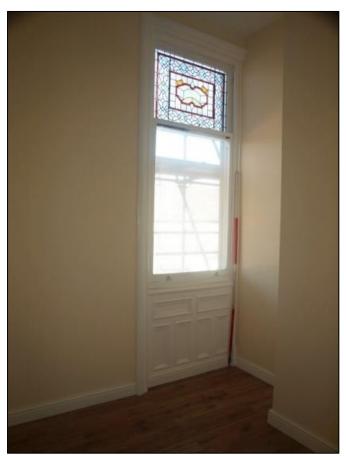
Plate 45: First floor stained glass window cut by inserted wall

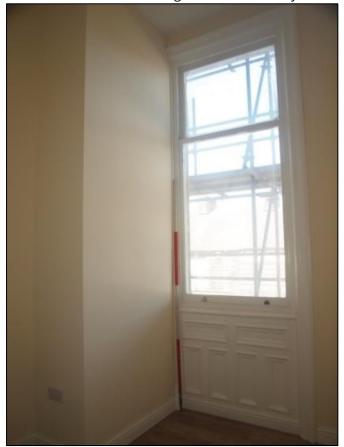
Plate 46: Other side of above

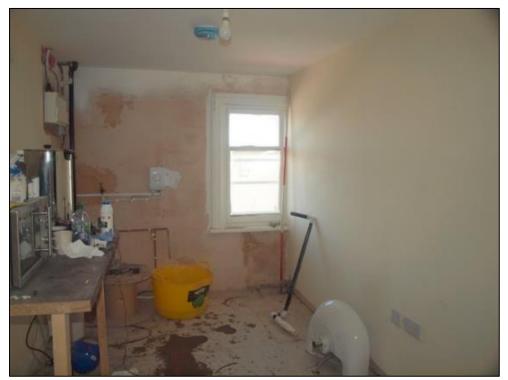
Plate 55: Second floor room showing window cut by inserted wall

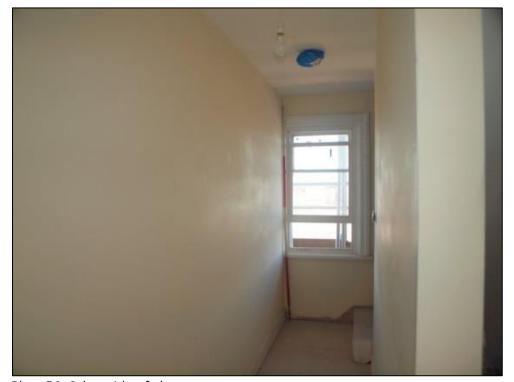
Plate 56: Other side of above

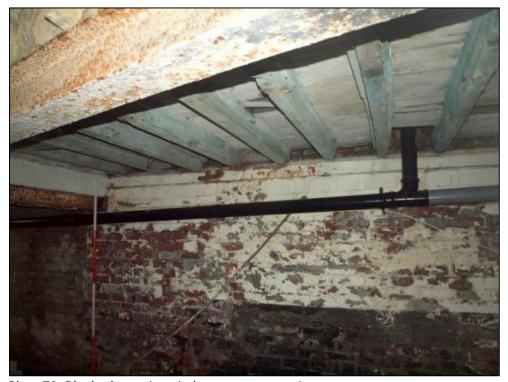
Plate 78: Blocked openings in basement room 1

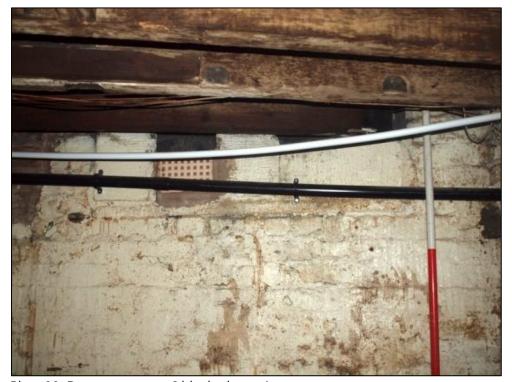
Plate 90: Basement room 6 blocked opening
