THE ARCHAEOLOGY CO.

Lawns Farm, Orrell
Historic Building Survey

July 2018

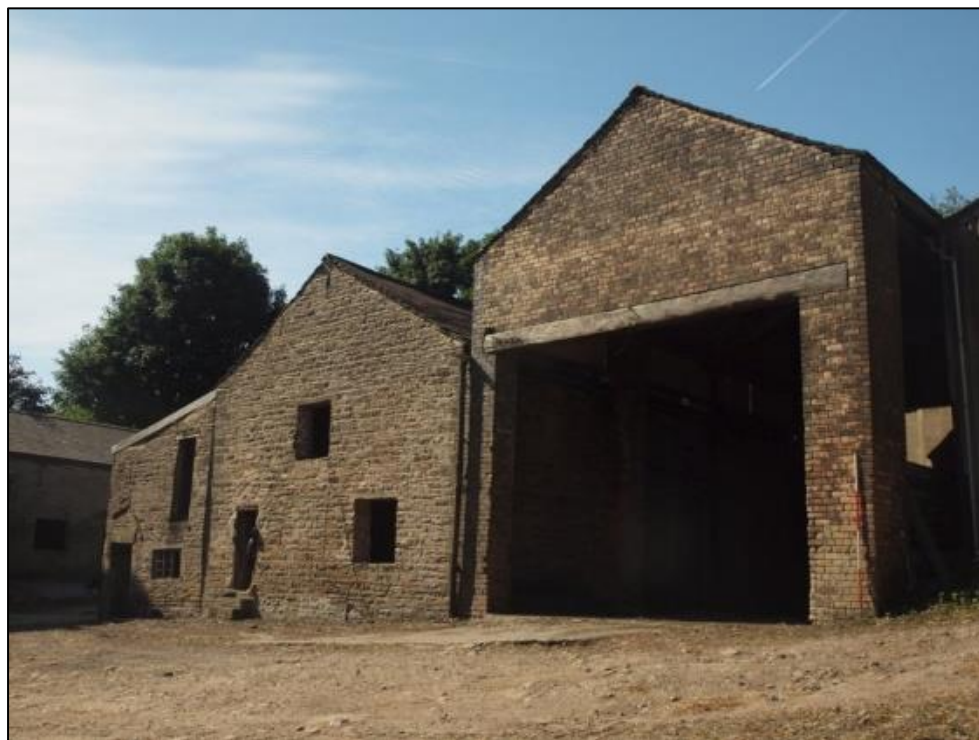
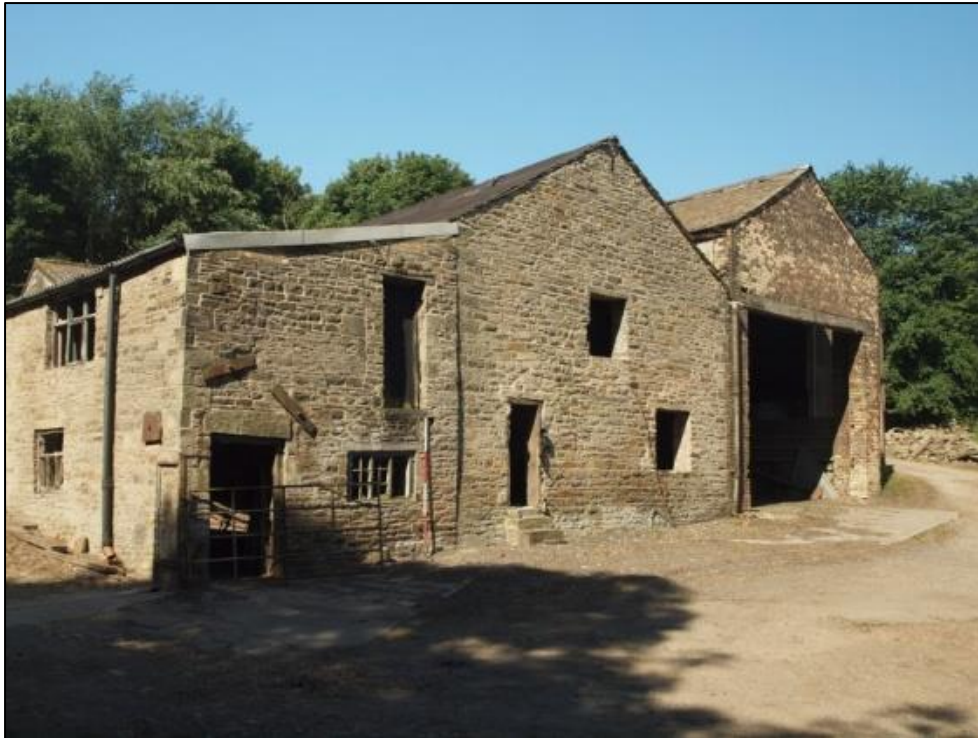
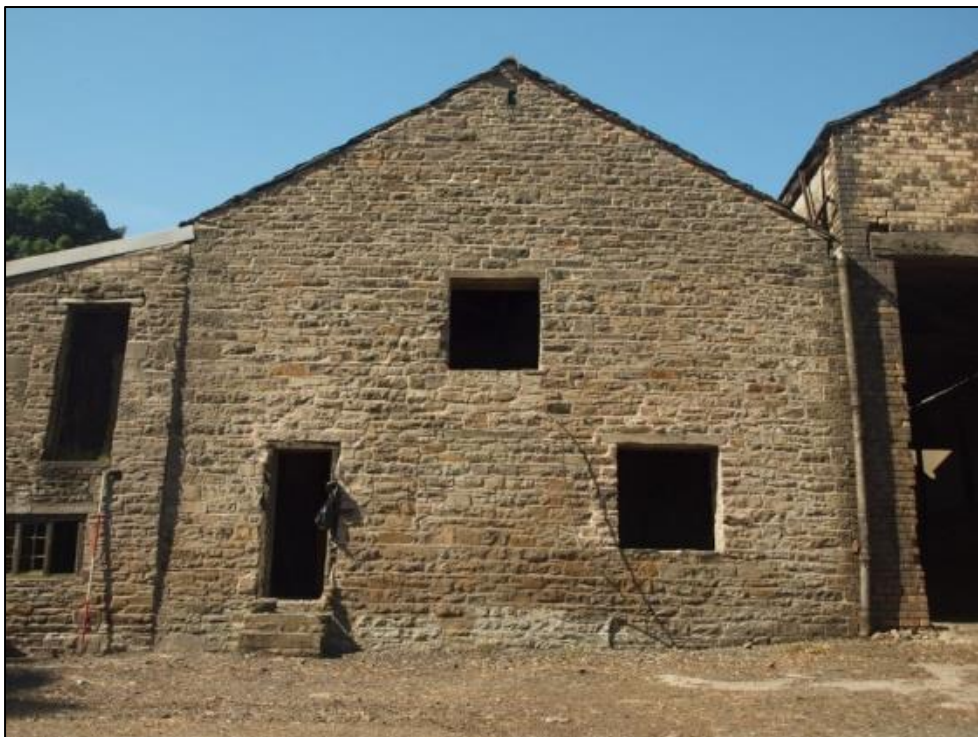
6.2 Northeast elevation (Plates 2 - 6). This forms the gable end of the barn and is comprised of three sections; to the left is the face of the lean-to, the barn lies in the centre and the open front of the Dutch barn to the right. The lean-to (plate 4) is constructed of rough sandstone rubble, occasionally brought to course and quoins run up the eastern corner. At the southeastern end is a personnel doorway, the large sandstone lintel of which has started to drop at one end. The frame is timber although no door is hung. To the right of this is a long landscape window with sandstone lintel over (plate 5). The timber frame is damaged although shows three lights of 6 panes. Above this a personnel doorway has been inserted with a timber lintel and concrete cill. At the eaves, brick rebuilding is evident. To the right is the face of the barn (plate 6). This is likewise constructed in rough sandstone rubble, occasionally brought to course and quoins can be seen to each corner. A doorway has been inserted to the southeast, with a set of stone steps up to it and a window inserted to the northwest. The doorway has a timber frame but the window is empty. Above, in the centre of the gable a doorway, possibly inserted, has been converted to a window, again with no frame. To the right side is the Dutch barn. The large opening dominates the face, with a large timber lintel spanning the gap

between the brick piers. Above the lintel the face is brick in English Garden Wall bond (4:1)

Plate 2: Barn 1 northeast elevation

Plate 3: Northeast elevation

Plate 6: Barn northeast elevation

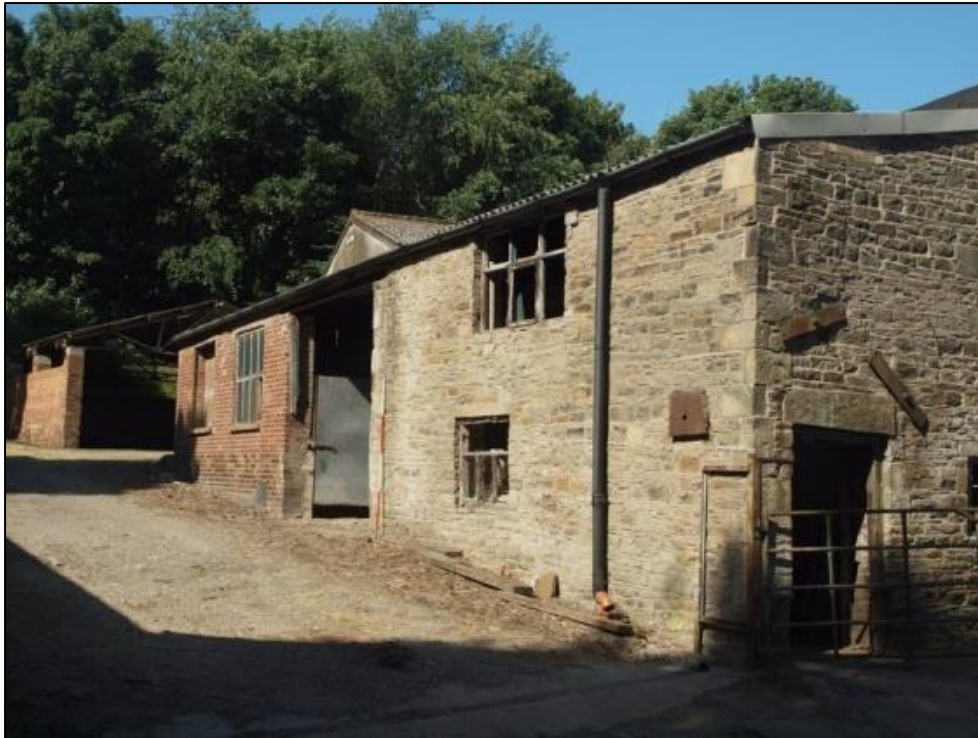
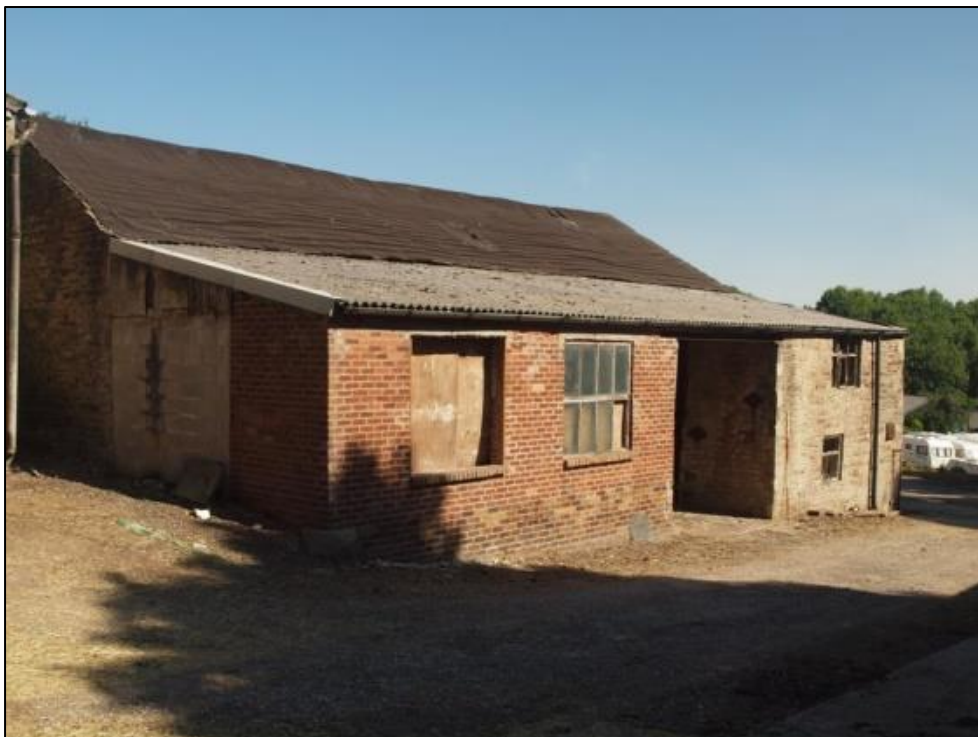
- 6.3 Southeast elevation (Plates 7 & 8). This forms the main elevation of the lean-to and is comprised of three parts; to the northeast is the sandstone built section and to the southwest is a brick built section. Between them is an open passage into the barn. At the northeastern end the face continues to be the rough sandstone rubble, occasionally brought to course as previous. A square window with sandstone lintel lies to the left of this area, with a timber frame of three lights and casement above. Above this, at first floor level is a landscape window with a timber frame of 6 lights. To the southwest quoins lies at the corner to the passageway. To the southwest the face is brick built in English bond. A pair of large square windows dominates the face, each with a concrete lintel and bull-nosed brick cills. Only the right window contains a frame, which is of timber with 8 lights.

Plate 7: Southeast elevation from east

Plate 8: Southeast elevation from south

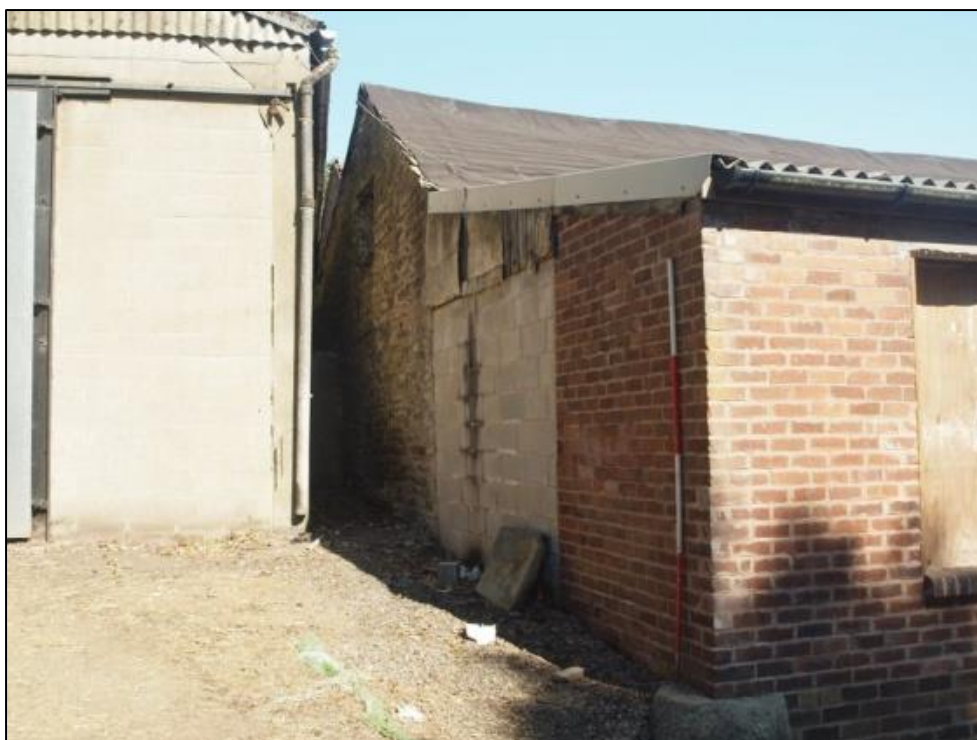
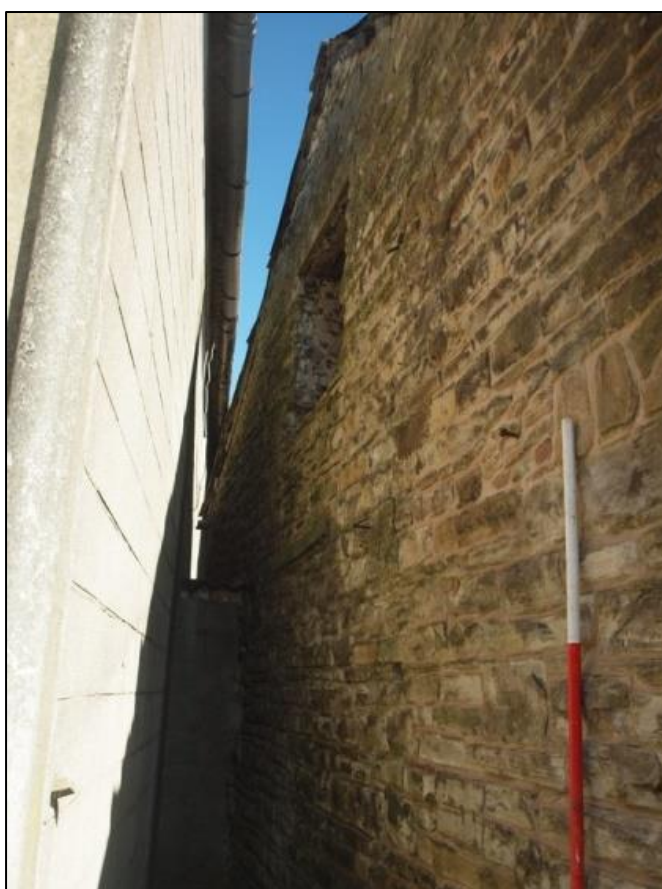
- 6.4 Southwest elevation (Plates 9 & 10). This face can again be separated into three parts; the lean-to to the southeast, the barn in the centre and the Dutch barn to the northwest. The lean-to is constructed of brick, with the southeast elevation, although the northwestern end is constructed of concrete block. The barn gable is again constructed of rough sandstone rubble, occasionally brought to course. This is featureless at ground floor level as far as it is accessible, and a doorway at first floor level has been converted to a window, matching the northeast elevation. The elevation of the Dutch barn was not accessible to be photographed, although it was similar to the northeast elevation. The exception was a central brick pier supporting the lintel.

Plate 9: Southwest elevation

Plate 10: Detail of window in southwest elevation of barn

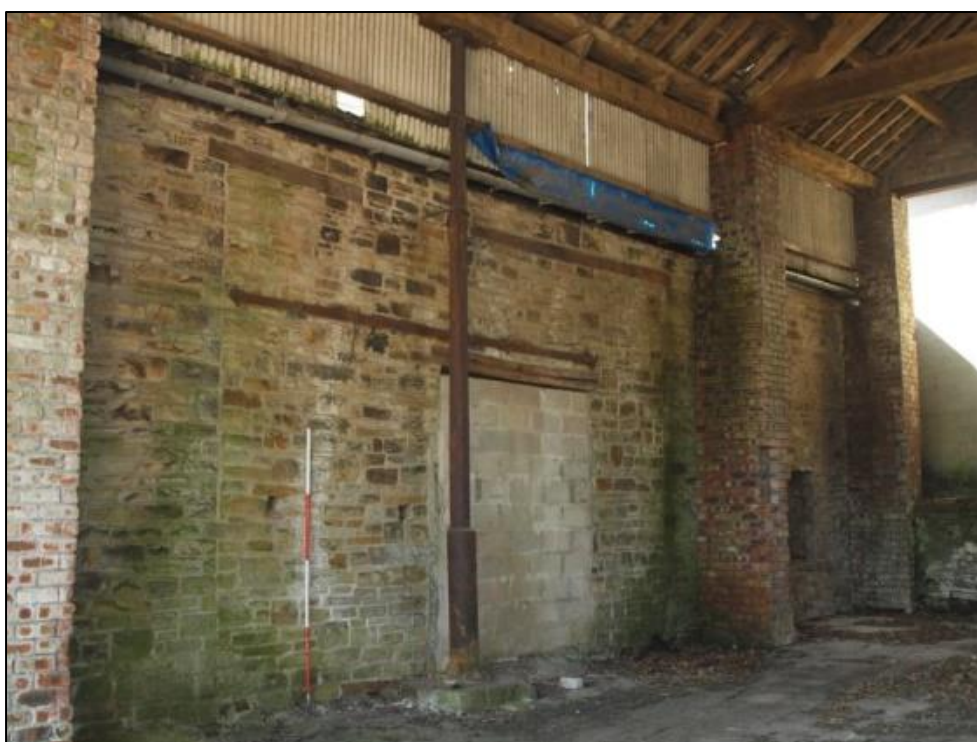
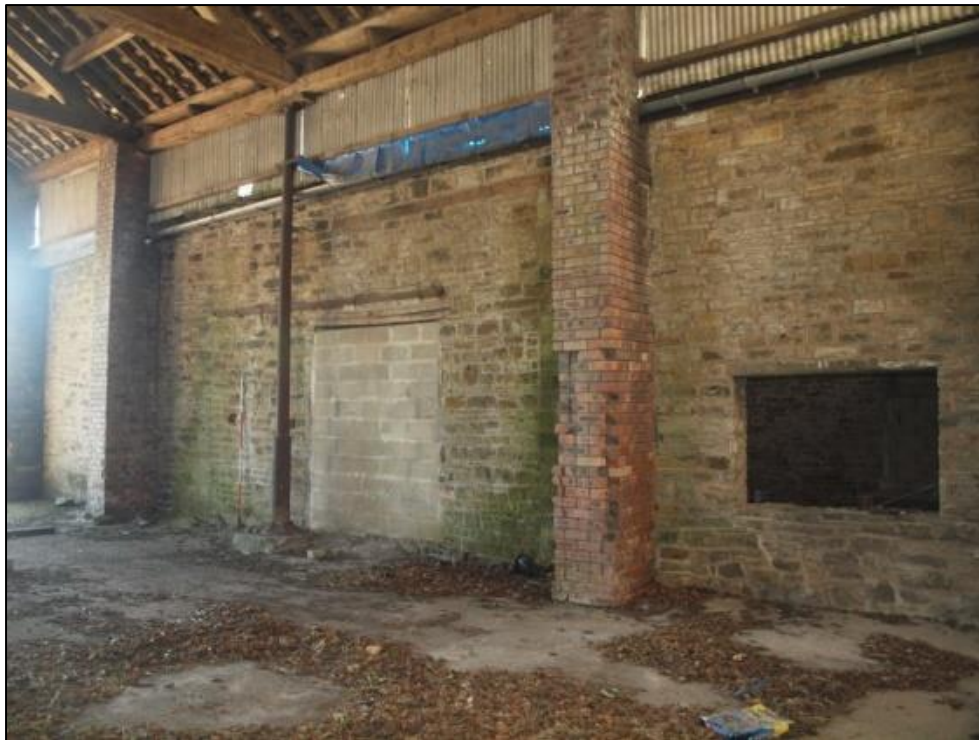
- 6.10 (Plates 12 - 15). The Dutch barn is constructed from a series of brick piers on all side supporting three machine cut timber king post trusses. The exception to this is the northwest side, which has cast iron stanchions set on brick bases supporting the trusses. Between the brick piers on the south west and northwest walls low stone walls have been inserted. The southeast wall is the former external elevation of the barn. This has an inserted landscape window at the southerwestern end without a frame. To the northeast is a large doorway blocked with concrete blocks. A rail above shows where a sliding door once hung. This doorway is set within a much larger blocked opening, the blocking here being of a rough sandstone rubble and marking the location of a former barn door. A timber lintel remains across part of the top.

Plate 12: Interior of Dutch barn showing blocked loading door within blocked barn door of barn

Plate 13: As above

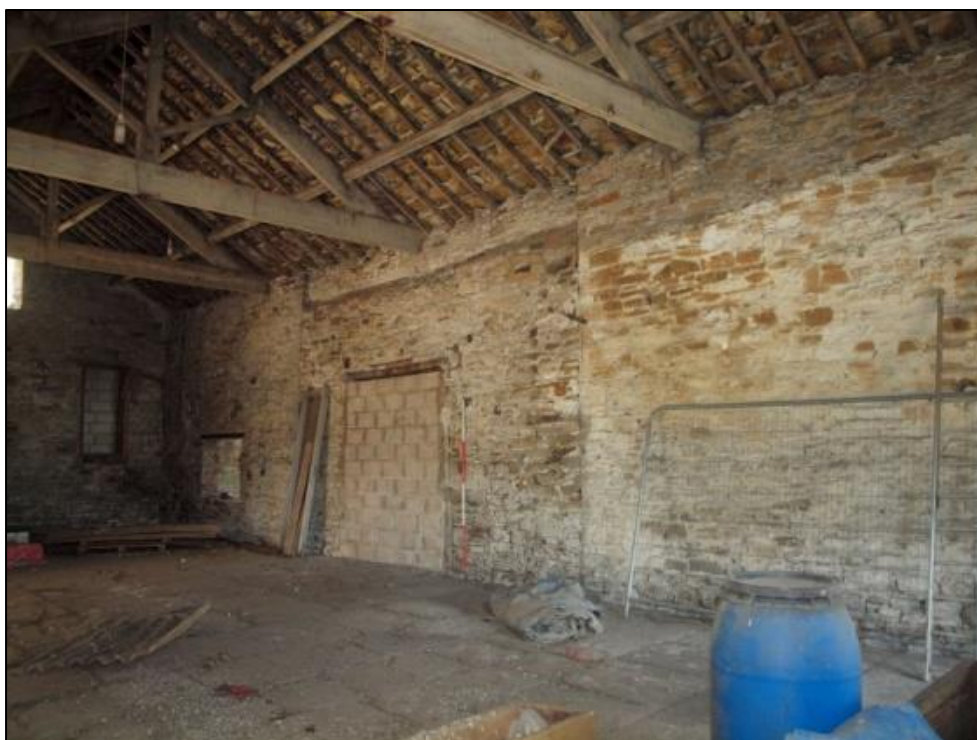
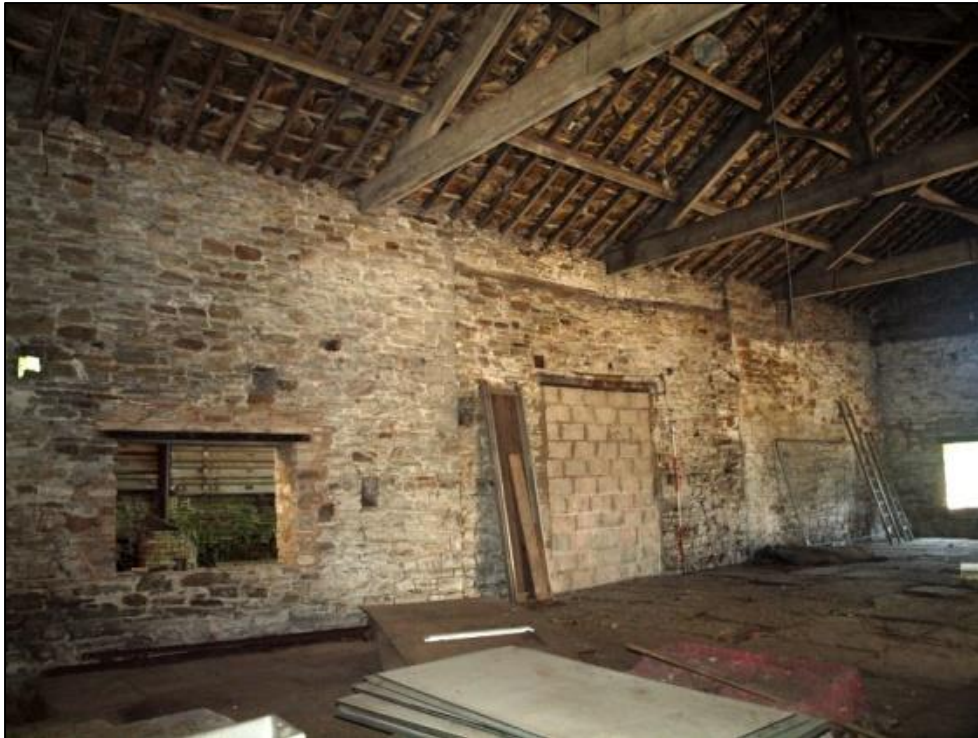
- 6.11 (Plates 16 - 21). The interior of the barn forms a single space open to the rafters with a stone flag floor. The roof is again supported on three machine cut timber king post trusses. To the northwest is the face described above, the blocked doorway set within the blocked barn door still evident, along with the inserted window to the west. Above the window are a series of joist holes, showing a partial first floor level. The southwestern gable also contains a pair of holes at a similar level, suggesting additional support for the floor. At first floor level the window is visible and to the northwest a doorway has been inserted, blocked with concrete block but with a timber frame. The doorway lies above the floor level of the barn, set at the level of the ground outside. The northeastern gable is much the same as it is externally. The southeastern gable has a window at first floor level, later converted into a doorway. This is set high in the face and no steps up to it remain, although it gave access to the first floor level of the eastern lean-to room. To the east of this a transmission window is set within the wall. To the west of the doorway a small circular iron fitting is located in the wall, set in a timber surround. Further west is the barn door. This lintel has been replaced with an RSJ with brick above, suggesting that it has been lowered. This gives access to the passage. To the western side of the barn door a large loading doorway has been inserted, with an RSJ lintel. This has been blocked with concrete blocks.

Plate 16: Barn interior showing other side of blocked loading door and barn door

Plate 17: As above also showing inserted window

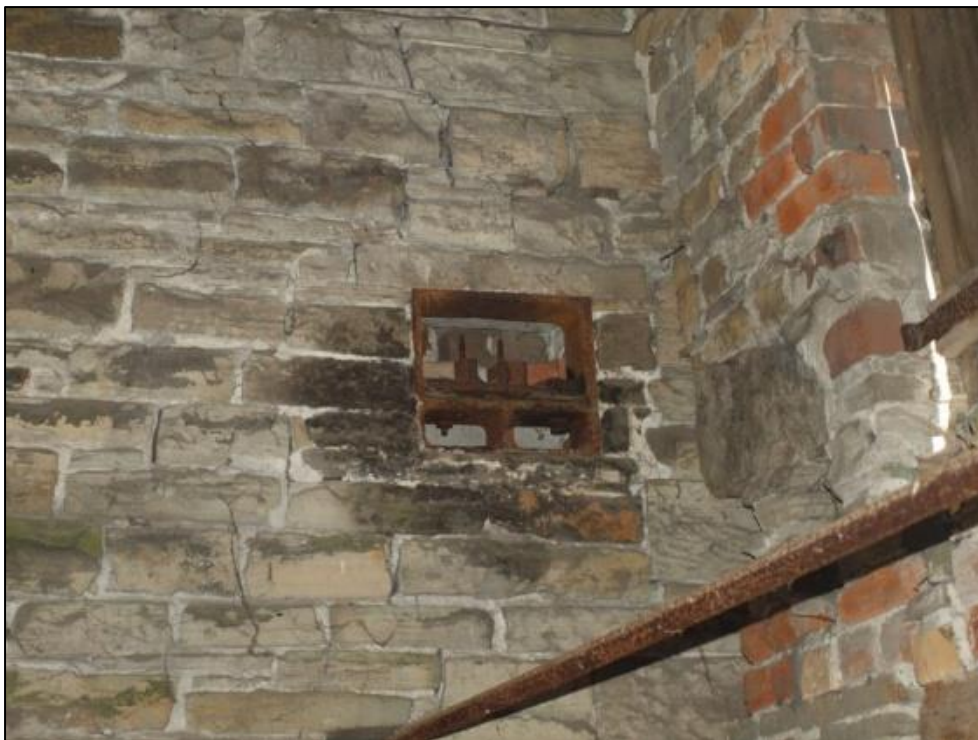
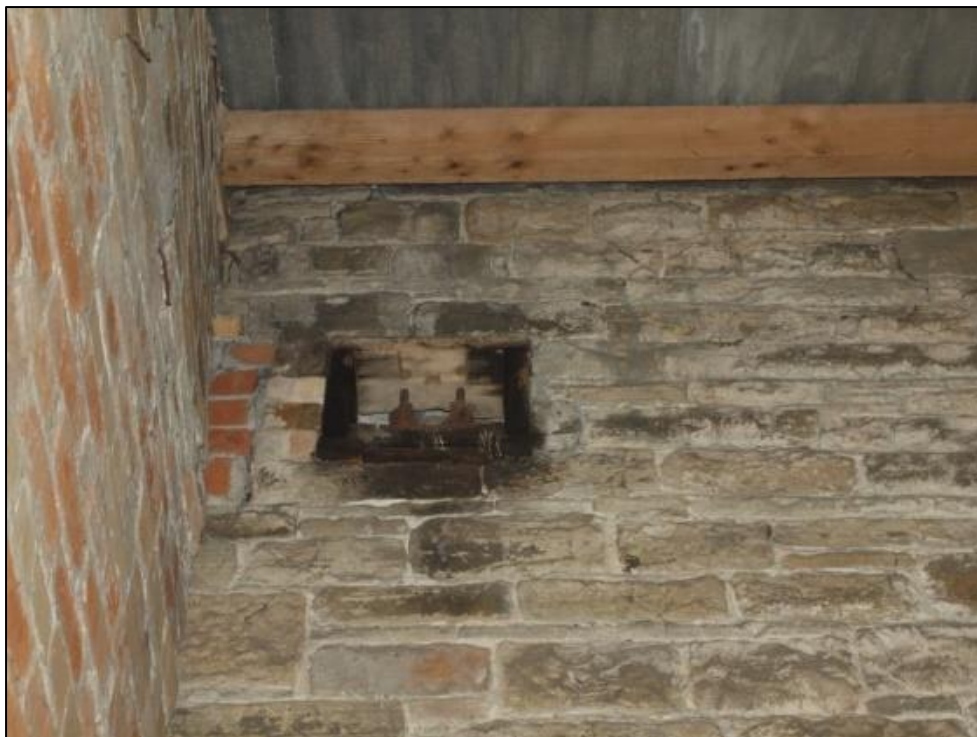
on a pair of RSJ beams. The northeast wall is much as it is externally, although brick repair work on the jambs of the window and doors is evident. A series of joist holes also runs across the face showing the location of the former first floor. The northwestern wall contains the doorway at first floor level, visible within the barn, along with the inserted transmission window to the east. A further transmission window is located to the west of the door, blocked on the other side. The southwestern wall is constructed of brick at ground floor level with brick above. A tall doorway has been inserted in the centre with a set of stone steps leading up to meet the ground level of the passage. The southeast wall is again much the same as it is externally.

Plate 24: Transmission window in eastern lean-to room

Plate 25 : Transmission window in eastern lean-to room

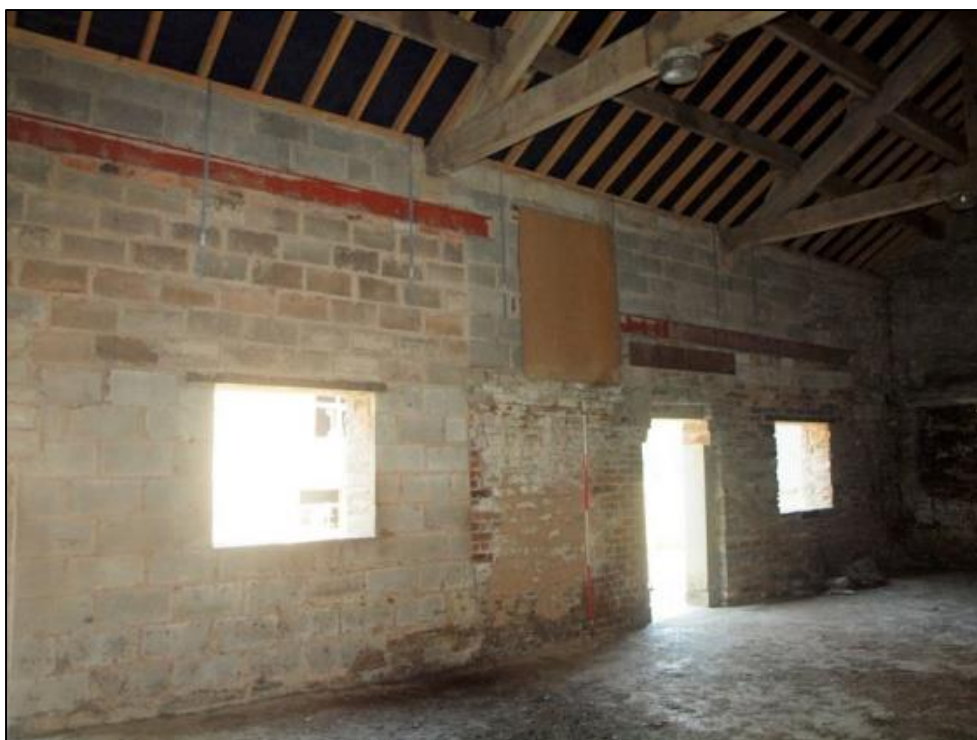
6.19 The interior is comprised of 5 rooms, along with the Dutch barn. The latter is constructed of RSJ beams and concrete blocks with a corrugated sheet roof (plate 40). Room 1 (plates 41 - 43) lies to the northeast end of the barn and comprises bays 1 - 3. The room is open to the two machine cut timber king post trusses supporting the rebuilt roof and the floor is concrete. The northeast gable is much

Plate 43: Room 1 interior showing rebuilt northwest wall

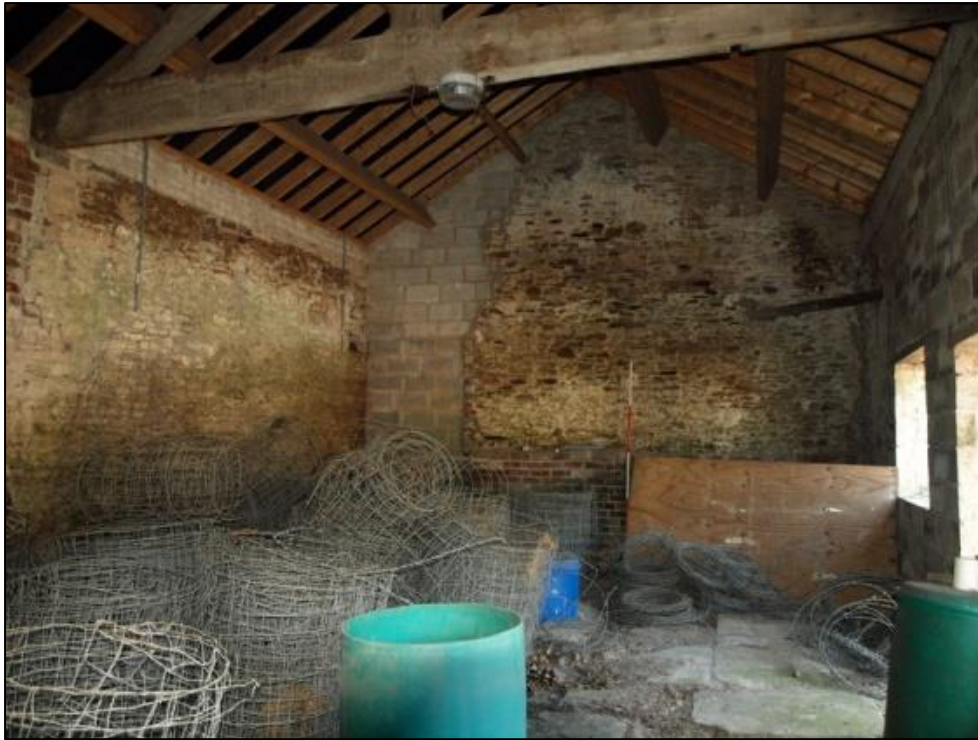
6.20 Room 2 (plates 44 - 46) takes in bays 4 and 5 and has a single king post truss supporting the rebuilt room and a stone flag floor. The doorway at first floor level from room 1 is visible set within the stone wall and the surrounding brickwork shows it to have been inserted. The southeast wall is again stone, although the top part has been rebuilt in brick for the new roof. The southwest party wall to room 3 is again stone, although a straight joint to the southern side marks an area of blocking for an opening, which then extends up to the roof. The northwest wall is again mostly rebuilt, showing a concrete block construction, although the original stone is present at the eastern end, at first floor level.

Plate 45: Room 2 showing blocked openings

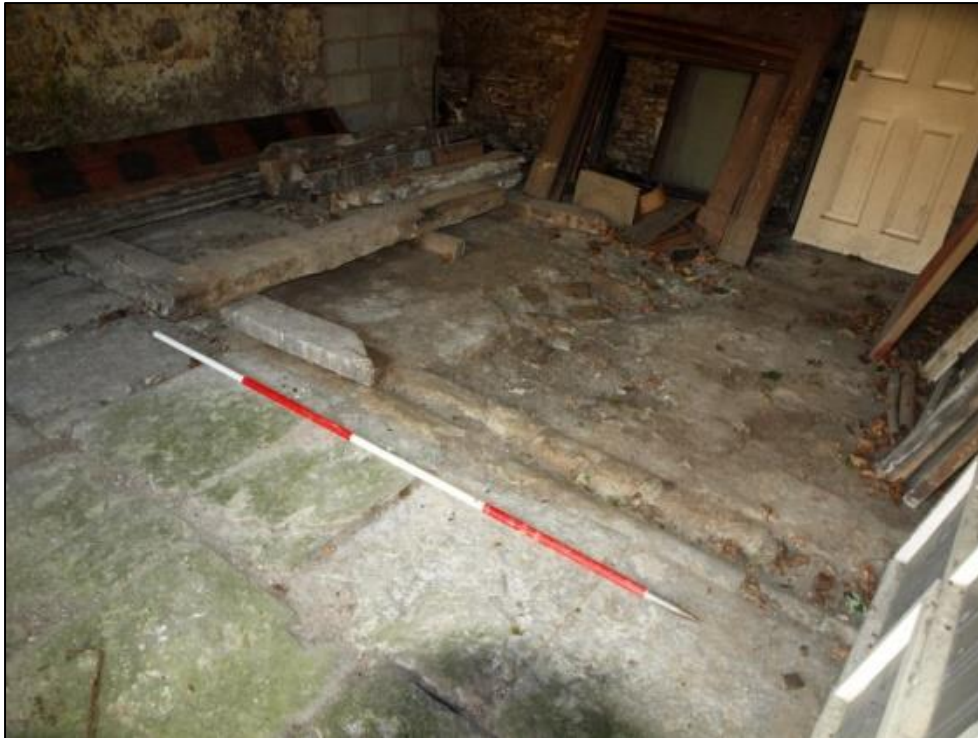
6.21 Room 3 (plates 47 - 49) takes in bay 6. The eastern party wall is stone, whereas the western is stone at the base and rebuilt above in concrete block. A blocked opening again lies at the southern end. The southeast wall is again stone and the northwest wall concrete block, with a small area of stone to the east side. The floor is stone flags and a pair of stone drains run along it aligned northeast - southwest.

Plate 49: Detail of drains in floor of room 3

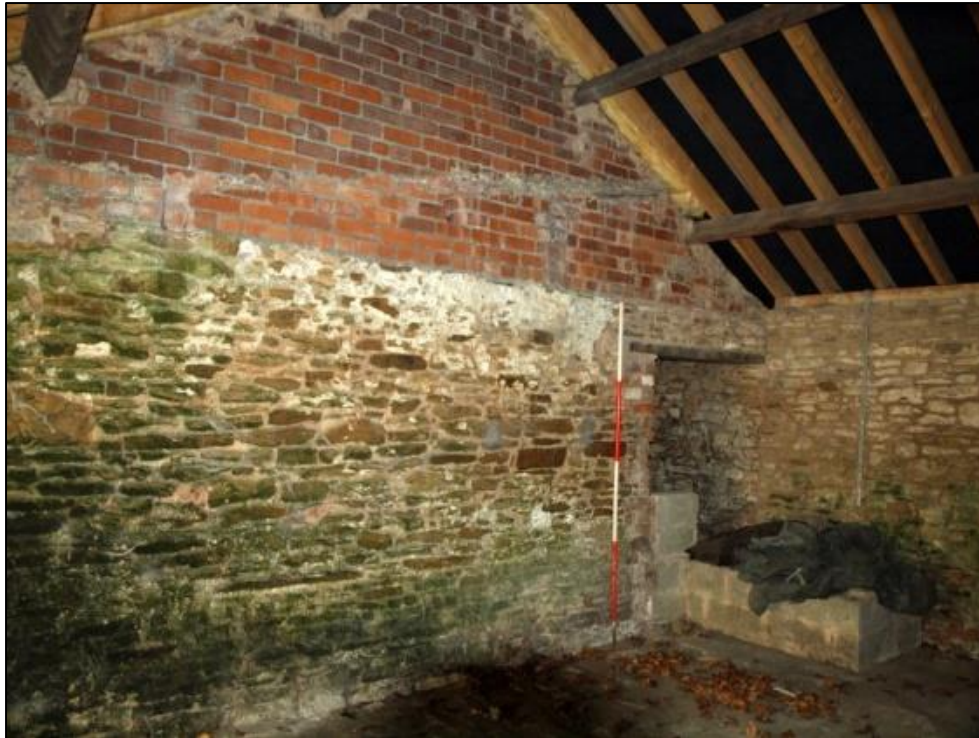
- 6.23 Room 5 (plates 53 – 55) lies at the southwest end of the barn and comprises bay 11. The party wall to room 4 is stone built with brick rebuilding above. The ghost of a former single pitched roof, likely a lean-to, lies in this brickwork. A doorway is set within the stonework to room 4 and a rough joint in the wall marks the end of the original barn and shows this room to be a later extension. This is also visible again at the western end, where the northwest wall butts up against the party wall. The southwest wall is mostly concrete block, although a small section of stone remains at the south corner. The whole of the northwest wall is concrete block. The floor of the area is brick.

Plate 53: Room 5 showing rebuilt party wall

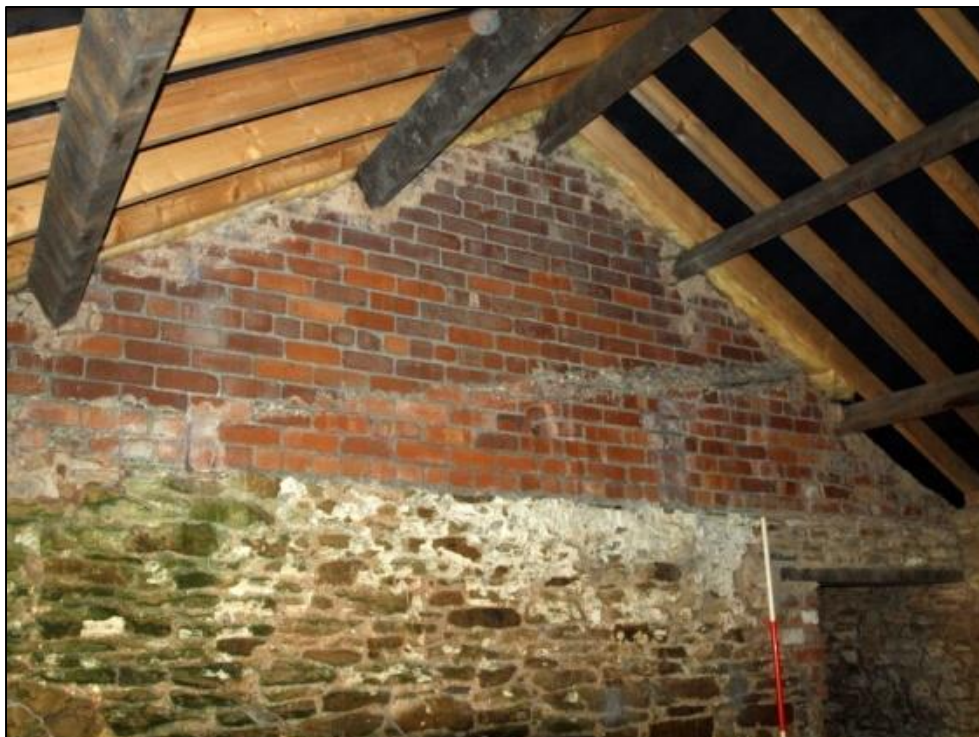
Plate 54: Detail of ghost of roof line

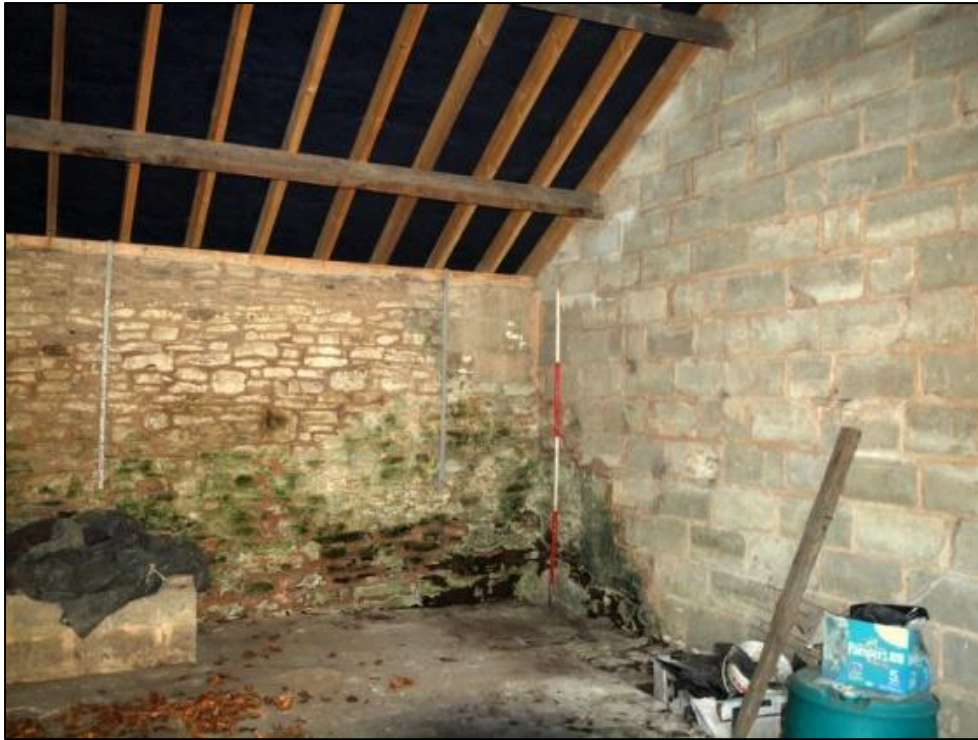
6.17 Southwest elevation (Plate 36). This is the rebuilt gable end of the barn and is featureless.

Plate 55:Room 5 showing rebuilt gable wall
