Myerscough Inn, Balderstone Historic Building Survey

July 2018

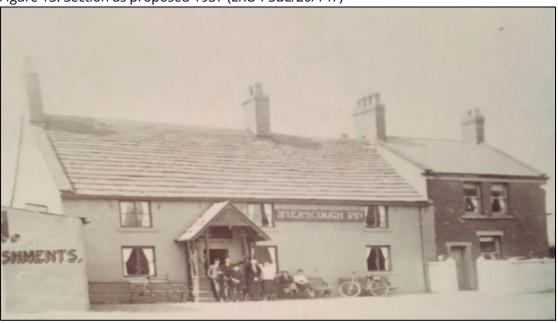
Figure 14: Undated photograph prior to 1930, note the bay windows have not yet been inserted

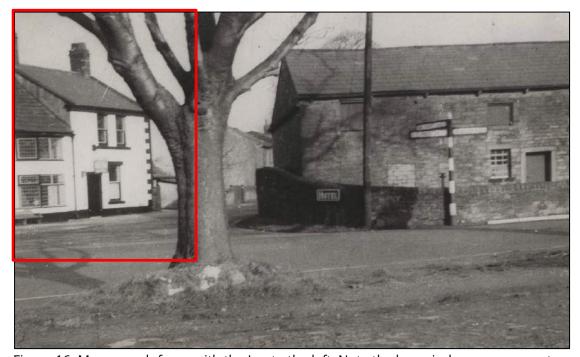
Figure 16: Myerscough farm, with the Inn to the left. Note the bay windows are present

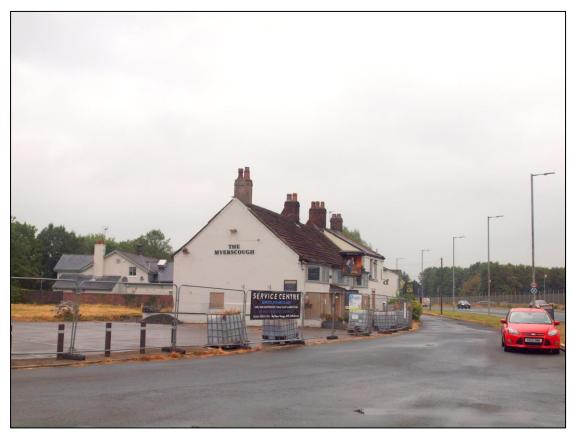
6.1 (Plate 1) The building is a rectangular 4 bay building aligned northeast – southwest with the main frontage facing southeast. It is two stories high over a cellar in the central two bays. The first bay is to the southwest with the fourth to the northeast. This latter bay is slightly taller than the rest of the building, with a separate roof. Both roofs are double pitched, with that of bay 4 covered with Welsh slate and the rest of the building cover with stone slabs. A brick built chimney lies at the southwestern end of bay 1, with a further brick built chimney at the northeast end of each of the bays 2 to 4. All have 2 pots with the exception of that to bay three, which has three pots.

Plate 1: General shot of Myerscough Inn

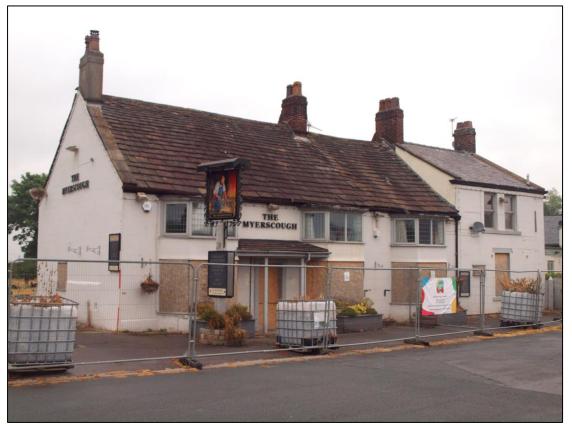
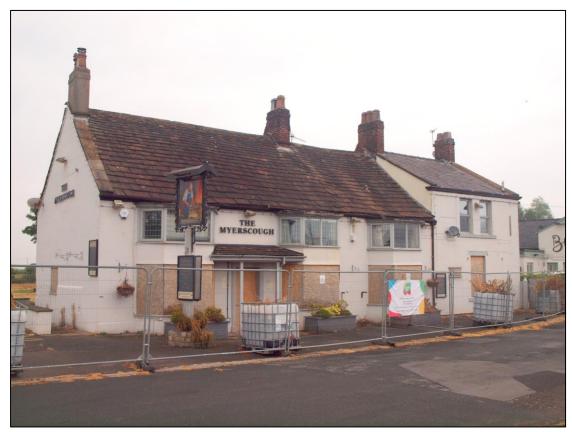
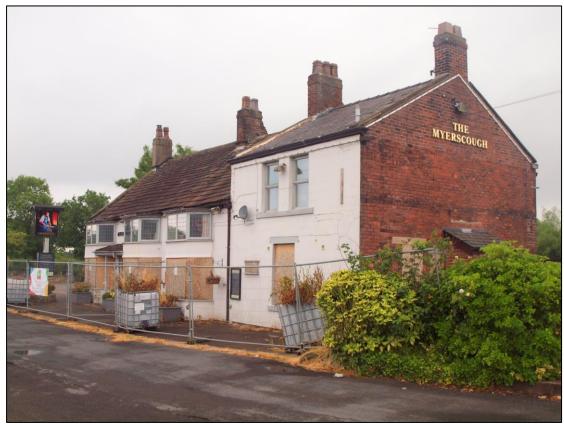
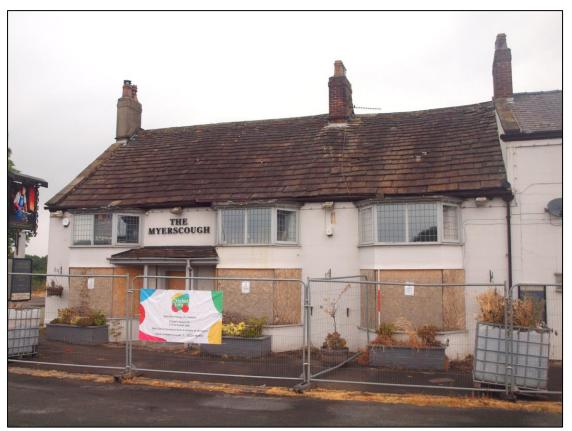
- 6.2 Southeast elevation (Plates 2 5). This comprises the main frontage of the building. The face has been rendered and in each of the bays 1 to 3 a bay window has been inserted at both ground and first floor level. Those to the first floor are shorter than the ground floor windows, with the eaves being level with the lintel. Between bays 1 and 2 is the main entrance to the building. The door is boarded over and a porch has been added over, between the bay windows. Above this is the sign "THE MYERSCOUGH". To the northeast is bay 4. This has been rendered to match although a straight joint is visible marking the end of bay 3. The face contains a central tall portrait window at ground floor level and a pair of timber framed sashes at first floor level.

Plate 2: Southeast elevation

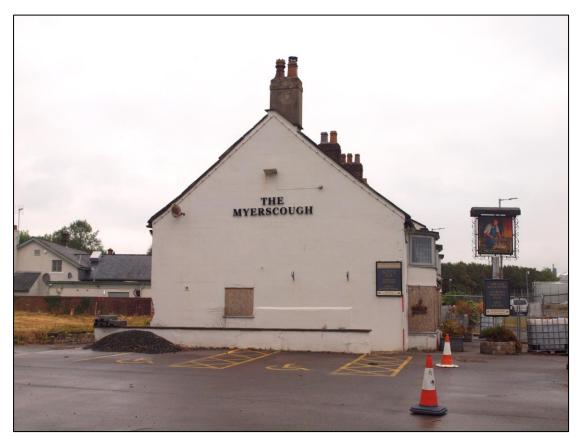
- 6.3 Southwest elevation (Plate 6). This forms the gable end of the building which has again been rendered. The face is featureless, with the exception of an area of protruding wall in the centre of the face at ground floor level. At the northwestern end of this is a window, boarded over, which shows evidence of having been a blocked door. AT first floor level is a large sign reading "THE MYERSCOUGH".

Plate 6: Southwest elevation

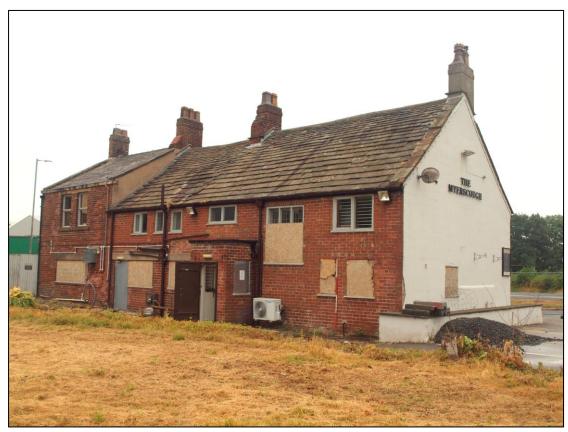
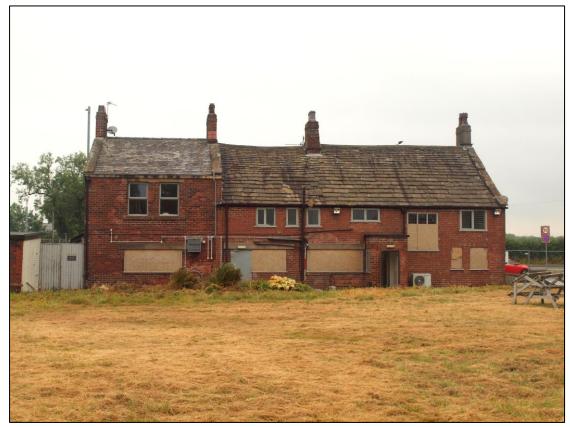
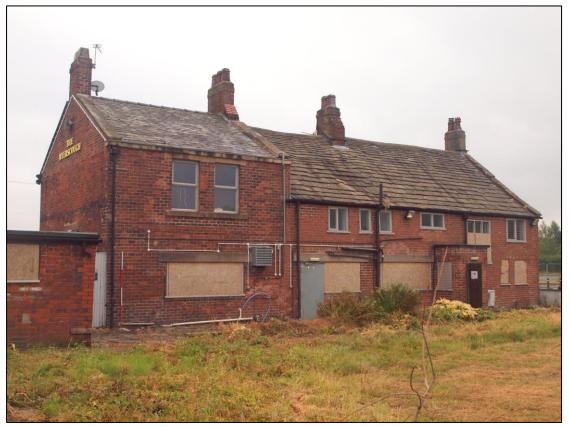
- 6.4 Northwest elevation (Plates 7 10). This constitutes the rear of the building. The render is not present here, revealing the brickwork. The majority of this face of

bays 1 to 3 has been rebuilt, in English Garden Wall bond (5:1). However, at first floor level a few patches of original brickwork remain, showing a stretcher bond. In bay 1 at ground floor level a pair of portrait windows have been inserted. These are boarded over. At first floor level is a timber framed casement window. Between bays 1 and 2 the large stair window has been inserted at first floor level. Bay 2 has a porch added to the ground floor, housing the rear entrance. Above this is a two light timber framed casement, a later insertion, with blocking visible beneath the cill, showing the former window. Immediately adjacent to the porch is an inserted long landscape window filling the remainder of bay 2 and into bay 3. Bay 3 contains a second matching inserted window at ground floor level, with a doorway inserted at the northeastern end. Above these are three small portrait windows at first floor level. The southwestern two have been inserted, whereas the northeastern is in its original location. To the northeast of this is a blocked window. Bay 4 is marked by a straight joint in the brickwork, which is also constructed in stretcher bond. At ground floor level a further inserted long landscape window has been inserted and at first floor level are a pair of timber framed casements.

Plate 7: Northwest elevation

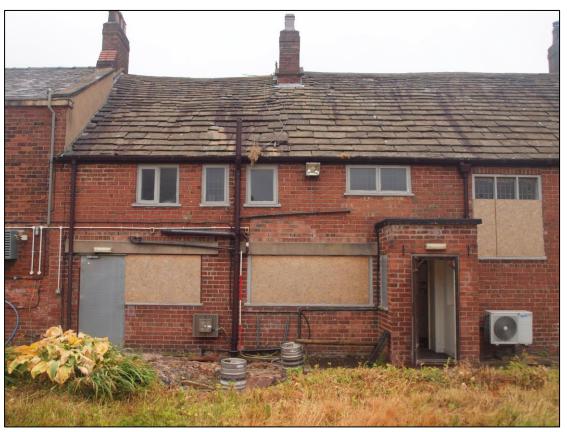
Plate 9: Northwest elevation detail

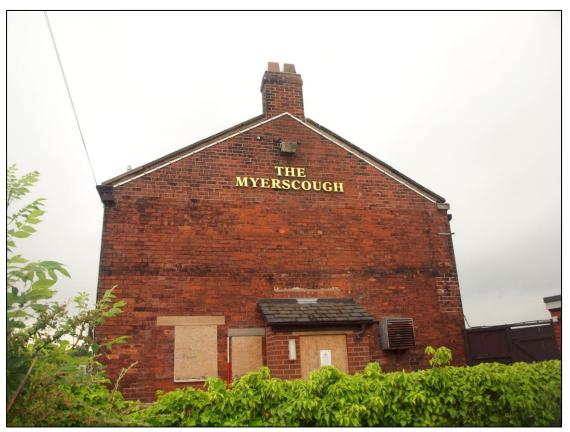
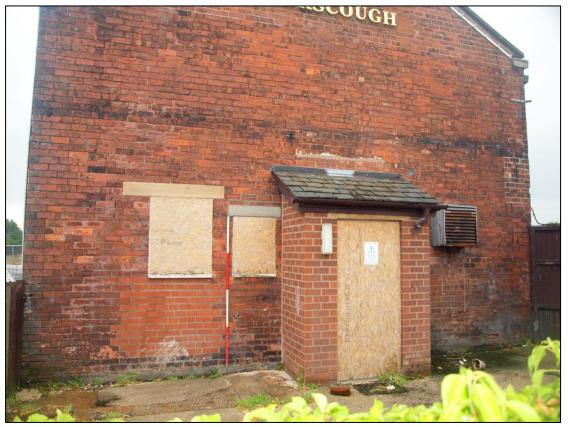
6.5 Northeast elevation (Plates 11 & 12). This forms the other gable end of the building. At the southeastern end is a window, boarded over, with a second inserted to the northwest of it. In the centre of the face is a brick built porch, above which is the line of an earlier removed porch. The first floor is featureless with the exception of a large sign reading "THE MYERSCOUGH".

Plate 11: Northeast elevation

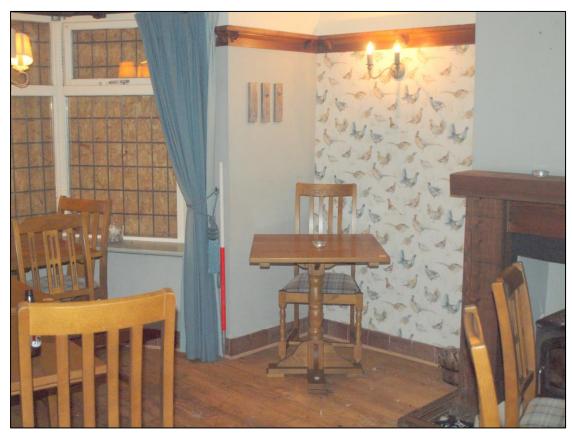
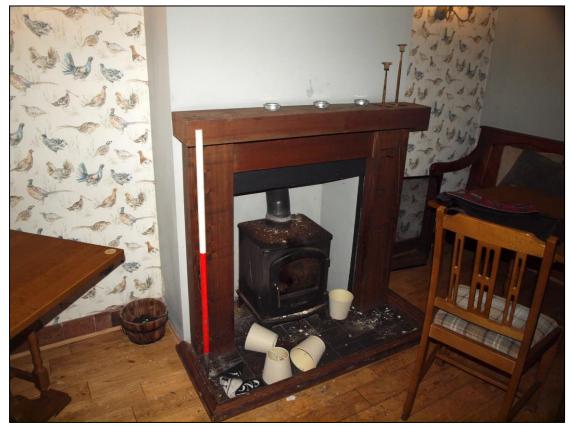
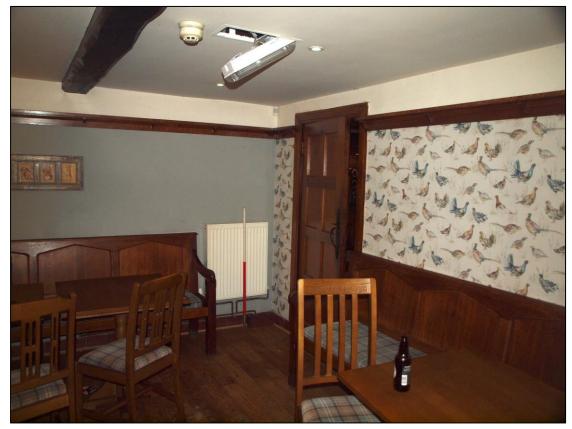
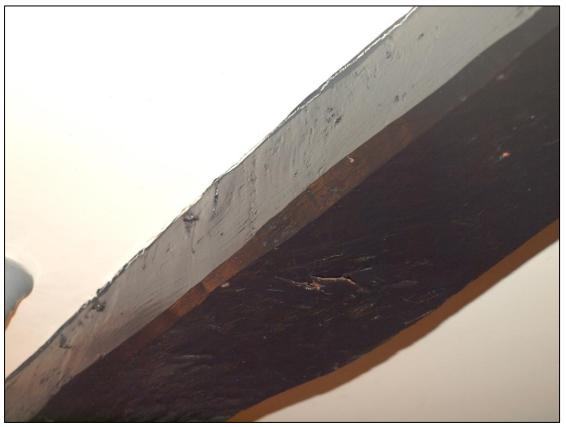
- 6.7 At the southeastern end of bay 1 is a small room (plates 19 22) accessed via doorway in the wall separating it from bay 2. This contains a fireplace in the southwest wall, with a woodburning stove inserted. The bays window in the southeast wall is spanned by a modern timber beam and an adze cut timber beam spans the room from southeast to northwest. The northwestern room of bay 1 is also accessed via bay 2. This is has been fitted out as a WC (plate 23) at the northern end with an access corridor to the southeast. In the northern corner of the bay a set of stone sets have been inserted leading down to the cellar. These steps are accessed via the corridor. To the northeast are the steps to first floor level and the rear porch (Plates 24 & 25). Bay 4 is accessed through doorways in the party wall with bay 3. To the northwest the room has been fitted out with a modern kitchen (plates 26 & 27) and to the southeast the room is a modern bathroom (plates 28 & 29).

Plate 19: Bay 1 southeast room

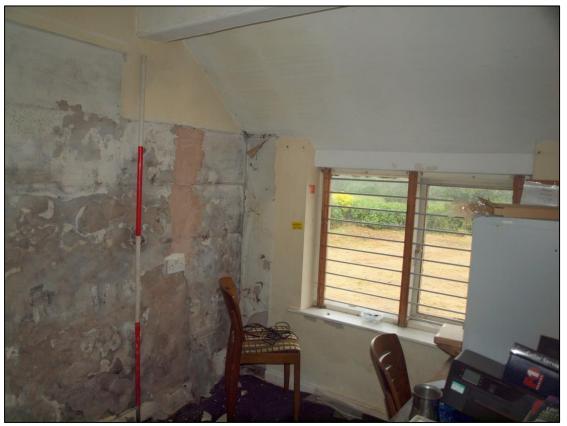
- 6.9 Bedrooms 1 and 2 lie within bay 1 of the building. Bedroom 1 (plate 32) is small, with a window in the northwest wall. A wall has been inserted in the southeast, forming the bathroom of bedroom 2. The steep slope of the roof is visible here, with the ceiling at the northwestern end of the room following the slope of the

Plate 32: Bedroom 1

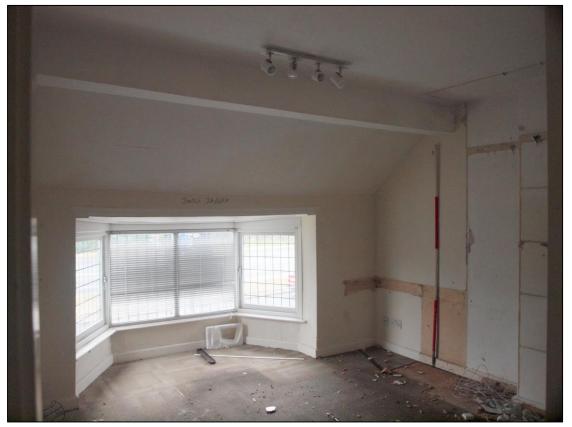
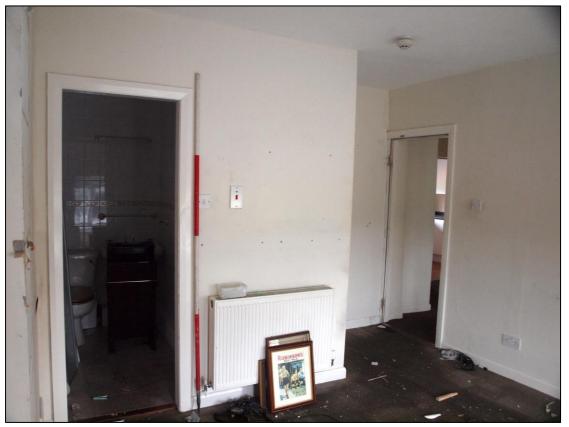
roof. This stops at a machine cut timber purlin where the rest of the ceiling is flat. This is the same though bays 1 to 3 on both sides of the building. Bedroom 2 (plates 33 & 34) has the bay window in the southeast wall and a partition has been inserted in the northwest end in order to form a bathroom. A possible blocked doorway lies in the centre of the northeast wall and a blocked fireplace in the southwest wall, cut by the bathroom insertion.

Plate 33: Bedroom 2
