5 - 9 Queens Road, Chorley  
Photographic Building Survey

December 2018

## **NON-TECHNICAL SUMMARY**

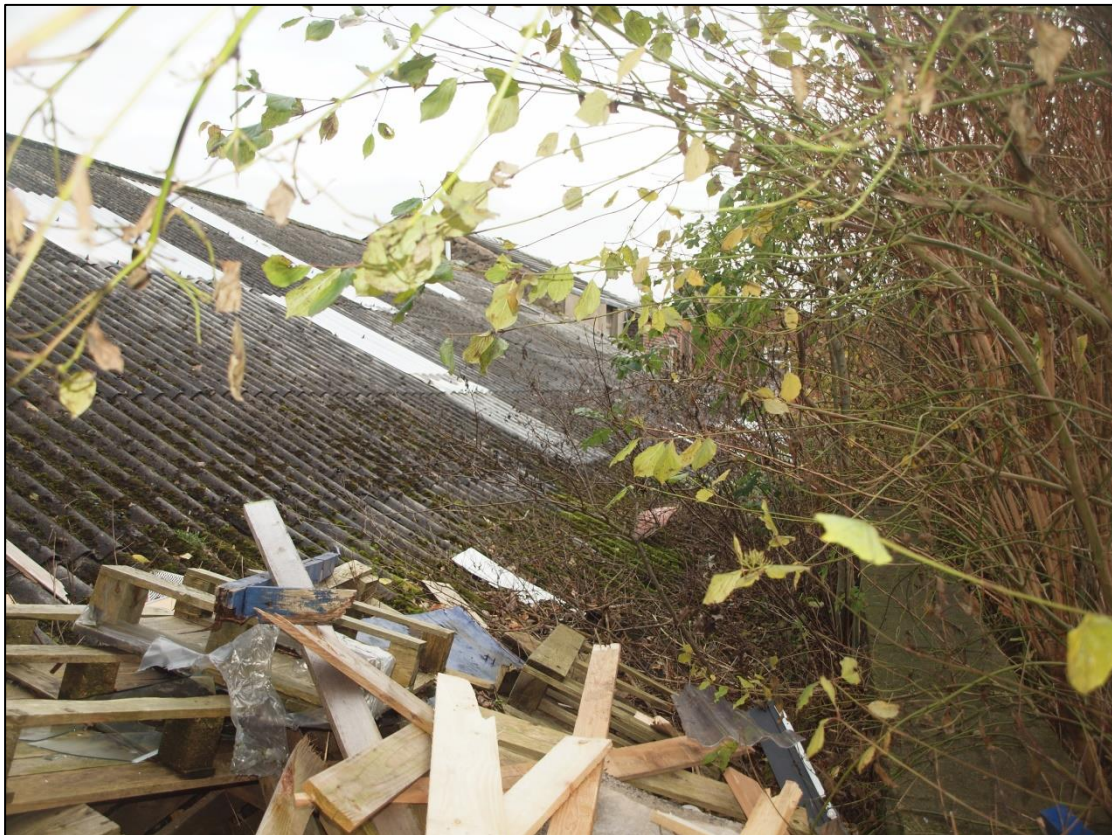
Plate 14: Corrugated asbestos roofing at rear of building

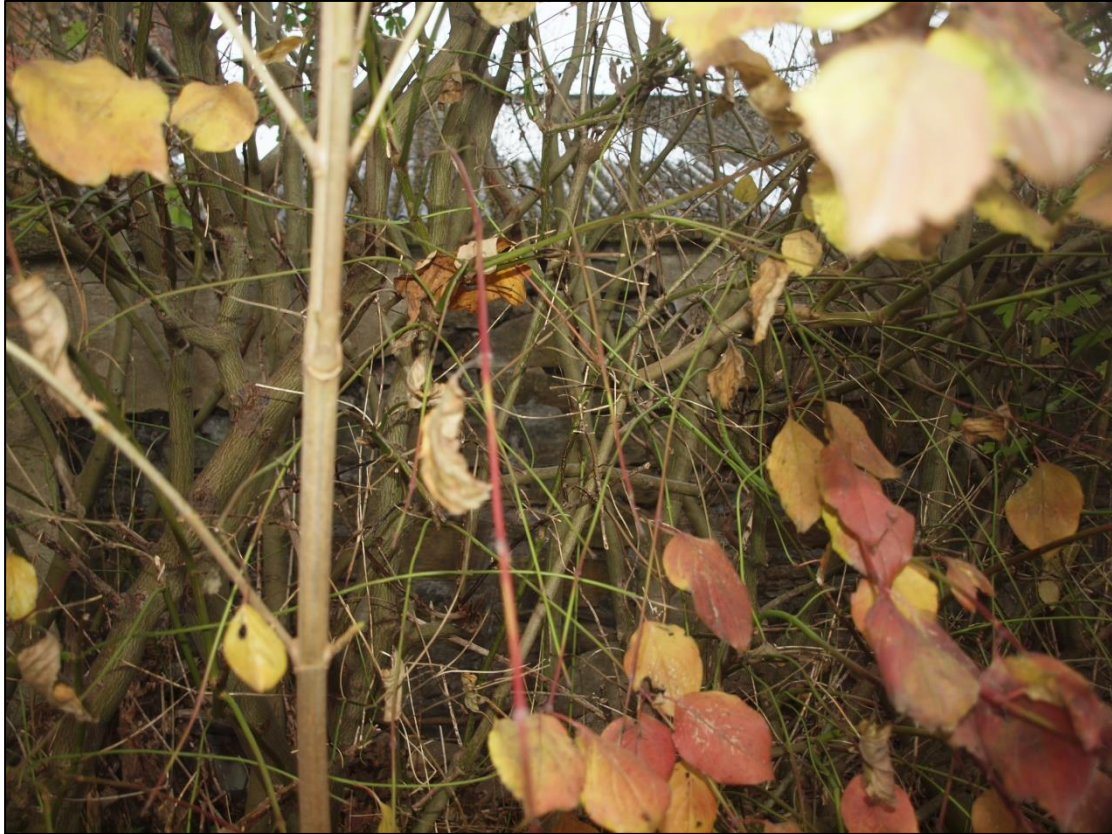
6.3 South elevation (Plates 14 - 16 ). The south elevation is formed via the former yard wall with the roof running down to it. This is a rough sandstone construction,

rendered, although this has deteriorated. This is masked by a row of hedges onto the car park.

Plate 15: Stone wall hidden by hedge at south elevation

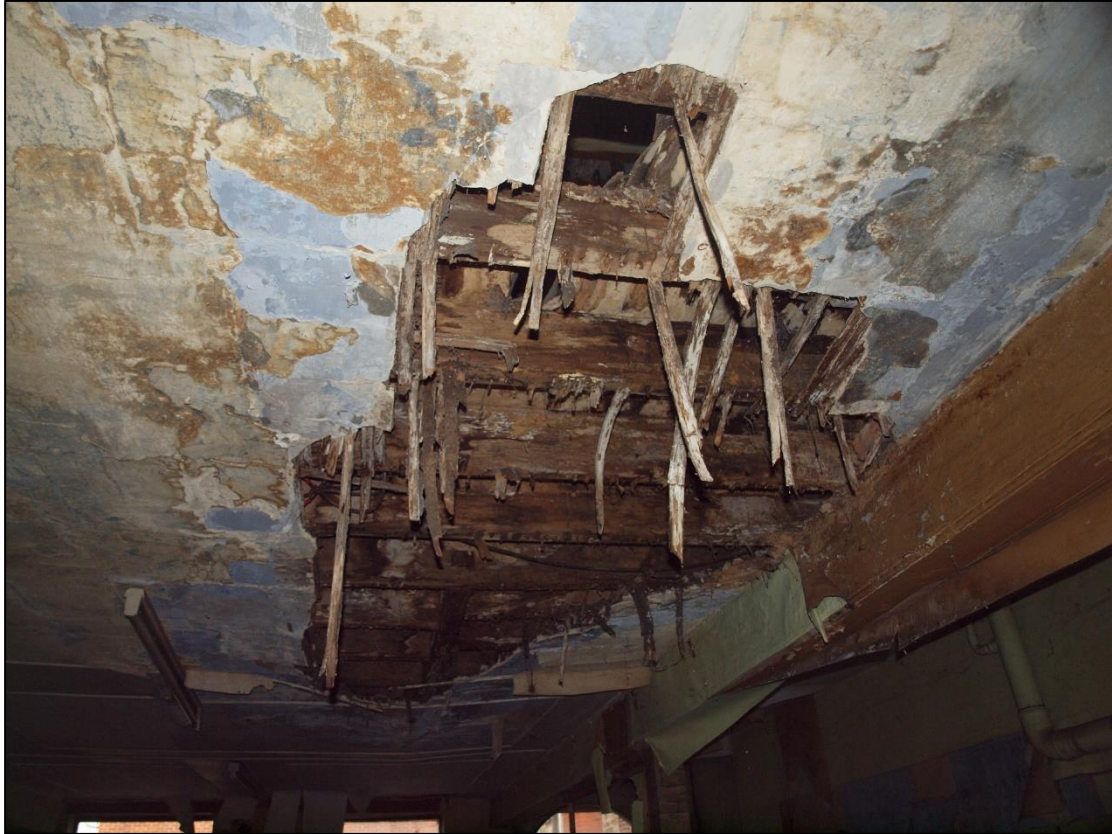
Plate 21: Dilapidated lath and plaster ceiling of number 5

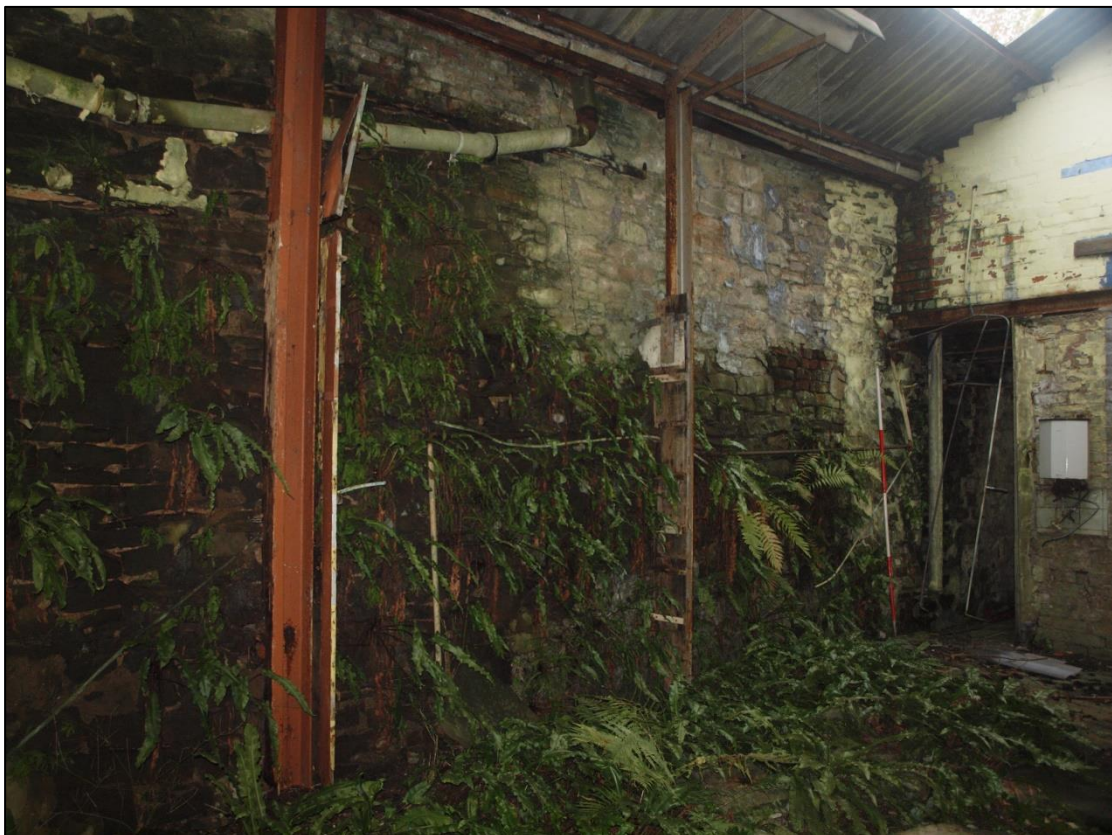
the yard is shown to be constructed of rough sandstone rubble is visibly damp, with plant growing upon it.

Plate 30: Southern wall of rear yard

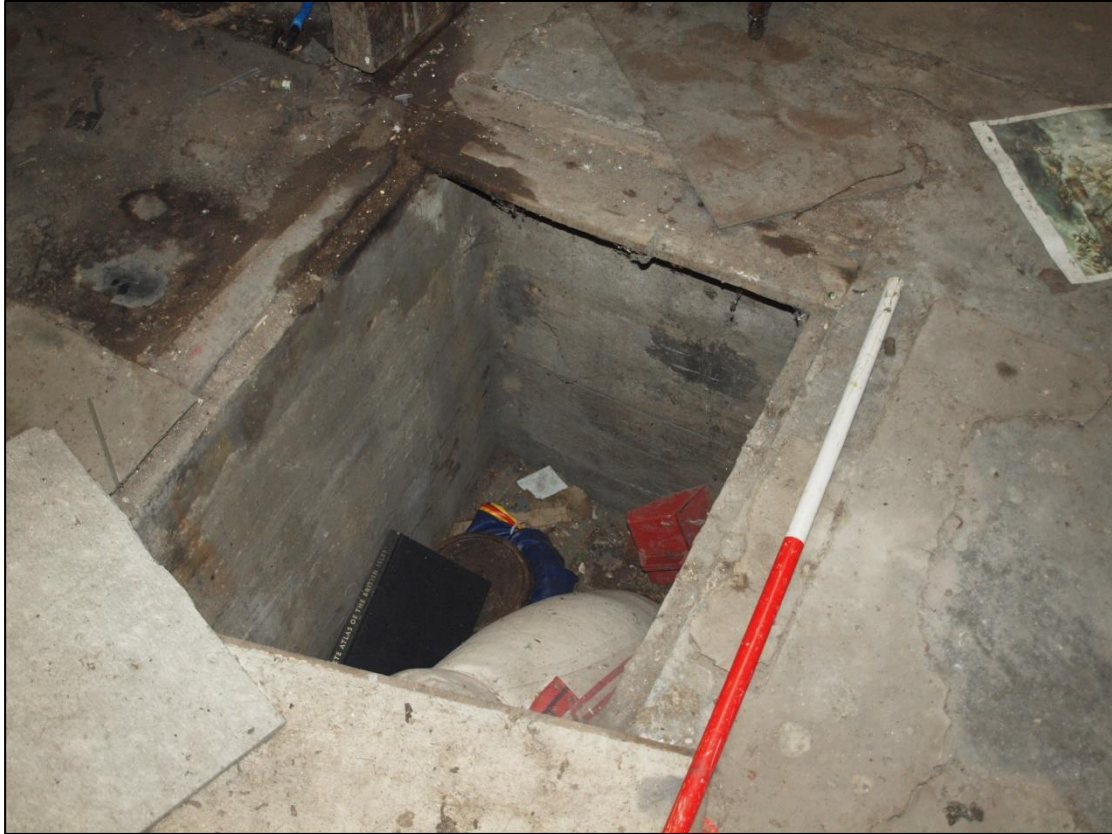
Plate 41: Concrete hole in floor of 7 - 9

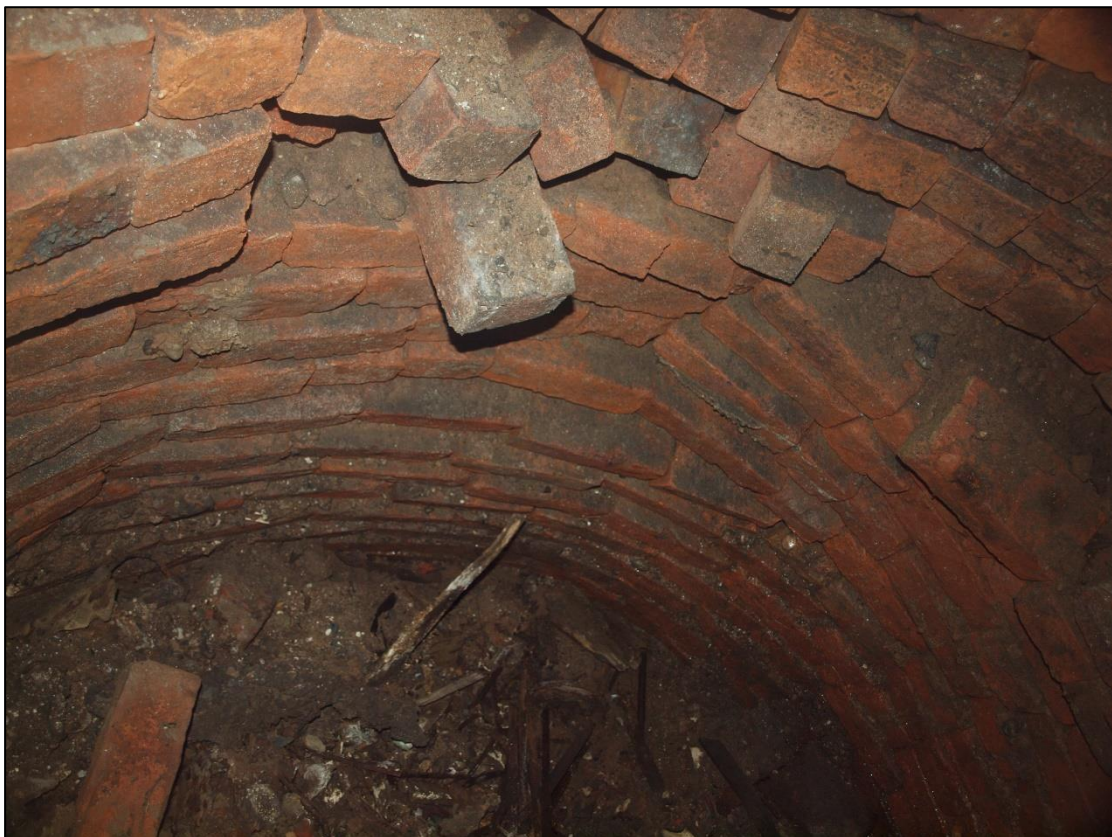
- 7.3 The presence of a 'well' found beneath the flagged surface of the cellar may indicate a method of ensuring the cellar was kept humid. It is not known how deep the well was or whether other 'wells' are located below other flags in the basement. The alcoves along the eastern wall have recesses half way up, as if to support a shelf. It seems reasonable to assume that the cellar may have been used as a hand-weavers loomshop, the presence of the 'well' suggesting the humid conditions and the alcoves used for storage. The cellar windows along the rear

Plate 48: Well below flagstone in cellar

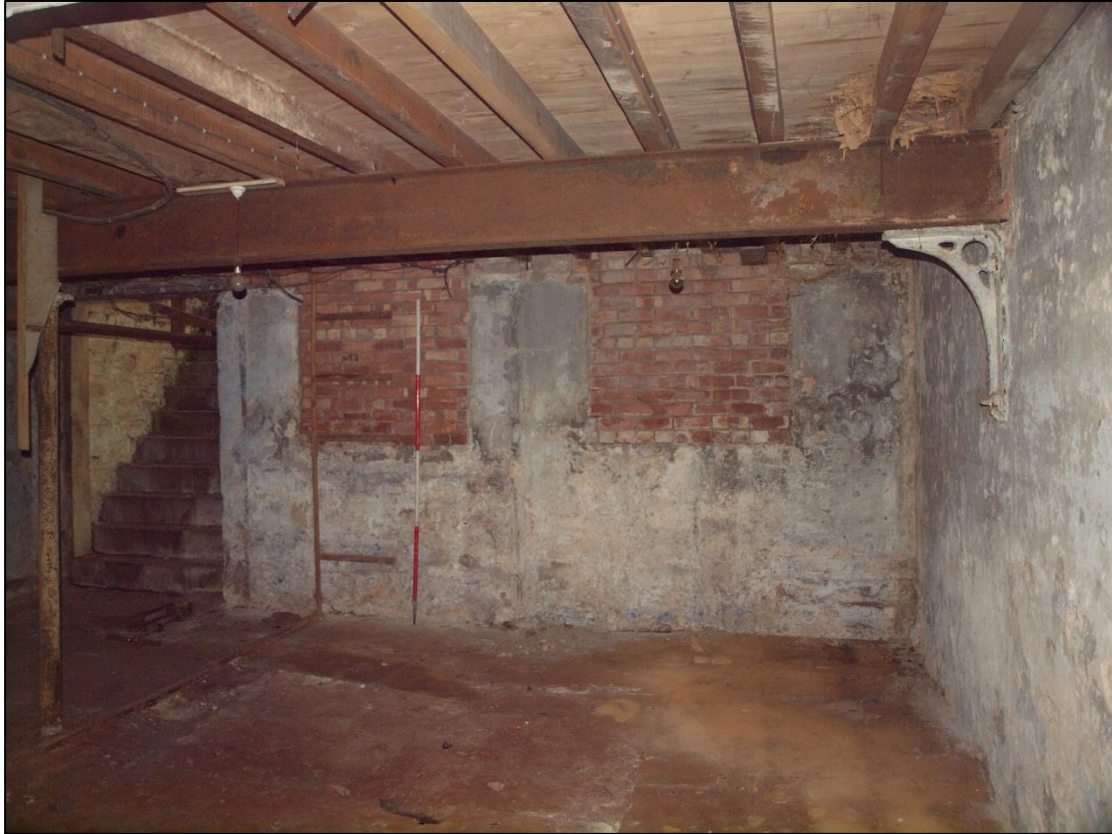
Plate 51: Blocked cellar lights in rear wall

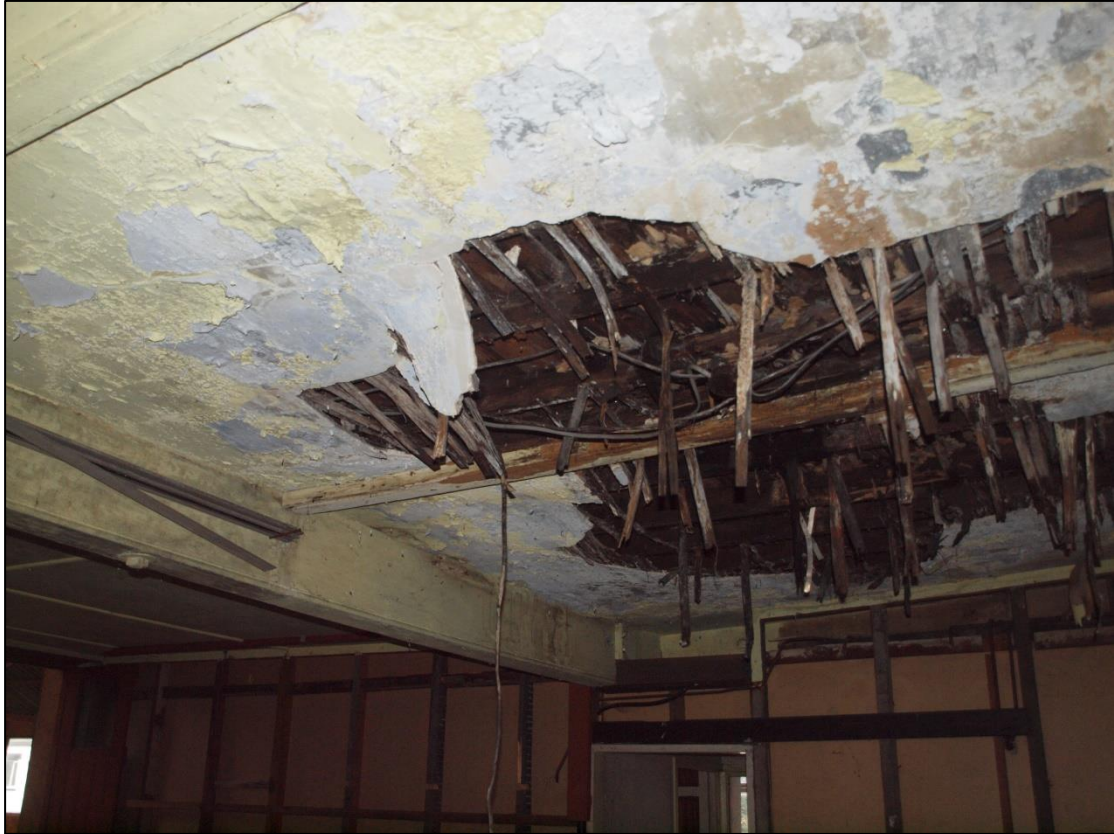
Plate 57: Dilapidated lath and plaster ceiling in first floor of number 5

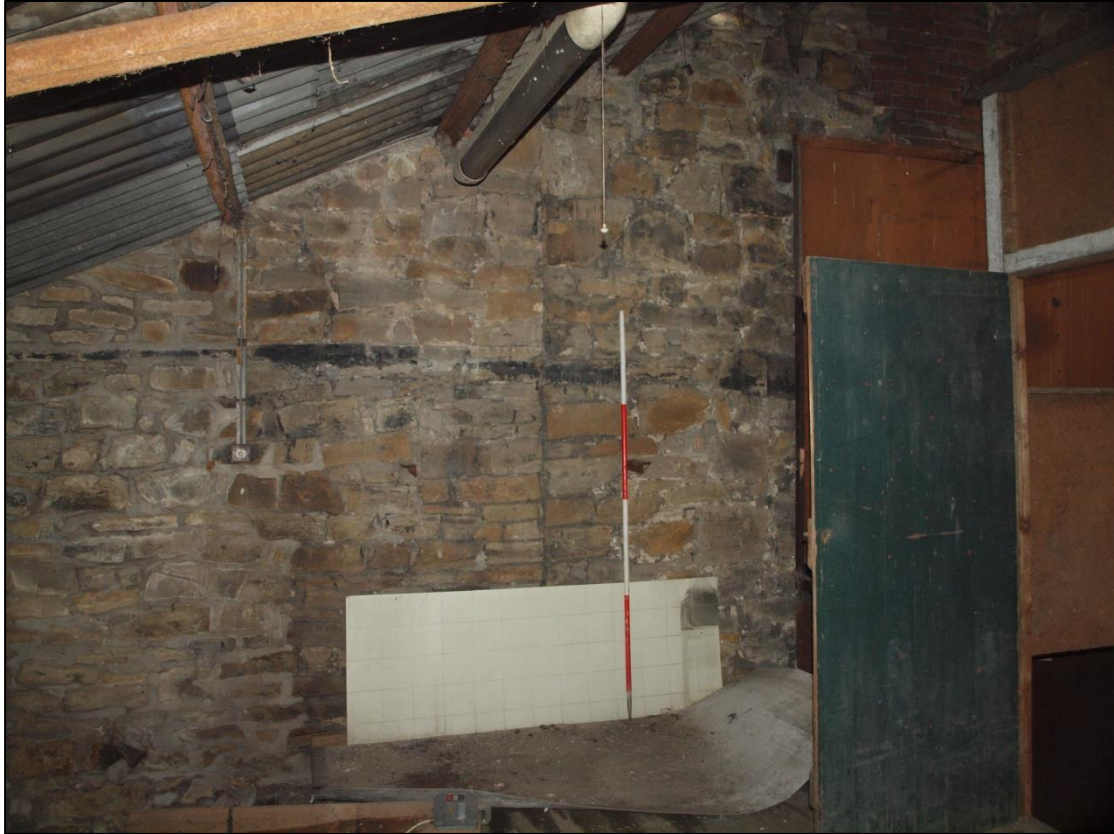
Plate 69: Detail of west wall showing straight joint
