Burgess Farm, Worsley Historic Building Survey

February 2020

An archaeological building survey was required prior to demolition of the farm buildings at Burgess Farm, Worsley. The work was carried out on behalf of Realacre Developments Limited by The Archaeology Co.

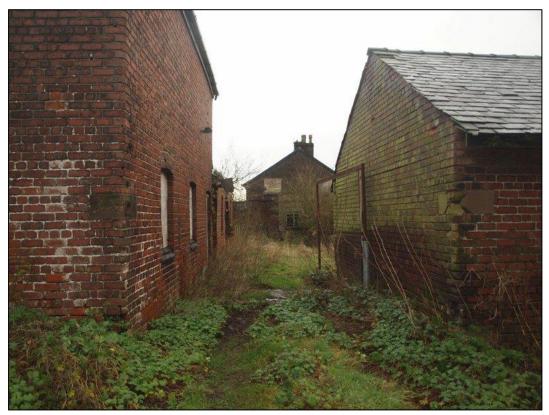
Plate 1: General shot of the farm showing the farmhouse (centre) with shippon (left) and piggery (right)

6.1 (Plates 1 – 3). The farm has a courtyard plan, with building 1, the farmhouse to the east side with the bothy (building 2) to the north of it. To the west of this is building 3, which forms the northern side of the courtyard. The pigsty forms western end of the courtyard and the large 'L' shaped shippon the southern. The whole area is overgrown and all buildings are brick built and in a very poor condition. All have slate roofs, in various states of disrepair and all three buildings are built of handmade brick.

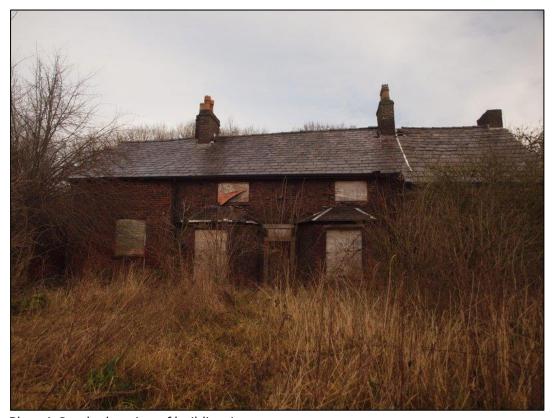
Plate 4: South elevation of building 1

- 6.2 South Elevation (Plates 4 – 9). This is the main frontage of the building, with extensions to the east and west. The western extension is built in English Garden Wall bond (4:1) and has a single, large portrait window in the centre of the face, at ground floor level. The cill is of thin sandstone and the lintel and jambs are brick. The window is boarded with ply. A straight joint runs up the face to the east, where it connects to the main three bay building. The bricks here are browner than the western extension and constructed in Flemish bond. It has inserted bay windows to bays one and three, each containing a tall portrait window to the south side, although these are boarded with ply. Between them is the main entrance, with sandstone surround and light over (again boarded over). At first floor level landscape windows are present, with the eastern being a later insert. To the east the eastern extension projects southwards. The face is featureless save for a narrow blocked window in the centre at ground floor level and is constructed in an orange brick in English Garden Wall bond (5:1).

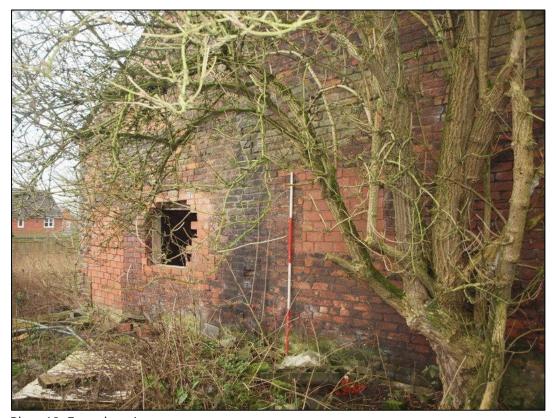
Plate 12: East elevation

- 6.3 East elevation (Plates 10 12). This is gable of the eastern extension and is likewise constructed in English Garden Wall bond (5:1), with a chimney stack rising at the apex. At the northern and southern ends are personnel doorways, both blocked with brick. That to the south has uneven jambs, possibly

suggesting the removal of sandstone. Above the northern doorway the ghost of a lean-to is visible; the scar of its southern wall is likewise visible. Between the doorways is a pair of windows, both blocked with brick. The northern is square whereas the southern is landscape and some of the brick blocking has been removed. At first floor level is a blocked landscape window, at the southern end.

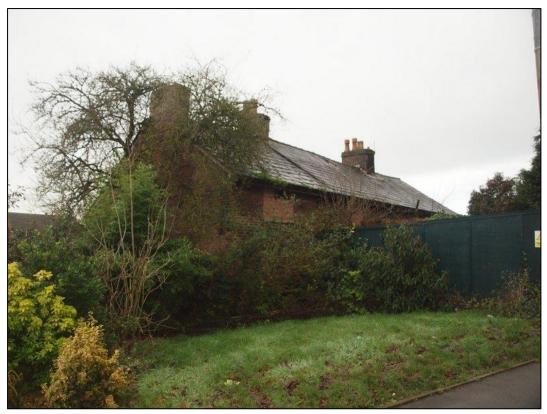
Plate 13: General shot of north elevation

- 6.4 North Elevation (Plates 13 - 18). At the eastern end is the face of the east extension. This is a single bay wide with windows in the centre at ground and first floor levels. Both are landscape and blocked. To the west a straight joint is visible where it connects to the main house body. This is constructed in English Garden Wall bond (4:1), although slightly haphazard in places, suggesting a possible rebuild. At ground floor level landscape windows lie to the east and west sides, both blocked with play and with brick surrounds. The western window has a rough sandstone cill and is a later insertion. To the east is a personnel doorway into the building. The jambs are brick although the lintel is sandstone and the light over is boarded. At first floor level are a pair of narrow landscape windows to the east and west sides. That to the east is blocked with brick, whereas the other has been covered with ply. To the west is the face of the western extension. This has a pair of small portrait windows at ground floor level, the western showing it to have been a former larger window. The first floor is featureless and the whole is constructed in English Garden Wall bond (4:1).

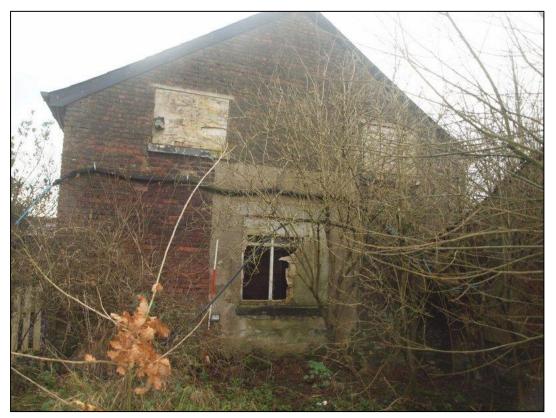
Plate 20: Detail of ground floor window above

- 6.5 West elevation (Plates 19 & 20). This forms the gable end of the west extension. In the centre of the face at ground floor level is a large landscape window, with parts of the timber framed casement still remaining. The whole are around the window is rendered. At first floor level are a pair of landscape windows, boarded over, but with sandstone cill and lintel.

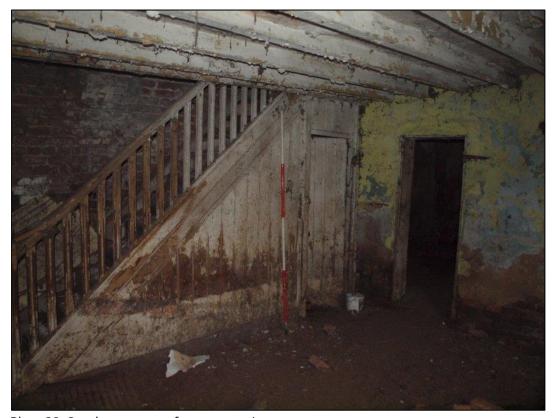
Plate 38: Southern room of east extension

6.8 All of the doorways to the eastern extension have been blocked, with the only entrance through the unblocked window on the east elevation. The southern room (plates 38 & 39) has plastered walls and the ceiling is open to the timber joists of the floor above. The western wall is unplastered, showing the bare brickwork and the straight joint where it meets the main house body. A staircase runs up the west wall from south to north, with a simple moulded timber handrail and square balusters (plate 40). Timber panelling is below, forming a small understairs cupboard. In the northeast corner of the room is an inserted and damaged corner fireplace. A doorway in the north wall leads to the northern room of the extension (plates 41 & 42). Here a blocked doorway lies in the north wall with a blocked window to the east. A fireplace lies in the east wall and in the alcove to the south is a blocked window. The walls and ceiling are plastered and whitewashed.

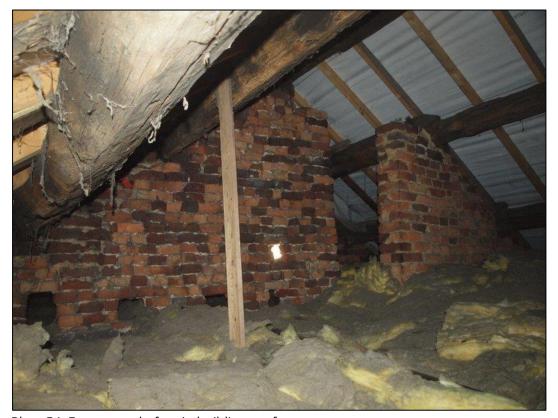
Plate 54: Eastern end of main building roof space

- 6.11 The roof spaces were accessed through holes cut in the lath and plaster ceilings. The main building (plates 54 58) contained no trusses, with the four hand-cut timber purlins supported on the rising walls. The eastern cottage extension (plates 59 & 60) likewise had no truss and neither did the western extension (plates 61 & 62). The pulins in both extensions were sawn and the whole building had been reroofed in recent times.

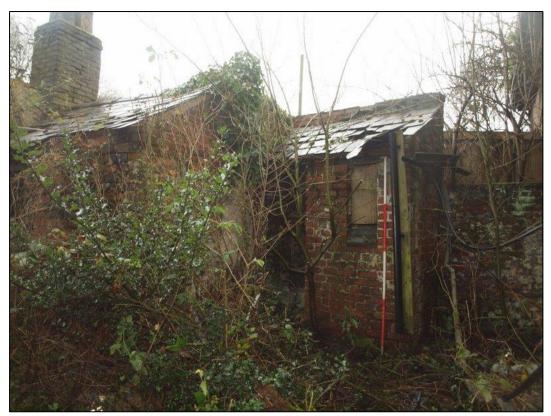
Plate 63: General shot of building 2

6.11 (Plate 63) The building is a small single story brick built building with double pitched roof of slate. It is constructed in English Garden Wall bond (5:1) and lies to the north of building 1. The east elevation was not visible, with a fence

butting against it. To the south of it is a lean-to extension, with a single pitched roof of slate.

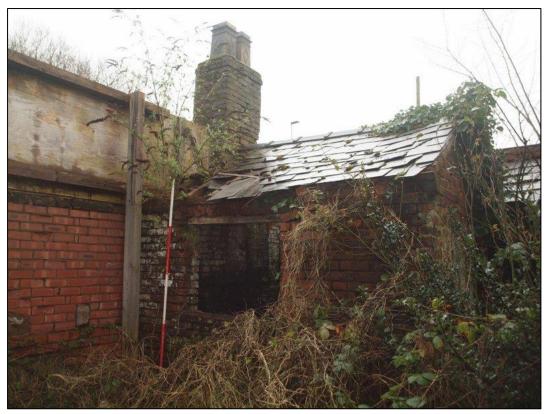
Plate 65: West elevation

- 6.13 West elevation (plate 65). This elevation has a large landscape window in the centre, although the frame has since been removed. The timber lintel over is still present, and the jambs and cill are brick. The southern end shows a rough joint with some rebuilding, suggesting the window has been altered. To the south the face of the lean-to is set back. This has a doorway at the northern end, with a timber frame. To the south is a small portrait window, boarded over.

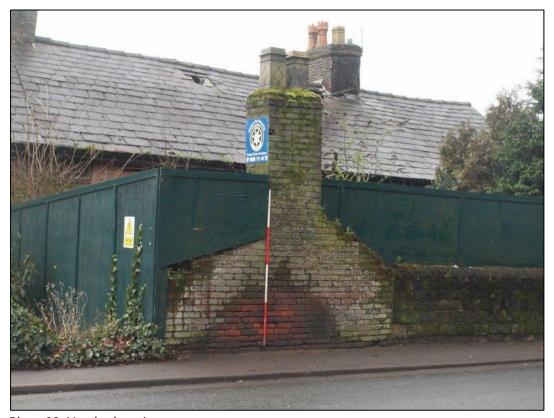
Plate 66: North elevation

- 6.14 North elevation (plates 66 & 67). This forms the other gable end of the building and faces onto Hilton Lane. The face is featureless, although has a chimney stack rising from the gable with two pots. To the west the building is butted by the sandstone boundary wall.

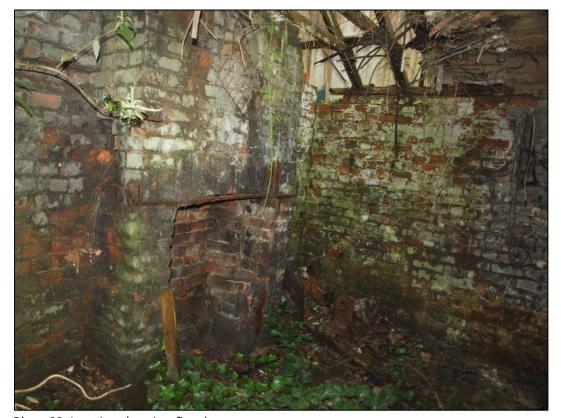
Plate 68: Interior showing fireplace

6.15 (Plates 68 & 69). The building comprises a single room with a brick built fireplace in the northern wall. The lintel of the fireplace is iron. The lath and plaster ceiling has decayed badly and the floor is earth. The doorway to the south has a timber frame and timber lintel above. The east wall contains a blocked window and the west wall the large landscape window. To the south, the lean-to is featureless although contains toilet.

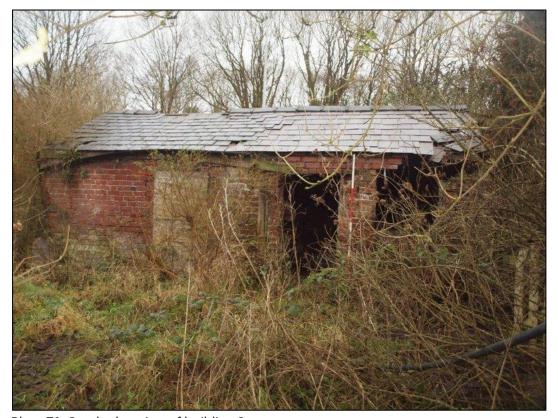
Plate 70: South elevation of building 3

- 6.17 South elevation (plates 70 & 71). This is the main frontage of the building with a damaged large square window to the east side of the face. West of this is a personnel doorway, with a timber frame still present. West of this is a further personnel doorway, although this is blocked with ply sheeting. The remainder of the face is featureless.
- 6.18 West elevation (plate 72). This forms the gable end of the building. A large landscape window in the centre of the face, blocked with brick. Otherwise the face is featureless.
- 6.19 North elevation (plate 73). This faces onto Hilton Lane and is blocked by the boundary wall.
- 6.20 East elevation (plate 74). This forms the other gable end of the building and is featureless.

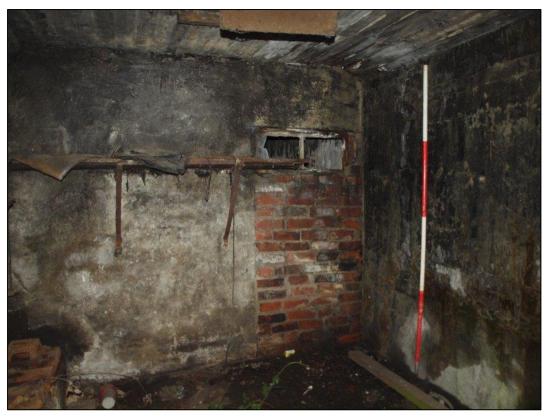
Plate 75: Interior of east room showing blocked door

6.21 (Plates 75 – 77). The interior is divided into two rooms. The eastern is accessed via the easternmost doorway. The brick walls have been rendered and whitewashed and the floor is earth. The lath and plaster ceiling has a long narrow hatch in the centre, and to the north and south the ceiling slopes to follow the roof pitch. In the west wall a personnel doorway is located at the northern end, giving access to the western room. However, this has since been blocked with brick although the timber framed window above allows visual access. This western room has a similar ceiling and floor, with walls also rendered and whitewashed. The blocked window in the west wall shows a four light timber framed window within it.
