**THE ARCHAEOLOGY CO.**

Naychurch Farm, Upper Hulme

Historic Building Survey

December 2020

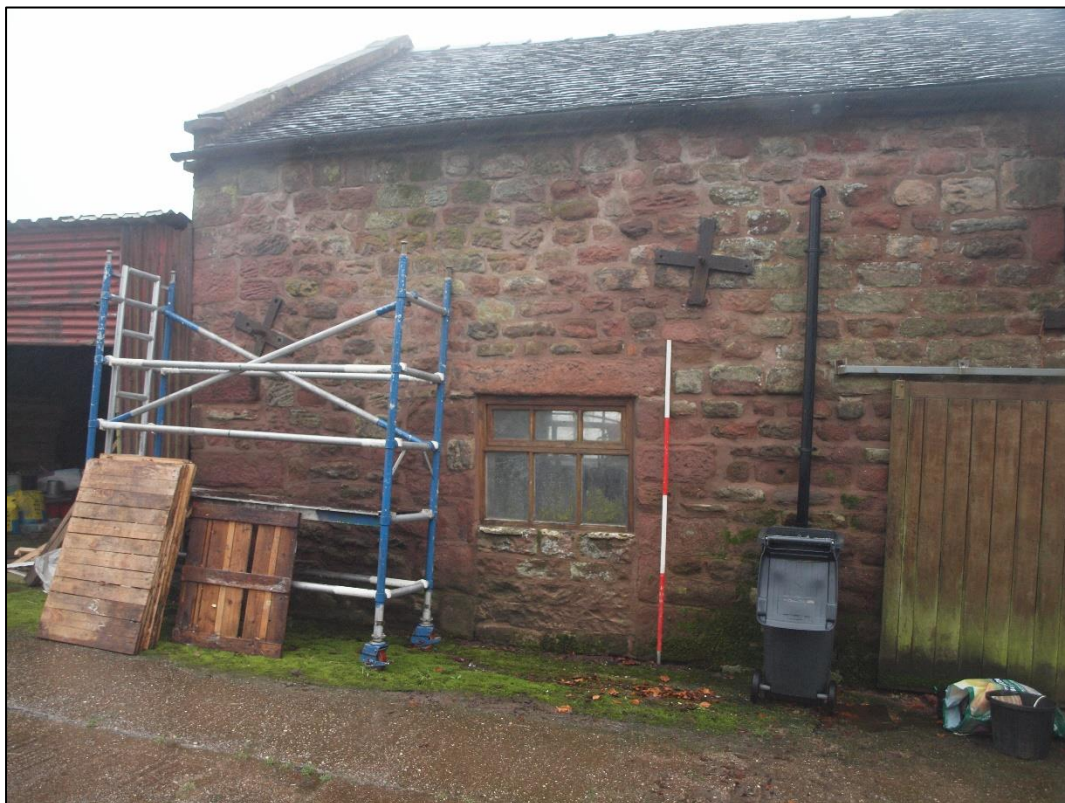
Plate 8: Window to bay 1

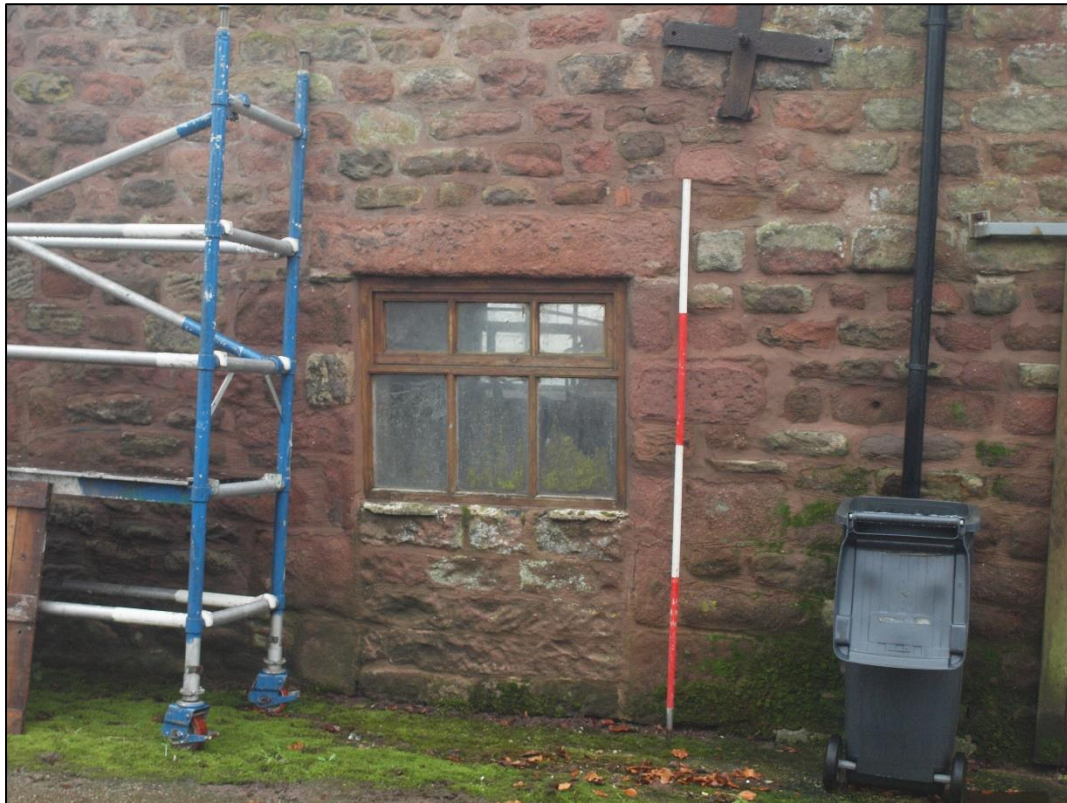
Plate 9: Detail of above showing blocking beneath

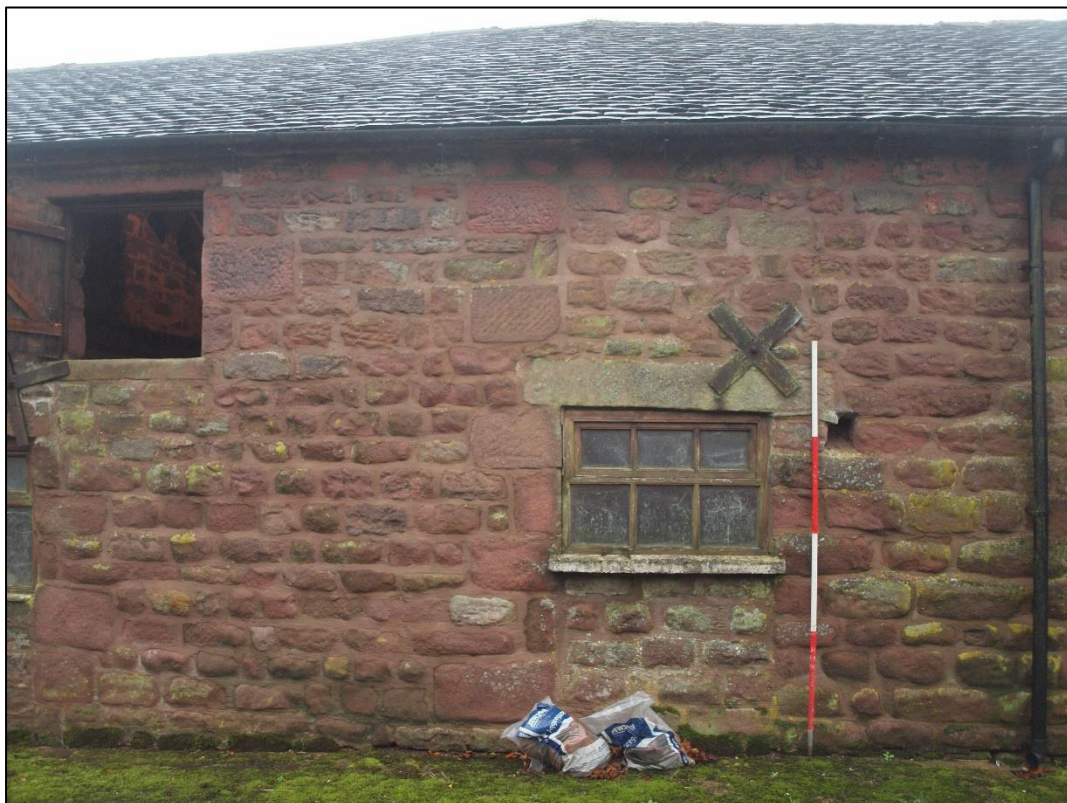
Plate 12: Straight joint between bays 3 and 4 with window to bay 4

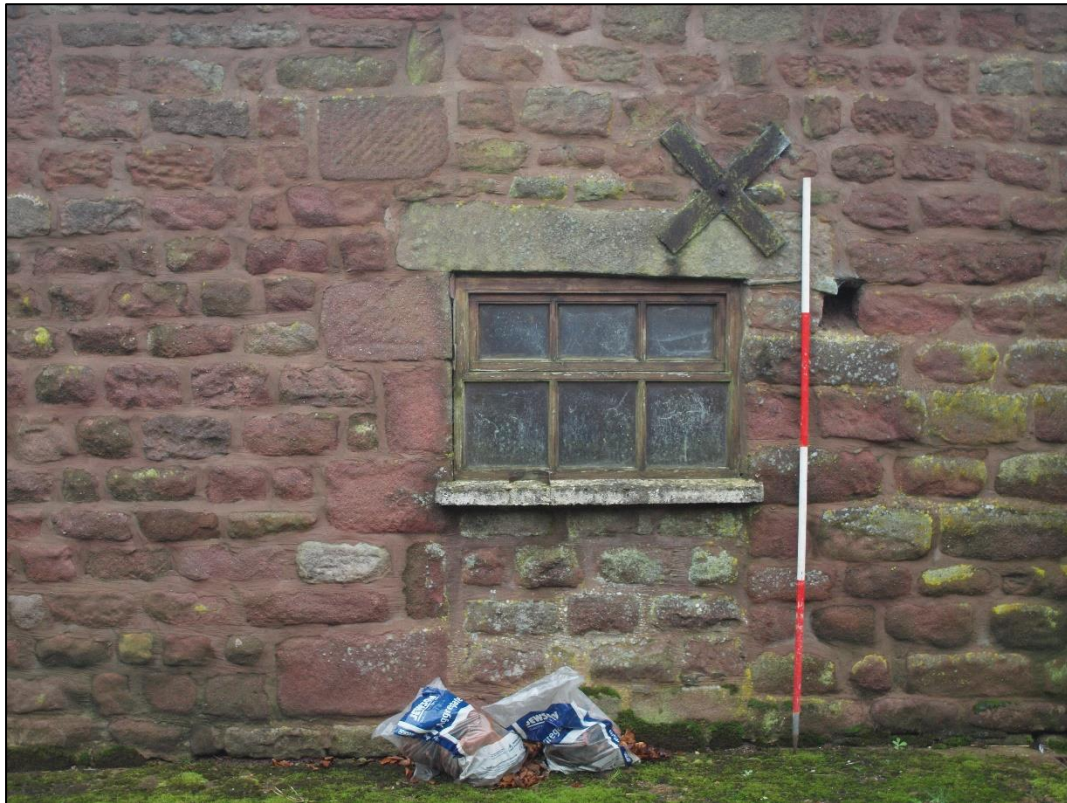
Plate 13: Detail of window with blocking below

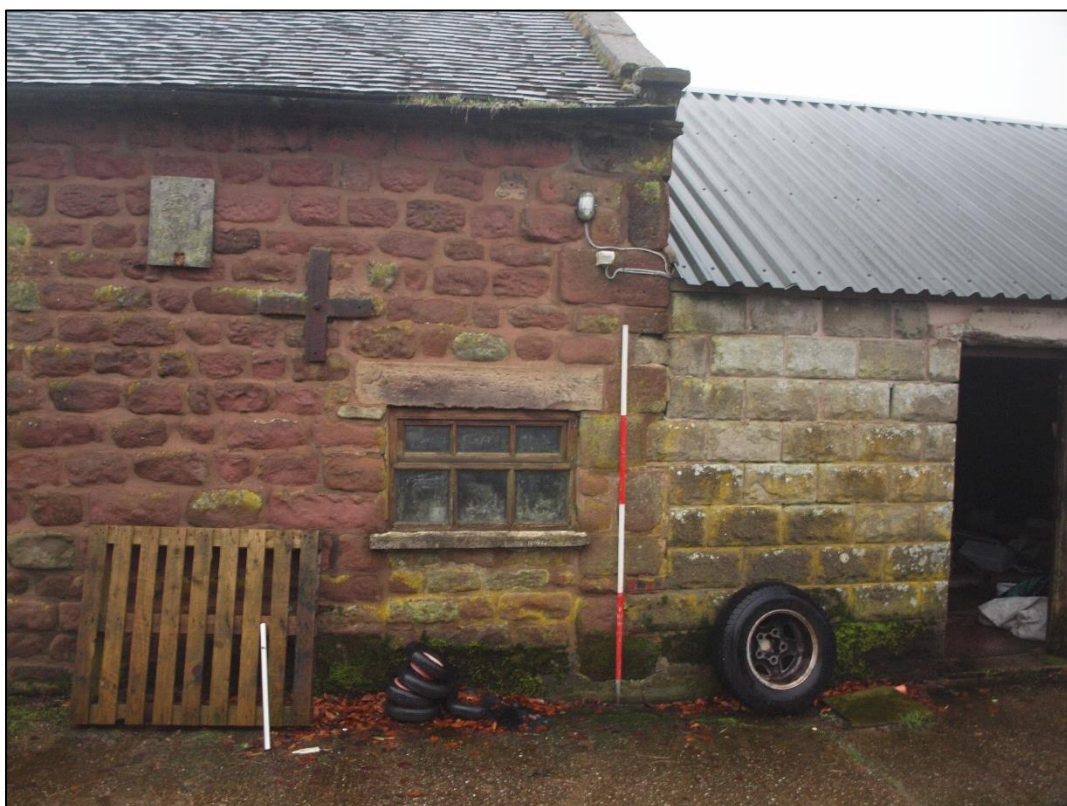
Plate 16: Detail of window with blocking below

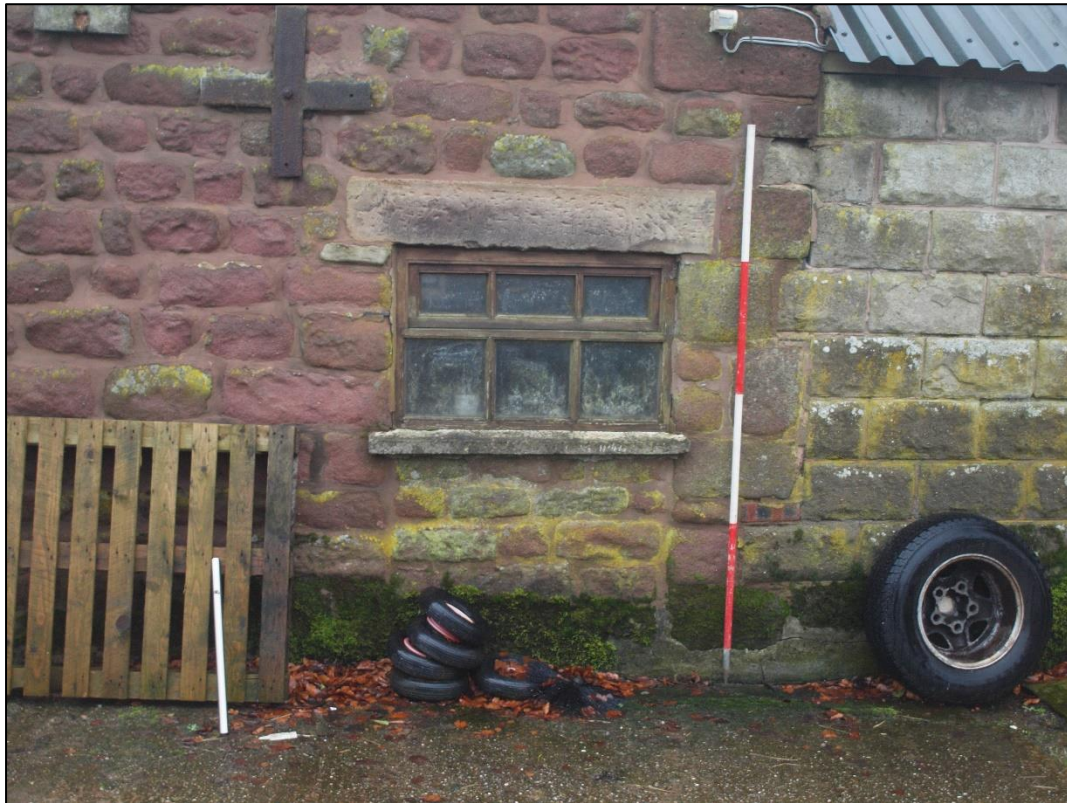
Plate 17: As above showing rough joint to modern extension

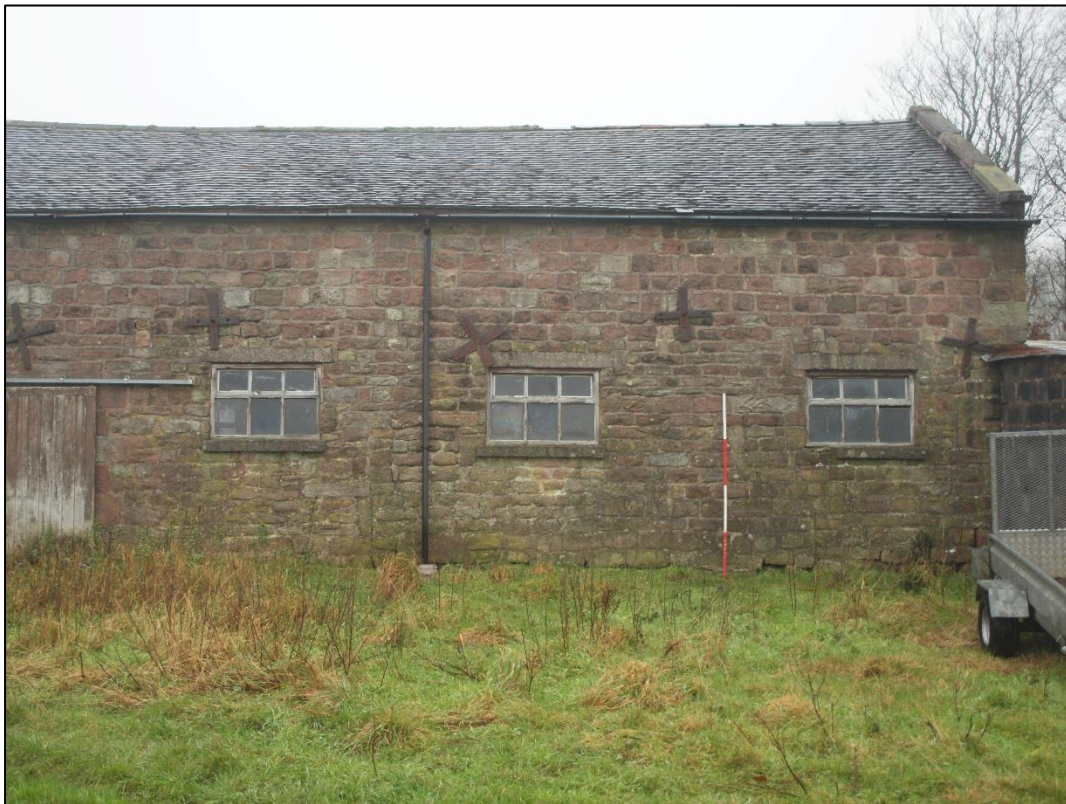
Plate 22: Inserted windows to bays 1 and 2

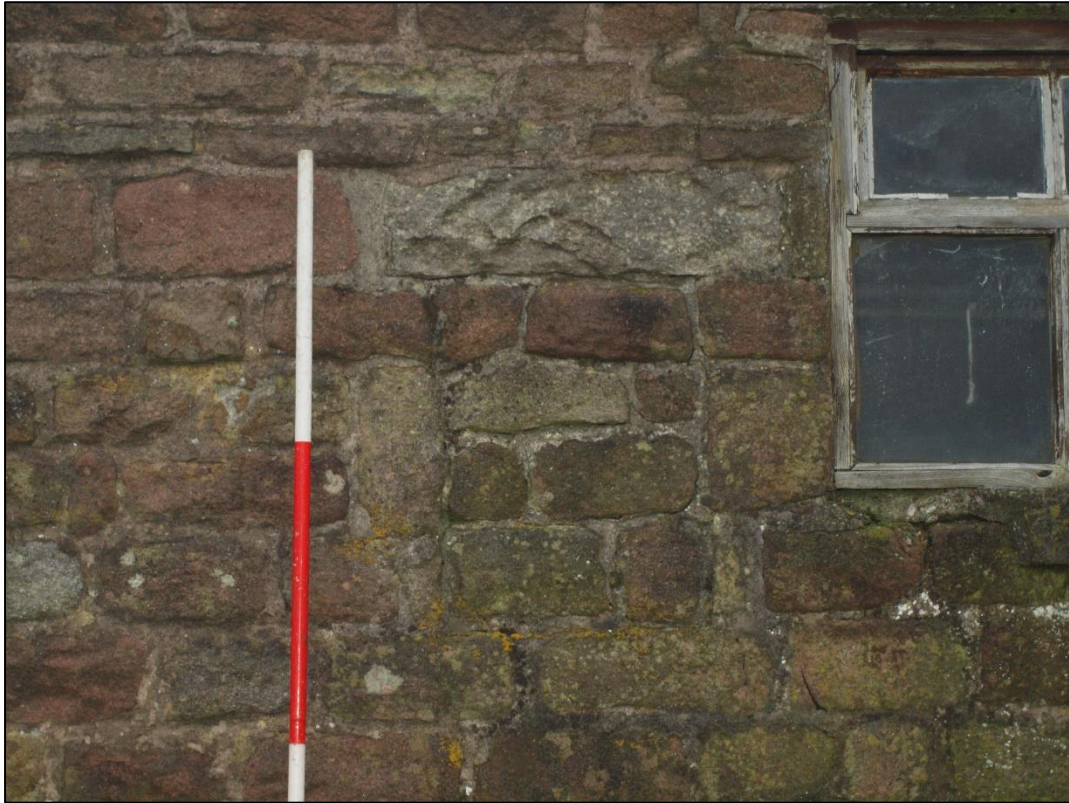
Plate 23: Detail of small blocked window to bay 1

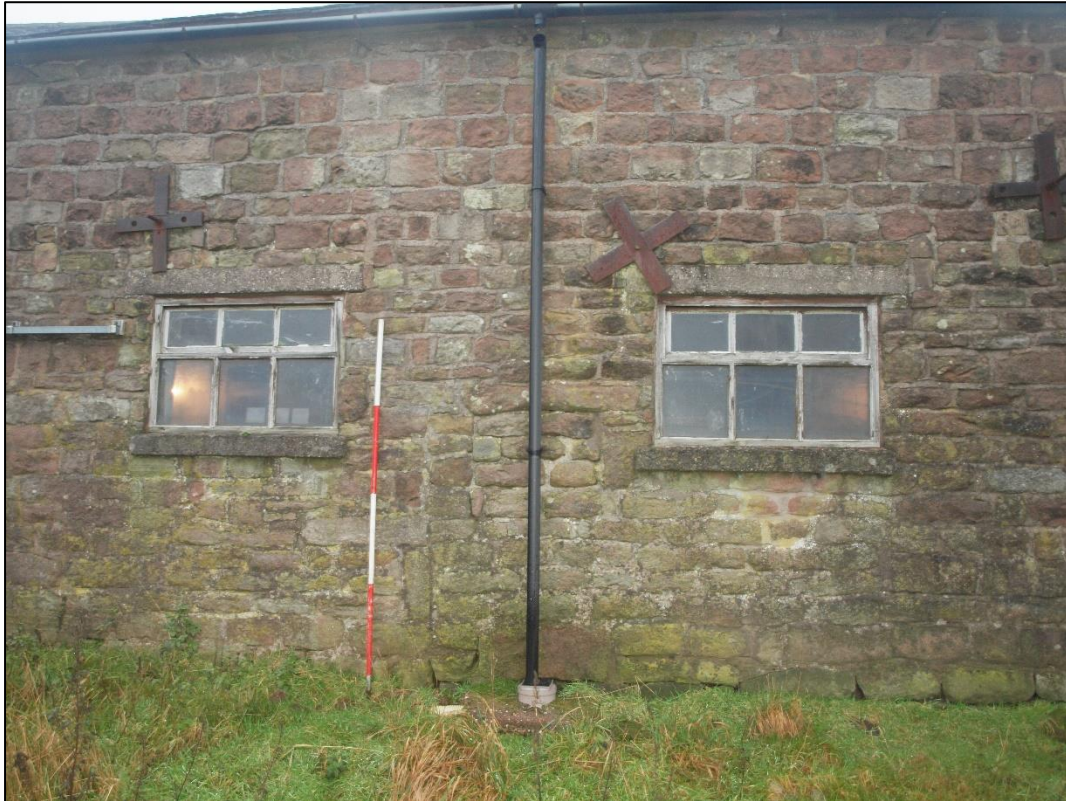
Plate 25: Blocked doorway to bay 2

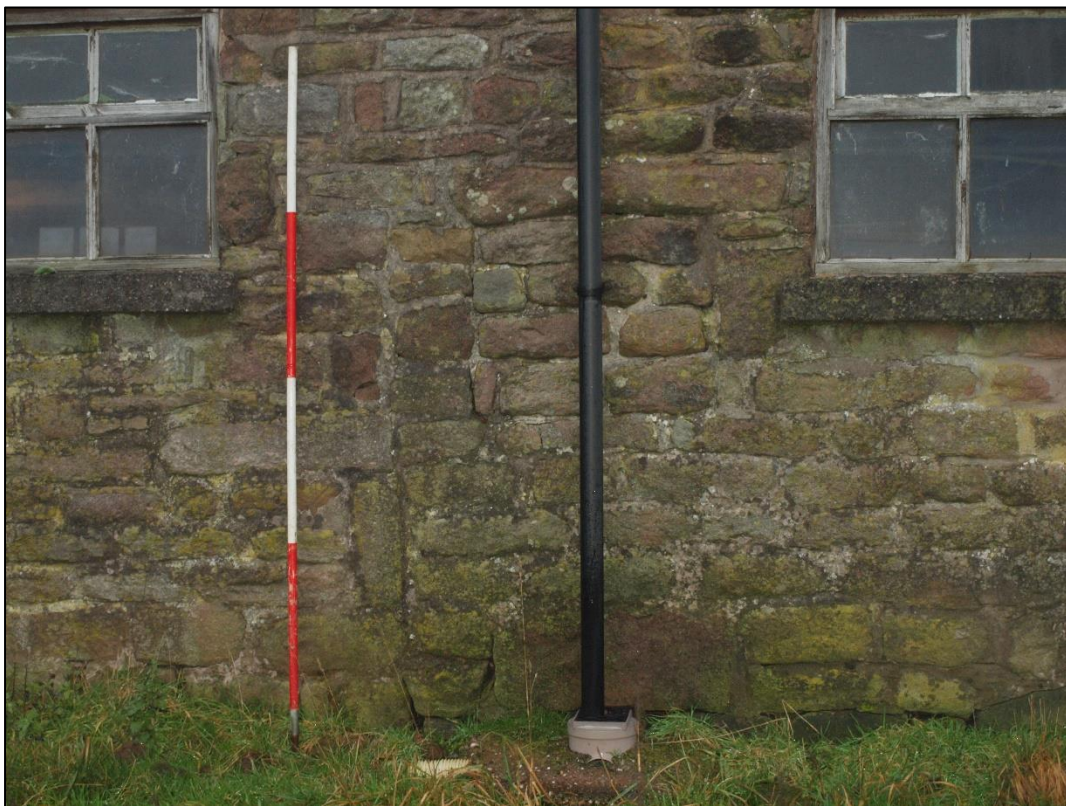
Plate 26: Detail of blocked doorway

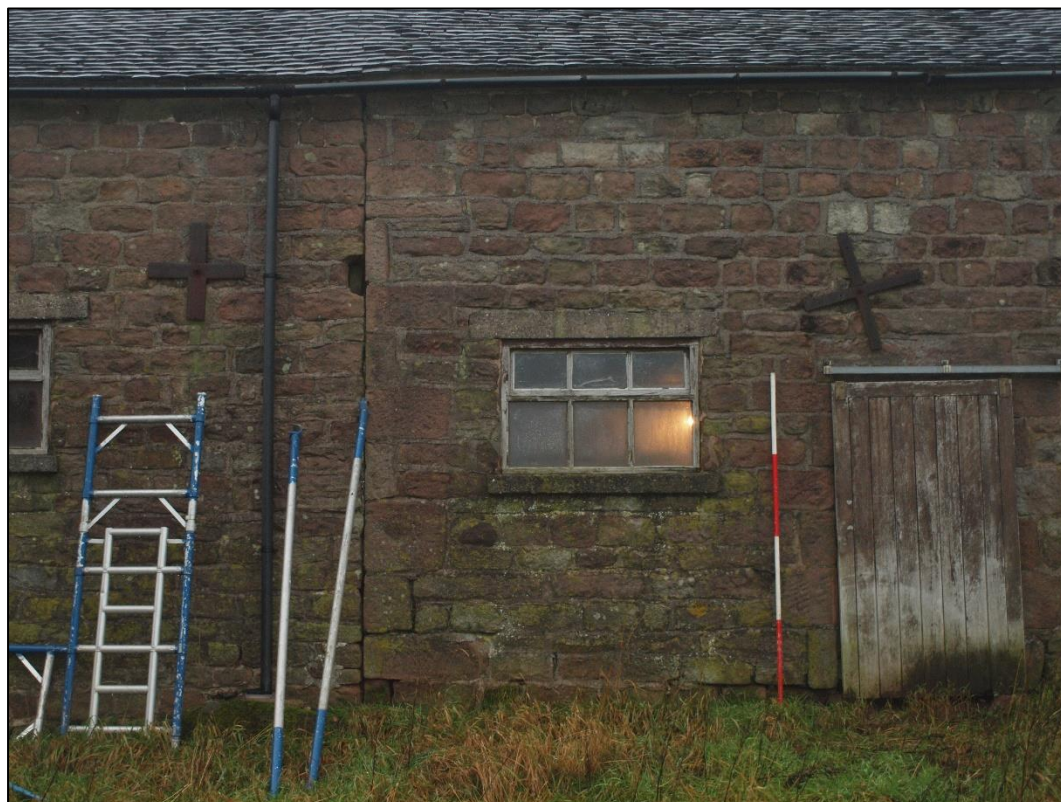
Plate 28: Straight joint between bays 3 and 4

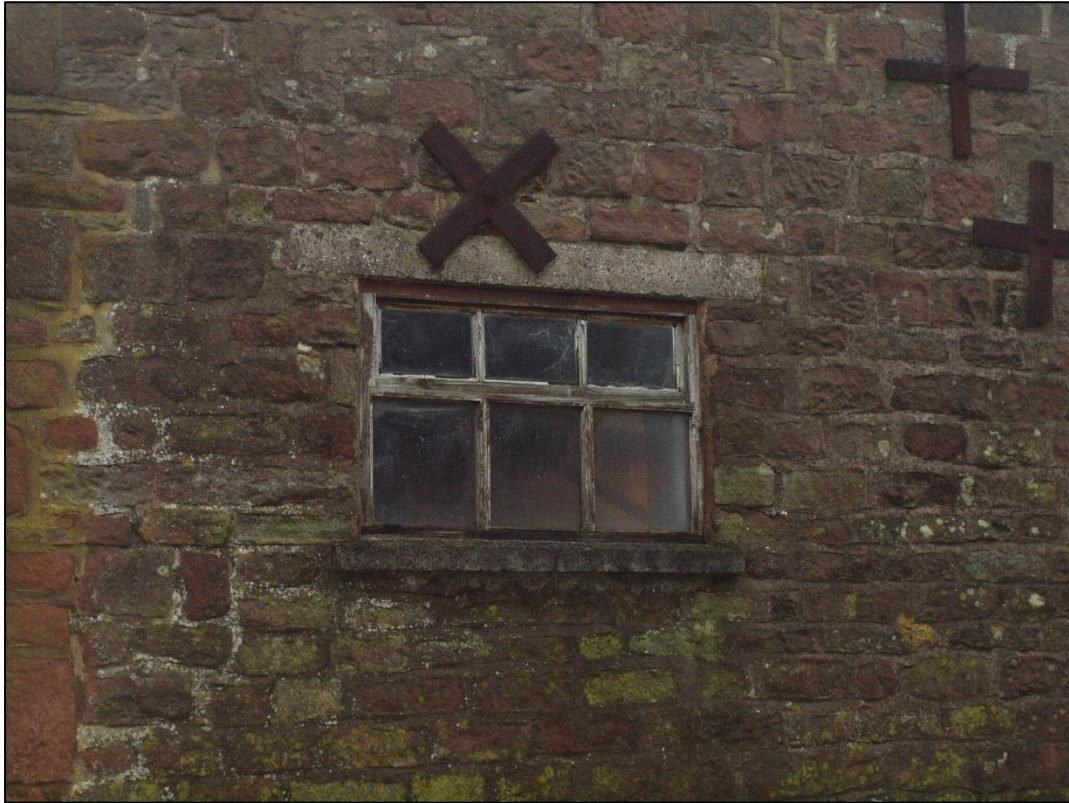
Plate 31: Detail of inserted window

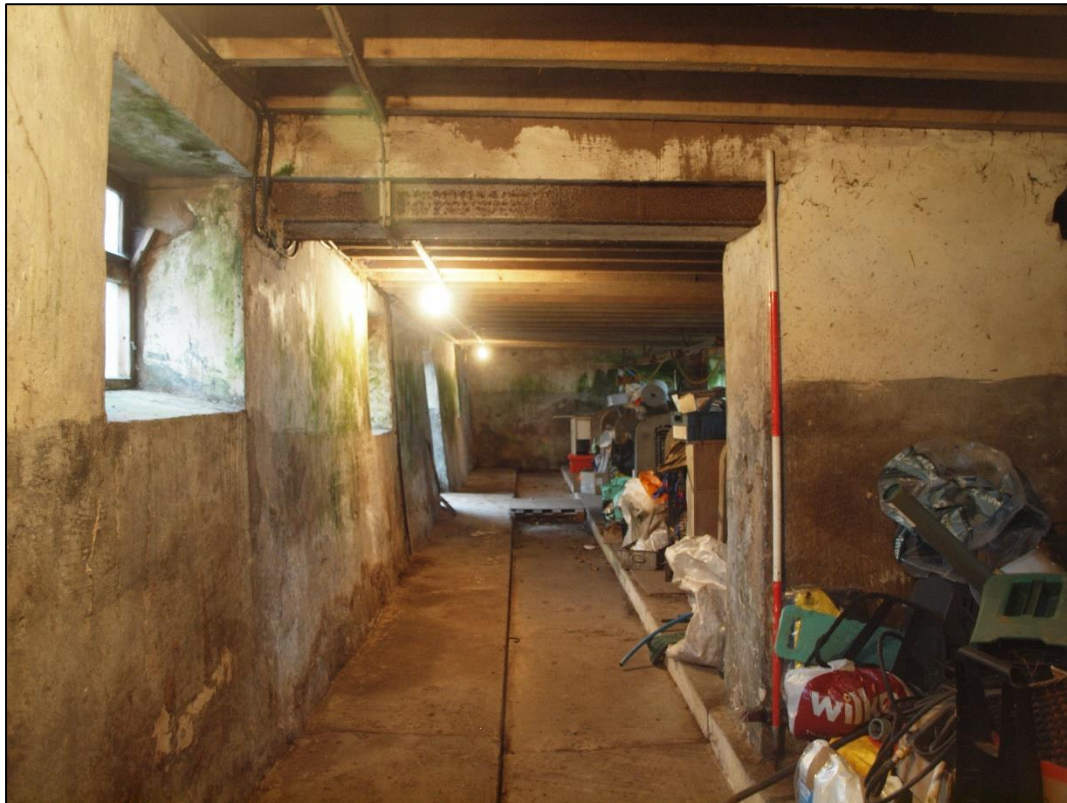
Plate 37: Inserted opening in cross wall

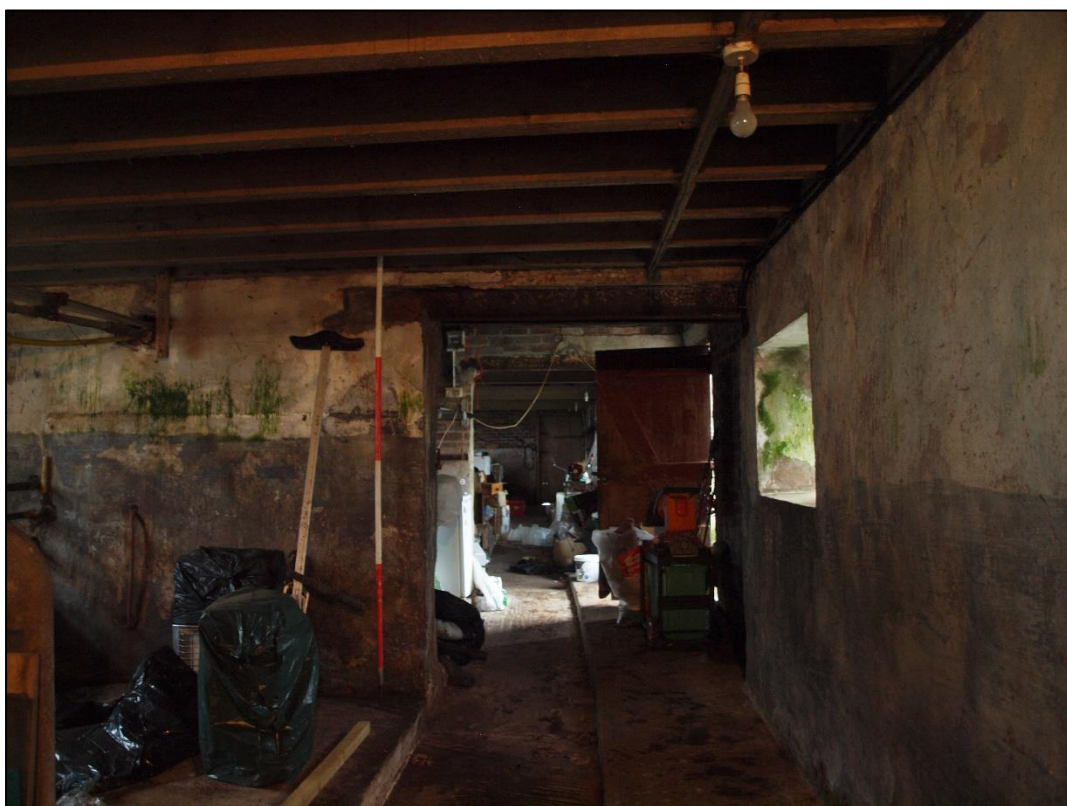
Plate 38: Inserted opening in gable end

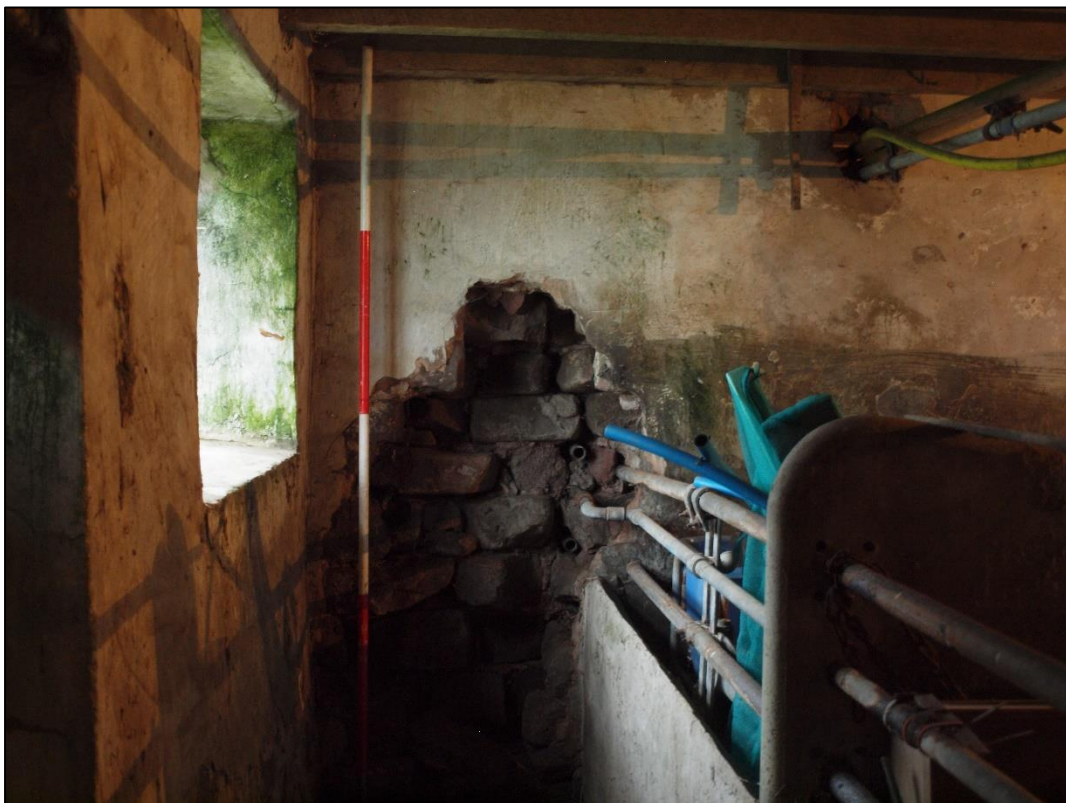
Plate 44: Detail of partially removed wall in cross wall where doorway would be expected

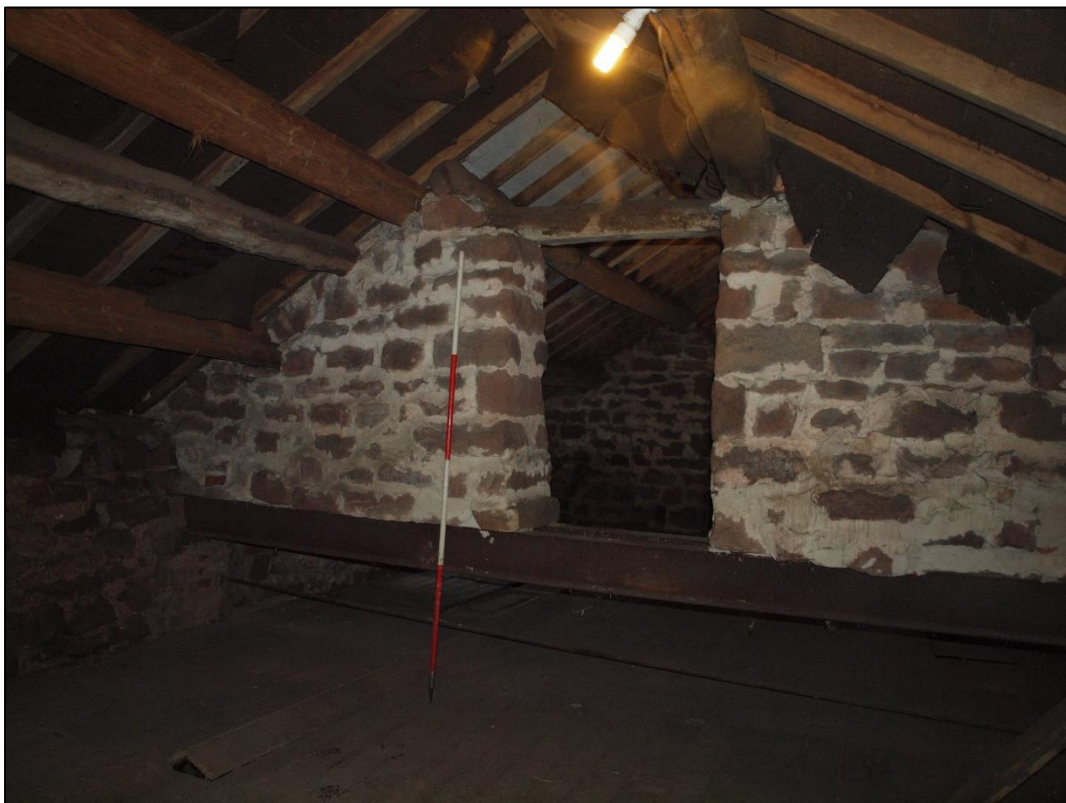
Plate 48: East end of first floor showing inserted beam carrying the remains of former cross wall

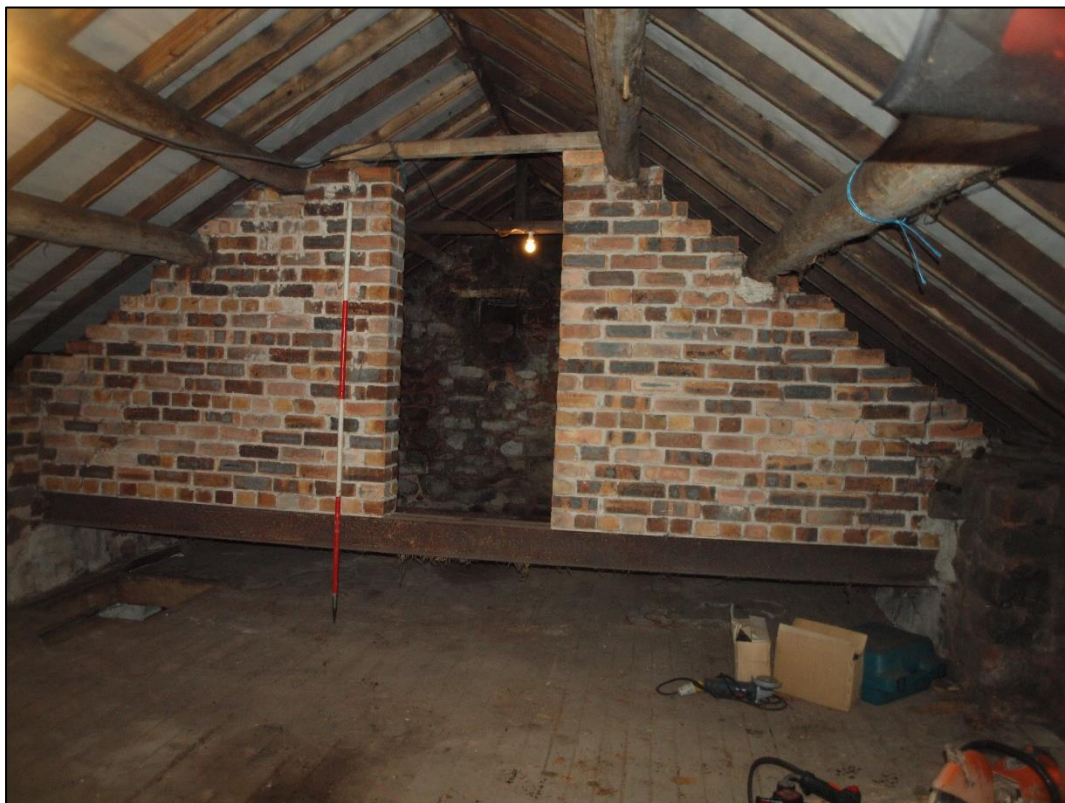
Plate 58: Modern supporting wall on beam supporting roof
