**THE ARCHAEOLOGY CO.**

Foot of Hill Farm, Rainford  
Historic Building Survey

January 2022

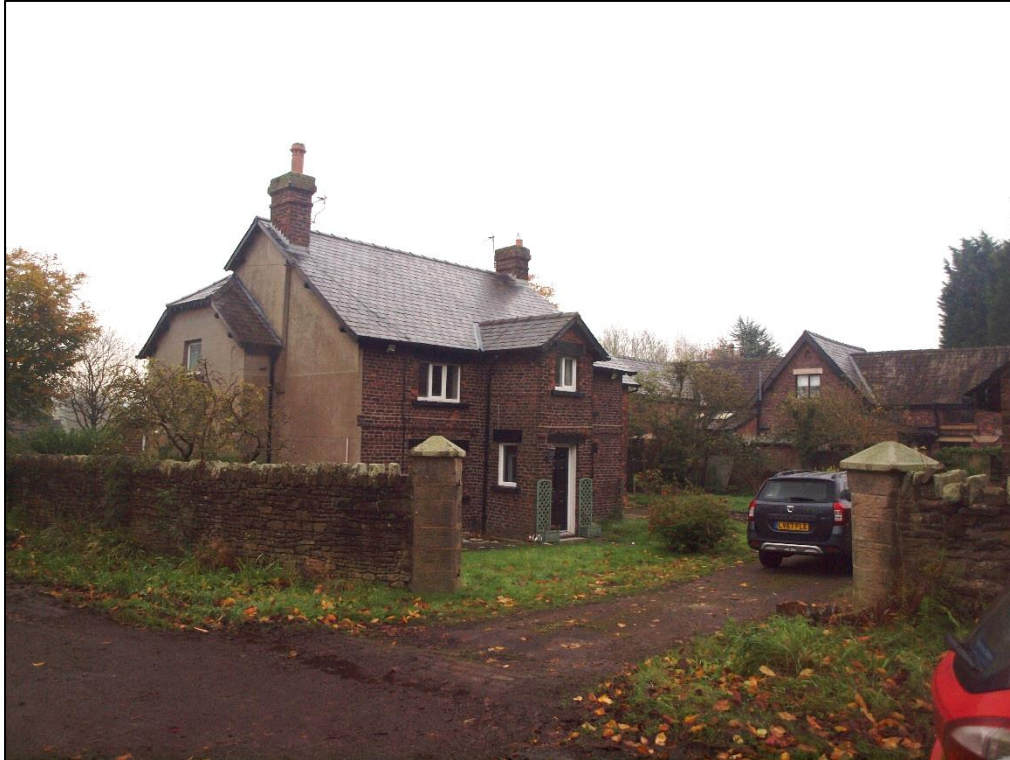
Plate 1: General shot of building

- 6.1 (Plate 1). The building comprises the main house constructed in a narrow handmade brick (8 ¾" x 2 ¼" x 4") in English Garden Wall Bond (3:1) with a large extension to the southeast. The roofs of both are double pitched and covered with slate. A chimney stack lies at each end of the main house building, each with a single modern pot.

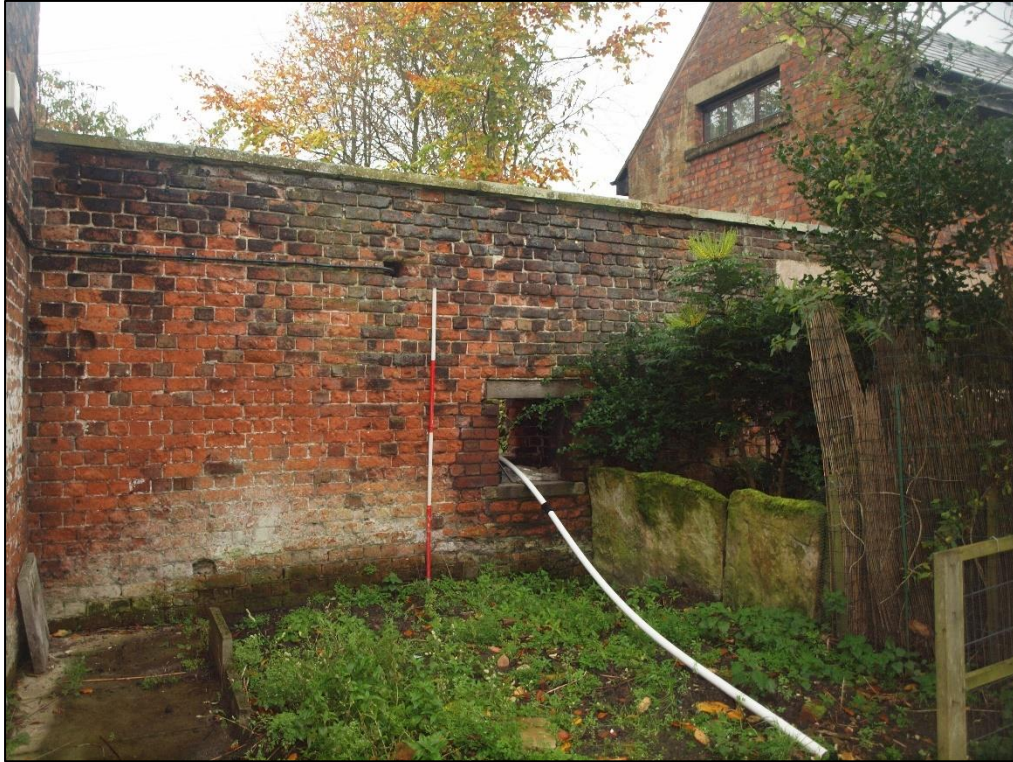
Plate 9: Southwest elevation of outbuilding

- 6.3 To the east is the face of the outbuilding (plates 9 - 11). This contains an inserted window towards the centre of the face, with sandstone cill and lintel. Rough joints and modern brickwork line the jambs. To the east is a personnel doorway. No door is hung although the timber frame is present

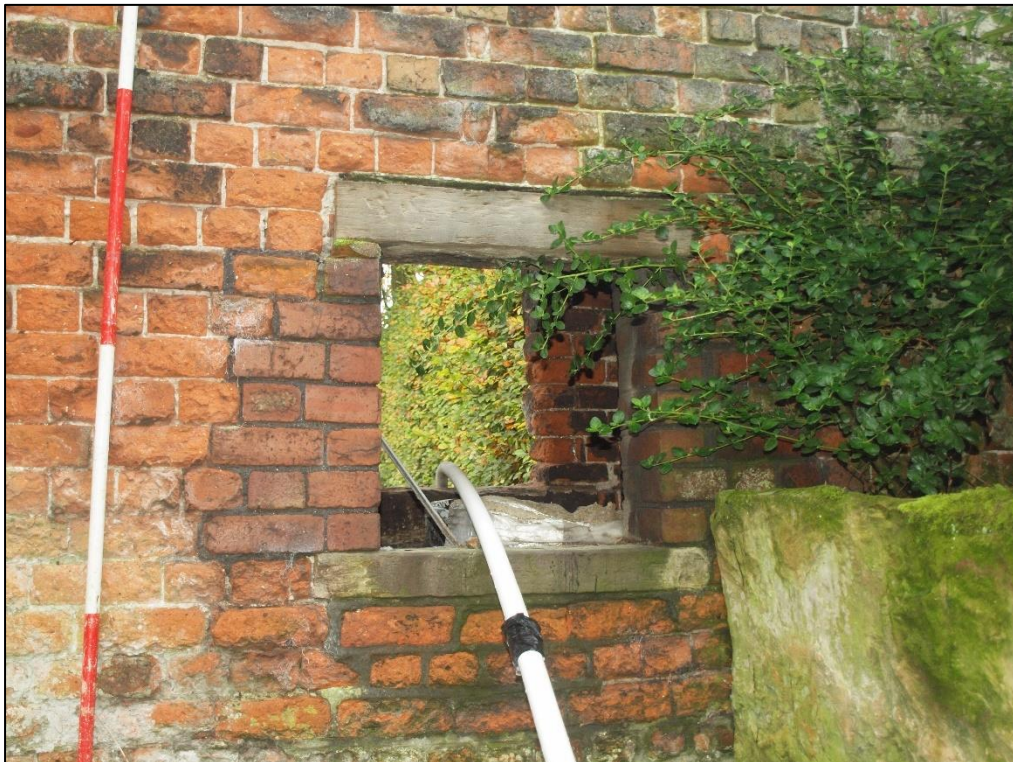
Plate 10: Detail of inserted window shown above

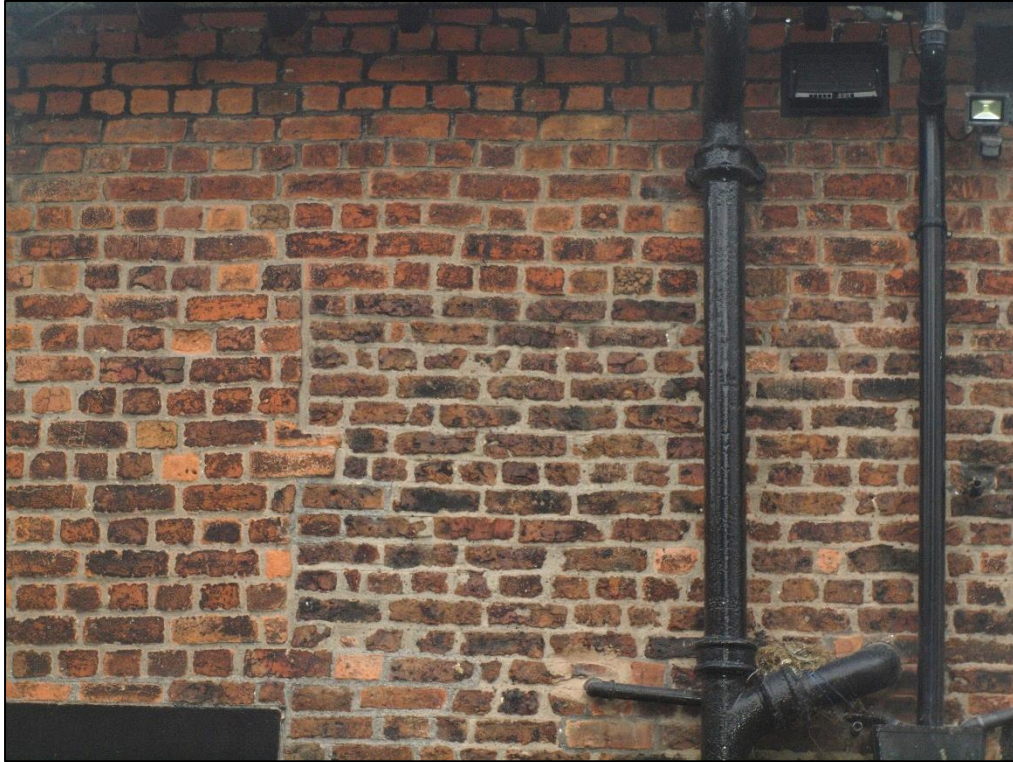
Plate 19: Detail of above showing straight joint and difference in brickwork

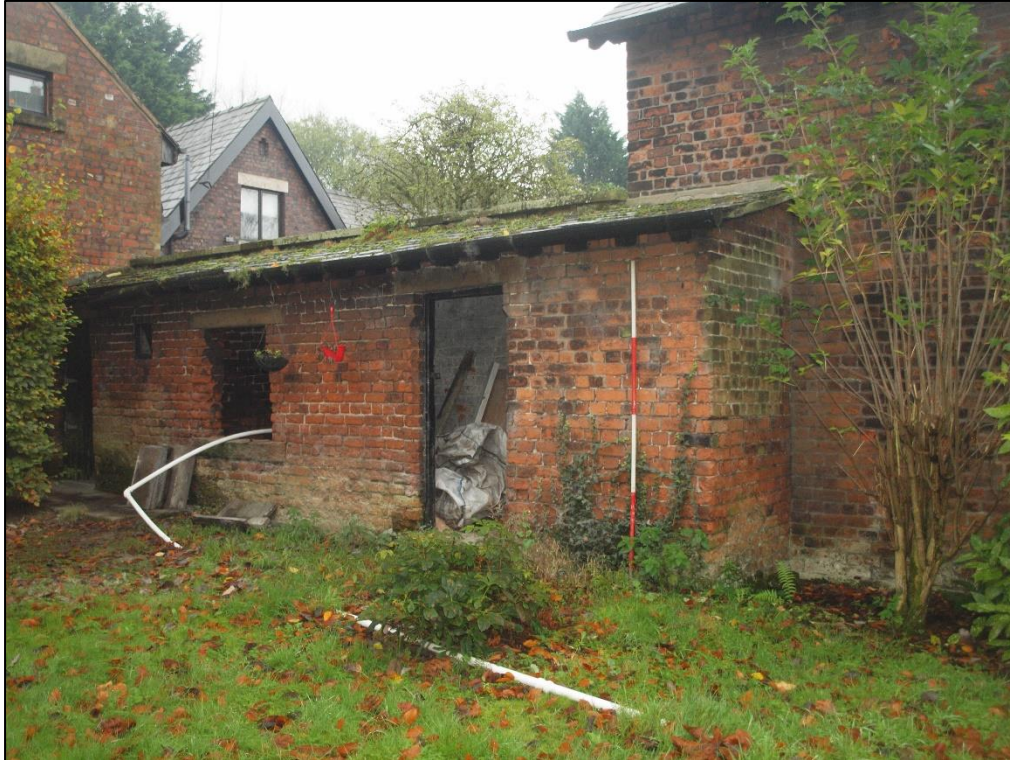
Plate 21: Northeast elevation of outbuilding

6.6 To the east is the face of the single story outbuilding (plate 21). This is also constructed of an orange handmade brick, although of a slightly larger size (9" x 3 1/2" x 4 1/2"). The face contains four openings within it; At the western end is a timber framed personnel doorway with no door hung. To the east and roughly in the centre of the face is a square window with no frame (plate 24). East of this, at the far eastern end is a further doorway with timber door hung. All have heavy sandstone lintels over and the window has a stone cill to match. Finally,

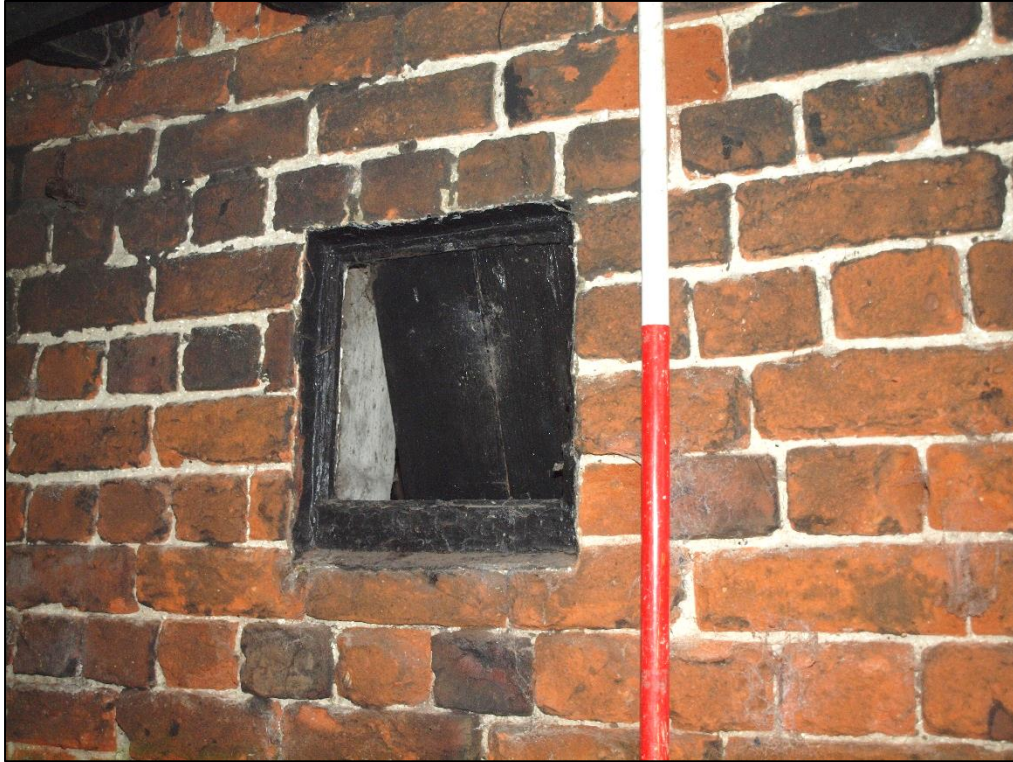
between the window and the easternmost doorway is a small, square timber framed hatch, high in the face (plate 23).

Plate 23: Detail of small hatch

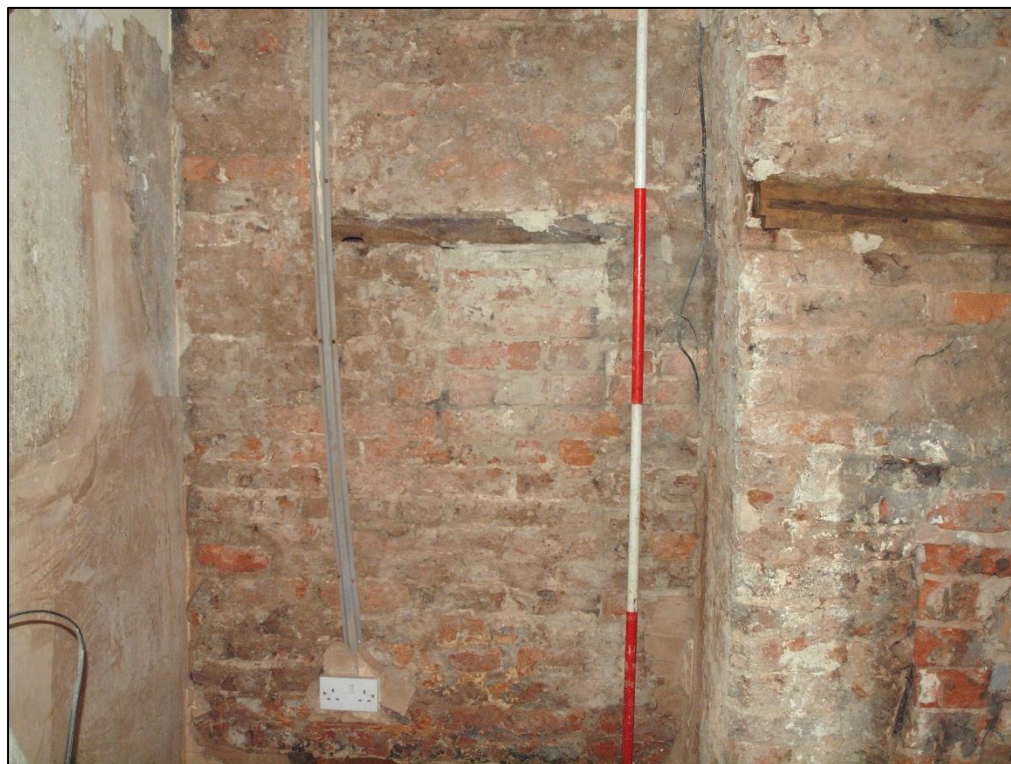
Plate 31: Blocked window to west of fireplace

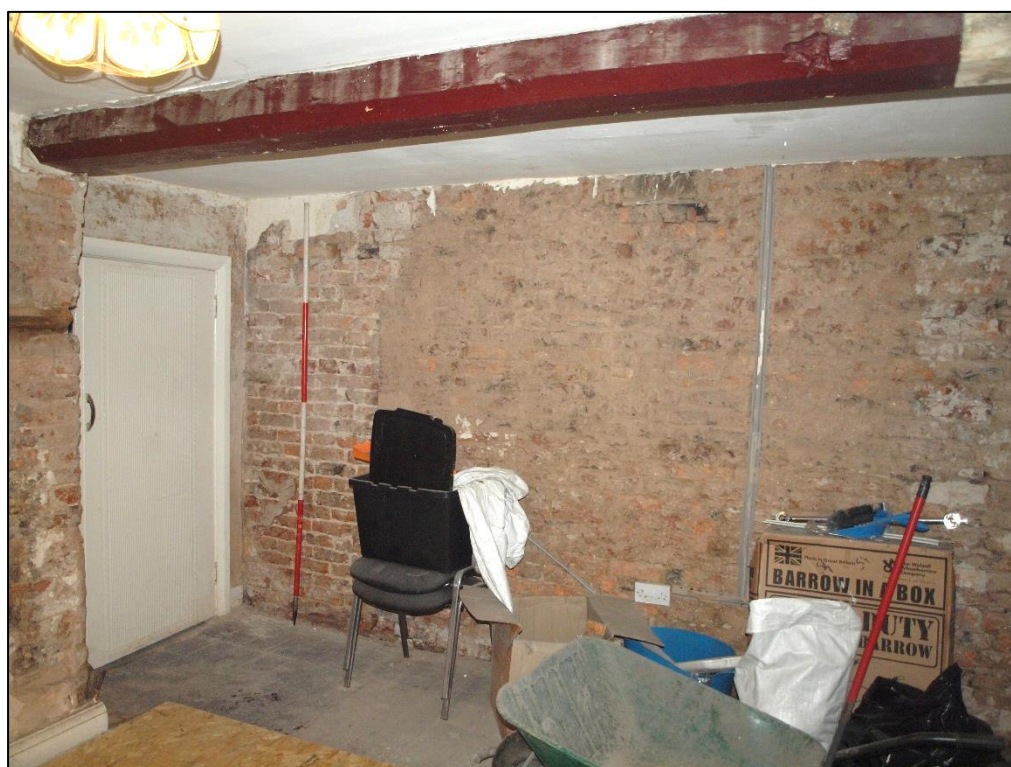
Plate 32: Blocked doorway in northeast wall

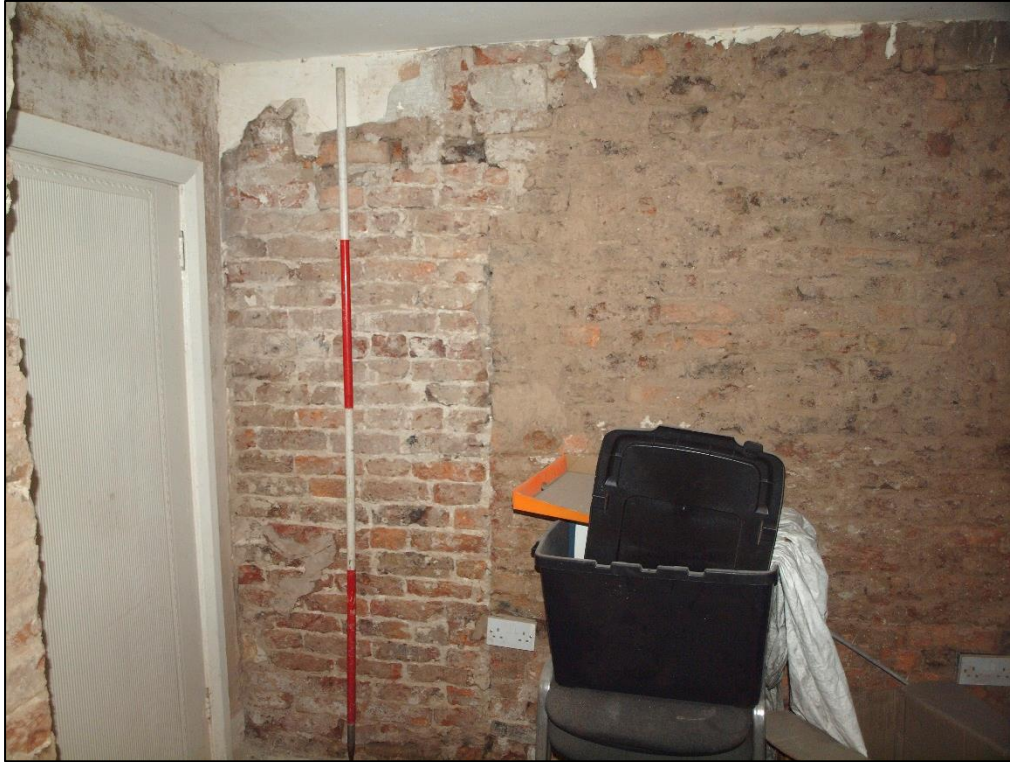
Plate 33: Detail of blocked doorway

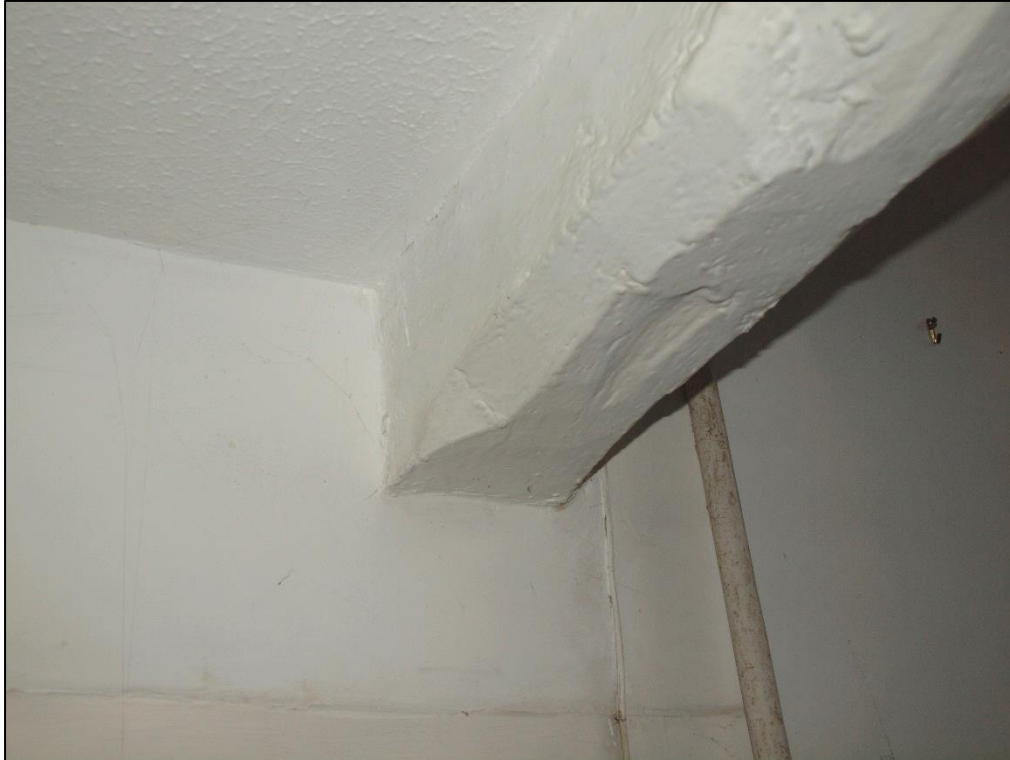
- 6.9 The doorway leads to a small hallway with timber dog-legged stairs rising up towards the northeast. A reused chamfered and stopped beam supports the ceiling (plate 37). A doorway leads to a small area below the staircase, with two stop steps down to a small flagged floor storage area. From the hallway, to the northwest a doorway leads into the kitchen. The kitchen walls are again bare brick and in the southwest wall the blocked doorway to the living room is visible with timber lintel over (plate 41). In the northwest wall a small blocked

Plate 37: Reused beam in staircase showing blocked soffit

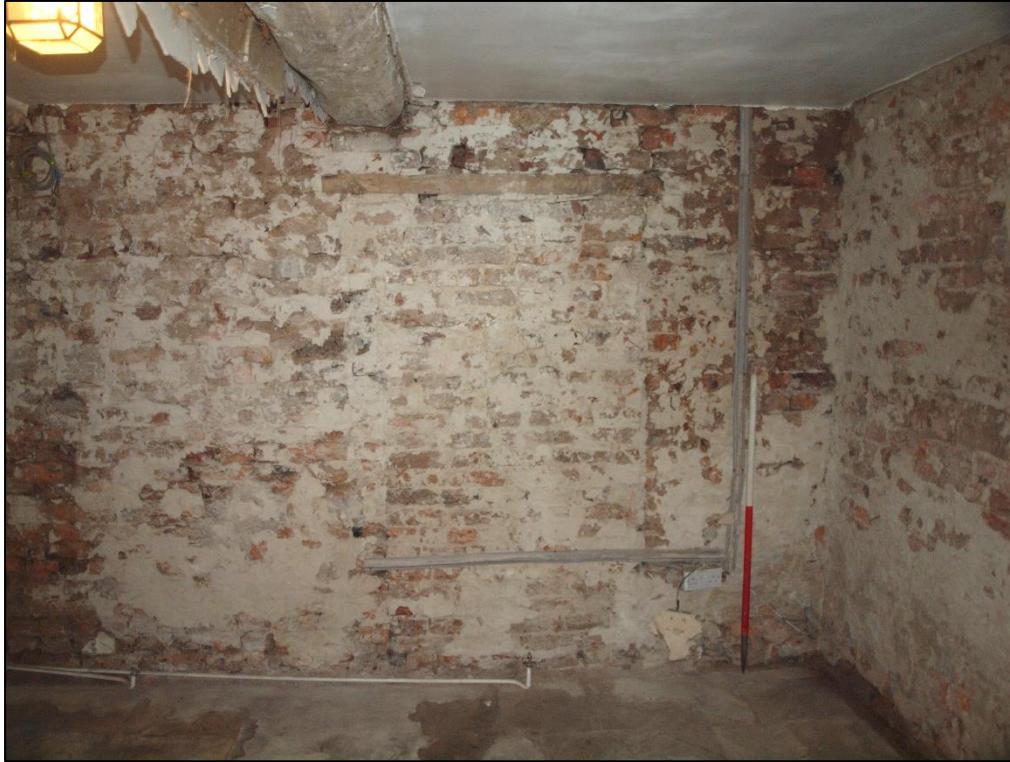
Plate 41: Detail of blocked door to living room

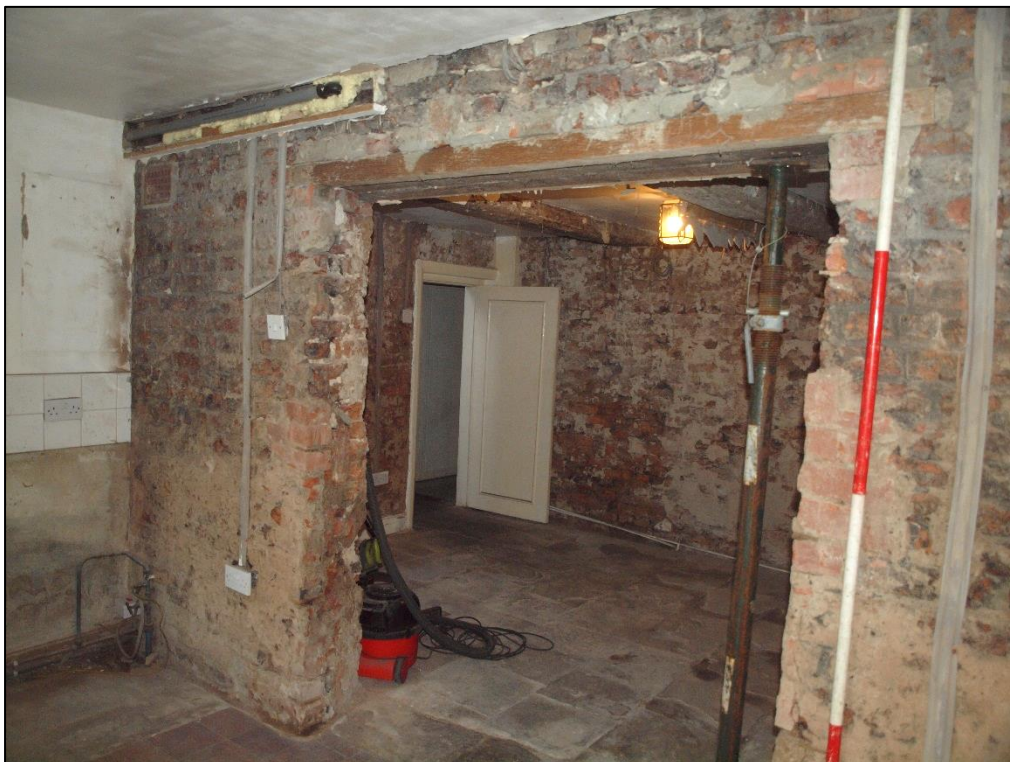
Plate 44: Inserted opening to kitchen extension

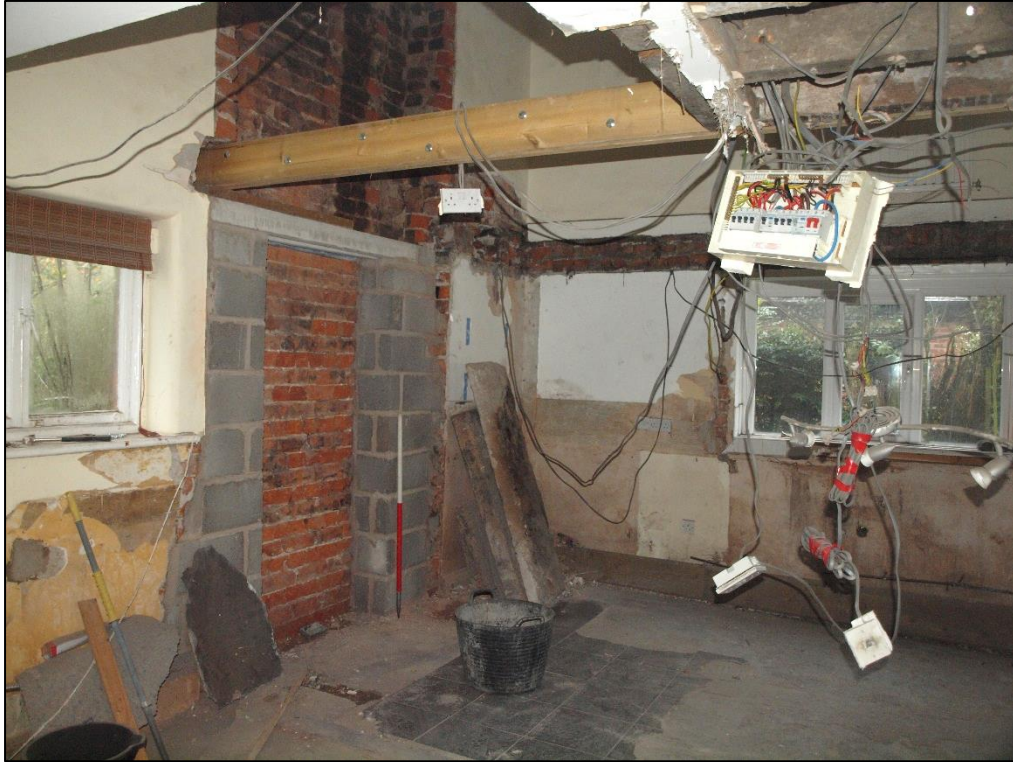
Plate 47: Interior of extension showing removed fireplace and ceiling

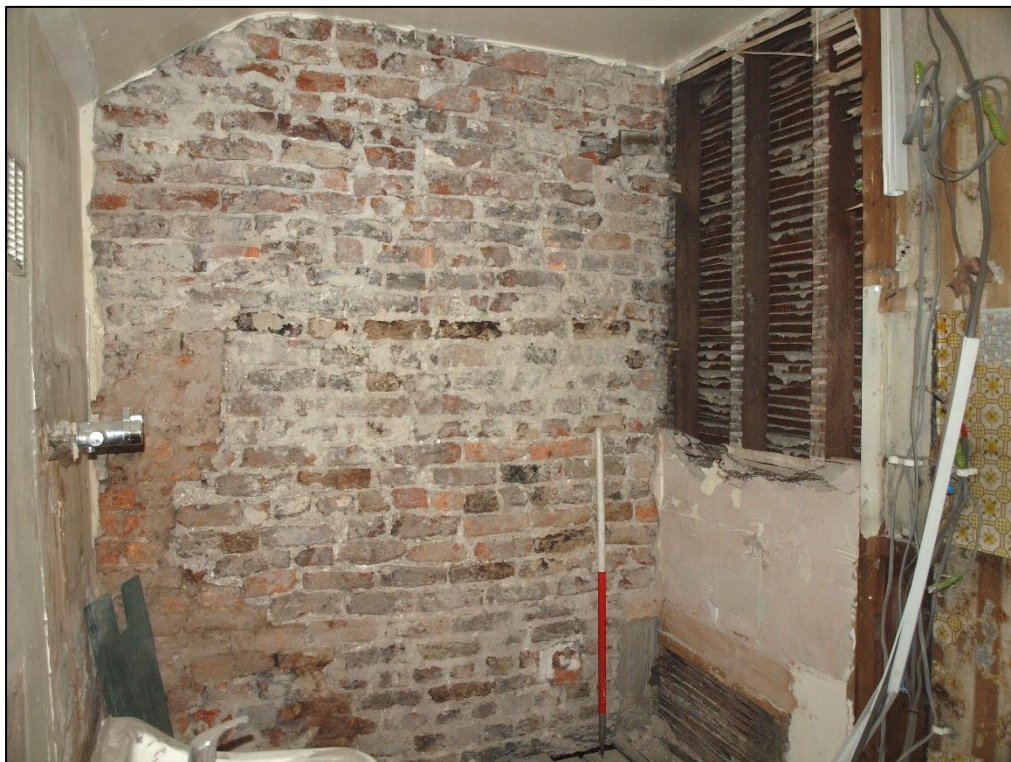
Plate 72: As above showing blocked opening in brickwork and lath and plaster wall

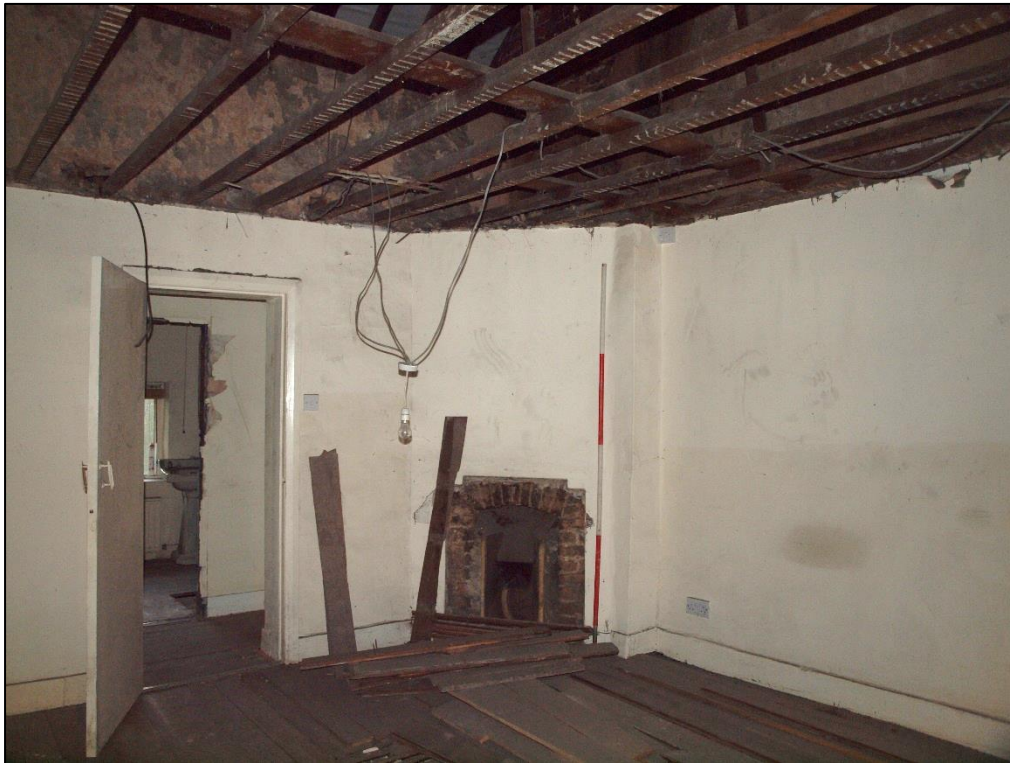
6.13 Towards the east end of the landing a pair of doors lie to the northeast and southwest sides. That to the northeast leads to a bathroom (plate 71), the walls having been stripped back to the bare brick and with a blocked opening visible in the southeast wall; the former gable end of the original building (plate 72). The southwest wall is shown to be lath and plaster. To the southwest the doorway leads to a further bedroom (plate 73). Like the previous, the floor has

Plate 73: Bedroom to south corner showing corner fireplace

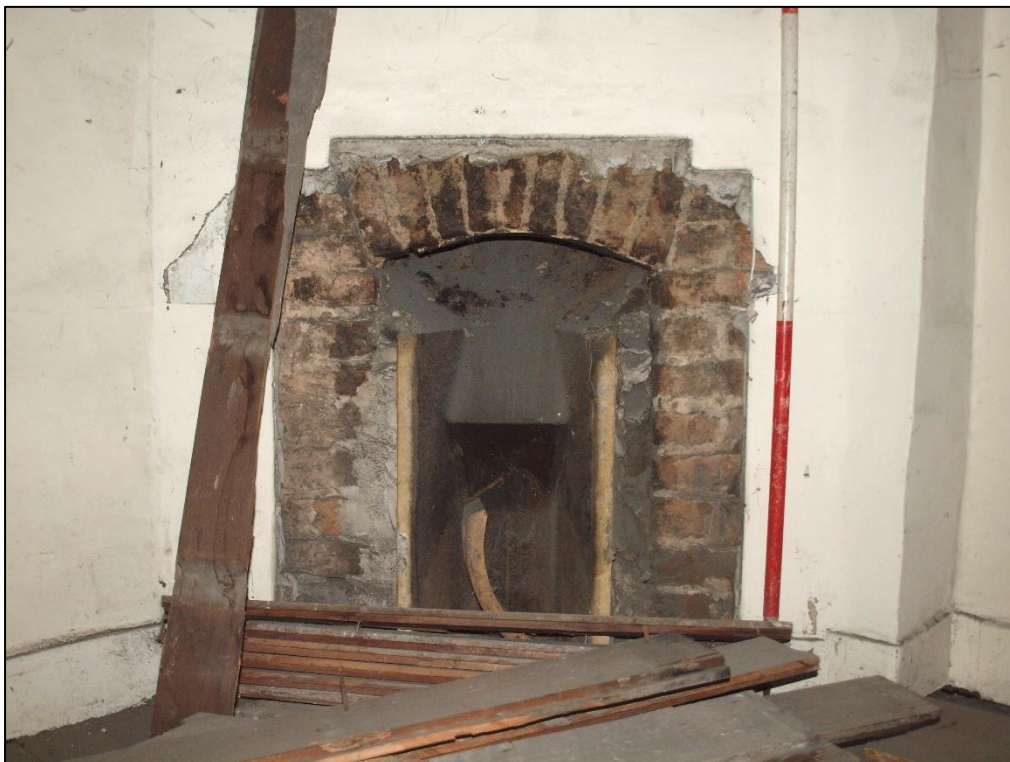
been stripped back to the bare boards (130mm wide) and the plaster ceiling removed. A fireplace lies in the eastern corner of the room (plate 74), the flue from the fireplace below having moved to accommodate it. As with the previous bedroom the attic space shows that the roof has been replaced. At the east end of the landing corridor the floor has been removed, looking into the open space of the eastern extension. This shows a removed fireplace in the northeast wall, above the removed fireplace found below. The ceiling is again plastered.

Plate 74: Detail of corner fireplace

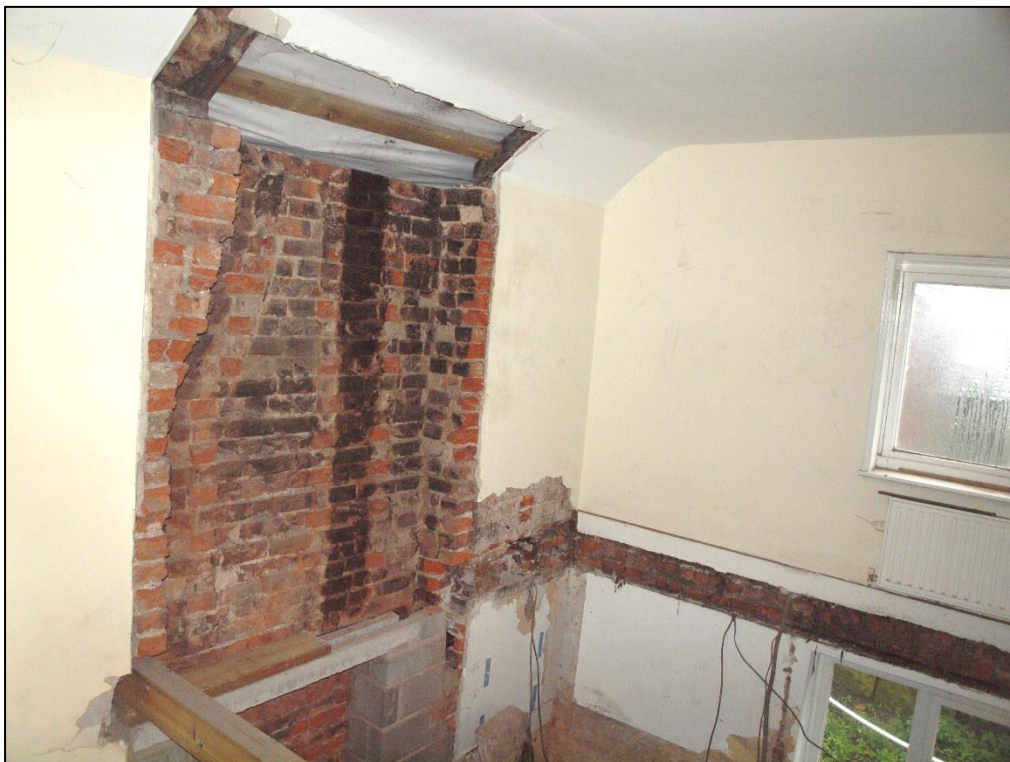
Plate 76: Extension showing removed fireplace
