THE ARCHAEOLOGY CO.

Dean Gate Farm, Bolton
Historic Building Survey

May 2022

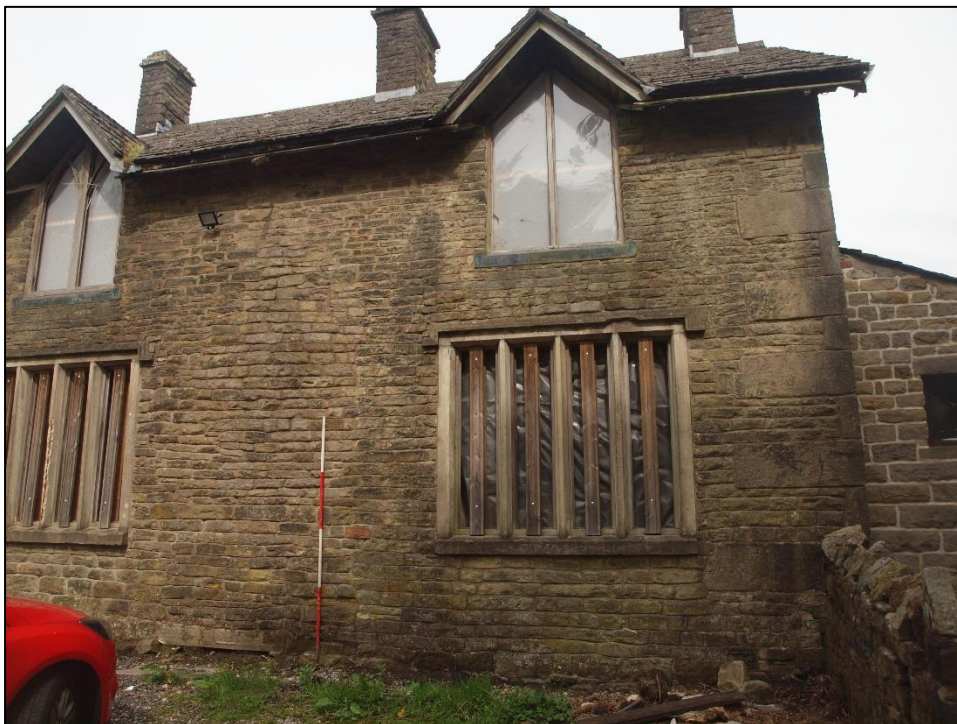
Plate 12: Eastern end showing rough joint

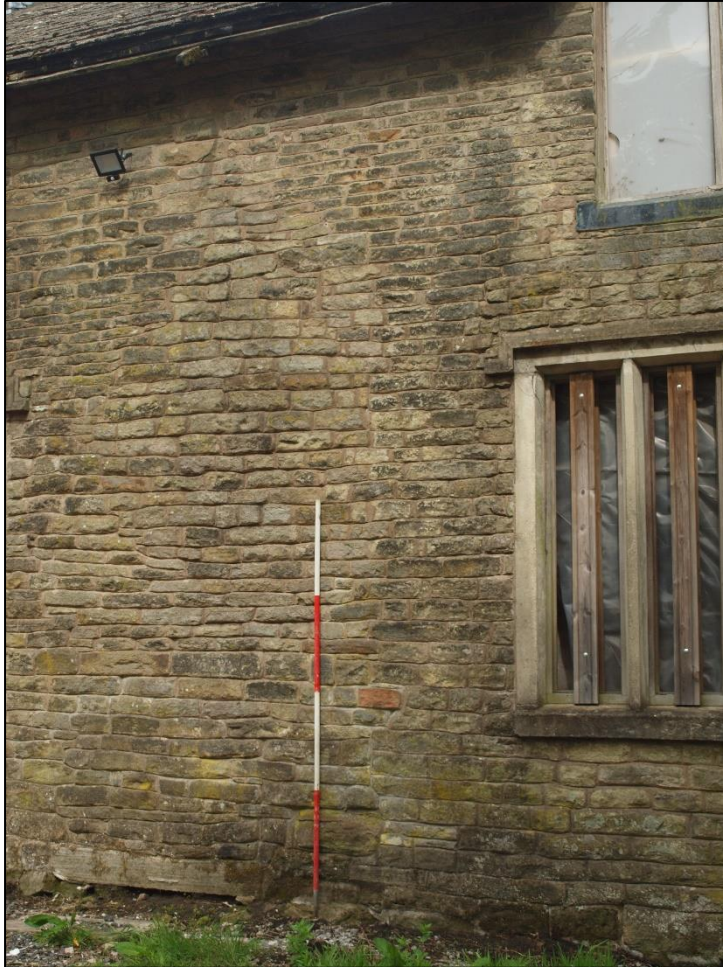
Plate 13: Detail of joint shown above

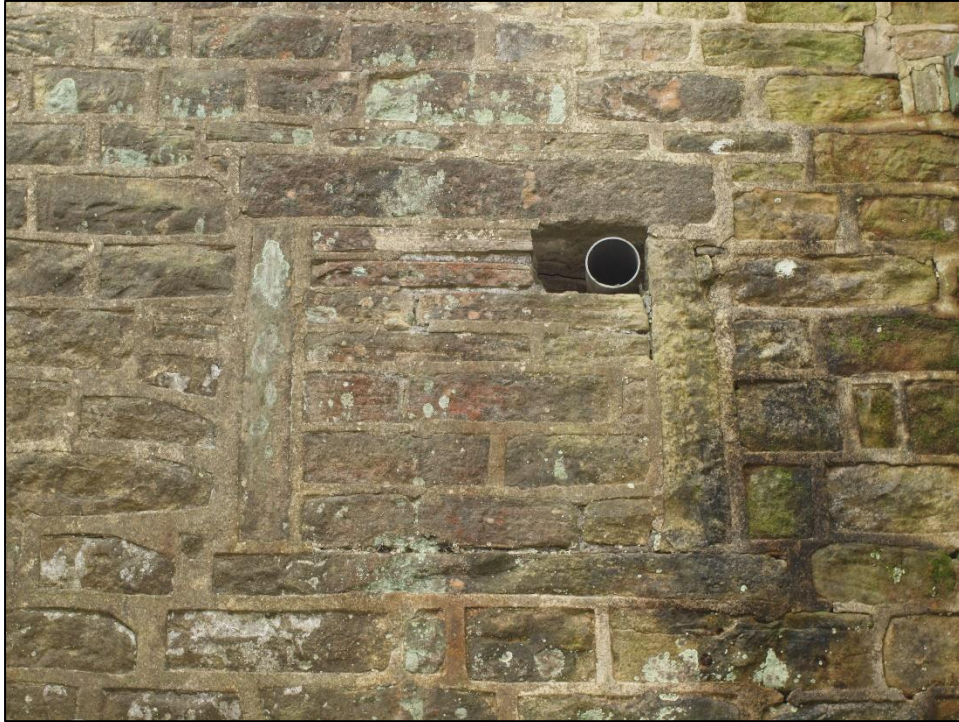
Plate 21: Detail of blocked window

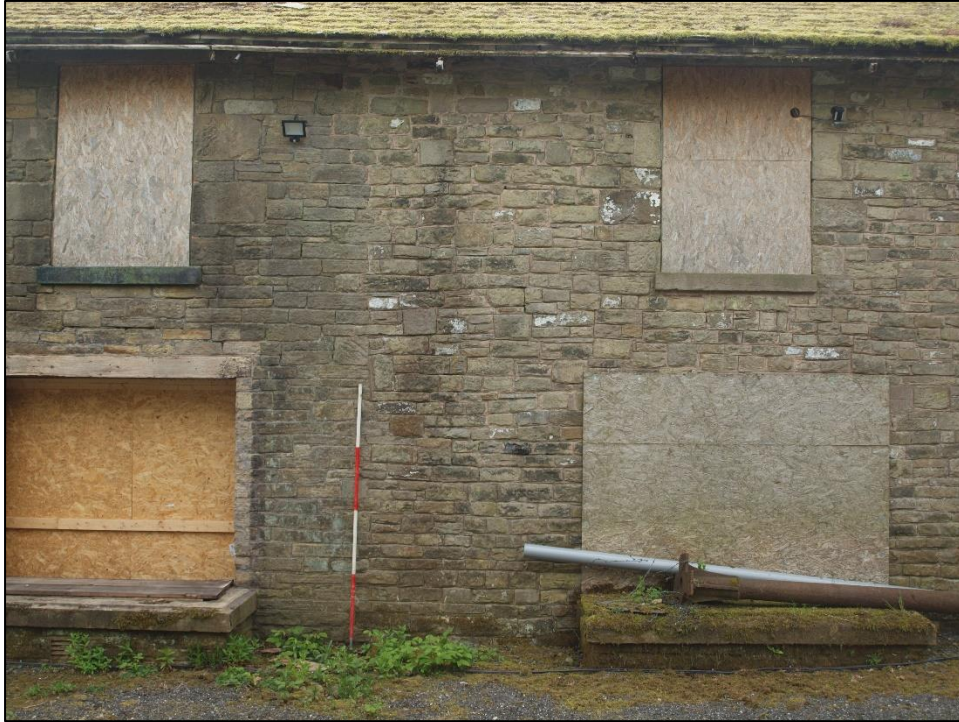
Plate 23: East end showing rough joint

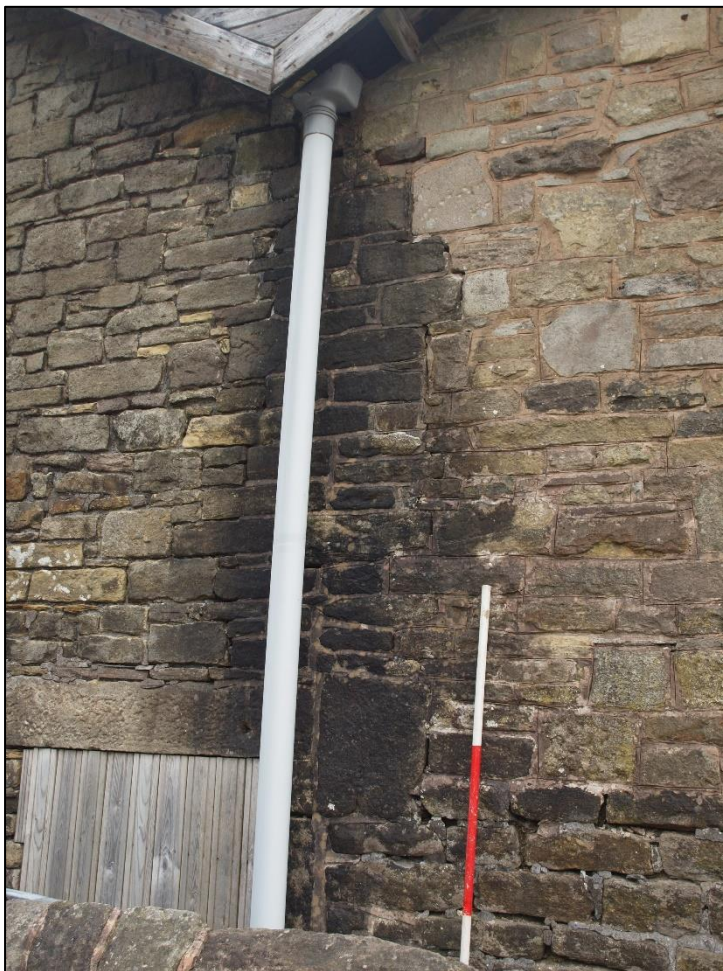
has a sandstone cill and lintel. A rough joint runs up the face between the gables, showing where the southern has been rebuilt at first floor level. A round pitching eye is located at first floor level, formed of concrete and badly damaged.

Plate 32: Rough joint detail

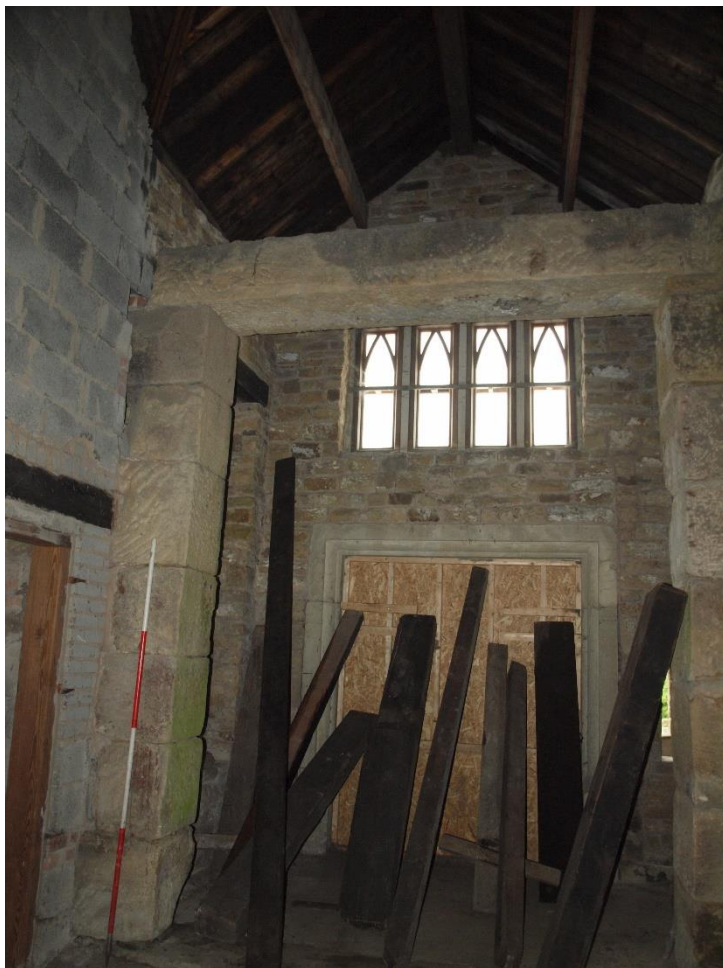
Plate 34: Porch detail showing reused stone

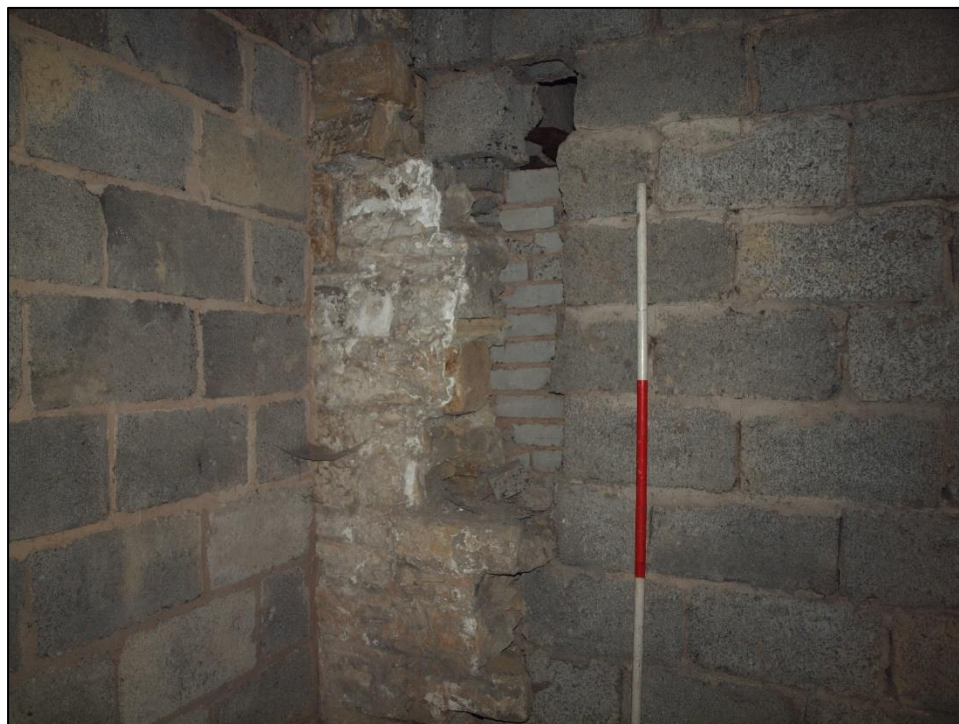
Plate 39: Remains of stone wall stub

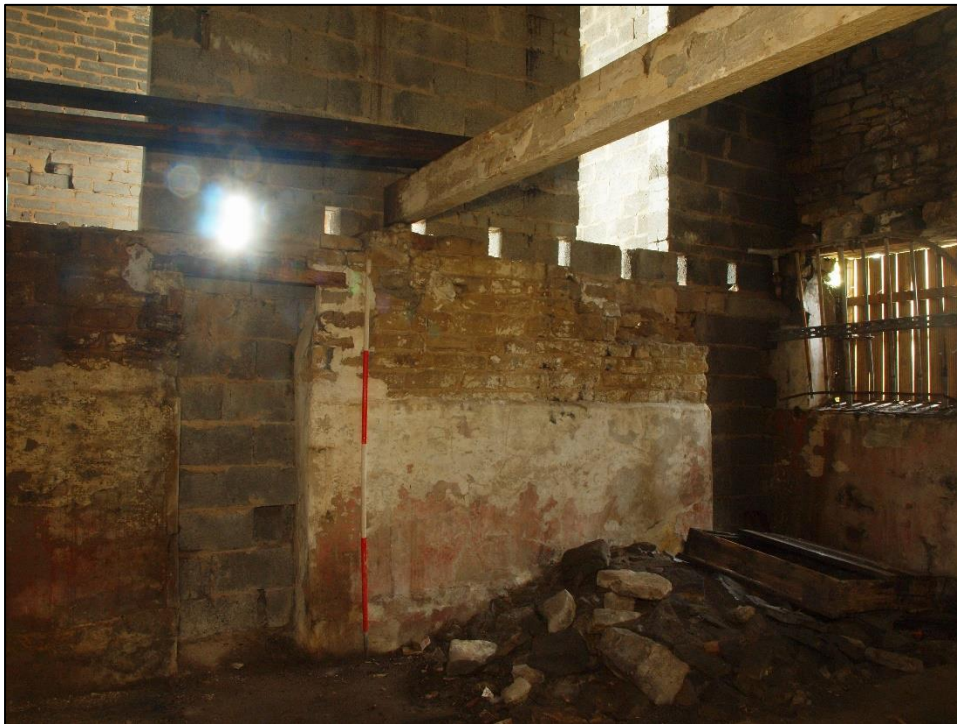
Plate 48: Blocked doorways in south wall

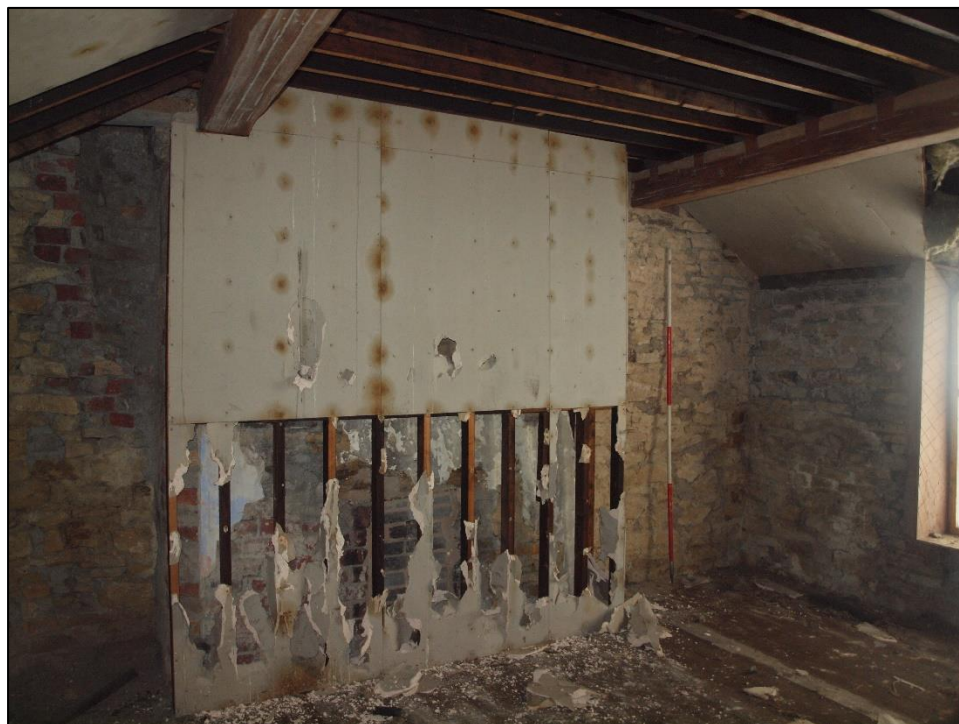
- 6.8 (Plates 64 - 72) The first floor is only present at the eastern side of the building, having been removed elsewhere and matches the layout of the ground floor, with a few inserted stud walls. The east – west corridor (plate 64) leads to a pair of rooms to the north side. The western is formed of concrete block, with the eastern showing stone construction. A wide landing lies at the eastern end, with modern timber posts supporting the machine cut timber trusses (plates 70 – 72). To the south of the corridor the large room has been divided by a concrete block wall with openings to the north and south (plates 65 – 67). At the east side stud walls have been inserted to provide a wc and bathroom. The stone work is visible here in the east wall, although has been replaced with brick to the south. To the east, in the 6th bay is a single room with landing and removed staircase to the north. The southern room contains a fireplace in the east wall. This is stone although has been modified with brick and later blocked (plates 68 & 69).

Plate 69: Stone fireplace, blocked with brick and plastered over

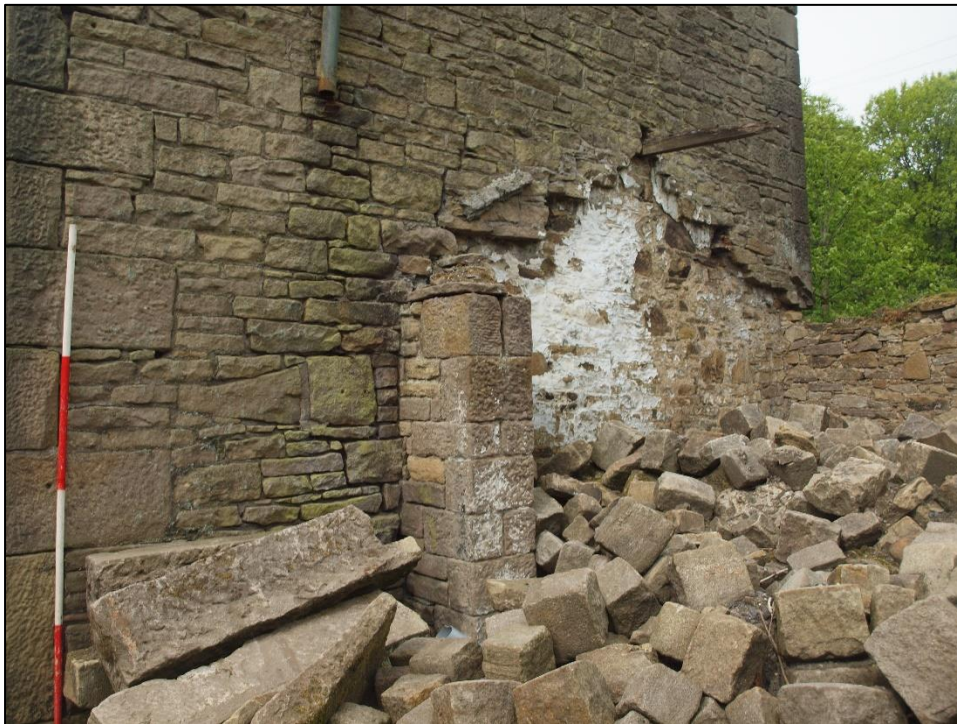
Plate 78: Interior of first unit showing wall scar

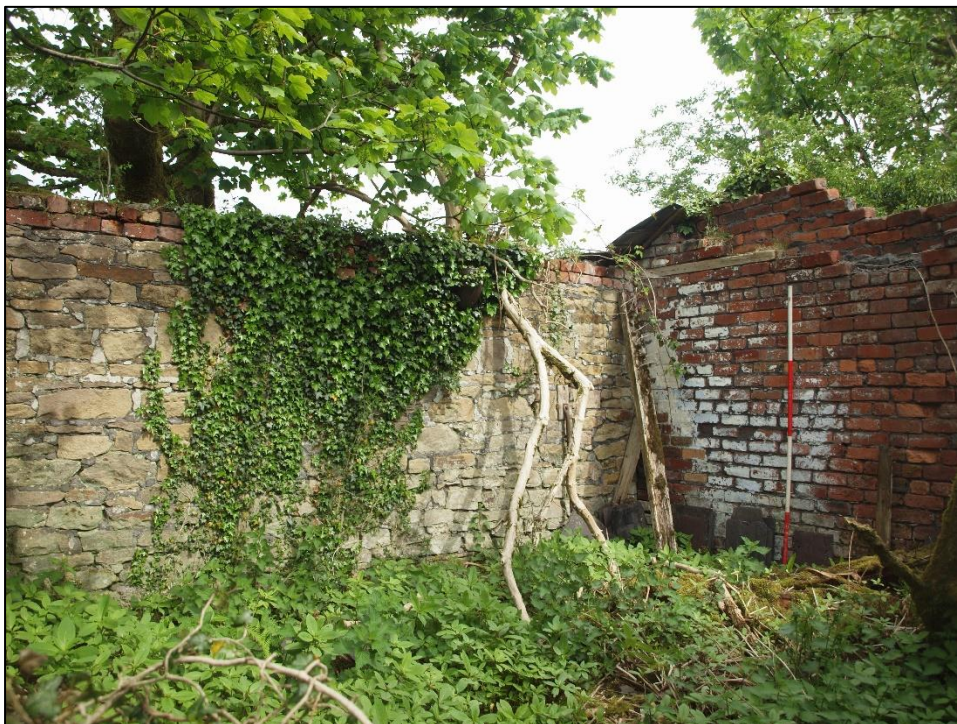
Plate 84: Interior of third unit showing inserted brick wall to the east
