Ling Villa Barn, Mickleton
Historic Building Survey

January 2023

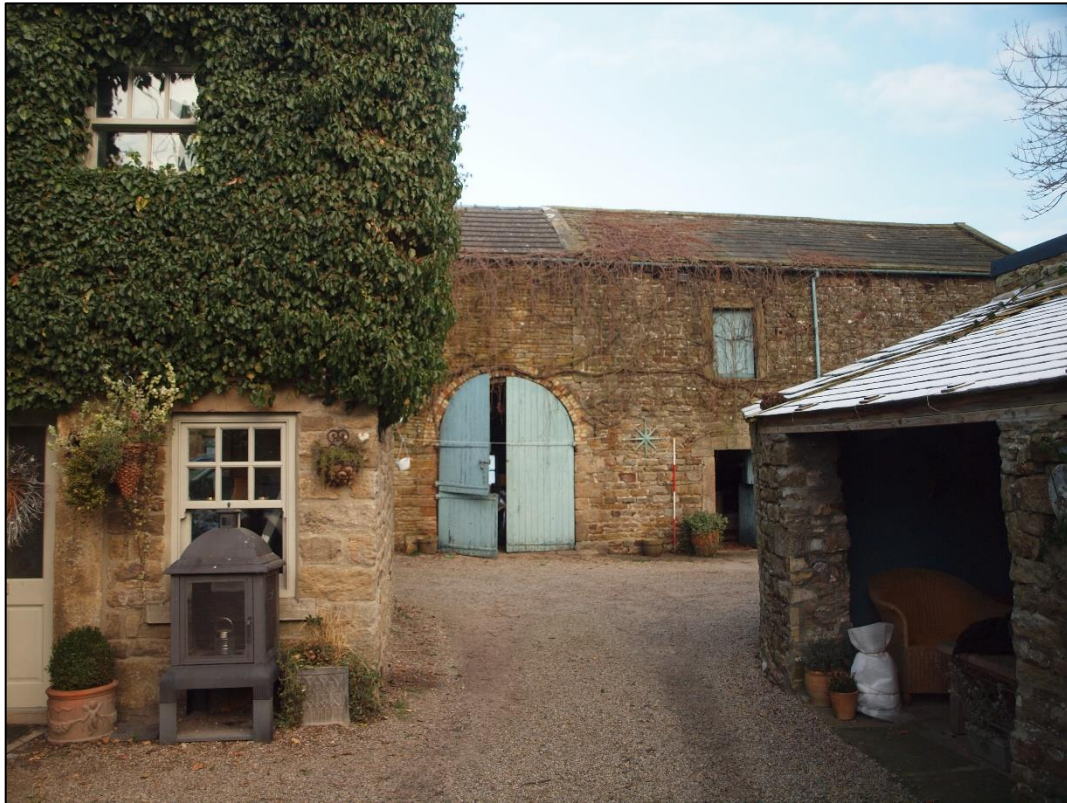
- 6.1 (Plate 1) The building is a two story stone built barn of 11 bays, with a small single story extension to the east side. The building is aligned roughly east – west, with the main frontage facing south. At the western end the building is attached to a neighbouring dwelling, and the first 2 bays are a single story only.

Plate 1: Ling Villa barn seen in relation to Ling Villa (left) looking north

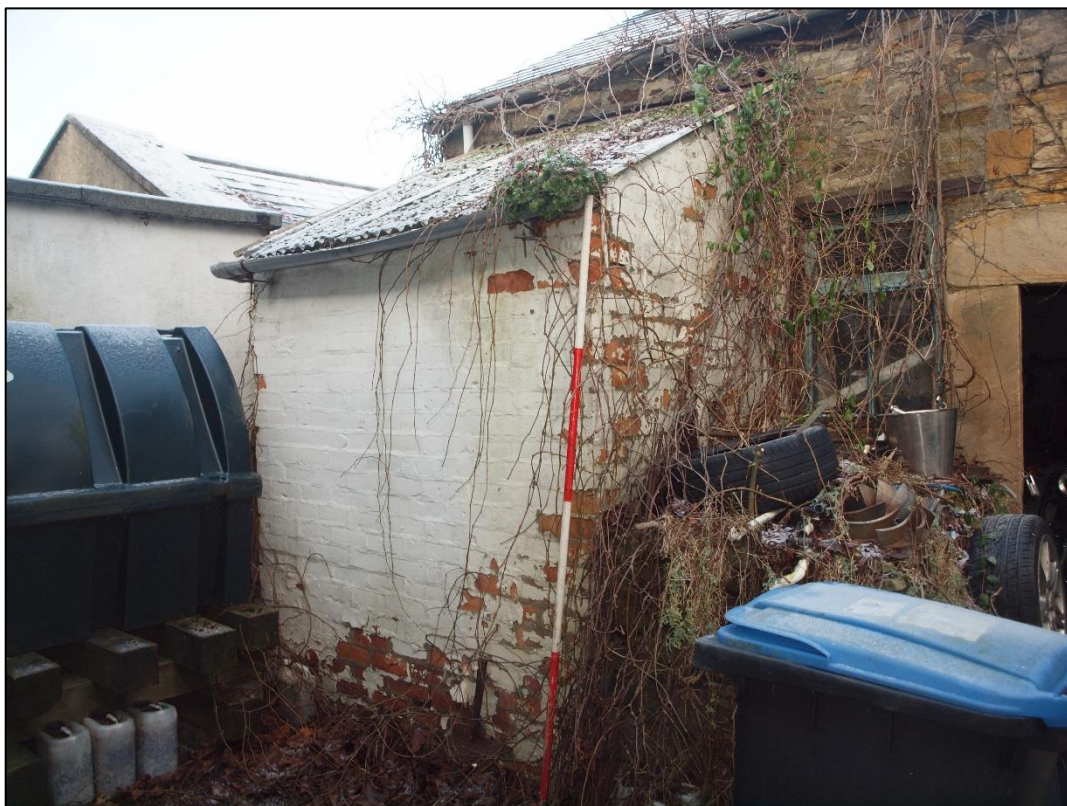
Plate 2: Brick lean-to to bay 1 looking northwest

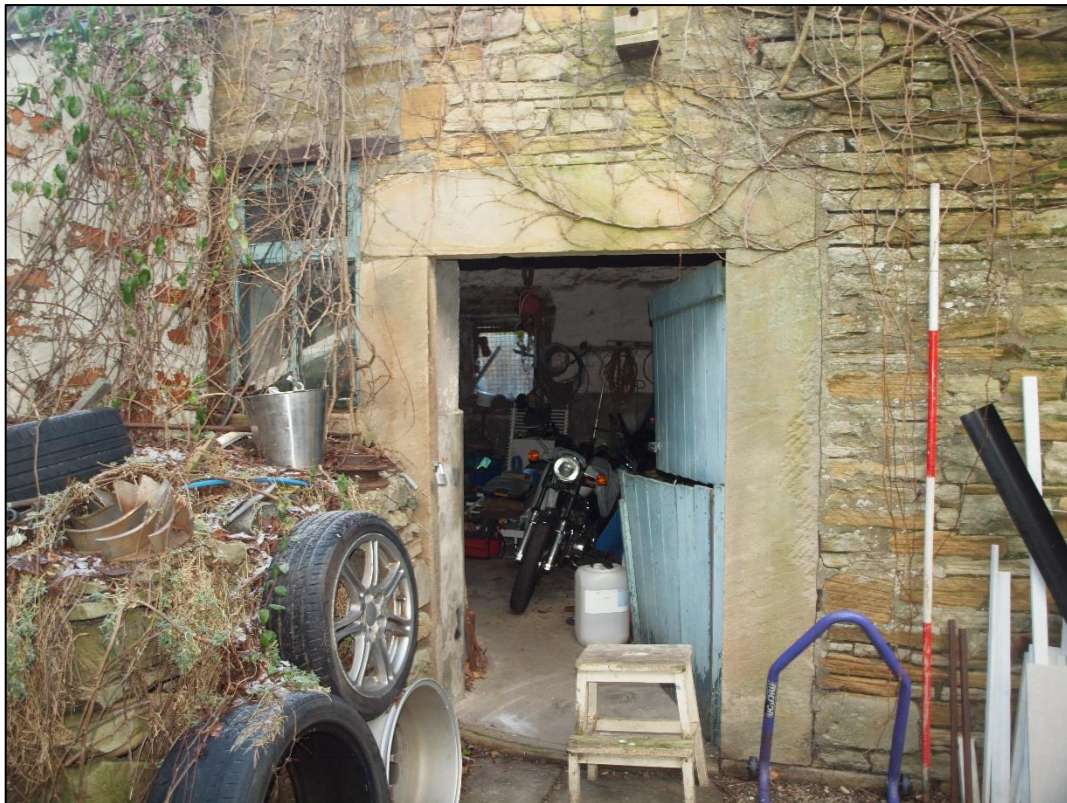
Plate 3: Doorway and window to bay 2 looking north

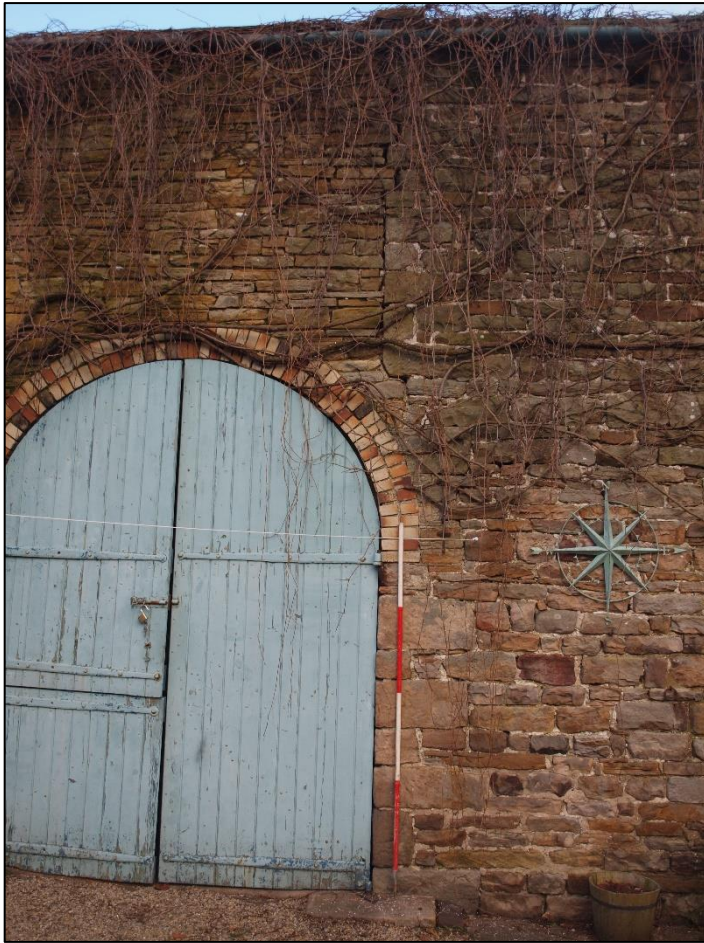
Plate 9: As above showing straight joint at first floor level looking north

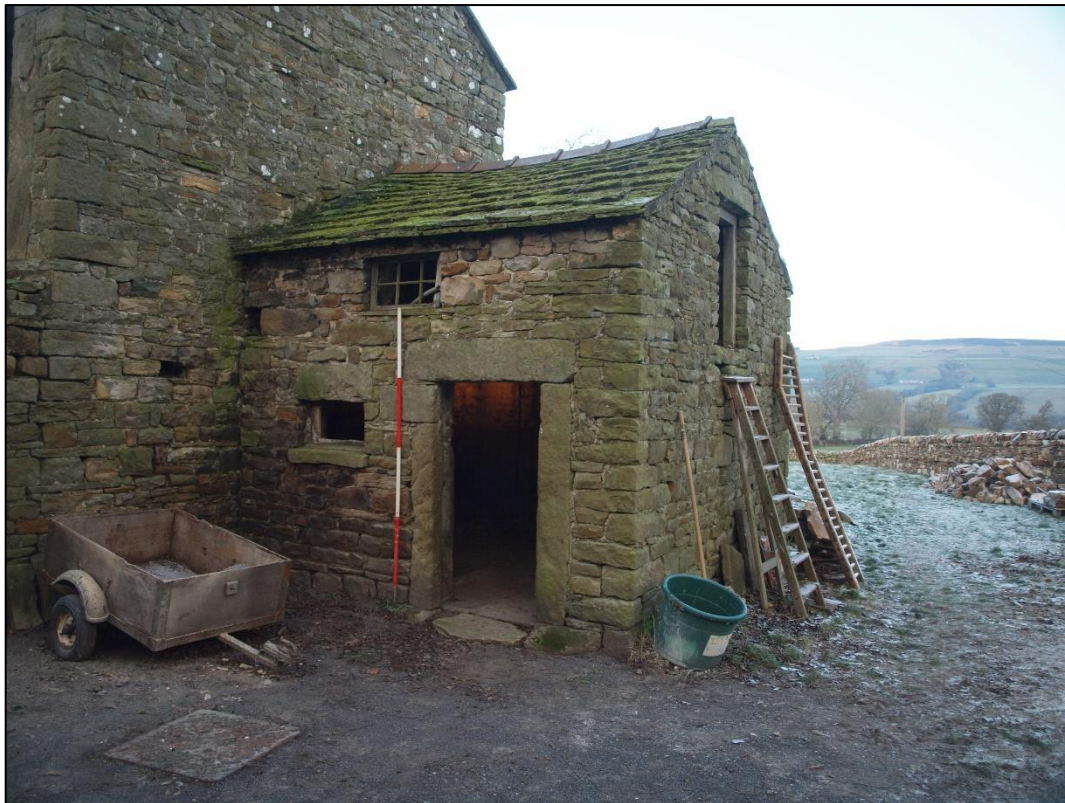
- 6.3 (Plates 17 & 18) Bay 11 is set back from the main barn elevation. It contains a doorway with sandstone surround to the east side with a small landscape window to the west with sandstone cill and lintel. Between them and above lies a further landscape window, close to the eaves.

Plate 17: Bay 11 extension looking northwest

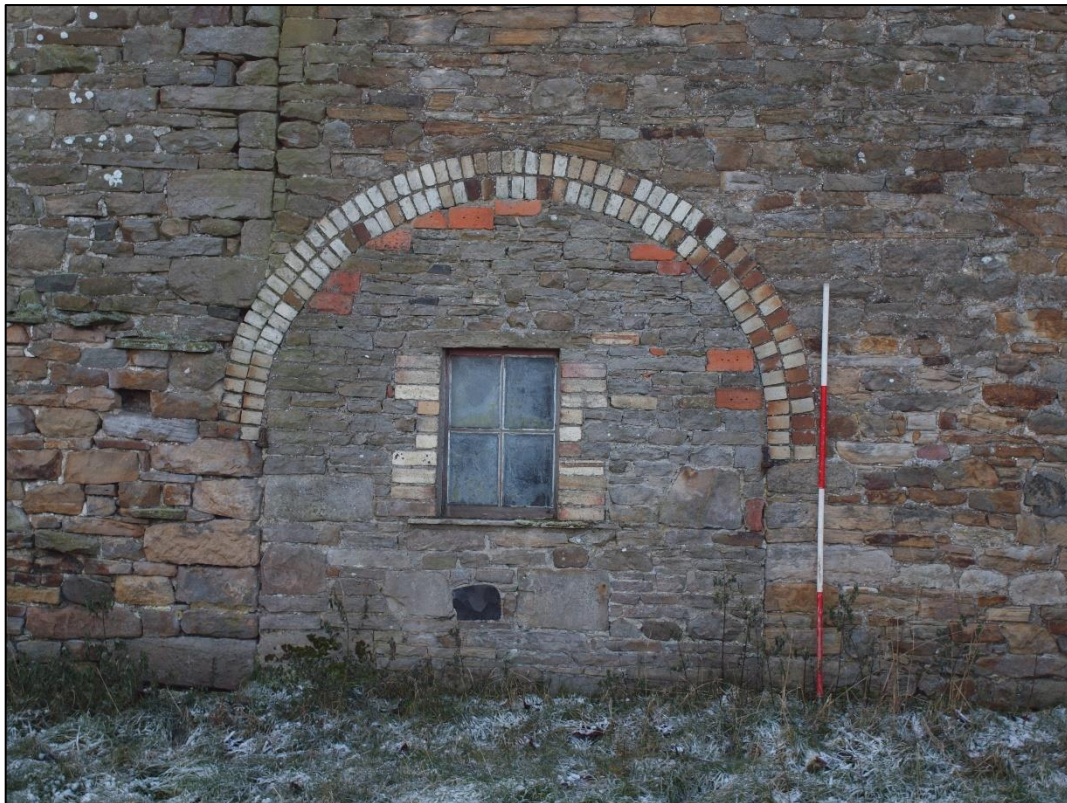
Plate 27: Blocked barn door with window inserted looking south

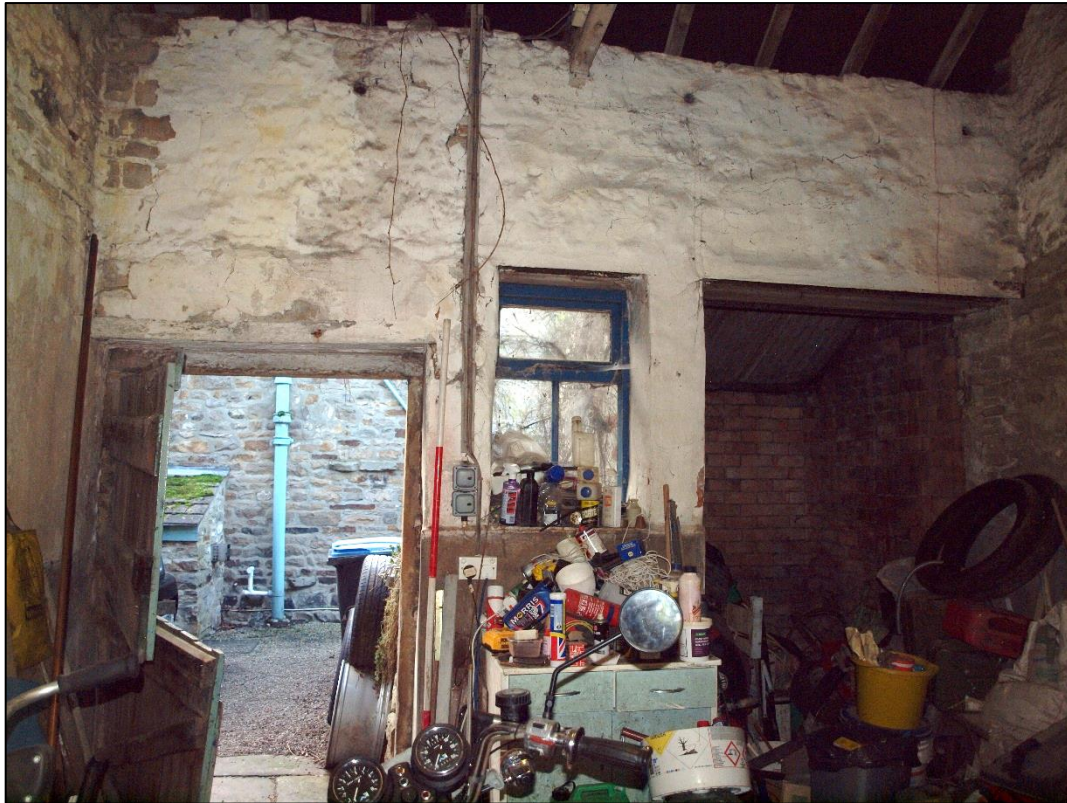
Plate 31: As above showing inserted opening to brick lean-to looking south

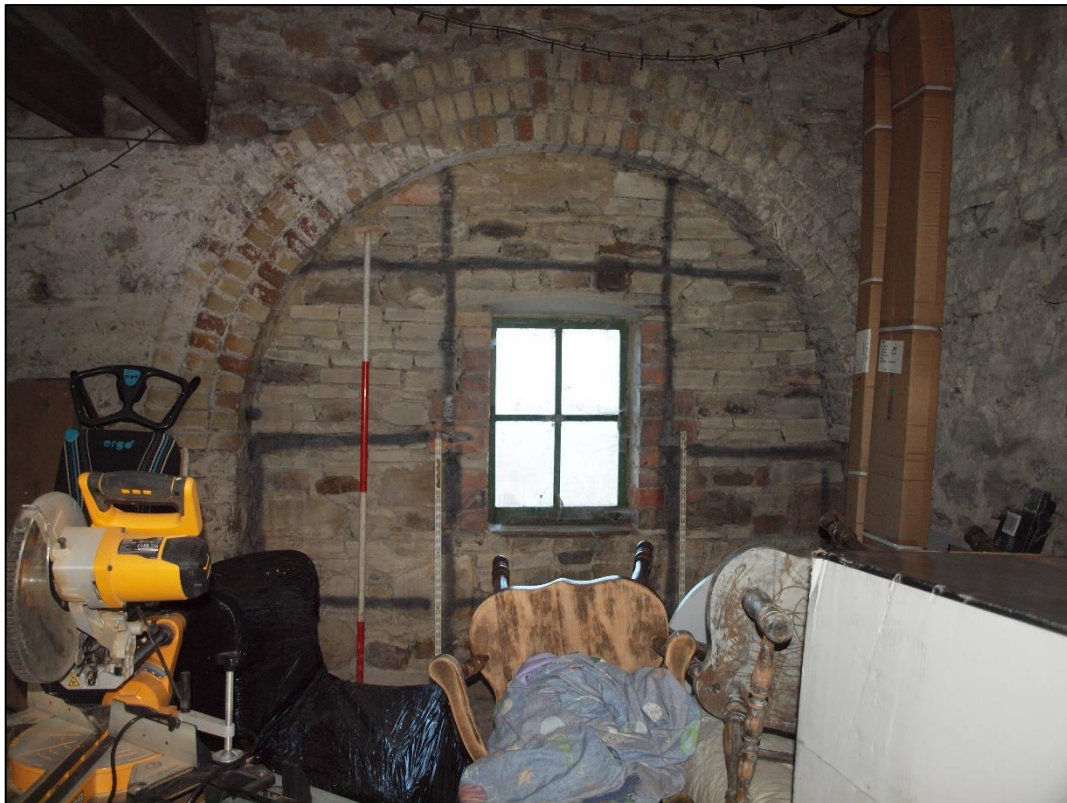
Plate 37: Blocked barn door in north wall looking north

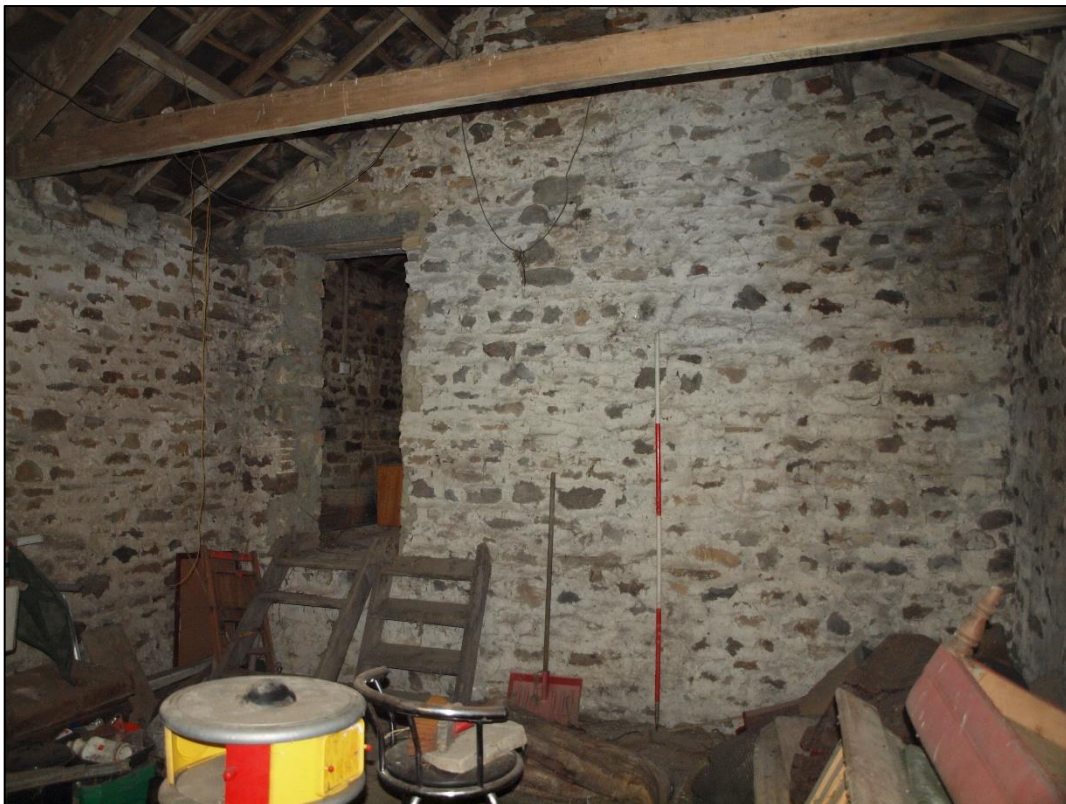
Plate 52: Internal cross wall of barn showing inserted doorway looking southwest

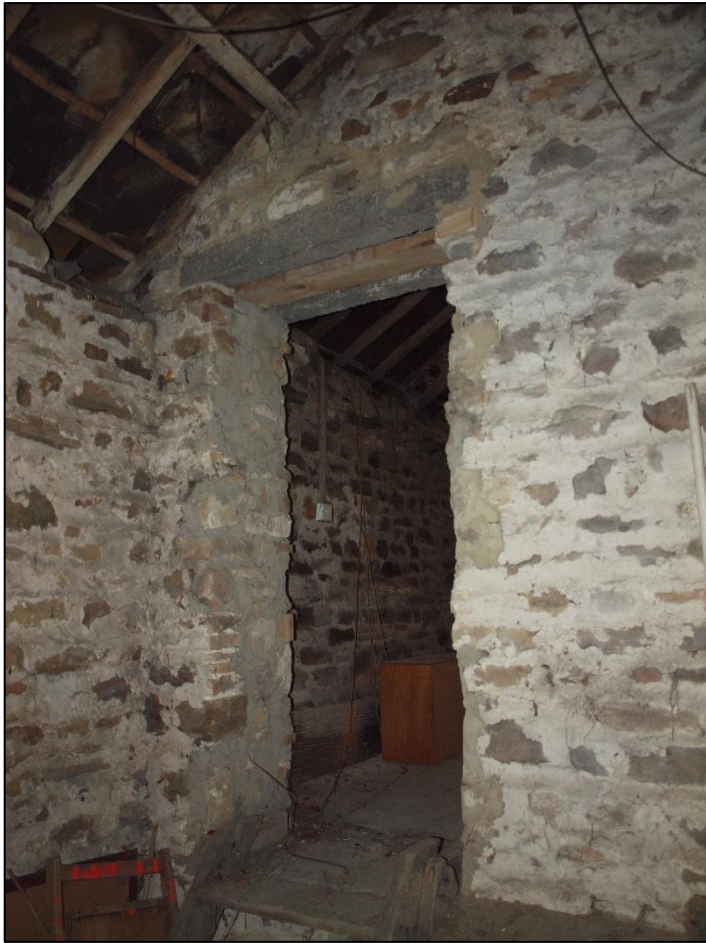
Plate 53: Detail of inserted doorway looking southwest

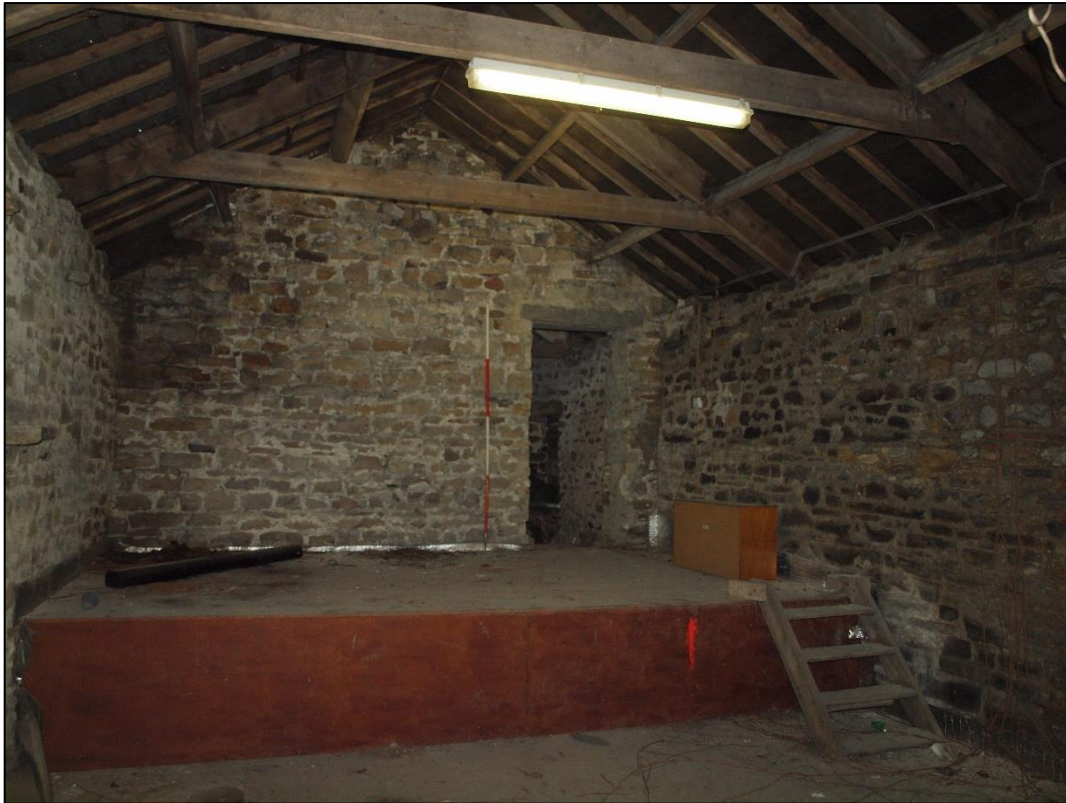
Plate 63: Former external west gable of barn with door inserted looking east
