Monument House, St Mary's Square, Gloucester, Gloucestershire

An Archaeological Watching Brief Report

Client:	Emily Shepherd on behalf of Dean and Chapter Gloucester Cathedral
Local Authority:	Gloucester City Council
Planning ref:	17/00937/FUL
LBC consent:	17/00944/LBC
Historic England List no	1245669
NGR:	SO 83013 18873
Project no:	UA181
Author:	Chiz Harward BA MIfA
Date:	April 19th 2018
Site Code:	MON18
OASIS ref:	urbanarc1- 301647

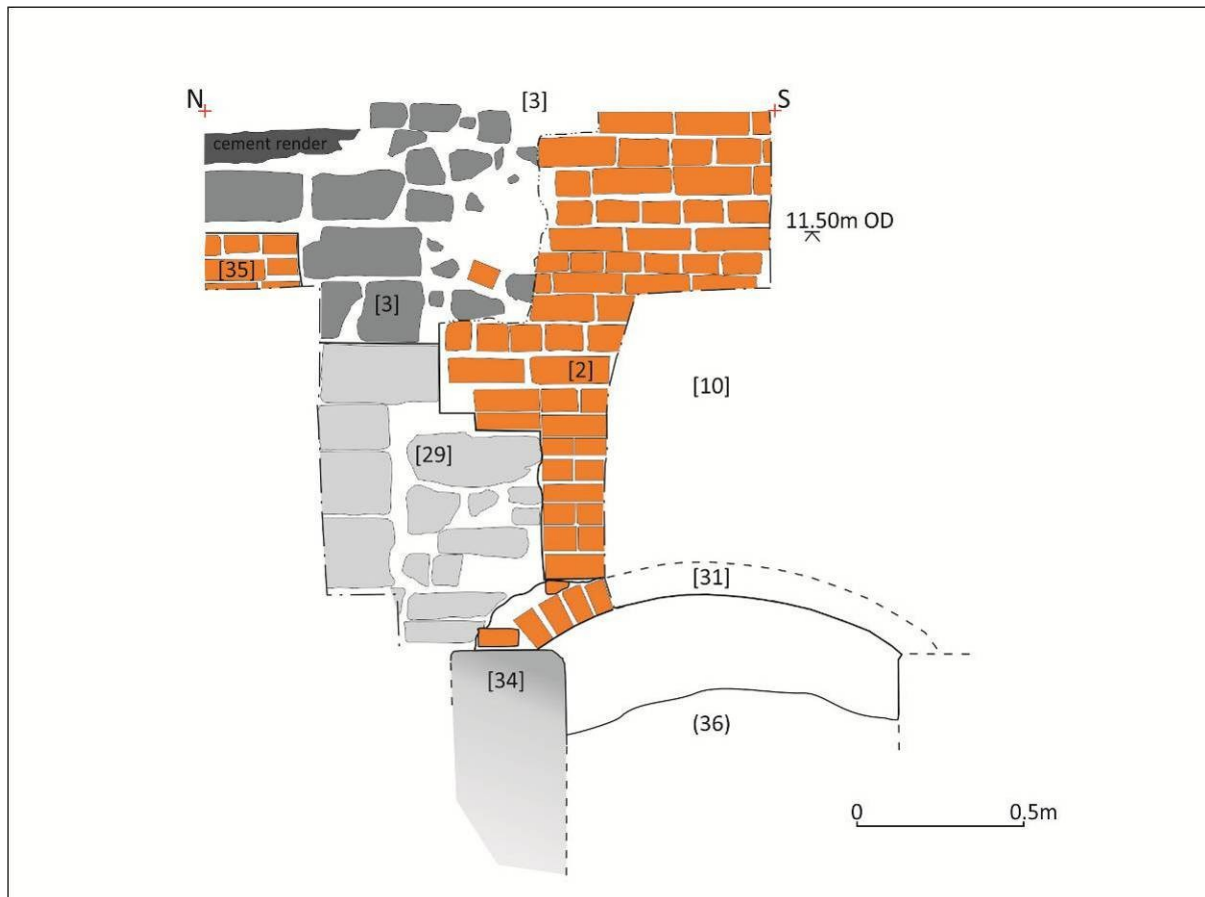
- 6.9 The Monument House foundation was built respecting culvert [34]: the foundation trench [32] was dug down to the top of the culvert walls, and the line of the wall was immediately north of the brick vaulted roof (Fig. 4). The culvert was incorporated beneath the new building, and may be the reason there is no northern basement. Cracks in the east wall of Monument House suggest the culvert is causing the wall to break its back.

Fig. 4 West facing section along eastern boundary of the site showing culvert

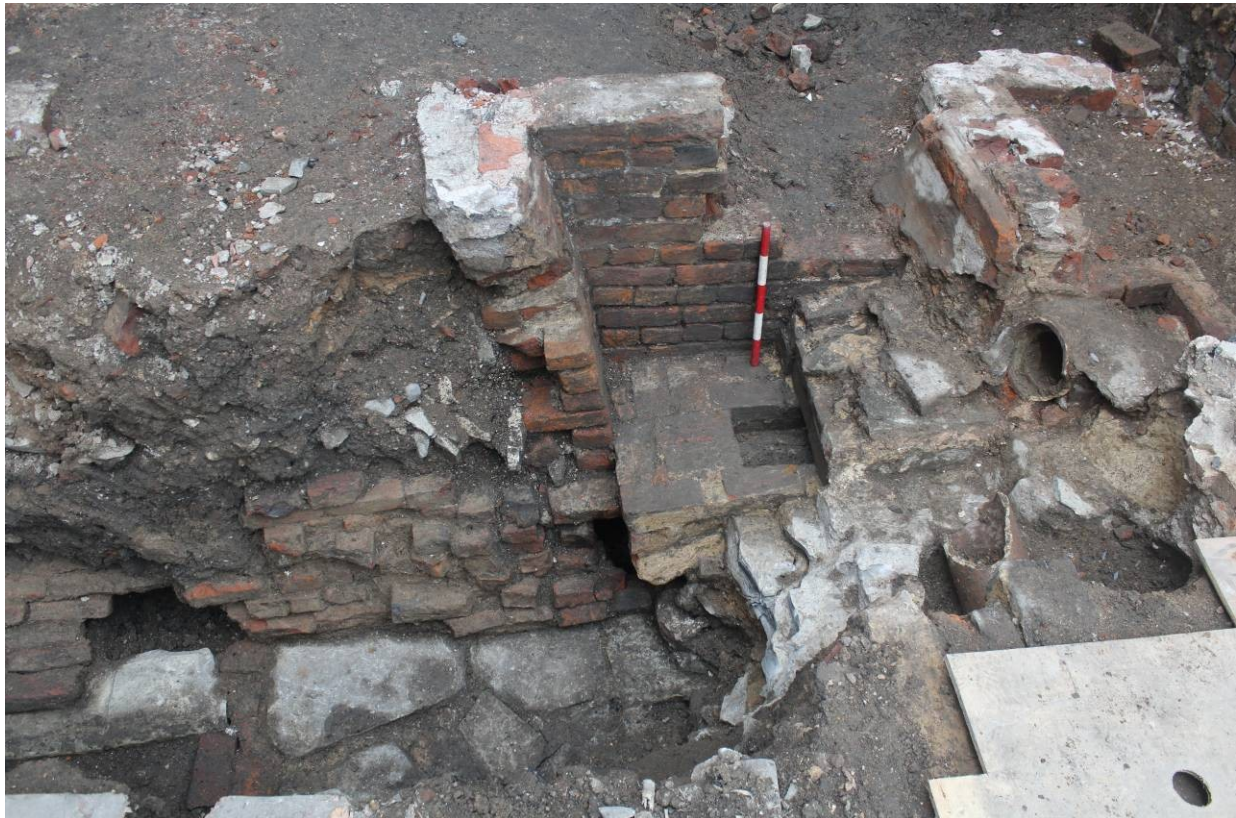
Fig. 5 Brick chamber [14], built against masonry foundation [29] and over brick vaulted culvert roof [31], looking southwest; scale 0.5m

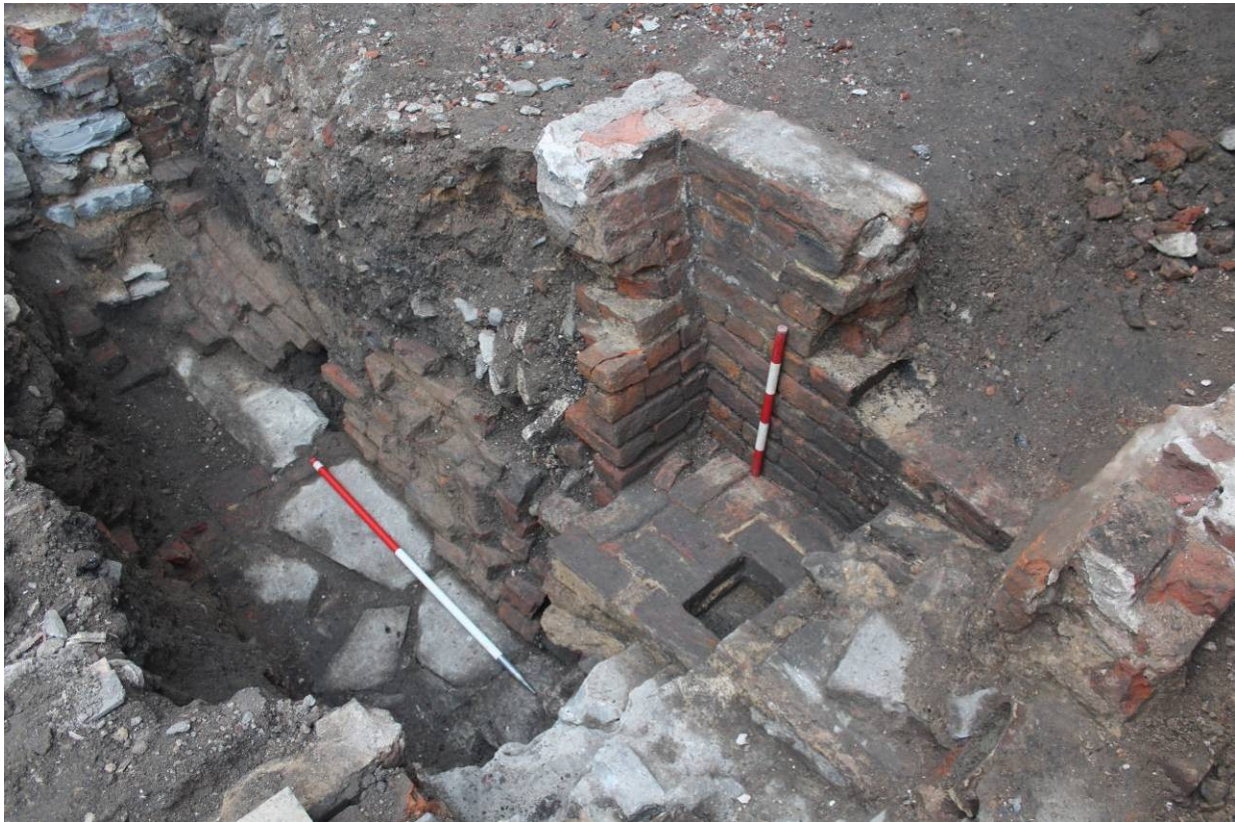
- 6.3 The southeast–northwest aligned parallel walls of a stone drain or culvert [34] were recorded in the base of the foundation trench (Figs. 3–7). The culvert appeared to be cut through the alluvial silt (33) but the relationship had been removed by later foundations and the culvert may have been cut from higher up in the sequence. The northern wall of the culvert was 0.5m wide and built of worked Lias and limestone blocks, neatly laid and with a top surface at 10.20–10.25m OD. The channel of the culvert was 1.0m wide, and probing of the backfill suggested that the culvert channel was at least 0.68m deep (9.57m OD).

Fig. 6 North wall of stone culvert [34] with brick vaulted roof [31] and brick chamber [14], looking southeast; scale 1m and 0.5m

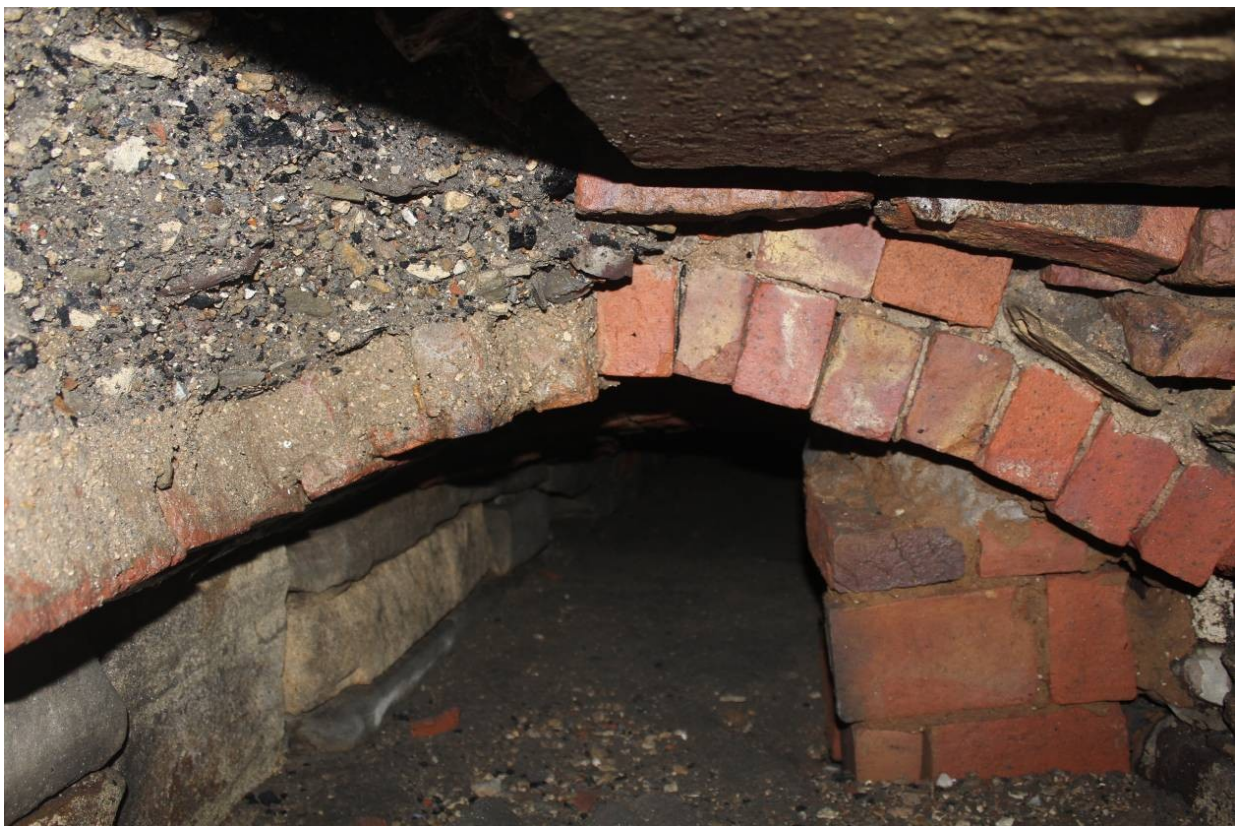
- 6.4 The culvert walls carried a brick arched vaulted roof [31], which sprang off the top of the stonework and was built in hand-made 17th or 18th century bricks laid in stretcher course. The crown of the arch was at approximately 10.80m OD, the culvert roof was intact for most of the culverts observed length.

Fig. 7 View looking along masonry culvert [34] showing brick arched roof [31] with brick support; no scale

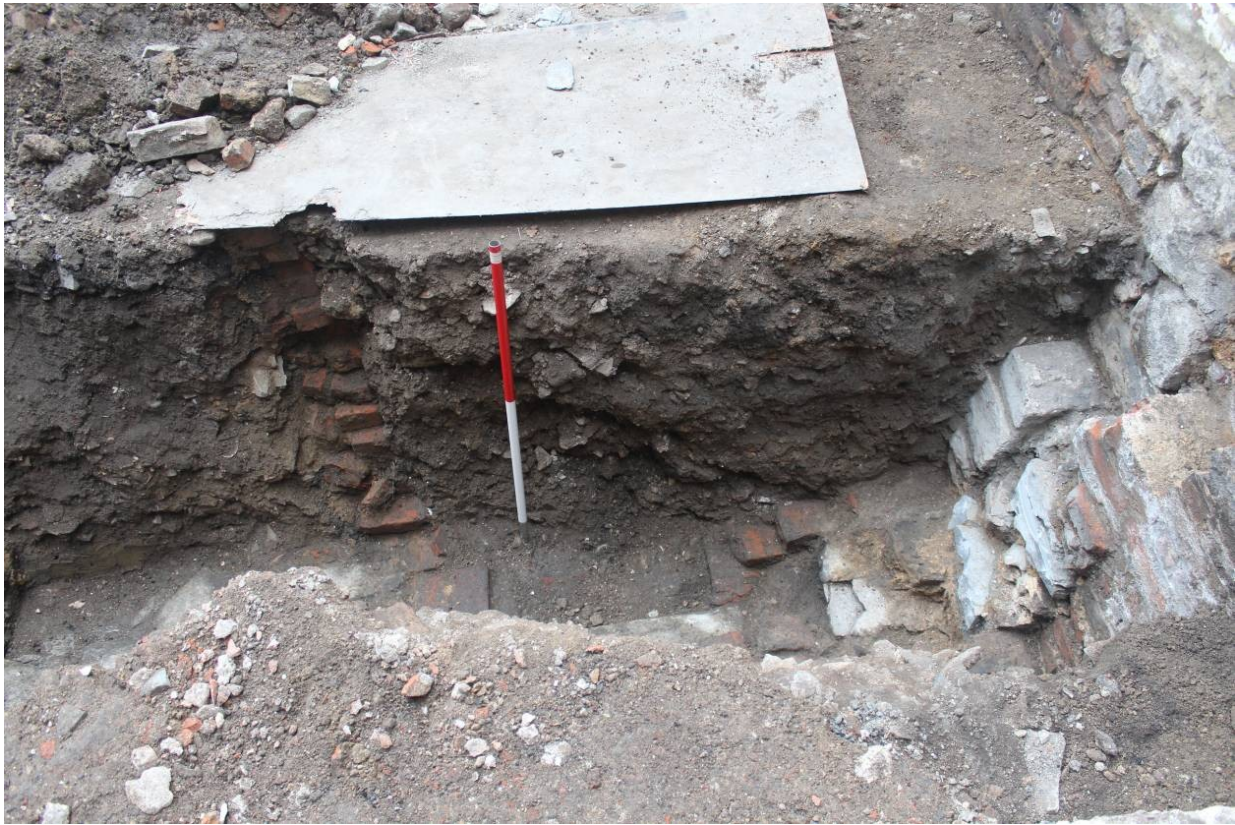
Fig. 8 View Cesspit lining [30], looking northeast. Cut through made ground (18); scale 1m

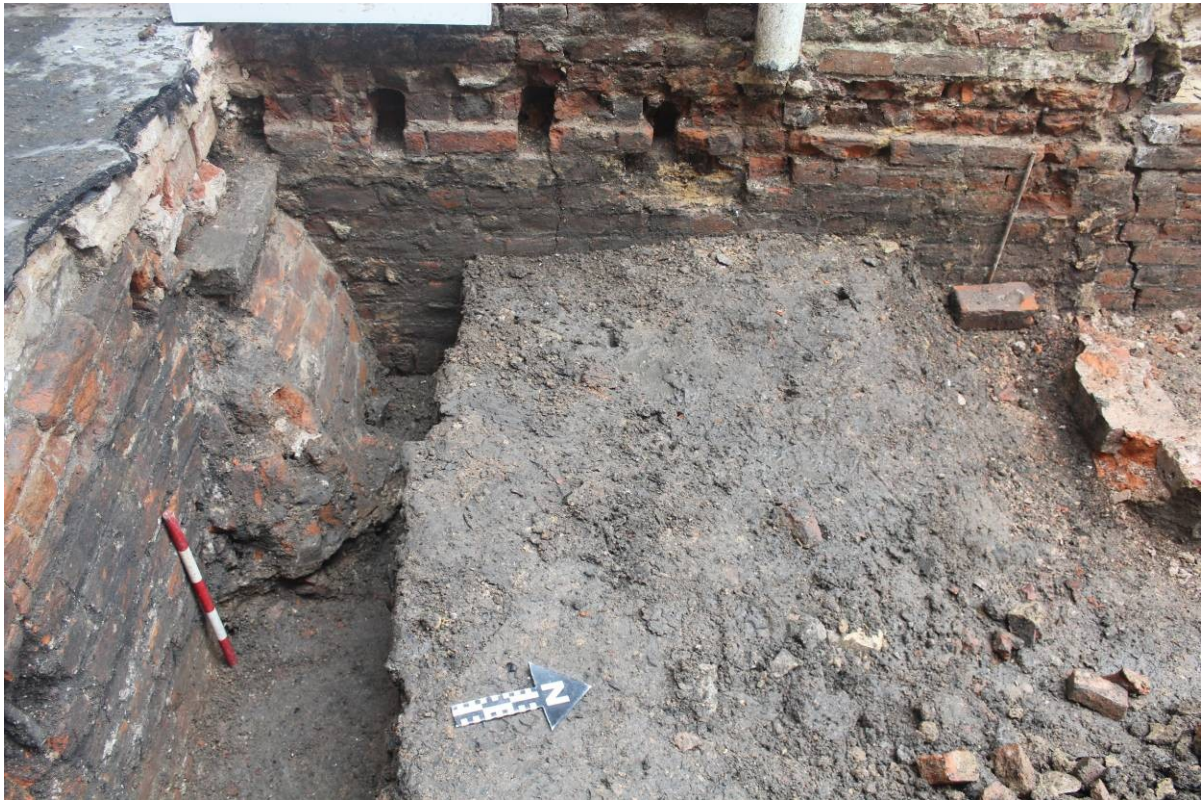
- 6.11 The privy block [4] at the southeast of the courtyard was built separately to the main building. Part of the north wall of basement barrel vault [6] was exposed in a foundation trench, with the external side of vault [27] projecting out from the building line, suggesting that this structure may possibly predate Monument House (Fig. 10). The south wall of the courtyard was repaired in red brick [5].

Fig. 10 Southwestern corner of courtyard with external face of projecting brick vault [27] overlain by Monument House external wall [11] with joist holes; looking northwest; scale 0.5m

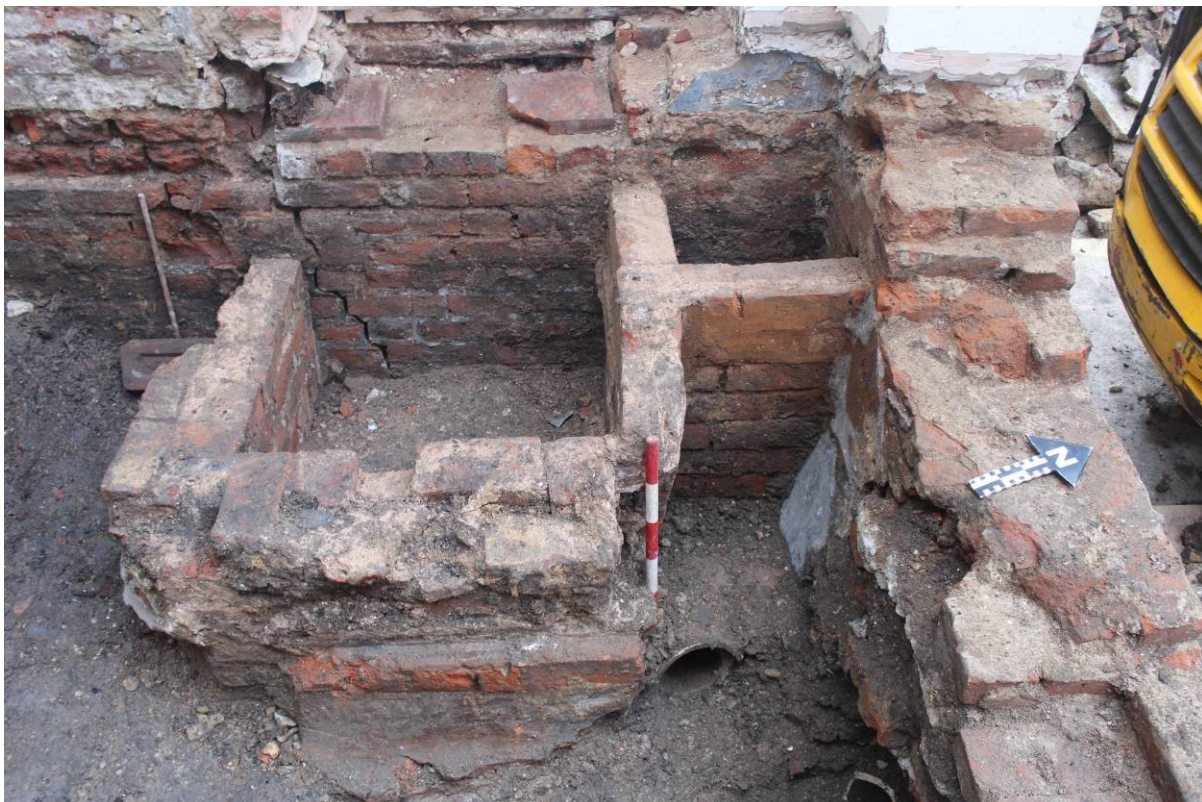
Fig. 11 Brick drainage structure [12] built against northwestern corner of Monument House courtyard, with main wall [11] to west and north, looking northwest; scale 0.5m

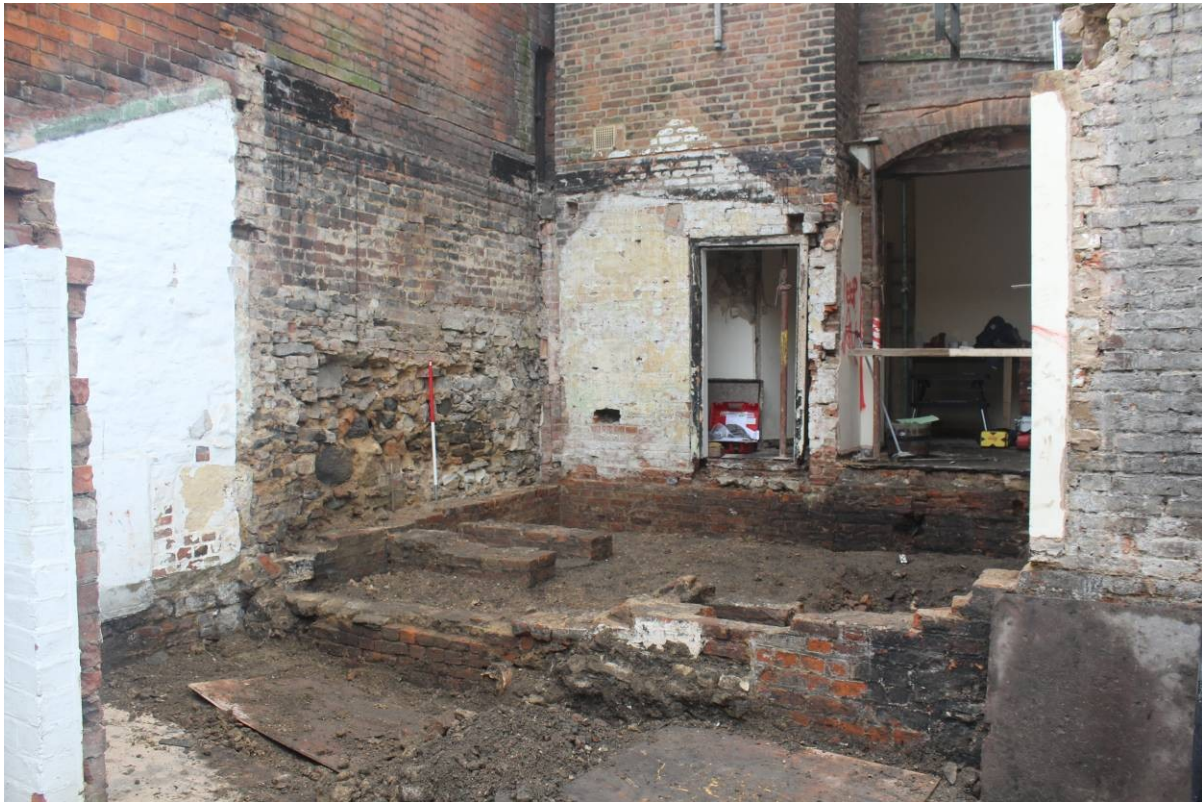
Fig. 12 Courtyard area looking southeast, with brick wall [11] forming northern boundary of courtyard, brick wall [2] forming the east wall and parallel walls [24] and [25]; note gable roof scar on north wall of Monument House and poorly built lower section of Community House extension [3]; scale 1m

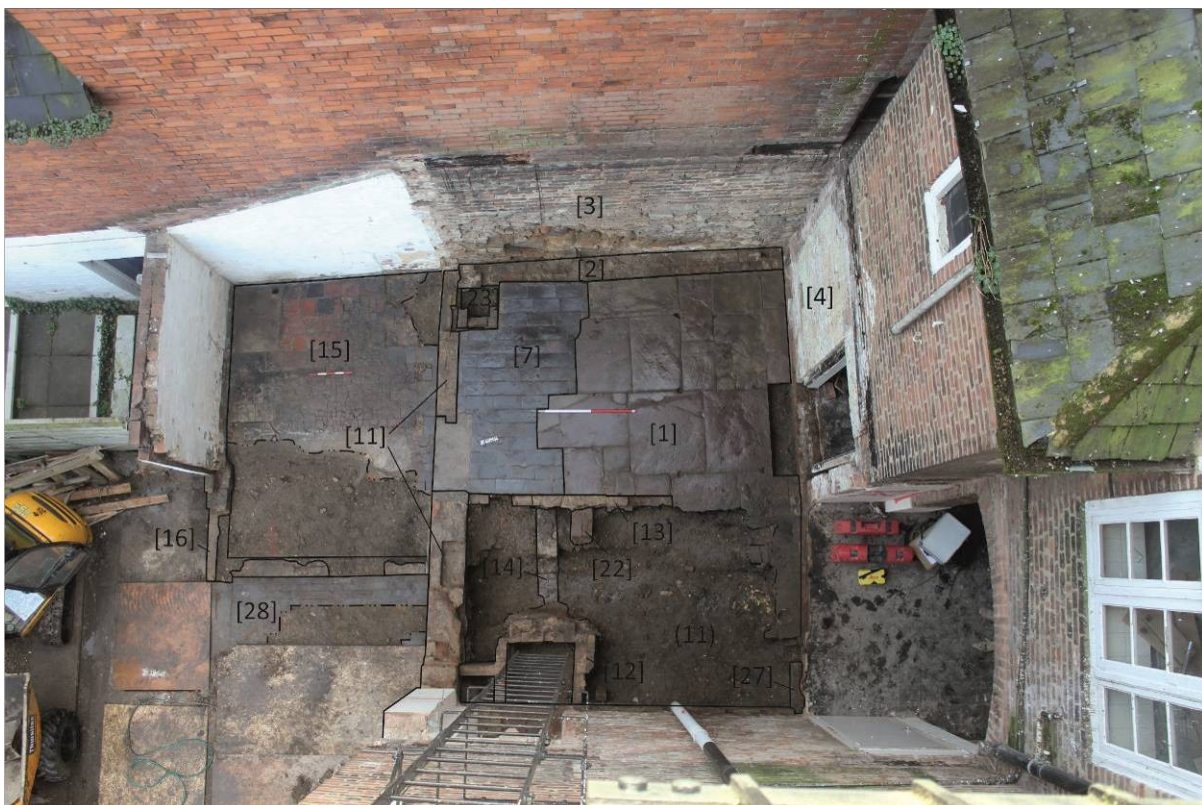
- 6.15 At some later point walls [24] and [25] were horizontally truncated and a new floor of Old red Sandstone slabs was laid with a surface at 11.85–11.92m OD (Fig. 13). This floor was later cut through by trench [9] which carried new salt-glazed drainage pipes to a new sewer located immediately north of the culvert. The floor was repaired using unstamped 'Staffordshire Blue' type floor tiles; a brick structure set in the northeastern corner of outhouse [23] is likely to relate to the new drainage system.

Fig. 13 Overhead view of last phase of Monument House courtyard, looking southeast; scale 1m and 0.5m

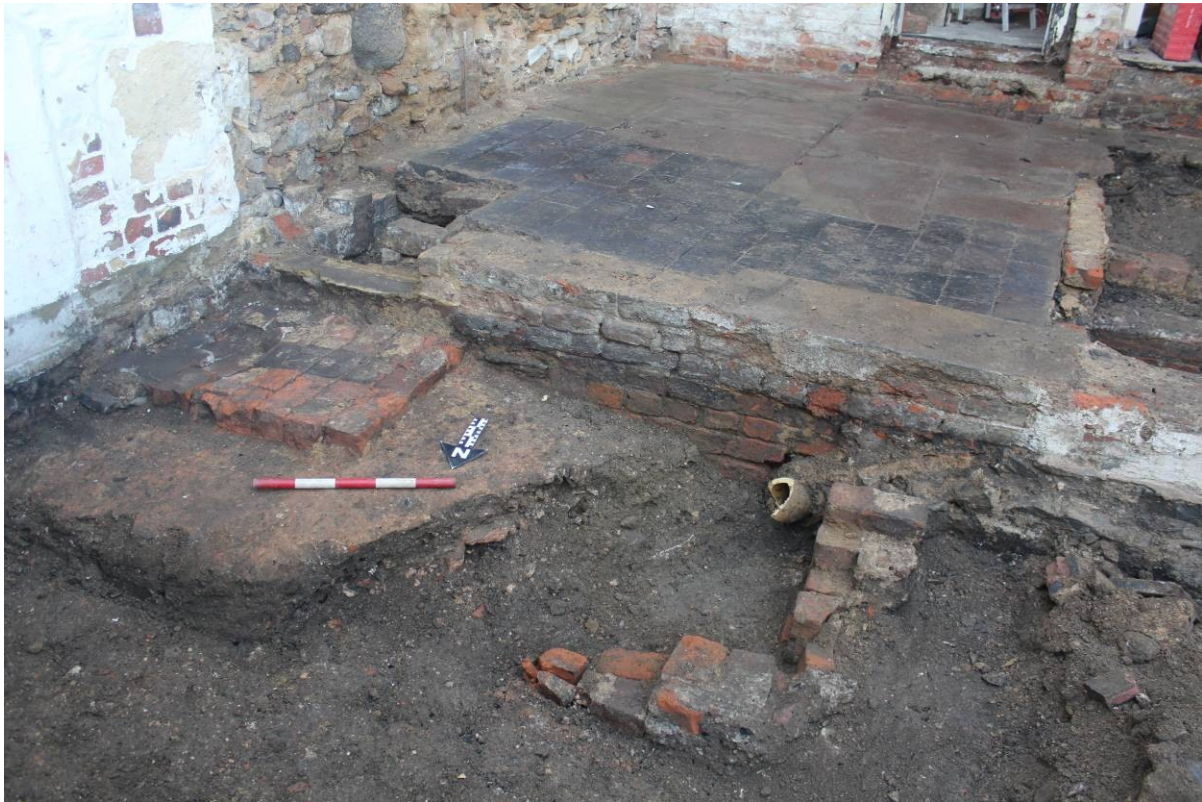
Fig. 14 Brick floor [19] and rebuild [20] of cesspit [30], both built against northern courtyard wall [11], looking south; scale 0.5m

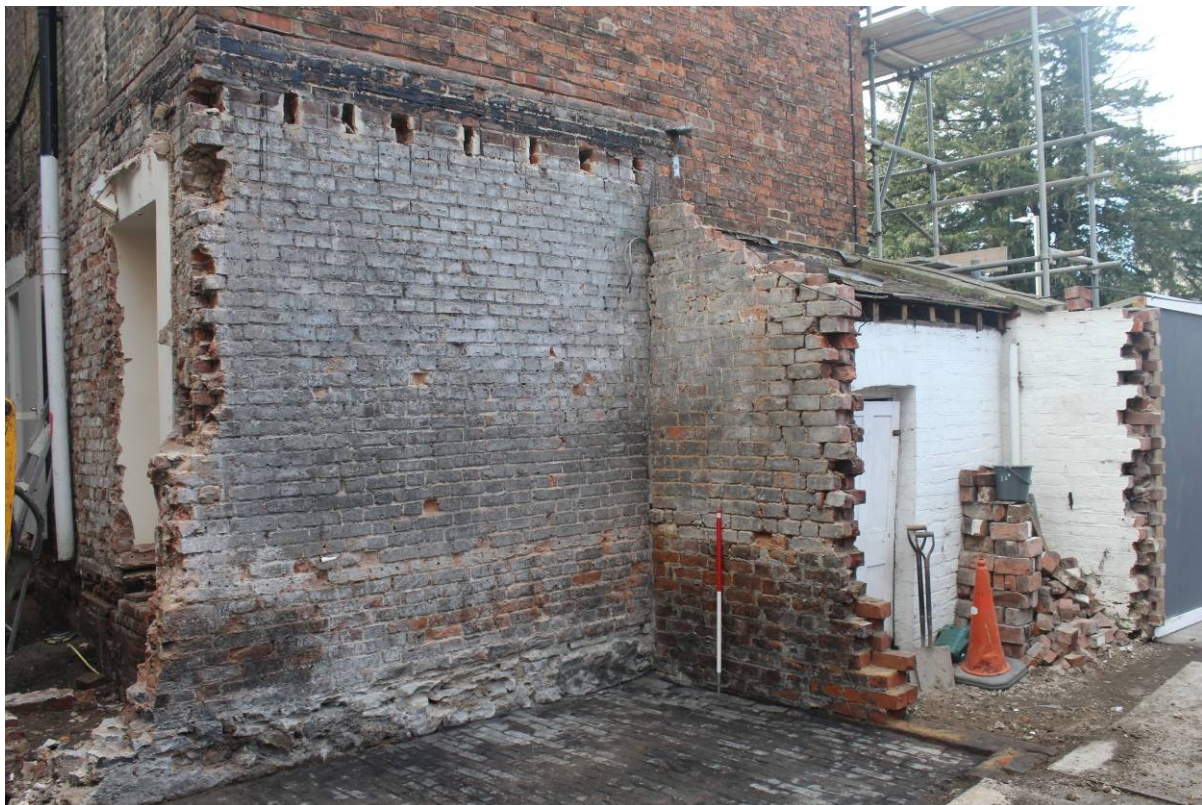
Fig. 15 Outbuilding to north of Monument House, with cavity brick wall [16], and brick floor [28], note stone foundation to Monument House superstructure [11], and superstructure extending east of building, looking southwest; scale 1m

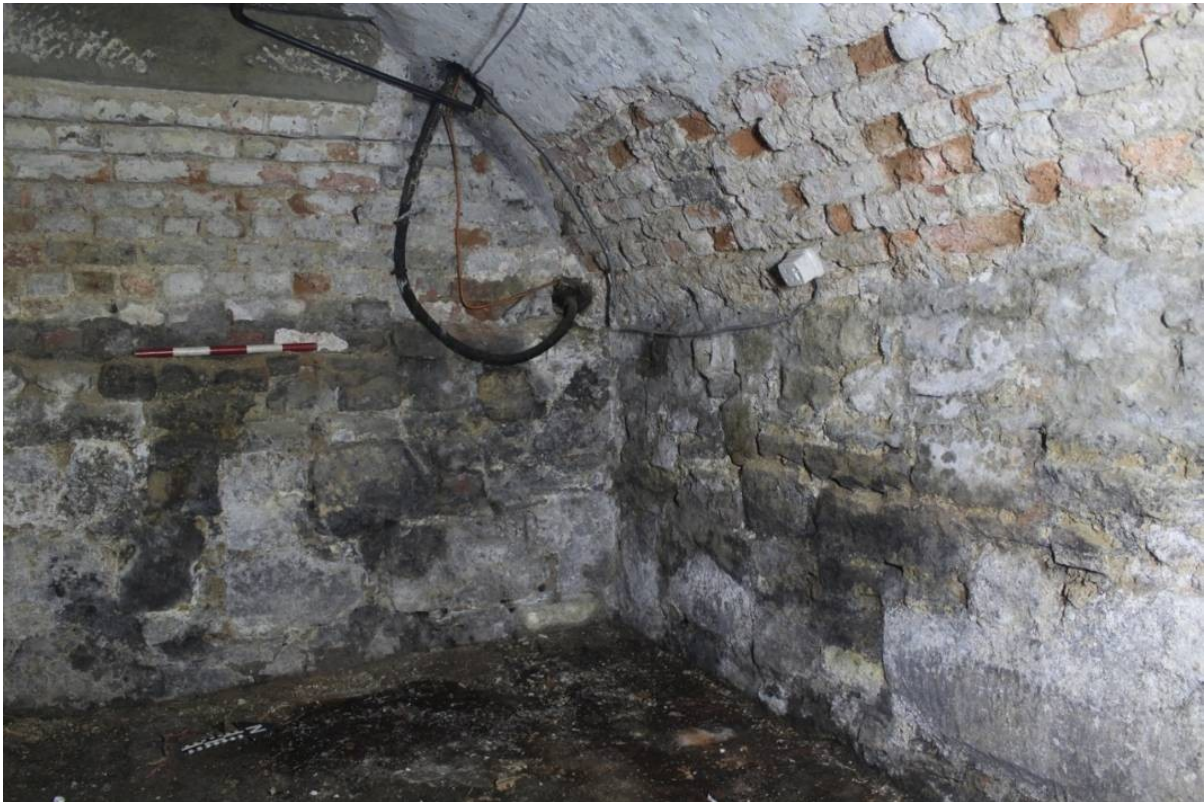
Fig. 16 West and north walls of Monument House basement, showing masonry basement walls with brick barrel vaults; looking northwest, scale 0.5m

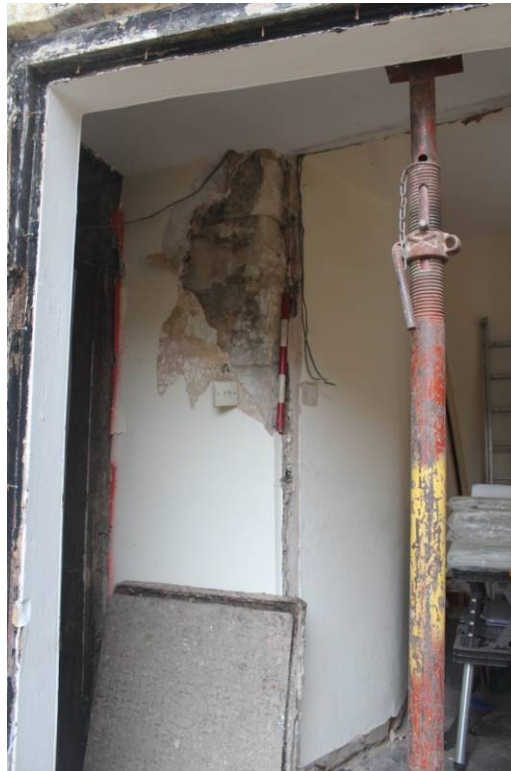
- 6.24 Removal of damaged plaster on the ground floor exposed masonry blocks of the chamfered corner of Community house (Fig. 18), and imply that Community House, or a building on its site, was standing prior to the construction of Monument House. There is some evidence for the reuse of an earlier north-south aligned brick wall which survived to first floor level (Fig. 19), the bricks were in a moderately hard orange-red fabric and measured 115 x 65 x 240mm (BTL). The wall is located above brick barrel vaults on the line of the rear of the masonry basement walls. The wall had been axed through (Fig. 20) to allow the staircase to be built, which implies it (and the barrel vaults it is built on) predates the Georgian building, but there was no other evidence for reused brick superstructure above basement level.

Fig. 18 Masonry corner of Community House (or predecessor) encapsulated within ground floor of Monument House; looking southeast, scale 0.5m

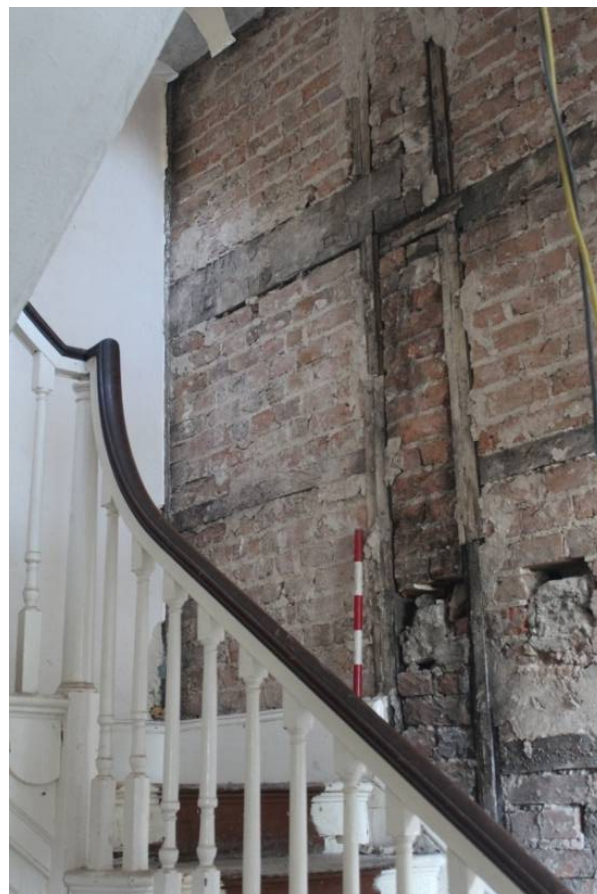
Fig. 19 Brick wall truncated and encapsulated within internal wall of Monument House, ground floor. The wall has been axed through, but survives to the first floor; looking southeast, scale 0.5m

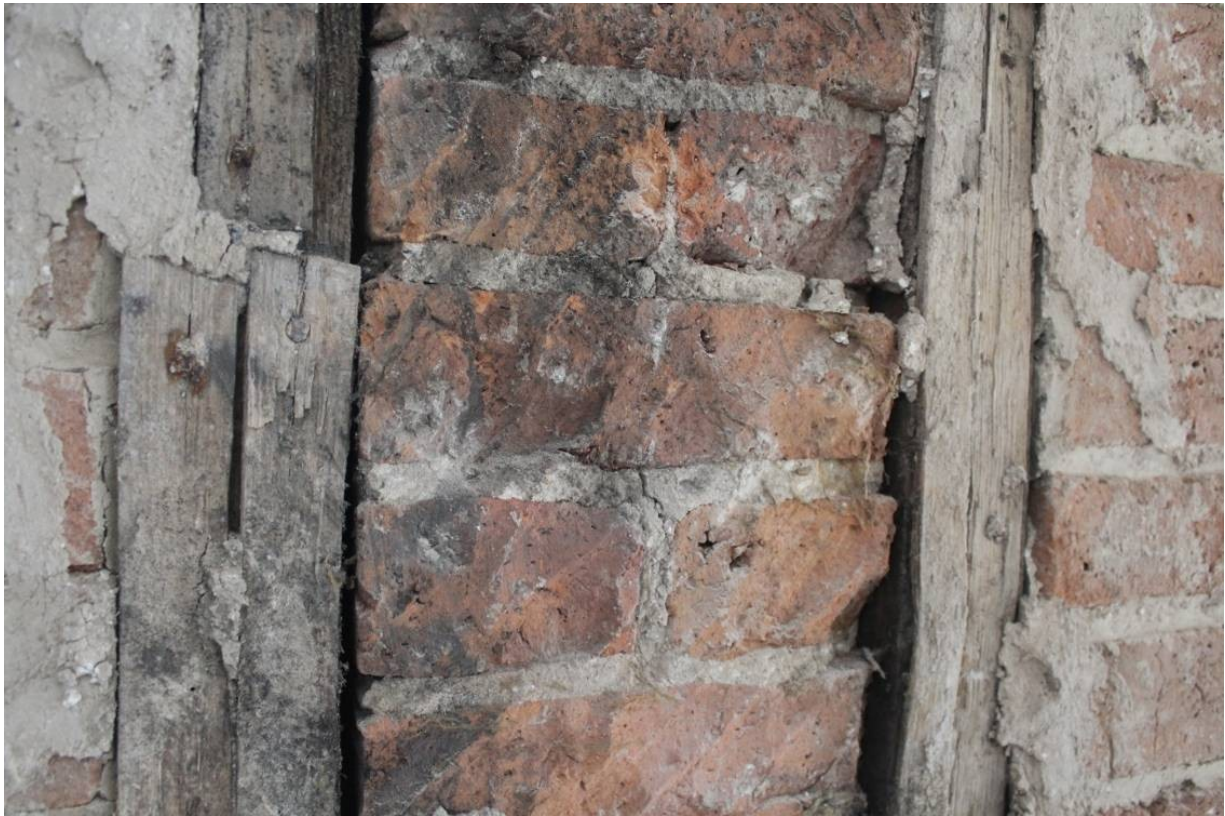
Fig.20 Axe marks on encapsulated brick wall within Monument House, ground floor.

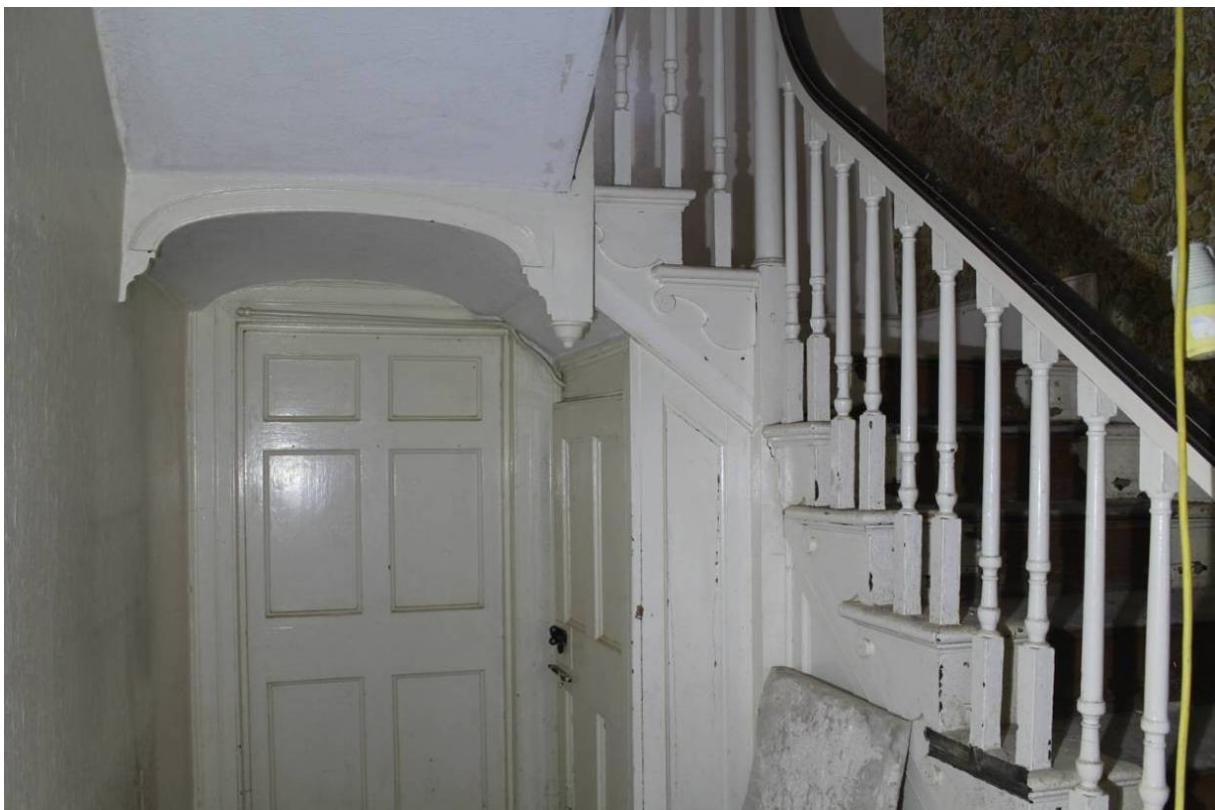
- 6.25 Much of the original timber detailing survives in good condition, including panelling, skirting, cupboards with original hinges, and the stairs and banisters (Fig. 21).

Fig. 21 Original panelling, doors, stair and banisters on ground floor stairwell of Monument House; looking east.

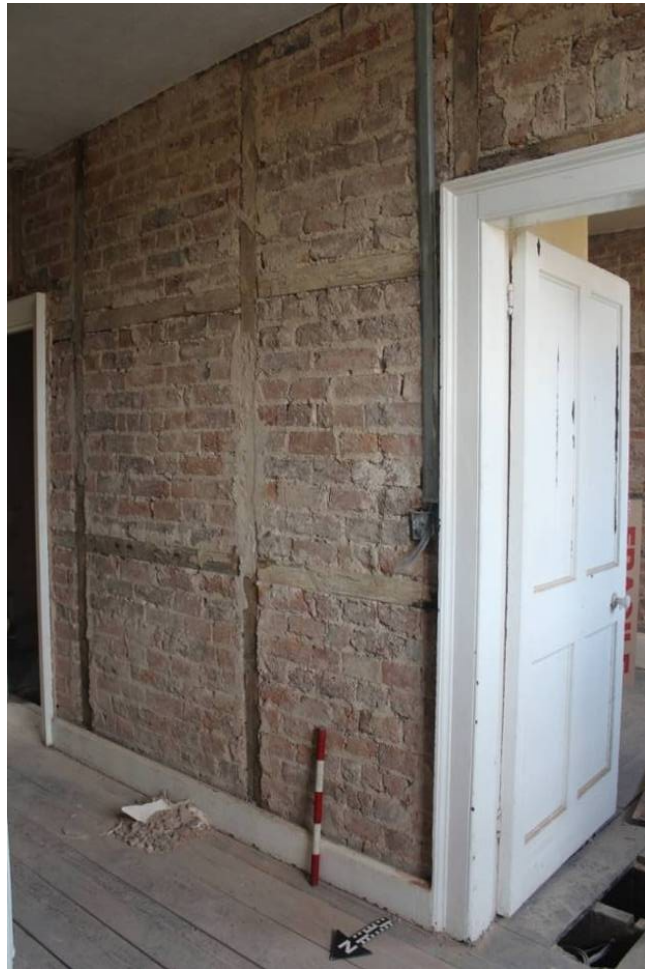
- 6.26 Removal of defective plaster showed that generally throughout the house the external shell walls were not tied in to partition walls, which were formed of pegged timber stud work with mortared brick nogging infill (Fig. 22). The studs included reused timbers; the studs were axed to key in the plaster (Fig. 23). Bond timbers were evident in the front and side walls, apparently to tie the walls together, however internally the brickwork of the north wall abutted the western, street frontage, wall (Fig. 24). Generally brickwork in adjacent walls was not tied in, but was butt jointed.

Fig. 22 Pegged timber studwork with mortared brick infill, second floor of Monument House, looking southeast, 0.5m scale.

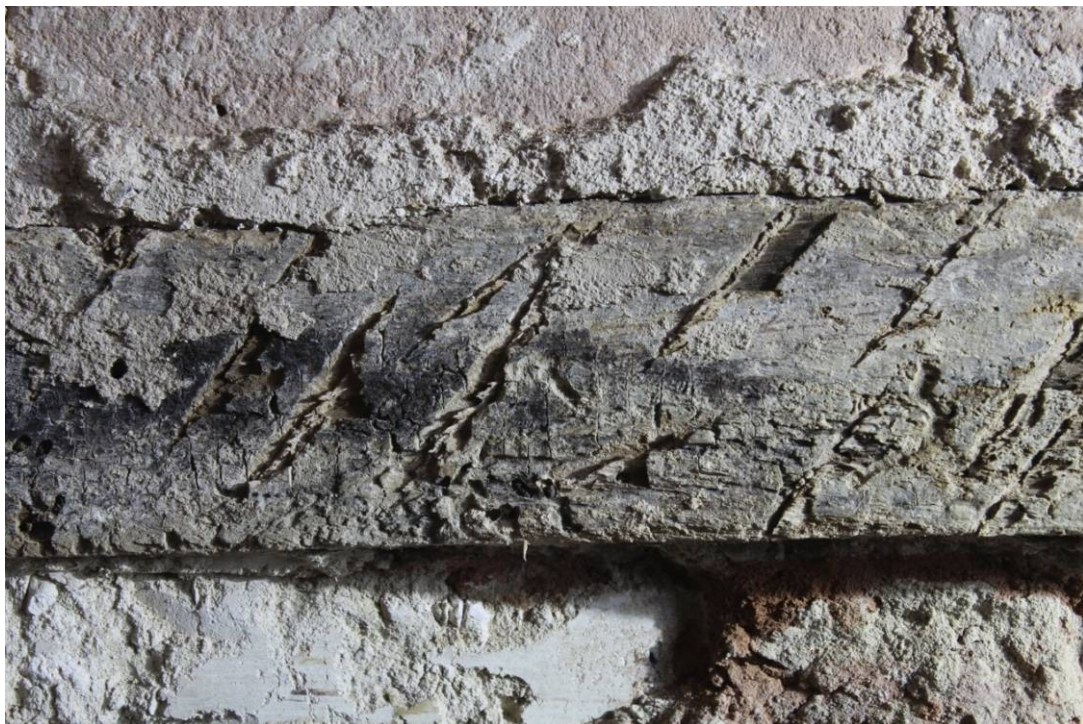
Fig. 23 Axe marks on timber studwork for keying to plaster

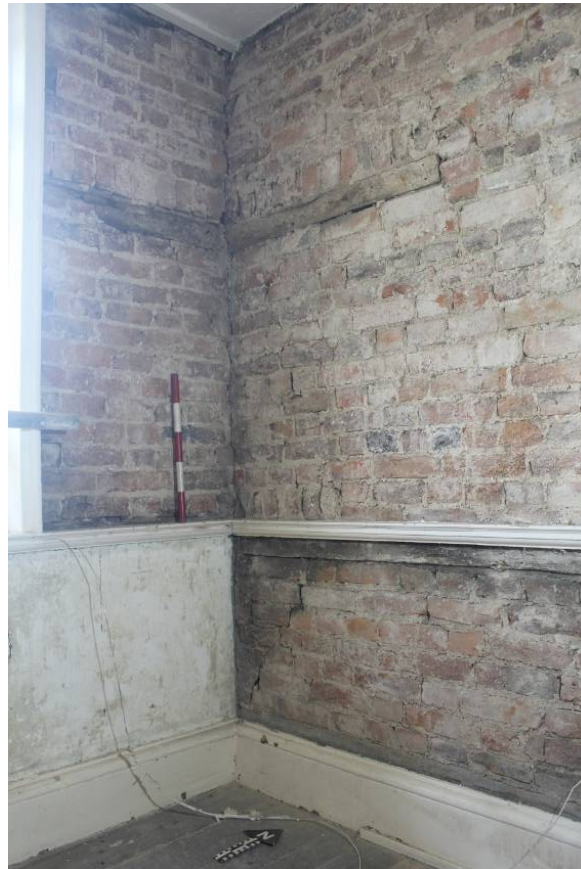
Fig. 24 Junction of western and northern walls of Monument House, first floor, showing bond timbers within brickwork, and butt joints between the walls, looking northwest, 0.5m scale

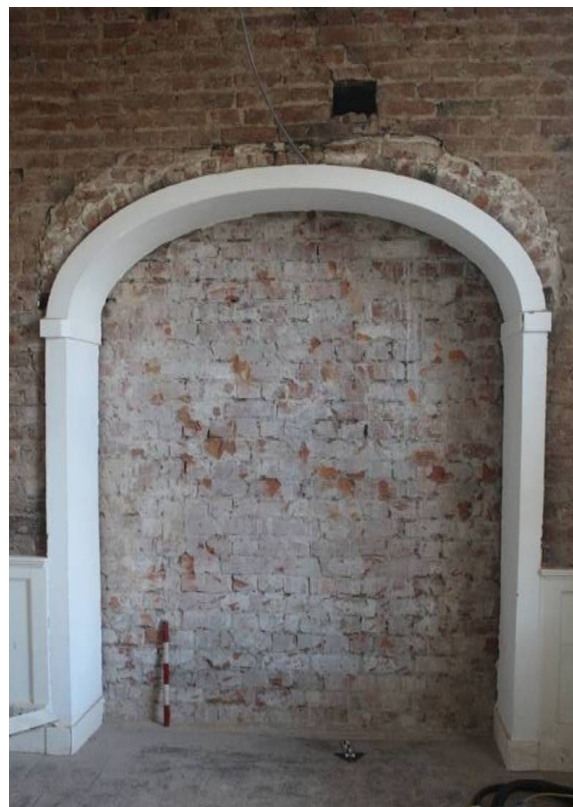
Fig. 25 South wall of Monument House, ground floor, showing inserted arched niche; looking south, scale 0.5m

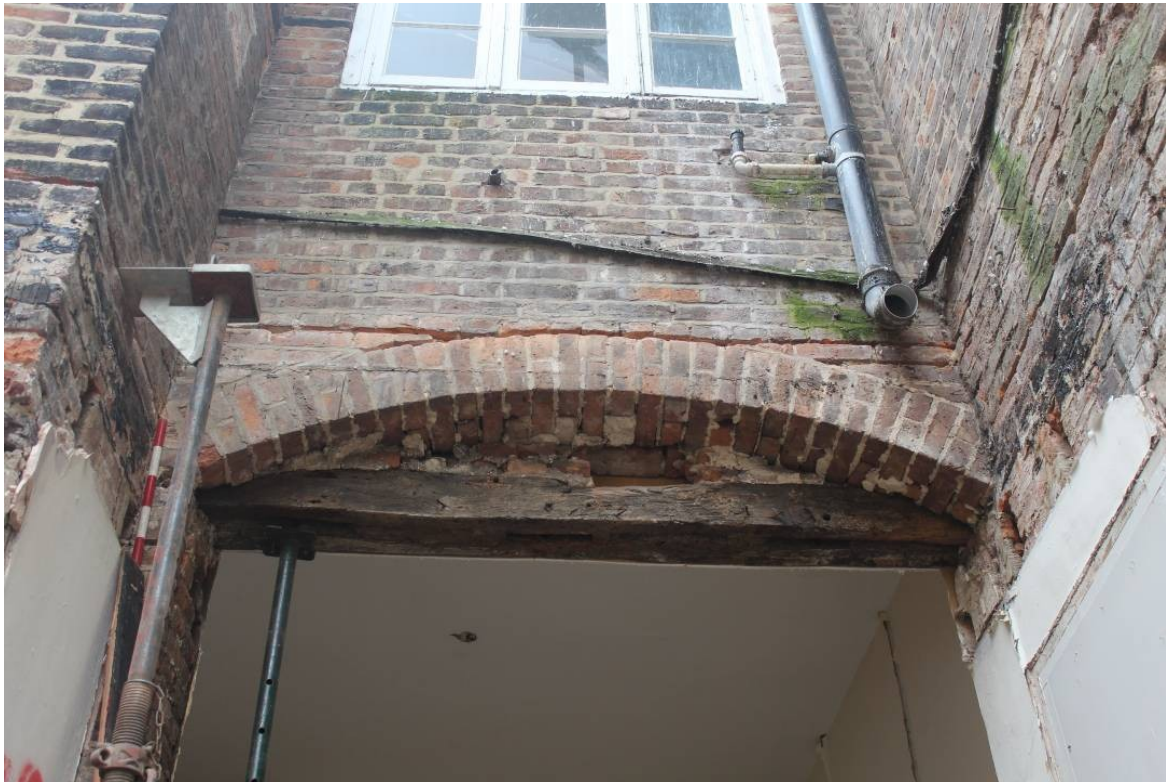
Fig. 26 Brick arch backed up by a reused oak timber with mortices; looking south, scale 0.5m

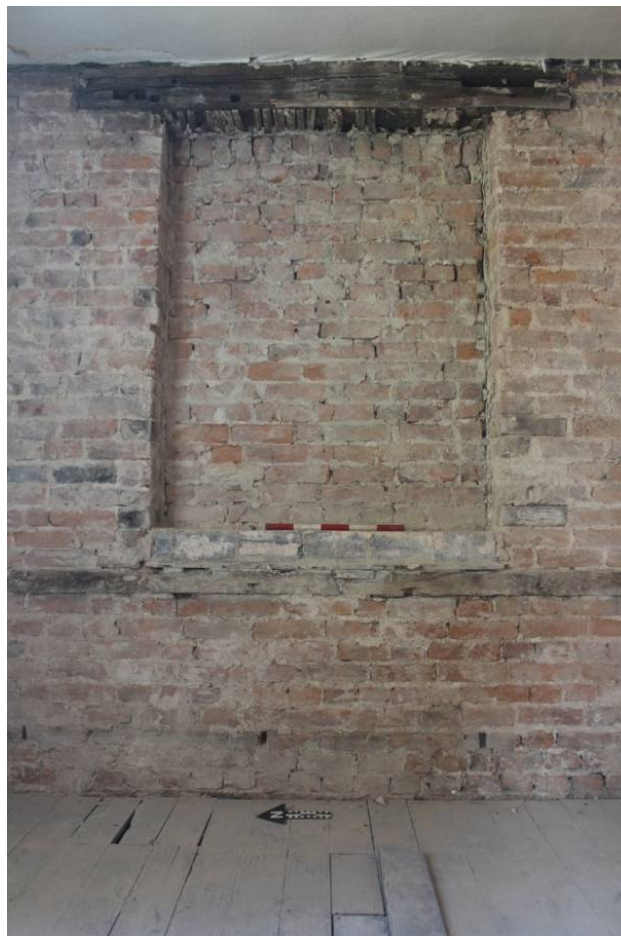
Fig.27 Blocked window in east wall of Monument House, second floor, showing mortar and lathe and plaster demonstrating the window was originally open; looking north, scale 0.5m

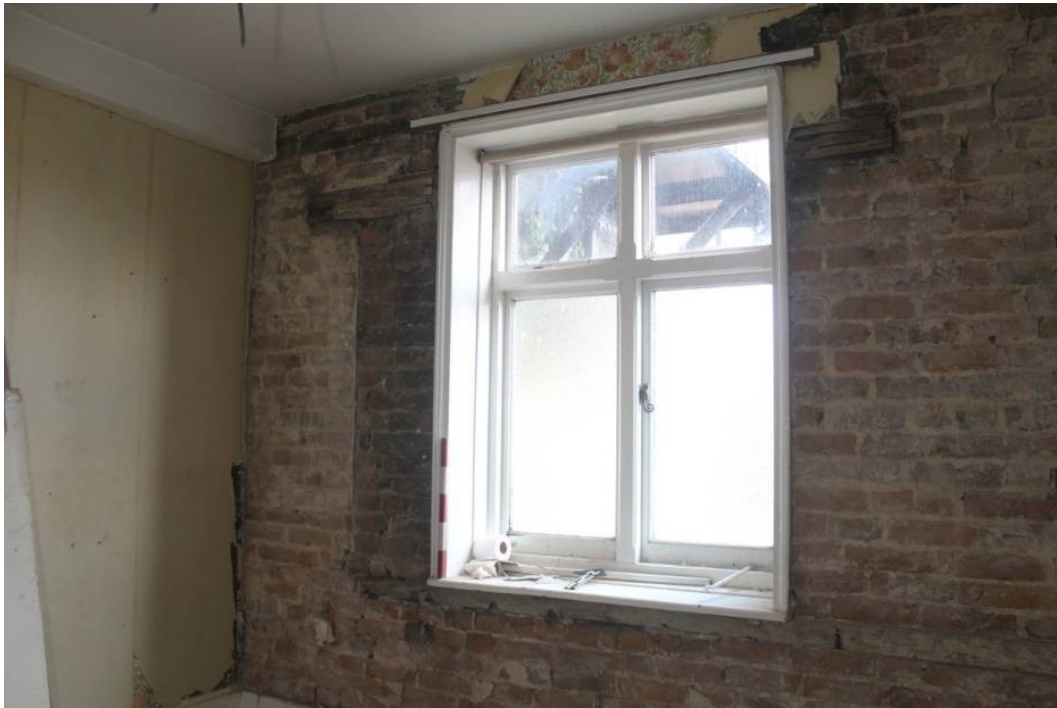
Fig. 28 Window alteration in north wall of Monument House, second floor, showing partial blocking of original window with insertion of enlarged window; looking north, scale 0.5m
