# Christ Church Downend South Gloucestershire

## Report on Archaeological Watching Brief

**Report on an Archaeological Watching Brief**

OS NGR ST 64962 76497

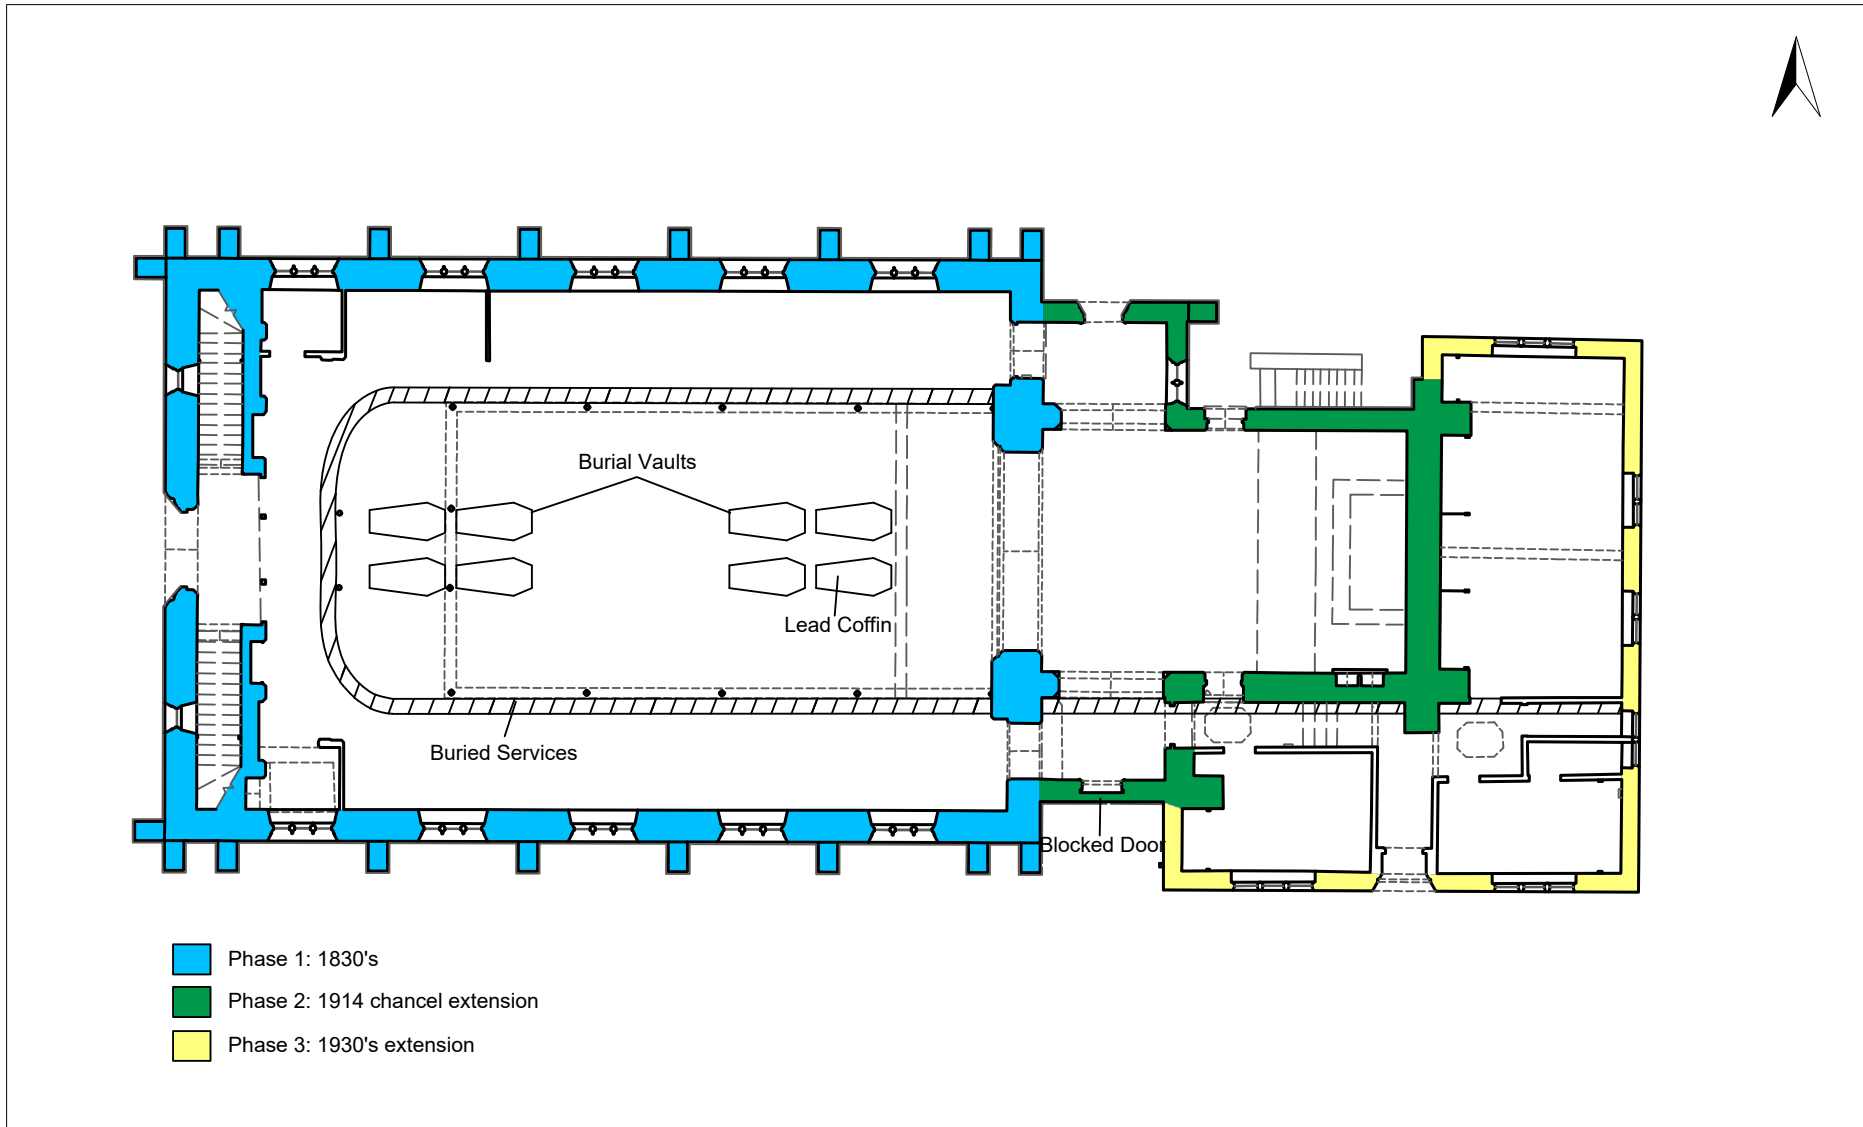
## Figure 2

A further extension to the east of the chancel, to provide additional facilities to the church, was made between 1920 and 1930. The three phases of construction can be seen within the ground floor plan of the building, and is evident on successive Ordnance Survey maps, which show changes in the shape and size of the church's footprint (Figure 2).

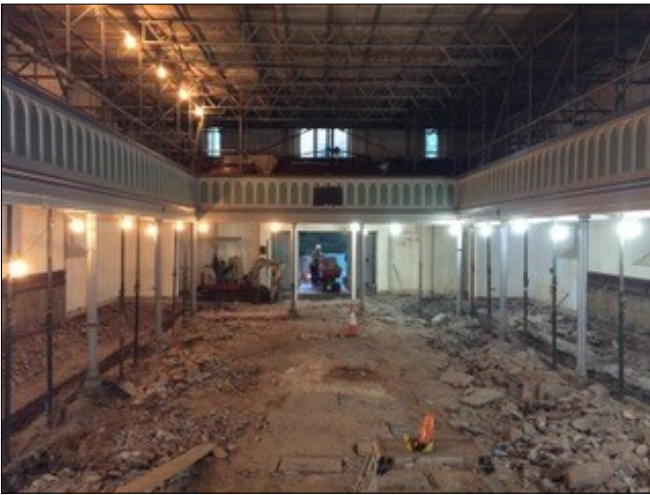
At the time of the site visit, the floor within the nave had already been removed, exposing a fairly consistent light brown, fine dust and rubble deposit throughout. The floor surface had previously consisted of floor tiles and ledger slabs. The surface removal exposed eight coffin shaped burial vaults in four sets of pairs located down the centre of the nave (Figure 3, Plates 2, 3 & 4). Each is constructed from roughly coursed, roughly hewn Pennant sandstone, capped with slabs, to a maximum depth of 2m. No burials and no human remains were visible, and most appeared to be unused.

**Plate 1:** Work to remove the floor within the nave, view west (photo courtesy of M. Nichols).

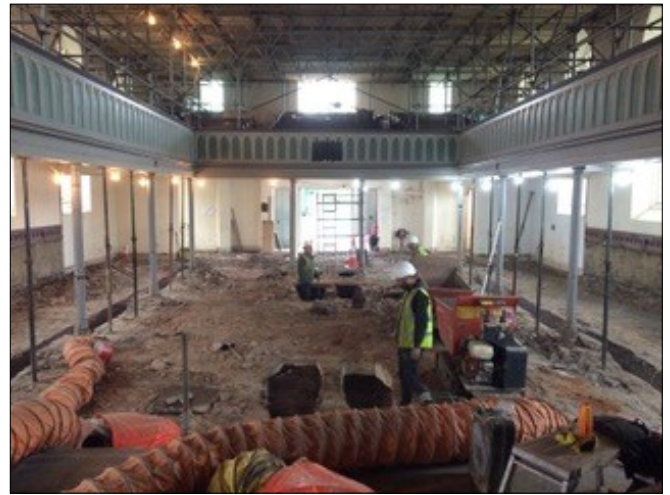
**Plate 2:** Tops of burial vaults exposed down the centre of the nave, view west (photo courtesy of M. Nichols).

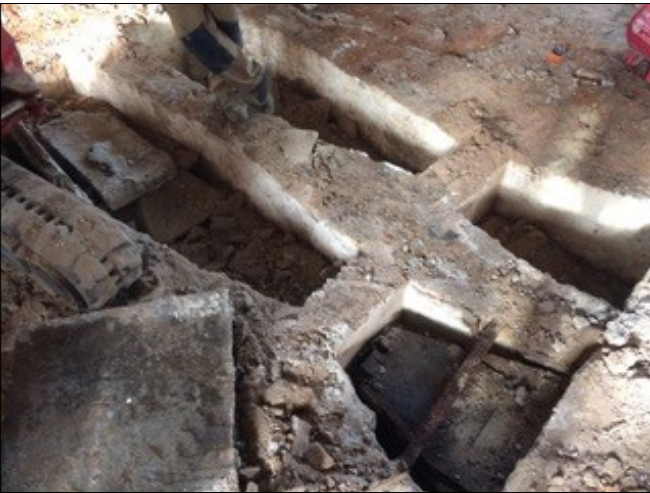
One of the vaults at the east end of the nave, directly in front of the chancel, was, however, used to capacity, the last burial having been made in a lead coffin which was centimetres from the modern floor surface (Figure 3, Plate 3).

**Plate 3:** Detail of four burial vaults. A sealed lead coffin can be seen in the vault, bottom right. (photo courtesy of M. Nichols).

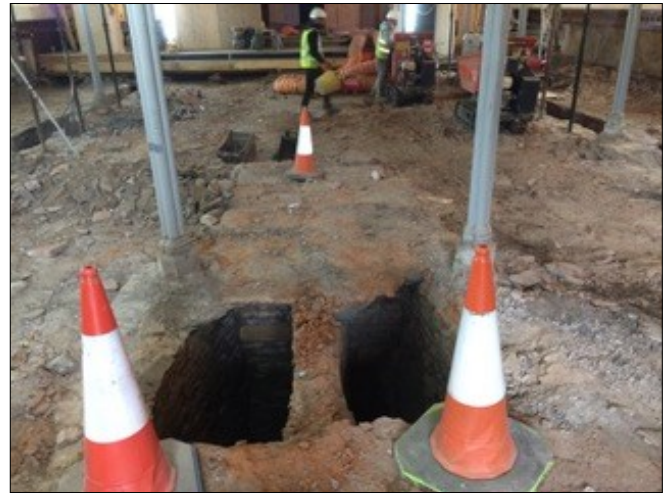
A pair of burial vaults at the west end of the church were directly below two supporting posts for the upper gallery. The fact that they are in this location suggests that these two vaults predate the gallery, which may have not been an original feature of the building when it was first constructed circa 1831. An outline of these vaults could be seen at the time of the site visit after they had been filled (Plate 10).

**Plate 4:** Two burial vaults directly underneath gallery supports, view east in the nave (photo courtesy of M. Nichols).

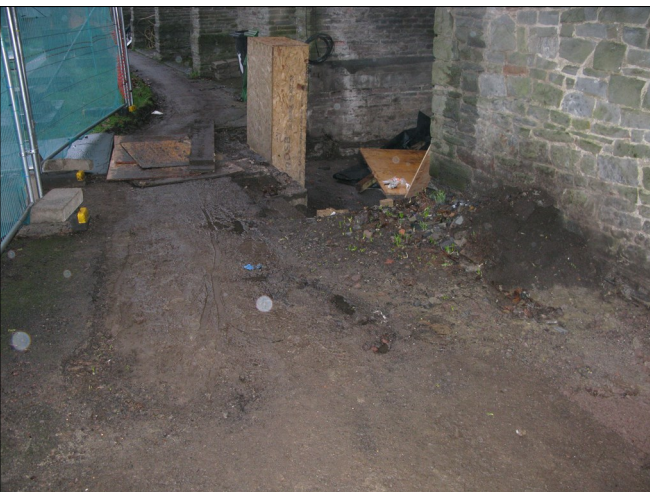
**Plate 5:** South side of Church where two ledger slabs removed prior to work to open south entrance.

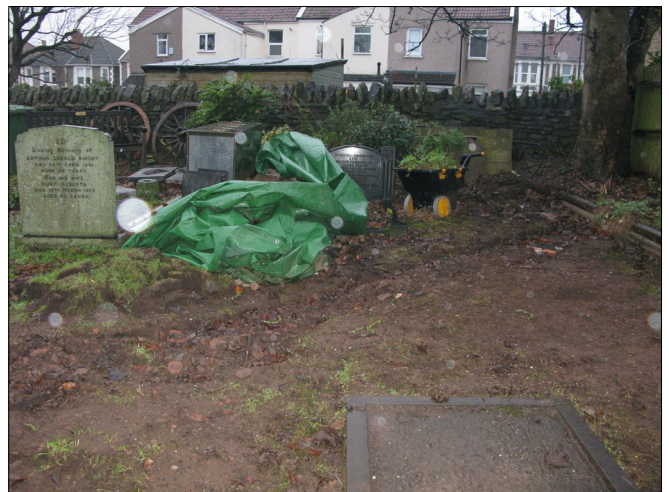
A trench for services had been excavated parallel to the outer face of the supporting foundation wall as shown in Figure 3. It is approximately 0.35m wide, and 0.4m deep, and lined with block and brickwork. It runs from the north east side of the chancel, around the nave, before passing into the rear extensions of the building on the south side. A corresponding trench on the outside of the church was excavated, but had been backfilled at the time of the visit.

**Plate 6:** Back-filled services trench, diagonally across shot, to wards mains connections in North Street.

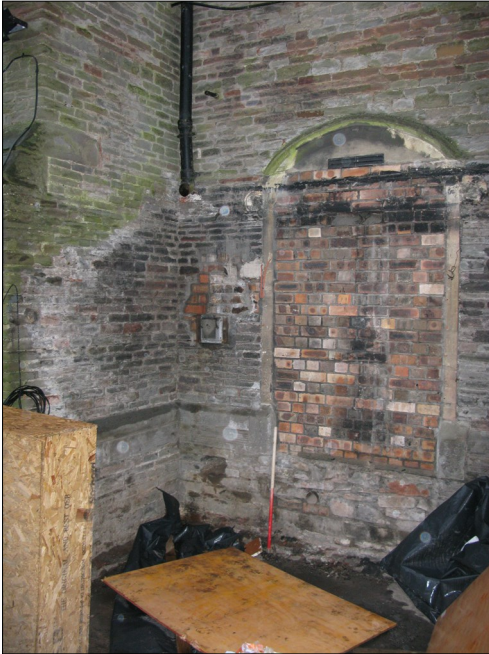
An entrance to the church was incorporated into the 1914 chancel extension. This has been blocked for many years (mid 20<sup>th</sup> century?) with a lean-to shed containing a gas boiler built up against it. The shed has been removed as the entrance will be re-opened as part of the current project. Plate 7 shows the blocked arched opening with a dark scar indicating the roof line of the gas boiler shed.

**Plate 7:** The blocked south entrance to the Church. A lean too structure which contained a gas boiler has been removed, but the scar is visible on the stone work.

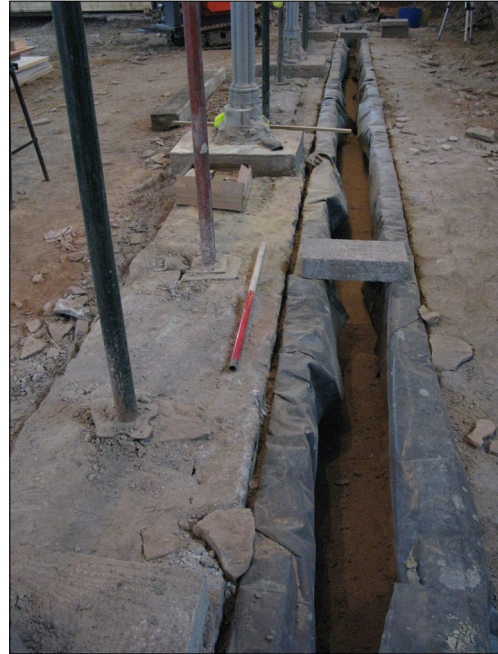
The upper gallery within the nave is supported by twelve quatrefoil pillars. Those situated along the north and south side of the nave are located on a structural foundation wall of approximately 0.65m wide (depth unknown, Plate 8) which was visible at the time of the visit. A return wall to form a west side was not visible.

**Plate 8:** New services trench, parallel to structural support wall, within the south gallery of the nave, view east.

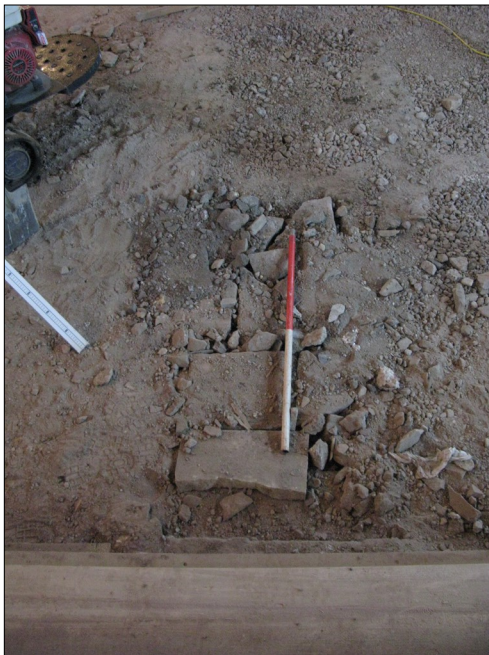
**Plate 9:** Back-filled burial vault at the east end of the nave. The vault contained the lead coffin which remains in situ.

The empty vaults were all filled with rubble to allow greater support to modern flooring.

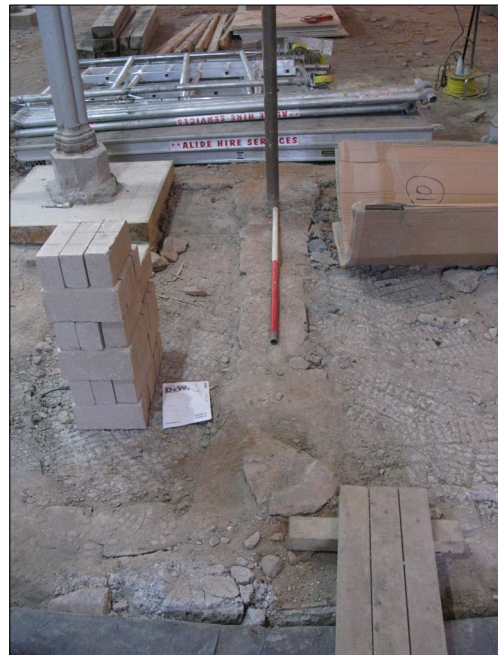
**Plate 10:** Just visible, the dividing wall between two burial vaults at the west end of the nave, found directly below gallery support columns.
