Land at the Former Luckwell Club and Scout Hut Site, Luckwell Road, Bedminster, Bristol

Report on Archaeological Watching Brief

City of Bristol Planning Application Ref. 15/01453/F

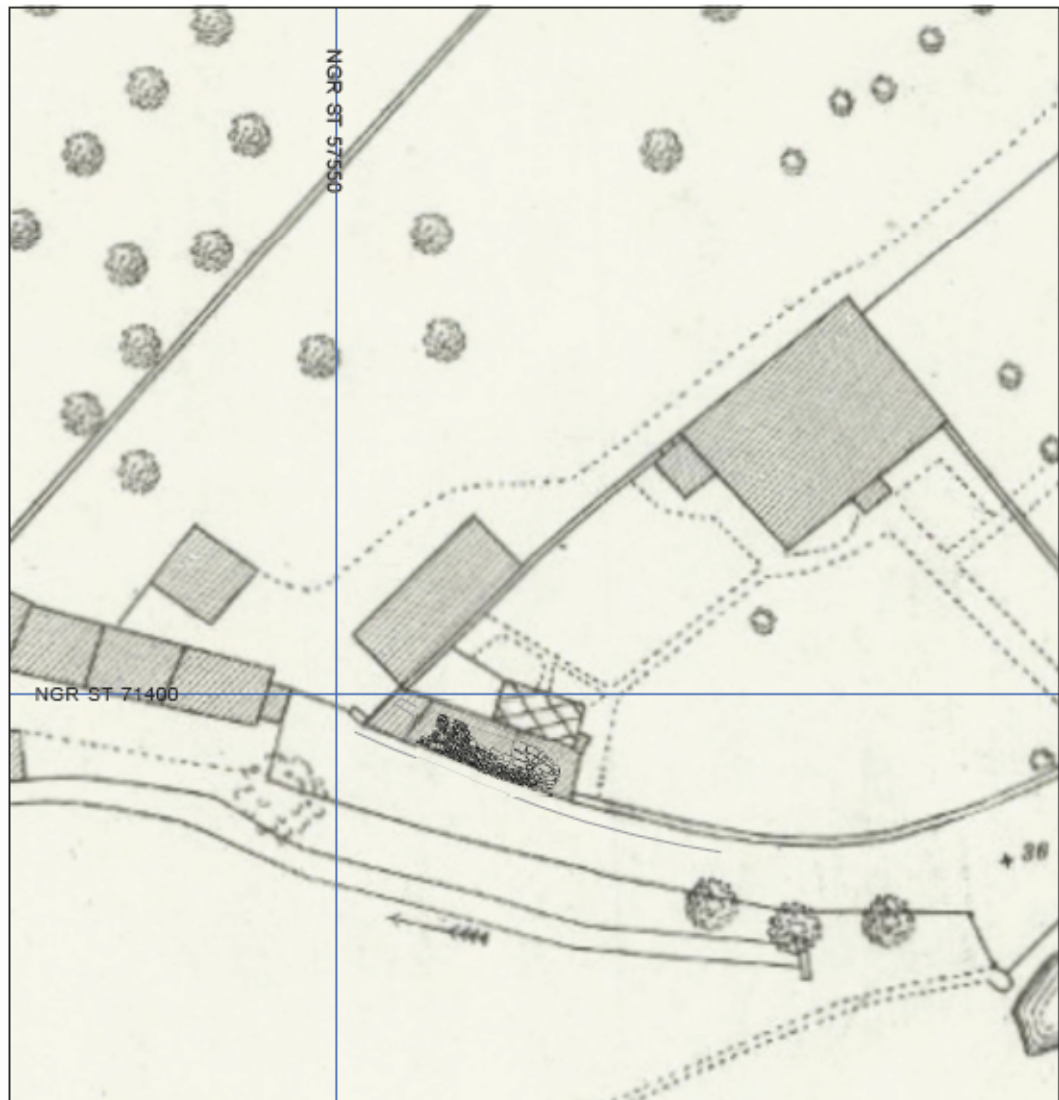
The Site - General Plan in Relation to First Edition OS

lean-to against the outside (north-eastern side) of wall (102). The 1:500 map, indeed, very much confirms the plan of these structures as recovered by the archaeology, leaving aside small differences easily accounted for by the vagaries of survey between the late 19th and early 21st centuries (**Figure 3**). These structures seem clearly to have been in place by the mid-19th century since as already noted, they are shown on the Bedminster tithe map of that time (**Cover**). The larger building was probably a functional, multipurpose storeroom/outhouse/shed, perhaps with provision for access for and storage of a small wheeled vehicle, maybe a small two-wheeled animal cart, as attested, in particular, by the width and design of the doorway from the street at the south-eastern end of the building. Indeed, it is also a possibility that the larger building may have been used even if only occasionally as stabling. What is particularly interesting about the general arrangement of the two putative access gaps into the larger space, is that they were made through the main boundary wall, which formed effectively the southern side of the building, and led out directly onto the street surface south of the boundary wall; the street level at the time that the access ways were in use being over 1m lower than it is today, and it seems clear that these entrances would by definition have to be blocked when the street level on the southern side of the main boundary wall was raised. As already noted, there did not seem to be any access to the larger building from the northern side, although it is possible that this is due to severe truncation of wall (102) on that side. It may partially reinforce the suggestion that the larger building was used for storing wheeled vehicles, for whom direct access out onto the street would be a logical requirement. There may, though, also be an element of social segregation here, because such an arrangement would mean that the occupants of the large house immediately to the north would not be disturbed by the constant comings and goings of gardeners, tradesmen and others of the 'lower' social orders, although this is speculation.

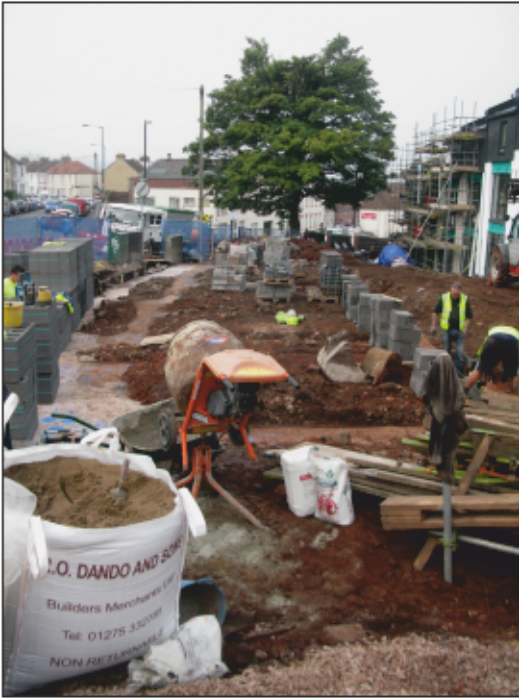
Wall foundation trenches for the final part of the development, which was for a small terrace of houses at the north-eastern side of the site, fronting onto Luckwell Road, were not monitored, as there was no callout from the developer before this work was carried out (**Plate 1**). On the north-western (Balfour Road) side of the site, the excavation of deep soakaway pits (roughly 2m below street level in Balfour Road), gave the opportunity to examine the ground to depth, but again, some of this work was undertaken with either no or late callouts, and the only result was what was clearly a relatively modern, brick lined well (**Plate 2**). As the development progressed south-westwards, down the gradient of the slope, foundation trenches were dug, and while, again, the actual excavation work itself was not

1. View to south-west from close to the north-eastern corner of the site. Footings of a small group of terrace houses fronting onto the north-western side of Luckwell Road, excavated and filled with concrete without monitoring.

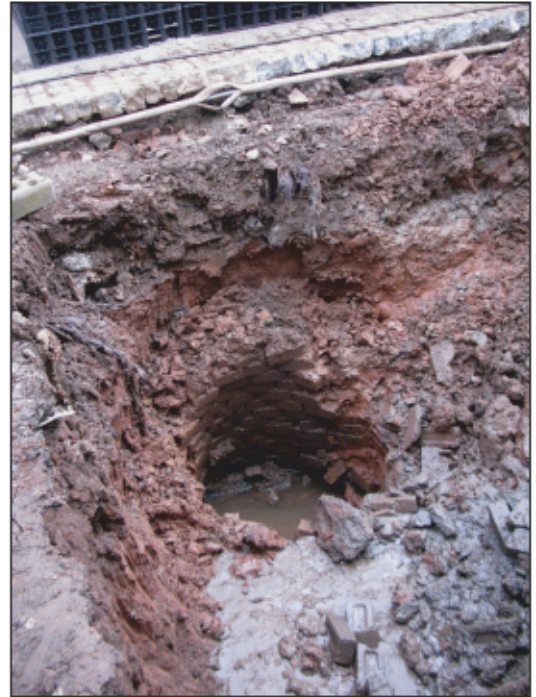
2. North-western side of the development, fronting onto the south-eastern side of Balfour Road, pit for soakaway, exposing brick-built well. The type of bricks used suggests machine manufacture and therefore relatively late construction, probably late 19th/early 20th century. Use of a scale was impossible due to the depth of the pit and the instability of the surrounding deposits, but the water seen at the bottom is at at least 2.5m below the cobbles on the south-eastern side of Balfour Road at the top of the image. View to north-west.

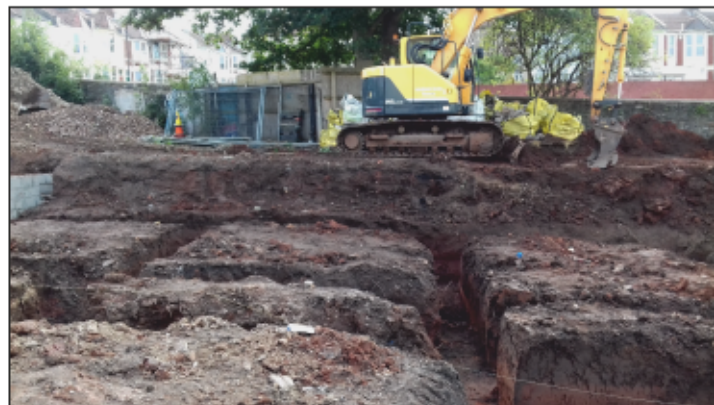
monitored in the absence of a callout to AAL, it was at least possible to inspect the open trenches prior to the concrete foundations being poured. Nothing of significance was noted in them, although the surface in this area had been stripped and truncated, and the natural Mercia Mudstone substrate lay close to the surface (**Plates 3 & 4**).

3. Footing trenches excavated in the central south-western part of the site, without monitoring. View to south-east. The main site gates in the top left part of the image open onto the north-western frontage of Luckwell Road.

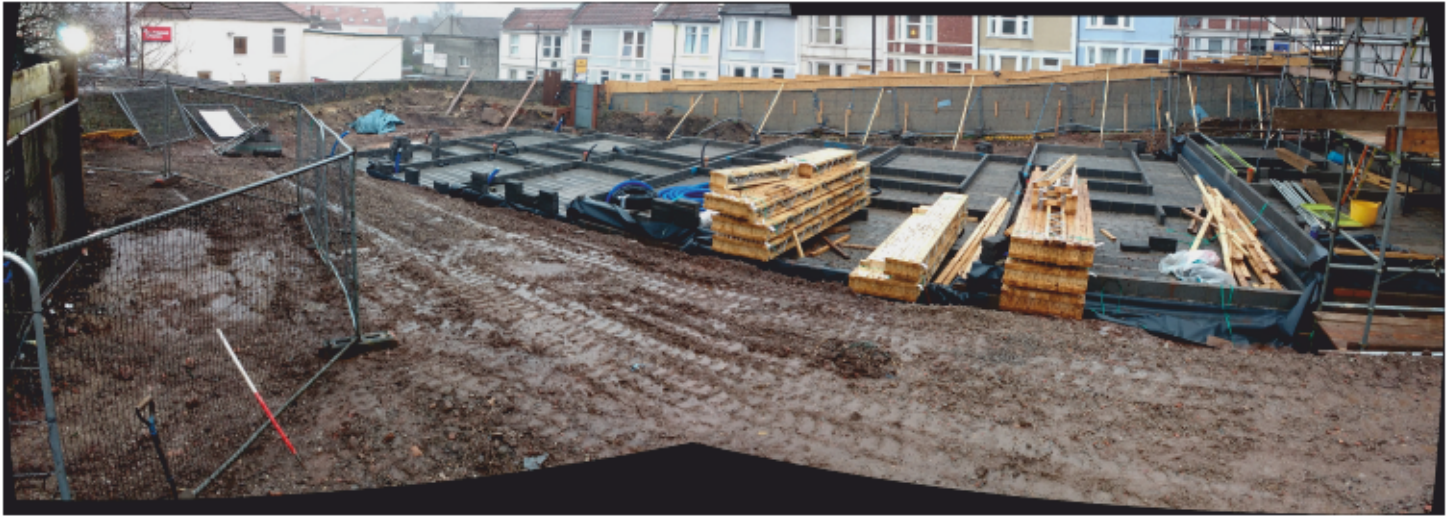
4. Composite panorama of the south-western part of the site, prior to investigations in the extreme south-western corner. The trenches shown in Plate 3, in the centre of the frame, have now been concreted, and construction of blockwork has commenced. The view pans round from south-west on the left-hand side, to north-west on the right-hand side. Houses lining the north-western side of Balfour Road are seen in the background.

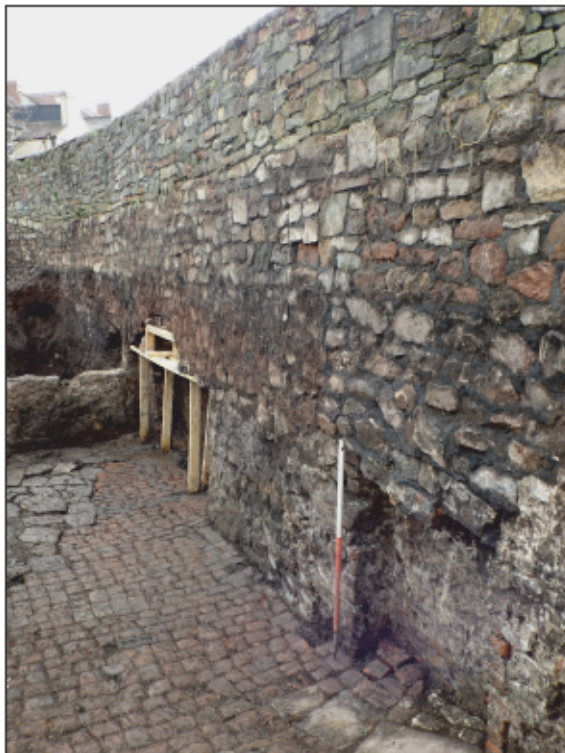
5. View of main boundary wall with (101) above white-washed elevation, and (104) below. Blocked opening (103) nearest to camera, (106) at further end with wooden bracing just inserted. Brick sett floor (105), with later flagstone repair (110), to bottom left. Note the 'tide mark' along the wall which indicates the depth of backfill removed to reveal these features. Scale: 1m. View to south-east.

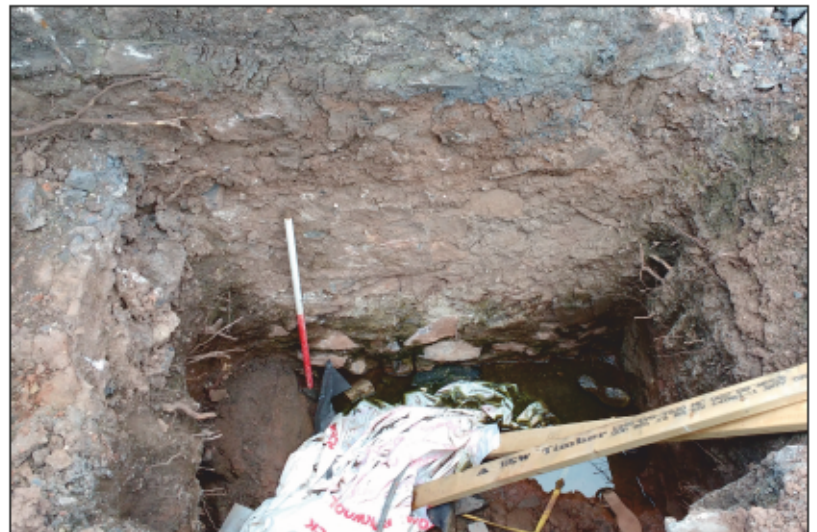
6. Sondage against northern elevation of ?original wall (104), immediately to south-west of wall (102). Scale: 1m.

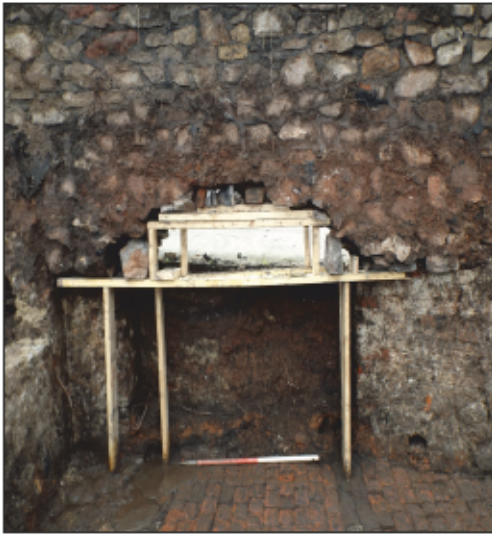
The lower, early wall phase (104) was also pierced by two openings, both of which are assumed to be secondary developments, ie not part of the original structure of the wall, and neither of which appeared to extend upwards into the later phase of the wall (101). The more south-easterly of the two openings (106) (here treated as effectively a cut) was 1.88m in width, and had two clear jambs, (108) and (109). Its height as found was 1.30m, but its upper section had clearly been truncated. The more easterly of the two jambs, (109), took the form of a short stub wall of stone inserted into that side of the gap presumably to neaten off and make good the hole that had been punched through (104). The other, more westerly jamb, however, (108), was of brick, and interestingly, displayed a long taper towards the gap, as though to give rather more access space on that side. This brick rebuild was 0.87m long, and while at its western end it was the same thickness as the wall (104) into which it had been inserted (ie 0.45m), at its eastern end, the 'nose' of the taper was only 0.16m thick (**Plates 7 & 9**).

It seems as though the opening (106) which is defined by these two jambs, punched through the original, lower part of the wall (104), was originally higher, but was truncated in its upper part by the rebuilding which seems to be represented by (101). The fact that it was possible to see right through the full width of the wall in this gap made it clear that the level of the road outside (ie on the south-western side of the main wall) has been raised by at least a metre by the dumping of general rubble and waste material, with original external street level at the same height as the floor of the structures identified here (**Plate 7**). This being so, it

seems most likely that (106) originated as a doorway to give access to and from the street, and is of a width to have accommodated a small dog or donkey cart. The taper in the more westerly door jamb may have been intended to facilitate turning such a vehicle westwards, into the body of the building.

7. Secondary opening (106) in original phase of main boundary wall (104). Stone jamb (109) to left, eastern end of tapering brick-built jamb (108) to right. Suggested rebuild or heightening of original wall above whitewashing (101). The south-western end of wall (102) appears at extreme left. Note modern ground level through the opening beyond the wall, with tarmac surface above a general dump of rubble and levelling clearly intended to raise its height. Scale: 1m.

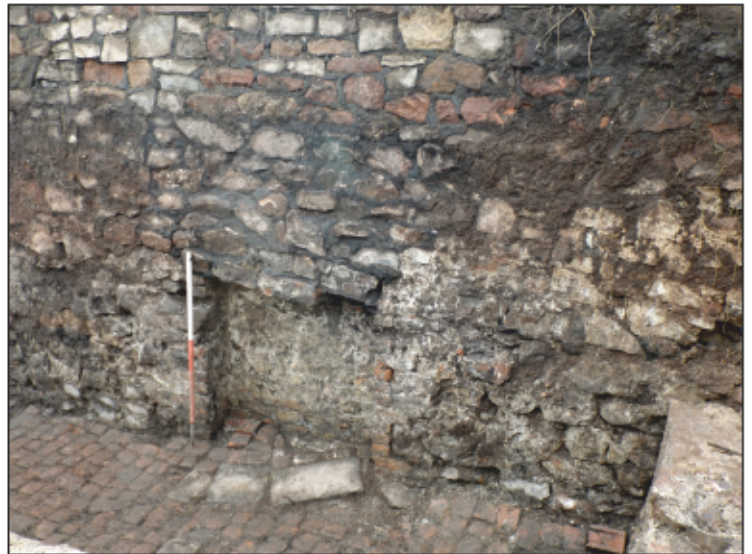
To the west of (106), feature (103) represents a further secondary intrusion into the main boundary wall (101)/(104). It was 1.1m in width, and 0.9m in height as found. Unlike (106), as found it did not penetrate the full width of the wall, but gave the appearance of a small alcove, 0.21m in depth (**Plate 8**), although the jambs were of brick, making good the truncation of the primary wall. This opening may not, however, have been truncated by the possible rebuild of the main wall represented by (101), as it looks as though it was made through both (104) and (101), its original height probably being represented by a brick blocking extending above the level of the lane on the external elevation of the wall (**Plate 10**). (103) seems therefore also to have been an opening which originally penetrated the full width of the wall, and gave access to the original street level on the other side, but was subsequently blocked. The lack of splays on either of the jambs may suggest that it is most likely to have been a doorway rather than a window, although the surviving elements of the feature may leave the question of its exact nature slightly problematic.

8. Feature (103), another blocked opening, possibly a doorway. Although the full blocking of this feature survives intact, it is also expressed on the external (southern) elevation of the main boundary wall (see Plate 10). Scale: 1m. View to south.

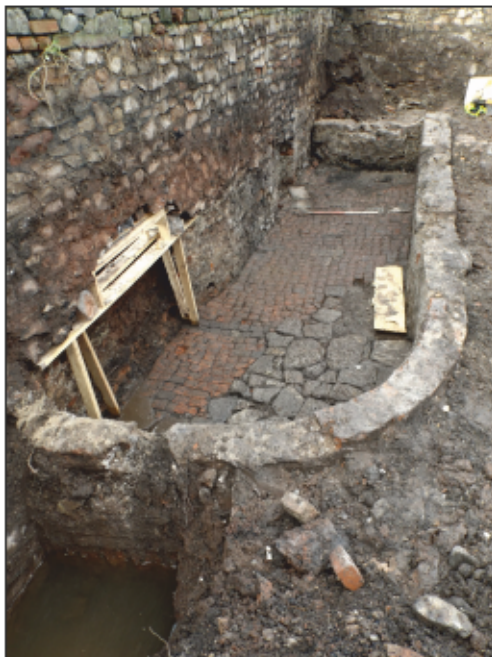
The major feature that was recorded in this part of the site was a wall running parallel to the main wall (101)/(104), and at the south-eastern end of which a curving return butted against the main wall. At the north-western end, it was almost certainly this same wall which also butted against the return of the main wall running north-east/south-west, and fronting onto the south-eastern side of Balfour Road (**Figure 4** and **Plates 9 & 11**). The main part of this structure was given the context (102). The total length of this part of the wall was 7.75m, in width 0.35m, and surviving to a height of 1m, although truncated in its upper courses. A maximum of 12 surviving courses were recorded. The internal (ie south-western) side of the wall was plastered and/or limewashed, so it was difficult to see the structure in detail, but it is most likely to have been of Pennant sandstone rubble, with occasional brick, perhaps representing repairs. It was bonded with a soft, buff-coloured lime mortar, with frequent flecks of charcoal. The curve at the south-eastern end of this structure is interesting and seemed quite deliberate, and the most likely explanation is that it was intended to

accommodate a small, wheeled vehicle turning into this building from the street, through opening (106) in the main historic boundary wall (101)/(104).

9. Wall (102) and, at the far end wall (107), returning south-westwards to butt against the main boundary wall, representing part of the same structure. The curve in the wall at the nearer (south-western) end of this building may be to accommodate a small wheeled vehicle turning in from the street, through opening (106) on the left. Scale: 1m. View to north-west.

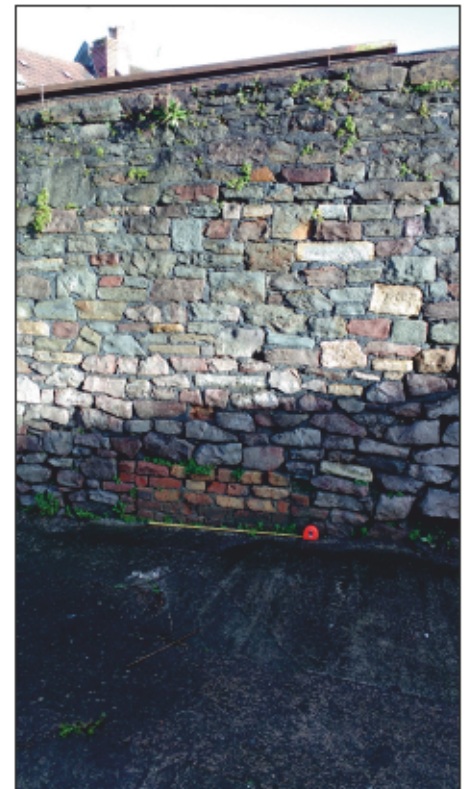
10. External (southern) elevation of main boundary wall, showing brick blocking of opening (103) in main boundary wall. See Plate 8. The tape in the foreground is extended to 1m for scale. View to north.

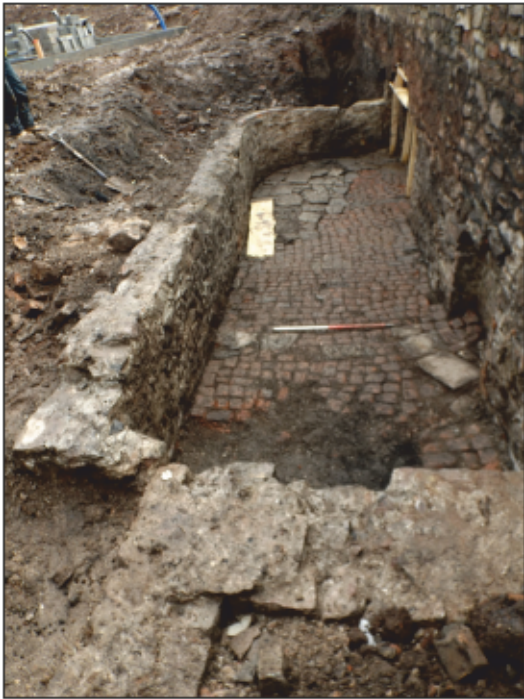
At its north-western end, this wall appeared initially to be in a butting, or at least a jointed relationship to a short return to the south-west, the south-western end of which butted against the north-eastern elevation of main wall (101)/(104) (**Plates 11 & 12**). This return was designated (107), and it was of roughly L-shaped plan, 1.82m in length south-west/north-east, and 1.85m north-west/south-east. As found it was 0.78m in height, and varied in thickness between 0.51m (north-west/south-east), and 0.62m (north-east/south-west). The structure was bonded with a dirty, mid-brownish pink, very speckly friable mortar, with frequent flecks of charcoal. There were traces of whitewash and/or plaster on the south-eastern elevation of the structure.

11. Wall (102) going away from camera, and joining (107) in the foreground. View to south-east.

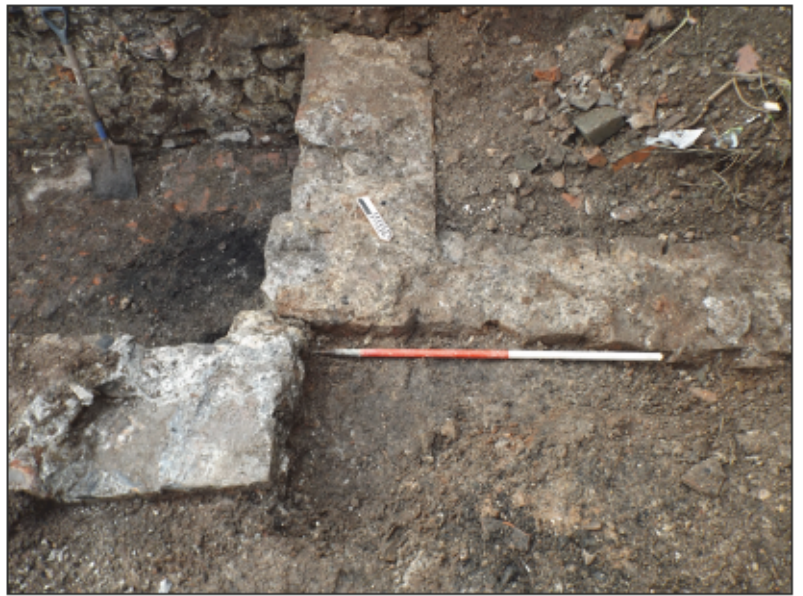
However, on closer inspection and after due reflection, we came to the conclusion that at its north-western end, wall (102) had simply been badly truncated, and that it was in fact a single build with both its south-western return (107), and indeed a short length of north-western continuation which butted against the south-eastern face of the north-eastern return of the main wall (101)/(104). All of these structures together defined what seemed to be an arrangement of two internal spaces or rooms, one, to the south-east, much longer than the other, at the north-western end, and which was almost square. The maximum width of the larger room was 2.06m. The smaller, square-ish room had an internal space of only about 1.40m.

12. Detail of junction between wall (102) (left of frame), and (107) (top right quarter of frame). It became apparent that this junction had been badly truncated and in fact originally, probably represented a staggered T-shape all of one build. Scale: 1m. View to south-west.

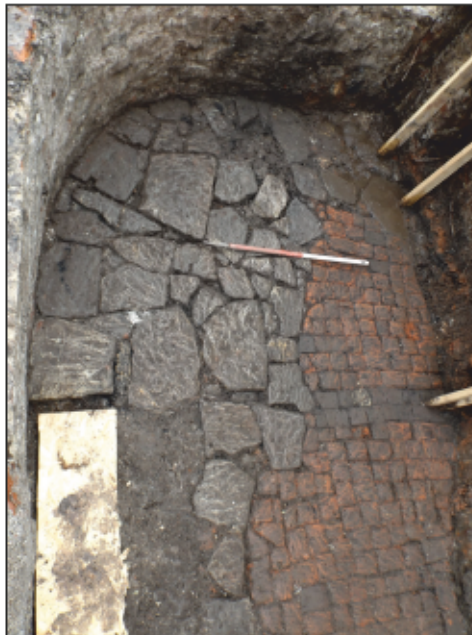
110	Length, SE/NW, 3.15m. Width, NE/SW, 2.32m.	A small area of stone flag surfacing at the south-eastern end of the long, narrow structure, right opposite doorway (106). Consists of very irregular, roughly dressed and roughly laid flags of very variable size. Max. size of a single flag, 0.61x0.40m. Some of the stones were clearly reused from elsewhere. At least one of them sampled for rock type may have been Carboniferous Limestone. This feature is almost certainly a rough repair to main brick sett surface (105).

13. Detail of rough flagstone repair (110) to original brick sett flooring (105), at the south-eastern end of the building defined by wall (102), seen running down the left hand side of the frame. The bottom of secondary opening (106) through the main boundary wall can be seen framed by the wooden shoring at top right. Scale: 1m. View to south-east.
