**Anne Hathaway's Cottage  
and Mary Arden's Farm**

**ARCHAEOLOGICAL  
WATCHING BRIEF**

PN 16-15

12/2016

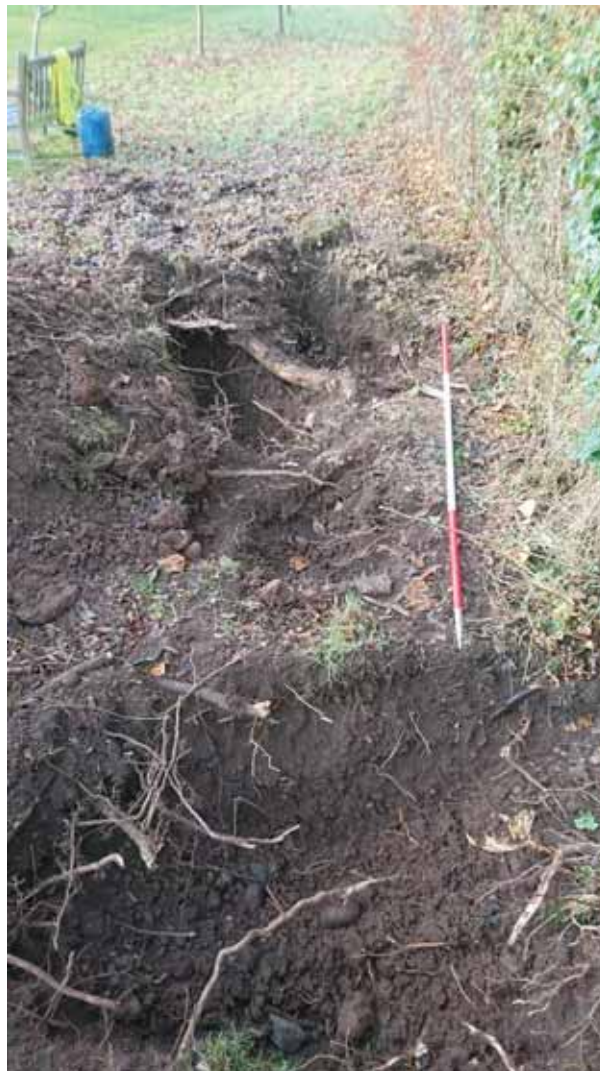
- 6.1.2. A mid-dark, orangey-red, clayey sand deposit with occasional inclusions of rounded pebbles (002) was identified approximately 0.3m below ground level. This subsoil deposit extended beyond the trench across the site. The presence of this layer confirmed there was minimal disturbance to the underlying layers, at this location.

- 6.1.3. Overlying this subsoil deposit was the topsoil (001). The topsoil was composed of dark-brown sandy-silt. There were occasional rounded pebbles and fragments of stone rubble included within the deposit and it was covered by turf (short cut grass). The deposit extended across the entire plot of Mary Arden's Farm and beyond. At various locations across the site there were modern tarmac paths and areas of hard-standing constructed to provide access around the property. There was evidence of minimal disturbance to the topsoil at various locations. Around these locations, several ceramic fragments were recovered, the earliest of which was late seventeenth century. Other fragments dating to the twentieth centuries were also present.

- 6.1.4. The trench was located along the location of what was thought to be the original thirteenth century plot boundary. Although no evidence was recovered to confirm the presence of this boundary. It is likely that the present hedge obscured any evidence of the existence of earlier boundaries.

**Plate 1:** Anne Hathaway's Cottage.  
Trench facing south west.

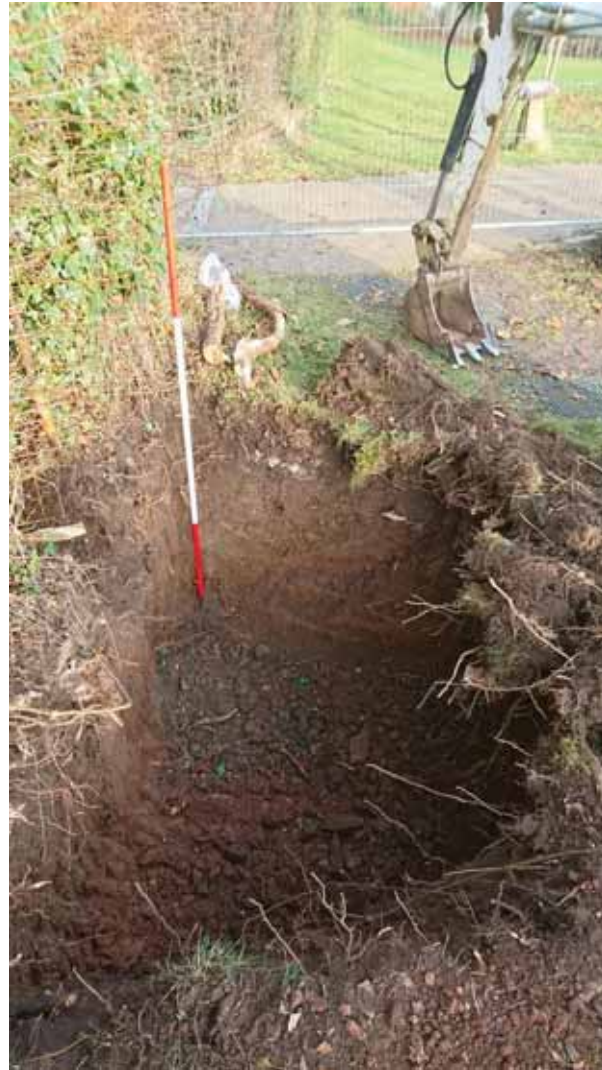
Plate 2: Anne Hathaway's Cottage.  
Trench facing north east.

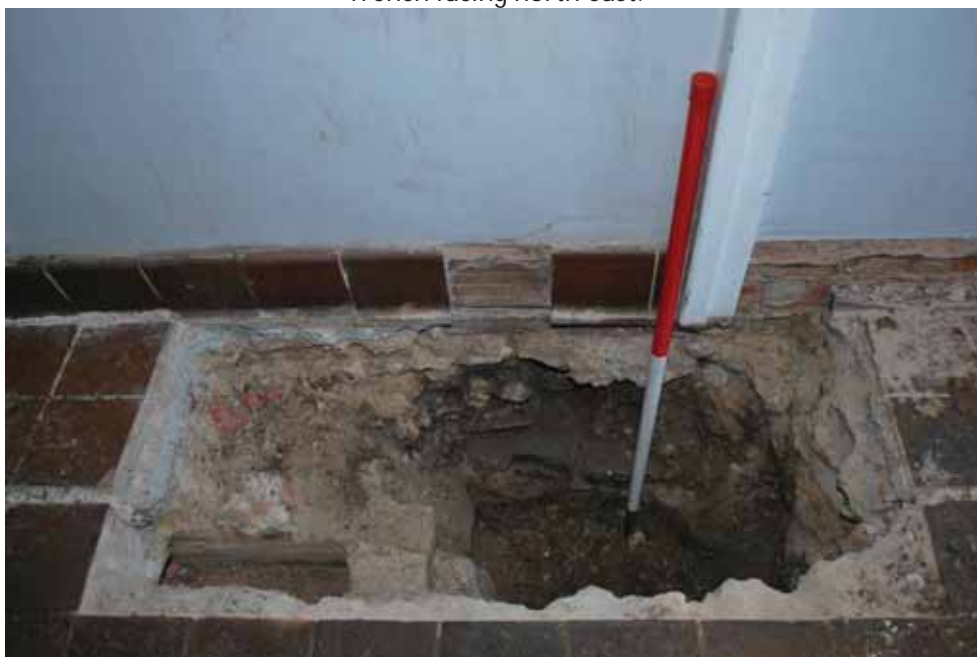
6.3.2. A dark brown, silty-sand deposit with frequent fragments of stone and brick rubble (**103**) was reached at a depth approximately 0.5m below ground level. This layer was partially exposed to a thickness of 0.2m, although it continued beneath this. The deposit had been used to level the area prior to the construction of the modern toilet block. The stone rubble contained within consisted of locally sourced Wilmcote limestone, the same used in the foundations of the farm buildings.

6.3.3. The foundations of the barn (**102**) were stepped (pad-stone) and were set upon a lime mortar bedding layer. The blocks were made up of rough-cut irregularly laid, Wilmcote stones. The wall of the modern toilet block had been attached to the earlier barn wall making it double skinned, although it remained untied to the barn wall. They differed considerably as the modern toilet block wall was made of brick. Deposit **103** had been placed up against the foundations.

6.3.4. A 0.3m thick layer surrounded the foundations and was located above layer **103**. This layer (**101**) was similar in nature to the deposit beneath (**103**) and was a mixed rubble layer used to level the area prior to the construction of the modern toilet block. The colour of this deposit was slightly lighter than **103**, but it contained the same inclusions, such as frequent fragments of stone and brick rubble, tile fragments and lime mortar.

6.3.5. A large brick structure was identified directly beneath the floor surface of the toilet block (**104**). The majority of this structure continued beneath the floor surface and appeared to have survived for up to 1m in both an easterly and southerly direction. The structure itself was constructed of red-orange hand-made bricks and had survived to a depth of at least 3-4 courses. The internal face of the walled structure had been lined using slate, presumably as a means to waterproof and damp proof the structure. Although it was not possible to record the exact dimensions of the structure, it was likely to have been large (a least 1.5m) and square or rectangular in plan. This feature could have been used as a sort of settling tank, storage or slurry pit for use on the 19<sup>th</sup> century farm.

6.3.6. The structure had been filled with a loose reddish-brown, silty-sand deposit containing brick rubble, mortar and clinker (**105**). There was a void between this deposit and the tiled floor above, presumably as a result of settlement and reduction of the filled brick structure.

6.3.7. The test pit was sealed by a sandy cement based mortar bedding layer (**100**) upon which the tiled floor and toilet block foundation had been built. The layer was yellow/cream in colour and composed primarily of sandy-cement based mortar with frequent inclusions of small rounded pebbles. The toilet block, along with its associated floor surface was laid around the 1960's, when Mary Arden's Farm was redeveloped as a museum for public use.

Plate 3: Mary Arden's Farm. Test Pit 1 facing south west.

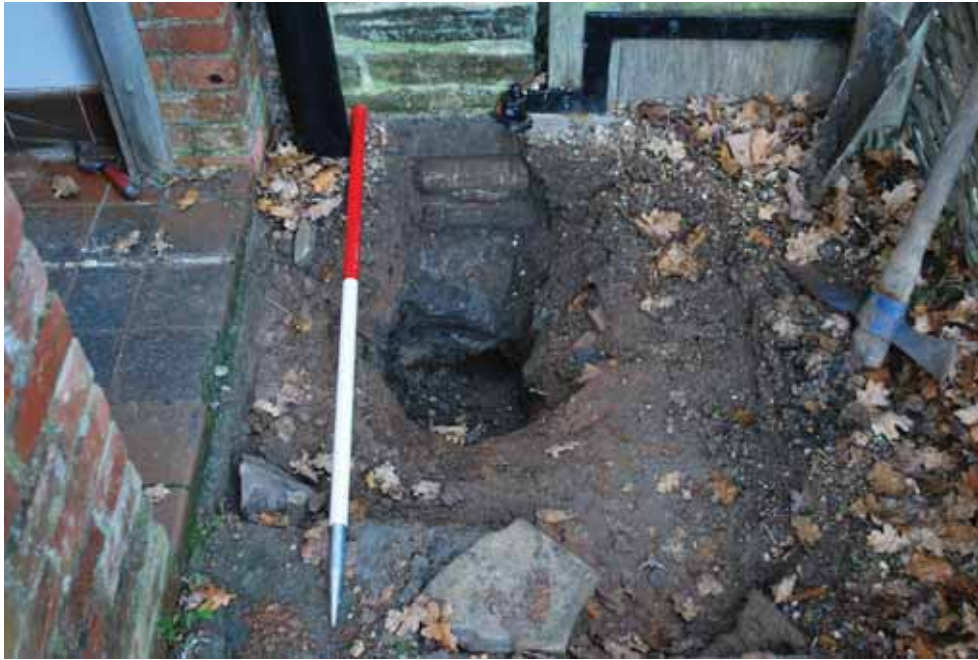
- 6.4.2. A dark brown, silty-sand deposit with frequent fragments of stone and brick rubble (**202**) was reached at a depth approximately 0.7m below ground level. This deposit was partially exposed to a thickness of 0.2m, although it continued beneath this to an unknown depth. The stone rubble contained within the layer consisted of locally sourced Wilmcote limestone, the same used in the foundations of the farm buildings.

- 6.4.3. Like test pit 1, the foundations of the barn (**201**) were stepped (pad-stone) and were set upon a lime mortar bedding layer. The blocks were made up of rough-cut irregularly laid, Wilmcote stones. Deposit **202** had been placed up against the foundations.

- 6.4.4. Deposit **202** was overlain by a mid-brownish red, sandy gravel bedding layer (**200**). This layer contained a high percentage of small (5mm+) pea gravels and it was used to provide the foundation for the flagstone pathway which ran between various different buildings on the property.

Plate 4: Mary Arden's Farm. Test Pit 2 facing south west.

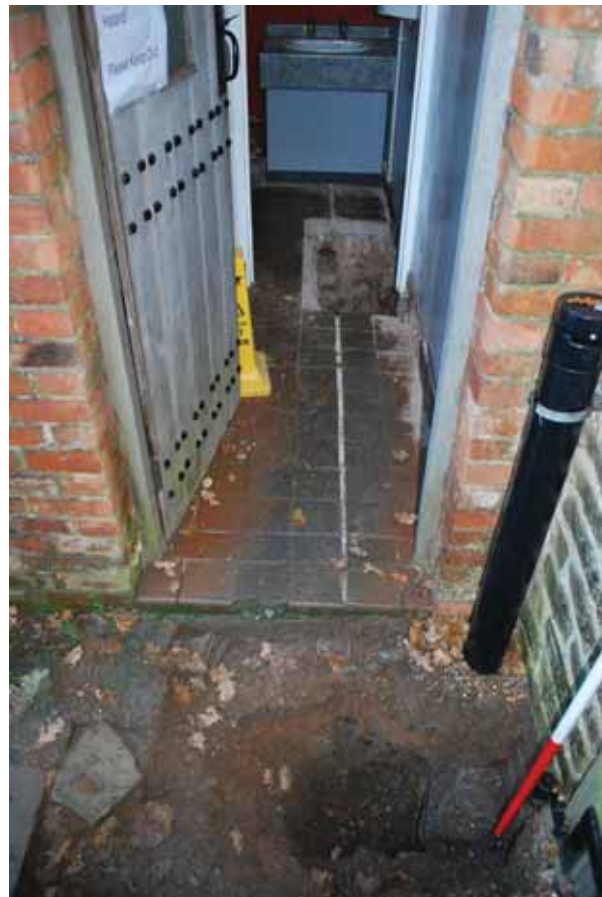
- 6.2.1. Two small exploratory test pits (Test Pits 1 and 2) were excavated at Mary Arden's Farm (Palmer's Farm) for the purpose of identifying the cause of the subsidence present in the toilet block wall attached to the barn. The test pits were excavated at a close proximity to one another. They were located within the main courtyard of the farm buildings and within the toilet block in the courtyard at Palmer's Farm against the eastern elevation of the main barn. Both

Plate 5: Mary Arden's Farm. Test Pits 1, 2 and toilet block facing south.

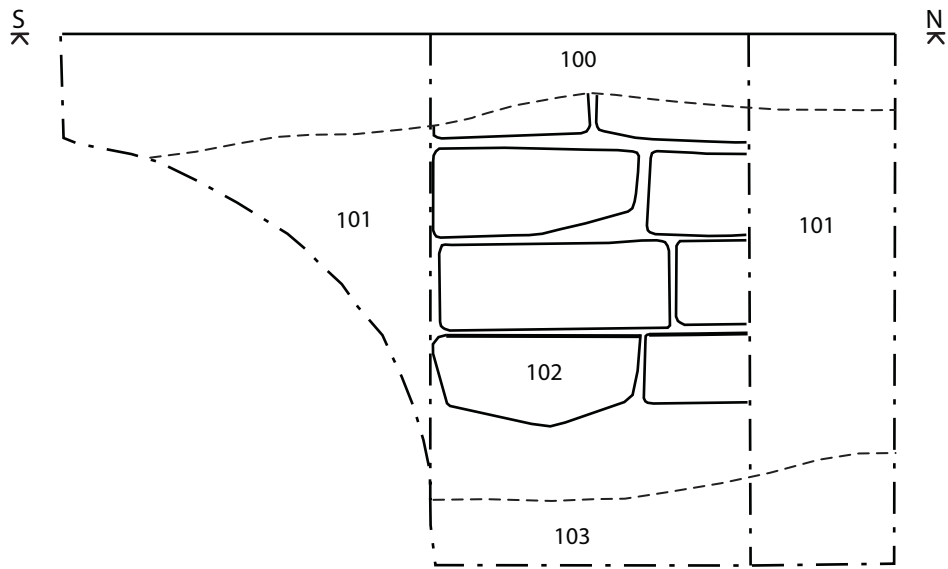
East facing section of Test Pit 1

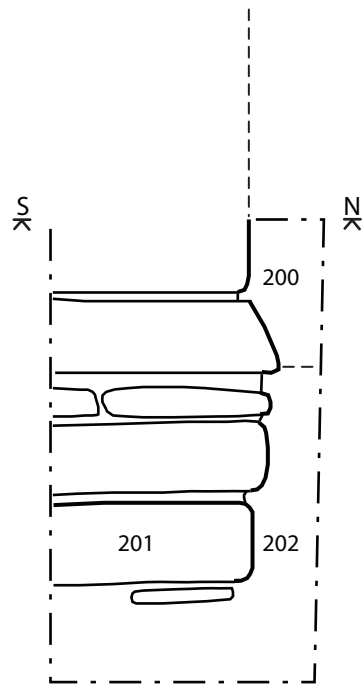
East facing section of Test Pit 2
