***Barns at Langton Caudle, Stonton  
Wyville, Leicestershire***

*Report on Historic Building Recording*

*Acorn Archaeology Report Number 38.0*

*July 2019*

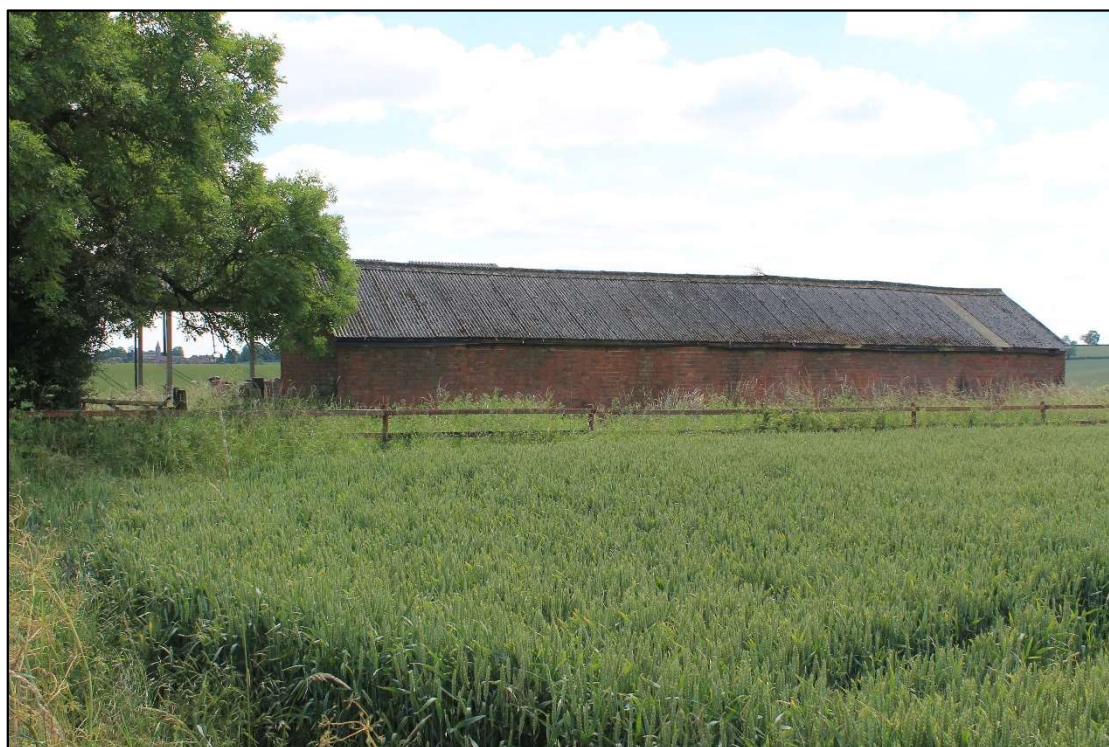
The north elevation of the range was plain brickwork with no openings or other detailing (Plate 4).

*Plate 4 Plain north elevation of brick structure, looking southwest*

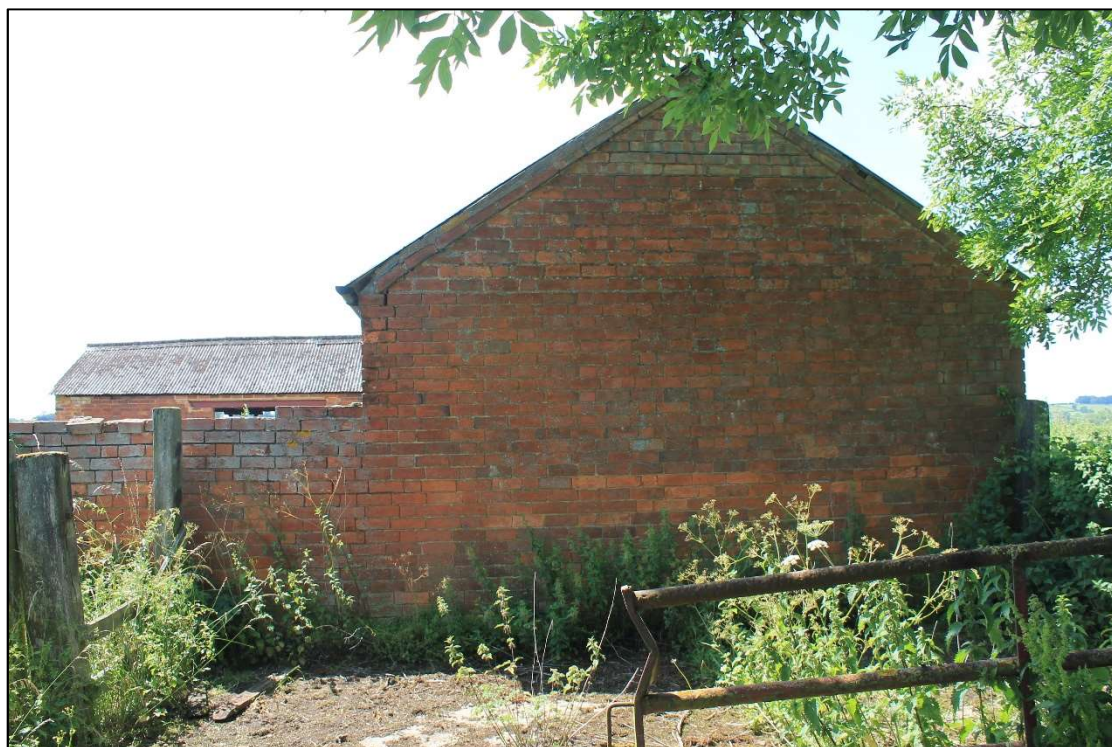
The apex of the east gable end of this room had been replaced or infilled with 20<sup>th</sup> century brick (Plate 5).

*Plate 5 East gable of cattle shelter, Room 2, looking west*

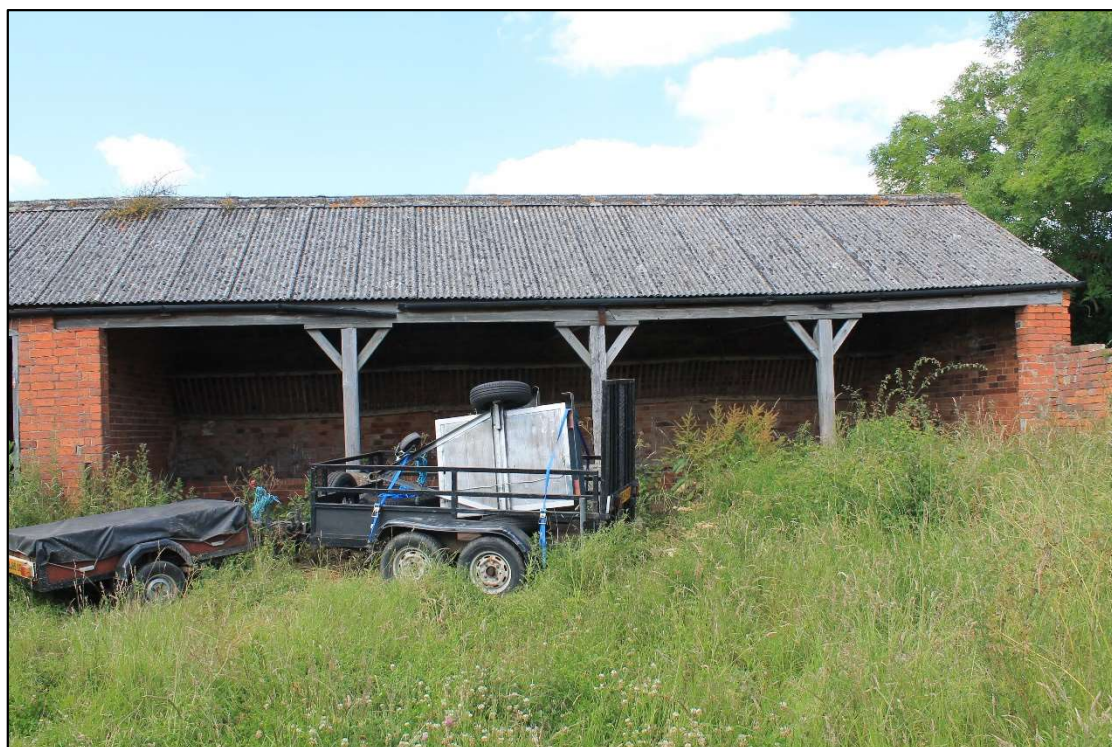
The open south elevation of Room 2 had a spliced timber wall plate supported on brickwork plinths at either end and three wooden posts with angled struts (Plate 6). Each wooden post was set on a red brick plinth with shaped blue bricks and the plinths had been the subject of later concrete repairs (Plate 7 & Plate 8).

*Plate 6 South elevation of cattle shelter, Room 2, looking north*

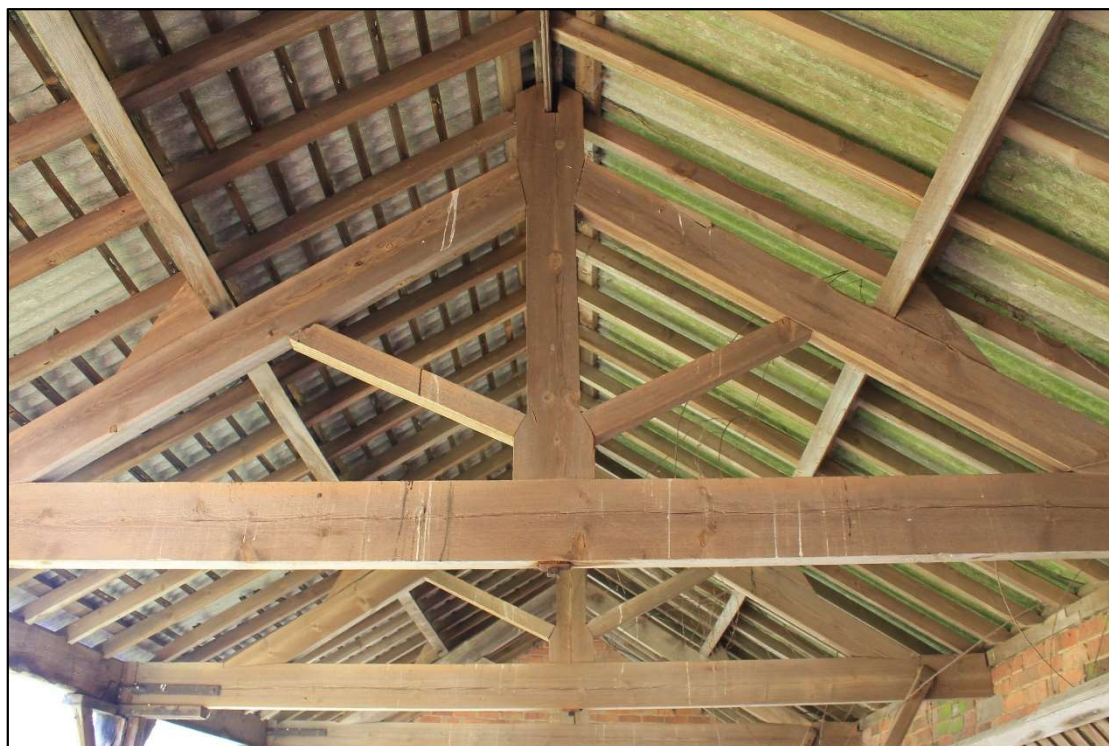
Each of the three wooden posts of the south elevation supported a king-post roof truss (Plate 8 & Plate 9). The roof timbers were machine-sawn. Purlins and rafters were noted, and laths to support tiles or slates survived on the south side of the room (Plate 9). The original roofing material had been replaced with corrugated sheeting, but the

*Plate 9 Detail of roof structure of cattle shelter, Room 2, looking west*

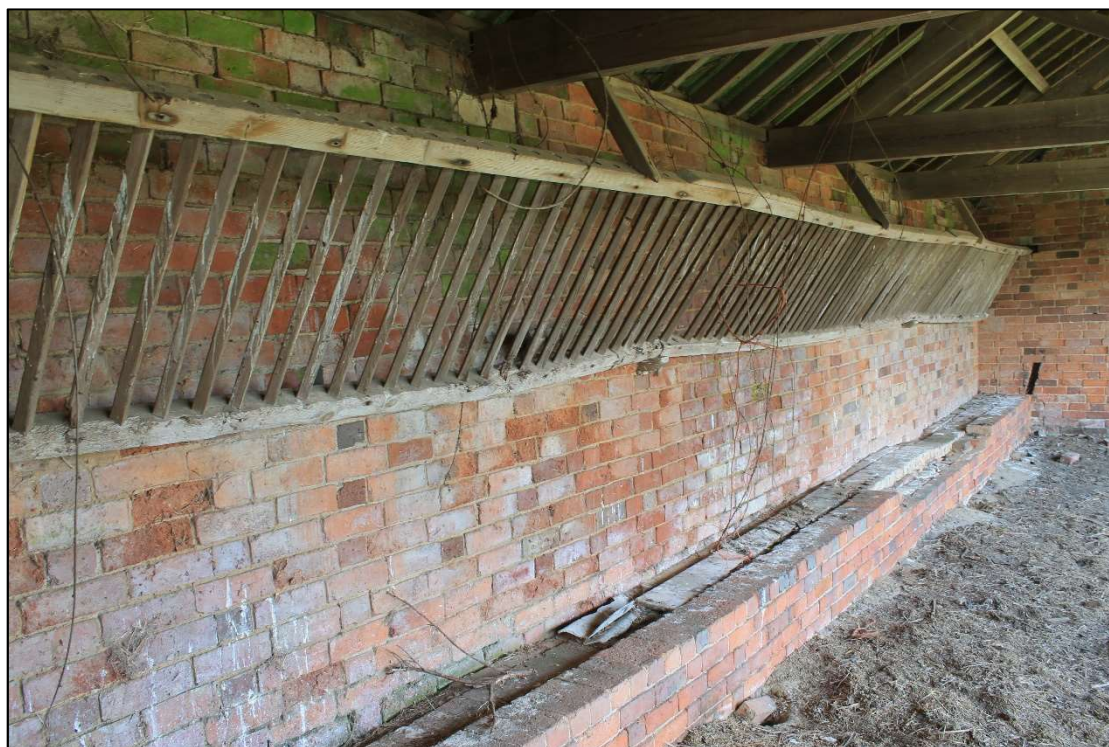
The long north wall of Room 2 was occupied by a low brick plinth (Plate 10). Angled holes in the brickwork of both gable ends of the room immediately above this indicated that this had formed the base to a manger, with a now-lost angled wooden upper section (Plate 10, Plate 8). A wooden hay rack survived above the manger, along the full length of the room (Plate 8 & Plate 10).

*Plate 10 Hay rack and manger along north wall of cattle shelter, Room 2, looking northeast*

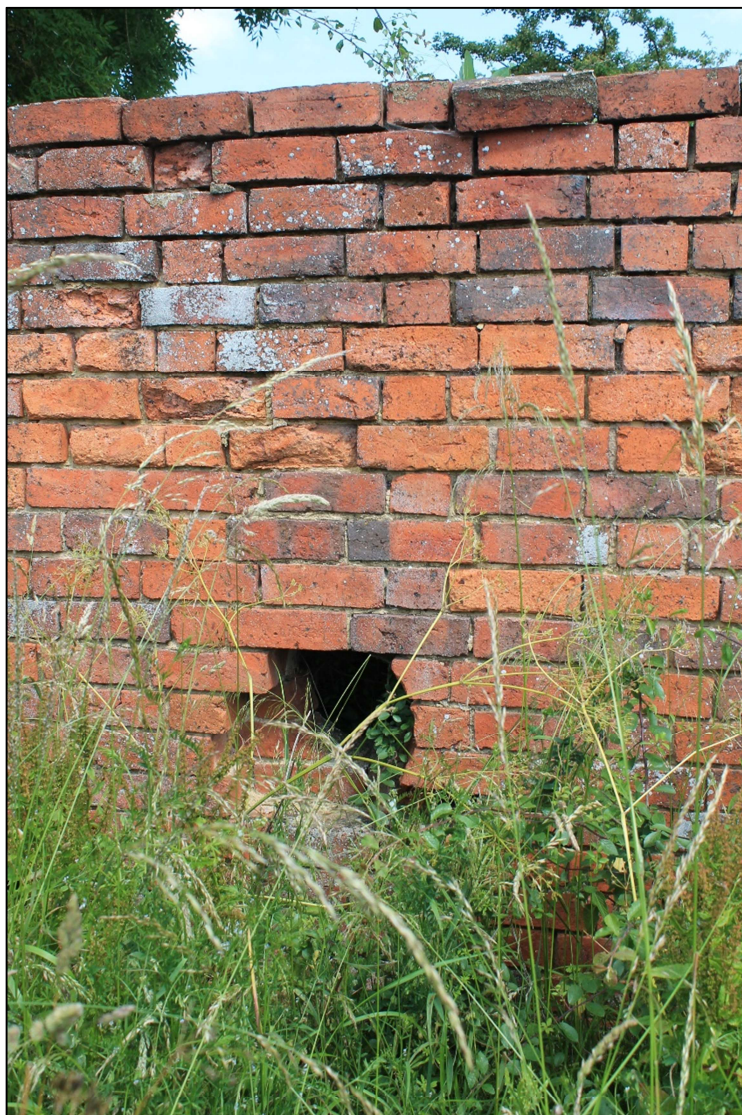
A small opening was noted in the east wall of the yard, perhaps having allowed for a former a pipe or machinery (Plate 14).

*Plate 14 Detail of east wall of cattle yard (Area 6) showing hole through wall, looking northeast*

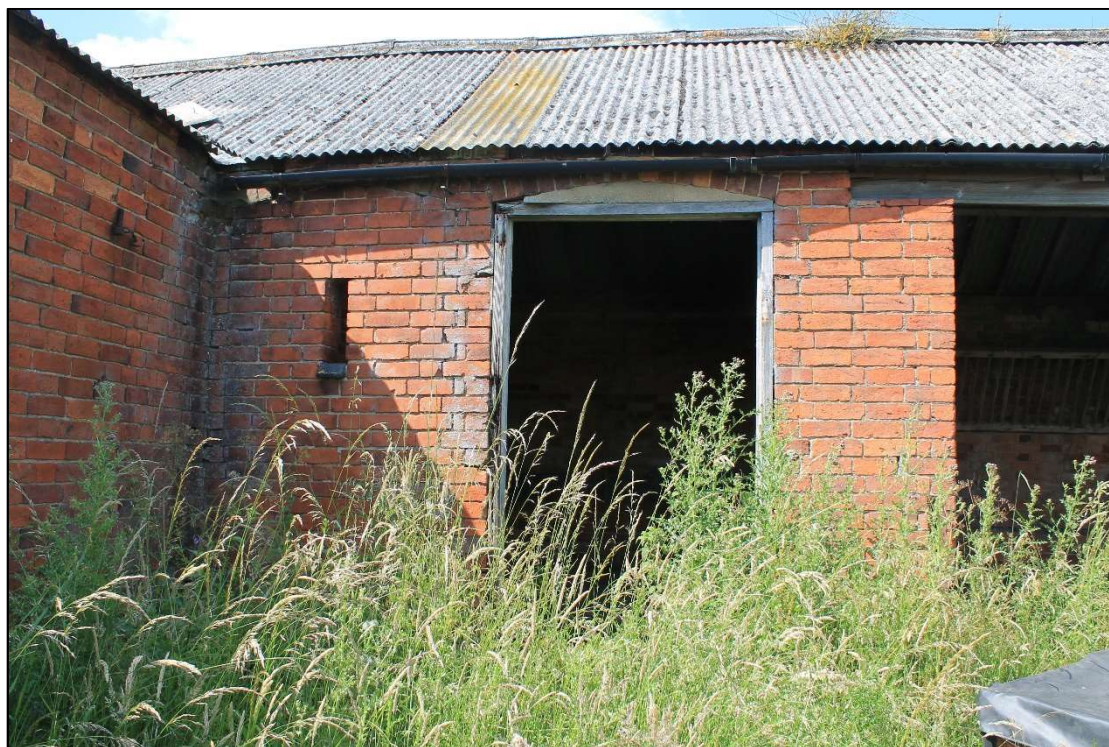
segmental arch over, matching that over the adjacent doorway. A single breather slit had been incorporated within the infill of the former window (Plate 15).

*Plate 15 South external elevation of Room 3, showing blocked window and inserted breather slit, looking north*

At some time after its initial construction the window of Room 3 had been blocked with brick and replaced with a single breather slit. This suggests that the room was used for fodder storage later in its life and would have been in a convenient position to serve this purpose, being adjacent to the shelter shed. The date of this alteration is uncertain, but the brickwork suggests a possible late 19<sup>th</sup> century to early 20<sup>th</sup> century date.

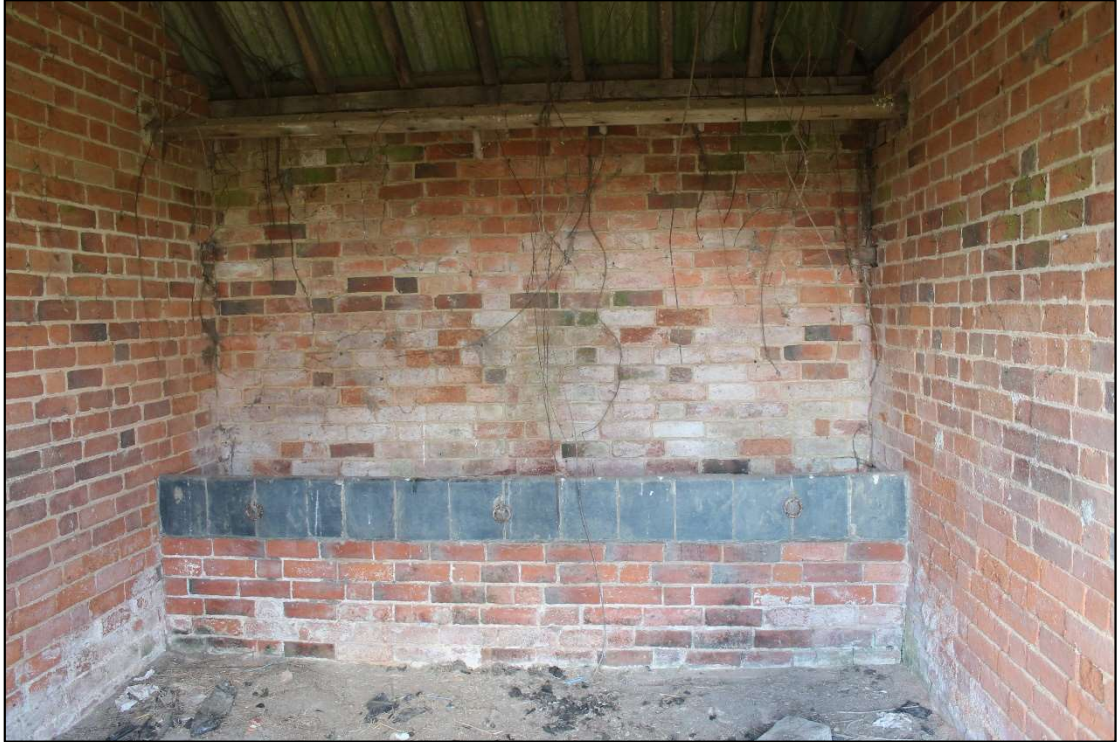
The northern wall of Room 3 was occupied by a brick manger, which incorporated shaped blue bricks at the top. Three iron tethering rings were attached to these blue bricks (Plate 18, Plate 19 & Plate 20). A single surviving horizontal timber with a few remnants of smaller vertical timbers attached, along with holes in the brickwork of the west and east walls, represented the remains of a hay rack over the manger (Plate 18 & Plate 19).

*Plate 18      Brick manger with iron tethering rings and remnants of hay rack inside  
Room 3, looking north*

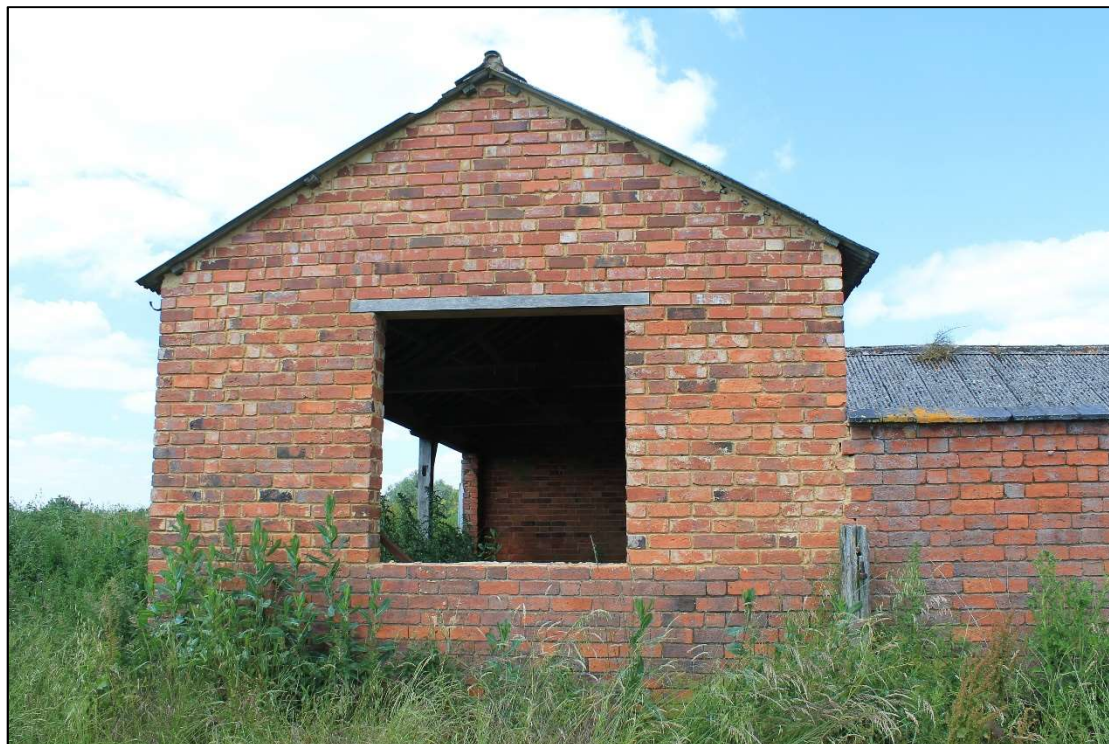
The southern gable end of Room 5 had been partially rebuilt (Plate 24), possibly due to the same leaning seen in the southern yard wall. Original walling, continuous with that of the adjacent yard to the east, was noted below the sill level of an opening in the gable. Above this, the gable met the yard wall with a ragged join, and had been

rebuilt possibly in the 20<sup>th</sup> century (Plate 24). It was therefore unknown whether the original gable would have included a similar opening.

*Plate 24 Substantially-rebuilt south gable of Room 5, looking north*

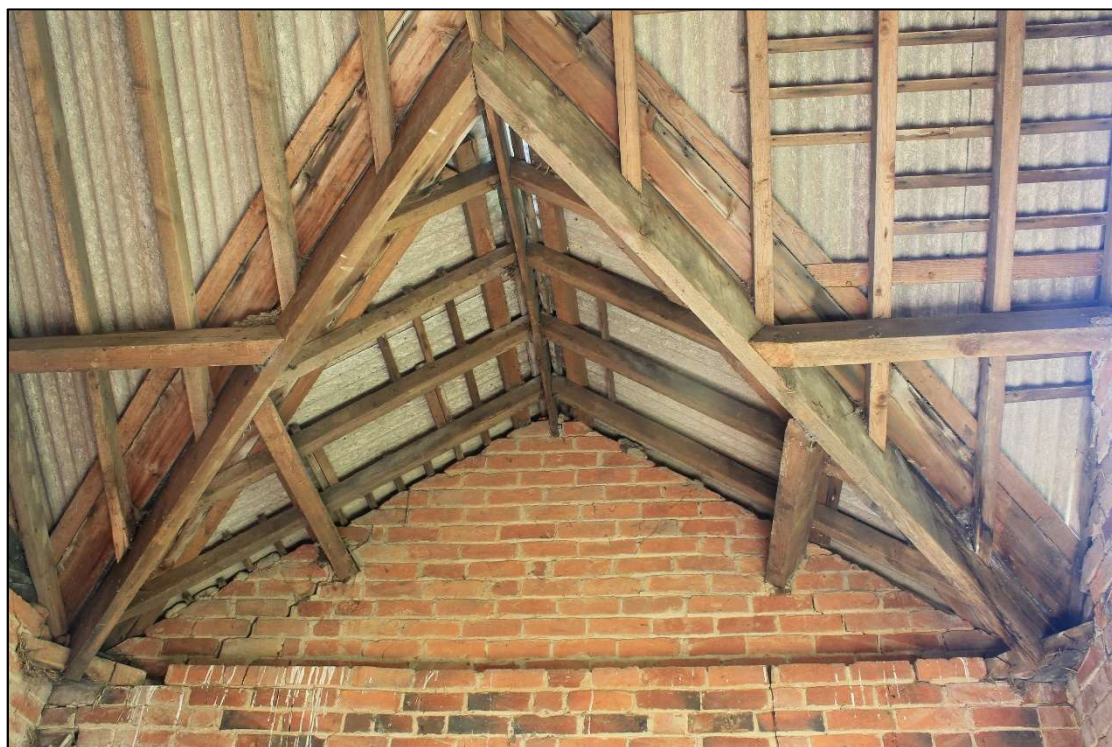
As in some of the other recorded rooms, roof timbers in Room 4 included laths, but the original roofing material had been replaced with corrugated sheeting (Plate 28 & Plate 29).

Plate 28 *Detail of roof structure in Room 4, looking south*

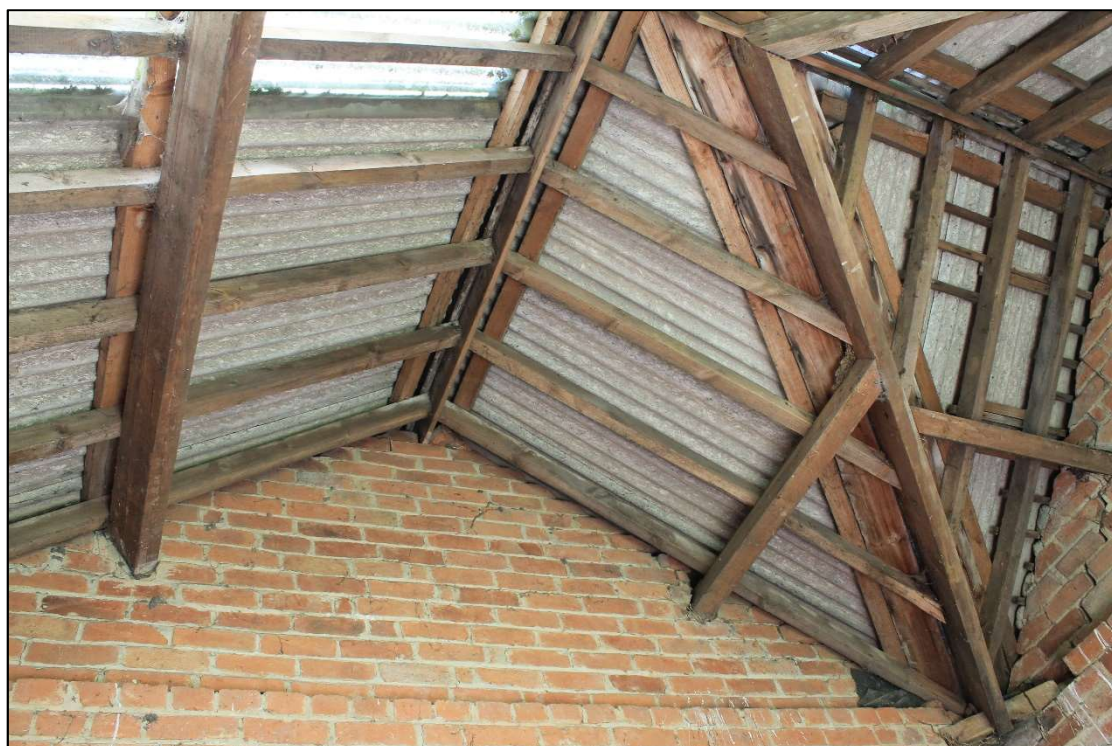
Plate 29 *Detail of roof structure in Room 4, looking east*
