Report

Level 2 Historic Building Record Burgage Wall, Daventry, Northamptonshire

Date: March 2020

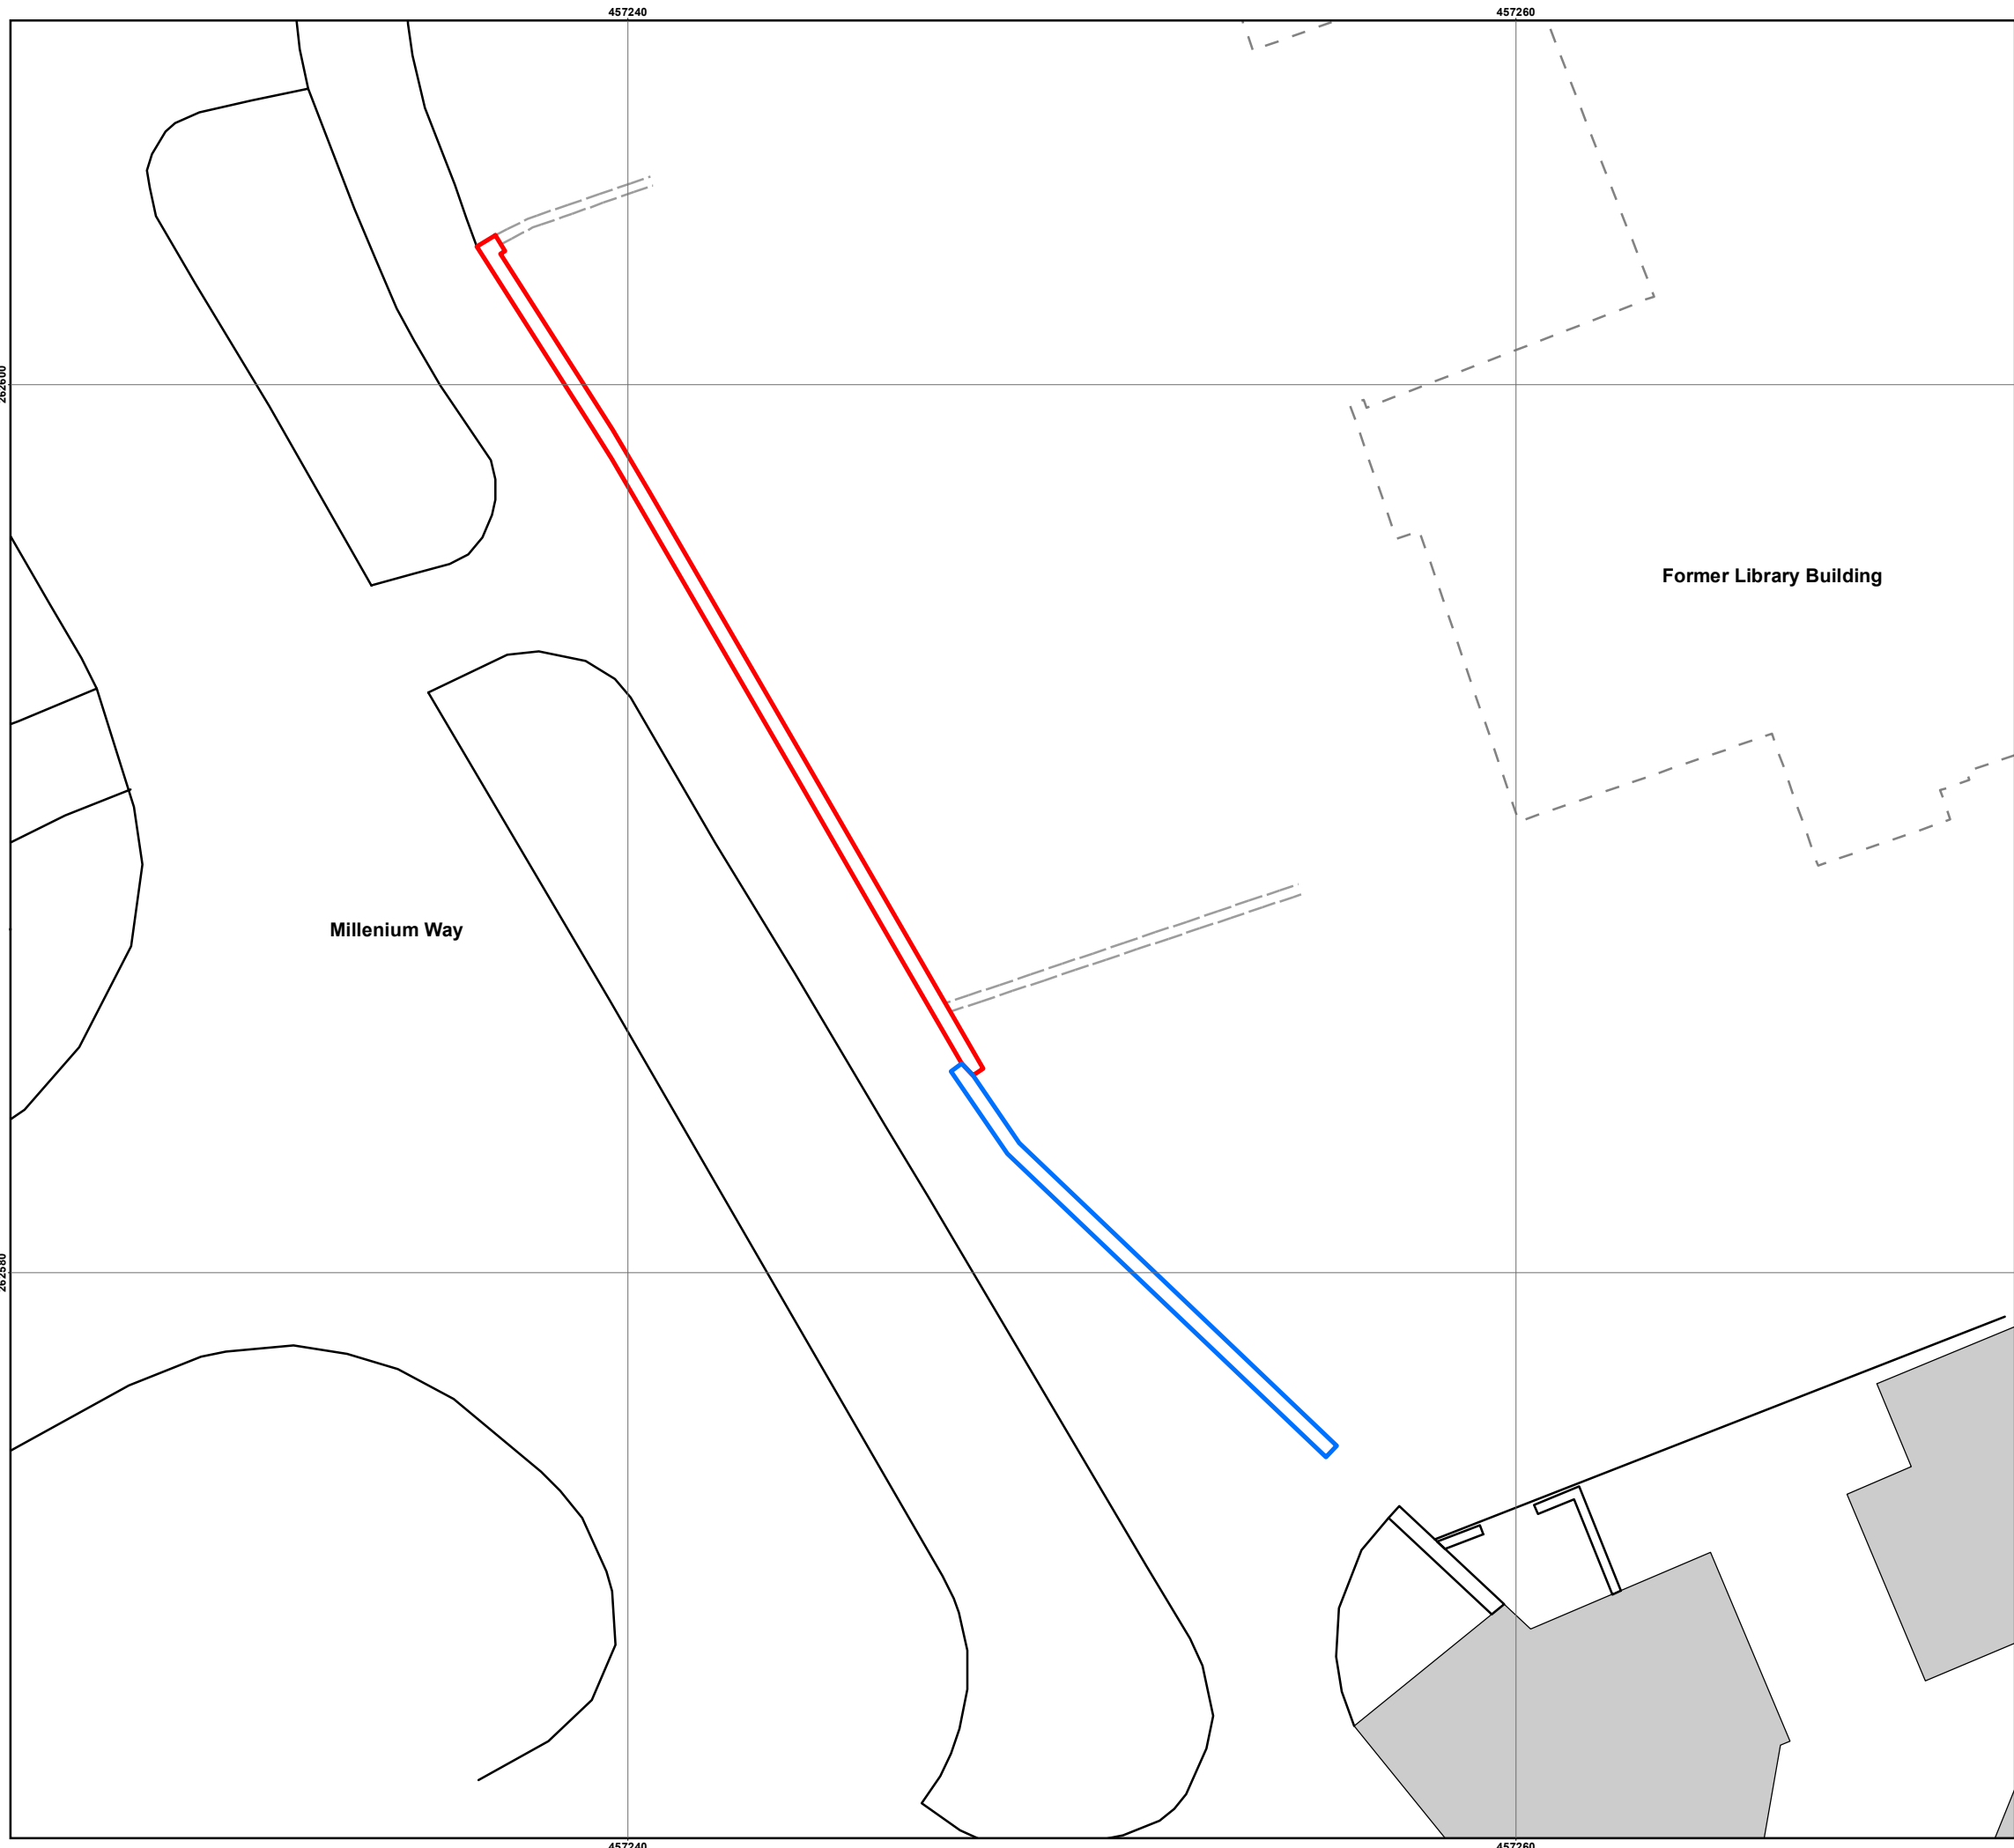
Figure 3: Phases of Construction

- Early 19th century
- Late 19th / early 20th century

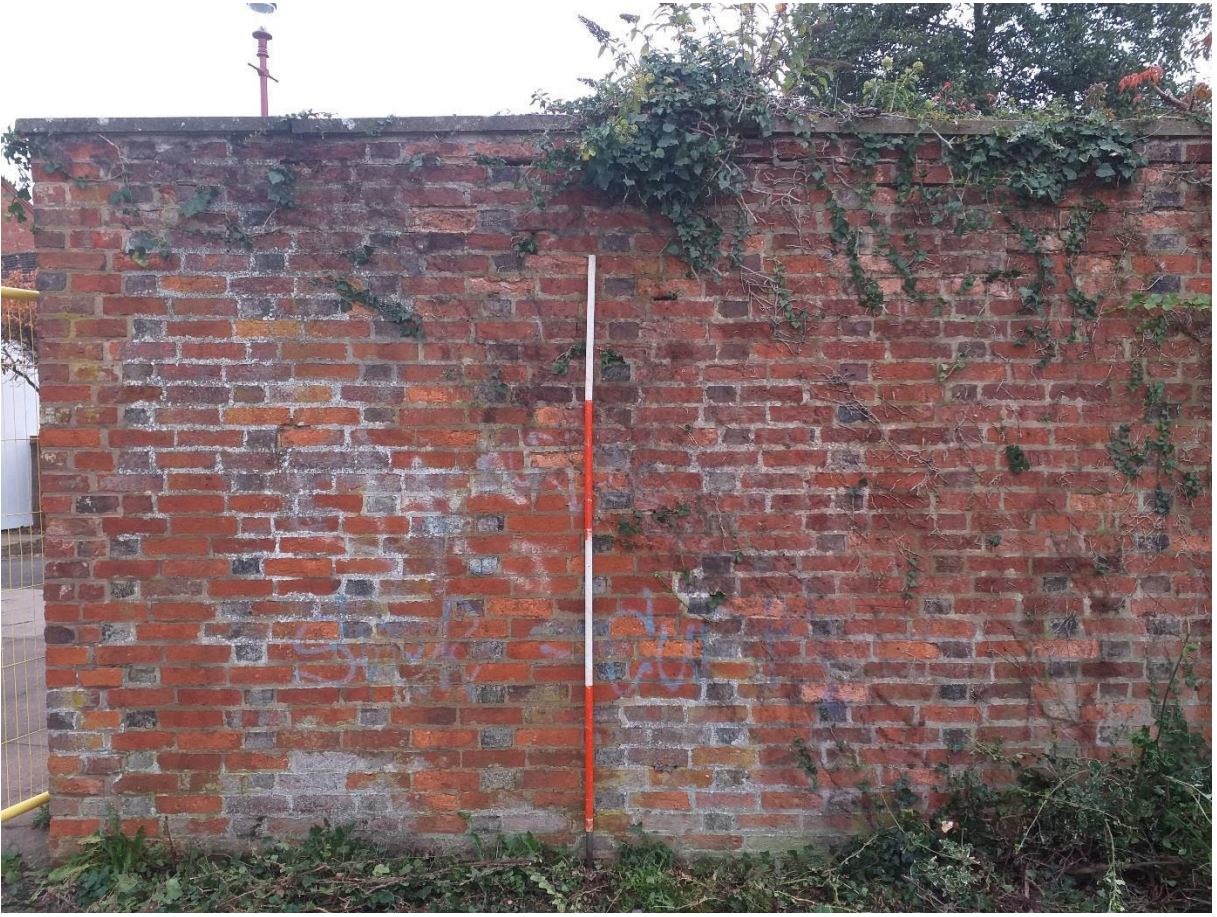
The Burgage Wall, Daventry, Northamptonshire		Photographic Survey
Client: Willmott Dixon	Photo No. 1	Date: 14/10/19	Direction Taken: SW
Description: View of the eastern elevation at the southern end.

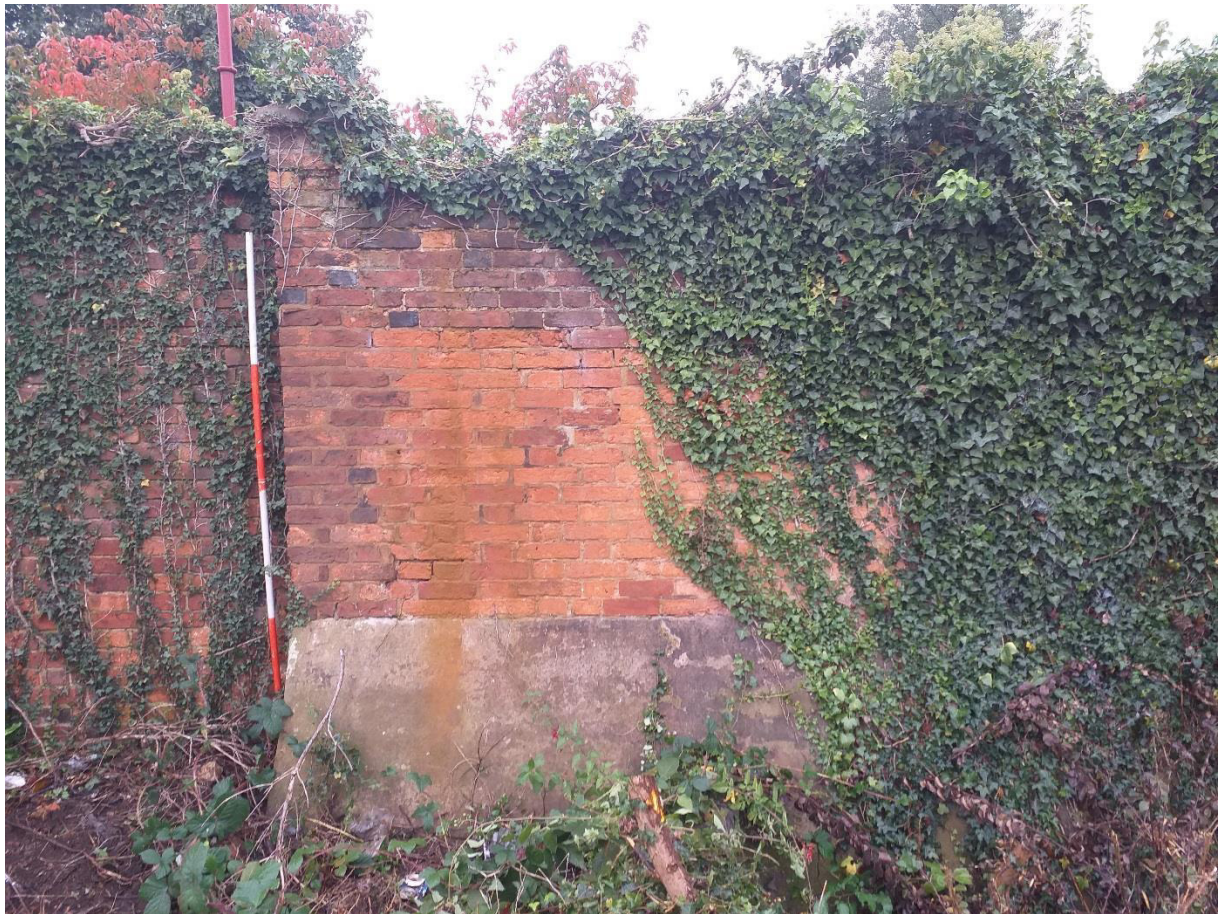
Description: View of the eastern elevation at the join between the southern and northern sections.

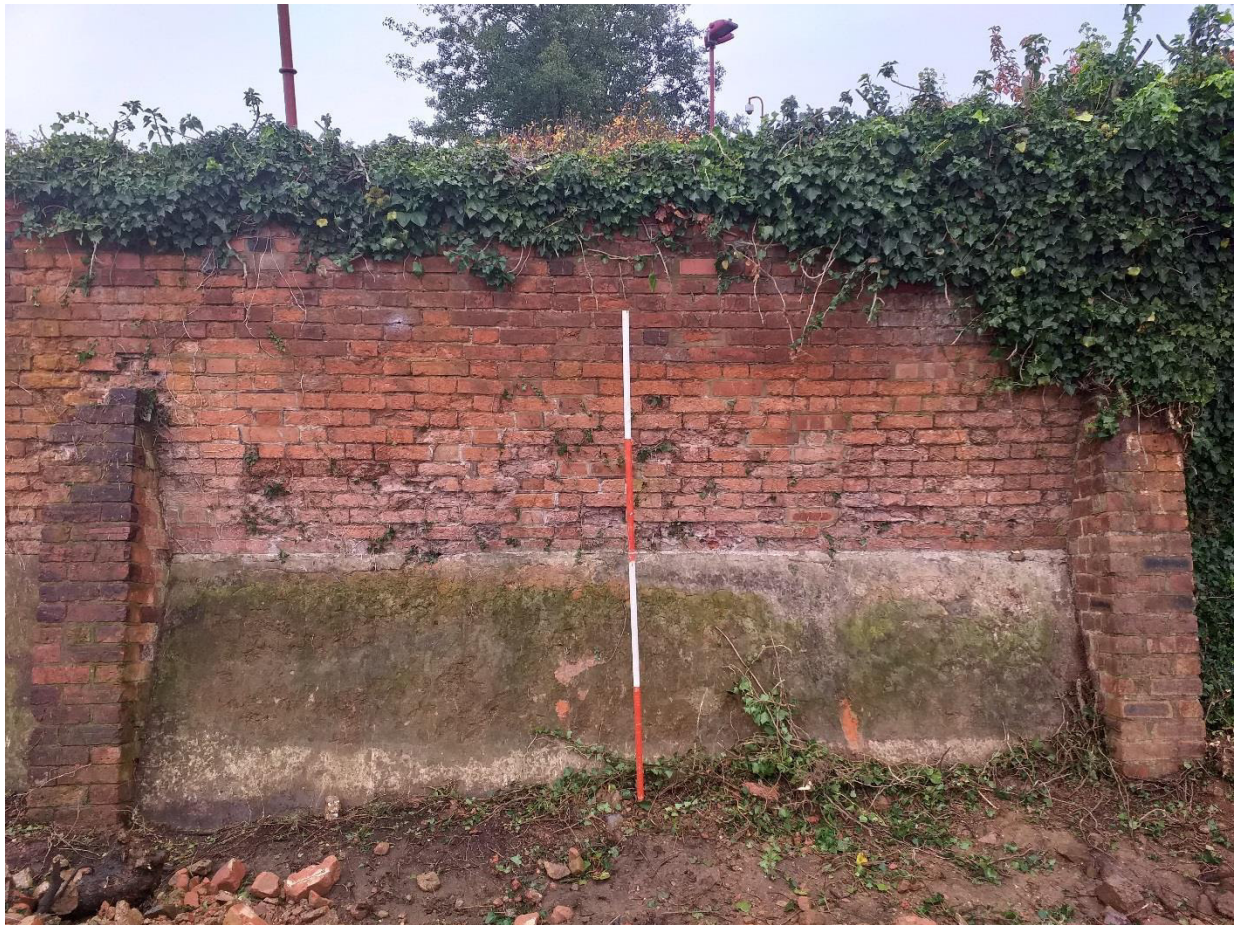
Description: View of the eastern elevation of the modern buttresses and concrete retaining wall.

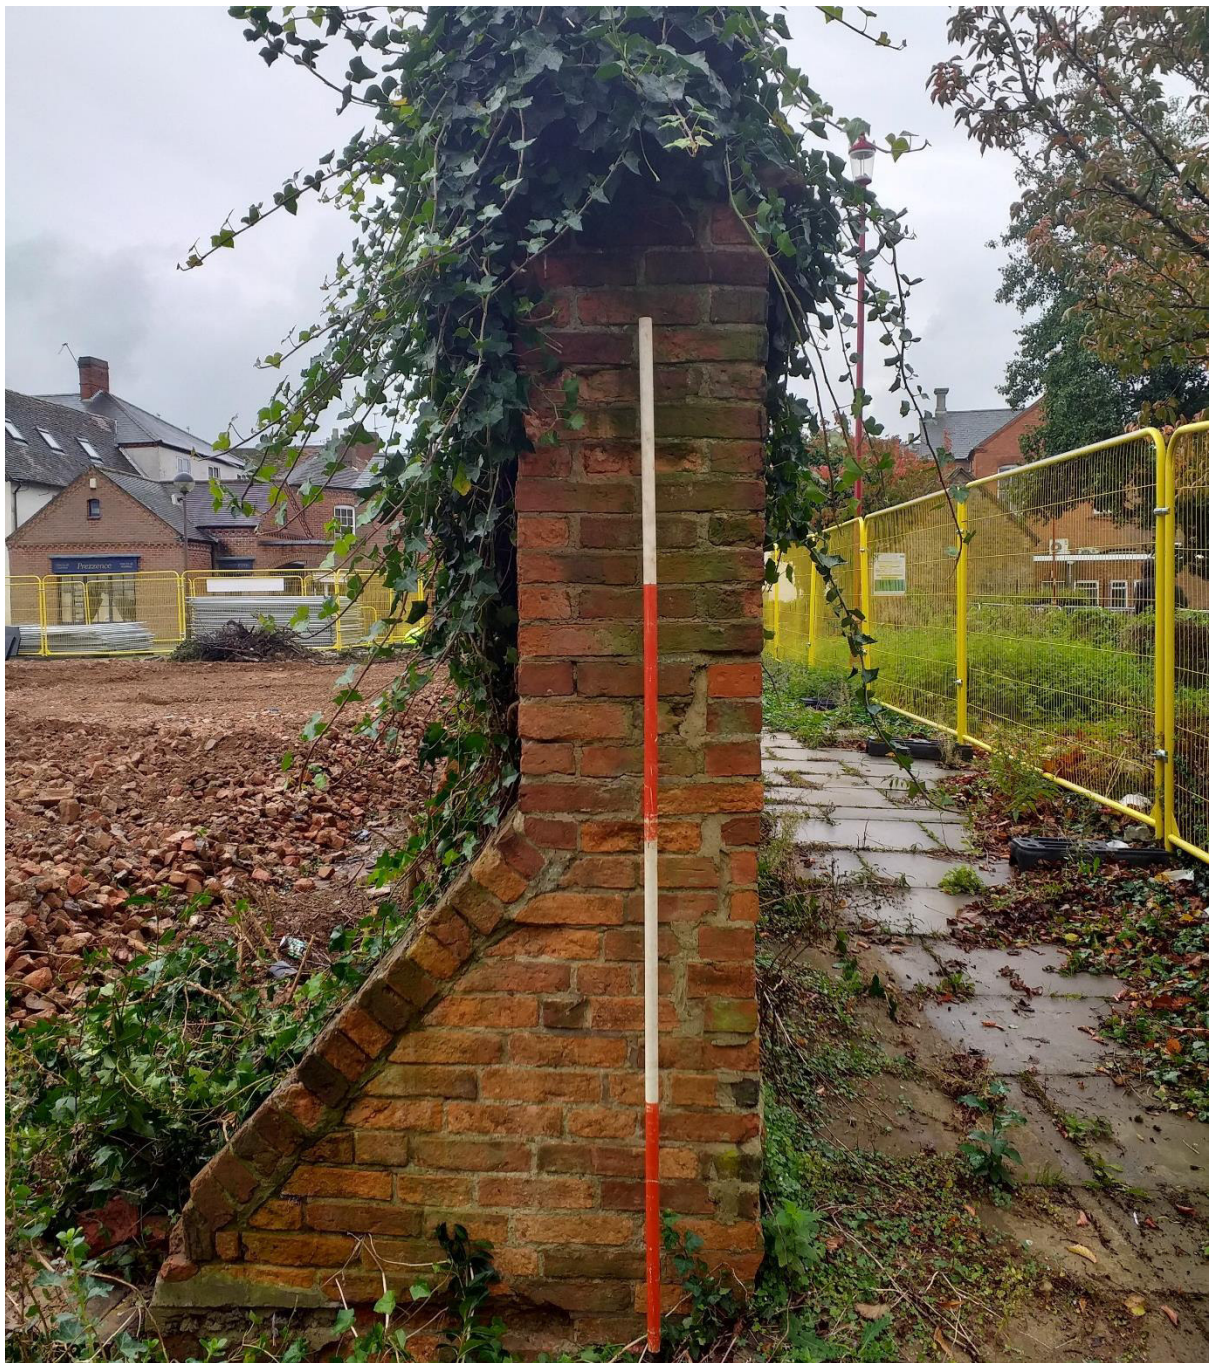
Description: View of the northern end of the wall

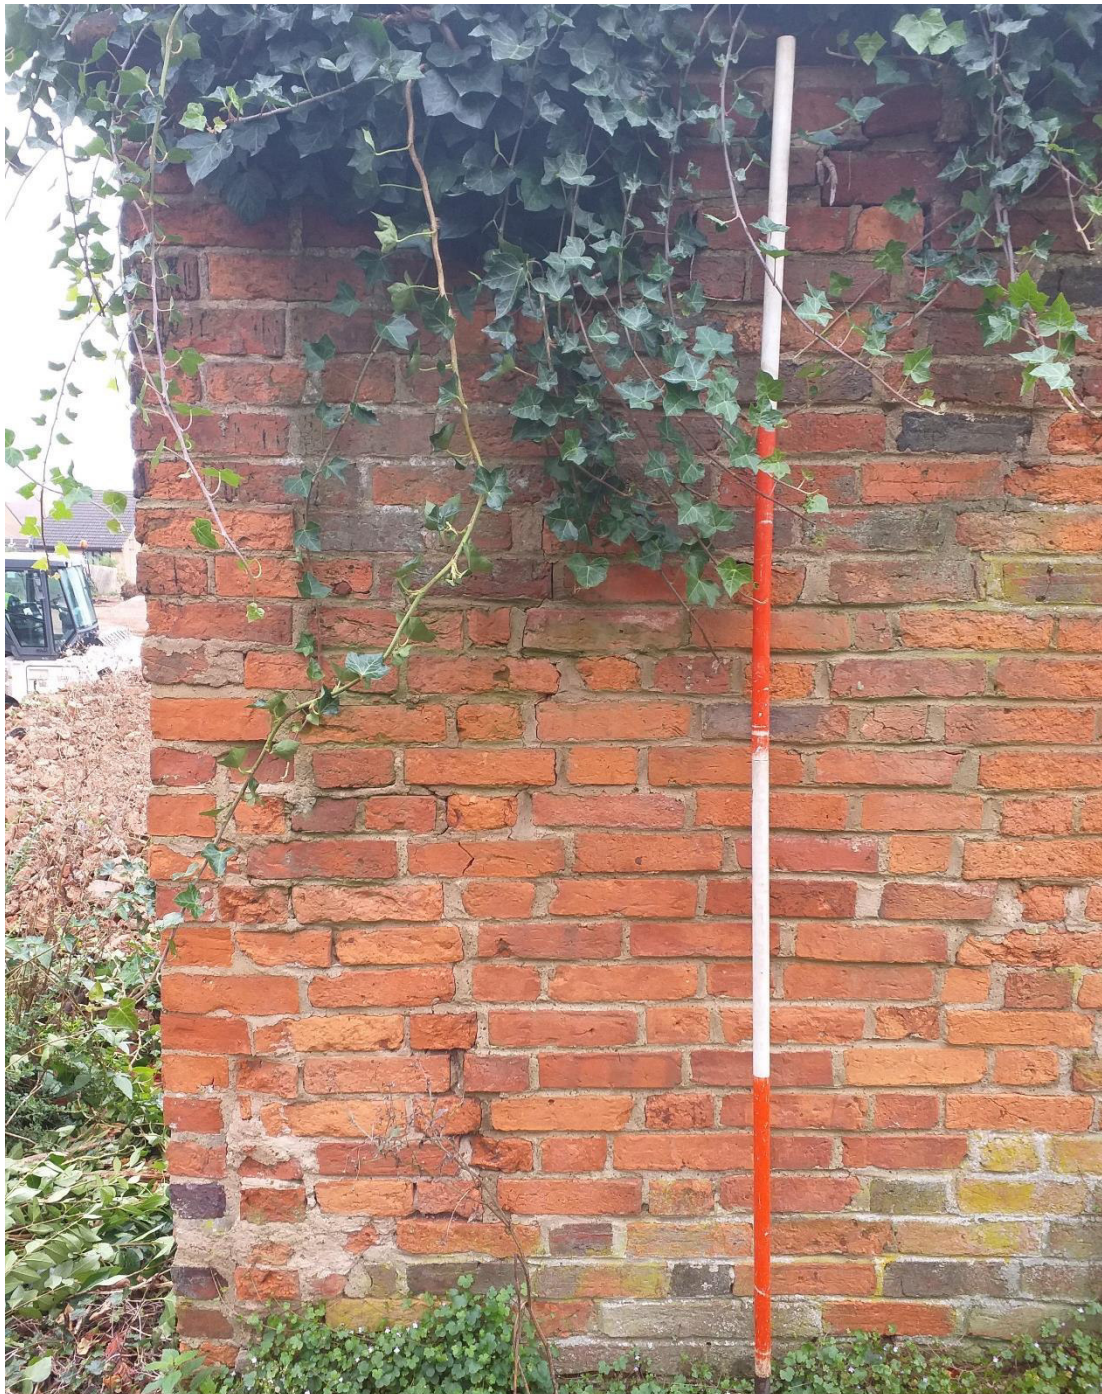
Description: View of the west elevation at the northern end

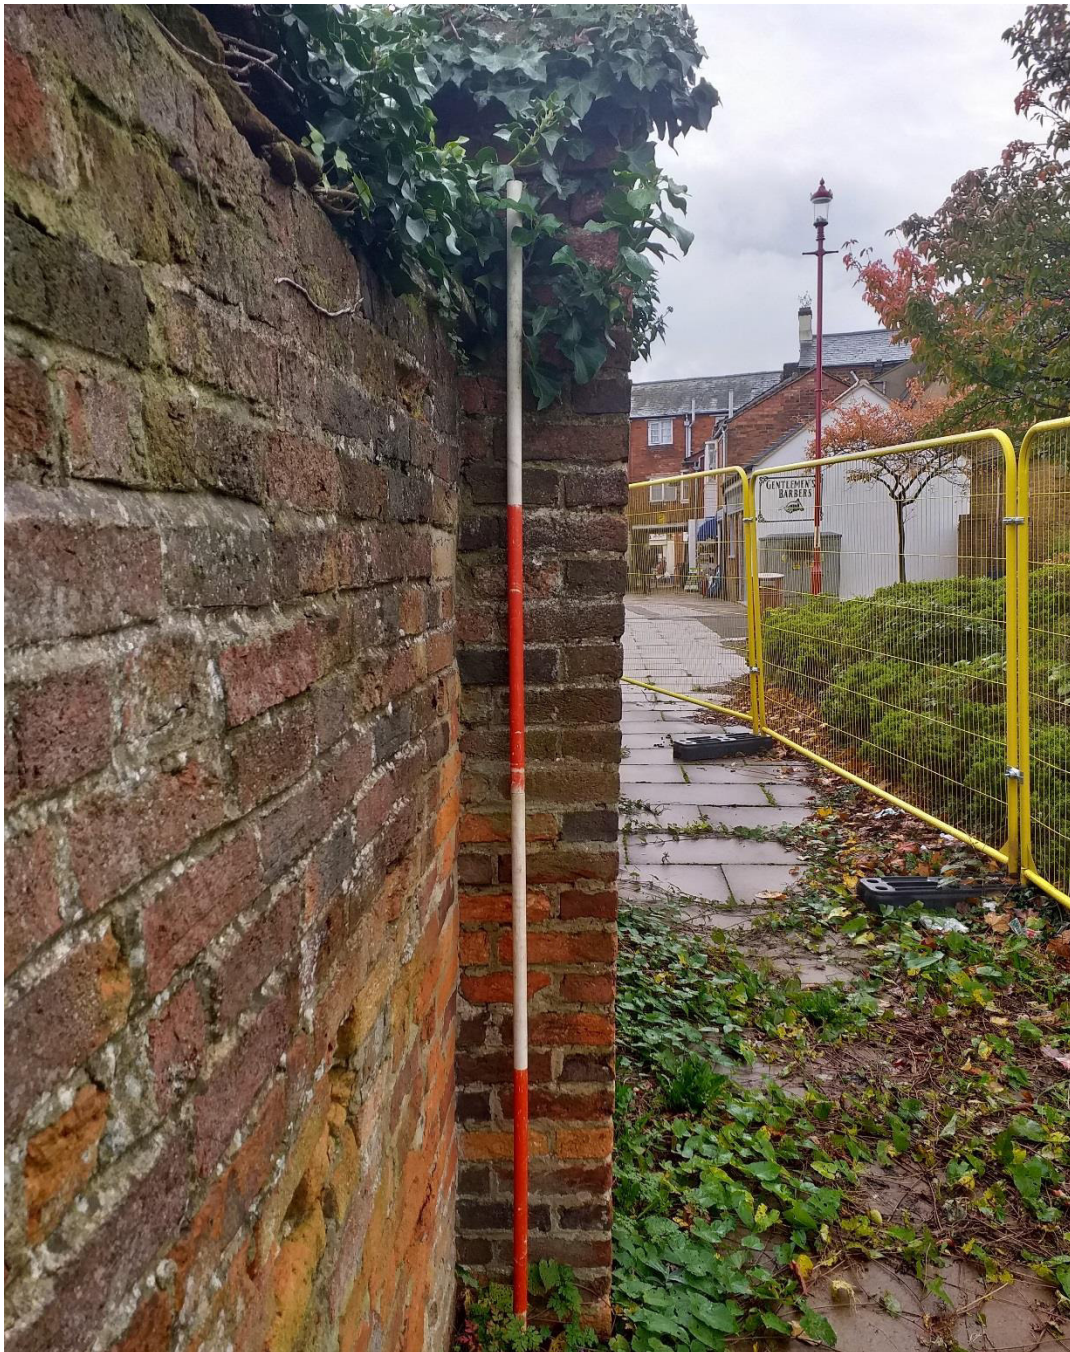
Description: View of the northern and southern sections of the wall

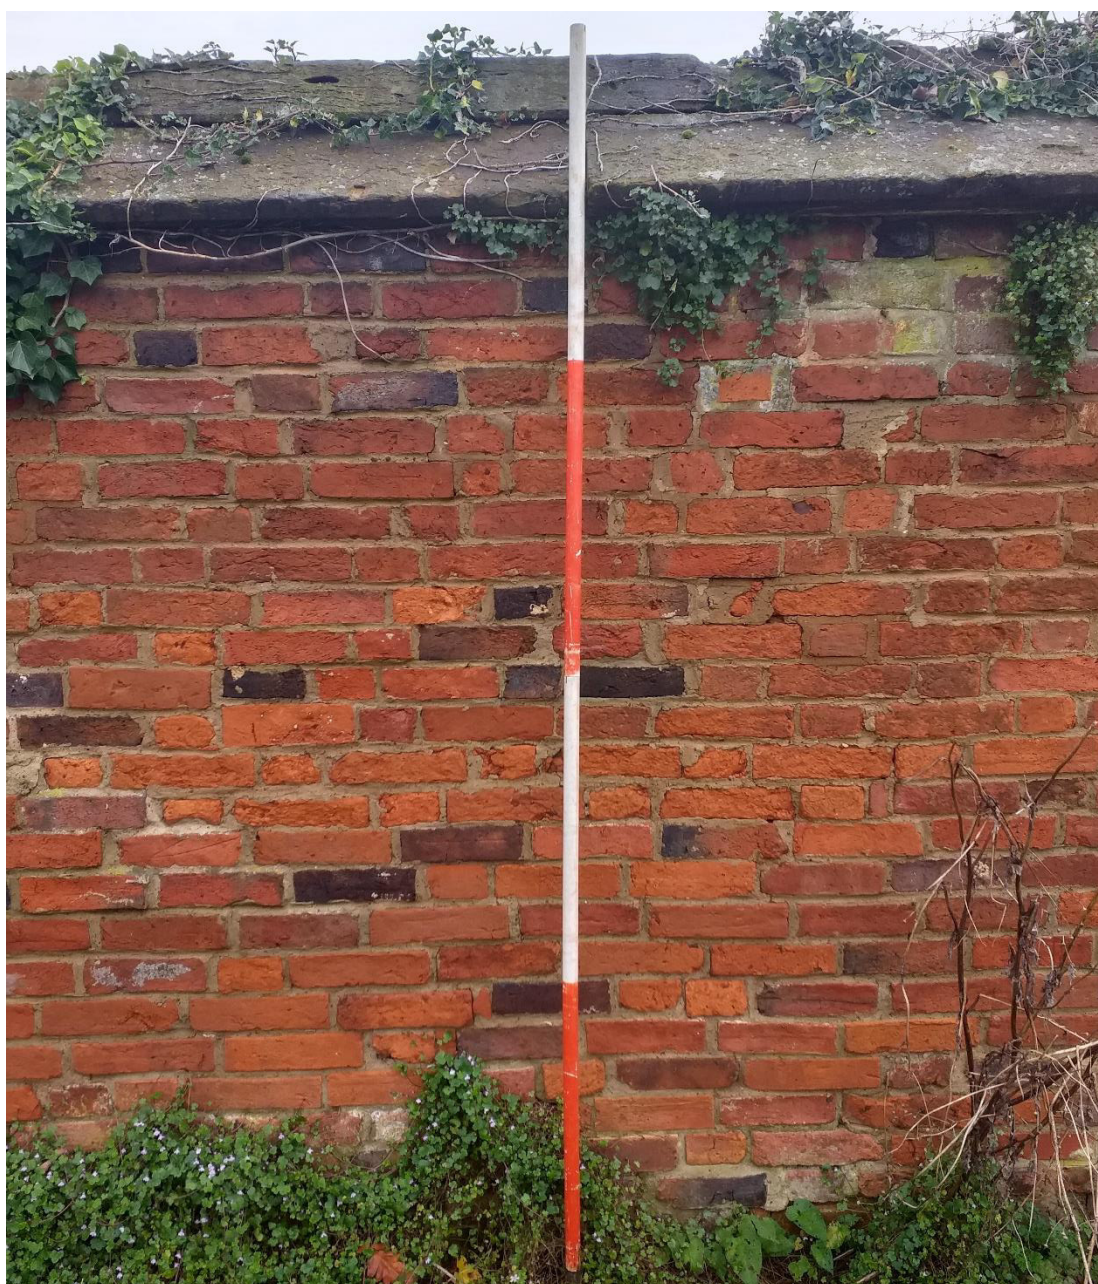
Description: View of the west elevation and coping stones

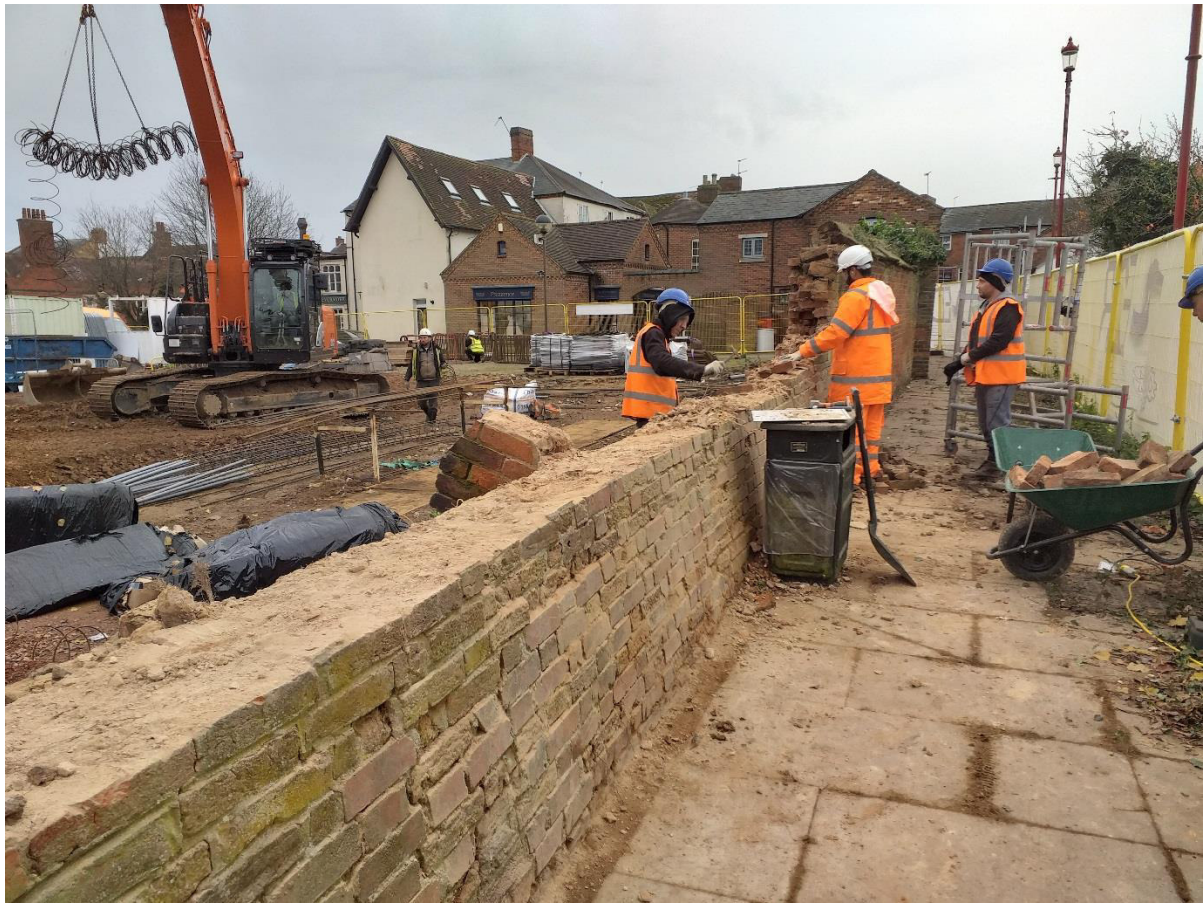
Description: View of the dismantling process.

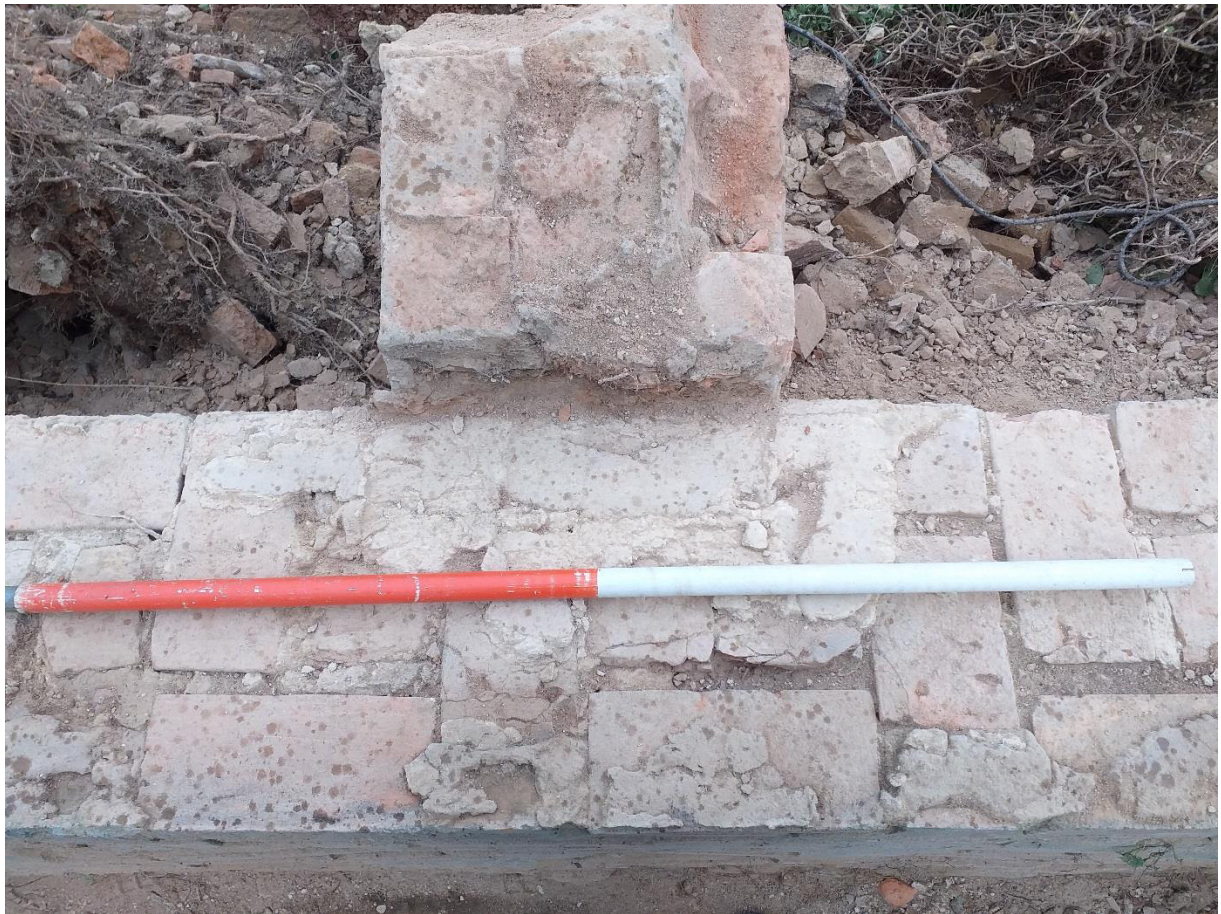
Description: View of interior of the northern section.

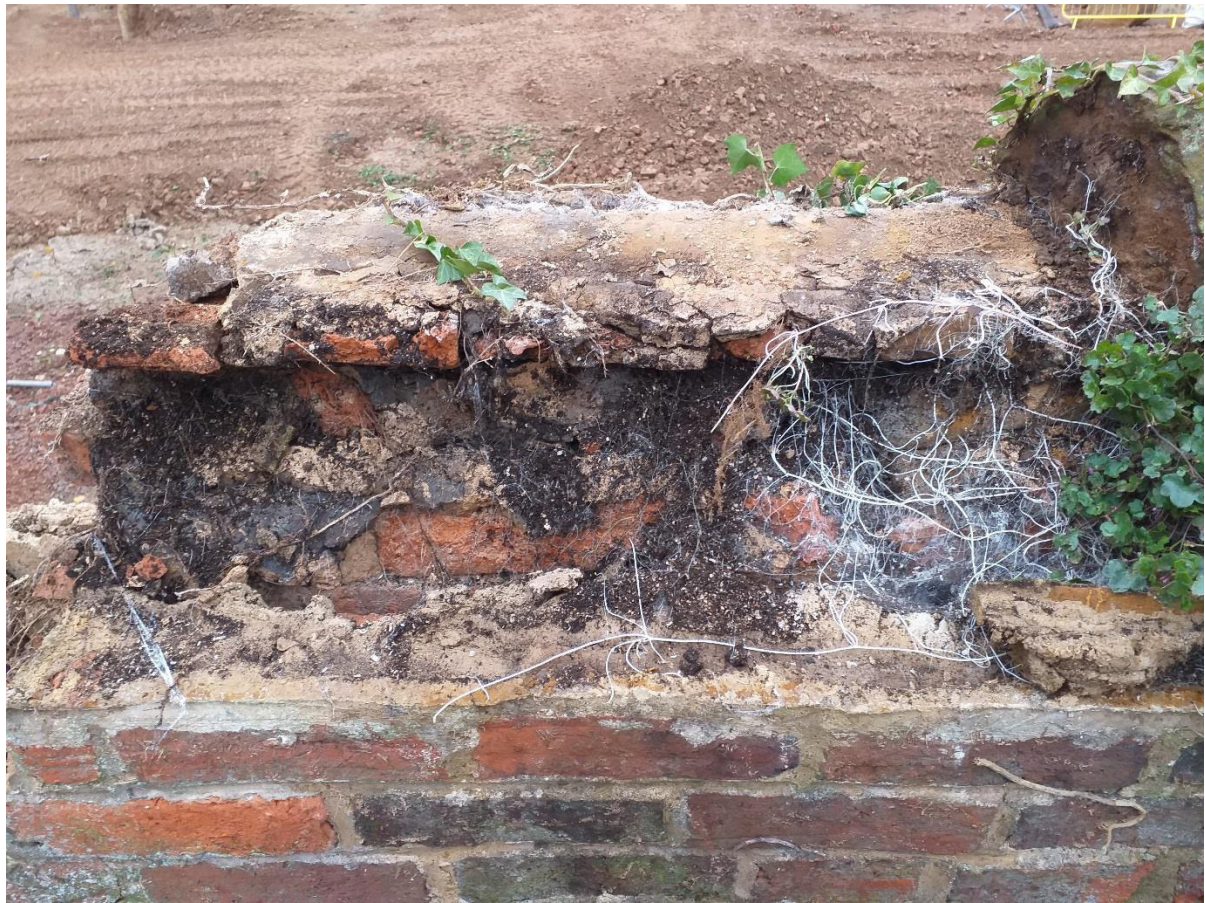
Description: View of the interior of the wall during dismantling.

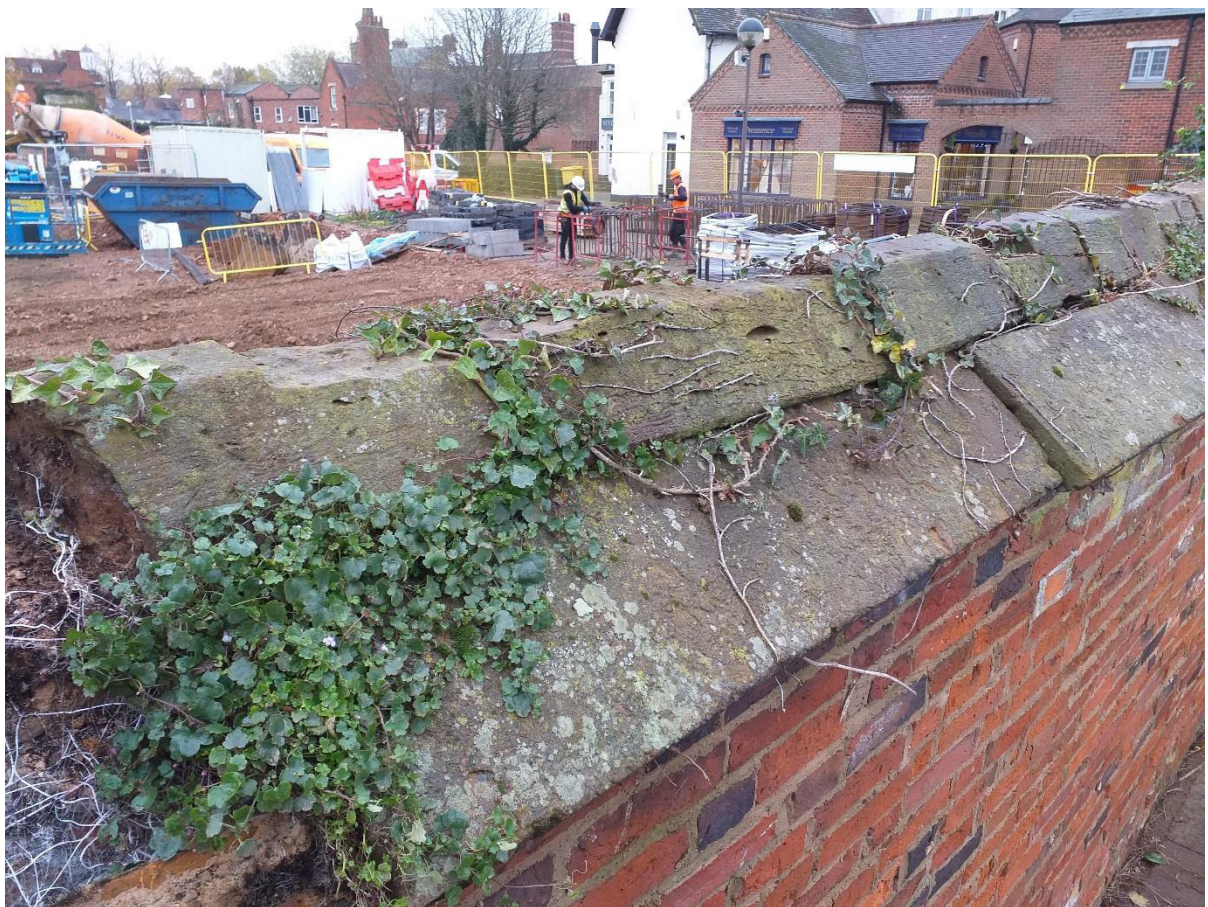
- 6.1.8 The sandstone coping stones situated along the northern section of the wall were not laid out in any uniform pattern and varied in size of up to 0.90 m in length and up to 0.25 m wide. These did not appear to have any mortar affixing them to the top of the wall however the stones are likely

Description: View of the sandstone coping stones.

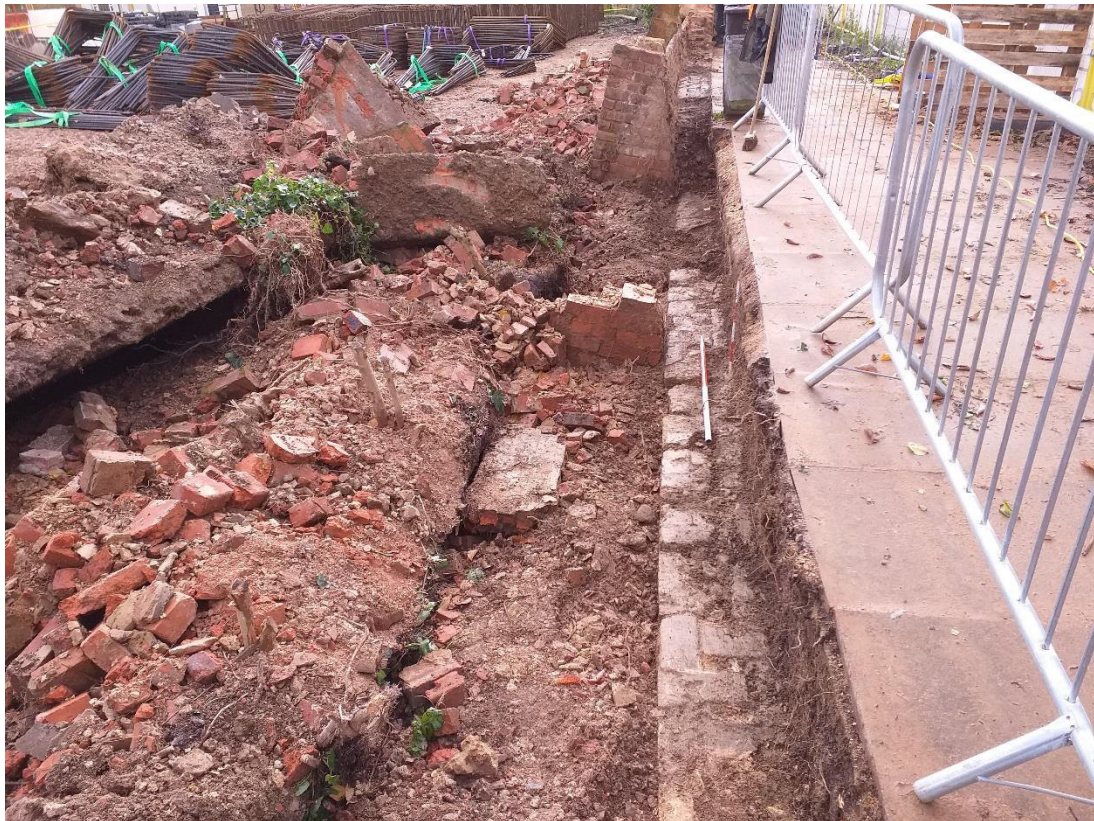
- 6.1.9 Following dismantling of the wall up to four courses of stonework with an overall depth of 0.60 m were recorded beneath the northern section of the wall. These hand carved stones were all derived from sandstone and laid out over four courses with the stones measuring up to 500 x 300 x 150 mm in size, mortar where present comprised of lime mortar. The stonework extended from the north western end of the wall for 21.05 m along the same alignment as the dismantled wall before it was truncated by the concrete foundation of the southern section of the wall.
- 6.1.10 The concrete foundation identified under the southern section of the wall measured 11.5 m in length and up to 0.50 m wide and was 0.65 m thick. Following the removal of this foundation no further foundations were observed.

- 7.1.5 The stonework recorded beneath the wall at the northern end was derived from sandstone similar to that of the coping stones. Whilst it is possible that this stonework was laid as a foundation of the wall, a potential practice in the 19th century, it is also possible that the stonework predates

the wall to an earlier period suggesting it is of archaeological significance and further assessment is recommended should it be removed.

Description: View of the stonework beneath the northern section of the wall

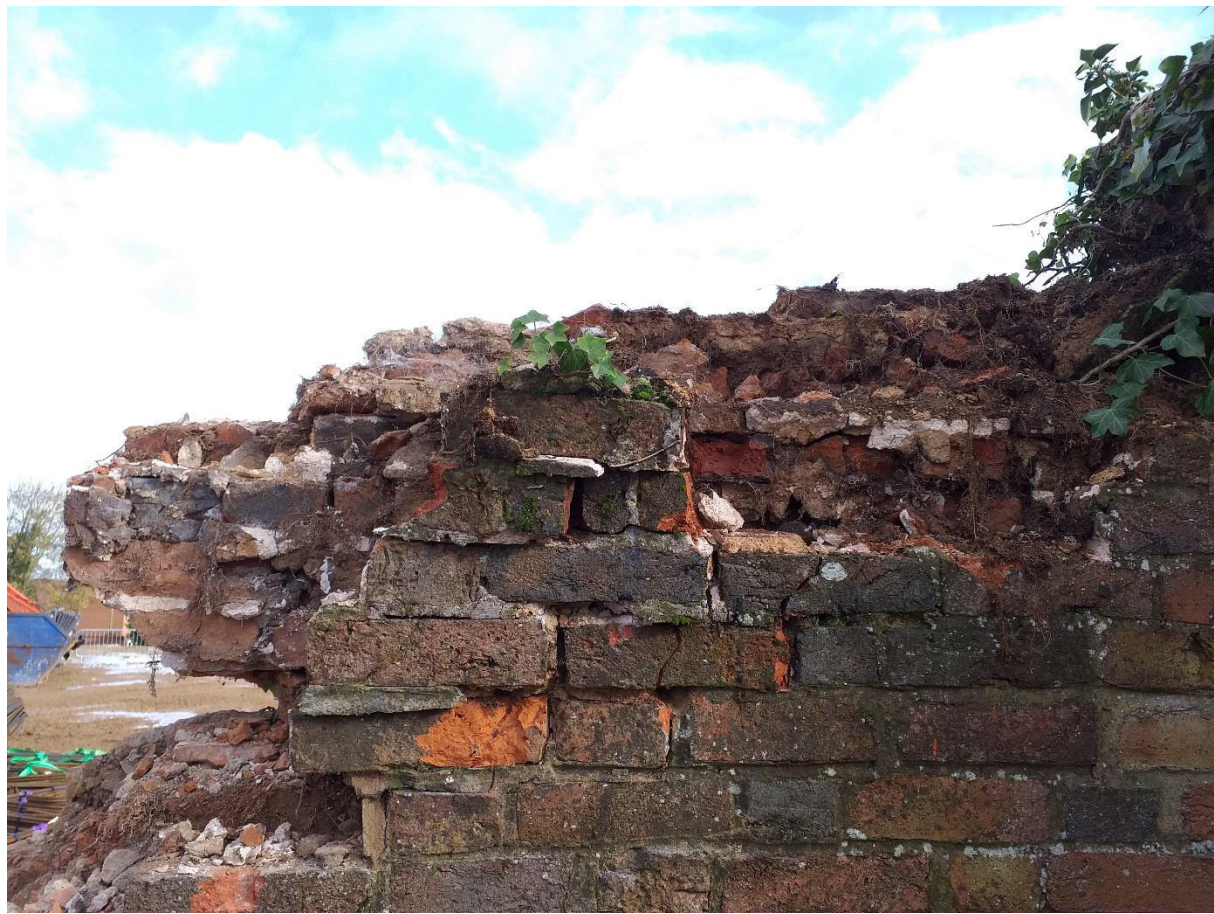
<p>The Burgage Wall, Daventry, Northamptonshire</p>		<p>Photographic Survey</p>
<p>Client: Willmott Dixon</p>	<p>Photo No. 120</p>	<p>Date: 11/11/19</p>	<p>Direction Taken: NE</p>

Description: View of the top of the wall during dismantling.

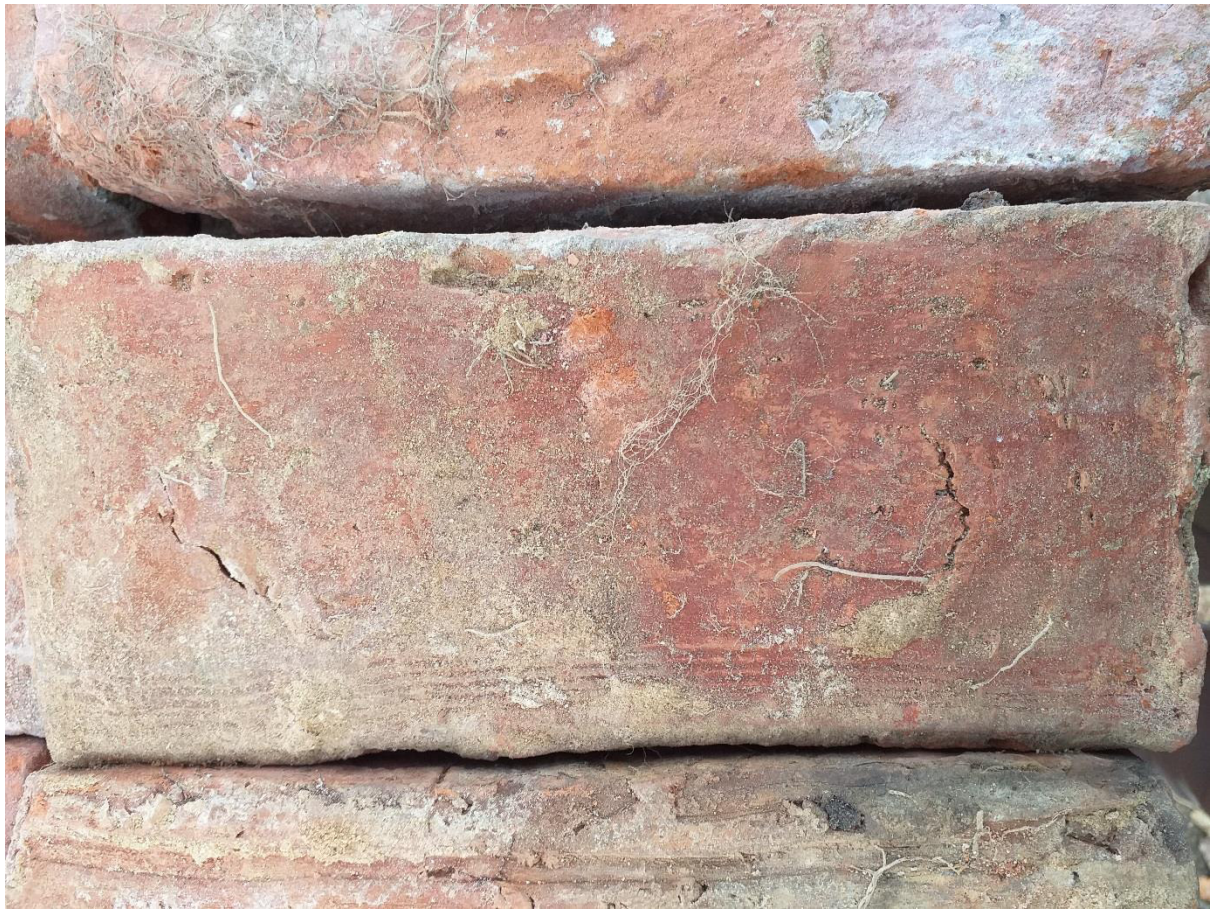
<p>The Burgage Wall, Daventry, Northamptonshire</p>		<p>Photographic Survey</p>
<p>Client: Willmott Dixon</p>	<p>Photo No. 129</p>	<p>Date: 11/11/19</p>	<p>Direction Taken: N/A</p>

- 6.1.7 The bricks that form the wall largely consisted of handmade unfrosted bricks measuring 240 x 110 x 60 mm with a lime mortar which were commonly used during the early to mid 19th century. Additional modern machine made bricks were also noted within the wall structure which are considered to be the result of modern repairs. The interior bricks that form part of the wall showed signs of severe decay likely caused by overhanging ivy roots and water to the point that several of these could not be salvaged.

Description: Bricks removed during dismantling of the wall.

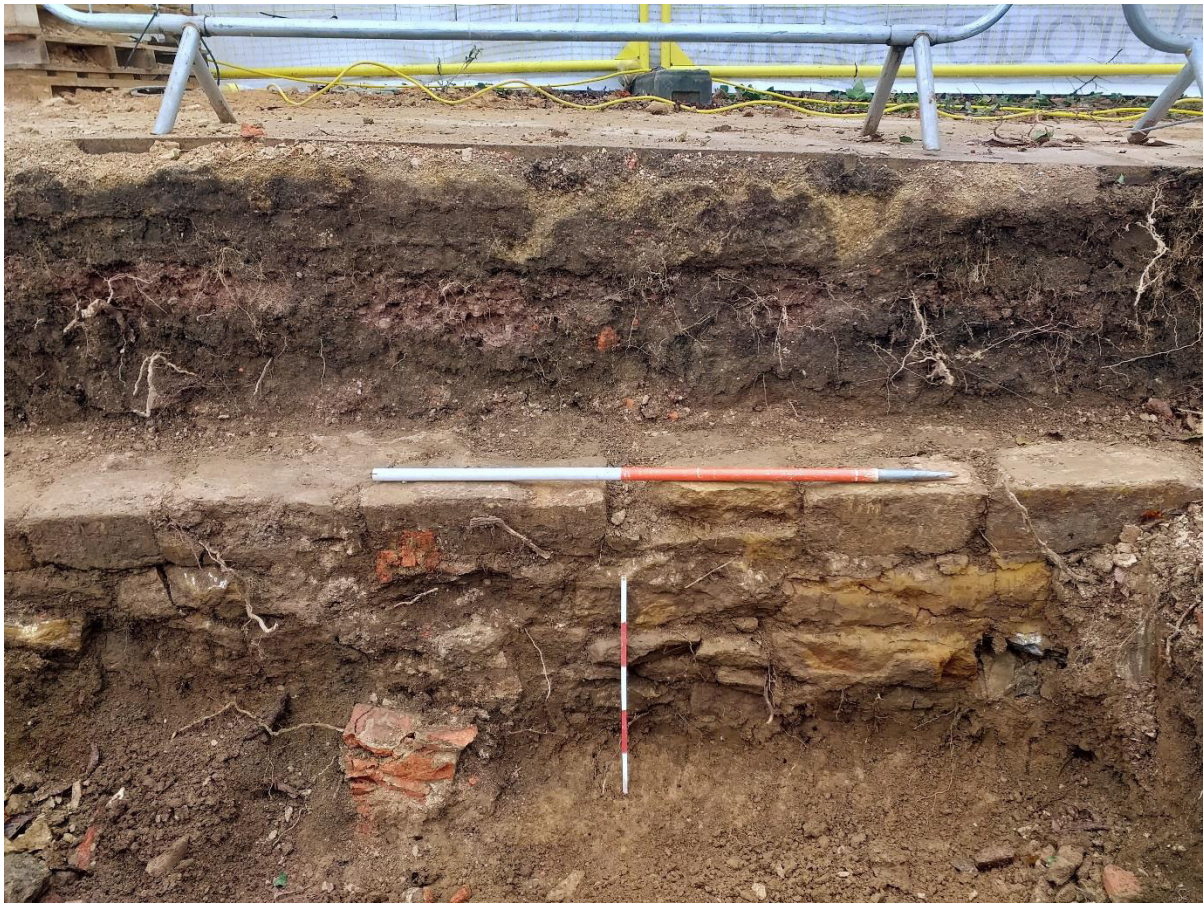
Description: View of the stonework found beneath the northern section of the wall
