## Outbuilding at Tregardock Farm Cottage, Delabole PL33 9ED

Heritage Impact Assessment: SH Ref TGAR1017  
23/10/2017

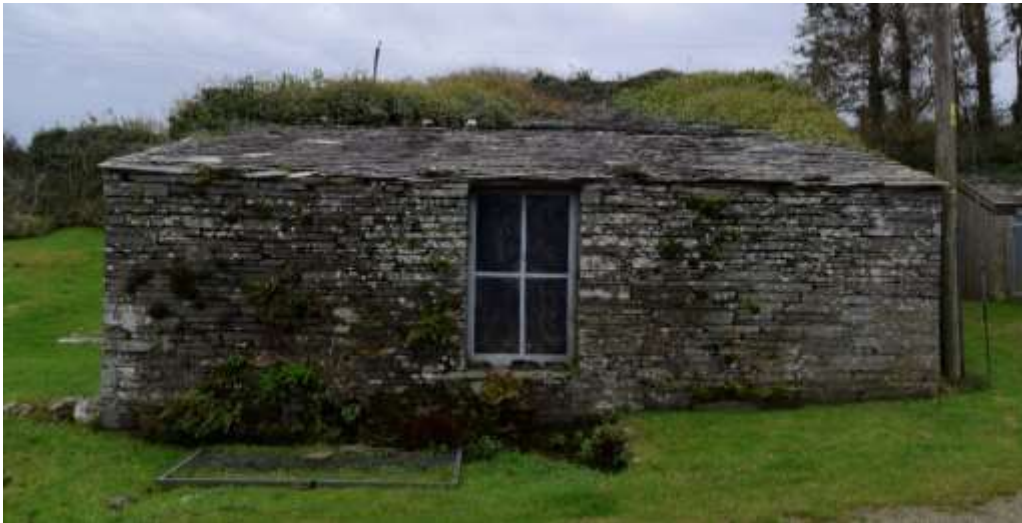
- 4.7 The western elevation, which has a concrete screed floor, is broken by a central doorway, closed with concrete blockwork, painted to give the illusion of a window (fig)

Figure 13 West elevation showing rag slate roof and blocked doorway / window (TGAR1017\_0015)

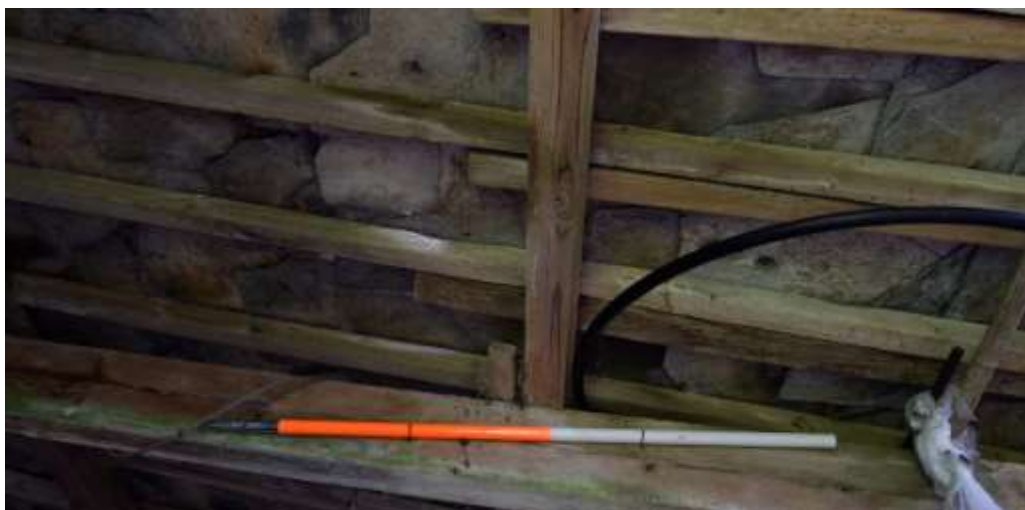
Figure 14: Detail of the garage range roof: Modern timbers support reused rag slates laid directly to common rafters (TGAR1017\_0023)

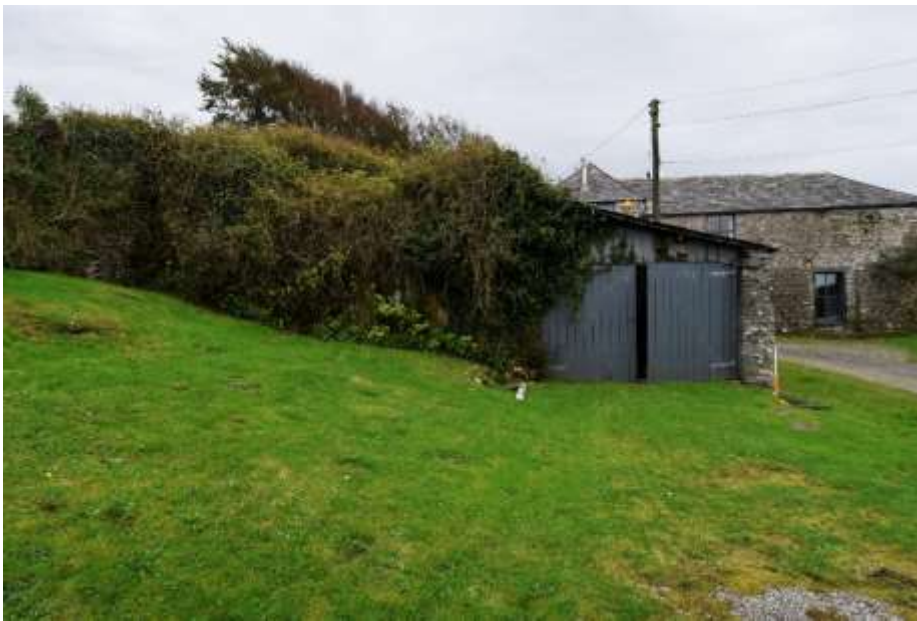
*Figure 15: The north elevation of the buildings demonstrates the current level of dereliction. Note the former driveway surface / level and the probable made ground to create a domestic garden within the old farmyard.*

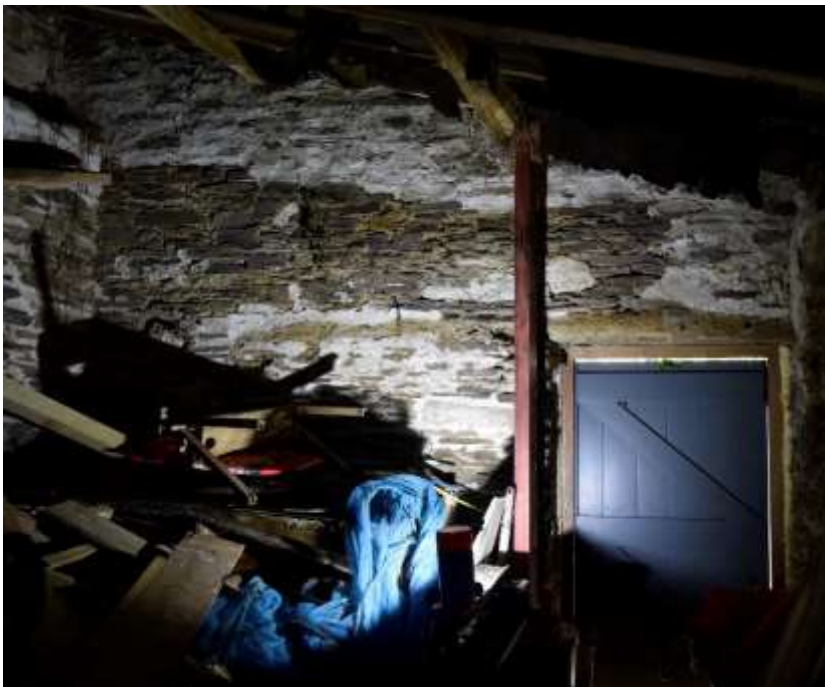
*Figure 16: The interior of the southern wall of the eastern range. The white mortar used in the 20C works shows the extent of modifications at this time, including the raising of this gable (note also the raised height of the retaining wall to left) and the blocking of the older door (beneath embedded lintel).*

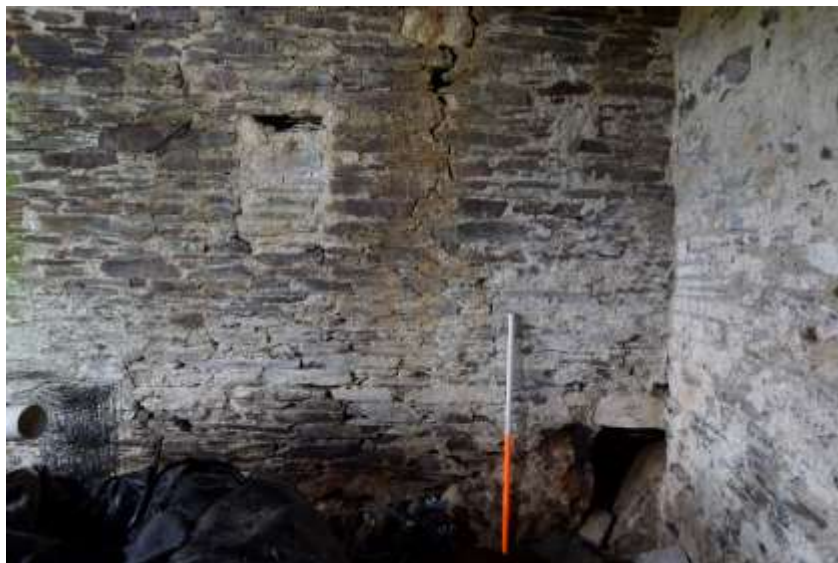
4.14 Within the long wall to the north west of the range, which is founded on large boulders, a common vernacular technique in Cornwall, is evidence of a blocked, internally splayed window opening under a wooden lintel (fig 17 and 18). This is about 0.8m in height, 0.4m wide externally and 0.65m wide internally and would have provided some low illumination of the southern end of this building. At the southern end of the north-western face of this wall there is a small void at floor level, which may have been provided to drain the interior of this space.

*Figure 17: Southern end of the exterior wall of the eastern range (taken from inside the garage) showing the blocked window and possible drain for the stable room. (TGAR1017\_21)*

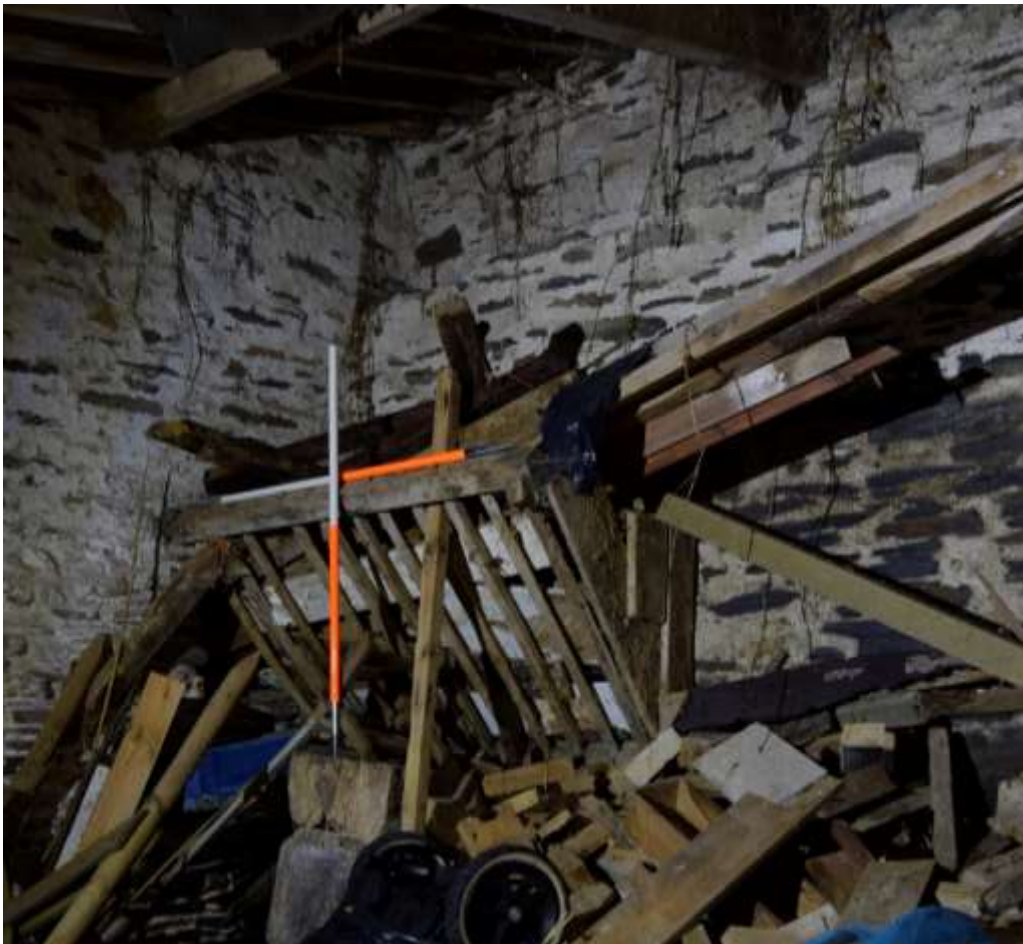
4.17 Fixed to the retaining wall in the north-east corner of the space is a traditional wooden hay manger (fig 19).

*Figure 19: Wooden hay manger (TGAR1017\_27)*

- 6.11 **Recommendation 5:** The wooden hay manager identified should be carefully removed in advance of works, sensitively repaired where necessary and re-installed within the finished development.

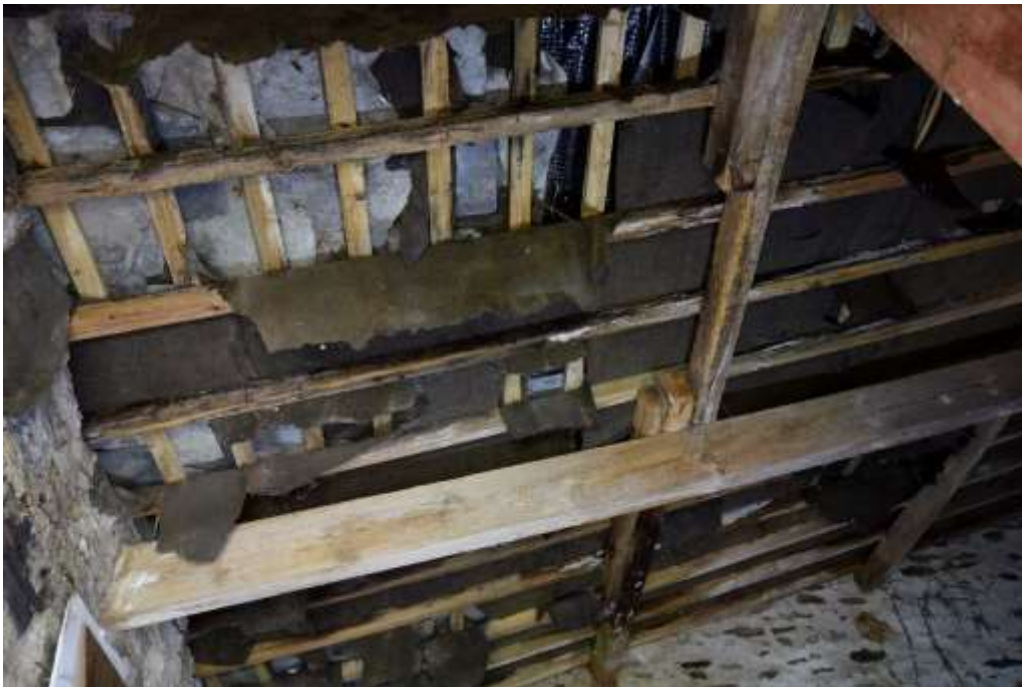
- 4.21 The roof of this part of the eastern range is also of rag slate. However, it has clearly been both re-built and relain in the mid twentieth century. Superficially of similar structure to the garage roof, this section re-uses some older, but not significant and now very damp, timbers as purlins (their short lengths suggesting something of a 'make do and mend' ethos) on which has been laid modern (now failed) roofing felt, before sawn fast grown softwood common rafters, similarly modern square profile battens onto which have been laid re-used rag slates.

*Figure 20: Rebuilt monopitch roof in eastern range with reused rag slate covering and failed modern felting (TGAR1017\_0032)*

6.5 **Recommendation 1:** We recommend that **the specification of the roofing material and style is changed to that of a new rag slate (using local Delabole material) covering. As a new addition any new walling required to raise the pitch of the roof) should follow the visual language and material palette of the garage, rather than the older elements.** In this circumstance the aesthetic contribution of the current roof will be conserved, and the effect of the raised angle will be minimised. Given the clear evidence on site that the roof's existing pitch is inadequate for the conservation of such a roof at this location, and the positive benefits of the replacement of the inappropriate roofing solution over the northern part of the eastern range and the failing roof coverings elsewhere (which will safeguard the overall future of the building) we consider that this change will be **neutral or slightly positive** to the significance of the building. The introduction of rooflights to the quantity shown on the plans would introduce some negligible – **minor less than substantial harm** which in our opinion is outweighed by the benefit of bringing these buildings back into use and safeguarding their

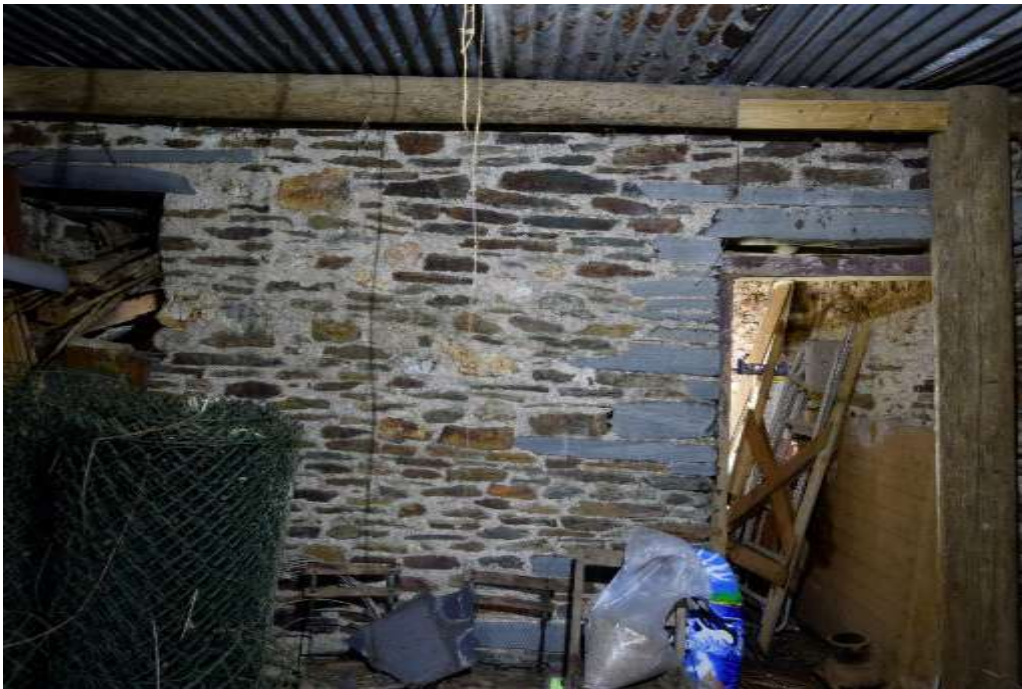
*Figure 21: The wall subdividing the northern and southern rooms of the eastern range has been substantially rebuilt, or may have originate from the same phase as the garage, making use of sawn Delabole slate. Note the telegraph pole and corrugated metal construction of the temporary roof structure of this room.*

- 6.9 **Recommendation 3.** The two ranges should be connected internally by making a new opening to the north of the same wall (from the proposed study) within the section of that wall rebuilt in the 20<sup>th</sup> century. This would reduce the harm of this change to **negligible less than substantial**.
