# Statement Heritage

## 5 Tehidy Terrace, Falmouth, TR11 2SZ

Heritage Impact Assessment: SH Ref **TEHT1117HIA**

12/02/2018

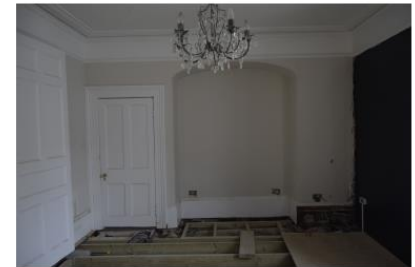
TEHT1117\_0029.JPG

4.11 **Treatment of rear wall for damp [29;33;38].** It is unfortunate that works to remedy damp within this wall have begun without professional recording, or documentation through the LBC process and that this has included the partial loss and temporary removal of the original fabric of the door / shutter casings. This represents a loss of evidential, architectural and some limited historic significance, reducing the authenticity of this room. However it is taken on the basis of good faith within this report that the timbers were, as reported, to be exhibiting evidence of dry rot and that consequently their removal and disposal was seen as good practice in the wider interests of the building. In the case of the timberwork we would highlight that the principal heritage value of this feature is in our opinion its *architectural design value* and that it is the intention to replicate this fabric – which repeats the forms of mouldings etc elsewhere in the reception rooms. The cementitious coatings applied to the rear wall would not normally represent good conservation practice, introducing non-permeable, inflexible coverings to a wall historically characterized by masonry and lime mortar. We propose:

- **Justification/ philosophy** . Test removal of the current coating was observed on 11/12/2017 with the author, the result of which was that it appears feasible to remove the recent coatings to the historic stonework without obvious risk to the historic fabric. Reversal of the un-authorized works is therefore proportionate, and allows for restoration of traditional lime plaster finishes.
- **Documentation:** The only element of this work now requiring Listed Building consent is the re-installation / restoration of the timber door surround – **1:1 profile provided within document ‘Joinery Profiles’**

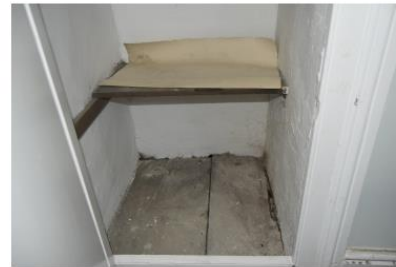
TEHT1117\_0077.JPG

- The small cupboard in Bedroom 2 shows sign of water penetration at the base where some woodwork has rotted out [0077]. We have recommended a minimal lead flashing at the junction of balcony and main wall as an appropriate minimal intervention. The conservation officer has recommended painting the vertical flashing to match the surrounding stucco. **Whilst this work is essentially de-minis we have included it within the client's LBC application.**

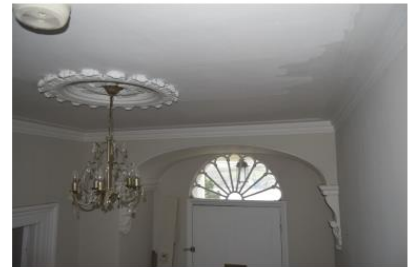
TEHT1117\_0152.JPG

- **Justification / philosophy:** Restoration.
  - **Documentation:** 1:1 Profiles provided within document 'Joinery Profiles.pdf'.
- 4.7 **Conservation of ceiling mouldings, plasterwork and cornice** – the deflections within the floors above, evidenced by the cracking of this ceiling and in the sagging of the flooring within bedroom 3 (client provided photo) have already been addressed by the introduction of structural cantilevered steels within the flooring of bedroom 3. Structural

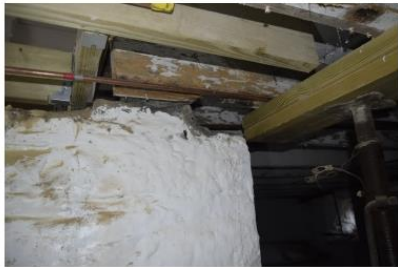
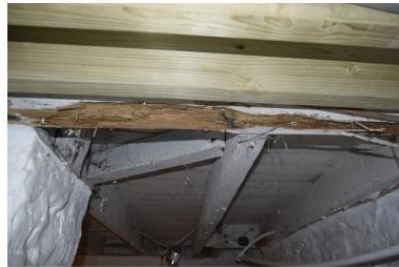
4.8 **Strengthening / consolidation of existing joists.** Many of the existing joist ends are showing an advanced stage of rot to their bearing ends [154-160], whilst their light scantling and notches cut for service (gas and electricity) installations combined with modern loadings is causing unacceptable deflections, risking the transmission of vibrations and movements to historic plasterwork above and potentially the future catastrophic collapse of the front room floorboards into the cellar void.

- Following discussion with the LPA Historic Environment Planning officer it was proposed that where ends have rotted that these be repaired using traditionally scarfed joints, whilst sistered timbers be bolted to the repaired timbers along their lengths to stiffen the overall structure. Further advice on this solution was sought from Chris Hunter MSc CHE MRICS, of Scott and Co a conservation accredited practice. Mr Hunter has provided an options appraisal of three alternative solutions including 1) sistering of the joists within new adjacent pockets; 2) introduction of an additional supporting wall and 3) scarf repair. Scarf repair has now been discounted due to impacts on the floor; in the expansion of existing pockets and a failure to strengthen the floor and so reduce deflection effects. As a result we now feel that option 1) is the best justified option
