Statement Heritage

8 Bank Street, St Columb Major, TR9 6AU

Heritage Impact Assessment: SH Ref BASC0418 Report v2
12/04/2018

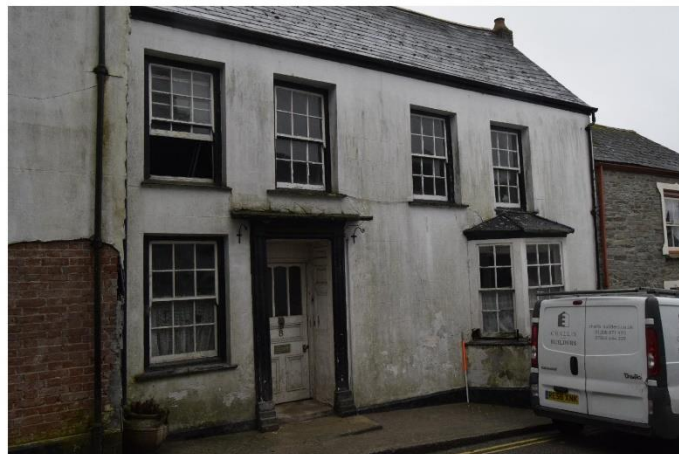
ii) 'Building 2' SE elevation

- 6.8 The client has expressed a wish to remove the render of the front elevation (see figure 2) of building 2 at ground floor level.
- 6.9 This would expose the underlying brick which local oral tradition (client pers.comm.) suggests has been previously exposed within living memory. In our view, and subject to an appropriate method statement from a lime plaster specialist, either removal or restoration would be appropriate. An incised 'stucco effect' is now not clearly visible on this section of the building, and so little would be gained from the restoration of the incised pattern on this section in isolation. Should restoration be considered we would advise that advice is sought from a suitably experienced craft professional in advance of restoration of this section only in plain render, taking care to use breathable materials. Similarly the paint / limewash finish to the rest of the front elevation would benefit from renewal in a breathable finish such as a mineral paint.

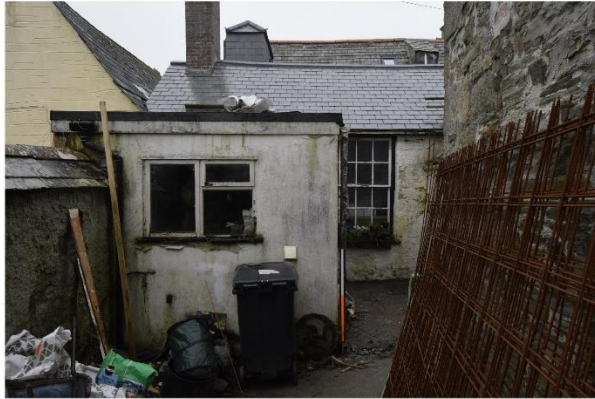
i) Rear Kitchen: NW elevation. Note blockwork construction, modern fenestration and felted flat roof

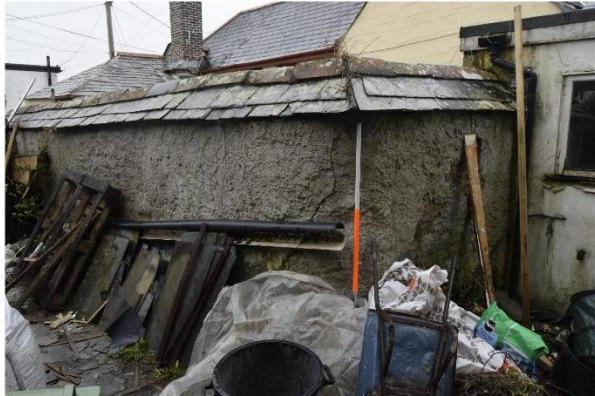
iii) Cob Wall: Cut by Rear Kitchen

6.13 The client intends to rebuild the slate capped cob wall (see fig 2iii) which abuts the rear wall of the kitchen along the footprint of the north wall of the kitchen to form the boundary with the adjacent property. This should be undertaken in either fresh cob or cob-block by a suitably experienced professional and capped in slate and re-used ceramic ridge tiles to match the existing section. Advice is sought from the LPA on appropriate supporting documentation.

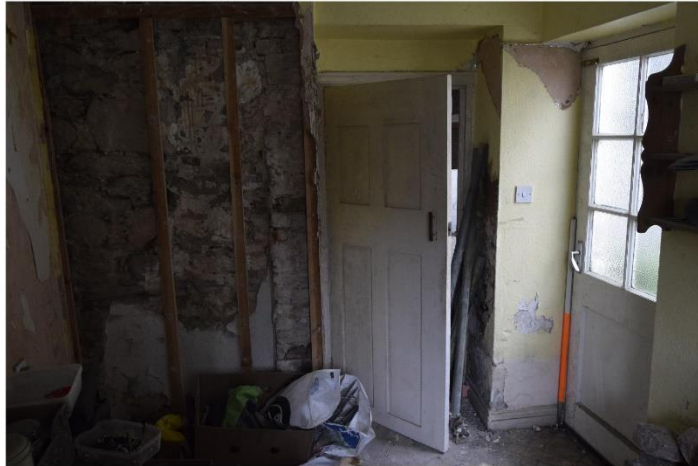
ii) Rear Kitchen: Interior facing SE.
Note Early C 20 4 panel door and
modern glazed exterior door

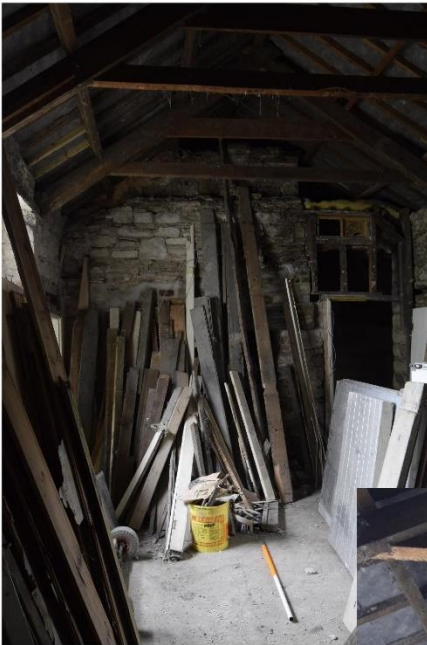
i) Building 4 looking NE. Note chimney / range stack. Access to service staircase is to the right of the stack. Double collar-trusses are likely C19 replacement of an earlier roof as there are filled truss sockets evident on the SE wall.

- 6.14 Stripping out works in this area have revealed a large hearth and chimneystack to its northern end of late 18th or early 19th century date (figures 5i and 5ii), a probable 19th century roof (figures 5ii and 5iii) and a blocked window in the east wall of this building and evidencing that the areas between buildings 1 and 4 was originally open.

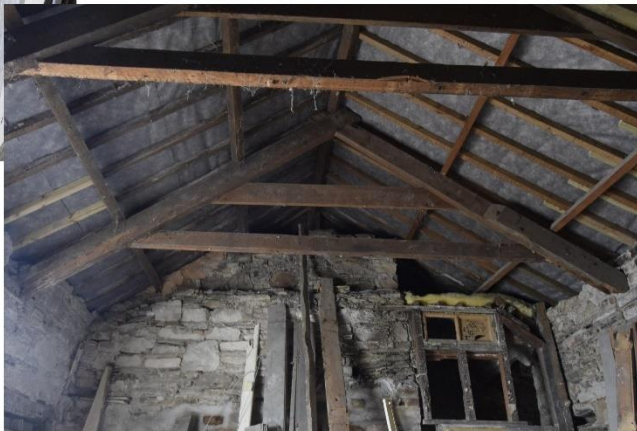
ii) Right: Building 4 Roof looking NE

- 6.15 The roof structure principals are three trusses of lapped and nailed sawn timber each with two original raised collars. Evidence in the masonry walls supporting these trusses indicates filled joist pockets indicating an earlier roof has been replaced. This roof structure is of only modest significance and has evidence of repairs to the ends of two principal members and two common rafters on the western slope. Structural advice should be sought on the capacity of the common rafters to accommodate rooflights, which would in our view cause **negligible impact as long as low profile conservation rooflights are used.**

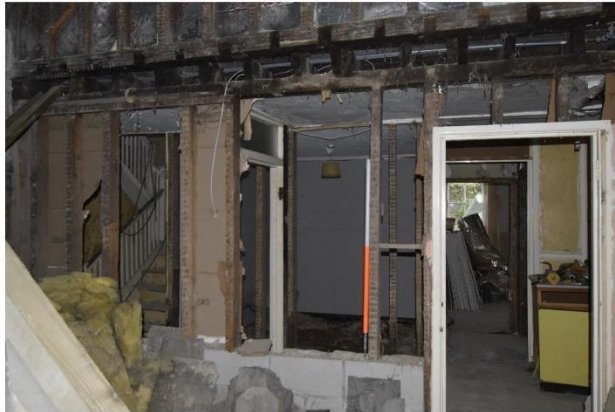
i) Building 3 - Service passage partition. Looking S from Building 4. Note C20 moulding detail around door and existing blockwork under studs

- 6.20 The studwork is formed by 2x4in 'scant' timbers at 12in centres, the 4th 7th and 8th studs (from east) missing. The base of the partition is formed of concrete blockwork indicating rebuilding or insertion of this partition in the 20th century. The studs have been most recently lined with plasterboard of early or mid twentieth century date (see figs 6i and 6iii). This plasterboard provides dating evidence of the sequence of construction being stratigraphically later than the blockwork (see 6i) to which it is fixed and earlier than the door frame forming the access to the 'service corridor'. This door frame which separates the eastern end of the service corridor and the main house, from the rear parts of the service wing, and the door frames of the other rooms leading off this corridor area (see figs 6i, ii and iii) all feature simple 20th century round moulding details, with two featuring obscured glass of 20th century character.

- 6.22 This phase does not contribute significantly to the architectural or historic significance of the service wing, and consequently, **conditional on the opinion of a structural engineer, removal of this partition, and repositioning of the door to the service passage would have a neutral impact on significance.**

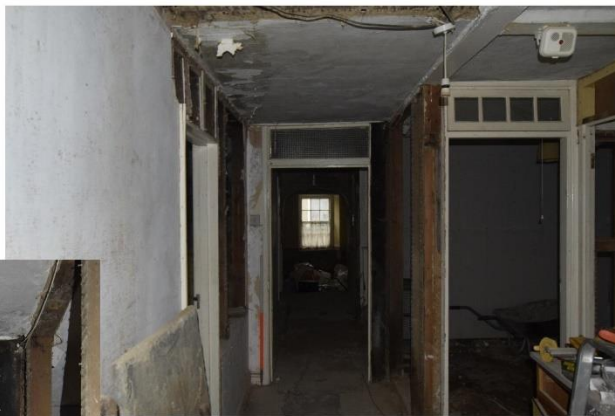
ii) Right: Building 3 rear service passage looking SE, showing mid C20 plasterboard finish to studs / blockwork

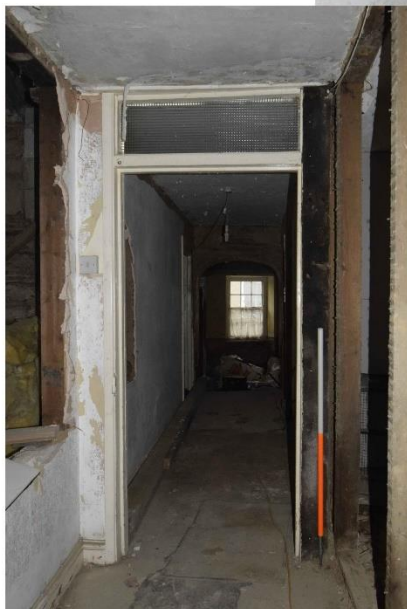
iii) Building 3 Passage way doorway detail. Mouldings are C20 as is glazed panel above.

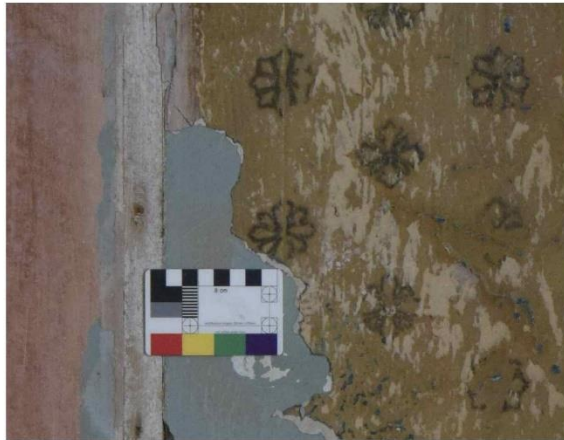
i) Detail of panel on north wall of B1 showing the pattern of a previous wallpaper which has seeped into a plaster skim within the panel. Note also the wooden bead embedded in the wall plaster to take the (probable bolection) mouldings which formed the frame. Credit card scale divisions in cm. Colours balanced to reference.

- 6.24 Section 4.10 of this report and Figures 7 and 8 document evidence of an original Georgian formal decorative scheme concealed until recently by later wallpapers.
- 6.25 It is proposed to restore this scheme 'like for like' by the restoration of wall surfaces and wainscoting using tradition materials to the original specifications and profiled beads to form the panel effects on the upper walls (it is recommended that the profiles of these beads should match the surviving originals within the bay window).
- 6.26 This restoration will improve the interpretation of the Georgian gentrification of the property, drawing on archaeological evidence, and should be seen as **a significant enhancement of its architectural and aesthetic values.**

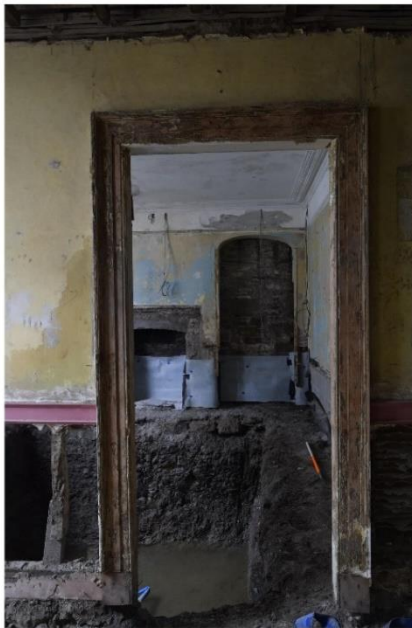
i) Looking into Building 2 from Hallway of Building 1 showing cellar

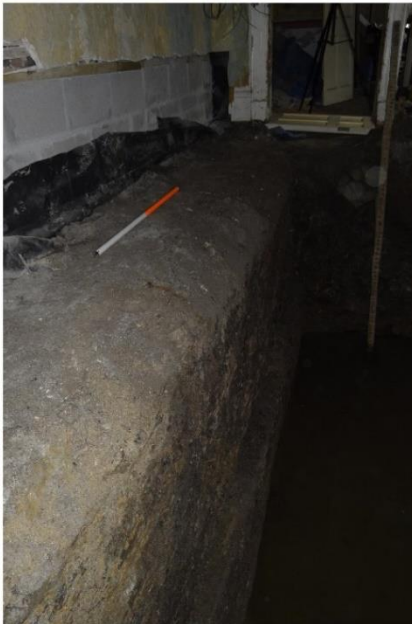
ii) NW wall of cellar within Building 2

- 6.27 This room, appears to have suffered significant and longstanding damp impacts, evidenced by the loss of the wainscoting level of the internal walls, of repairs to the timber frames that form its northern (very significant Phase 1 or 2 fabric) and western (less significant Phase 3 or 4 fabric) [see figure 9]. Works by the clients have demonstrated the presence of an infilled cellar, probably of Phase 1 date. It is possible that infilling of this cellar and provision of a concrete floor in the 20th century intensified the capillary action of damp into its walls.

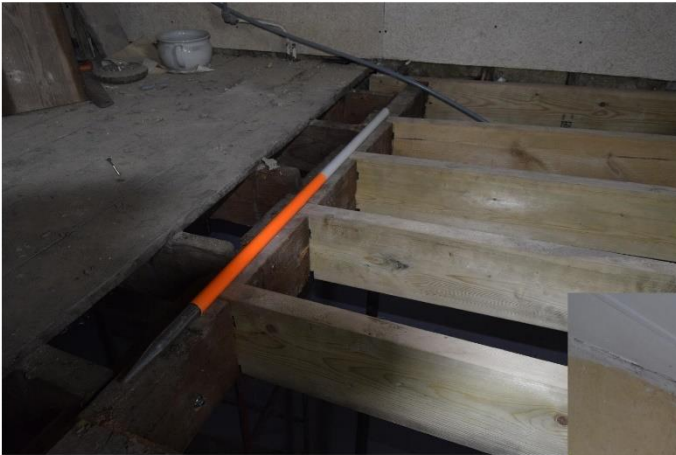
ii) Building 3, Bathroom 2. Showing like for like mortice and tenon jointed carpentry repair.

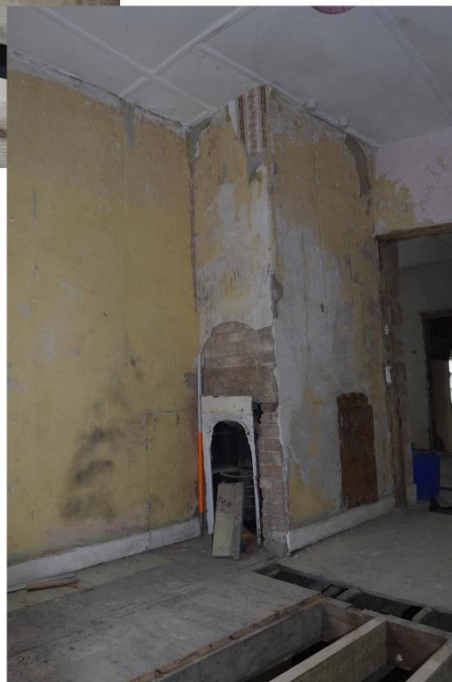
iii) Building 3, Bathroom 2. re-opened hearth in central chimney to be retained with reclaimed fire inset.

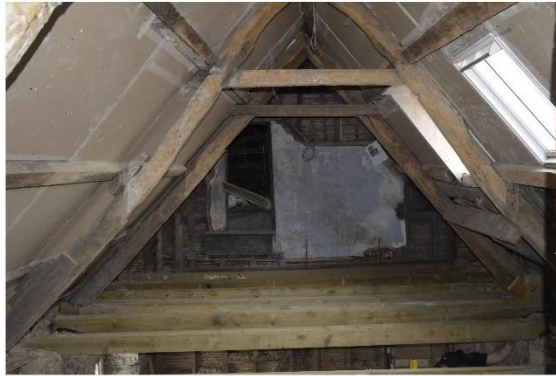
i) Building 1, Attic space showing historic roof trusses with replaced tie beams. Looking SW towards the timber framing which divides B1 from B2. This is a 'through purlin' truss (Brunskill 2000, 84) with crossed blades at ridge. The principles have been worked 'green'. The squared seasoned collars are later and have been fixed with iron pins, possibly in the 19th century to provide headroom when the

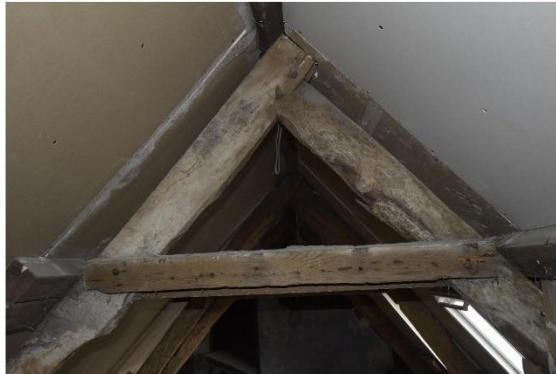
ii) Building 1: (left) Detail of apex of second truss from north showing wooden fouble pegged jointing technique
