BREAN DOWN STEPS INSTALLATION ARCHAEOLOGICAL WATCHING BRIEF 10-11 JANUARY 2017 – Nick Hanks MA ACifA

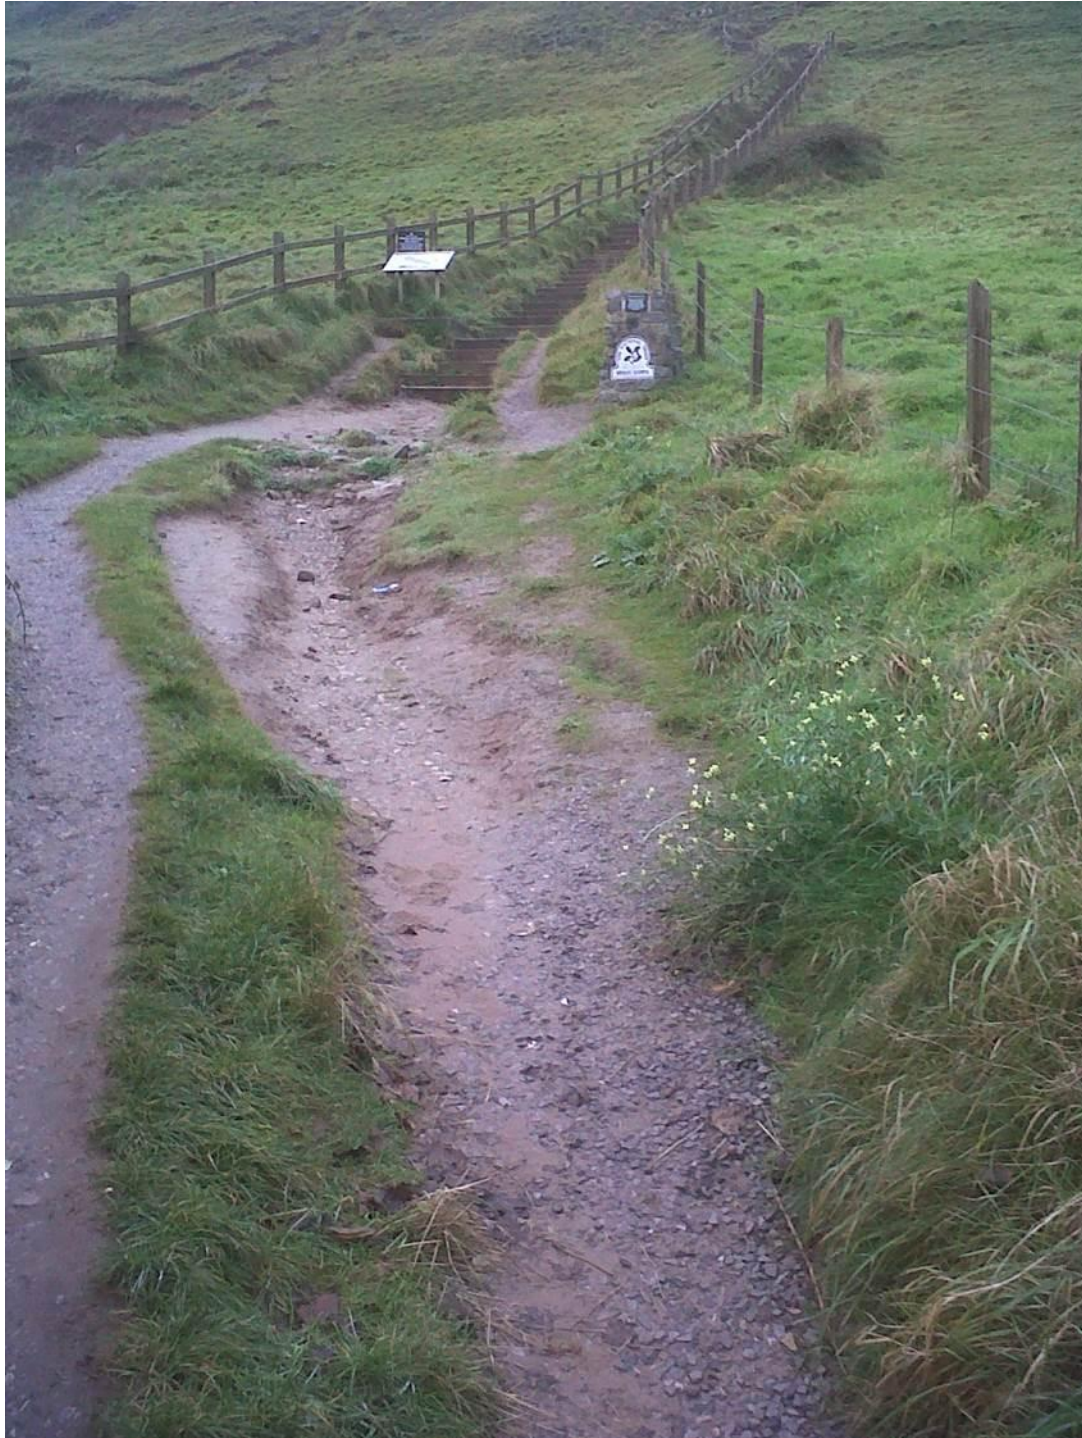
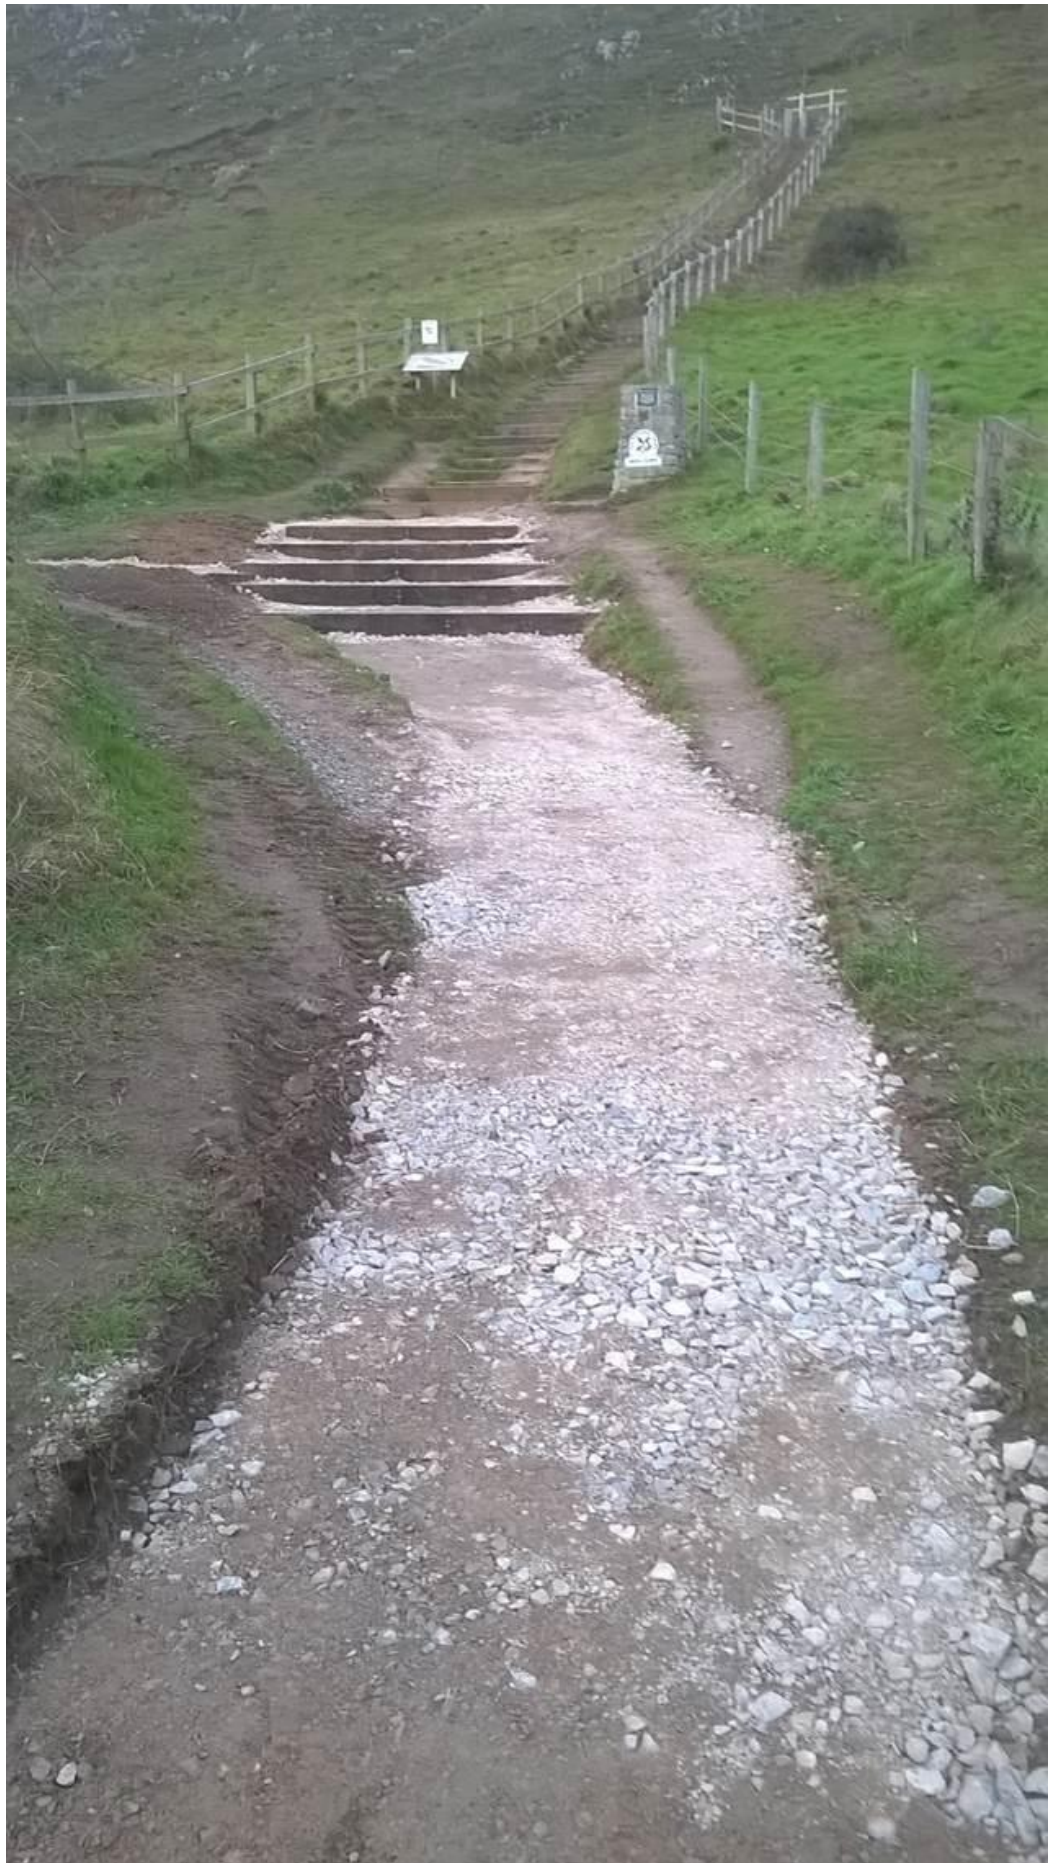
The photographs 1 and 2, (taken by Rebekah West, National Trust Area Ranger) show the condition of the area of the works before and after installation of the railway sleepers.

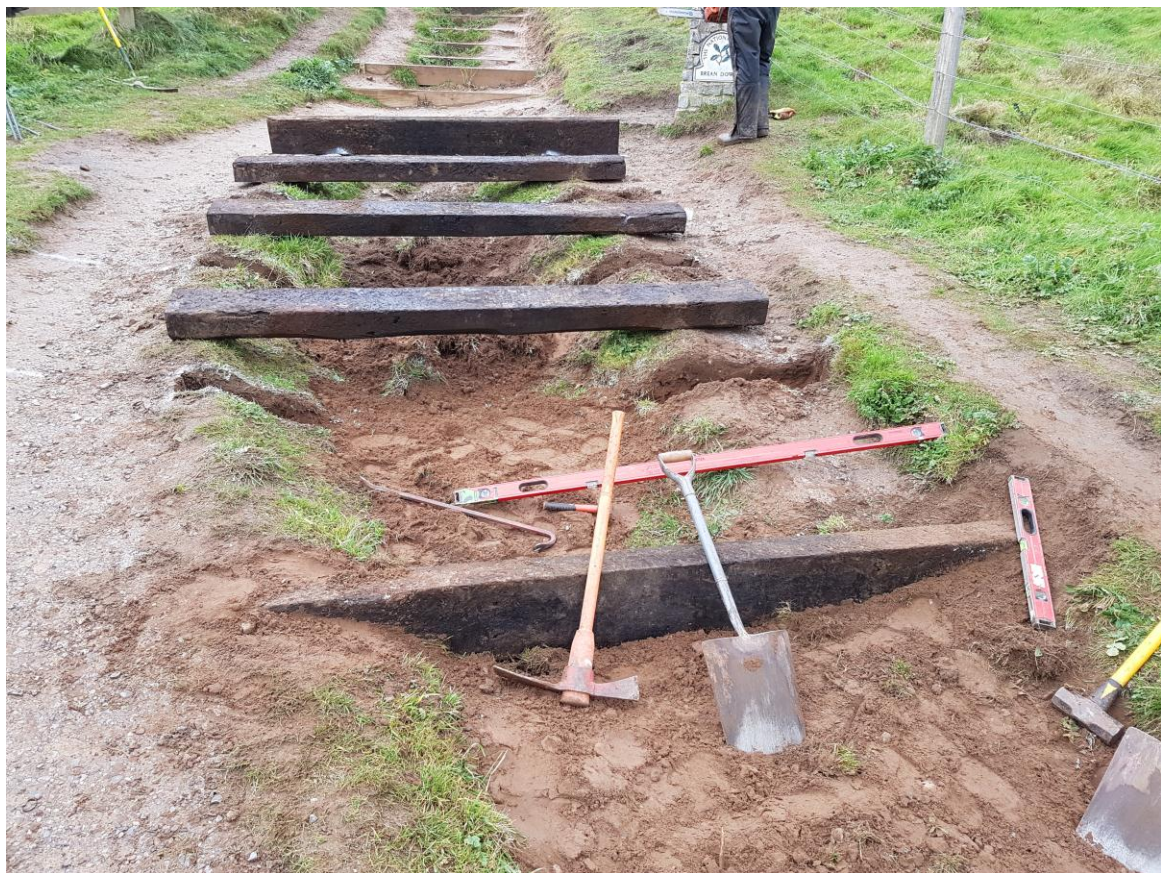
Photograph 3 (taken by Nick Hanks) shows the middle stage of construction. This shows that the profile of the erosion was such that material was added to the centre of the path to raise it. Only at the ends of the sleepers, and then only for their thickness, was there any excavation of soil. The one exception was on the line of the highest sleeper where three rough c.30-40cm rocks were removed. The three rocks were on the same alignment as the sleeper forming a rough step. These were almost certainly from previous repairs to erosion as they protruded from the surface in the centre of the visitor route. Below these the soil was a mixture of natural top soil, the redder subsoil below and some hard rock from previous path repairs.

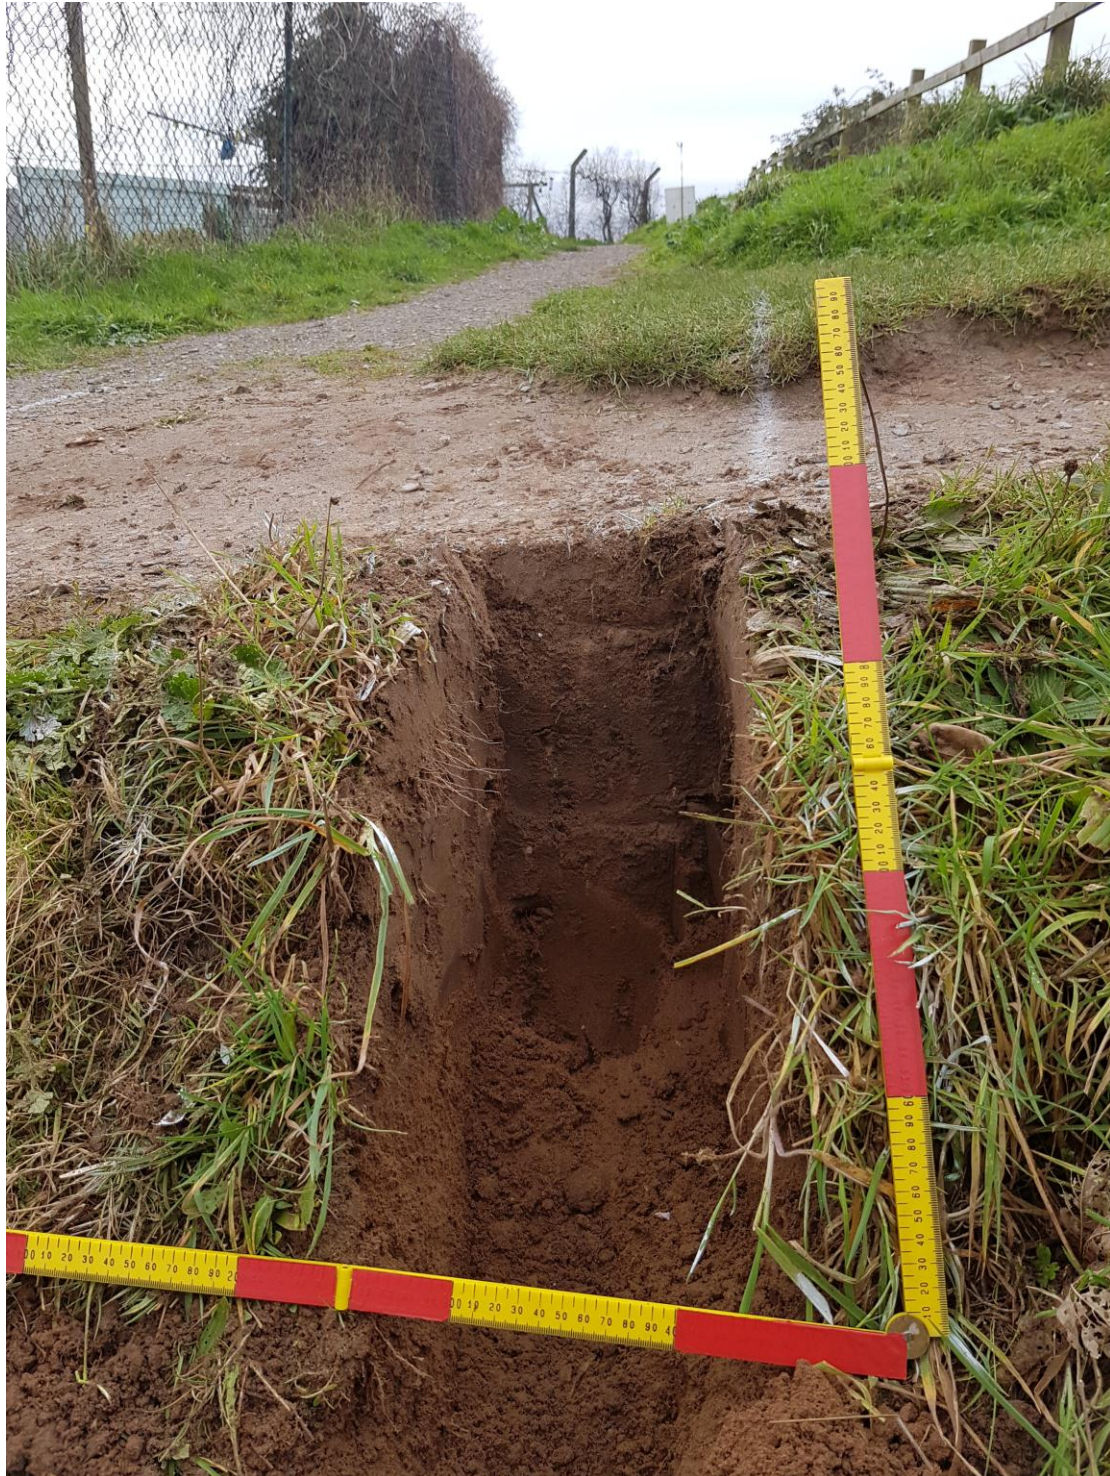
Photograph 4 (taken by Nick Hanks) shows the maximum depth excavated was 30cm, and then only at the ends of the railway sleepers. Here the difference between the top soil and the first red subsoil layer could be observed. However, the soil in all of the locations observed during the watching brief was sterile and without any artefacts, gravel or stones, as shown in this photograph.
