Post Investigation of East Service Wing
'The Wells' Addendum to Building
Recording of Salvation House Ranelagh
Road Malvern Link WSM69253

Grid Reference OS National Grid Reference: SO 79066 48034

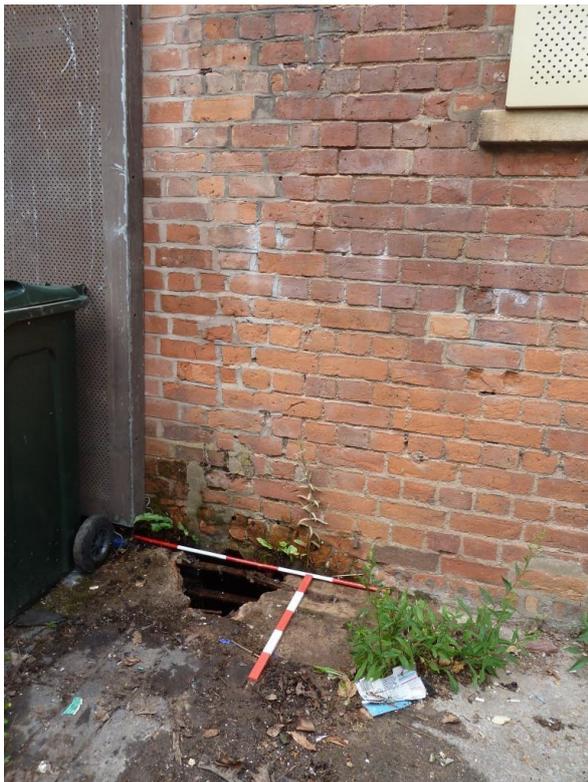
1 P1120061 View from Courtyard to Outside Well Photo Position 061
1m & 50 cm photographic scales

Inspection of the outside well was only possible through a small irregular opening to the well that had been excavated adjacent to the external wall [P1120061 & P1120062] through which there was limited access so that it was only possible to record with flash camera at arm's length inside. Within the external wall of English bond brickwork a low relieving arch of header bricks was visible rising above the opening.

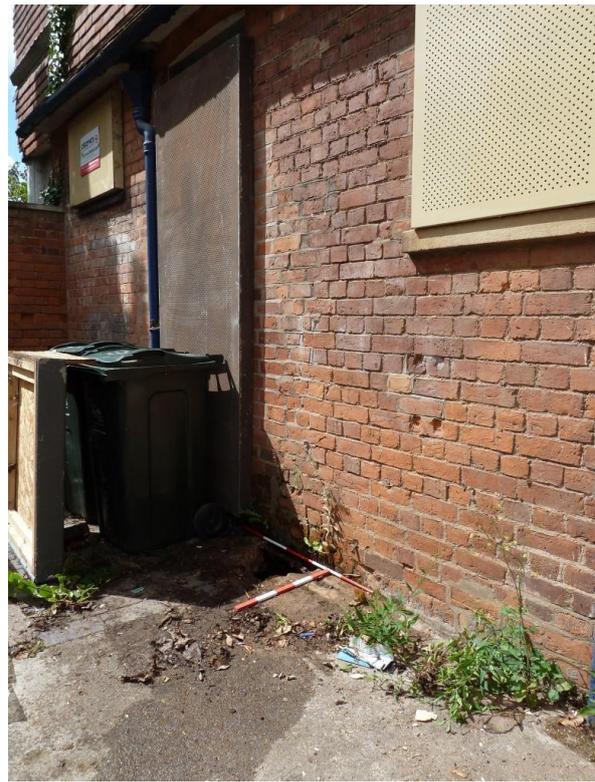
2 P1120062 Overall View from Courtyard to Outside Well Photo Position 062
1m & 50 cm photographic scales

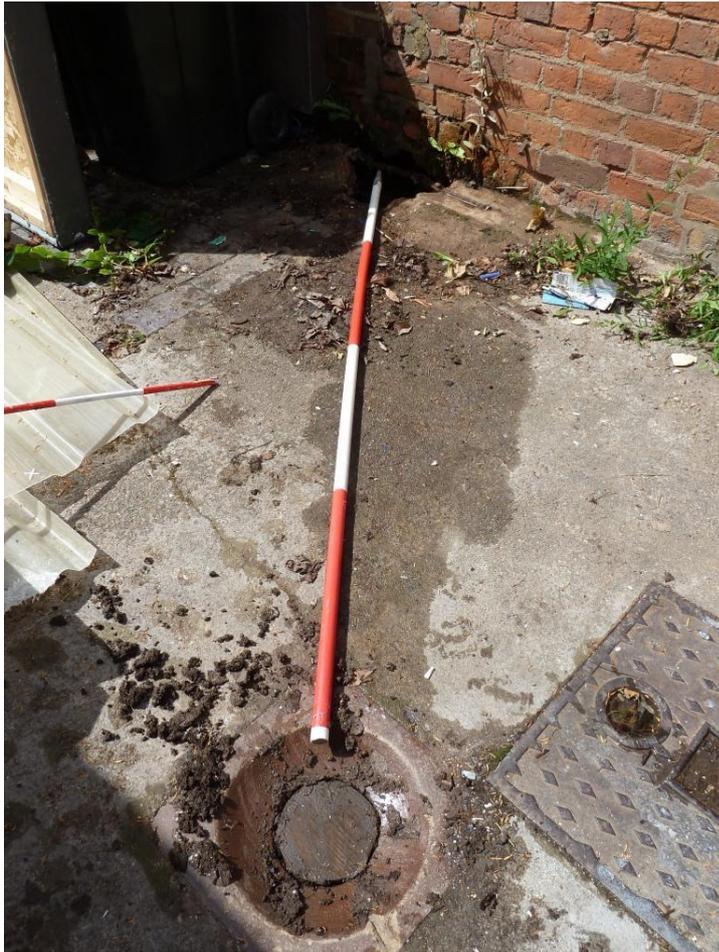
3 P1120064

Outside drain and wooden plug 2m photographic scale to location of Well Photo Position 064

2 m diagonally from the well a drain with a wooden cap the salt glazed ceramic pipe suggests 19th century origins. [P1120064 & P1120065]

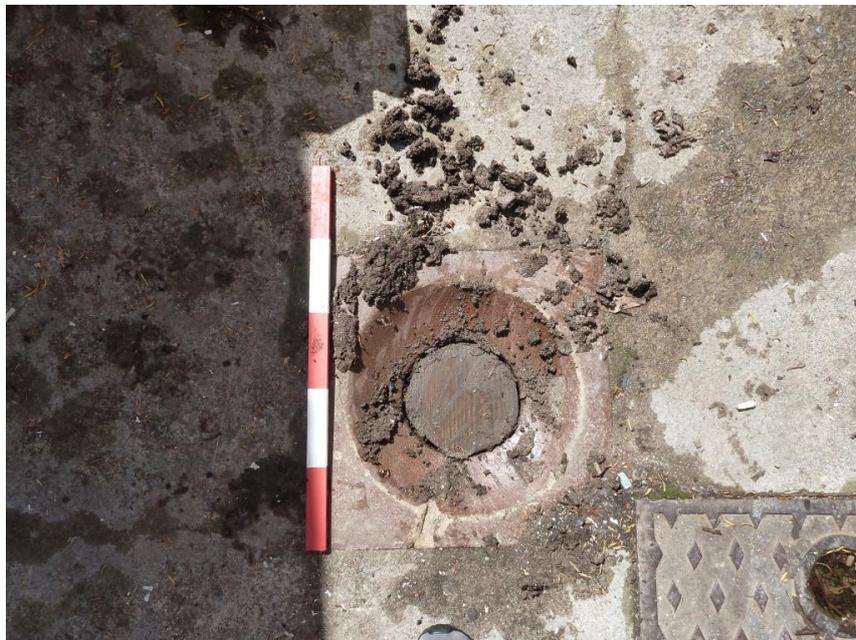
4 P1120065 Outside drain 50cm photographic scale Photo Position 065

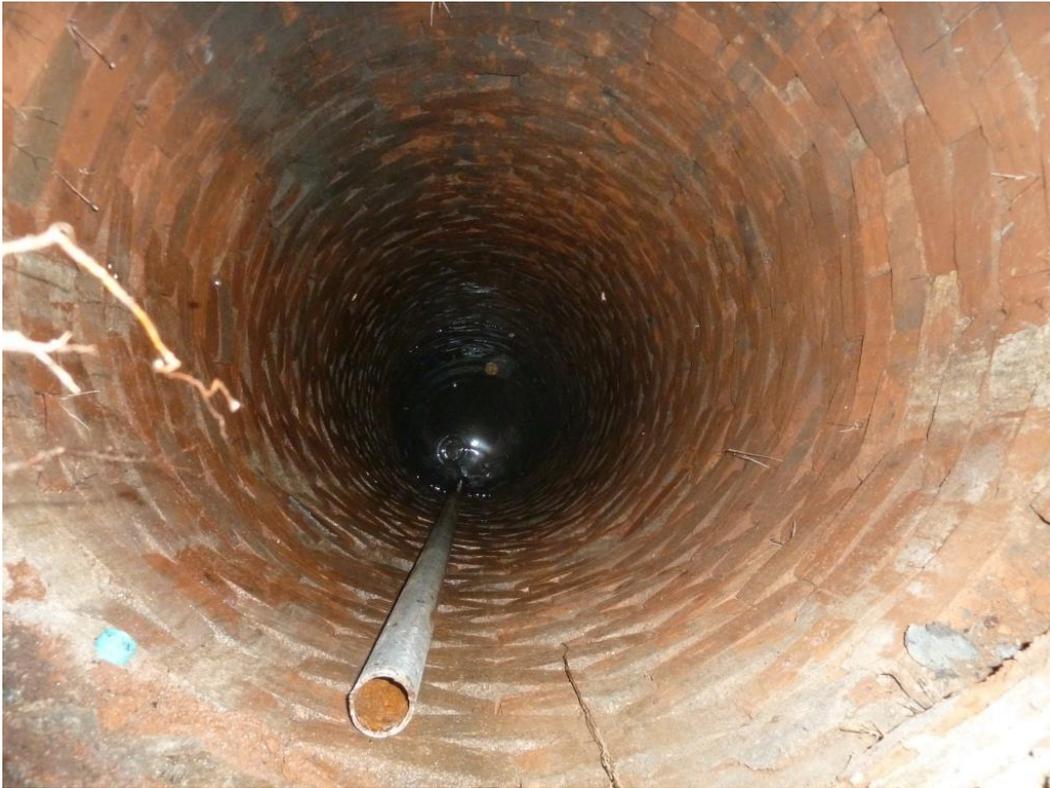
5 P1120057 Internal photograph of Well looking straight down shaft

The well steining *was of brickwork in a circular form [P1120057] made up of stretcher bricks as the lining. Water was visible at the bottom with the use of a weight and plumb line the well was found to be approximately 9 metres deep, the well width being approximately half a metre. The brickwork seemed in good condition with a lead pipe visible running from the top of the opening down into the water some 9 m below. Beyond the brickwork of the relieving arch it was just possible to see a large flagstone possibly sandstone set into the brickwork.

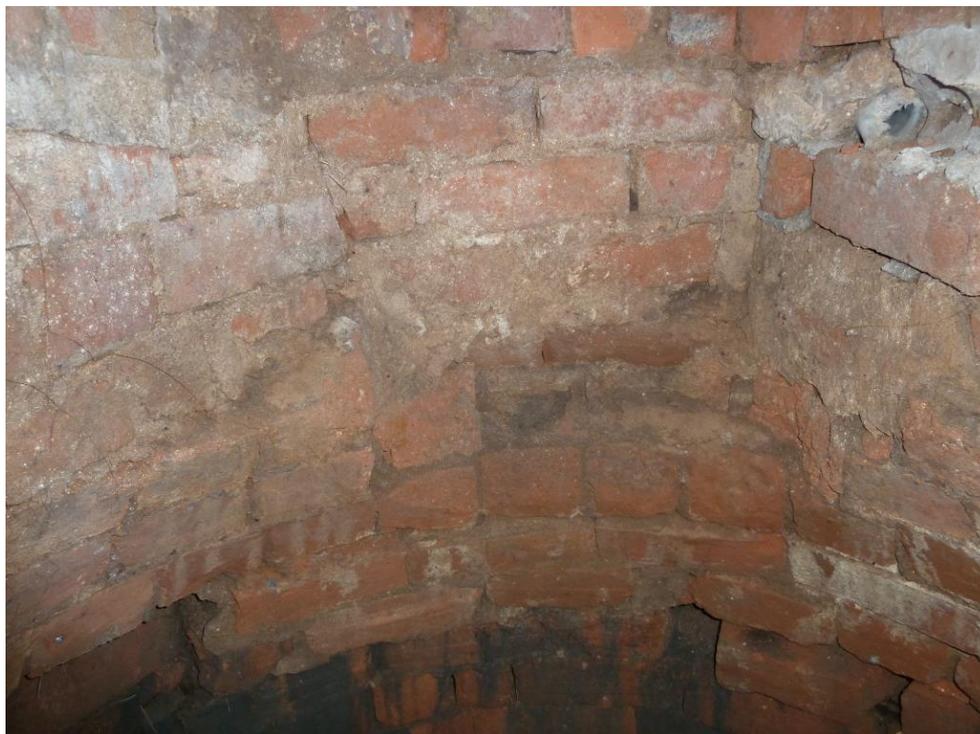
6 P1120058 Detail of brick work above shaft

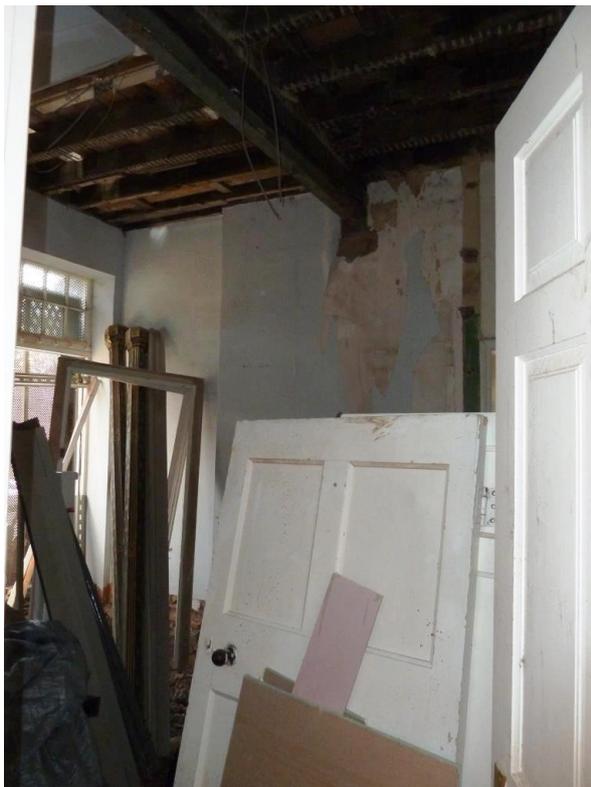
7 P1120067 View of Room to South and structural partition wall Photo position 067

The internal space/room of the possible former Laundry is currently being used to store building materials, and architectural elements from elsewhere in the house [P1120067 & P1120068], the floor has been excavated by half a metre [P1120071] which has exposed the relieving arch of an internal partition structural wall, the relieving arch being approximately 2metres width [P1120072]. An opening had been recently excavated through infill brick work beneath the arch, with the well opening apparent to the left hand side and a small opening to the adjacent room to the right. In the wall of English bond brickwork this low relieving arch of header bricks is visible rising above the opening with a curved iron bar support.[P1120074]

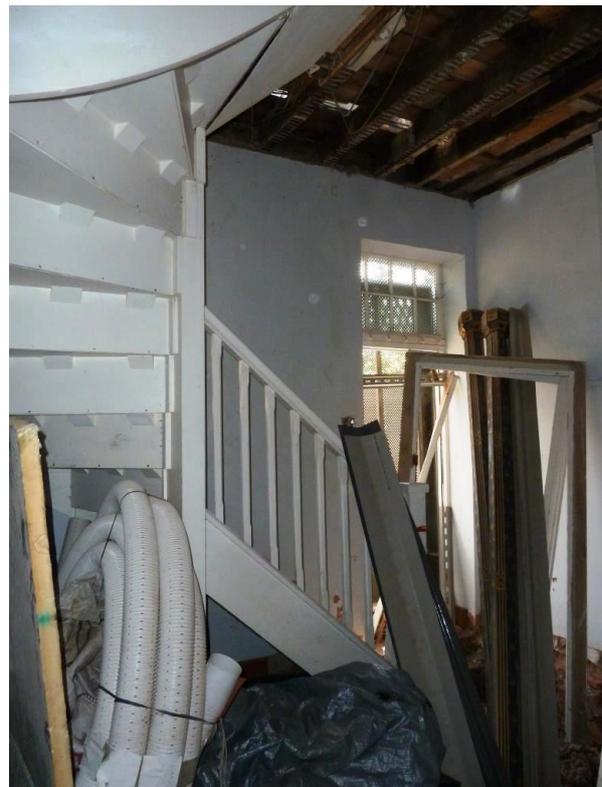
8 P1120068 View of Room to East External Door and Staircase Photo position 068

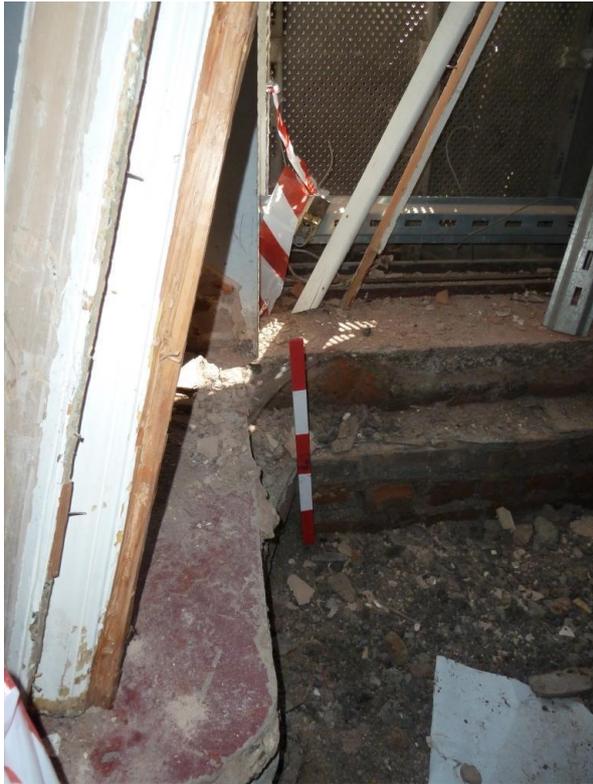
9 P1120071 Floor Excavated by Approx 50cm Photo position 071

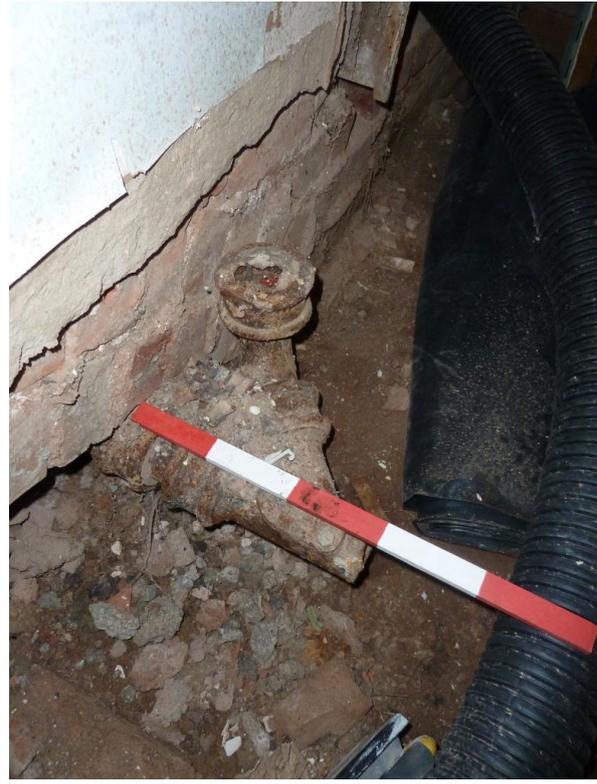
10 P1120075 Cast Iron Pipe by Internal Wall Photo Position 075

To the right side of the opening there is evidence of a heavy cast iron pipe which continued into the wall and had a vertical section, this possibly had a hand pump for use in the laundry .[P1120075]

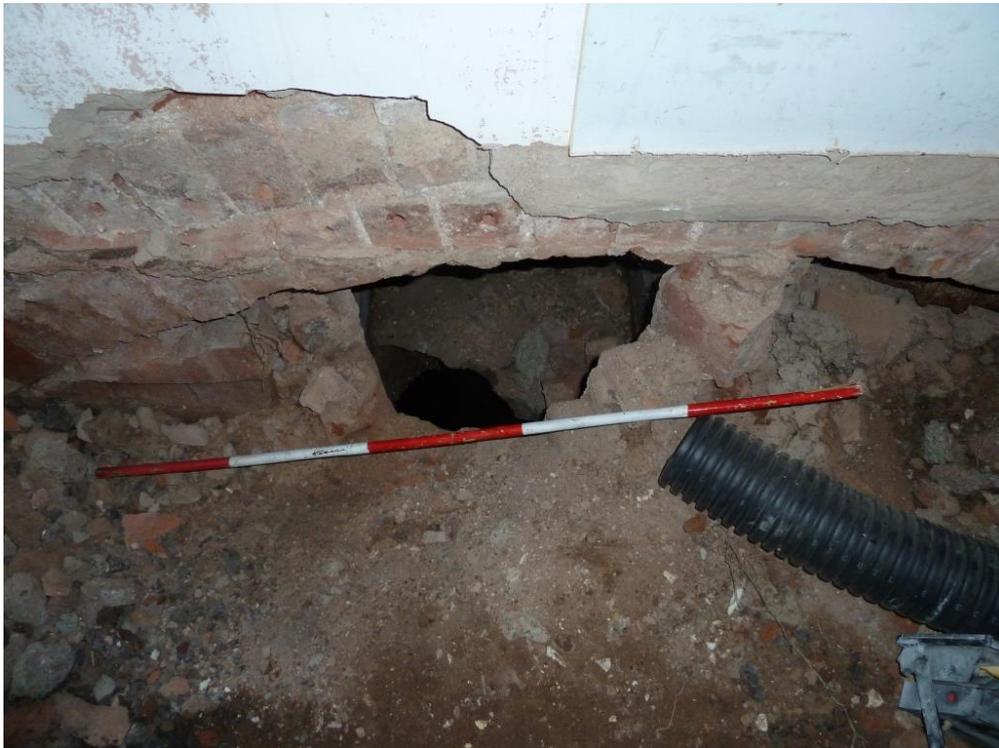
11 P1120072 Brick relieving arch 1m photographic scale Photo Position 072

Inspection of the internal well/tank was only possible through a small irregular opening to the well that had been excavated adjacent to the wall, through which there was limited access, so that it was only possible to record with flash camera at arm's length [P1120072]. .

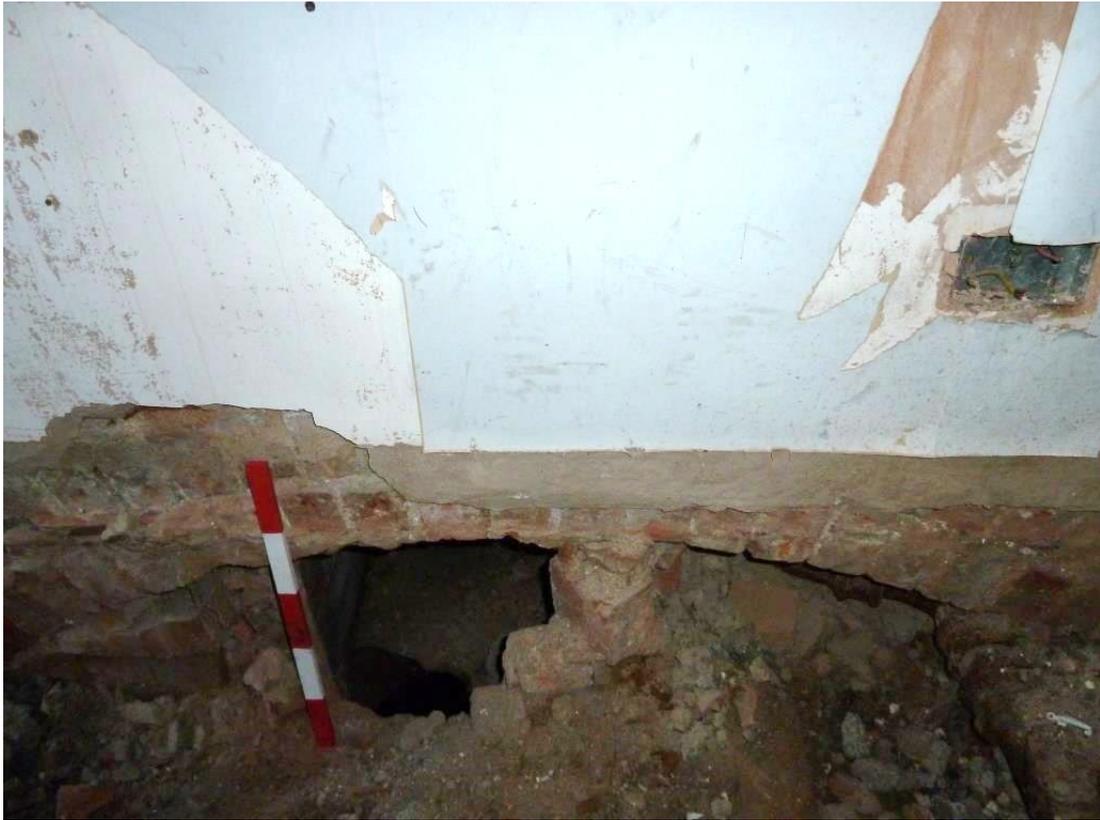
12 P1120074 Brick relieving arch with 50cm photographic scale Photo position 074

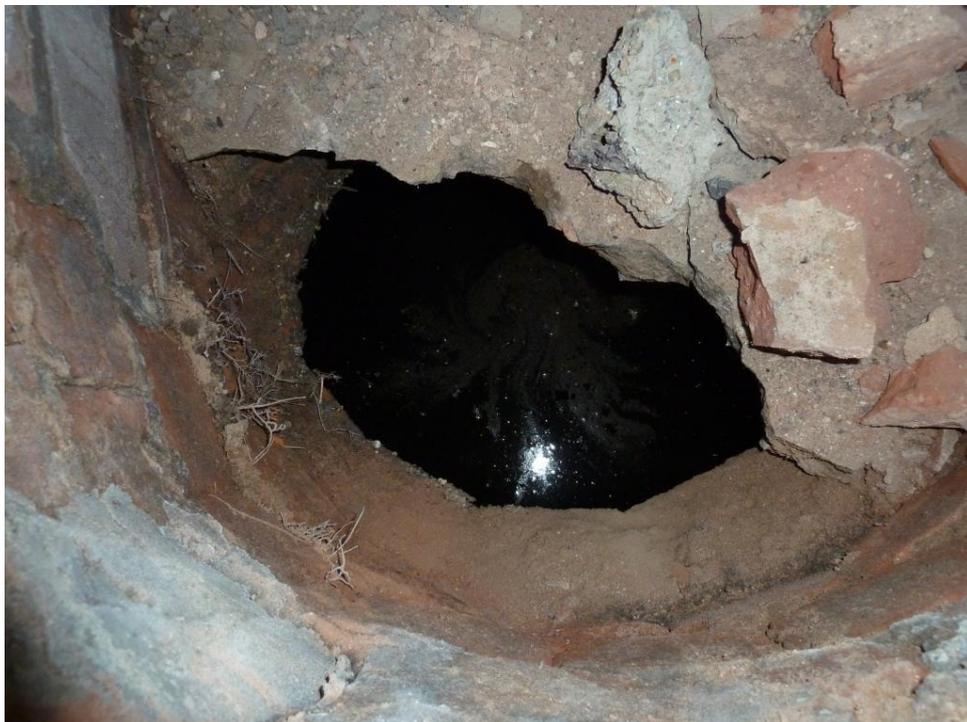
13 P1120076 The Well head

Within this wall cavity, is a small opening to the well, where water was visible just below the well head, a hole had been broken through the well cover.[P1120076] It is difficult to assess whether this had been a cap or original cover. The Well/tank depth is approximately 2 metres, although there could be build-up of sediment, it could be a cistern tank. Above the well opening within the wall was a similar stone flag lintel to the external well [See Section 3.3] with a hole evident at its centre, the diameter of which would accept a lead water pipe[P1120077], the back of the space had been bricked in which was apparent in the adjoining room. Heavy cast iron pipe work runs horizontal from both sides of brickwork above the opening.[P1120077] It is not clear if this was plumbing contemporary with the well or later but materials used would suggest 19th century.

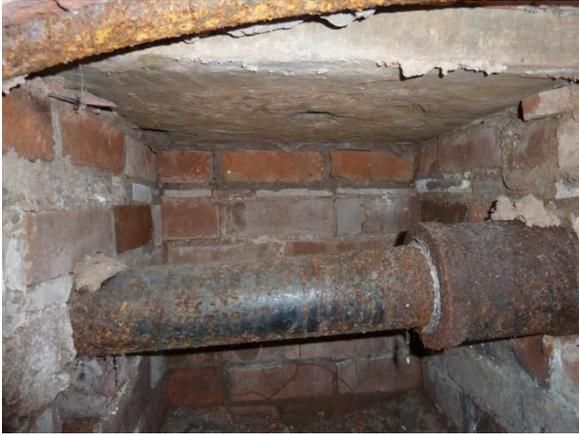
14 P1120077 Cast Iron pipe

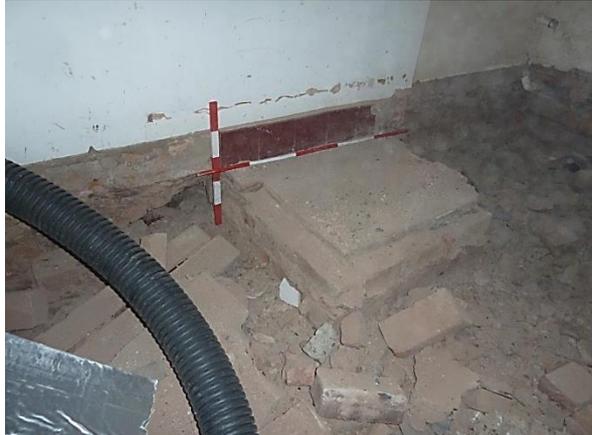
15 P1120090 Room other side of structural partition wall with brick possible inspection cover
Photo Position 090

In the adjacent room, which has also recently had its floor excavated and original plaster ceiling removed [P1120086] there is a square of original floor level /possible brick inspection cover 3-4metre square left in situ. [P1120090] The Relieving arch and cast iron pipe work is also visible through the wall on this side.

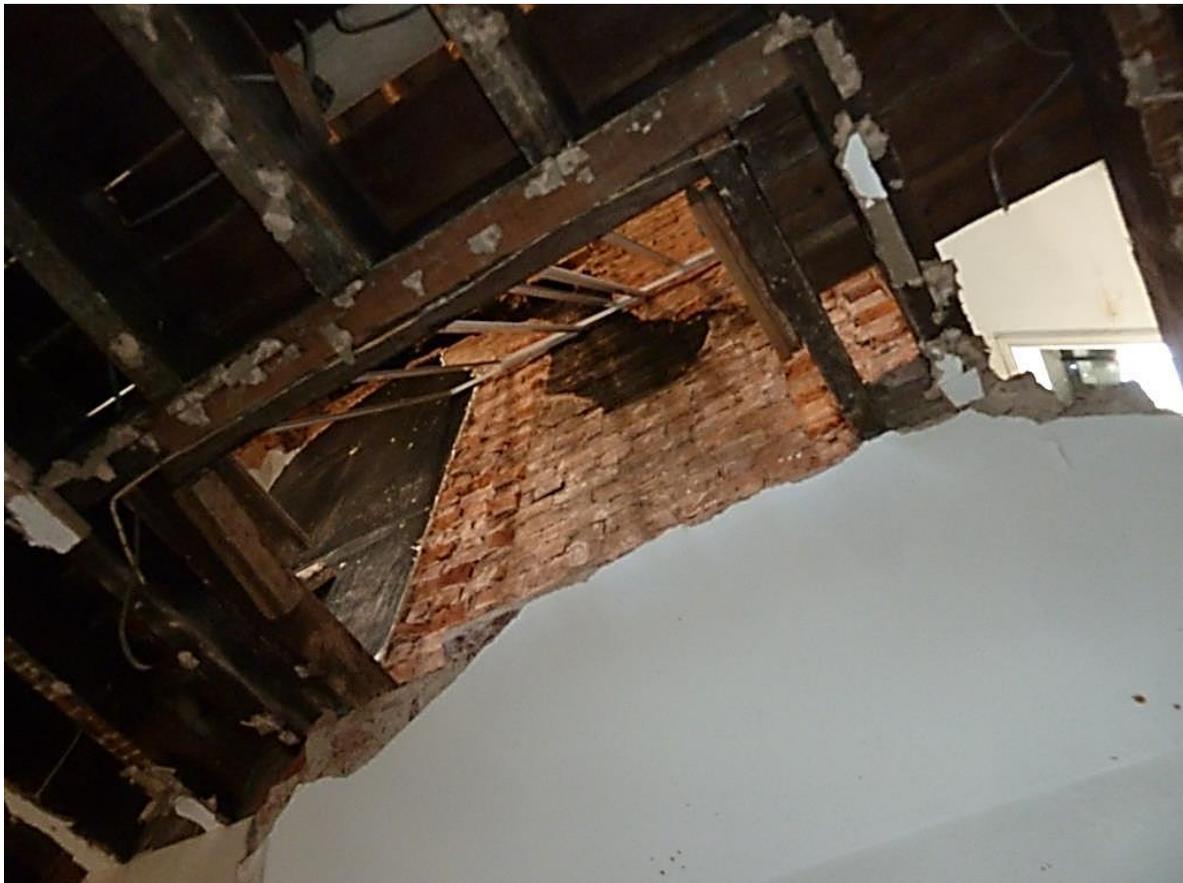
16 P1120086 Room View up from GF with removed ceiling [J] to Room above [W] FF Fireplace ,chimney breast , recessed arches removed during building works. Photo position 086
