Heritage Assessment 2 Manor Farm  
Cottages Atch Lench Worcestershire  
WR11 4SW

### 1 and 2 Manor Farm Cottages Atch Lench Worcestershire WR11 4SW

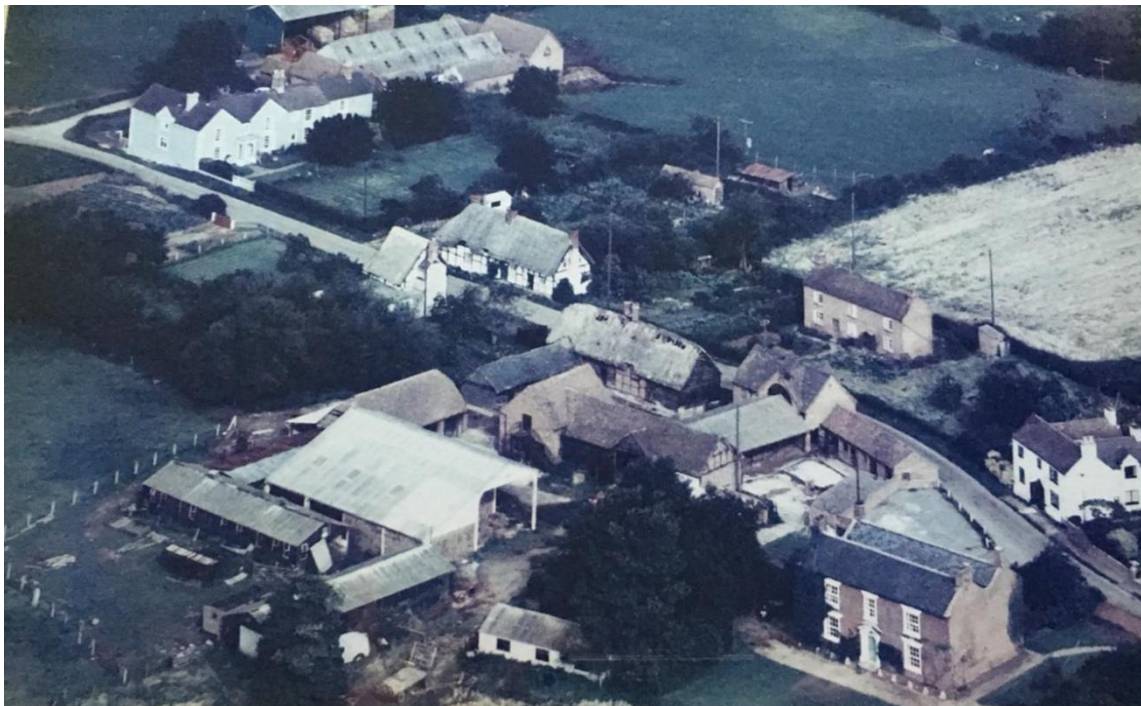
**Analysis:** Aerial View shows rear of Manor Farm Cottages with deteriorated thatch roof and attached wing of a barn [ since demolished See 1960s]. Manor Farm has x2 yards with threshing barn with timber framed gable[ since demolished] attached to Granary. Open Cart/Cowshed still stands

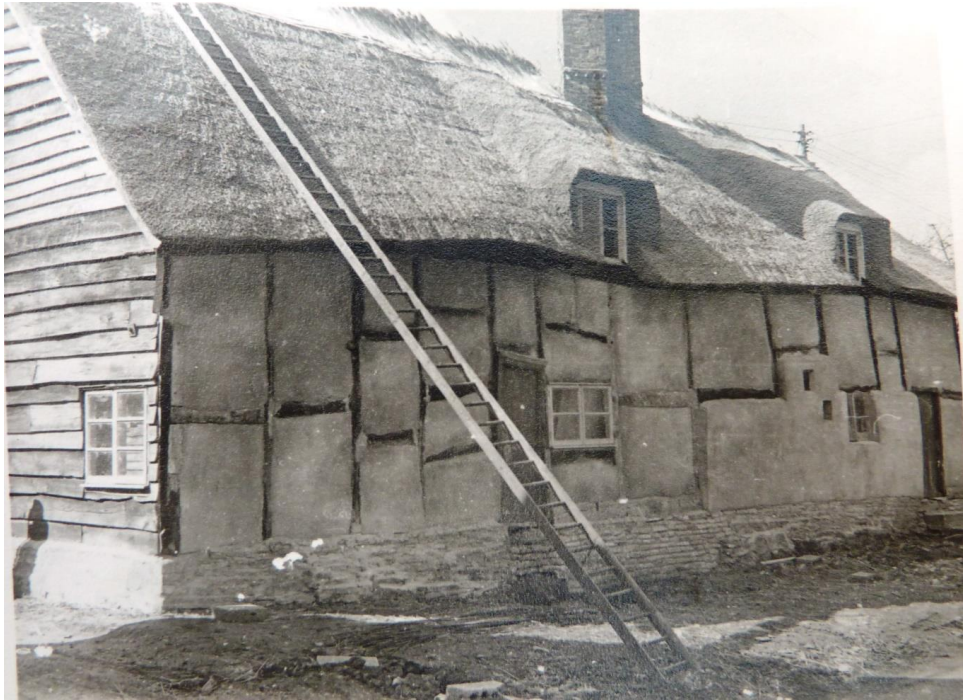
**Analysis:** Weatherboarding removed No 1and timber panels re rendered. Stone walling appears to have also been rendered. Rendering all probably in cement not lime. Weather boarding to end gable repaired or replace; casement window inserted ground floor. Re thatching and two dormers to eaves; new windows. Steps removed and repair to stone lias plinth walling. Entrance doorways appear to remain in same position. Small fire window and end of bressumer beam still remain.

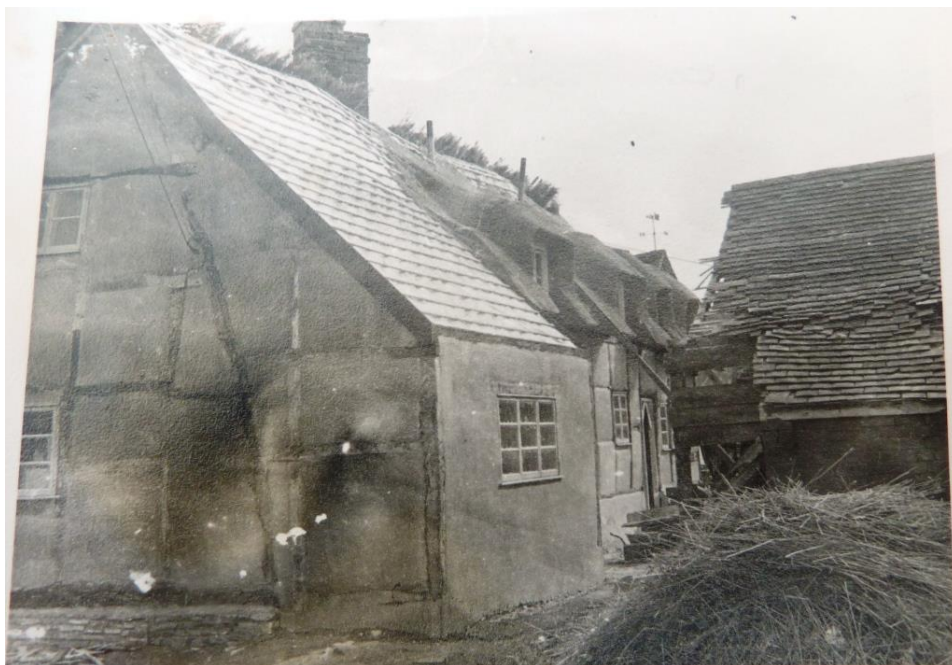
**Analysis:** West end with cruck. Attached barn removed and kitchen extension added; rendered wall with x3 light casement. Stone walling to ground floor seems to have been removed and panelling exposed or timbers added. Plinth wall with sill beam added? New windows to Ground floor and upper in similar position to earlier photos.

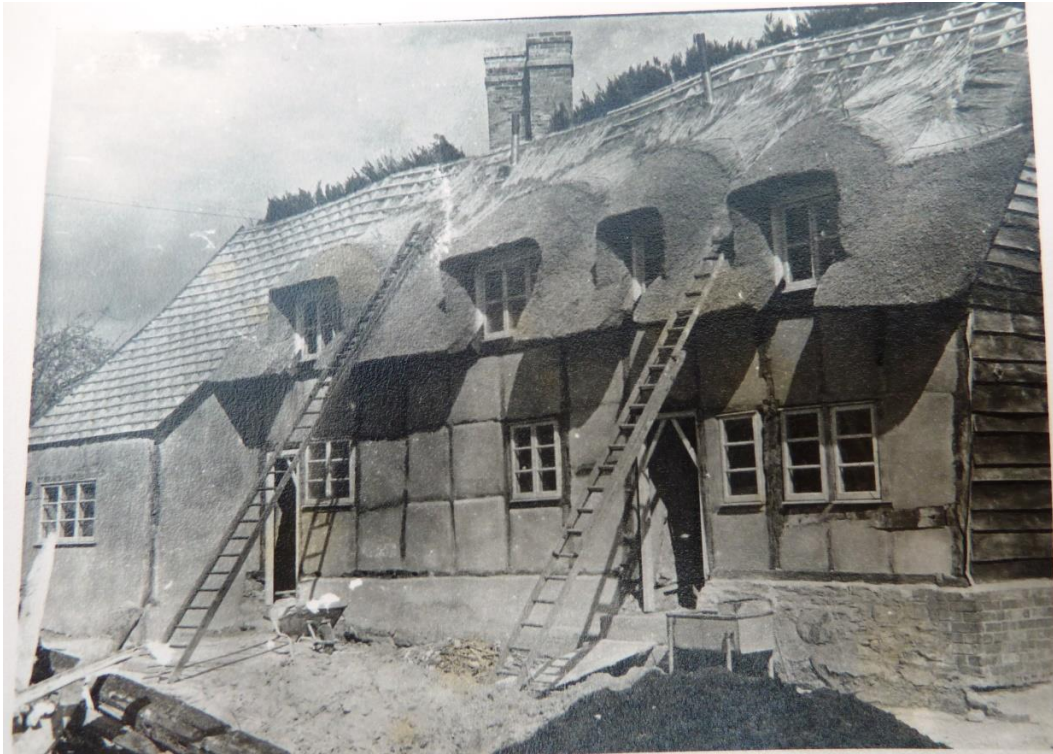
**Analysis:** rear elevations of both cottages. X4 dormers added in roof and re thatching. Weatherboarding removed from rear and timber panelling exposed and filled and rendered. Ground floor windows and doors added. Rear kitchen extension to No 2

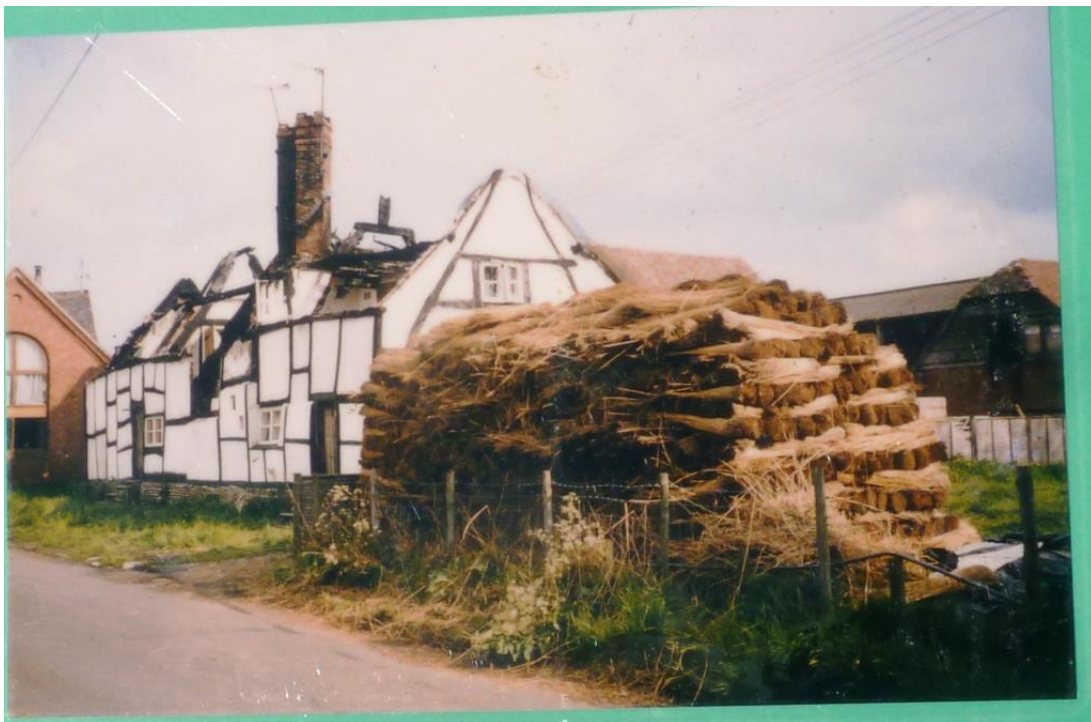
**Analysis:** Fire damage to all of roof. Note the charred Cruck blade apex joint with short king post strut to Cruck blade 4. Cruck Blade 5 intact on side elevation. It is possible to count the Crucks and see the chimney stack in the cross passage. Photograph Courtesy of neighbour in village

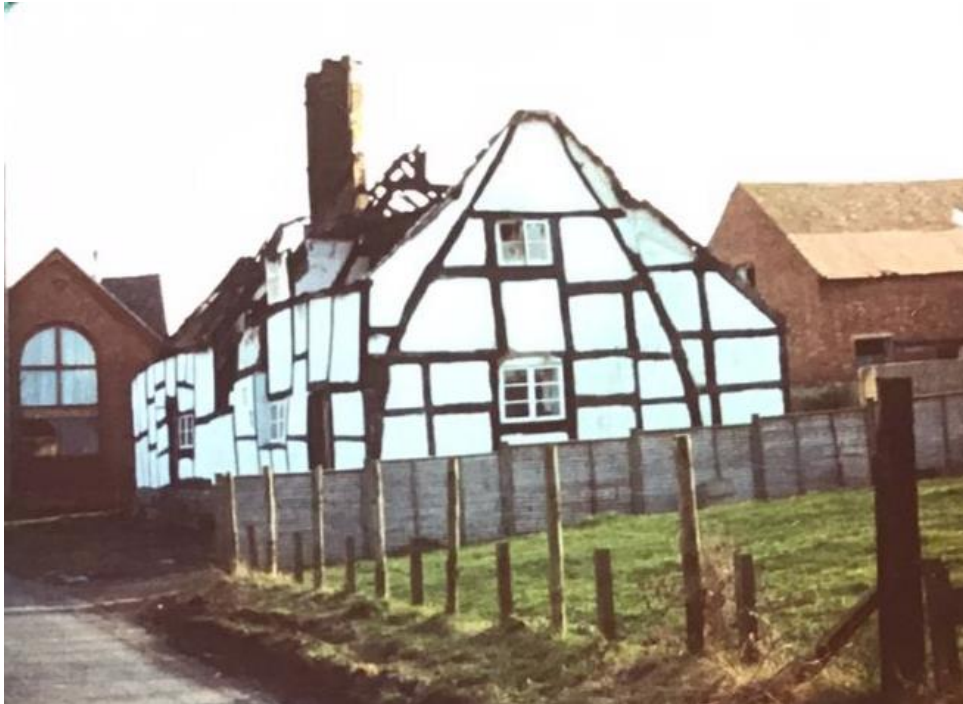
**Analysis:** Fire damage to all of roof. Note the charred Cruck blade with king post strut to Cruck blade 4. Cruck Blade 5 intact on side elevation with x2 casement windows. It is possible to count the 5 crucks and see the chimney stack in the cross passage The side wall of kitchen extension survives.

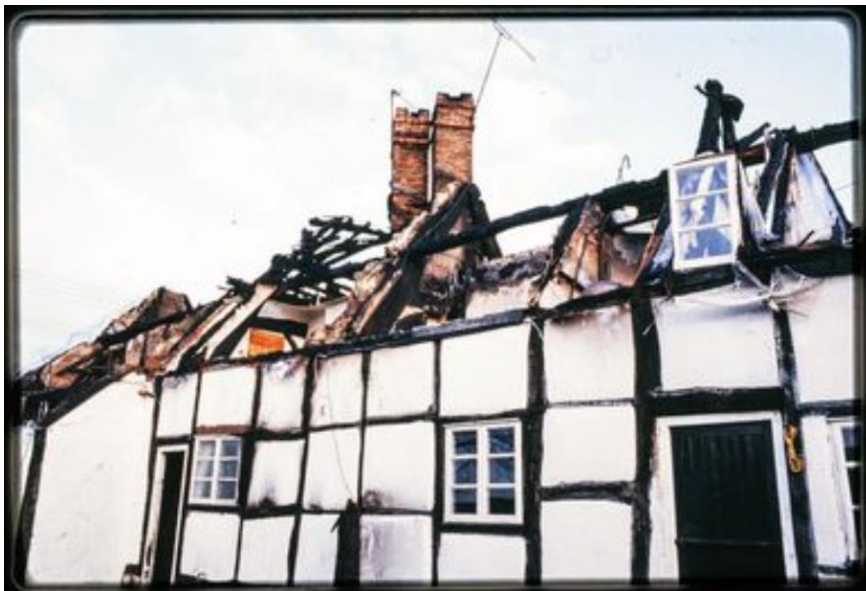
Ref Omnia Manor Farm Cottages Atch Lench 1983 Image Archaeology Data Service

**Analysis:** Front elevations survive with windows. Roof and dormers destroyed. Possible to make out the 5 Cruck blades

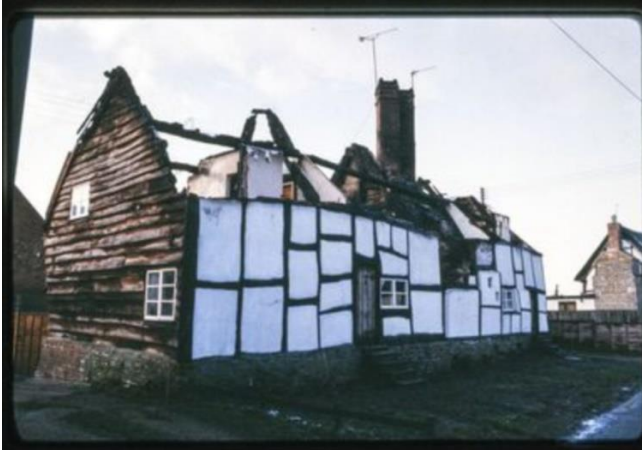
Ref Omnia Manor Farm Cottages Atch Lench 1983  
Image Archaeology Data Service

**Analysis:** Cruck blades charred 1-3 view from east end. Weatherboarding survived with x2 casement windows

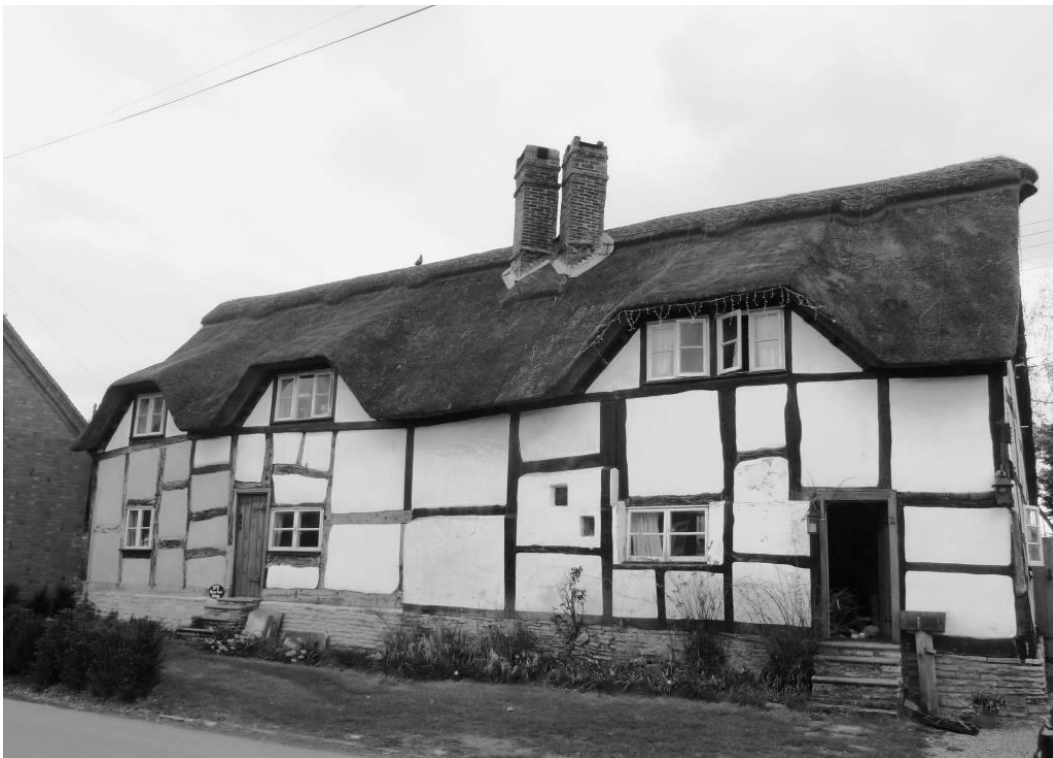
courses have been altered [evidence 1984] and both chimneys have two sets of corbels separated by three and four courses; lower courses of brick with thin smaller bricks suggest a much earlier date, possibly C16, (2 inches high by depth 4 inches length 9 inches ) chimneys have brick coggling at roof level; both chimney stacks have slate on top simple openings, to stack. Eyebrow dormer at eaves [altered in 1984] with 2 pairs of replacement 1980s casement windows; set in frame; first floor is of large and small square panels; timbering painted black at ground floor level; although framing appears to be timber and infill at first glance; is in fact stone walling to the front elevation [see photo below] with the small fire window glazed with perspex, and end of the bressumer beam of the large inglenook fireplace; (**Photo C**) this is of cement render over lias stone which has had the frame painted to give the appearance of continuing the timber framing at ground level. Two casement windows set in stonewalling; frame and wall sits on rebuilt liars stone plinth, and rebuilt lias and concrete steps to replacement circa 1960s front door [**Photo A & D**] adjacent to door GF more rendering to a stone wall with horizontal black painted false timber. Above FF infill panels of woodwool cement rendered in 1967.

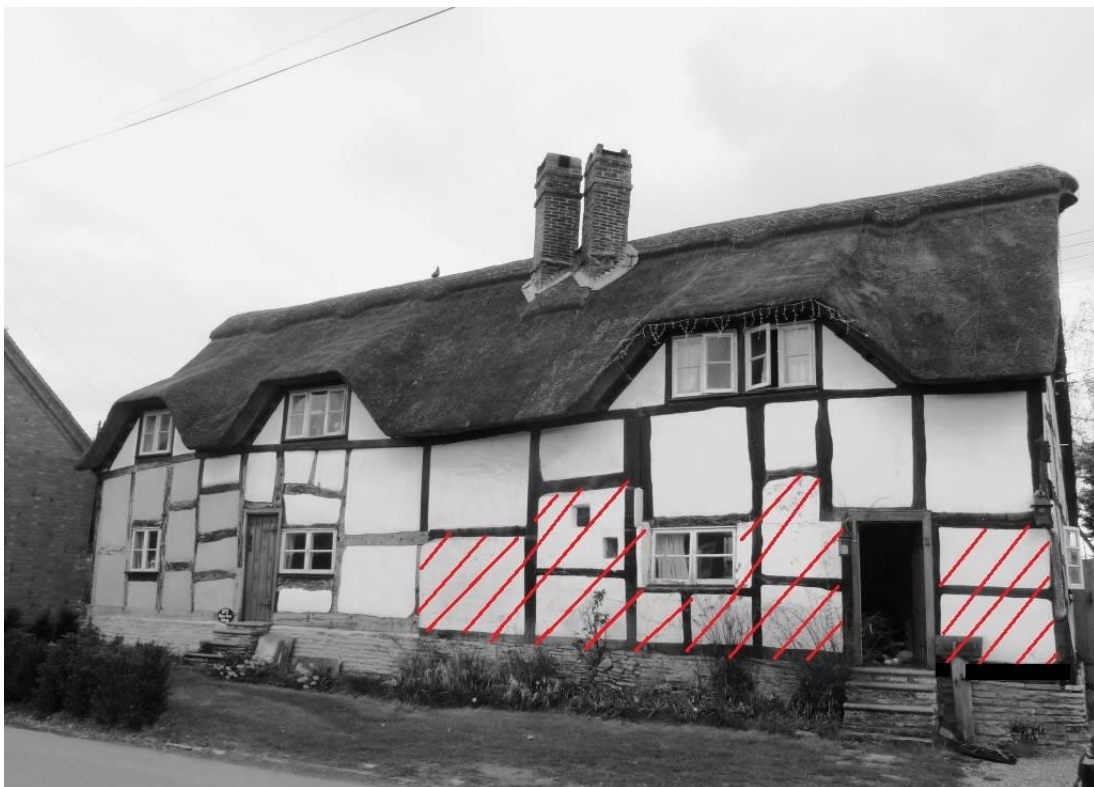
Front Elevation shading in RED showing rendered stonework/false painted panels

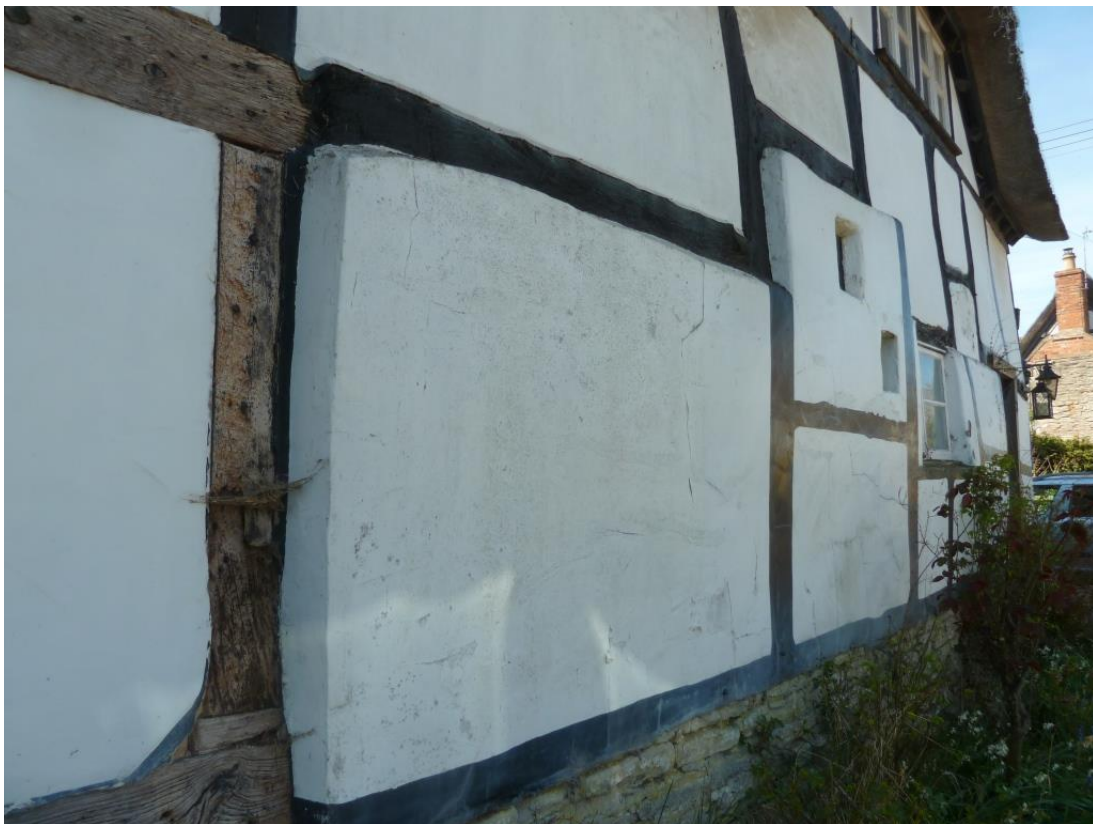
Photo C stone walling to the front elevation rendered and protruding/painted black false timbers

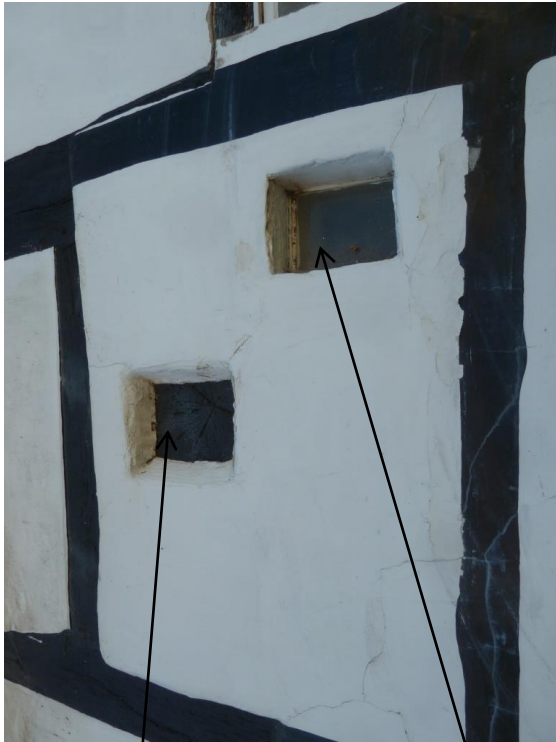
[Photo C] End of the bressumer beam and Small fire window opening with Perspex

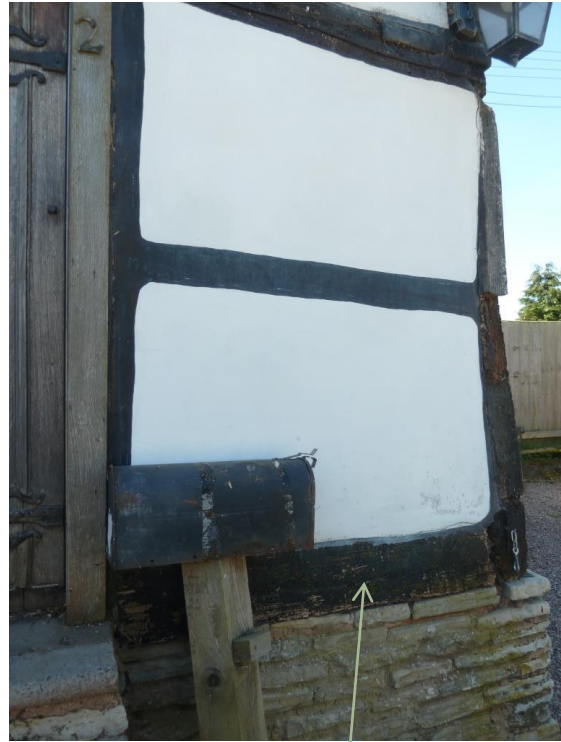
[Photo D] rendering to stone wall with horizontal black painted false timber. Timber sill probably a replacement

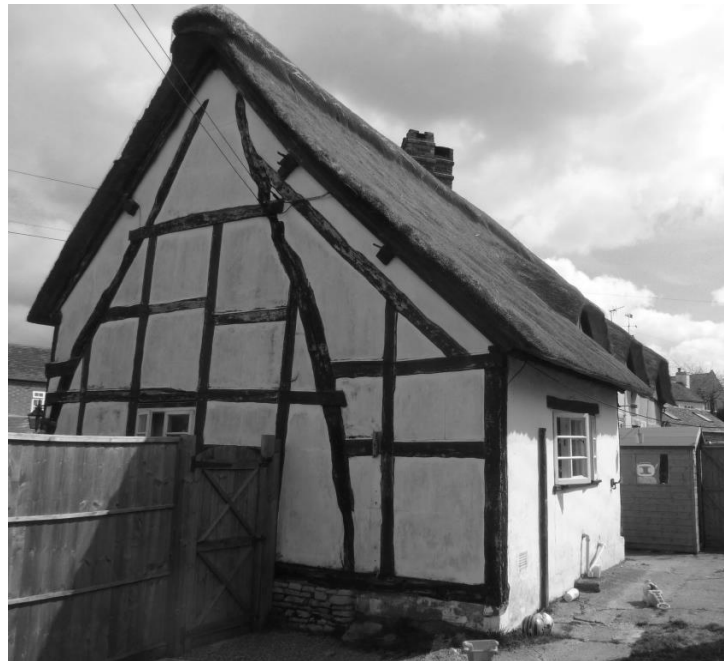
**[Photo B]** framing square panels; wood wall cement rendered

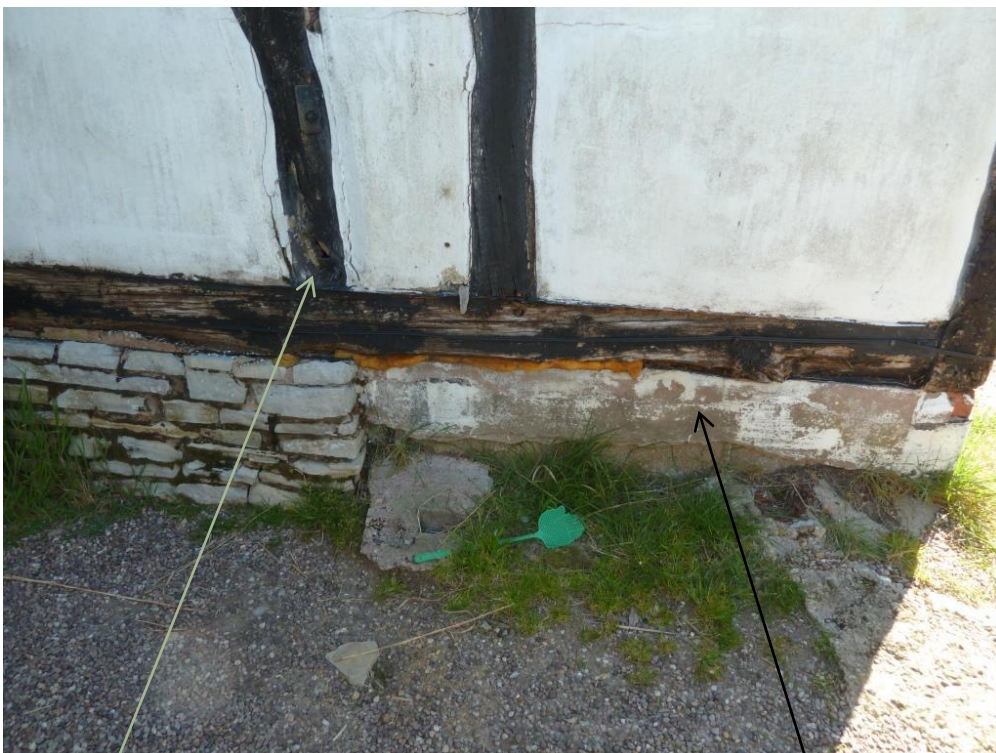
[Photo E] crack blade sitting on sill plate with DPC with cement rendered breeze block plinth of outshut of 1967

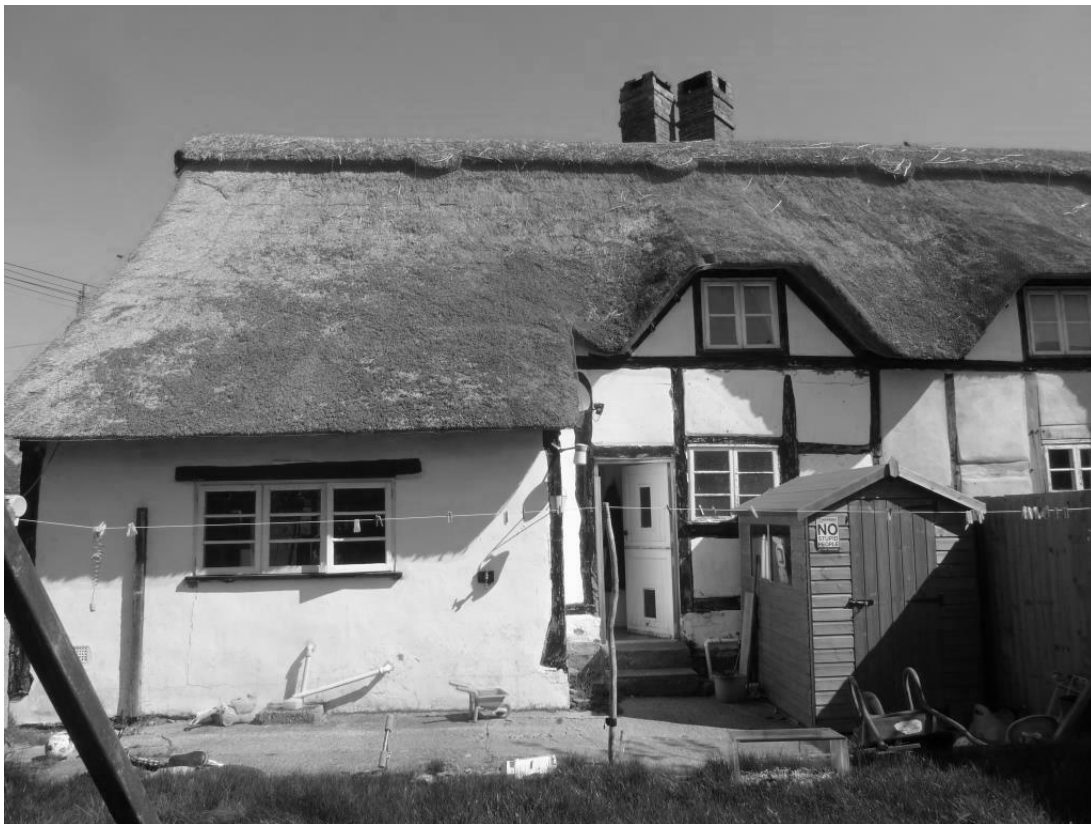
Rear Elevation **Photo A**

South elevation. (Rear). **(Photo A )** South roof is thatched with heavy ridge; two diamond shaped brick chimneys; the top 6 courses have been replaced and both chimneys have two sets of corbels separated by three and four courses; lower courses of brick thin smaller bricks suggest an earlier date(2 inches high by depth 4 inches length 9 inches )brick cogging at roof level; both chimney stacks have slate on top of simple openings. Eyebrow dormer's at 2nd floor Level. Three dormer's installed in 1967 and reconfigured in shape in 1984;There is a continuous outshut roof to left that runs over small kitchen extension; dormer with 2 light casement window in dormer to right all replaced in 1980s . Dormers changed in 1980s; replaced due to fire timber wall plate runs beneath dormers at eaves. At ground floor level the cottage has a timber stable style; door single light to top and cat flap to bottom; 2 light timber casement window to right side; frame is sitting on stone lias plinth which was rendered in 1967; x2 concrete steps to garden area. Wall frame made up of square panels; photograph of renovations in 1967 show all being equal and regular spacings for infill that were cement rendered. Kitchen outshut of 1967 extension cement rendered block or brick; airbrick; Triple casement window each with X3 lights has timber lintel above; posts visible on either front corners, are sitting on rendered brick plinth.
