Standing Building Recording 3 Link Lodge, Pickersleigh Road, Malvern Link WR14 2RP WSM20391

# WORCESTERSHIRE HISTORIC ENVIRONMENT EVENT NUMBER WSM78248

**JULY 2022**

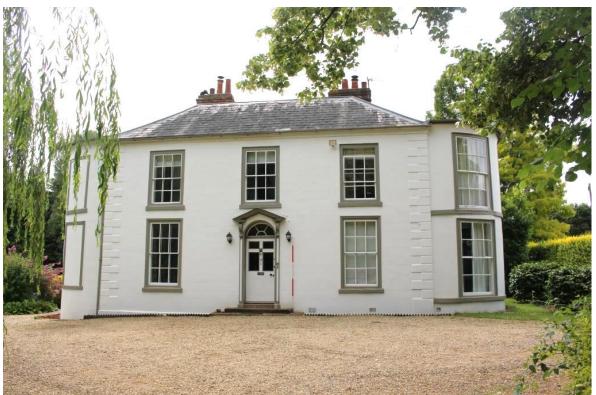
PLATE 1. Front elevation

Slate hipped roof with central valley incorporating two two storey semi-circular bays; painted ashlar effect stucco render; flat leaded roofs with window openings flanking either side of main building. Bay to the west with six full heights 6/6 curved sliding sash windows; bay to the east with its north windows blind but defined by mouldings and two further full height 6/6 sliding sash windows. Main elevation; symmetrical with painted plaster quoins; painted ashlar effect stucco render; five 6/6 sliding sash window; one above the central door opening; approached by symmetrical 3 steps. Typical late 18th century early 19th century door case with triangular shallow pediment hood; simple decorative timber fanlight more reminiscent of Georgian period; door original six panels ;two panels raised, with four panels now with fixed glazing; probably inserted at a later date

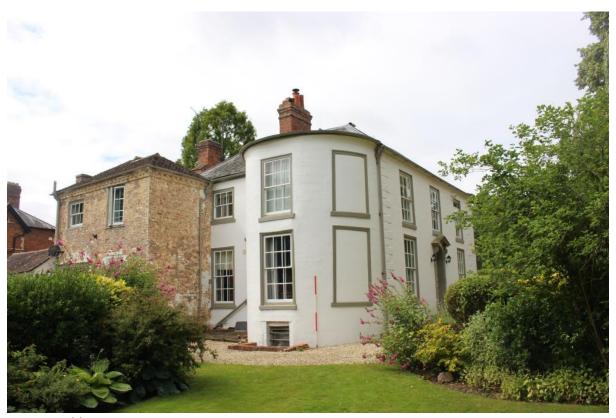
PLATE 2. Oblique view

The East Elevations would appear to show a joining of two buildings; [PLATE 2. PLATE 3]a Regency early  $19_{th}$  century portion; painted ashlar effect stucco render with slate hipped roof flanked by an earlier building; or an adaptation of the frontage to the north of an earlier building to keep up with the current style in Malvern in the early  $19_{th}$  century. The east to the north; bow bay ;painted ashlar effect stucco; flat lead roof with two full height 6/6 sliding sash windows; beneath semi basement window to cellar underneath. Adjoining is a continuation of the main building ;painted ashlar effect stucco render with further two window openings GF with 6/6 sliding sash windows, and FF 4/4 sliding sash windows

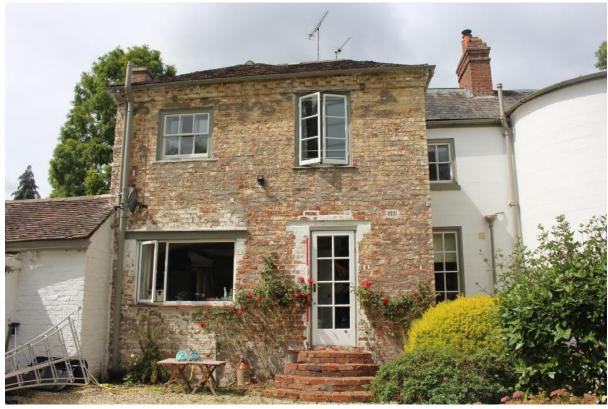
PLATE 4. East elevation detail

The adjoining building under a separate clay tile hipped roof with dentil brick eaves is more farmhouse in character. Bricks; English Bond; unpainted. GF modern C20 window; maybe the original timber lintel; C20 8 pane glazed door. The door is approached by four semi-circular brick steps. The door opening appears to have been narrowed as the door lintel is wider than the current door opening. Two FF 19th century windows one casement and the other 3/3 sliding sash window. Adjoining this building are the brick outbuildings appear to be of the same period [PLATE 4. East elevation detail] [PLATE 5. Detail rear outbuilding]

Entered by an exterior C20 8 pane glazed door[PLATE 34]; approached by four semi-circular brick steps [PLATE 4]The door opening appears to have been narrowed as the door lintel is wider than the current door opening. Pantry on a higher level than the Kitchen Dining Room and is approached by steps from the Kitchen.

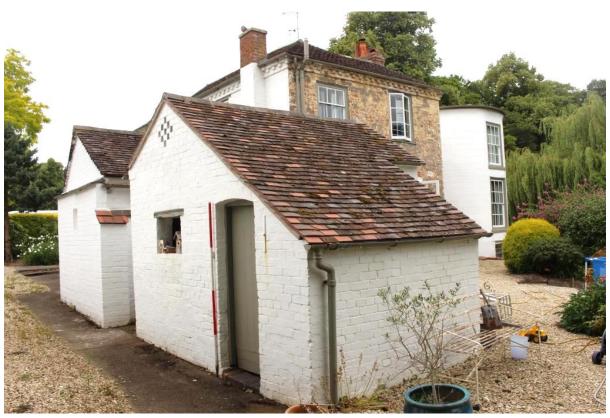
PLATE 6. Oblique view outbuildings

Principal elevation [PLATE 7, PLATE 9] painted brick over clay tiled gabled roof with skylight; dentil eaves. To the left ,set back, painted ashlar effect stucco where there once was another wing since demolished that probably was the stone and tiled stables or cowhouse [Ref RDA Heritage Assessment 2020] Early 19th century alterations have attempted to disguise this wall with stucco; however dentil brick eaves are evident; internally this is the stoned walled Utility Room; former scullery; one face of the clay tiled hipped roof has been covered in slate to match the west elevations. FF windows central landing window Crittall probably dating from the 1930s; either side one fixed light single casements. Left hand with possibly original lintel and window surround. Right hand looks more a later insertion. GF inserted C20 timber boarded enclosed porch; flat felted roof; fixed two panelled glazing; to the west C20 patio style sliding doors; C20 open porch/veranda/leanto continues with flat felted roof. GF window has been enlarged and inserted with a C20 window. External chimney stack to the right associated with the service end of the house. Brick outbuilding store adjoins main building to the right that houses a water tank [PLATE 6. Oblique view outbuildings,PLATE 8.]

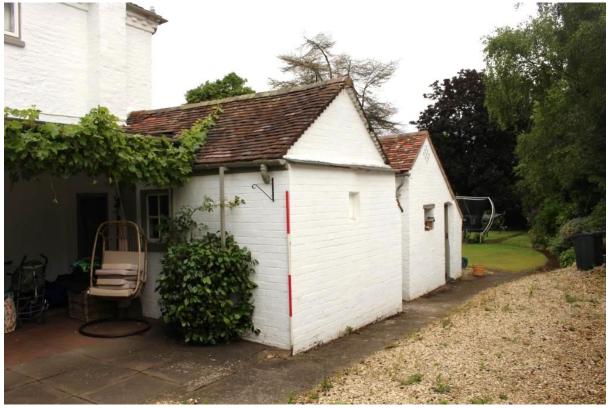
PLATE 8. Outbuildings south elevation

One of Two single storey painted brick outbuildings over clay tiled gabled roofs; formerly part of stable yard; one building [PLATE 8] attached to the main building incorporating a chimney stack; external C19 timber plank entrance door[Plate 16]; 2/2 pane C19 casement window with original latch.[Plate 16]; tiled floor; dividing wall with a timber door/hatch [Plate 17] where modern water tanks have probably replaced older water tanks [still evident and visible] that would have been housed here[Reference RDA Heritage Assessment 1933 Auction description p20]

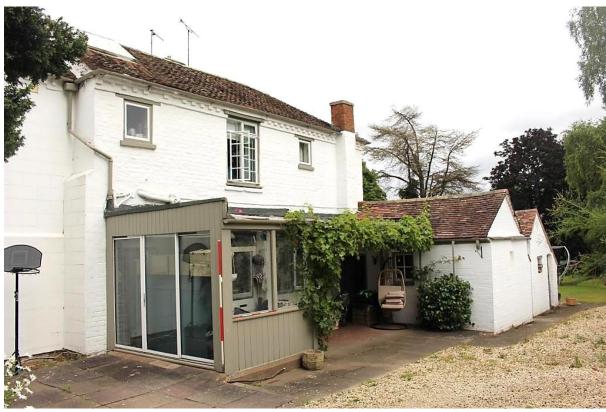
PLATE 9. Oblique view south elevation rear porch

C20 timber boarded enclosed porch with side timber door[PLATE 23]; fixed two panelled glazing[PLATE 24,25]; to the west C20 patio style sliding doors[PLATE 24, ExteriorPLATE 9]

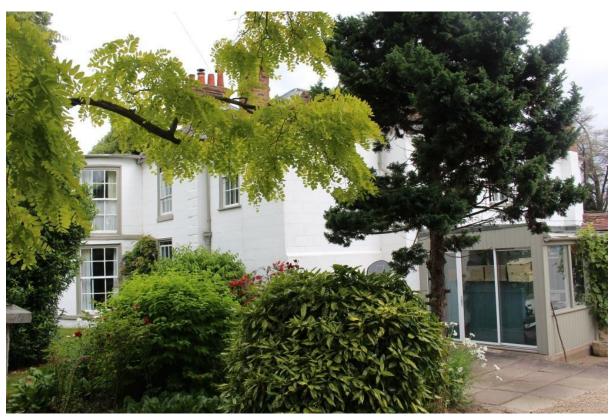
PLATE 10. Oblique view west elevation

Principal larger elevation [PLATE 10. PLATE 11] painted ashlar effect stucco render with slate hipped roof with central valley; brick chimney stacks adjoining brick clay tiled building that has been faced with ashlar effect stucco render and has one hipped roof covered in slates facing Pickersleigh Road. The principal larger side has a two storey Bay to the north [PLATE 12] with six full height 6/6 curved sliding sash windows; further two 6/6 sliding sash windows to GF and FF. A brick wing with clay tiled roof; brick chimney stack to front elevation; slightly set back faced with ashlar effect stucco render; FF 6/6 sliding sash windows; GF 3/3 sash window to Utility Room; room set partly underground with external solid stone walling faced with ashlar effect stucco render to match the principal building. Boundary has character criss cross pattern fence panels in a Regency style between 19th century brick pillars and low brick walling with hedges.

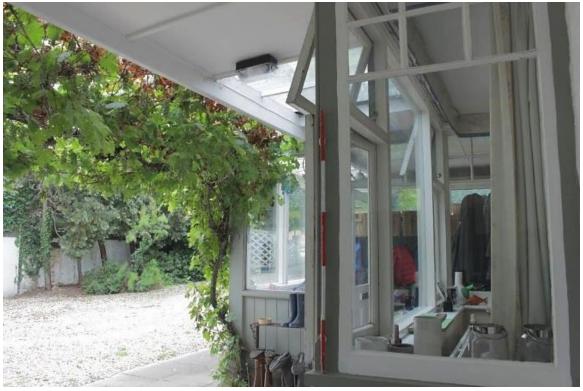
PLATE 18. Lean-to

Flat felted roof; C20 open porch/veranda/lean-to .GF window of house has been enlarged and inserted with a C20 bay window[PLATE,18 19]

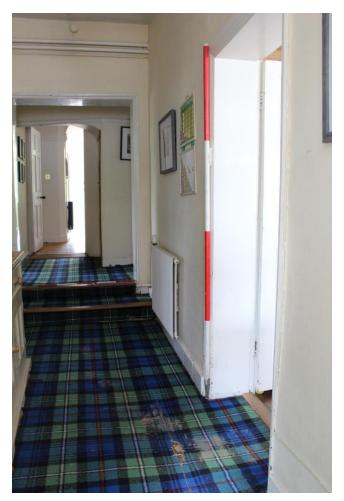
PLATE 26. Hallway

The lower entrance hall approached via timber C20 door [PLATE 27] from C20 porch within the possibly earlier brick farmhouse; wide doorway to Regency part of house; no door; simple timber architraves. [PLATE 26]Wide planked timber door leads to former scullery/laundry now Utility Room to the west and to the east central door opening leading to Dining Room Kitchen [PLATE 26]

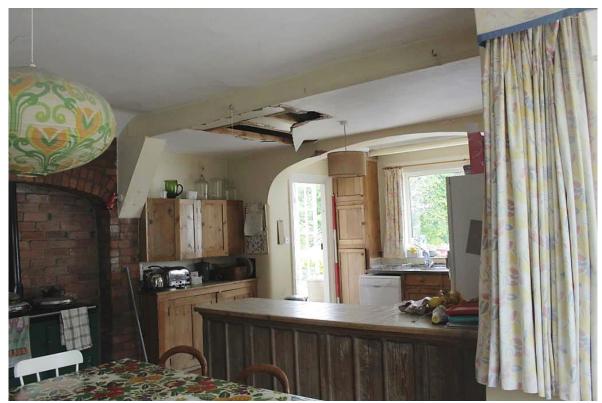
PLATE 28. Kitchen/dining room

This room has undergone the most changes. It appears to have been opened up [PLATE 28]. Entrance door from corridor; x 4 panelled raised and fielded mid C19 door; heavy architrave maybe late C19 or reproduction. [PLATE 31]. Door to lobby and pantry also x4 panelled mid/late C19 door with bolection type mouldings. [PLATE 32]. Fireplace undergone alterations and its recess is not deep. [PLATE 31]. Floor; timber pine boards; C19 recess stripped fitted pine cupboard. [PLATE 31]. To the east is the inserted Upvc window [PLATE 29] and to the south the C20 Porch with C20 timber casement bay window and outside Lean-to. [PLATE 30]
