**Archaeological recording to test pits
dug at St. Catherine Lock, Godalming
Navigation, Artington, Surrey**

NGR: SU 9958 4772

**by
Christopher K Currie
BA (Hons), MPhil, MIFM, MIFA
CKC Archaeology**

Report to the National Trust (Southern Region)

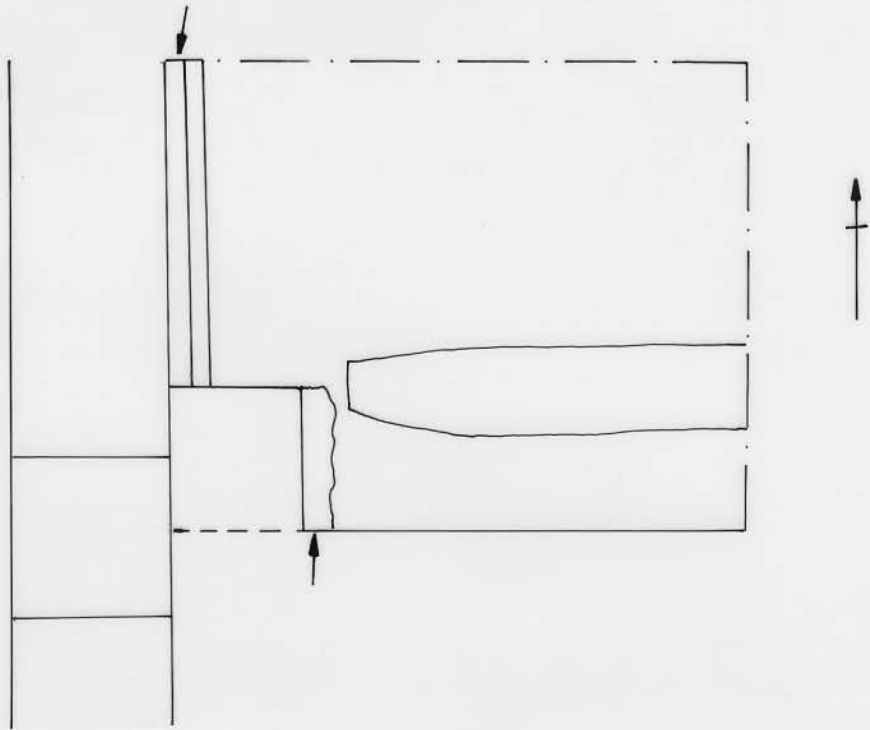
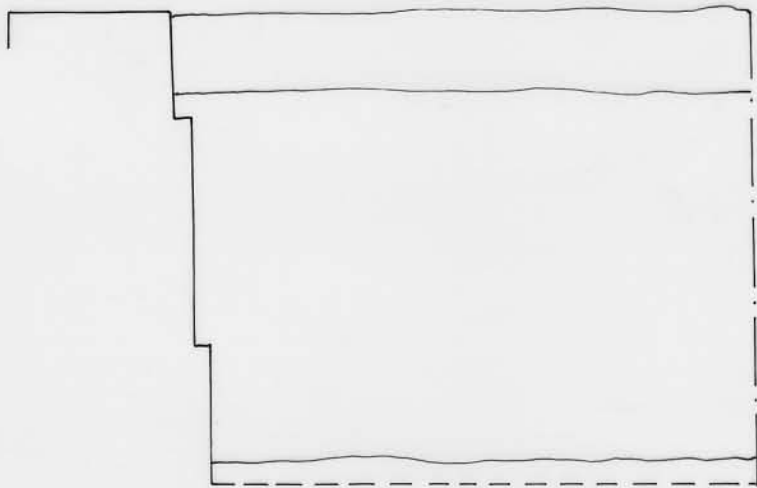
Fig. 3: Trench 1 plan & section

This test pit was 1.6m E-W by 1.3m N-S, excavated on the east side of the lock. It was situated at the approximate join of the brickwork around the southern gate and the concrete of the lock chamber. It was excavated to a depth of approximately 1.2m. Beneath the turf a brick buttress was revealed about 0.38m square [context 05]. It was attached to a deep brick wall [context 06] that extended at a right angle to the side of the lock roughly in line with the northern end of the brickwork surrounding the lock gates. This was laid in English Bond. It extended the full 1.6m length of the trench. Both brick wall and buttress extended to the full depth of the pit, although traces of a rougher foundation to the buttress were just becoming apparent at the maximum depth of the trench.

Behind the concrete side of the lock chamber there was no trace of a previous brick wall. The back of the concrete wall [context 04], 0.45m wide, could be clearly seen. This contained two 0.05m steps at depths of 0.3m and 0.92m below the turf. Behind the concrete wall was about 0.25m of topsoil [context 01] followed by about a metre of brown sandy clay [context 02]. There was no trace of residual brick walling that would have been apparent through fragments of brick within the fill behind the concrete. At the bottom of the trench the soil turned into a dark grey, wet and very organic layer of silty clay [context 03]. Set in this was a substantial timber preserved by the waterlogged conditions. This was 0.25m maximum width, with a slightly tapered end. That part seen was 1.1m in length. It extended from a few centimetres to the east of the buttress, disappearing into the east baulk of the trench. It was exactly parallel with the brick wall, and about 0.25m to the north of it.

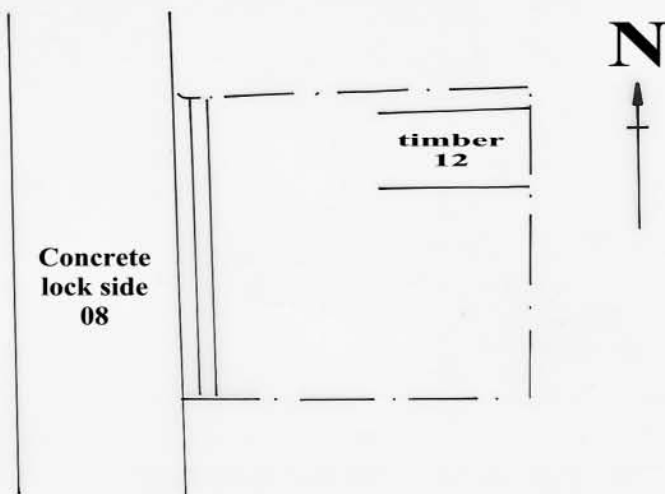
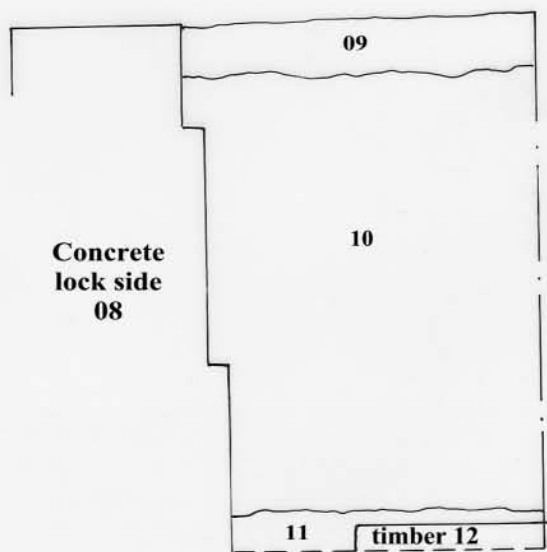
Fig. 4: Trench 2 plan & section

This test pit was 0.9m E-W by 0.8m N-S, excavated on the east side of the lock 8.8m in from the bridge at the north end of that same lock. It was excavated to a depth of about 1.4m at which point the trench bottom became waterlogged. The soil sequence behind the concrete lock wall [context 08] was the same as in trench 1. Topsoil [context 09] was followed by just over a metre of dumped sandy clay [context 10], which overlay dark grey silty clay [context 11]. In the bottom of the trench was another large timber [context 12], similar in size, shape

and alignment to that found in trench 1. It was set back about 0.54m from the edge of the concrete wall of the lock, roughly the same distance back from the wall as that found in trench 1. There was no trace of a brick wall, nor any sign of residual brick fragments in the clay dump behind the wall.
