**Historic Building Survey Report  
of  
The Stable Block,  
The Old Mill House, Donington on Bain, Lincolnshire**

This historic building survey has been prepared by Keystone Archaeology  
for Mr R. Osmond  
The Old Mill House, Welsdale Road, Donington on Bain,  
Louth, Lincolnshire. LN11 9QZ

Nat. Grid Ref: TF 23332 83438  
Accession Code: LCNCC : 2016.177  
Planning Reference: N/042/02464/15  
Site Code: OMHS16

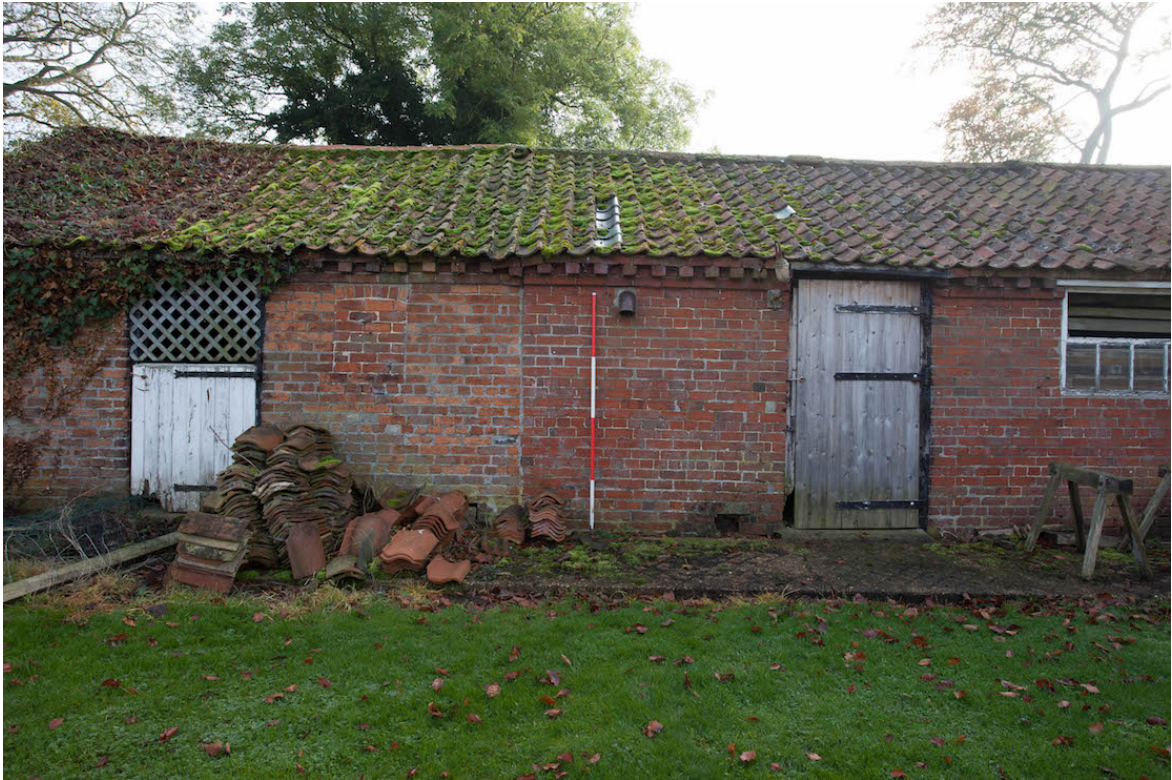
- 6.2 All the brickwork in both sections of the building is constructed in English Garden Wall Bond.
- 6.3 The north western elevation is entirely brick in construction with a clear joint or abutment line visible between the northernmost third and southern two thirds section. There are two doors and two window openings in this elevation

Plate 3 (shot 4) – Central section of north western elevation showing extension join, looking south east.

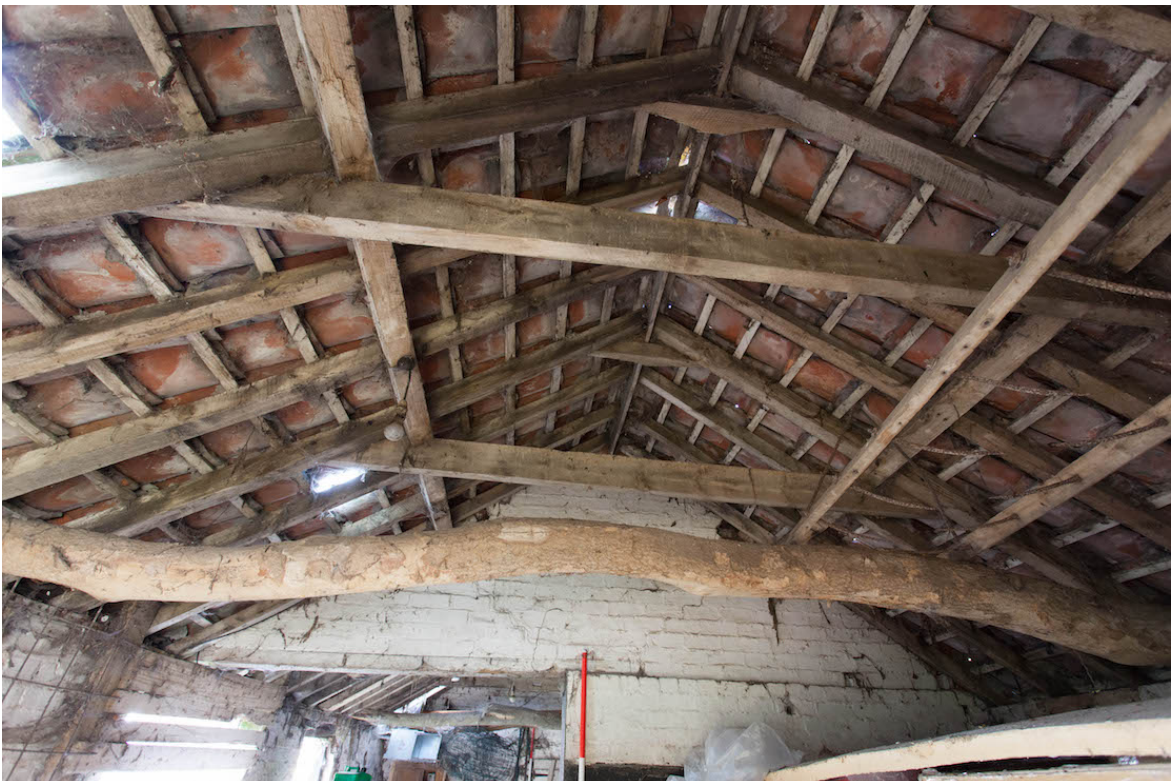
- 6.17 The roof in the southern section of the building is a later collar tie design with crude joists, probably installed later to act as rafter ties and address roof sag and wall spread. The purlins are of a through design and are supported by a central partition wall. The purlins, rafters, ridgeboard and collar ties are all rough sawn timber and show no signs of reuse.

Plate 20 (shot 33) – Interior roof detail of southern section, looking north east.

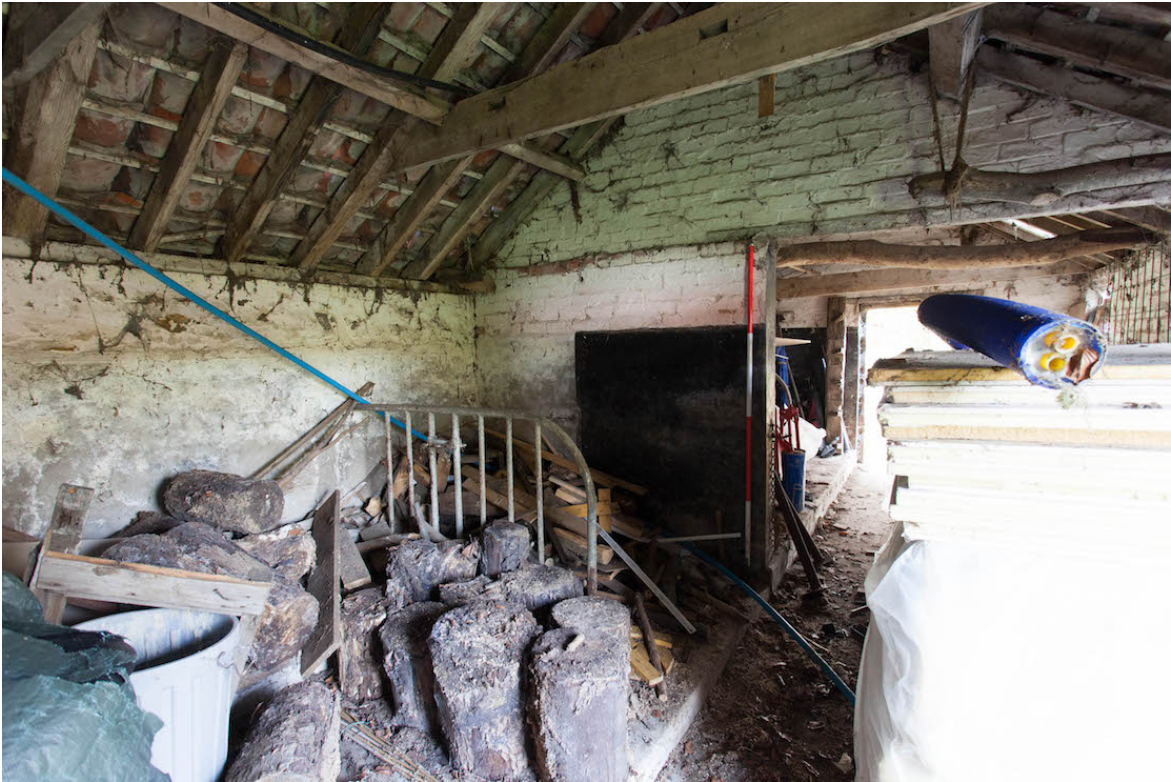
- 6.13 The internal walls in the southern section match the exterior in construction but have universally been covered in a modern cement render to between 1.25 – 1.5m in height – presumably linked to the reuse of the building as a milking parlour in the 1950s.  
There is a central wall of brick construction to divide this southern section of the building into two roughly equal parts.  
A number of modern galvanised cattle dividers are present.

Plate 21 (shot 34)– Interior of southern section showing galvanised cattle dividers, looking south west.

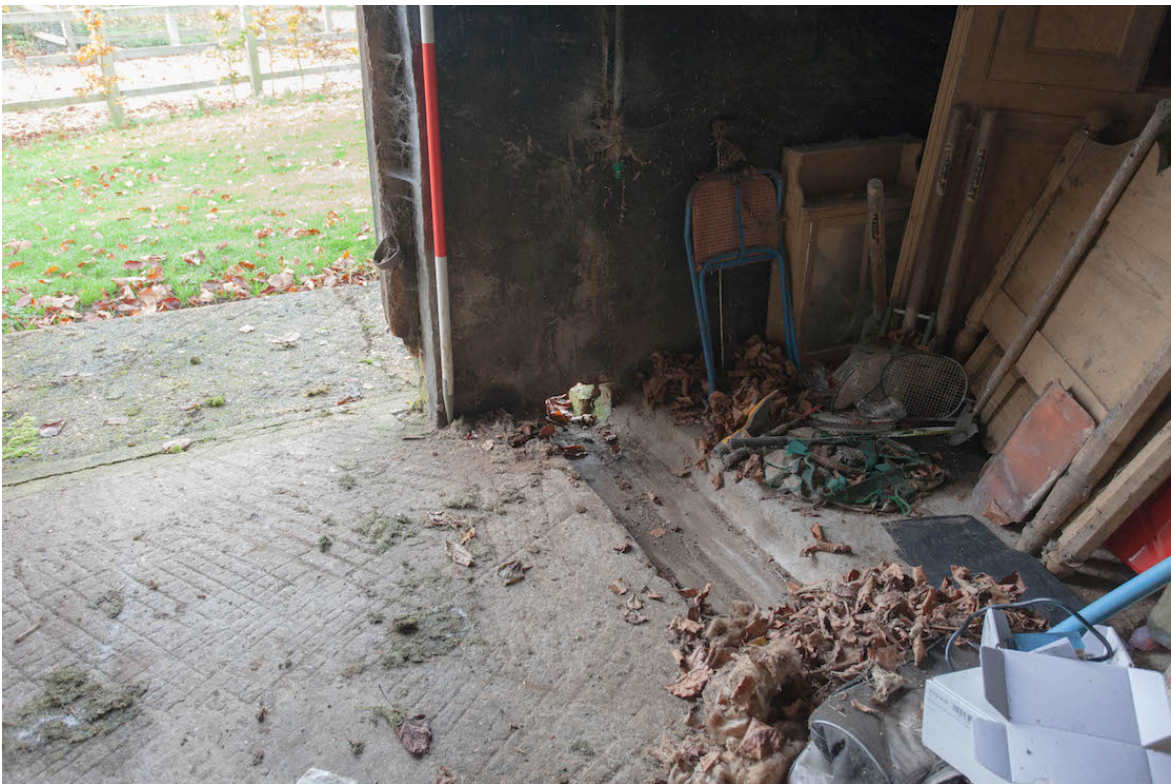
- 6.14 The floors in both sections of the building have been covered in a deep layer of concrete with a rusticated cross hatched surface for grip and a central gully present to facilitate the wash out / drainage of animal waste. At the point where the gullies reach the wall, a small hole has been knocked through with the removal of two bricks to form an exit for the waste. These small holes - one in each section of the building - have been reinforced with a thin slate lintel; likely a reused roof tile.

Plate 22 (shot 35) – Interior of southern section showing modern concrete floor with gully, looking north.

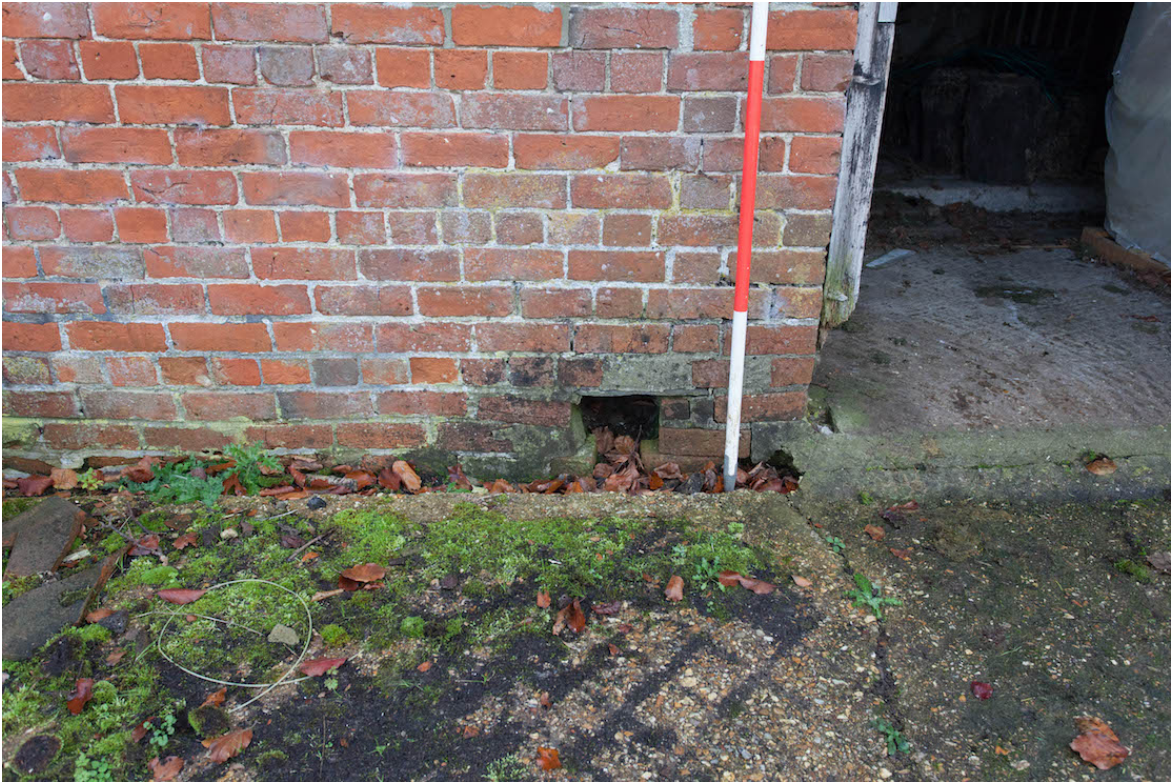
Plate 23 (shot 36) – Exterior gully opening in southern section of north western elevation, looking south east.

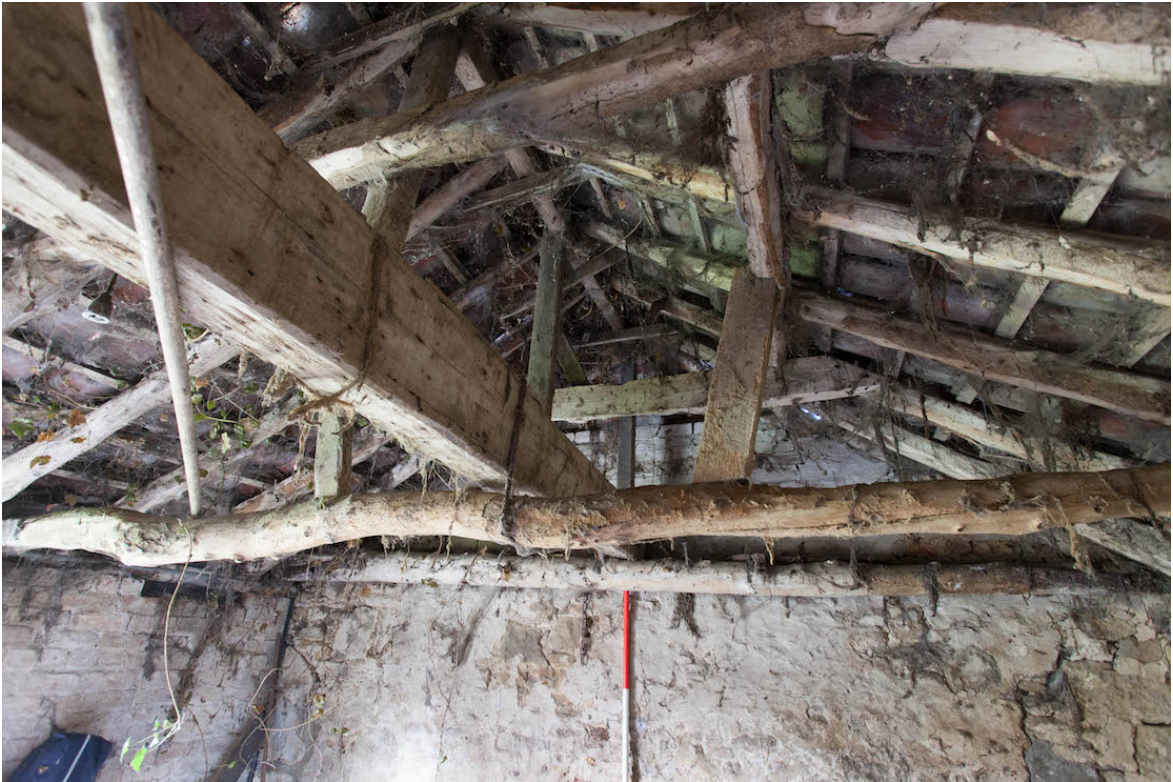
- 6.16 The roof in this northern section is a hybrid structure with rough cut joists made from natural timbers still with the bark on. The joists are then tied to a central large section hanging beam with heavily corroded ironwork. The purlins are propped from the joists and additionally tied with collar tie beams. The rafters are semi dressed but still retain much of their naturalistic nature.  
The hanging beam and ridgeboard are properly dressed (but still rough sawn) and the collar ties and purlin props nearly all show signs of reuse with evident sockets from mortice joints.

Plate 25 (shot 38) – Interior roof detail of northern section, looking north east.

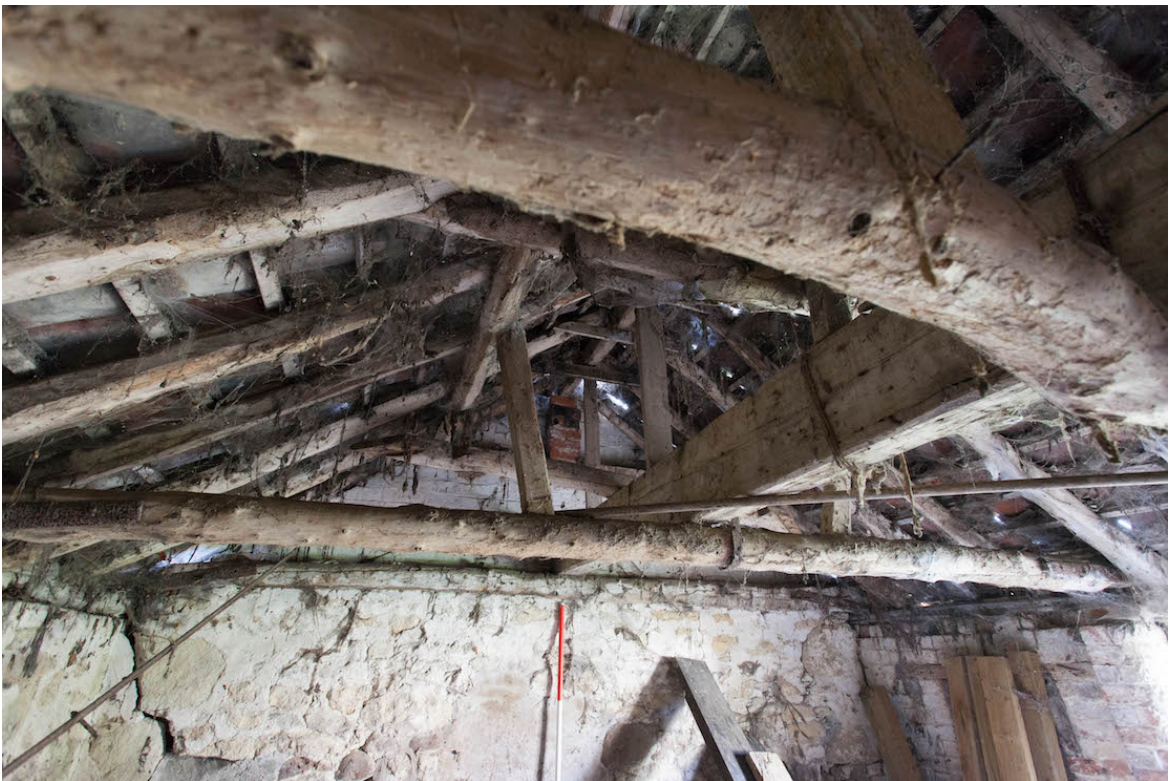
Plate 26 (shot 39) – Interior roof detail of northern section, looking south west.

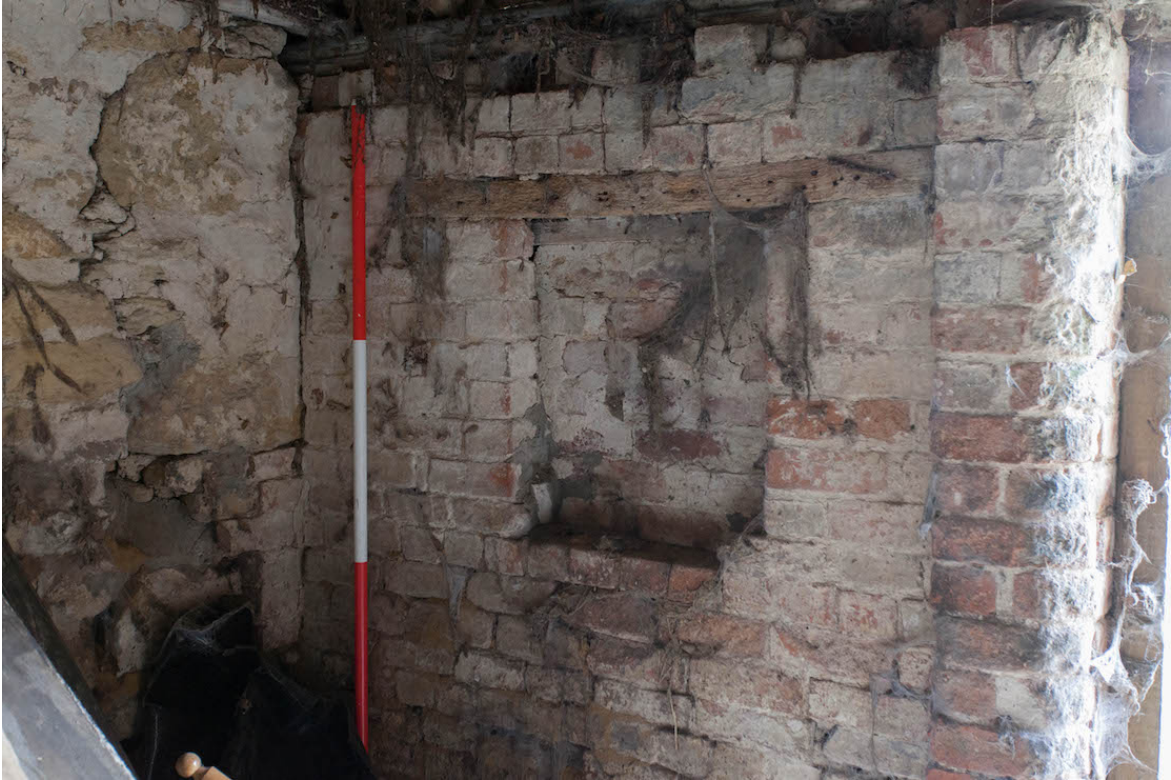
- 6.4 The doorway in the northern third is reinforced with a column of bricks on either side forming a slight internal return. These have been rounded off by hand exposing the 'reduced' centre (brick core) in an attempt to create the look of bullnosed bricks. Within the portal hangs a lower half stable type door. Next to the doorway is a small blocked in window with single brick segmental arch and wooden internal lintel.

Plate 29 (shot 44) – Interior of northern section showing blocked in window, looking west.

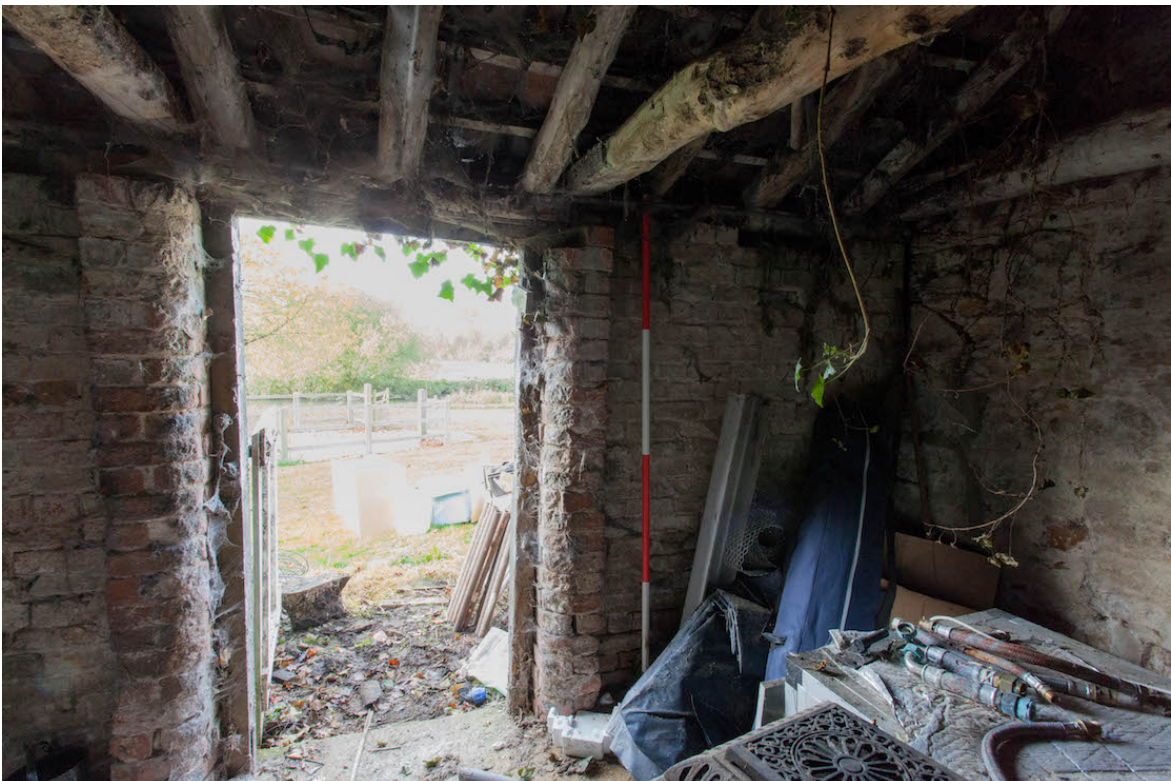
Plate 30 (shot 45) – Interior of northern section showing reinforced brick door pillars, looking north west.

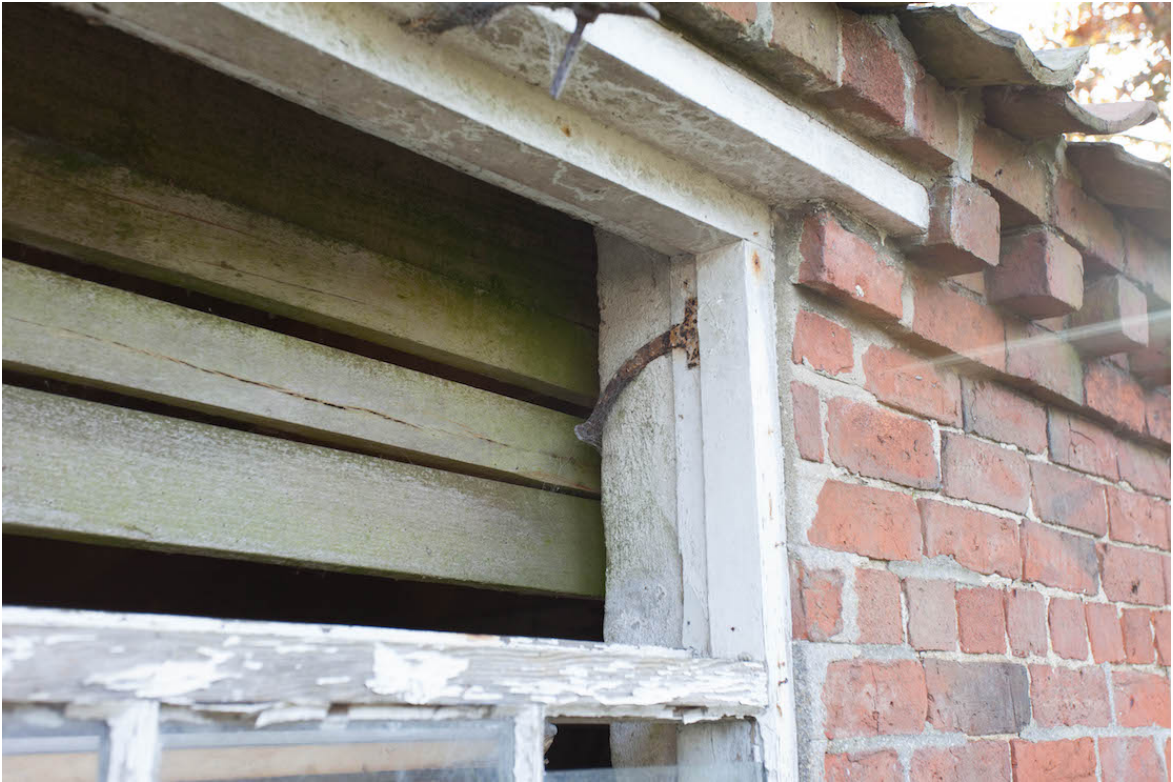
- 6.5 The doorway in the southern section of the north western elevation was unremarkable and held a reproduction single piece reproduction stable type door. The largest window had a wooden lintel within the brick corbelling of the roofline, a hinged opening top light for ventilation (now absent) above a series of five glazed panels beneath. The smaller of the two windows in this north western elevation also had a wooden lintel within the brick corbelling, was non-opening and three small glazed panels.

Plate 31 (shot 46) – Exterior of southern section showing missing upper ventilation casement in large window, looking south.

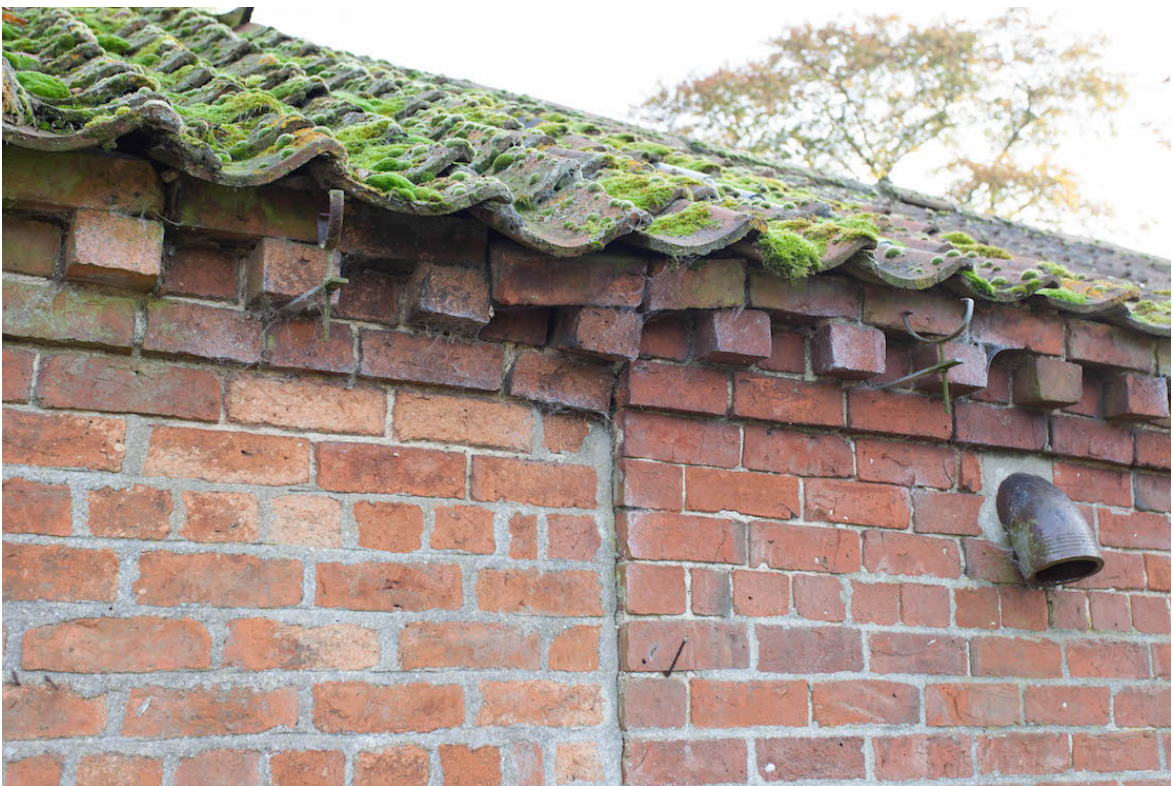
- 7.1 The clear differences in roof construction methods, the abutment line in the western elevation, the different bricks used in each part and the differences in wall construction all provide good evidence to show the building was originally much smaller than it currently stands.

Plate 32 (shot 47) – Settlement at join between northern and southern sections, looking south.

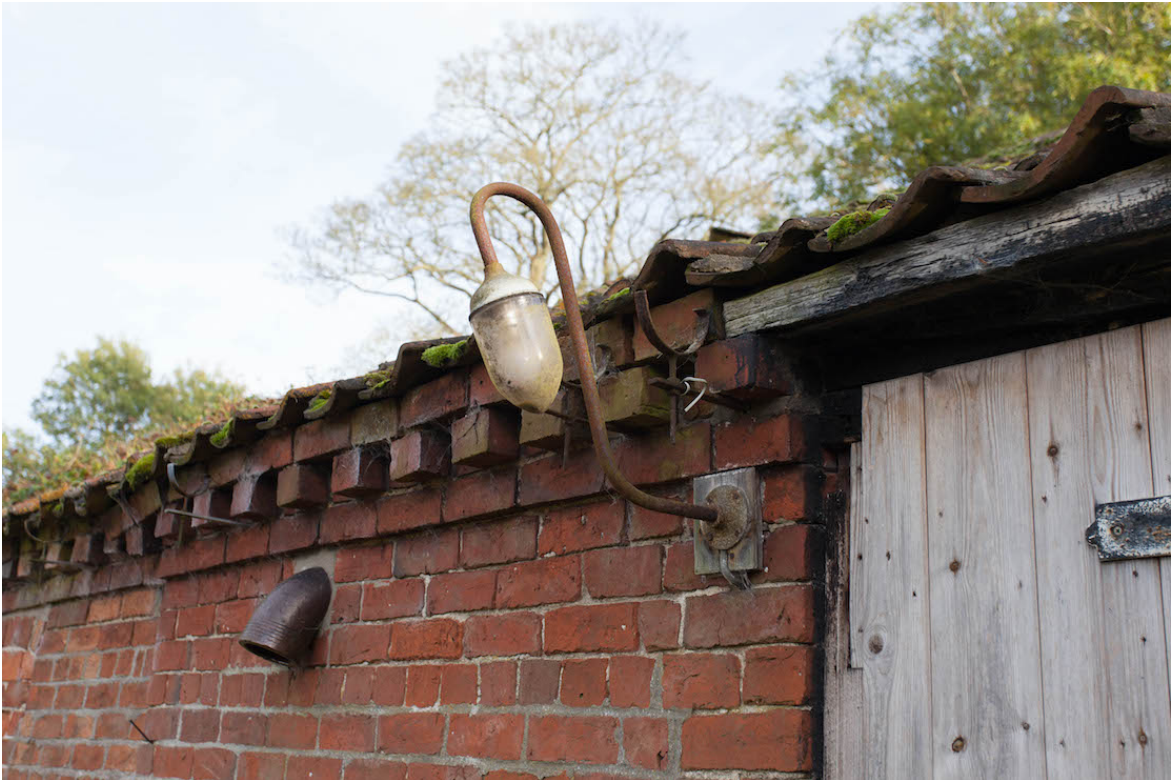
- 6.15 The top of the north western and south eastern elevations have brick corbelling and some of the earlier ironwork rainwater goods are still present.

Plate 33 (shot 48) – Exterior of southern section of north western elevation showing modern light fitting, iron rainwater fittings and reused drainage pipe set into wall assumingly for ventilation, looking east.
