*WEST BARN  
CWARELAU FARM,  
NEWTON  
HEREFORDSHIRE.*

Archaeological Excavation

Evaluation Excavation

TAC Job No: CBNM-EV-002

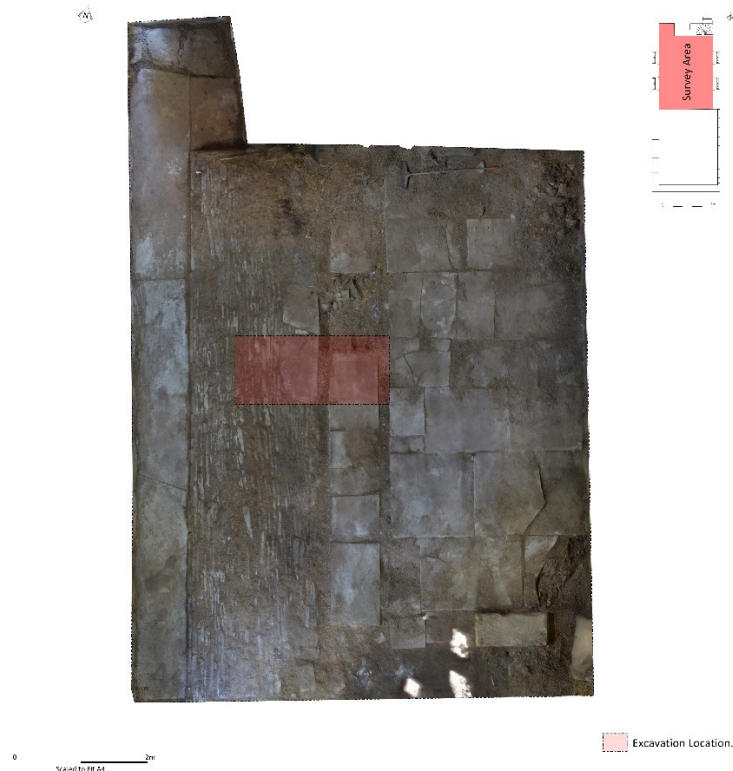
*Illus. 2 showing location of the evaluation excavation within the building.*

A single test pit was excavated within the floor surface of the west barn measuring approximately 1.20m in length with a width of 0.60m the test pit was excavated to a depth of approximately 0.44m (maximum) at which level a natural geological stratum was encountered. The test pit was positioned to investigate a change in the construction of the existing floor surface. (See *Illus. 2*)

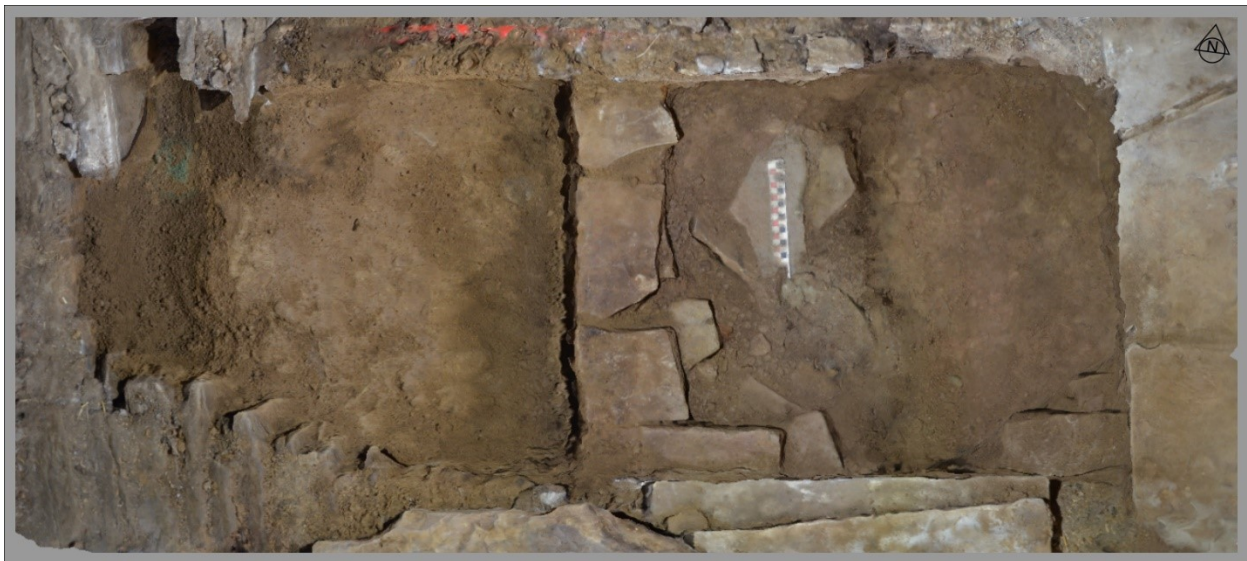
The removal of the floor surfaces (101) and (106) exposed two different floor levelling deposits separated by a retaining wall, (102). (102) consisted of an unbonded stone structure of approximately four courses, constructed from flat angular stones laid in an interlocking pattern, aligned north-south and following the division line in the floor surfaces between (101) and (106). (See Plate. 1, *Illus. 3*)

*Plate. 1 Overview of the evaluation excavation showing the retaining wall and levelling deposit.*

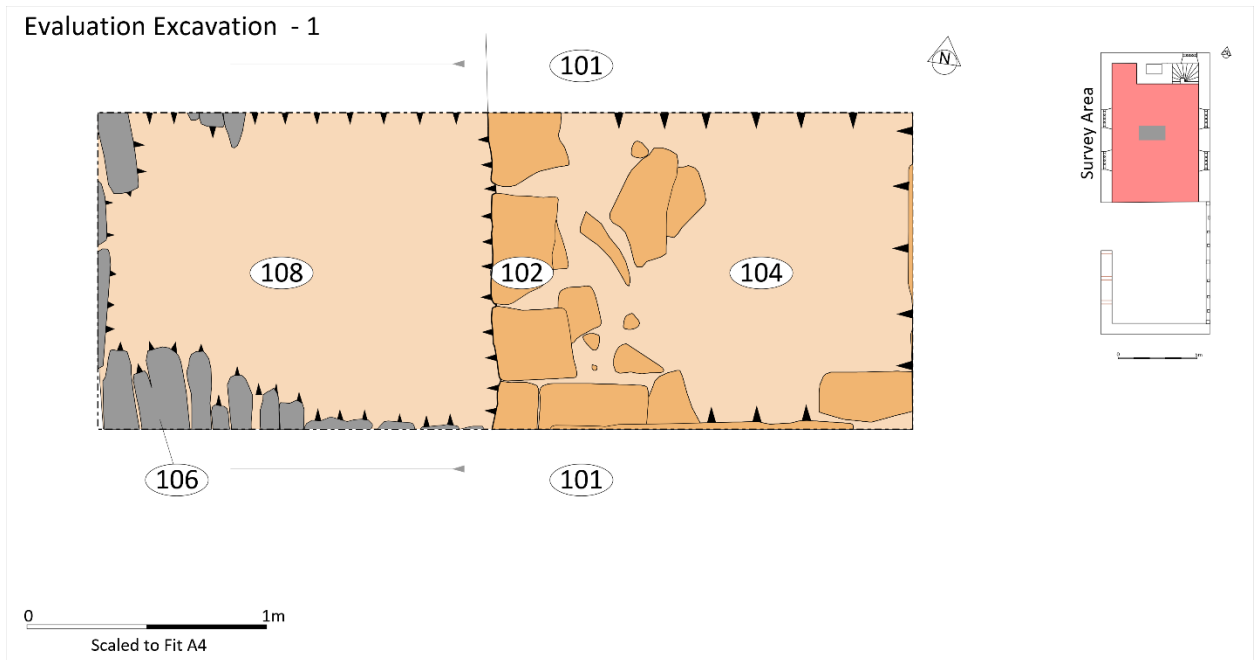
Illus. 3 Plan showing evaluation excavation details.

To the east of 102 a stone deposit (105), comprise an orange brown silt clay loam with frequent inclusions of fragmented flat and thin angular stones. (105) formed a hard-packed levelling deposit with a depth of approximately 0.30m overlaying a natural geological archaeological sterile horizon of a red brown silt clay with occasional small flat angular stones (104). 104 was partially excavated to a depth of 0.45m below present floor level, matching the existing and lower ground level seen within the southern half of the west barn, no change was observed (See *Illus. 3*). it was considered that any further excavation would be unnecessary as the excavated base level was 0.25m below the recently identified hearthstone within the existing fire place.

Towards the west of (102) a noticeable change in the floor construction was observed during the excavation. Floor surface (106) consisted of vertically laid stones set in a red brown silty loam (105) overlaying the natural geological (108). Examination of (108) concluded that it was the same geological deposit as (104).

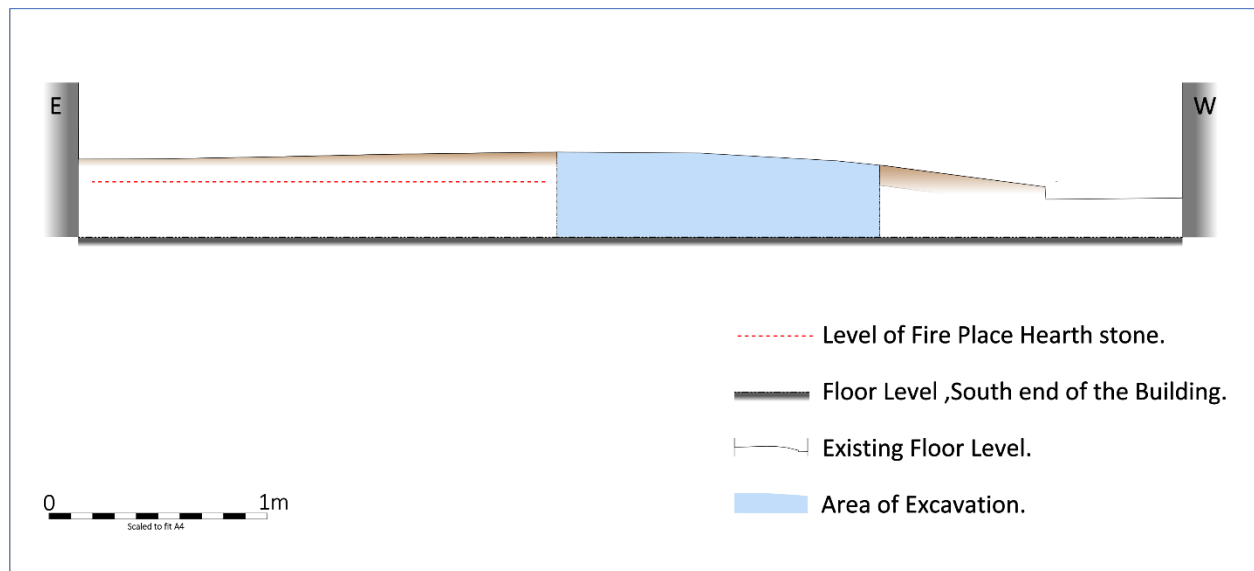
Illus. 4 Profile showing change in floor levels.

The evaluation identified that no evidence for an original floor surfaces remained below the existing floor surface, however the opportunity to excavate within the building revealed the construction details of the existing floor surface. From the evidence observed the original floor surface was removed and a new floor surface was constructed at a higher level.

The level of the recently identified hearthstone within the existing fireplace would suggest that the floor level was raised up by a minimum of at least 0.25m however for the original floor surface to correspond with the northern door way the original floor surface would have been at least 0.30m below the existing floor surface. (*See Illus. 4*)

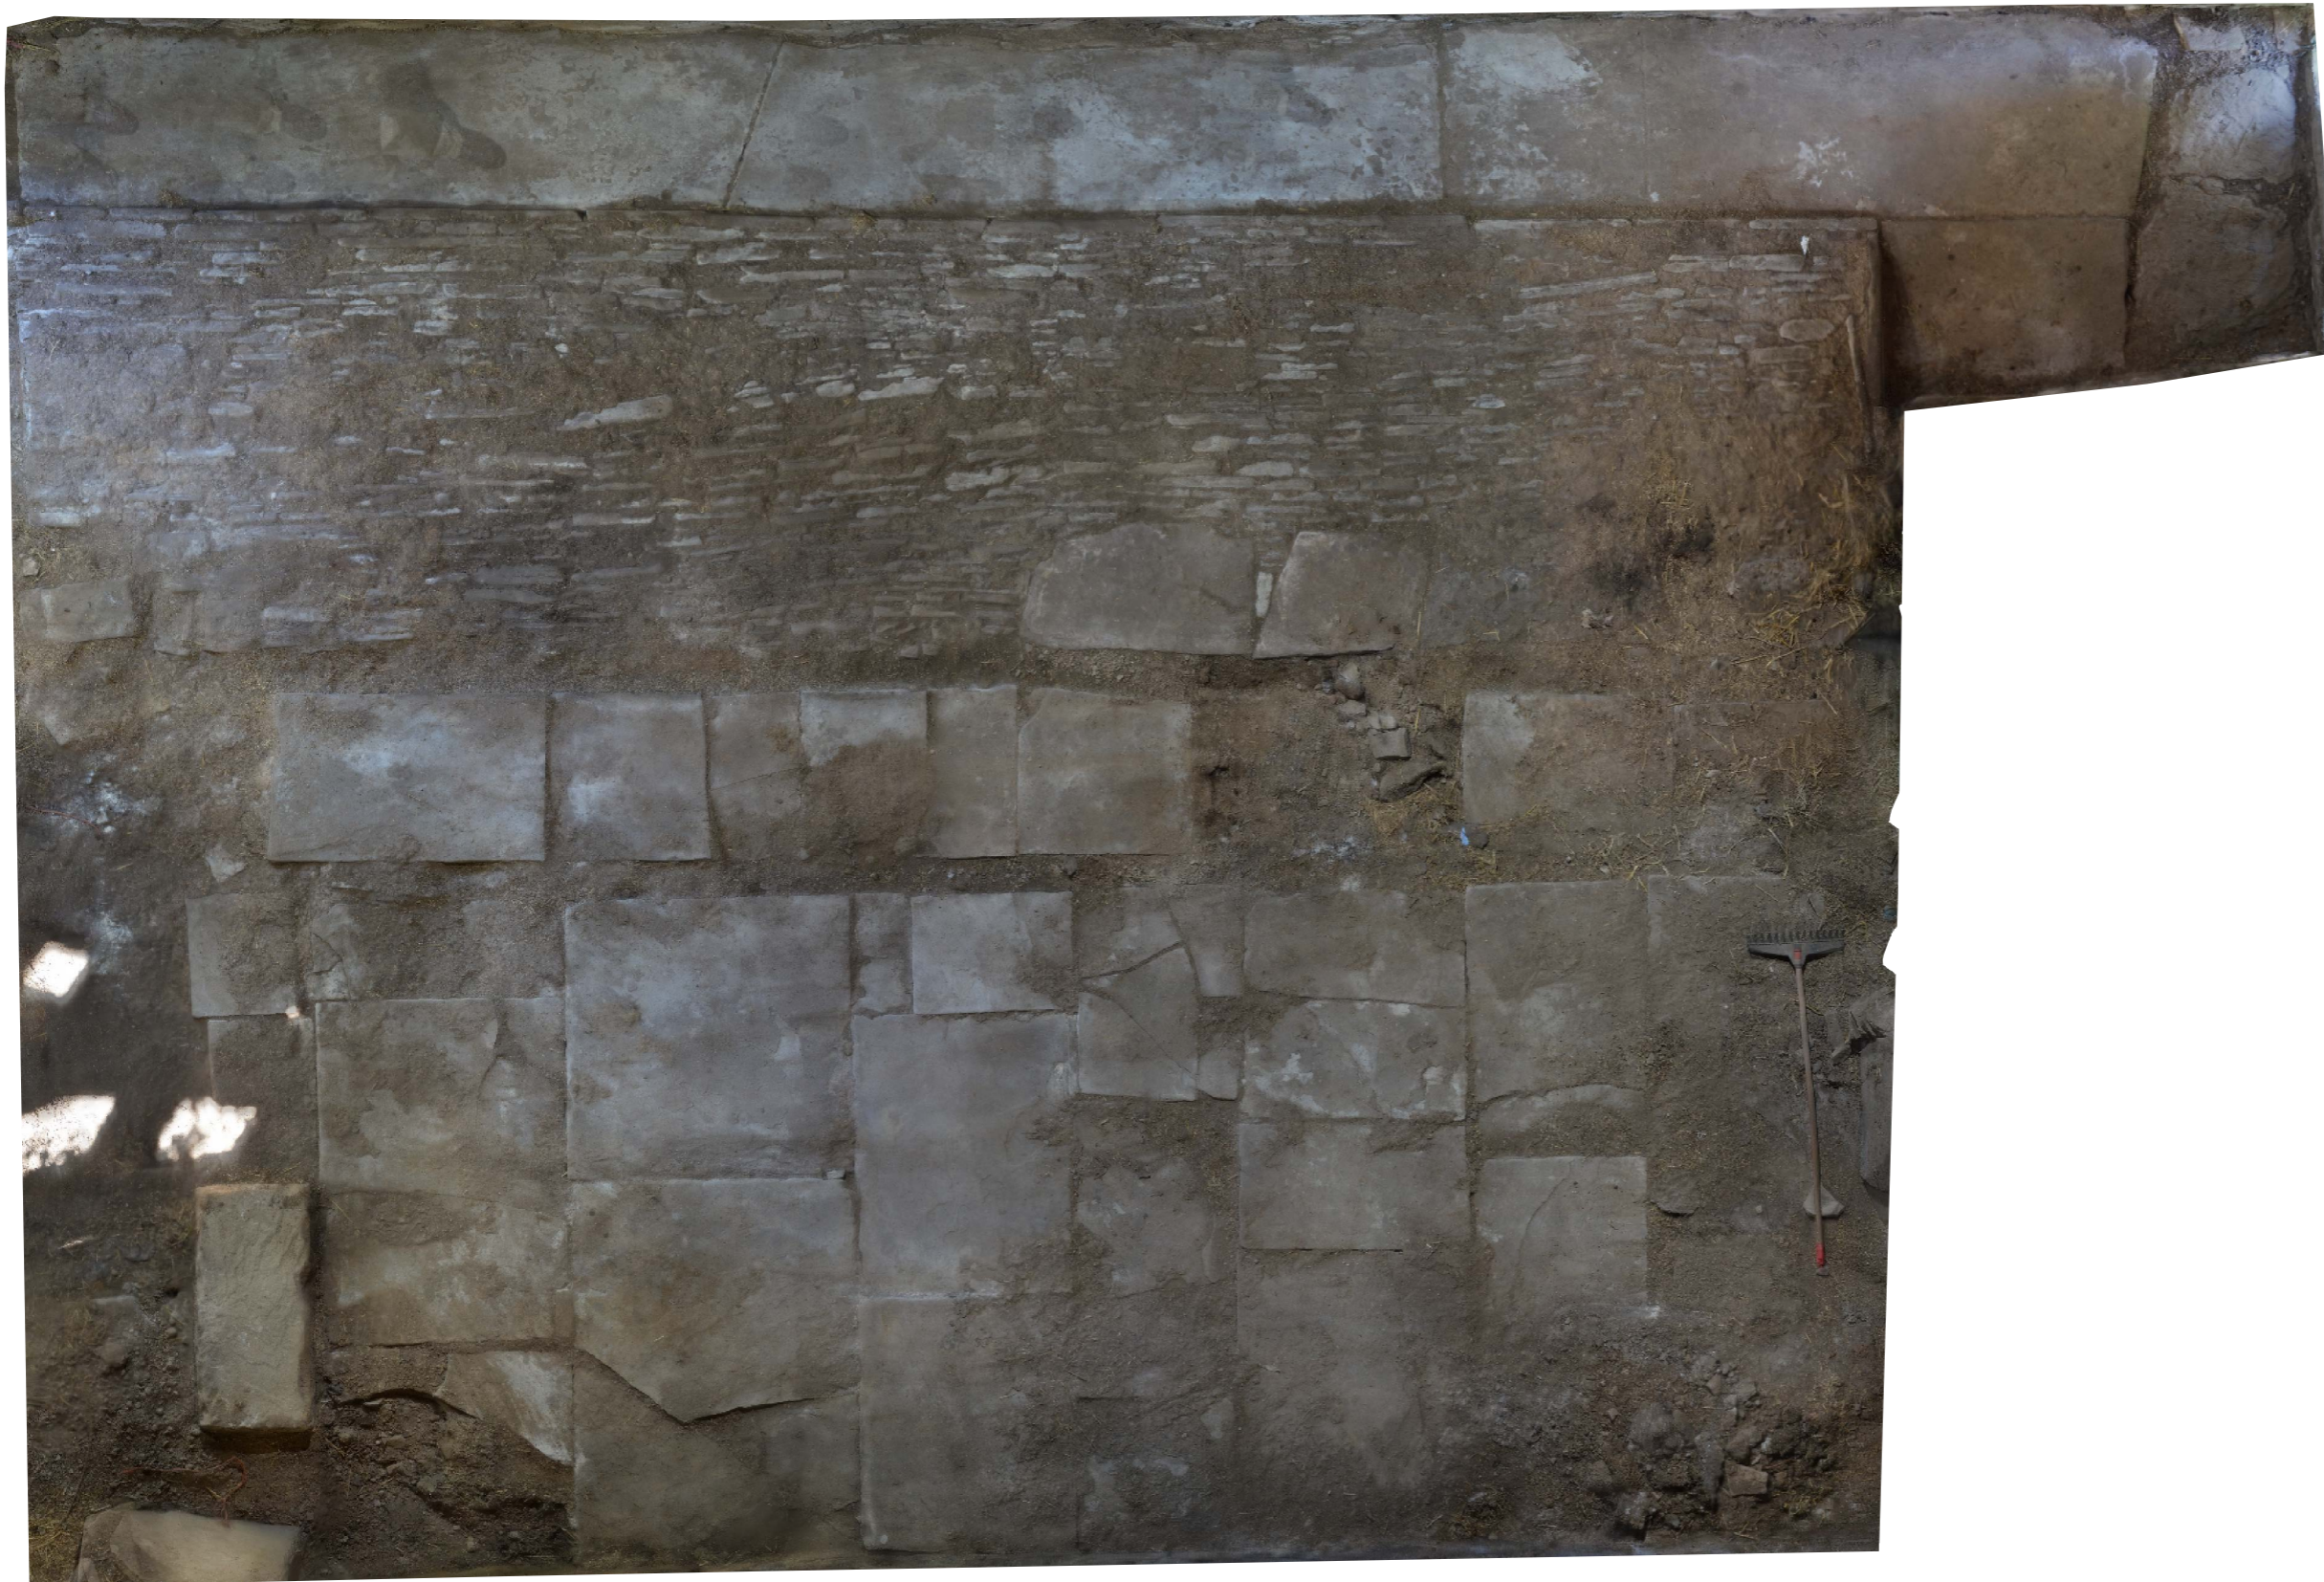
Plate.2 Photogrammetric record of existing floor surface.

The existing floor surface within the building consists of three distinctive areas, the larger part of the floor is formed of large laid flag stones, an area of vertically laid thin stones forms a sloping run off area flowing in to a lower level large gully formed of very large rectangular flag stones. Within the building the stone floor surface is raised above the level of the south end of the building by approximately 0.45m, the floor surface within the southern end of the building appears to be formed of earth. The change in floor construction corresponds with a vertical construction break indicating that the building has been extended. During the evaluation works the area of the existing fireplace was cleaned of debris, the removal of this material identified the original level of the hearthstone.
