*The Barns Hotel and Restaurant, Cocksparrow Lane,
Huntington, South Staffordshire.*

Level 2 Building Recording.

December 2019.

Report No. BR/thebarns/AH340/05/12/19V1

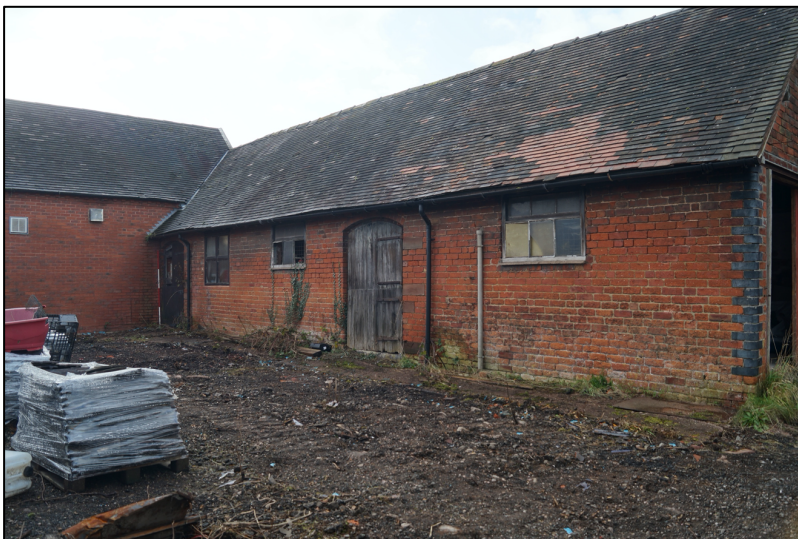
Barn 2 has a rectilinear planform, is single storey and constructed of red brick, the bricks being crude and handmade and jointed with lime mortar. The roof is low pitched and covered with blue tiles and topped with ridge tiles. The east facing elevation (Plate 1), which is the front elevation of the building, presents two wide stable doors with recessed segmental arches and original plank and batten doors with strap hinges on pintel hinges (Figure 6). There are two original windows to either side of the northern stable door comprising a wooden frame with transom and mullion glazing bars. Next to the southern stable door a modern window has been inserted to cater for the already converted southern half of the barn.

Plate 1. West facing elevation of Barn 2.

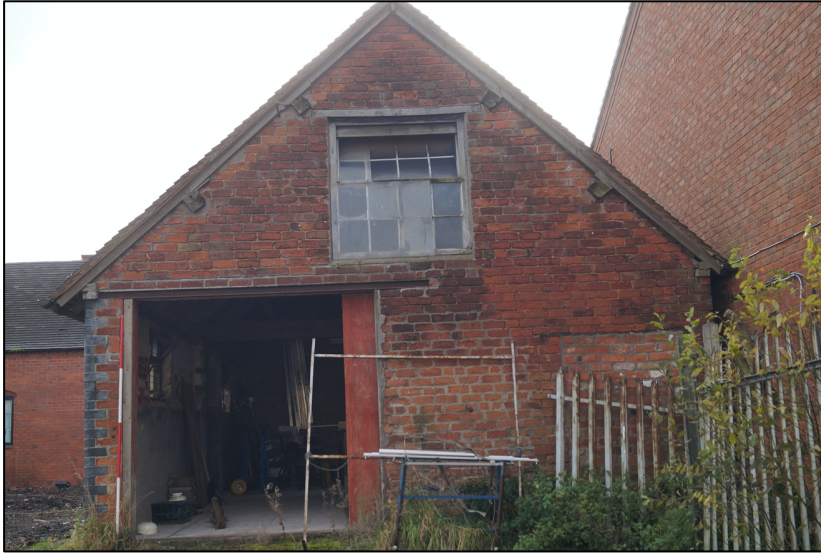
The west facing elevation is only partially visible but appears to be generally blank with only one original doorway at the north end of the elevation. Otherwise a second central doorway with an adjacent window are modern interventions arising from the conversion of the southern half of the barn. The only visible gable end of the barn is at the north of the building where this elevation (Plate 2) presents evidence of a blocked doorway to the west side of the elevation and retains an original timber framed glazed window in the upper part of the gable end. The large doorway with sliding door is a modern intervention. There is quoining on the southeast side of the elevation comprising blue bullnose bricks and the roof purlins project from under the roof.

Plate 2. Gable end of Barn 2.

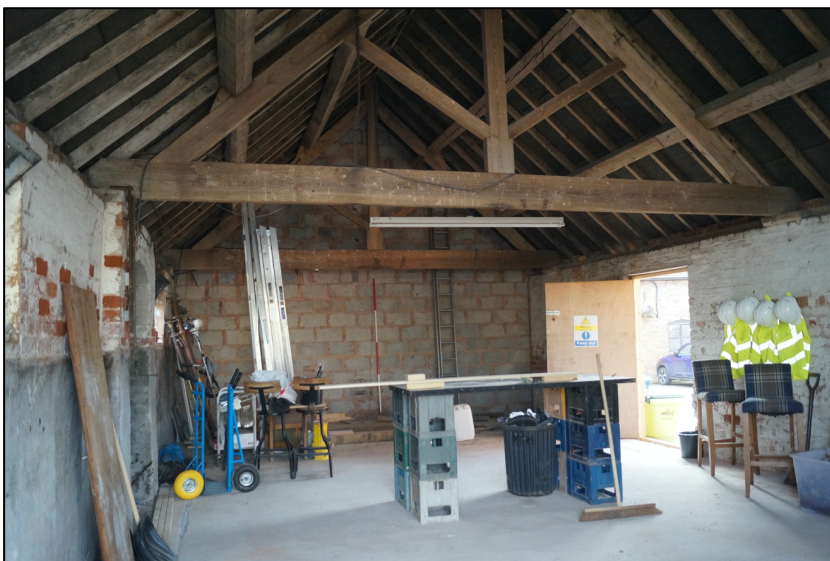
Internally, the barn has been stripped of any original fixtures and fittings and has been partitioned from the converted half of the building by a breeze block wall. The floor is made of recently laid concrete. The roof timbers are machine cut softwood with trusses of jowelled king post construction (Plate 3). The trusses and wall plate sit back from the front of the walls suggesting the roof is later than the body of the barn. The interior of the east wall is half rendered whilst the whole interior has been limewashed. The stable doors are recessed with segmental arches constructed with headers. (Plate 4).

Plate 3. View of interior of Barn 2 looking south.

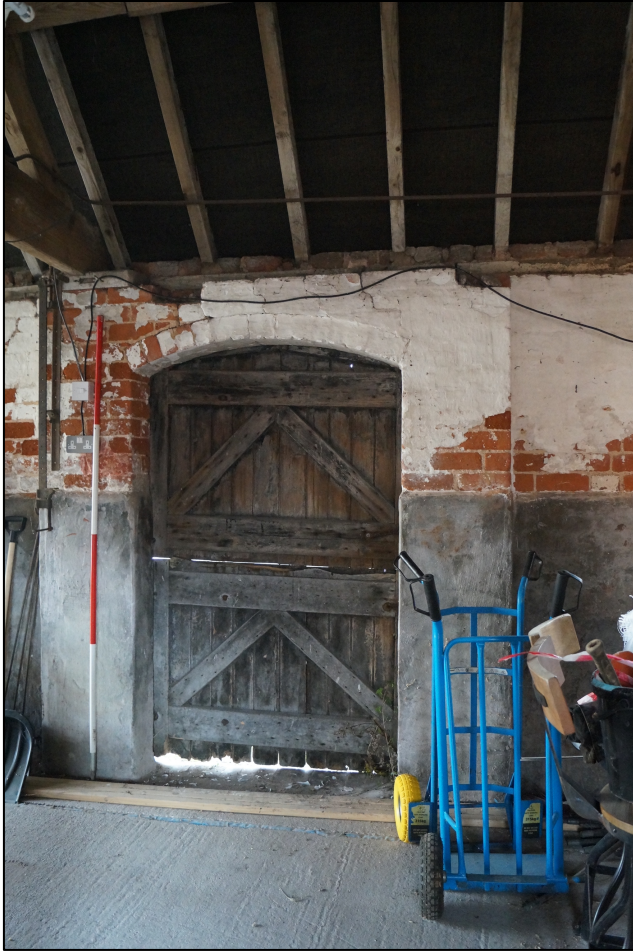
Plate 4. Detail of half rendered east wall with stable door.

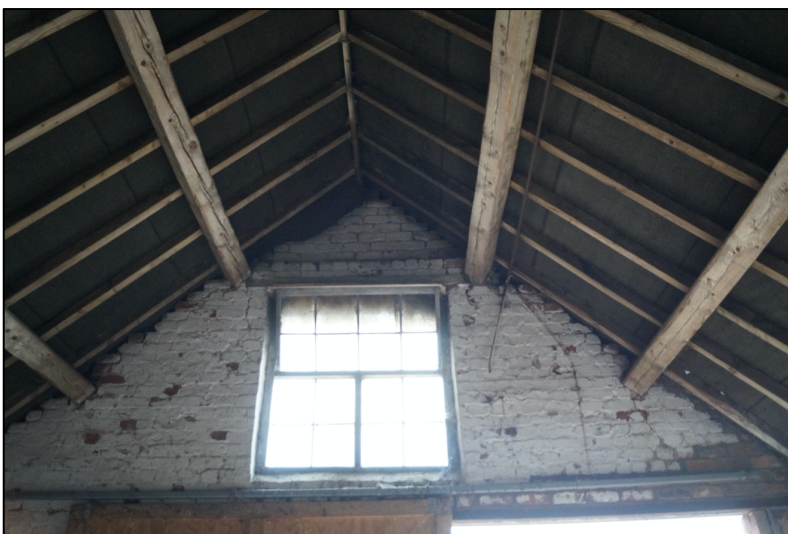
The window in the upper half of the gable end has a fixed lower half with a mullion and transom but the upper half is a hopper (Plate 5).

Plate 5. Detail of hopper window in gable end of Barn 2.

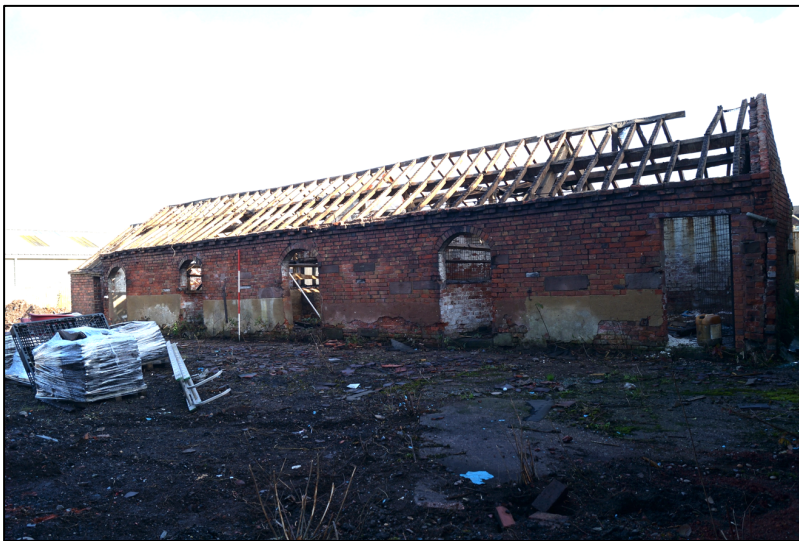
Barn 3 is a free-standing building, constructed of crude handmade bricks and rectilinear in planform. The roof covering has been removed exposing the roof timbers and corbelled eaves. The west facing elevation is characterised by four doorways under segmental arched openings in headers and a doorway at the southern end of the elevation with a flat timber lintel (Plate 6). At the northern end of the barn a small extension with a pitched roof and narrow doorway adjoins the northern elevation of Barn 3. The brickwork suggests a later phase of building activity the bricks being less crude than those of Barn 3 and possibly machine made. The extension comprises a single celled room with a square hatchway in its north facing elevation (Plate 7). In addition, there is small square opening in the brickwork halfway up the northern wall of the extension. The extension to the barn is stepped out at the bottom of the walls and sits on a brick plinth. The west facing elevation of Barn 3 has been rendered along the lower part of the wall.

Plate 6. West facing elevation of Barn 3.

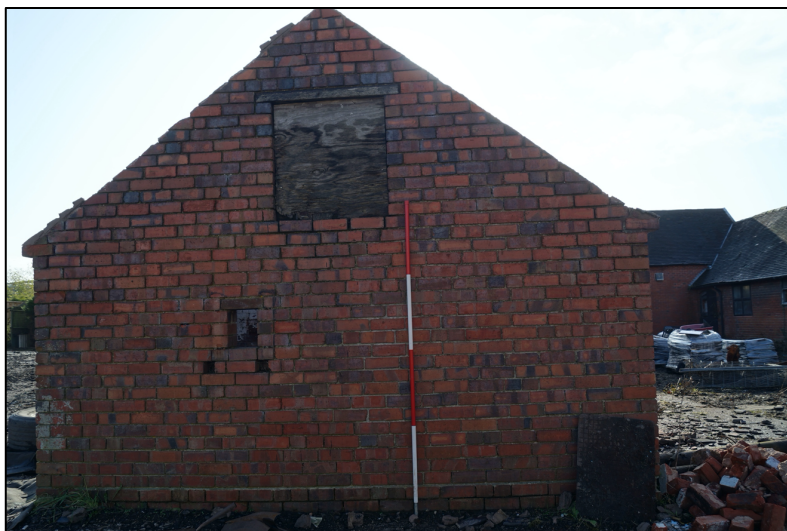
Plate 7. North elevation of extension to Barn 3.

The extension adjoining the northern elevation of Barn 3 does not contain any evidence of feeding troughs and may have served a different function. The presence of the taking in hatch in the gable wall suggests that it may once have had a loft and may mean that the building was used to store animal feed.

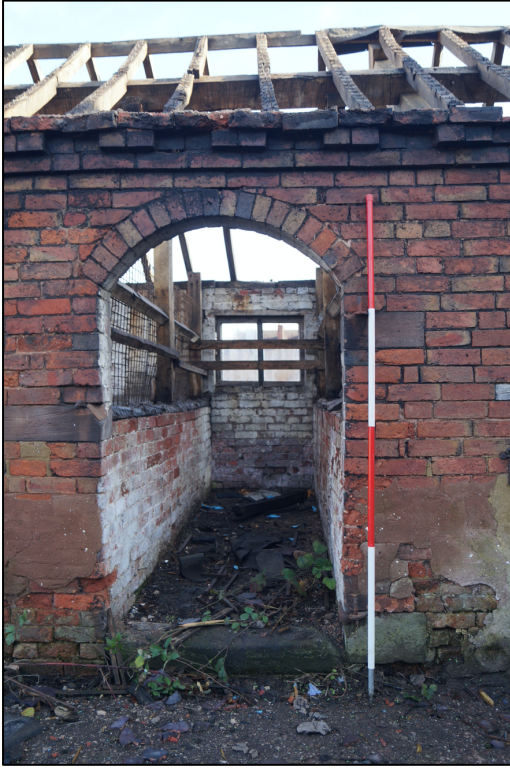
Each of the arched doorways in the west facing elevation of Barn 3 give access to corridors delineated on each side by half brick walls with coping stones and timber partitioning above (Plate 8).

Plate 8. Example of corridor beyond arched opening.

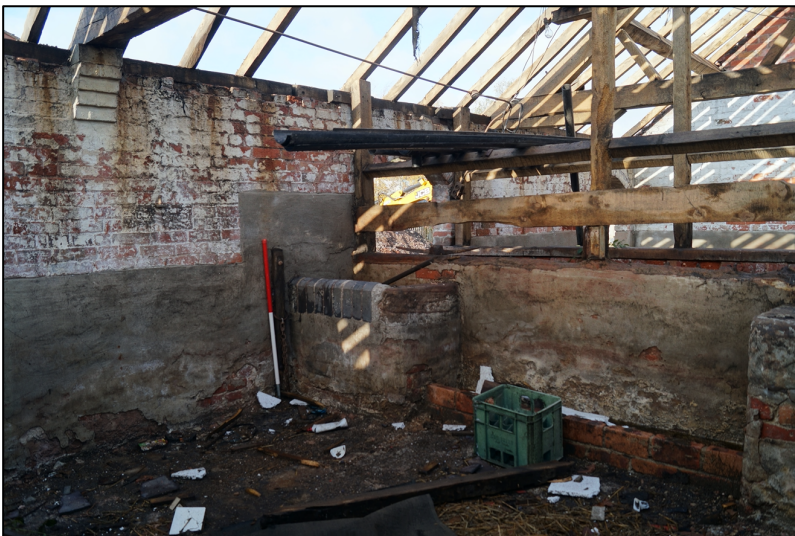
Internally, Barn 3 is divided into five small cells which are part rendered and part limewashed. The two central cells retain feeding troughs constructed of rendered brick, with blue bullnose brick in soldier formation at the top of the troughs (Plate 8). The side of each trough comprises a squared sandstone block and it is possible that these represent part of the original construction of the troughs with the blue bullnose bricks being later patching where sandstone blocks have degraded. Between each trough is a low brick trough two courses high. To the side of the troughs are in-situ timber tying up posts with chains suggesting that each cell housed two livestock at a time.

Plate 8. Interior of one of the cells with feeding troughs and tying up posts.

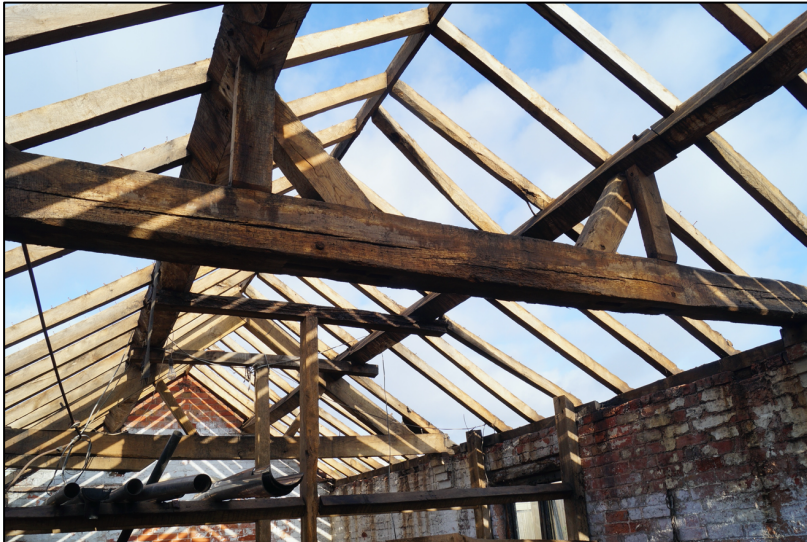
The roof timbers and the partition timbers are oak and roughly squared. The trusses are supported by corbelled brick brackets and by the uprights of the partitions (Plate 9). Two of the roof timbers show carpenters marks suggesting the timbers may have prefabricated and brought into the site from elsewhere (Plate 10).

Plate 9. Detail of roof timbers.

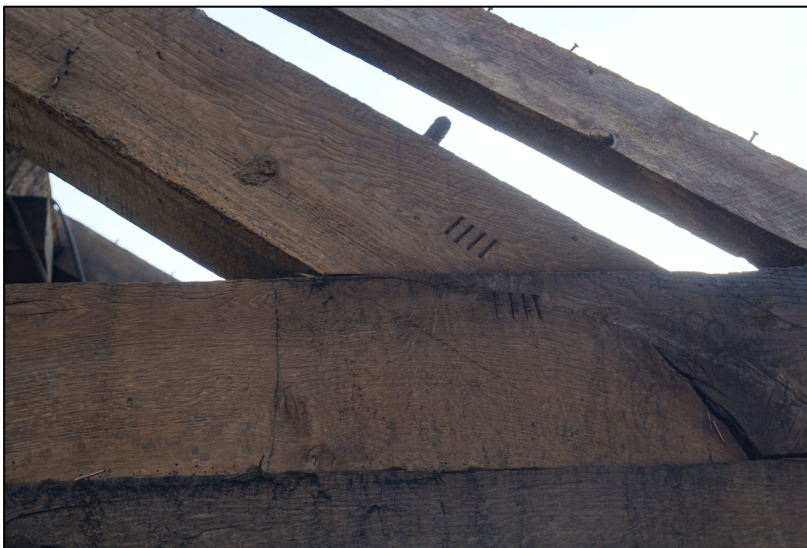
Plate 10. Carpenters marks on two roof timbers.

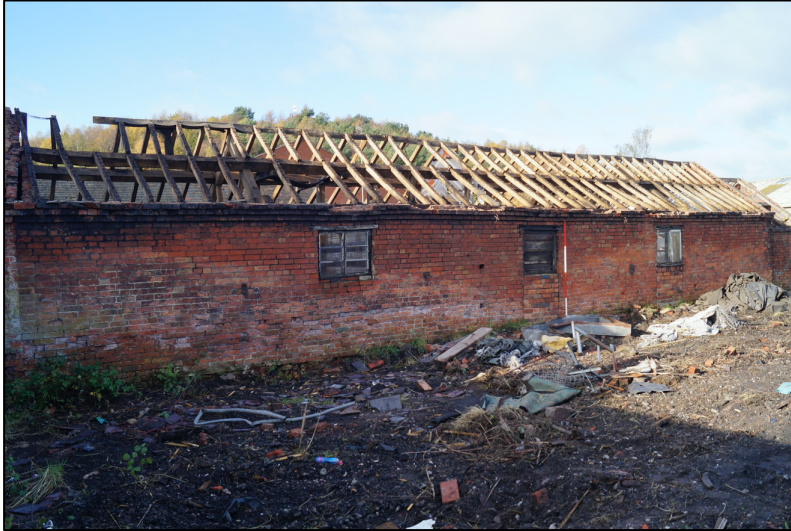
The west facing elevation of Barn 3 is characterised by three window openings (Plate 11). The two openings in the northern half of the elevation show that they have been inserted into blocked doorways which correspond with two of the corridors inside the building, showing that passage through the building was originally open from both sides of the building. The northernmost building comprises a mullion window frame with glazing between a timber lintel and cill. The adjacent window, a shutter window on wooden pegs, may have been related to ventilation (although in recent times pigeons were kept on the site and the shutter window may be connected to this activity).

There is a third window towards the southern part of the elevation which has a wooden frame and timber lintel. The window is divided into 6 glazed panes and typologically looks 1930s or 1940s in date.

Plate 11. East facing elevation of Barn 3.

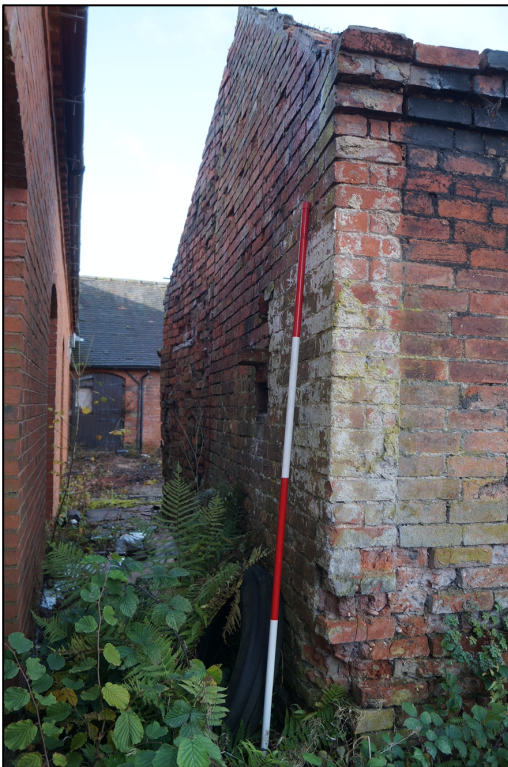
The southern elevation of Barn 3 contains a square brick opening and a straight joint marking the western side of the gable end. This suggests that this part of the barn had been modified, extended or rebuilt at some time in the past.

Plate 12. Southern elevation of Barn 3.

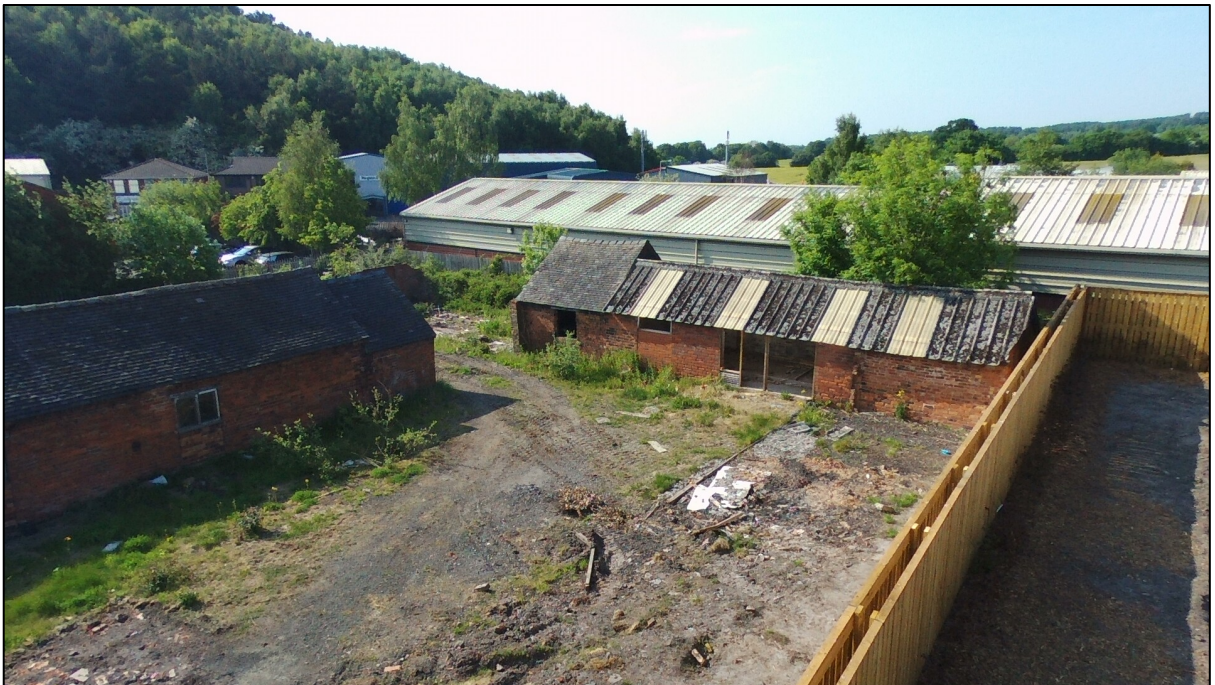
From a photograph of Barn 1 taken by the owner of The Barns prior to the barn's demolition (Plate 13). It appears that Barn 1 comprised two phases of building activity with the original roof of the barn being replaced at some time by an asbestos roof. The south facing elevation of the barn also appears to have undergone later modification in terms of the large opening at the centre of the building leaving a small section of the original tiled roof at the west end of the building. The photograph suggests that there was a window opening directly beneath the eaves inserted into a blocked doorway at the western end of the barn. Barn 1 was also adjoined by a small squarish building on its west facing elevation. This building has the original pitched roof with blue tiles and ridge tiles. There is a single doorway into the building and there is a suggestion of a stub wall on the west corner of the elevation which may mean it once joined another building or structure. The brickwork looks to be the same as that used on the other two barns being generally stretcher courses with occasional headers as through bricks for wall support.

Plate 13. South facing elevation of Barn 1.

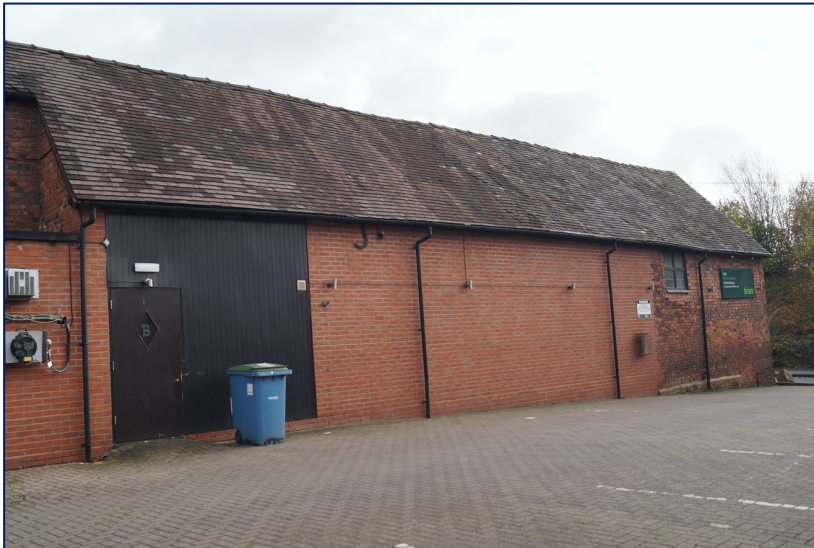
In terms of the functions of the barns the only real clue to the use of Barn 2 is the presence of two stable doors. As no other internal features or fixtures and fittings are present the assumption has to be that Barn 2 functioned as a stable, maybe for heavy horses working the land. Barn 3 with its corridors, allowing access to filling feed troughs without entering the animal stalls, and the in-situ tie up posts indicate that it was used for housing livestock, most likely cows. It is difficult to identify the use of Barn 1 from the photograph but again the planform would suggest housing of livestock. Evidence from elsewhere in the complex of buildings at The Barns Hotel suggests that crops were processed on site. This is in the form of a large threshing barn (Plate 14) and granary at the side of the entrance into the hotel complex. Although much of the front elevation of this barn has been rebuilt in modern brick there is sufficient original brickwork at the southern end of the building to indicate that it was contemporary with the Barns 1, 2 and 3. The original full height double doors of the threshing barn have been replaced with modern timber infill and the opposing door has now been absorbed into the hotel.

Plate 14. Modified threshing barn showing east facing elevation.
