LIGHTOAKS - STABLEBLOCKS

LEVEL 2 /3 BUILDING RECORD

Prepared on behalf of Purple Circle Homes

8th December 2015

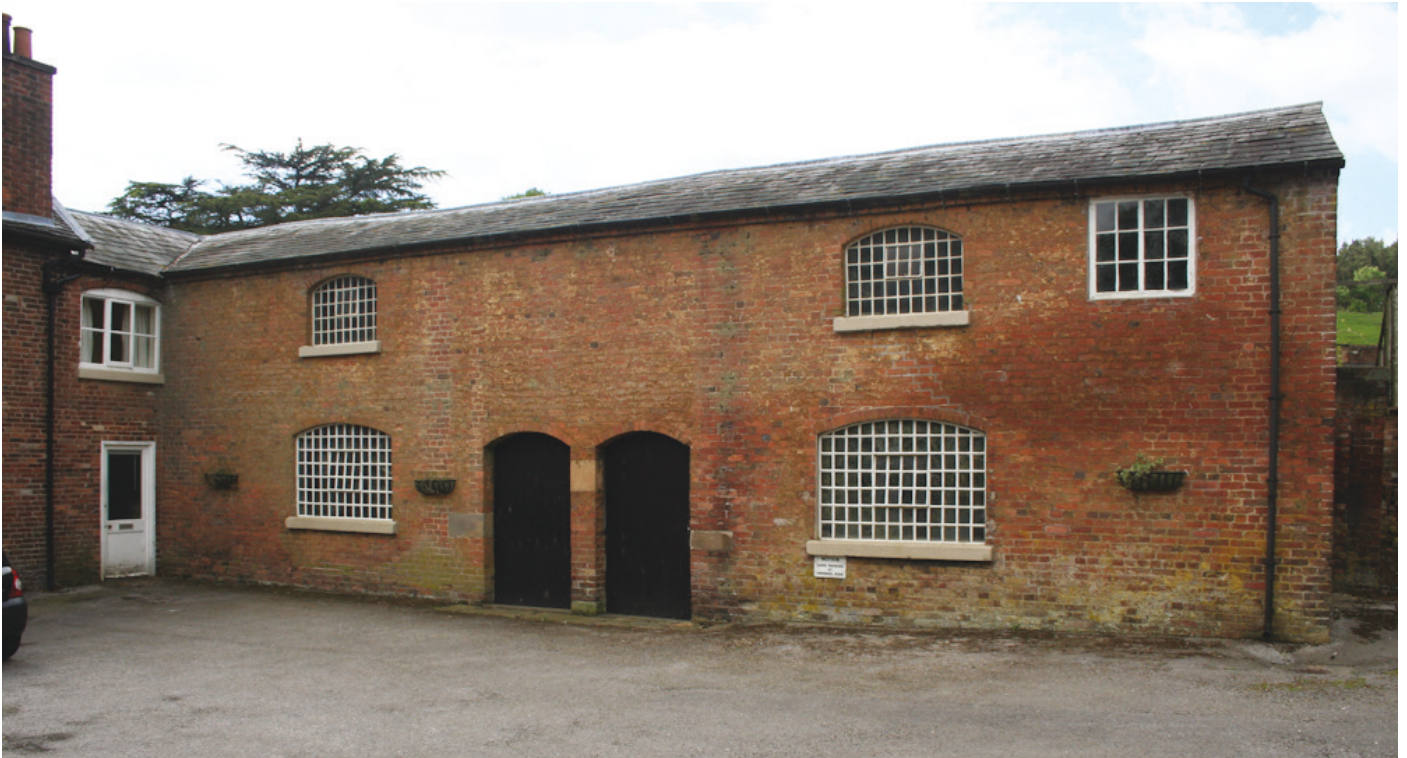
Exterior_001 - Stableblocks

The block to the west (above) was originally built as a sister stables to the block to the east. The late Georgian symmetry of the design is clear from this elevation of the eastern block, altered by the inserted window at first floor level, C20 (of no interest). Cast iron windows were inserted at first floor level to replace the original horizontal sliding timber shutters when the building was adapted as a laundry and ancillary storage.

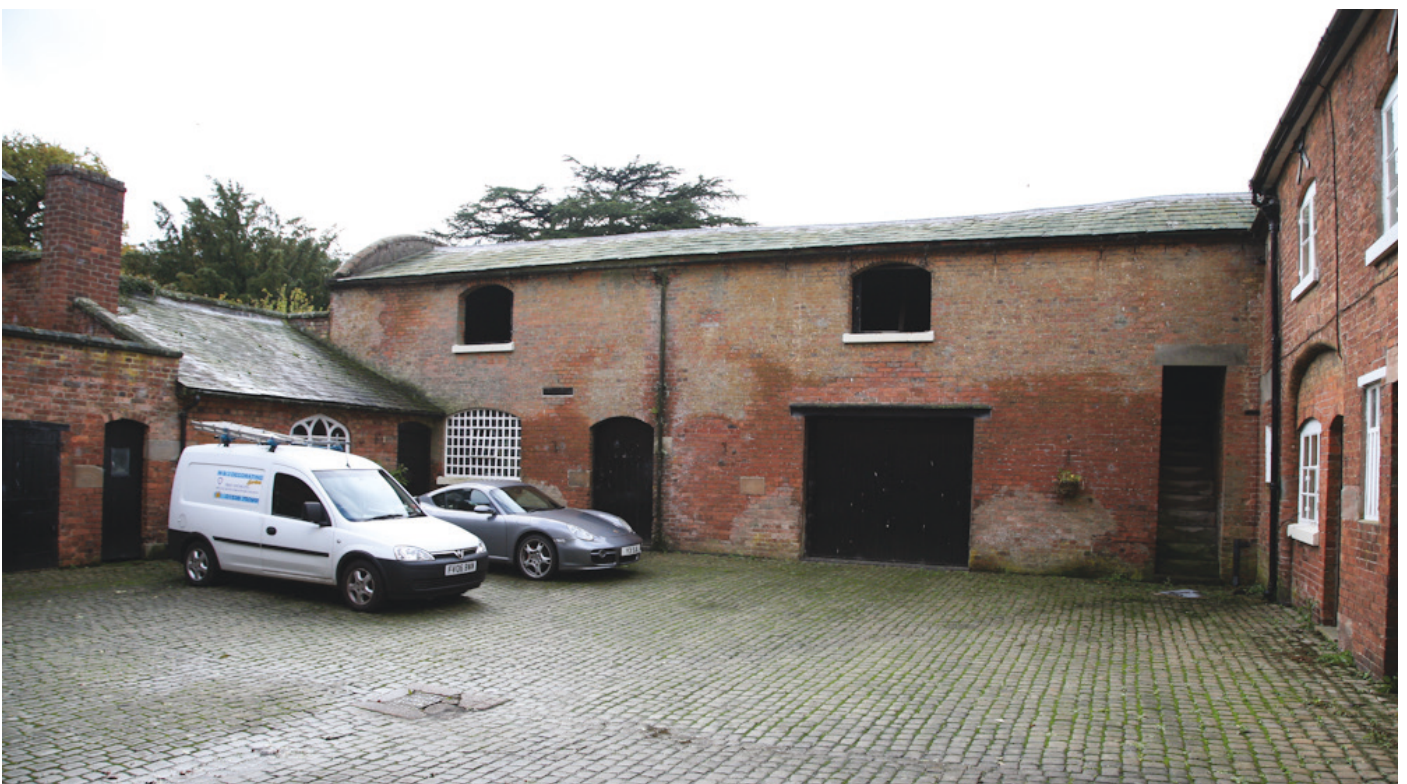
Exterior_002 - The block to the east (below) was designed with an integral staircase to the attic floor, in-situ. The symmetry of the original design has been altered by a twentieth century garage. Some time before this was inserted, the stable door to the left was blocked up. Limewashed at one time, this has slowly eroded and this is now visible under the eaves.

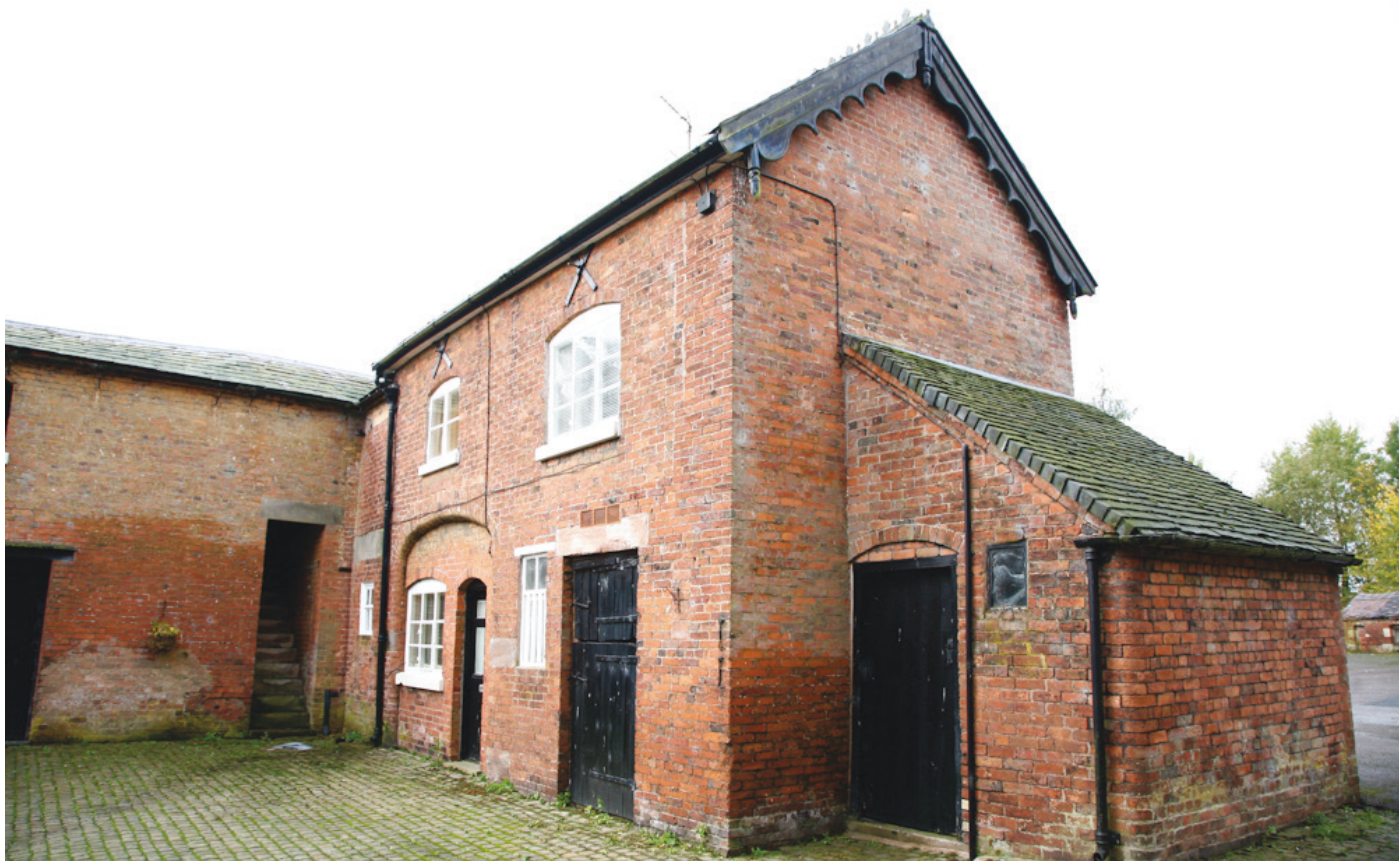
Exterior-003 - The "Bothy" or Groom's Cottage

The brickwork in the gable end of this building and a short section of the return brickwork reveals an 18th century sized brick, with narrow 2" x 9" bricks. The narrow gauge brickwork finishes at eaves level, with gable built in larger size brick, perhaps indicating an original hipped roof. The building also contains a cross wall in stone, with carefully and precisely tooled stone masonry, which appears to be a former outer wall (see photo Ground_012). Later modifications to this building include the reconstruction of the first floor, which incorporates keyed brickwork, hence the staggered straight joints, the infilling of the gap between this and the Stableblock, and the adaptation of part of the ground floor cart / gig bay into a dwelling. The building has had at least 4 phases of significant changes.

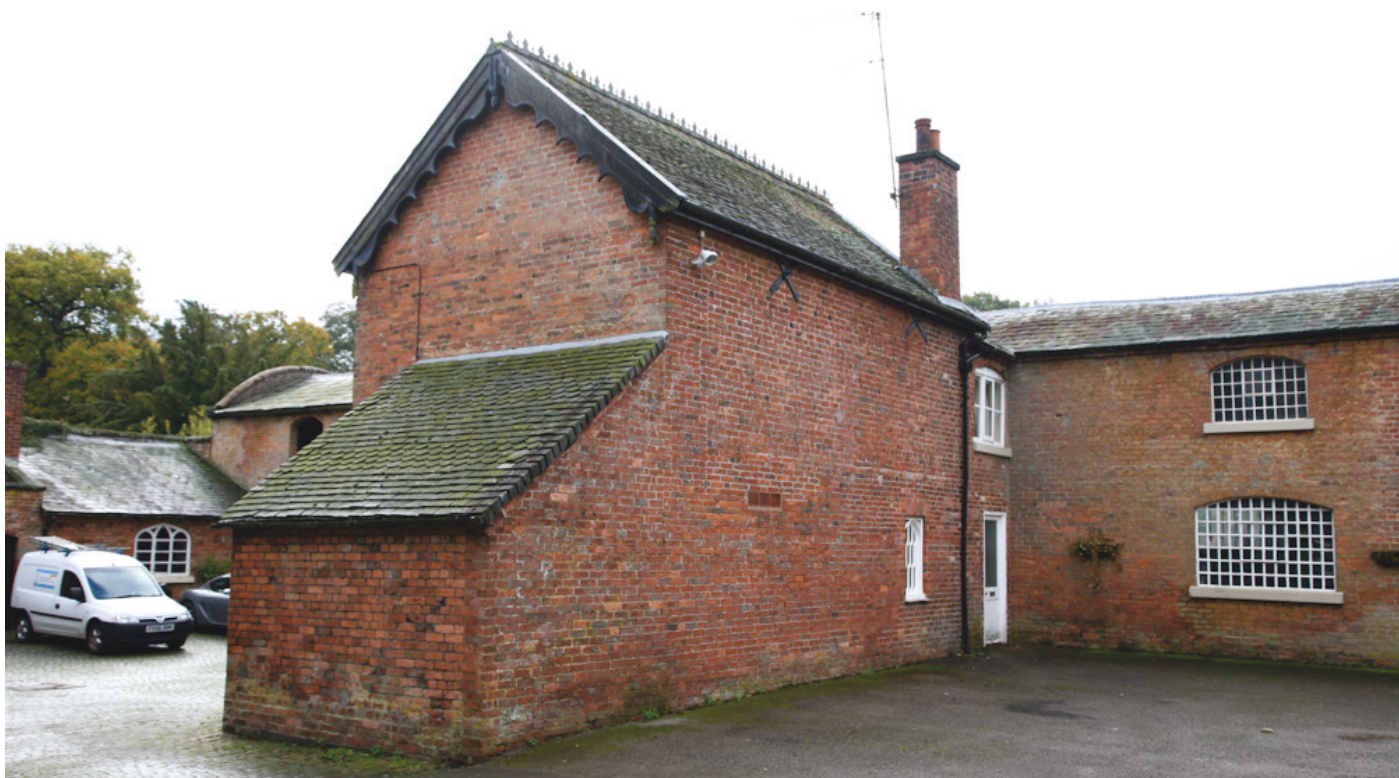
Exterior_004 - Below - rear elevation with large area of 18th century brickwork, rebuilt using original 2" bricks.

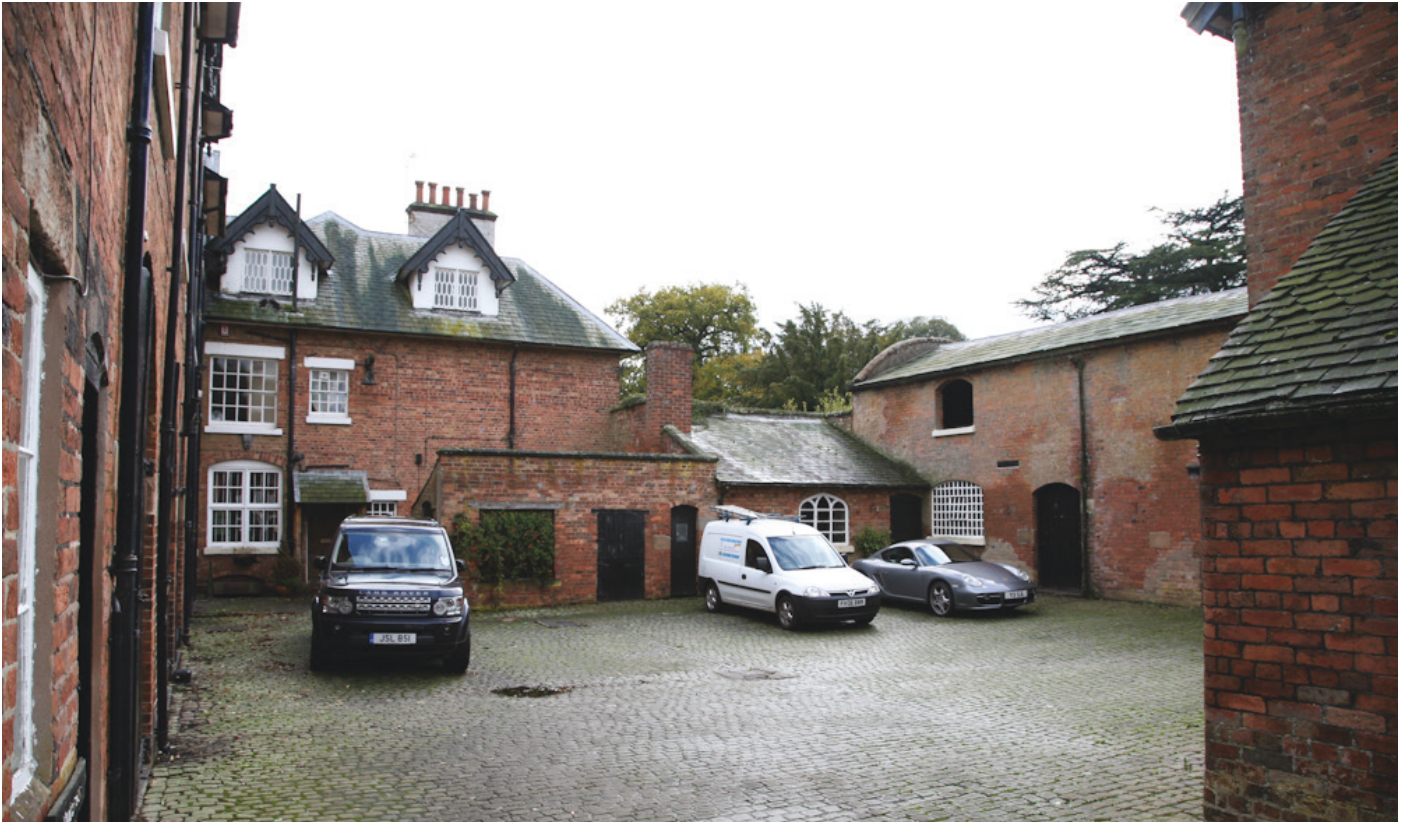
Exterior_005 - Courtyard

The small lean-to harness and tack room was added between 1881 and 1900, as map regression clearly reveals, there being nothing attached to the stables on the 1874 estate map or 1881 OS map. This looks much older, as the window incorporates an earlier timber window with Gothic tracery, which could be the one seen in the earlier photograph (pre 1881) of the back elevation. It certainly appears that the Gothic windows were recycled in ancillary buildings.

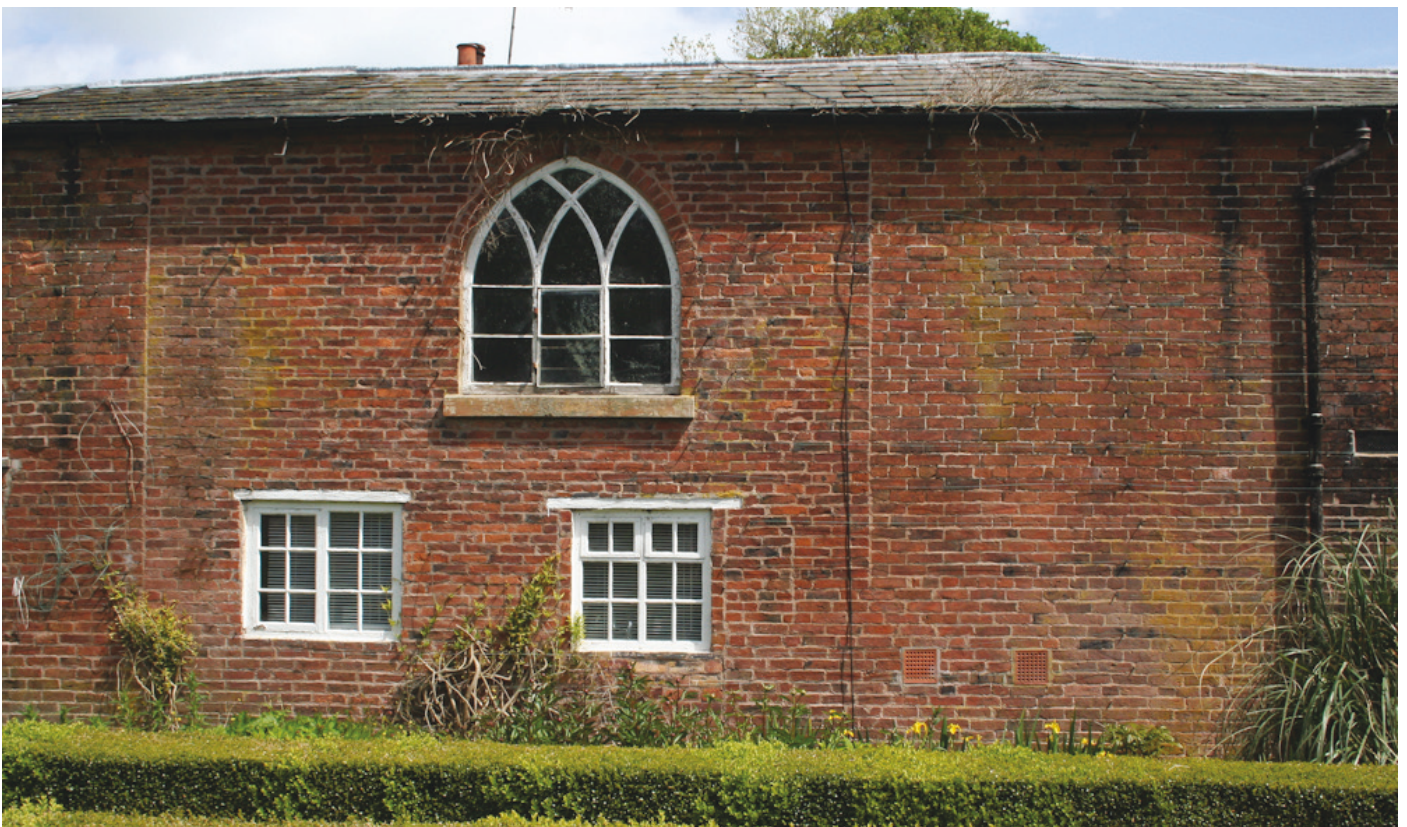
Exterior_006 - Rear (south) elevation of Stableblocks

The Gothic arched window is a later adaptation, re-using a window from another part of the complex during adaptation to provide staff accommodation. The straight joints reveal that the Stableblocks were probably built onto an earlier building. Casement windows at ground floor are both 20th century.
