SUTTON BARN, BROOK LANE, ENDON

LEVEL 3 SURVEY

Prepared on behalf of MR and MRS D PENNINGTON

21ST SEPTEMBER 2016

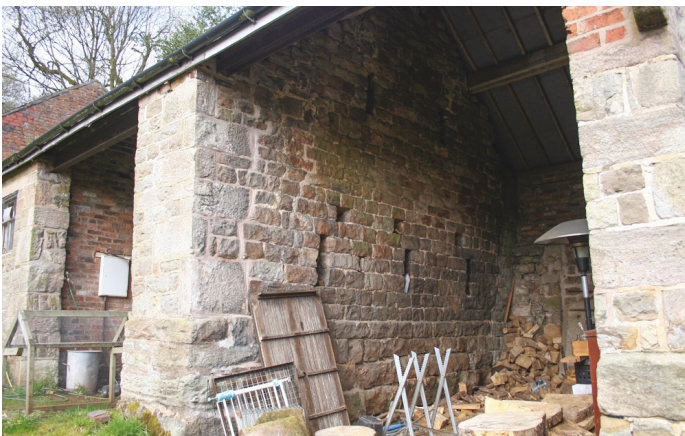
The former end wall of a late 17th century barn survives within the dividing wall of the 19th century cart bays

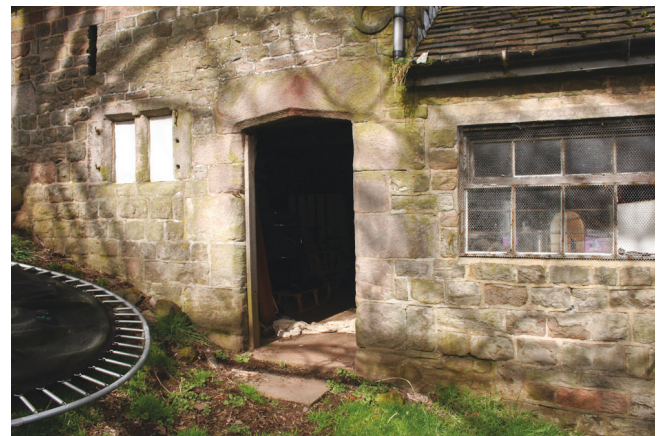
The Tudor-arched stable door and window are coeval with the end wall (left) with its ventilation slots

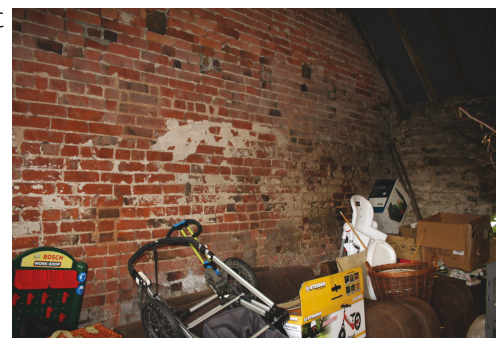
Brickwork dating from after 1725 divides the bottom bay from the upper two bays.

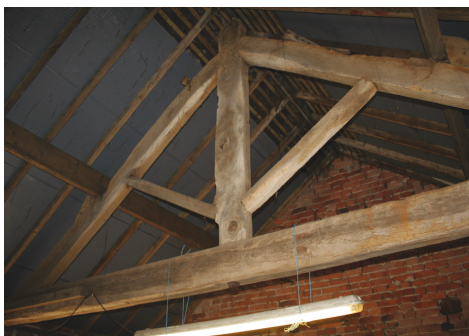
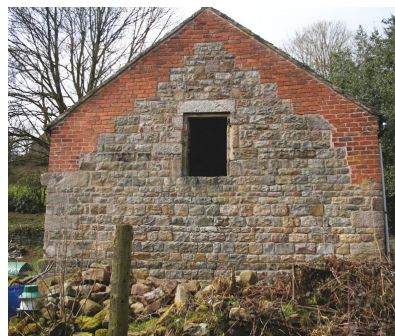
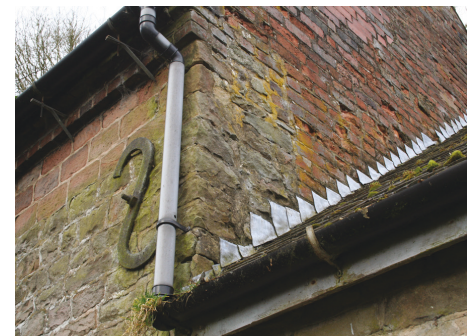
19th century re-roofing comprised inserting king post roof trusses, raising the eastern gable in brick, and lowering the eaves of the barn, remodelling the stable and inserting a new brick dividing wall to form a separate brick gable

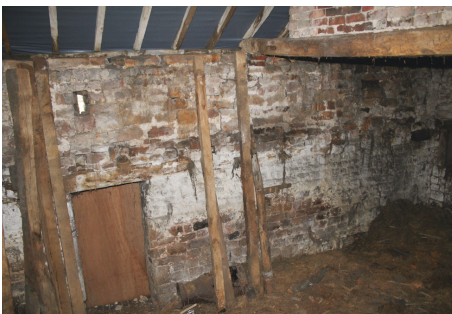
Oak posts (former joists) set aside. The sockets for the joists can still be seen in the masonry

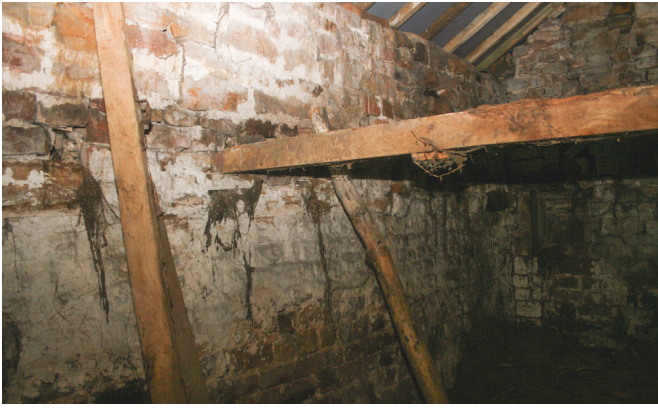
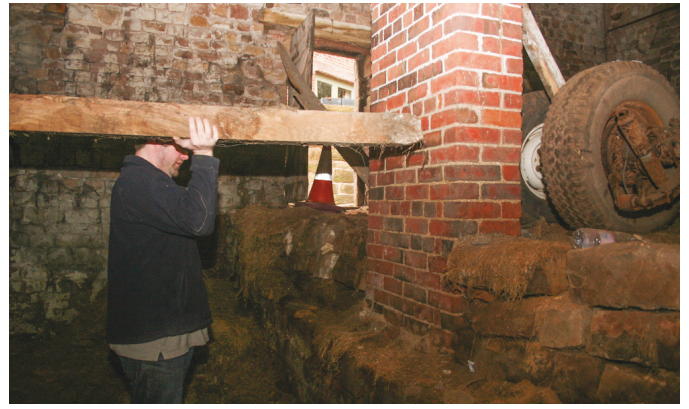
Oak joist re-positioned in wall socket and supported to demonstrate the level of the former hayloft floor. This demonstrates that it would have been efficient and simple to pitch hay and straw into the loft from the barn floor.

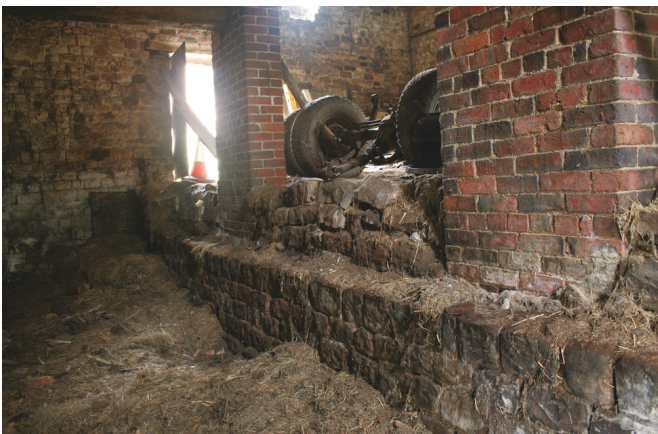
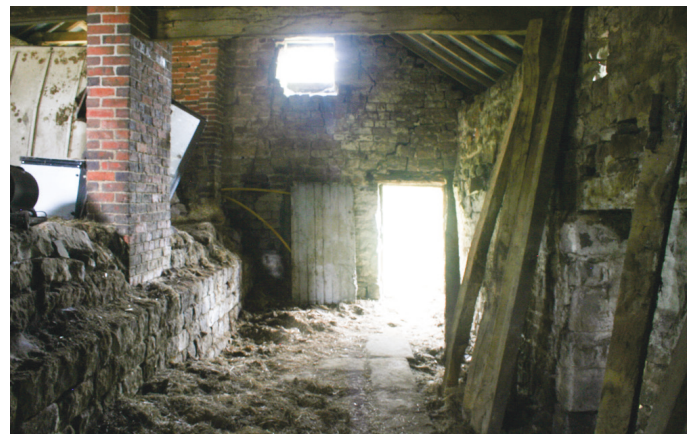
Left - coursed and mortared stone plinth (looking south), which would have supported a short timber-framed structure of posts and horizontal rails; sockets survive in the south wall. Right - the cowhouse looking north, with 19th century brick piers.

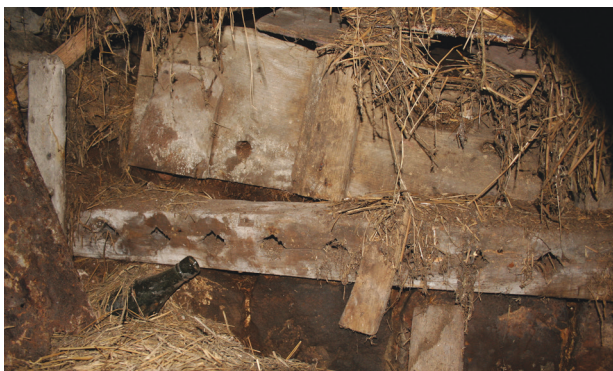
Fragment of oak rack with sockets for staves is part bedded in the lower wall

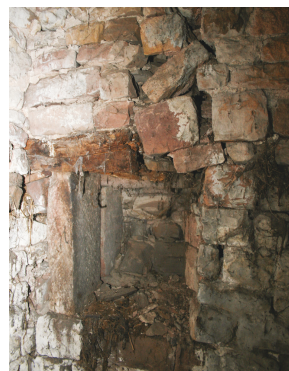
Window - to south wall recently blocked

There was a later window inserted in the southern elevation, which has been rather clumsily blocked up in stone, and this would have provided some limited light and ventilation at ground floor level, and is part of the interesting development of the building and changing agricultural practices. The addition of a second, later, doorway to the roadside elevation (probably 18th century) also suggests that it may have been adapted as a milking shed, with a second doorway to enable a continuous in and out process and a much easier way to remove manure. Practices varied around the country and in some places cows were tethered, nose towards the cross wall, and tail onto a single manure passage, the fodder being brought to individual feeding boxes from within the building from the upper level and dropped down. This appears to have been the last designed use of the building.

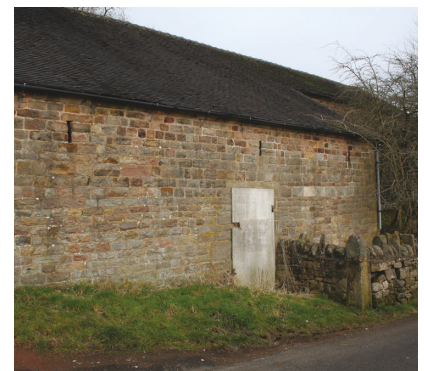
Roadside elevation, with inserted doorway (C18?)

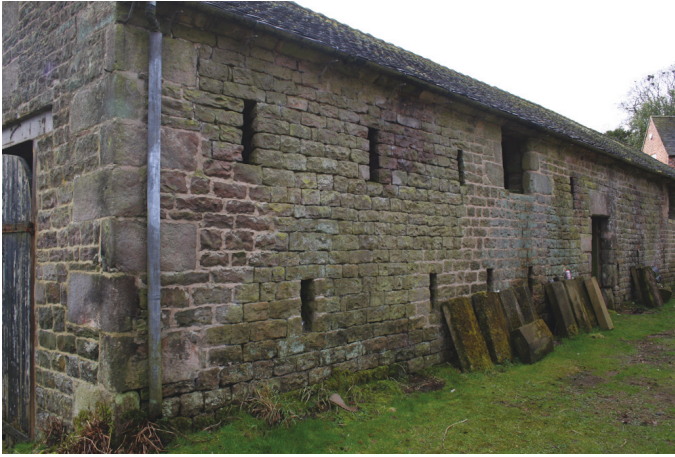
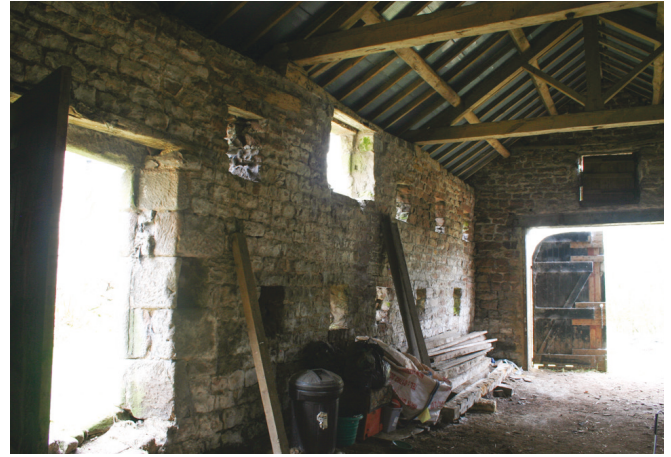
Left - three-bay threshing barn with multiple levels of ventilation for an open internal structure. Right - the door on the left is the main door, the two pitching eyes enable a continual process of adding unthreshed crops into the barn during harvest, until it slowly filled up. The large double-doors opening in the northern gable is a 20th century insertion.

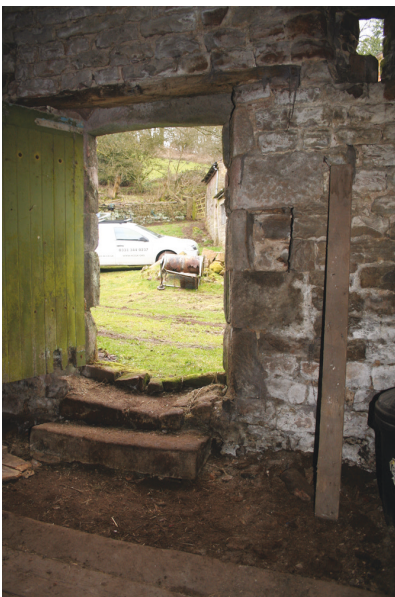
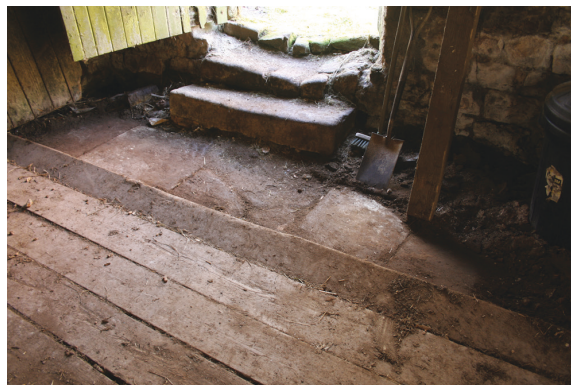
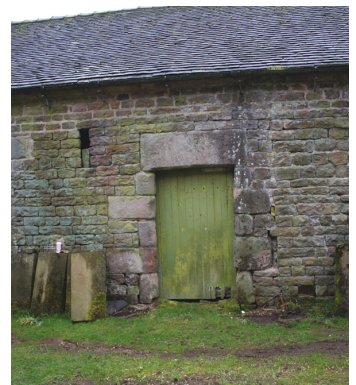
Main door (left) with keeping hole to the right. Above - stone threshing floor and 20th century butted boards, which may have replaced an earlier timber floor. Right - front elevation of wide doorway to threshing barn.

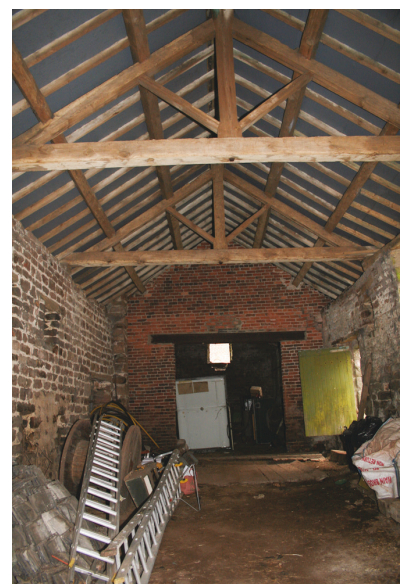
The building was re-roofed during the 19th century with a king post truss construction (pictured right) and double purlins but we can establish from the physical evidence that it once had a very different roof structure; during re-roofing in the 19th century the principal oak posts, with the tied trusses and struts were replaced with the present pair of brick piers. The roof was still supported in part by the existing stone eaves to the western side (facing the slope of the hill), but the roof pitch was lowered, which necessitated the removal of the stone coped gables and some of the larger verge stones. The reconstruction drawing (Plate 4) shows how this was carried out, leaving a section of the original large verge stones in-situ in the lower catslide wall.

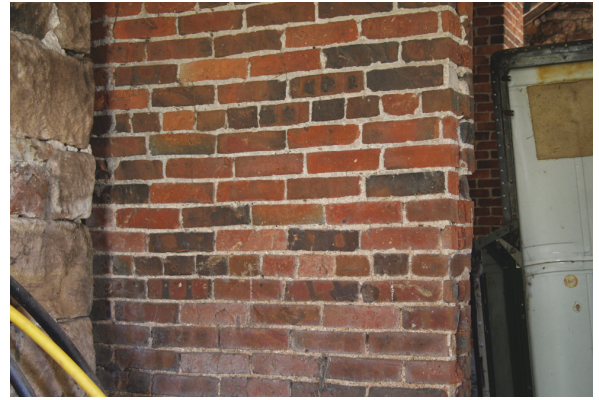
The two halves of the building were separated in the 18th century by a brick dividing wall. The lower section of brickwork is built in English garden wall bond and the bricks measure 9½" x 2½" (pictured right). Although there were government statutes controlling brick sizes, local guilds still tended to control brick sizes, and it is not always reliable to use this for dating evidence. Nevertheless, we can definitely see that the brickwork predates the mid 19th century brickwork and the bricks are a similar size to the brickwork in the Stable block. They were probably made after 1725, when place bricks were to measure 9" x 2½" by statute.

This brick dividing wall was heightened during the 19th century, when the original roof was replaced with the present king post construction. The later 19th century bricks measure 9" x 2¾". Much of this dividing wall has been removed and the brickwork chopped out and supported with a steel lintel, although the surviving piers of 18th century brickwork are still of some historic interest. The 19th century brickwork above has very little interest and has been remodelled. The wall is free-standing and not tied into the stone structure; the depth of the wall at 9½" is particularly thin over this distance to support the weight of the four purlins and associated roof structure. It is stable and there are no signs of movement but any works to disturb the footings through inserting a new floor may require the wall to be stabilised and strengthened. There is no evidence that there was an earlier internal, stone, dividing wall and indeed we might expect there to be a timber-frame wall in this location subdividing the bays, if the brickwork was only added after 1725.

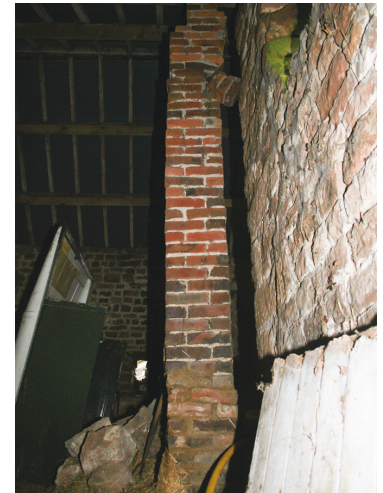
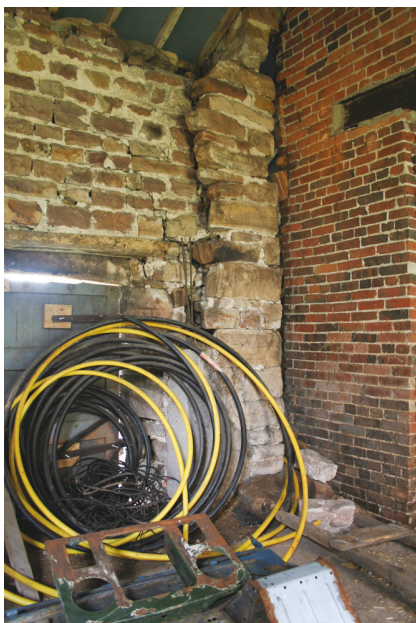
The large lump of coursed and dressed masonry which survives near the large brick dividing wall (pictured left) seems to represent the point at which the barn was originally divided. This masonry has no reasonable explanation other than that it was required to support both the base of a truss to the long western wall and the end of the wall-plate for the southern section of the building. The construction techniques are consistent with other parts of the early masonry, with long dressed stones. They appear to be left unfinished deliberately, rather than represent a section of masonry that has been removed, and the long eastern masonry wall of the threshing barn is recessed behind this inner corner; this could simply be explained as a reinforced section of masonry, required at a point in the building which was supporting two roofs.
