APPENDIX 2 - PHOTOGRAPHS

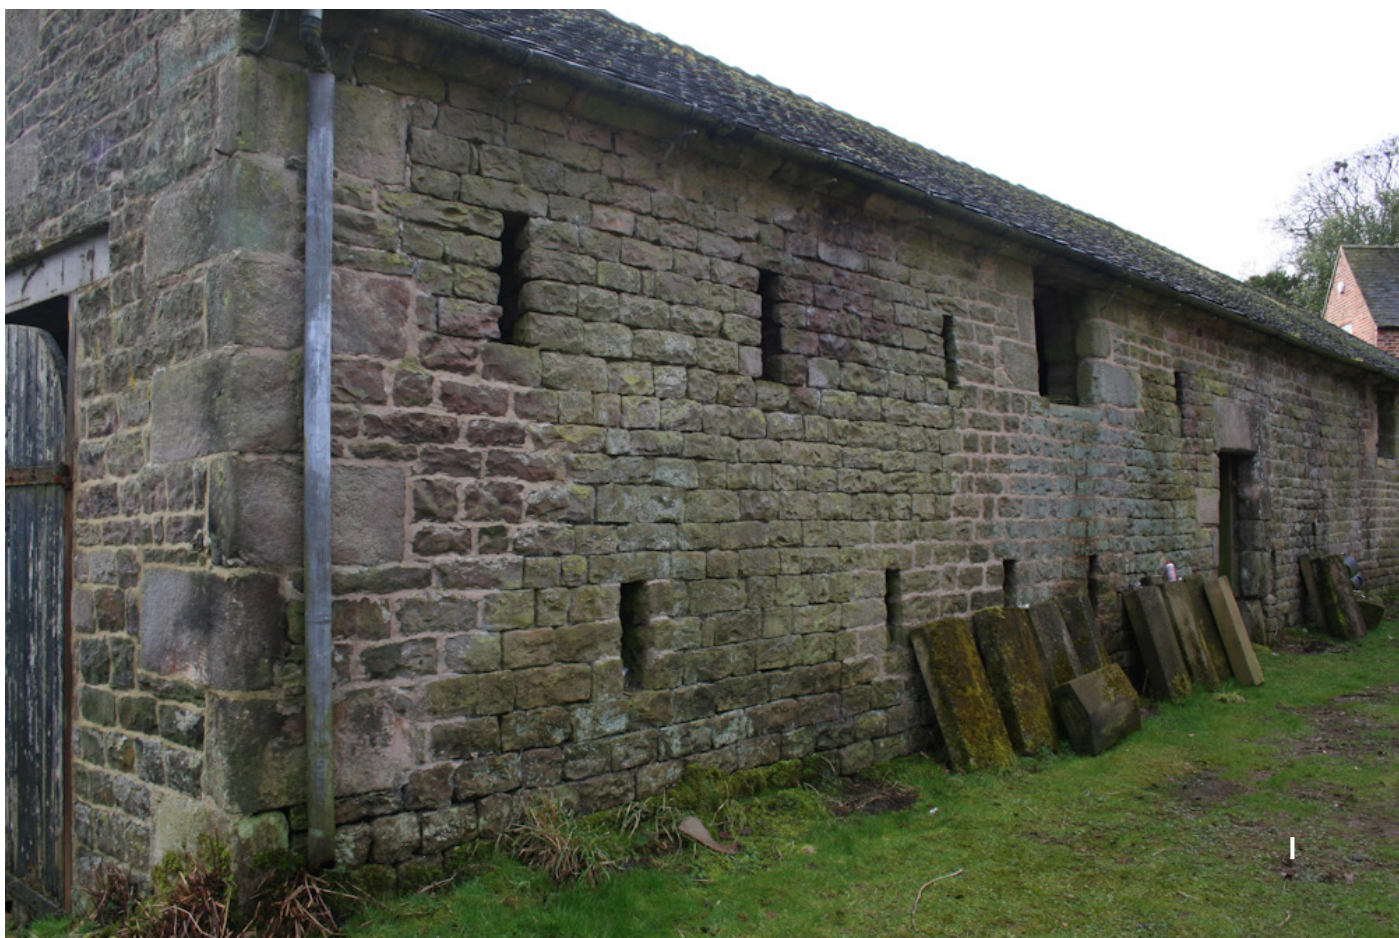
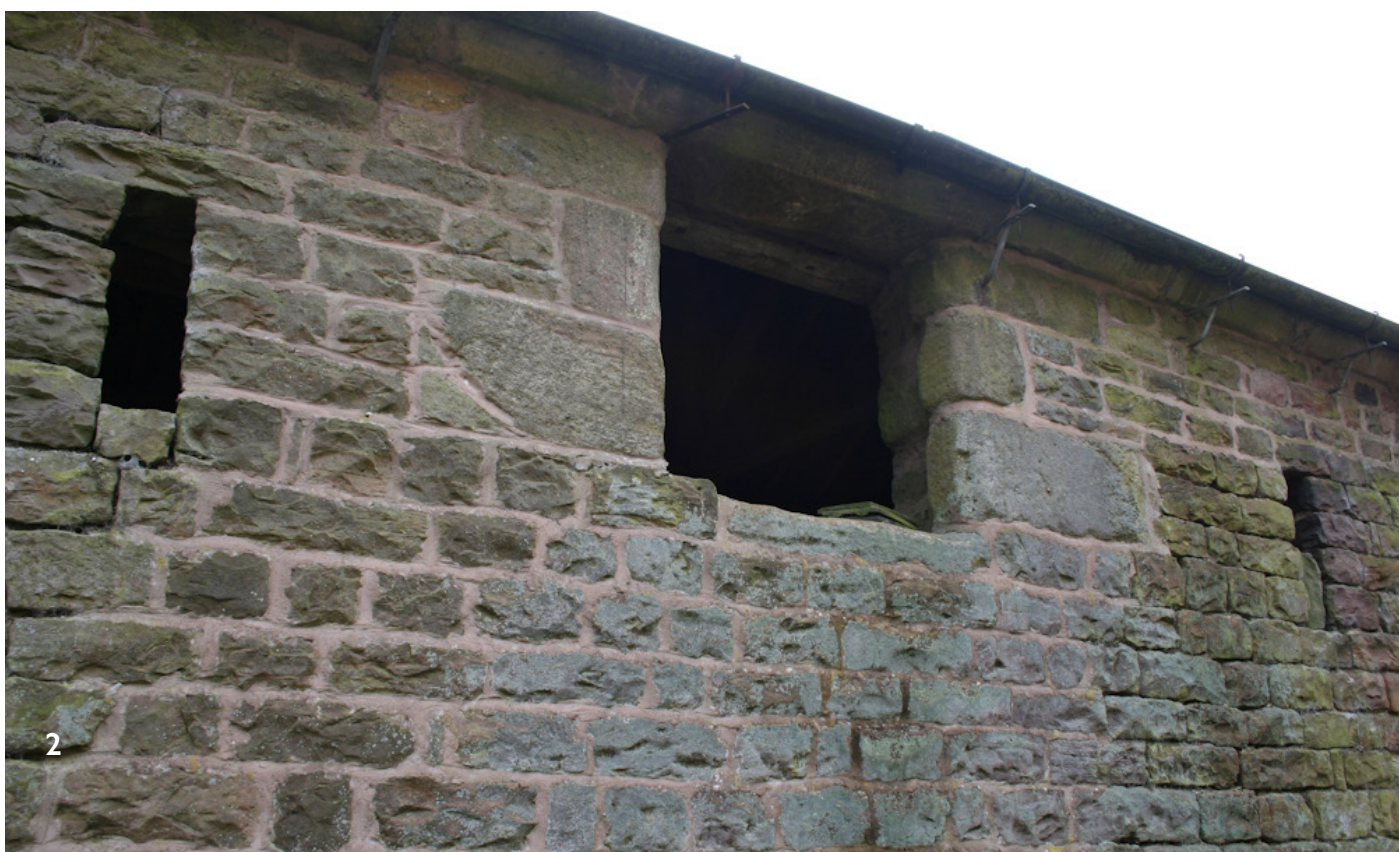
1 - Threshing barn with large ventilation slits, large stone quoins, squared rubble, chamfered surrounds to pitching eyes and doors, and straight chamfered stone eaves. 2 - chamfered surround to quoined pitching eye, with rebated masonry. The split-faced coursed surrounding masonry shows surprisingly few signs of weathering and age, compared with the dressings, but there are no indications that this has been rebuilt and it is entirely consistent, perhaps reflecting a different quarried source.

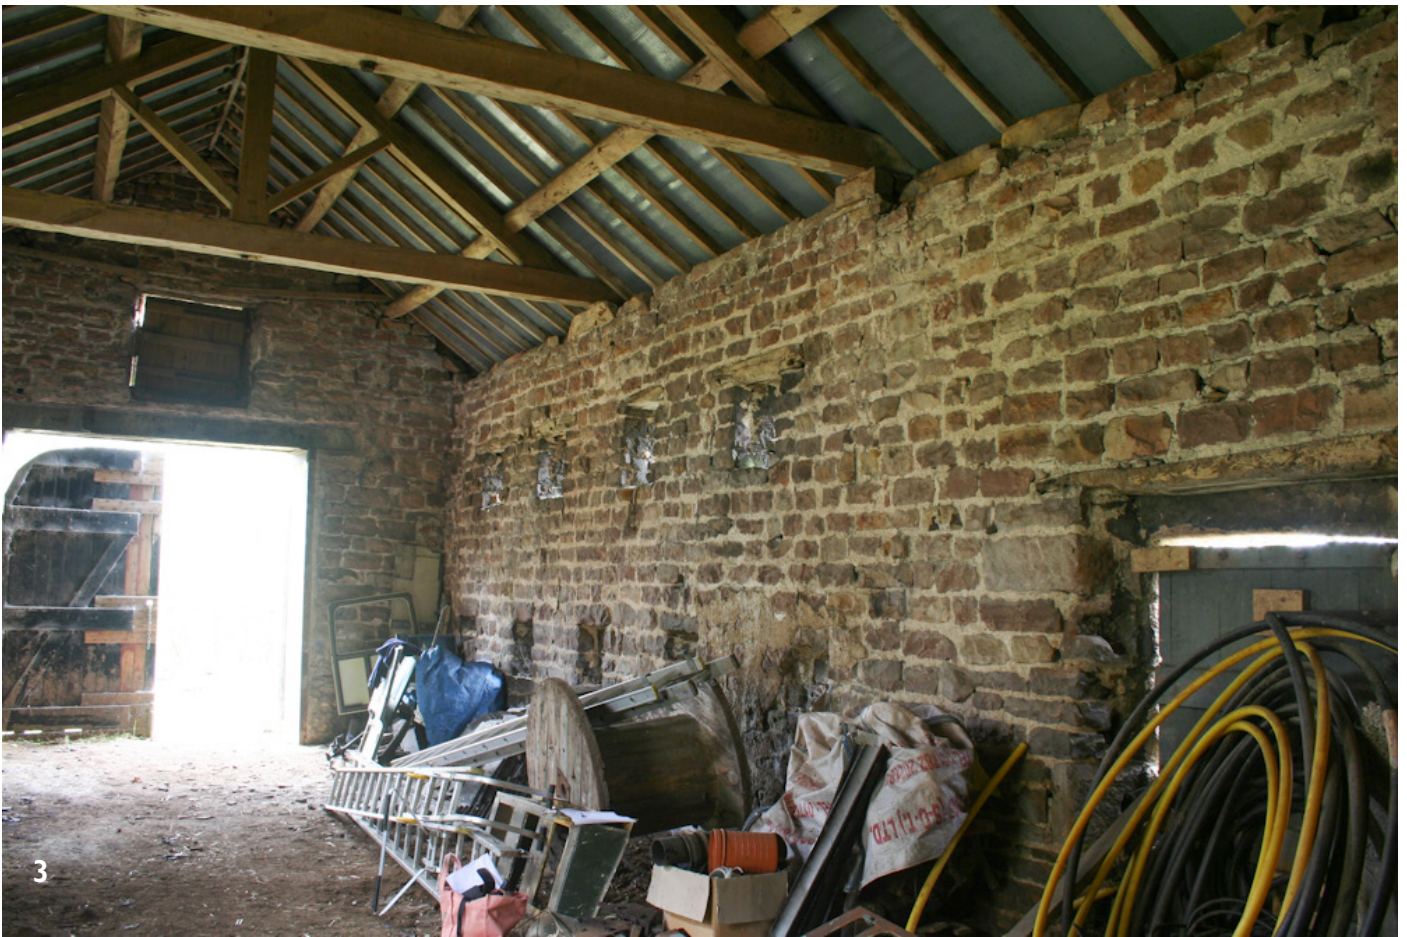
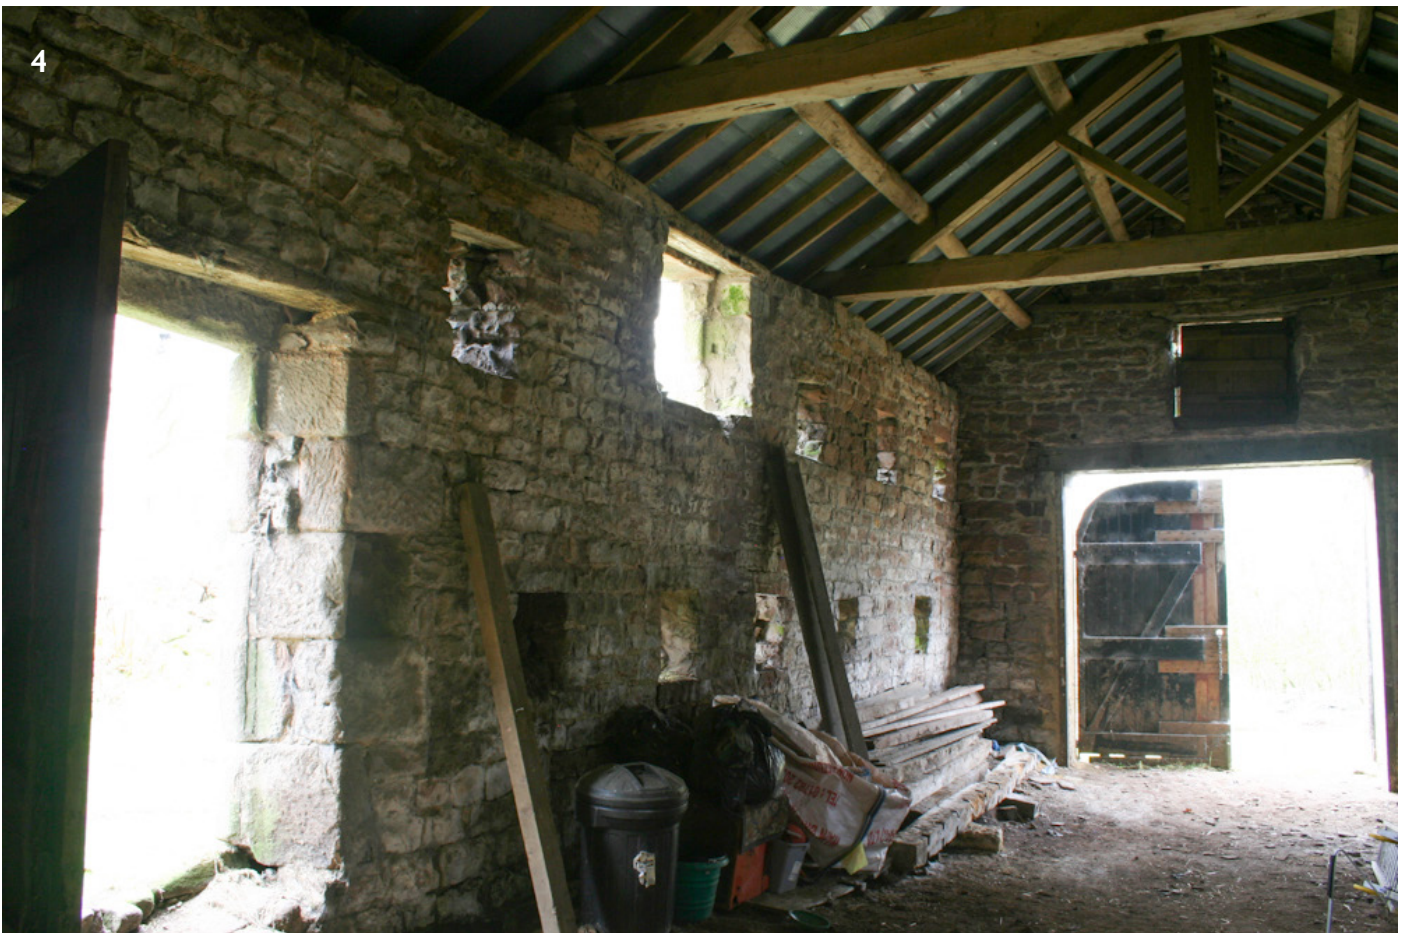
3 - Eastern internal wall of threshing barn with large chamfered ventilation slits, stone lintels to ground level slits and oak lintels to higher level. The door to the right is the "winnowing" door.
4 - Western wall to threshing barn with pitching eyes to upper wall and gable end. The main barn door lies to the left, with heavy dressed chamfered surround. Roof of Scots pine (Baltic timber) inserted in mid 19th century with king post trusses.

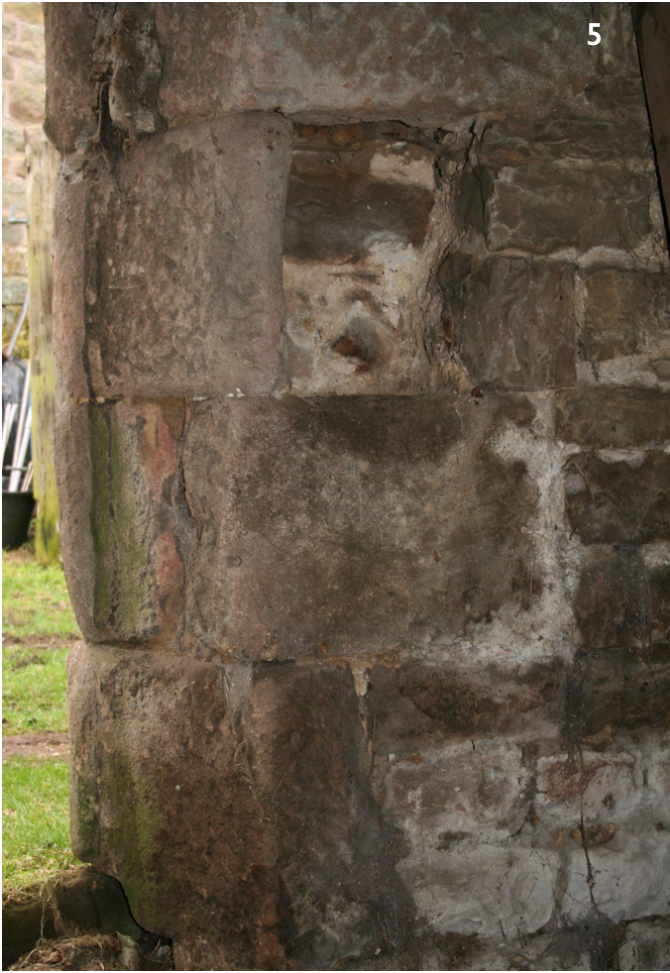
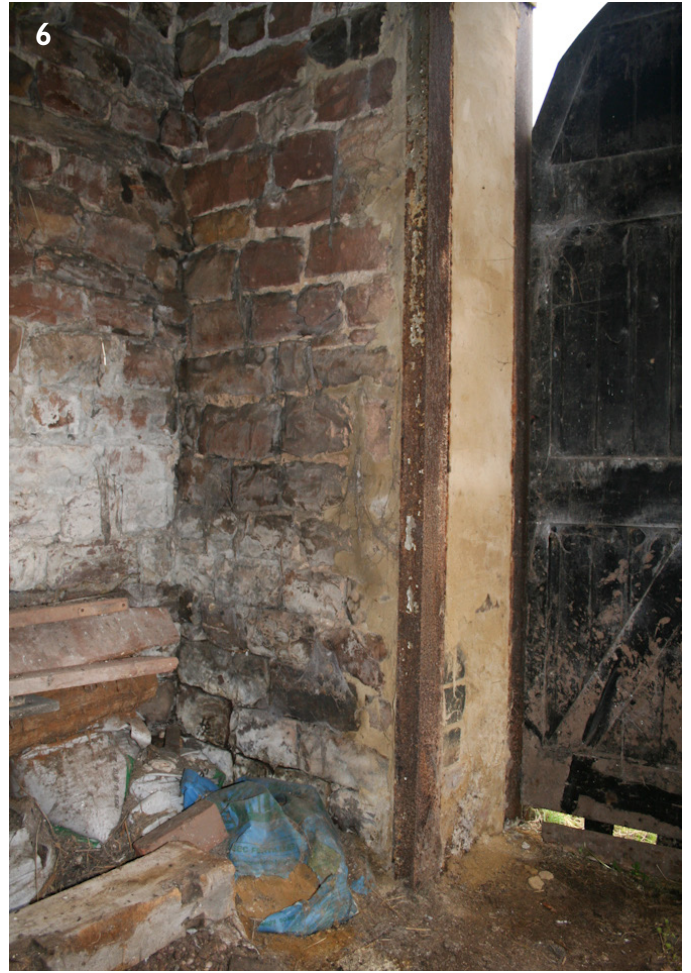
5 - Main door to threshing barn with rebated frame, splayed internal angle, and "keeping hole" to right.

6 - Steel angle iron inserted to protect masonry around inserted 20th century tractor entrance

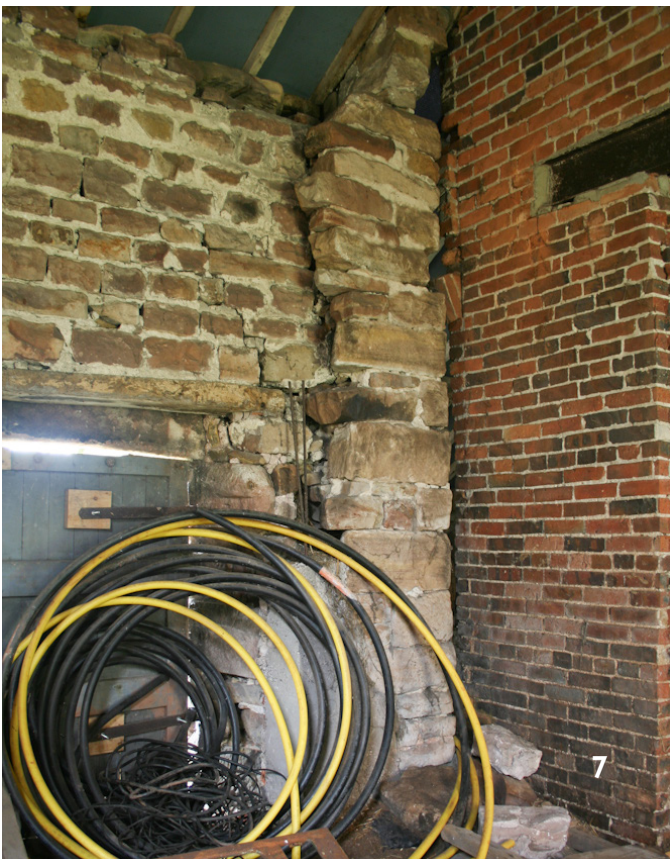
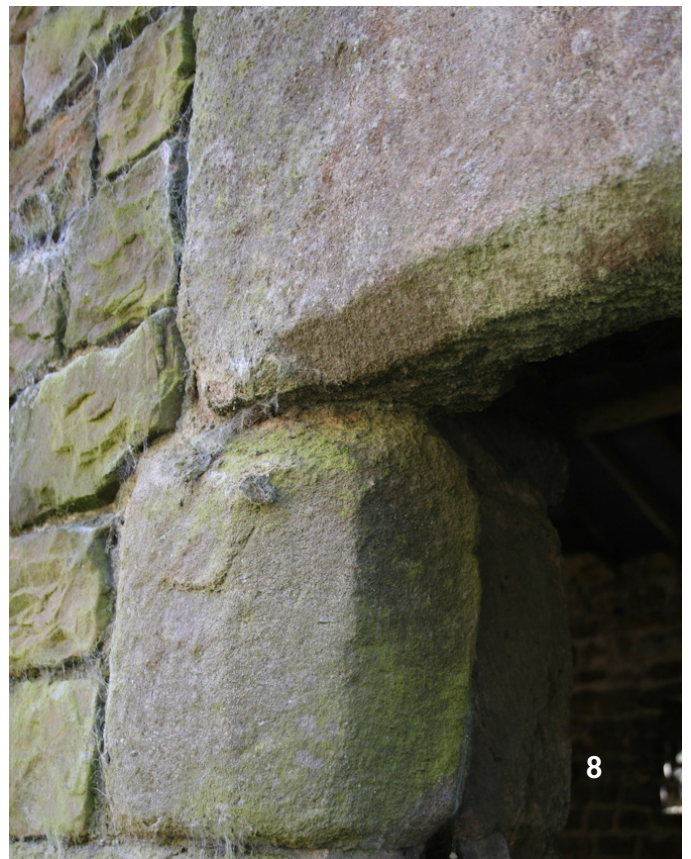
7 - Masonry pier of large squared quoins on internal angle of 17th century wall. This supported the base of a truss and the wall-plate of the southern range behind. Brickwork to the right of English garden wall bond, with mid 18th century bricks.

8 - deep chamfered surround to doorway with shallow run-out stops to lintel

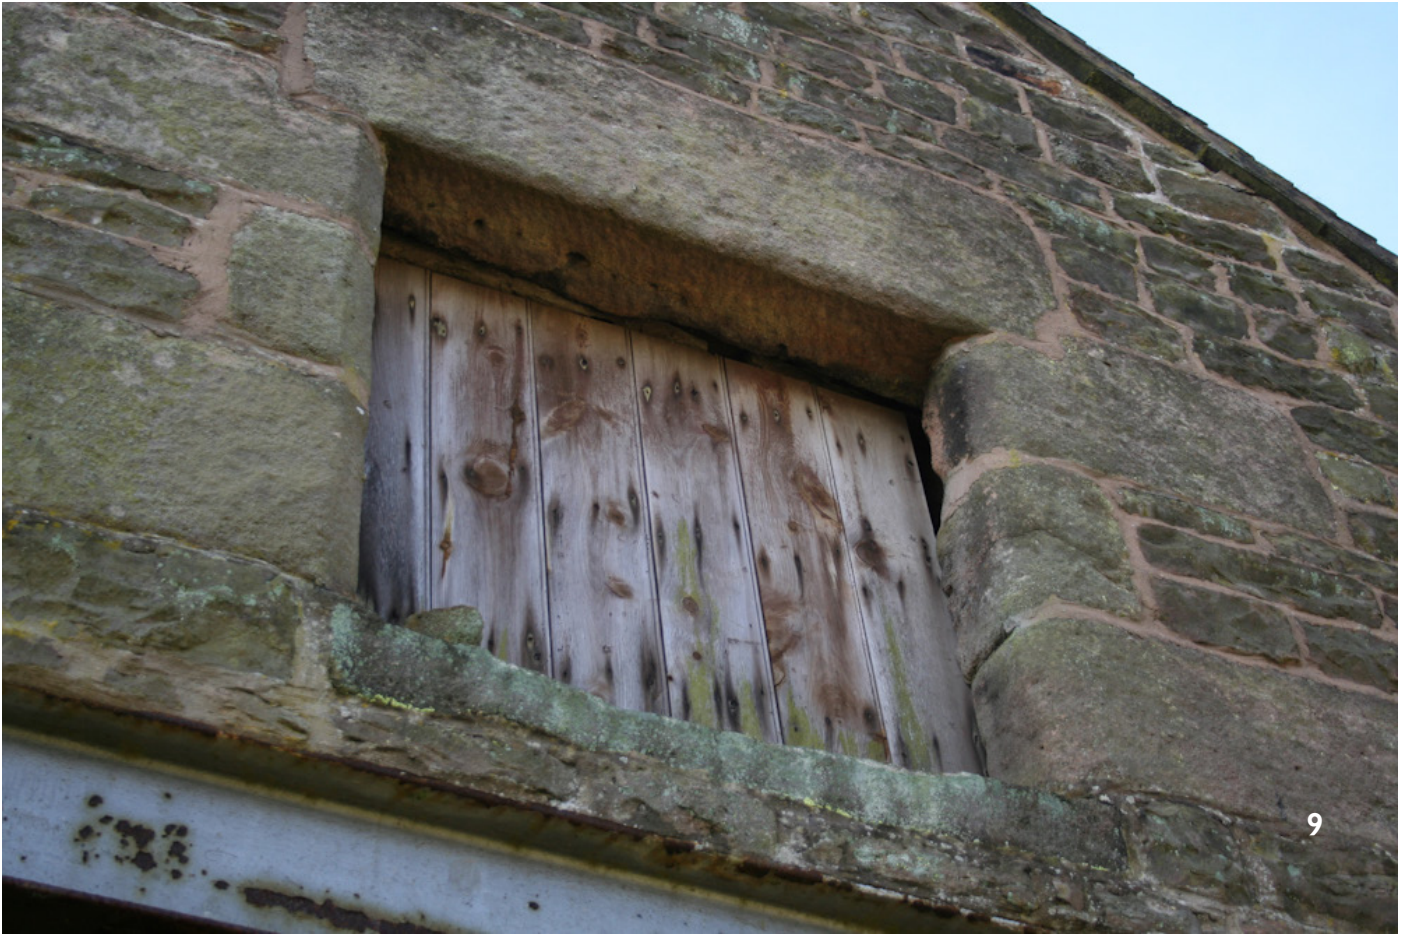
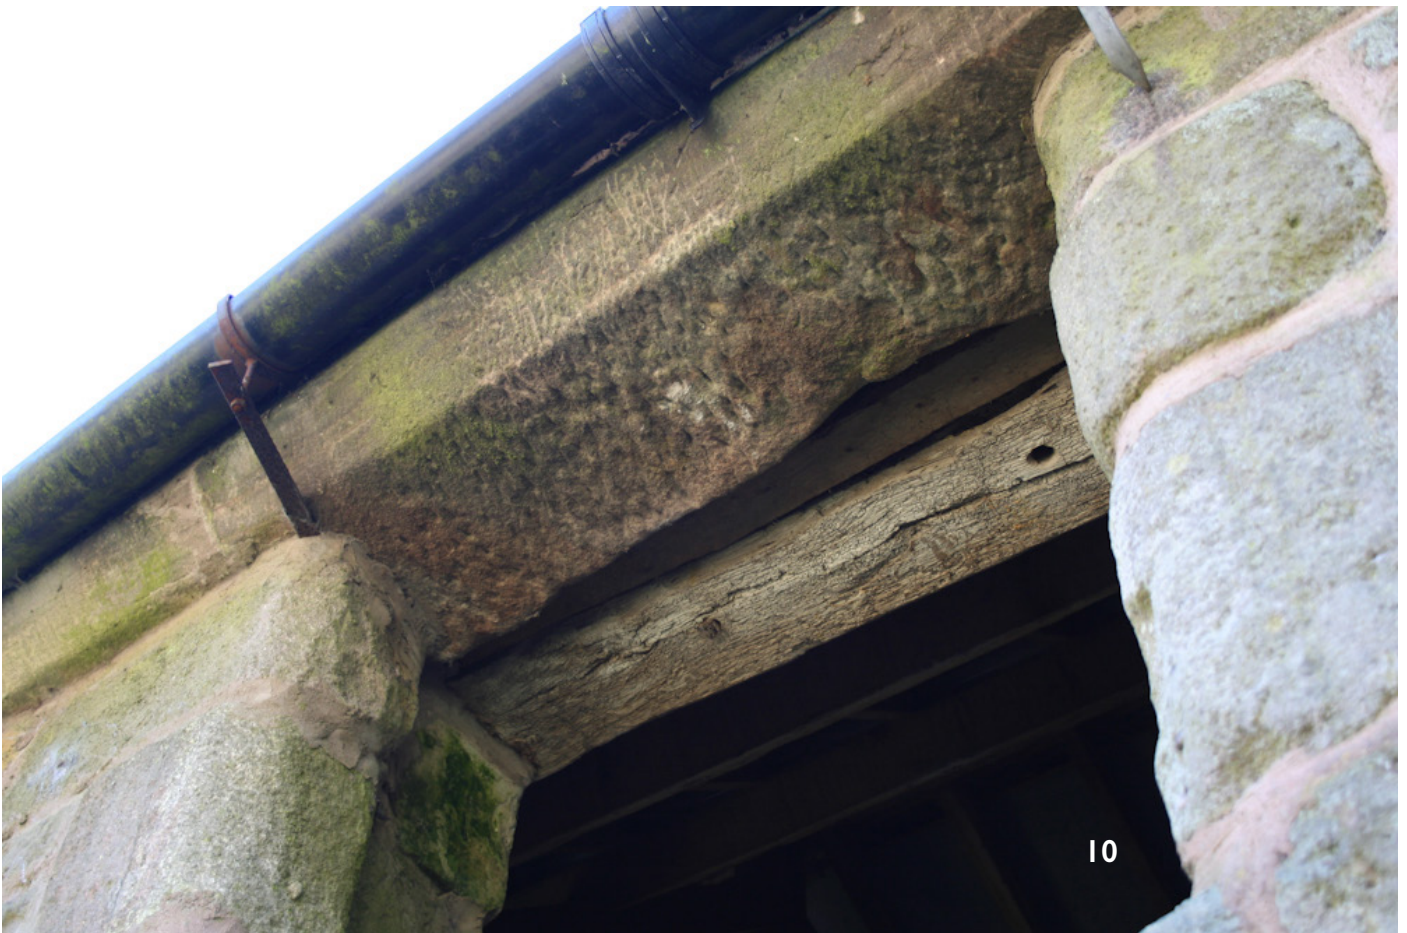
9 - Pitching eye to northern gable end, with chamfered surround, rebated stone masonry and shallow chamfered lintel, and heavily worn cill

10 - stone eaves to threshing barn with weathered surround to pitching eye and oak lintel to inner wall

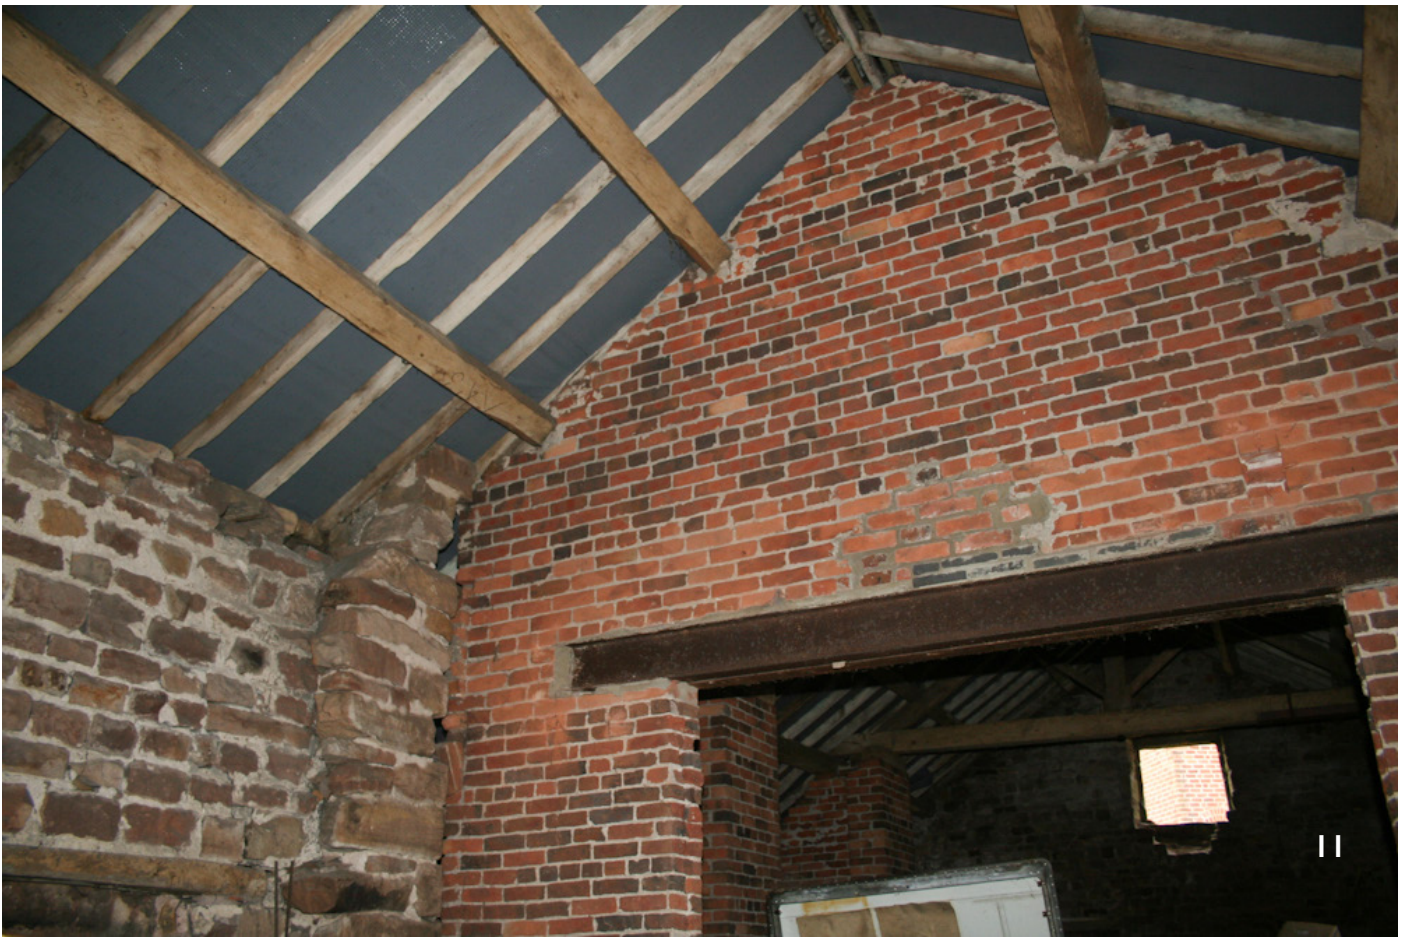
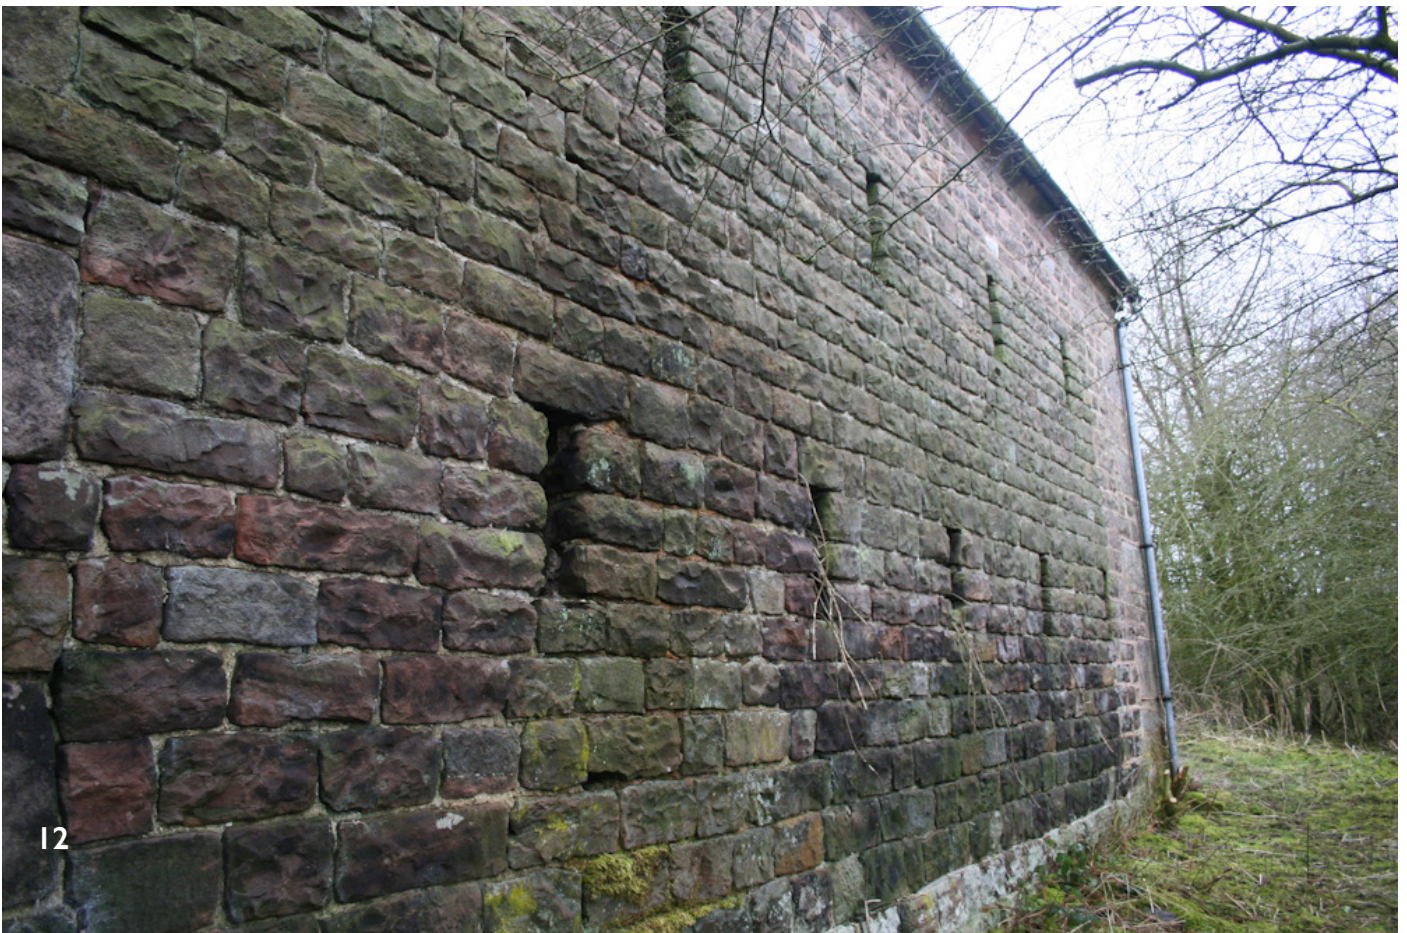
11 - Inserted brick wall, with 18th century brick piers (cut back) and 19th century brickwork at the level of the steel lintel and above. Steel lintel inserted during 20th century.
12 - eastern wall of the threshing barn with regular coursed masonry and two tiers of ventilation holes

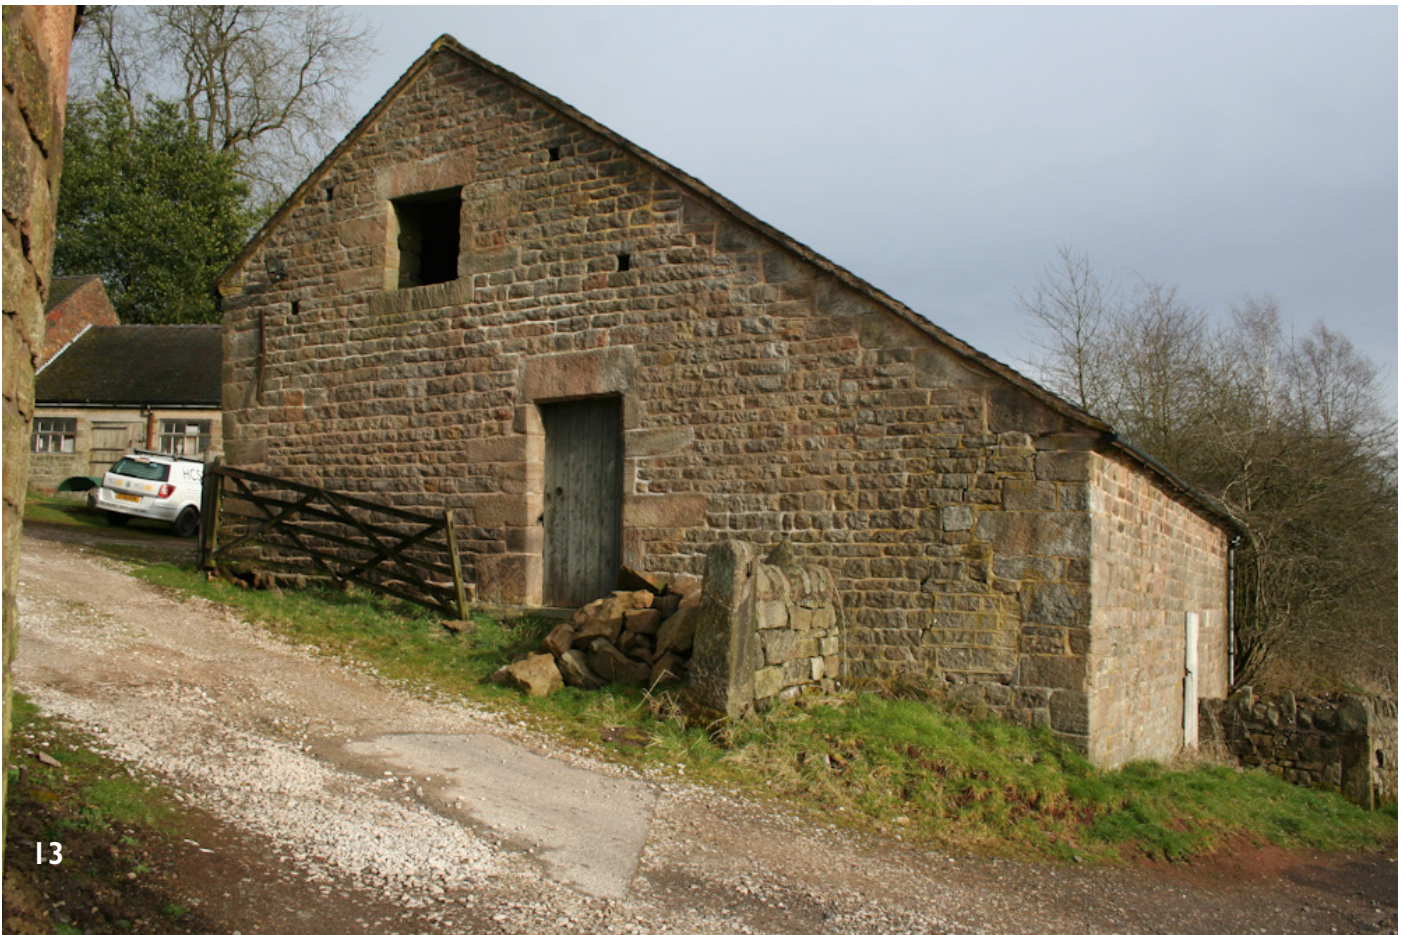
13 - Bank Barn - view from Brook Lane. This view shows the original verge stones to the raised stone coped gables in-situ at the lower level

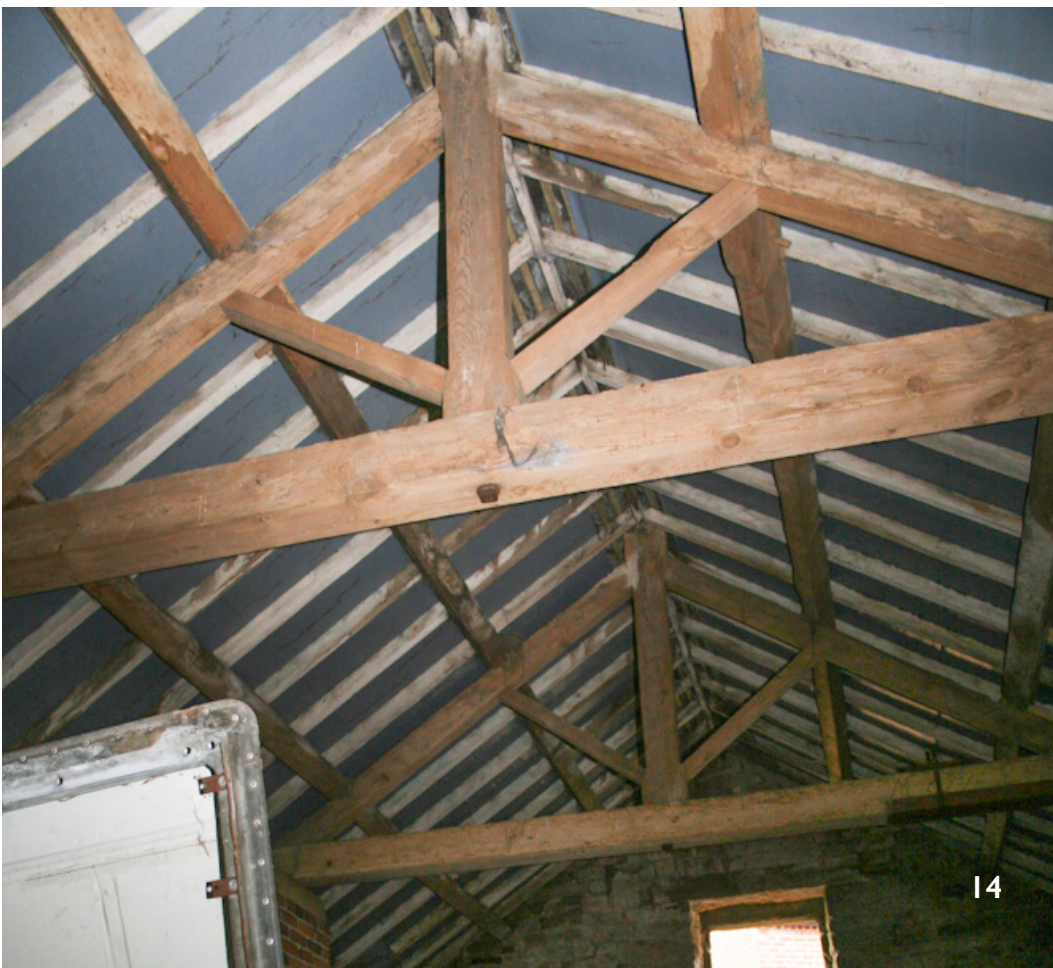
14 - king post trusses to the southern half of the Bank Barn, with double purlin roof construction, coach bolts through the tie beams and king posts and struts. All of the inserted roof is Scots pine.

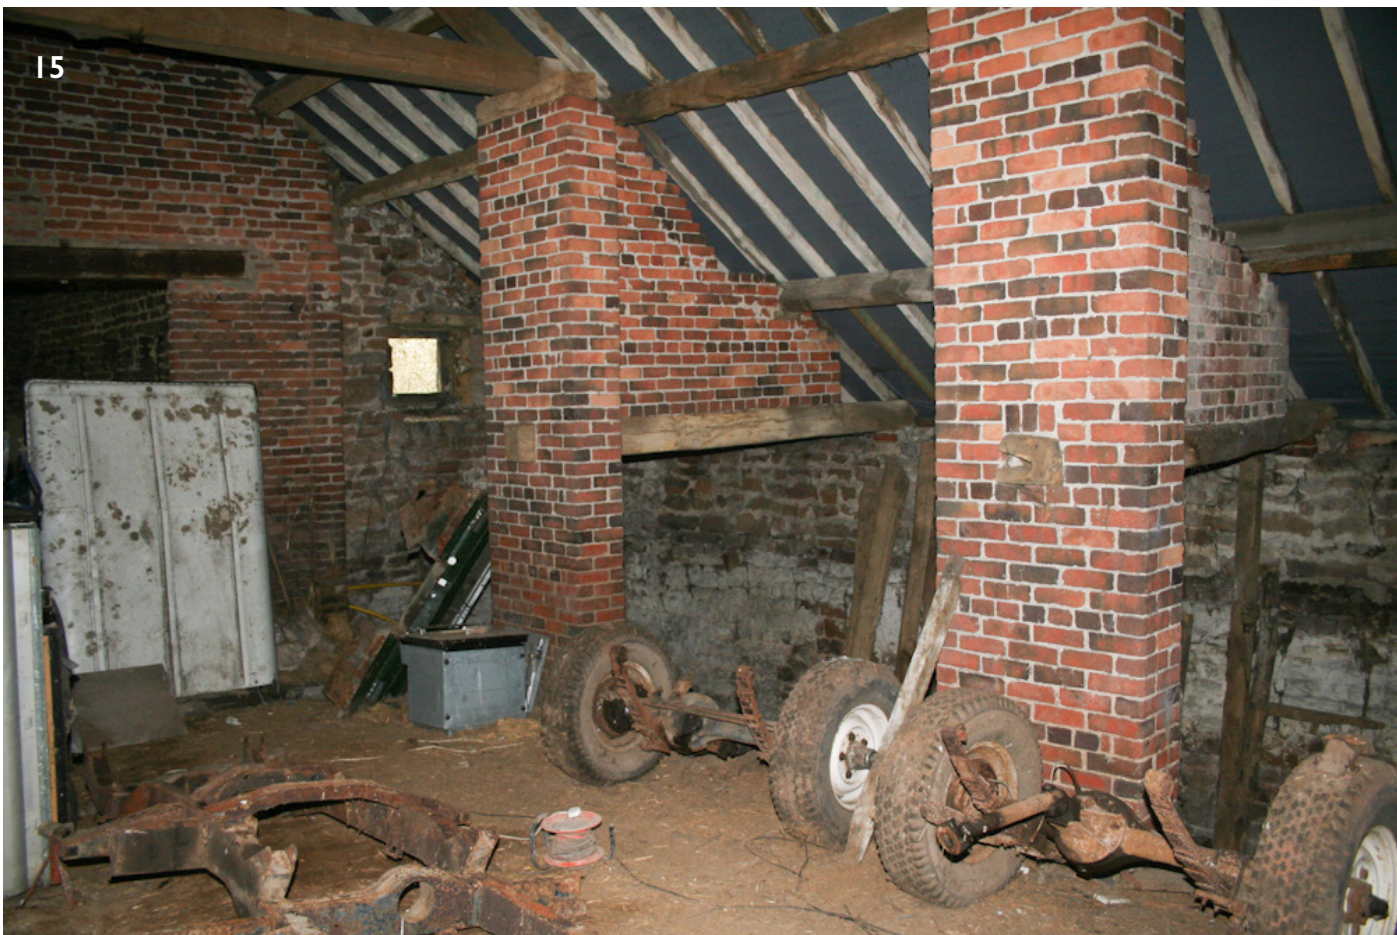
15 - Southern half of the Bank Barn, with view of inserted 19th century brick piers and cross wall to the cowhouse and view through to the cowhouse at the lower level.

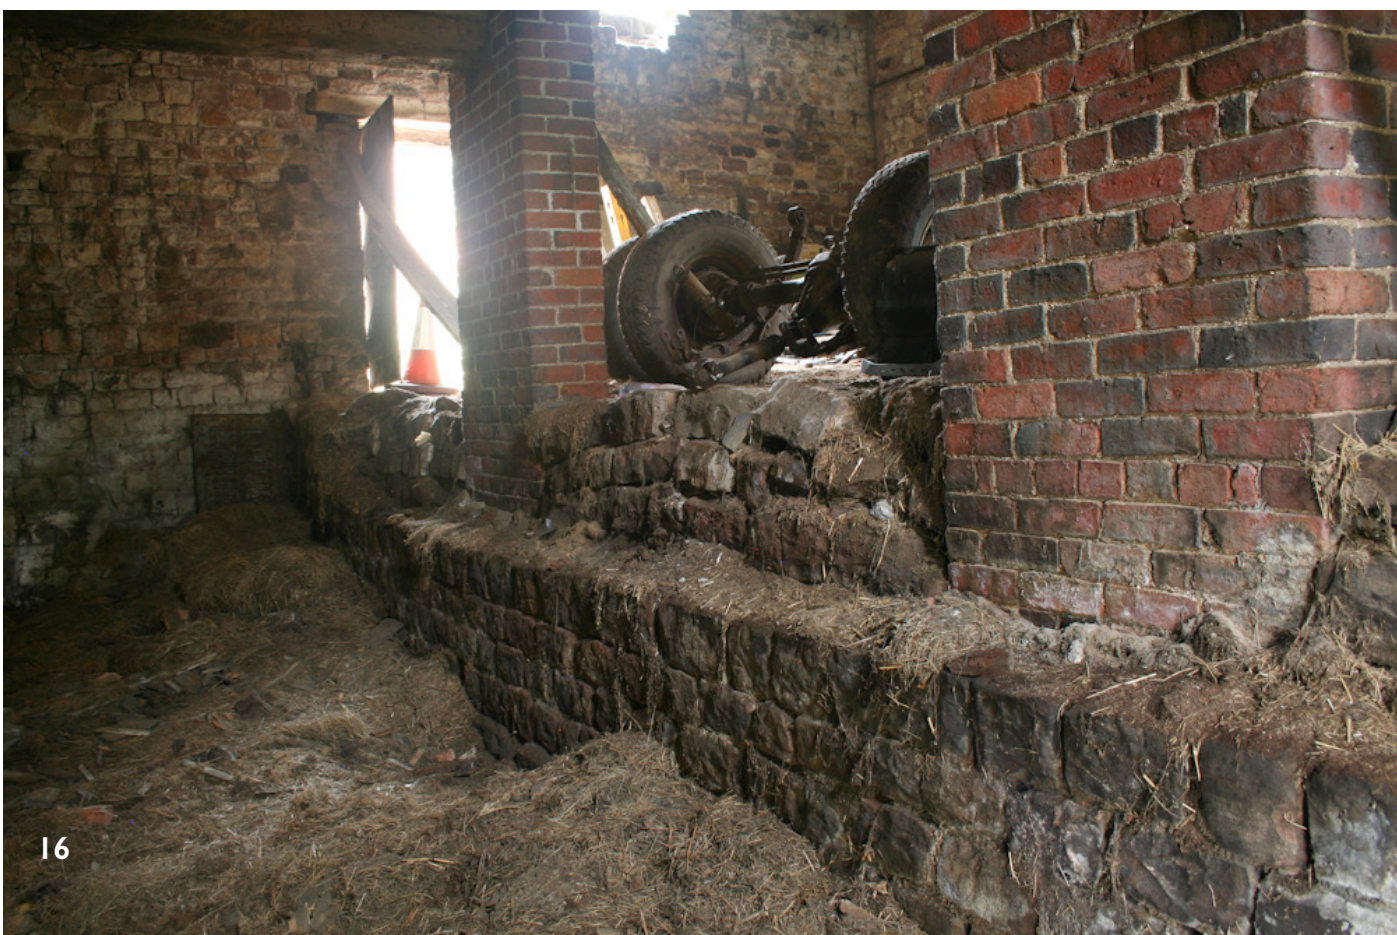
16 - Cowhouse looking south up into the large barn; the coursed stone plinth at the lower level supported the timber framework and the brick piers were inserted in the 19th century. Rubble stone infilled the gaps and the floor may have been re-laid.

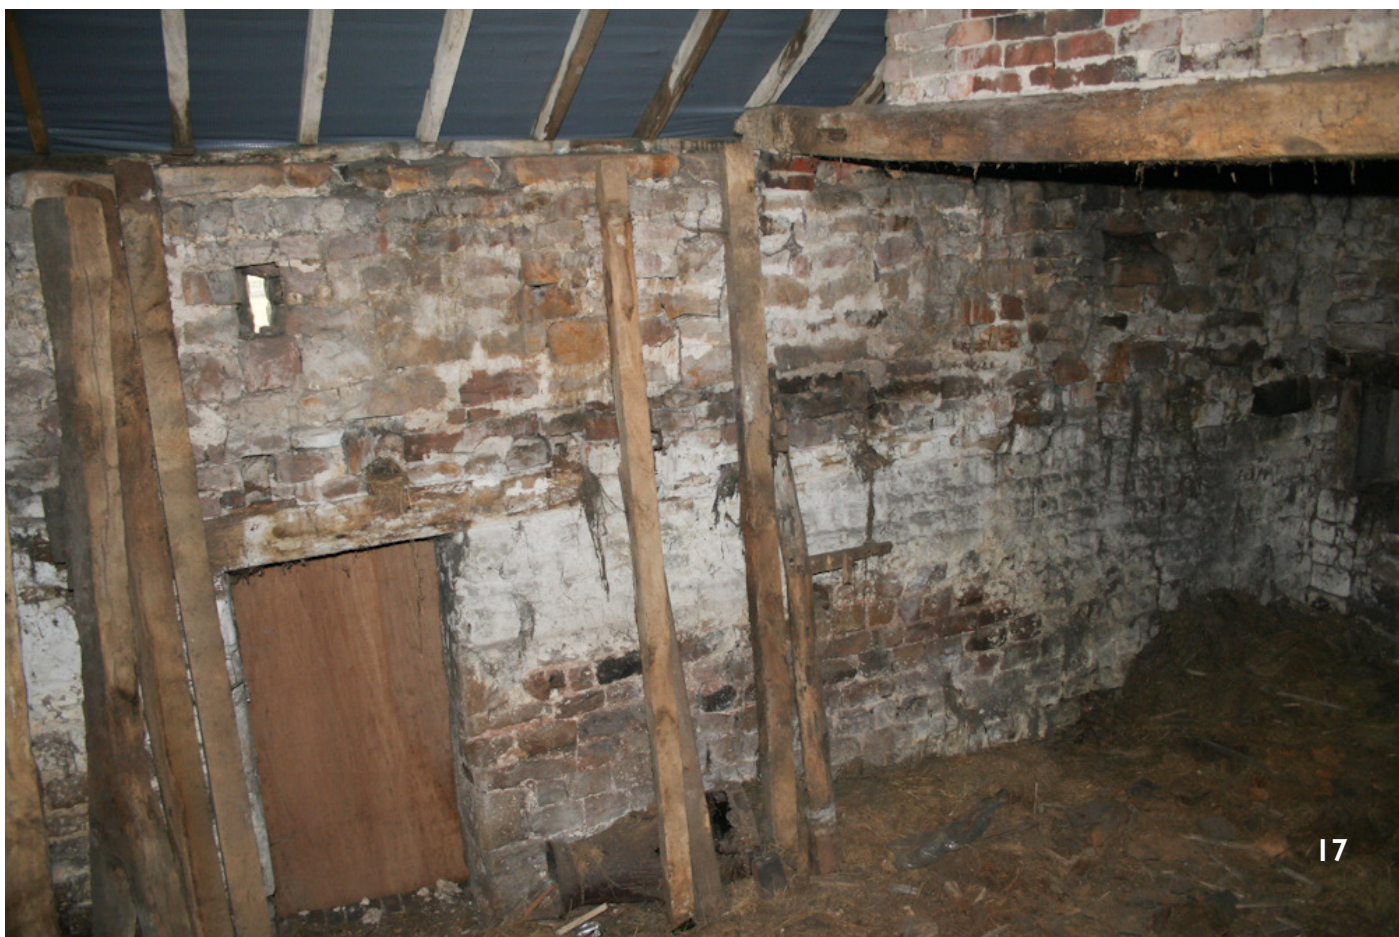
17 - View looking towards the eastern wall of the cowhouse, with oak floor joists set aside and re-used oak bond timbers bedded in the wall.

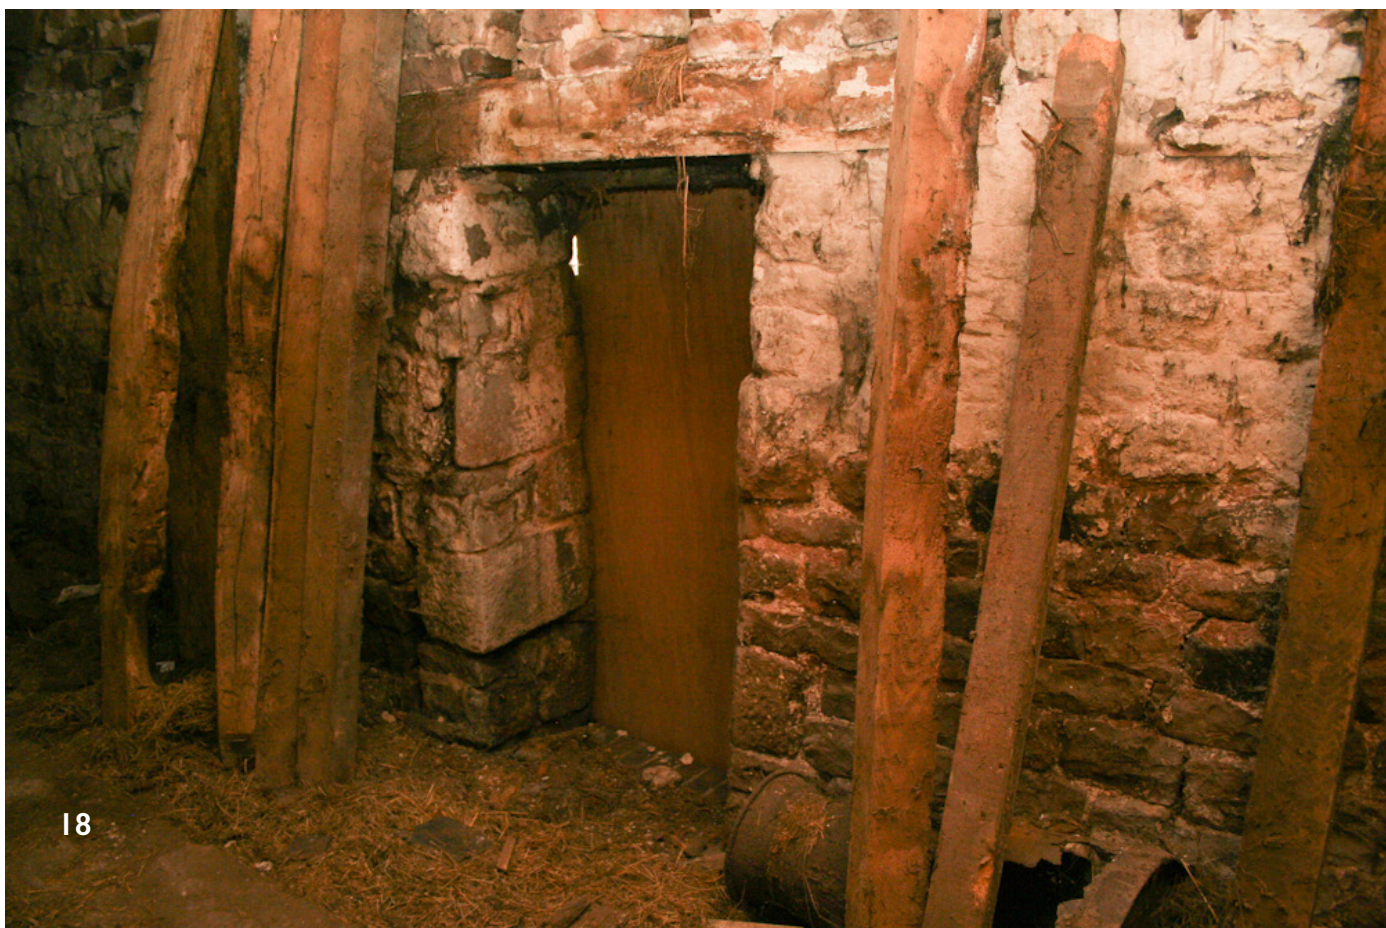
18 - Doorway inserted into the eastern flank wall of the cowhouse. The lack of rebated masonry and splayed angles and the smaller and square dressings to internal and external walls indicates a later modification to the cowhouse.
