APPENDIX 2 - PHOTOGRAPHS

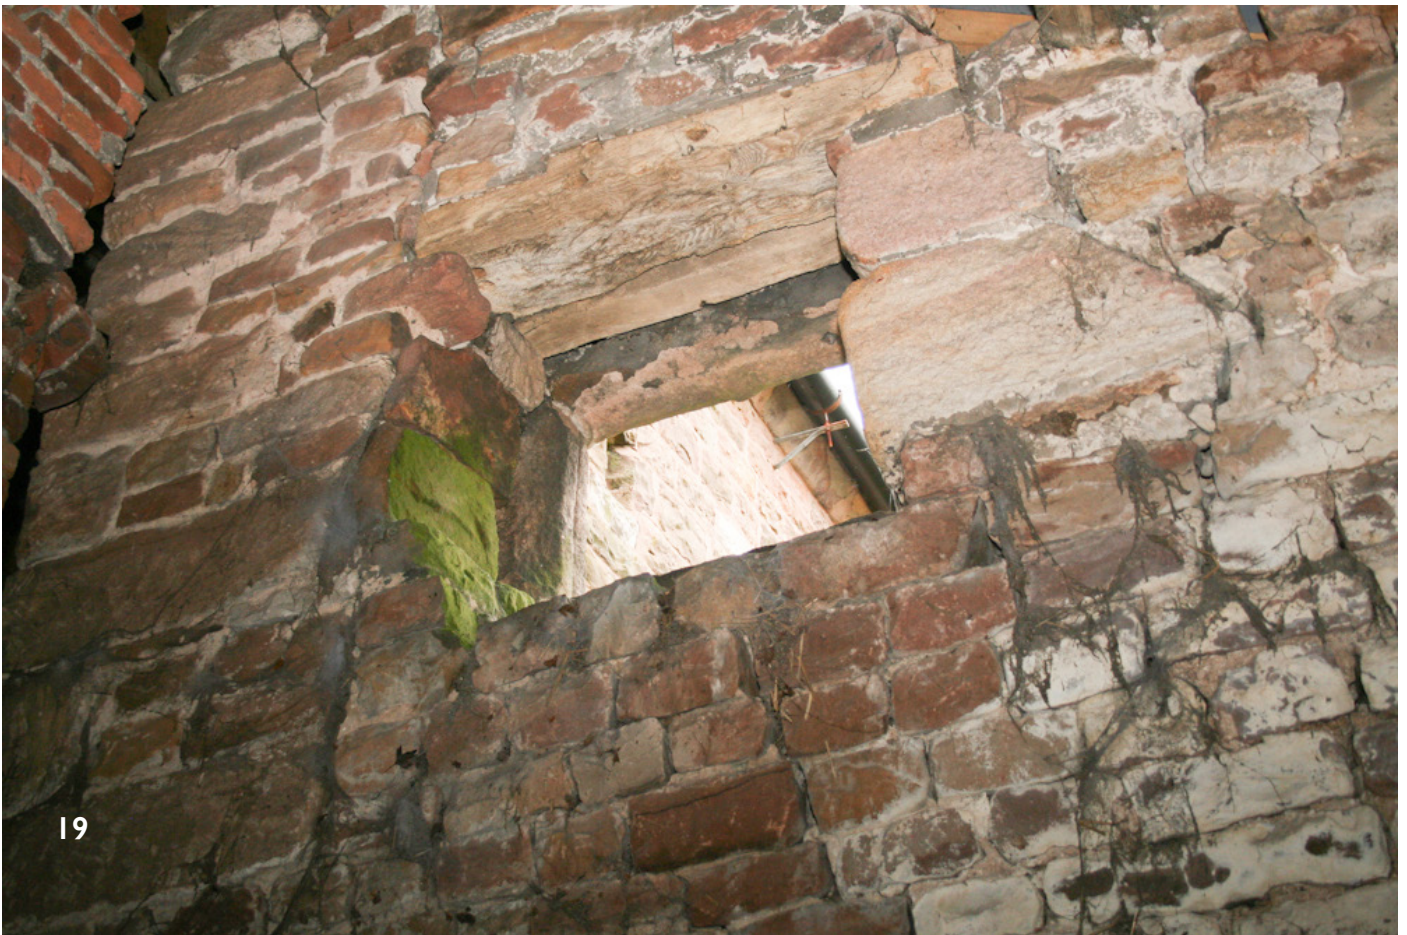
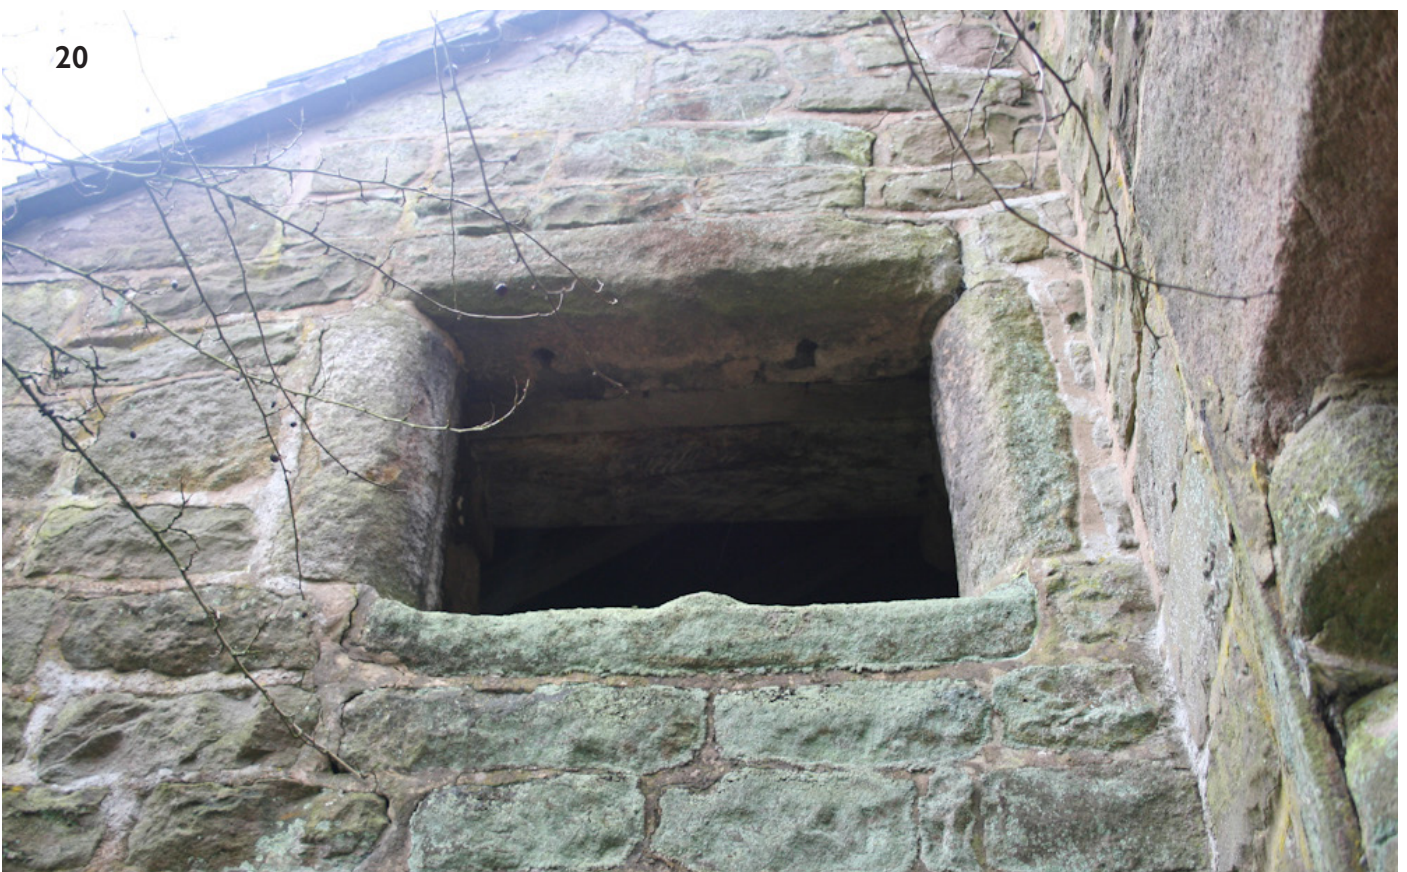
19 - deep chamfered mullioned window to northern return, with large internal oak lintel, central mullion missing, weathering and stools in situ, diamond-section sockets for iron vertical saddle bars. Massive masonry surround.

20 - view of the same window from the north. The window was glazed and has a narrow groove for the leaded light panels to each side of the window. The leaded light indicates that the hayloft required a independent source of light for working which did not rely upon a door being open.

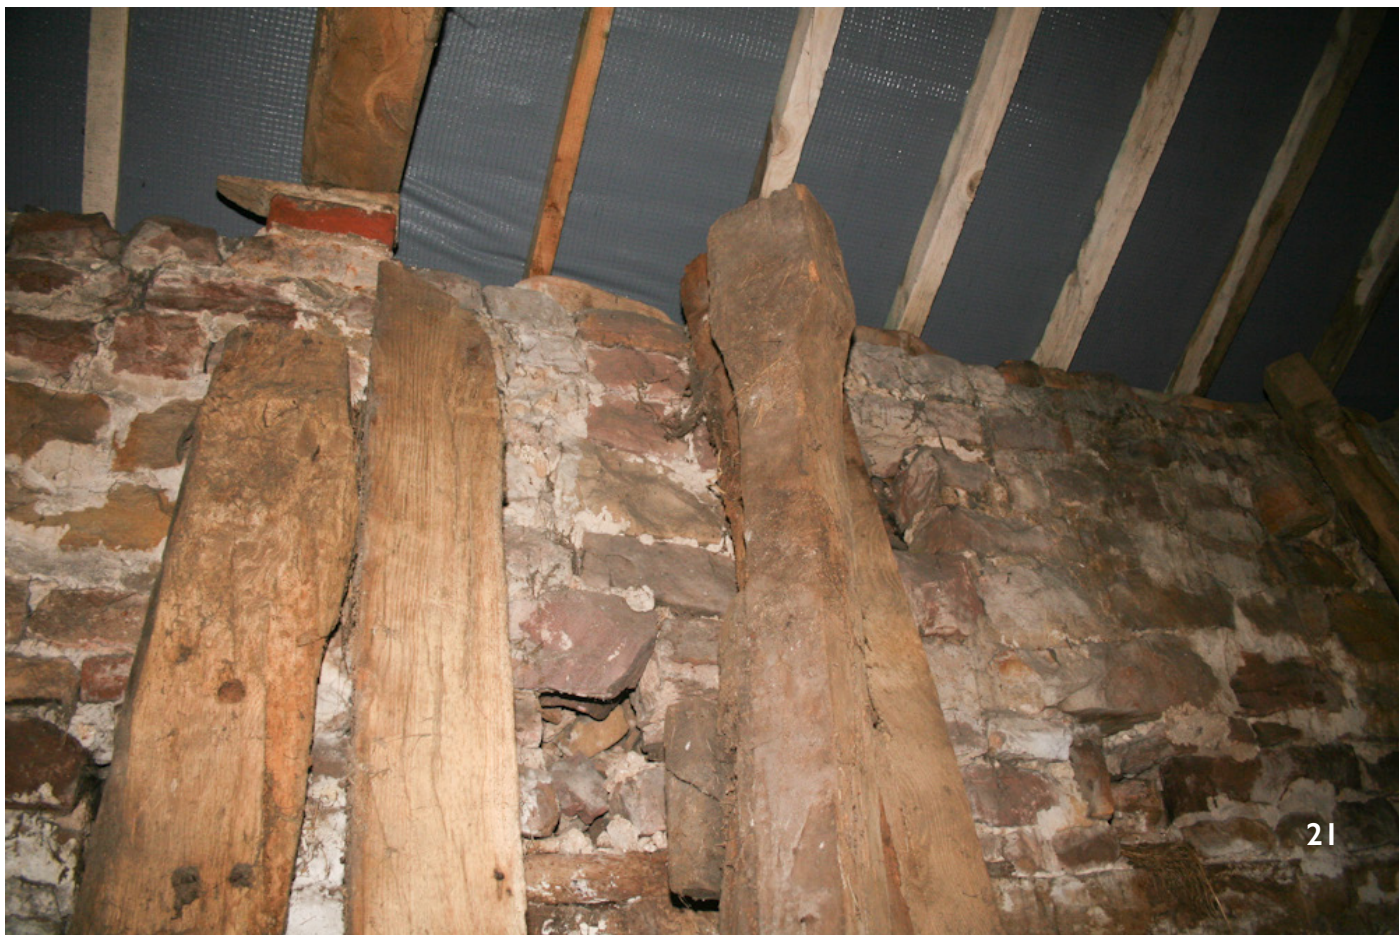
21 - Oak posts and joists ex-situ. The square section of the joists supports a date of circa 1700. The oak post on the right is chamfered and has a square base, which may have been lodged into a socket in the floor.

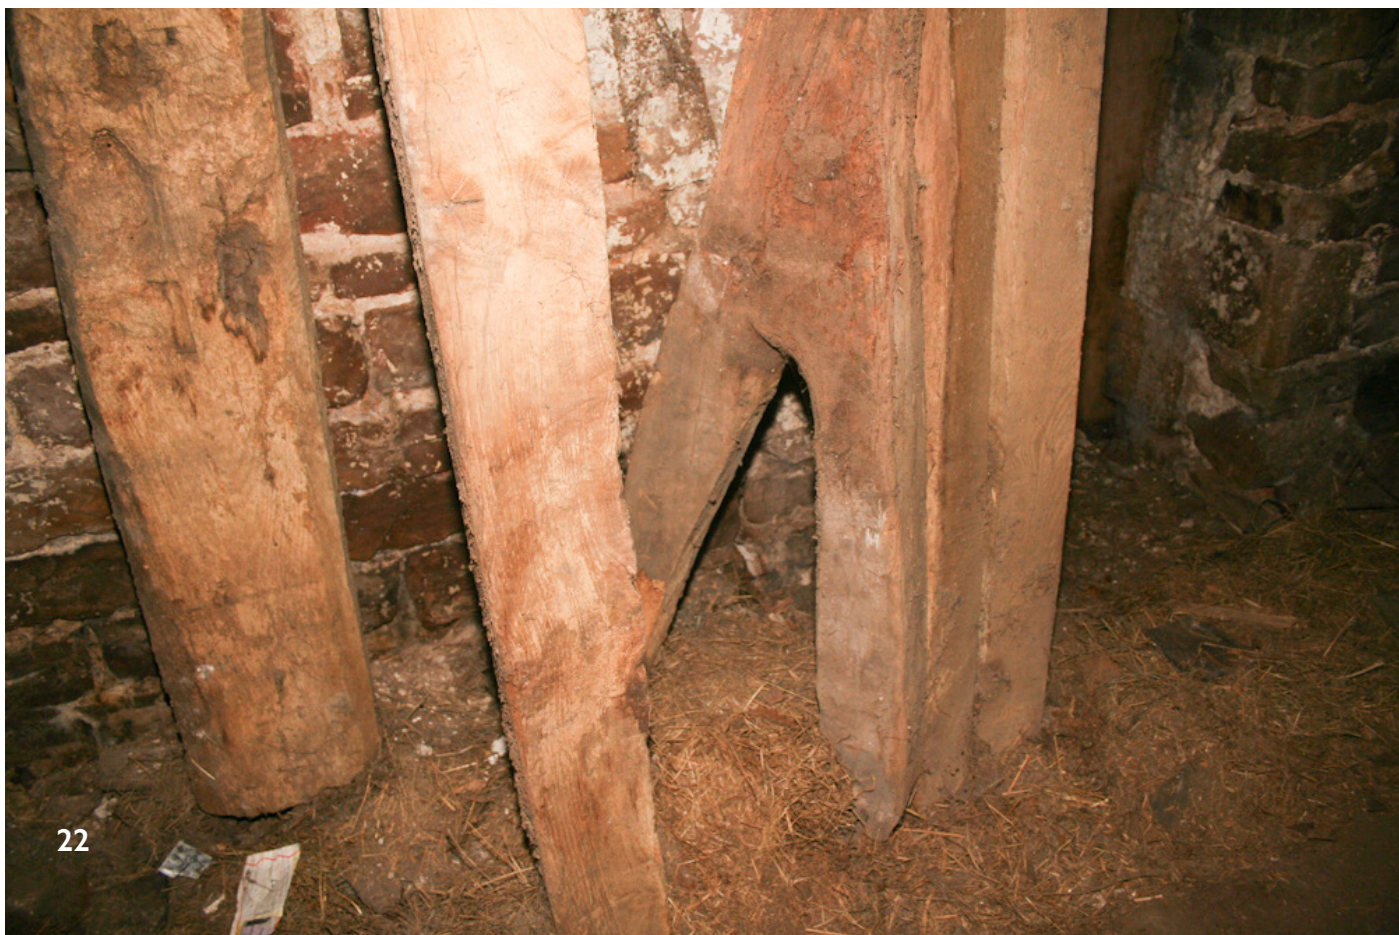
22 - base of the oak post on the right, with a forked 'yoke', designed to support the free end of a joist or spine beam

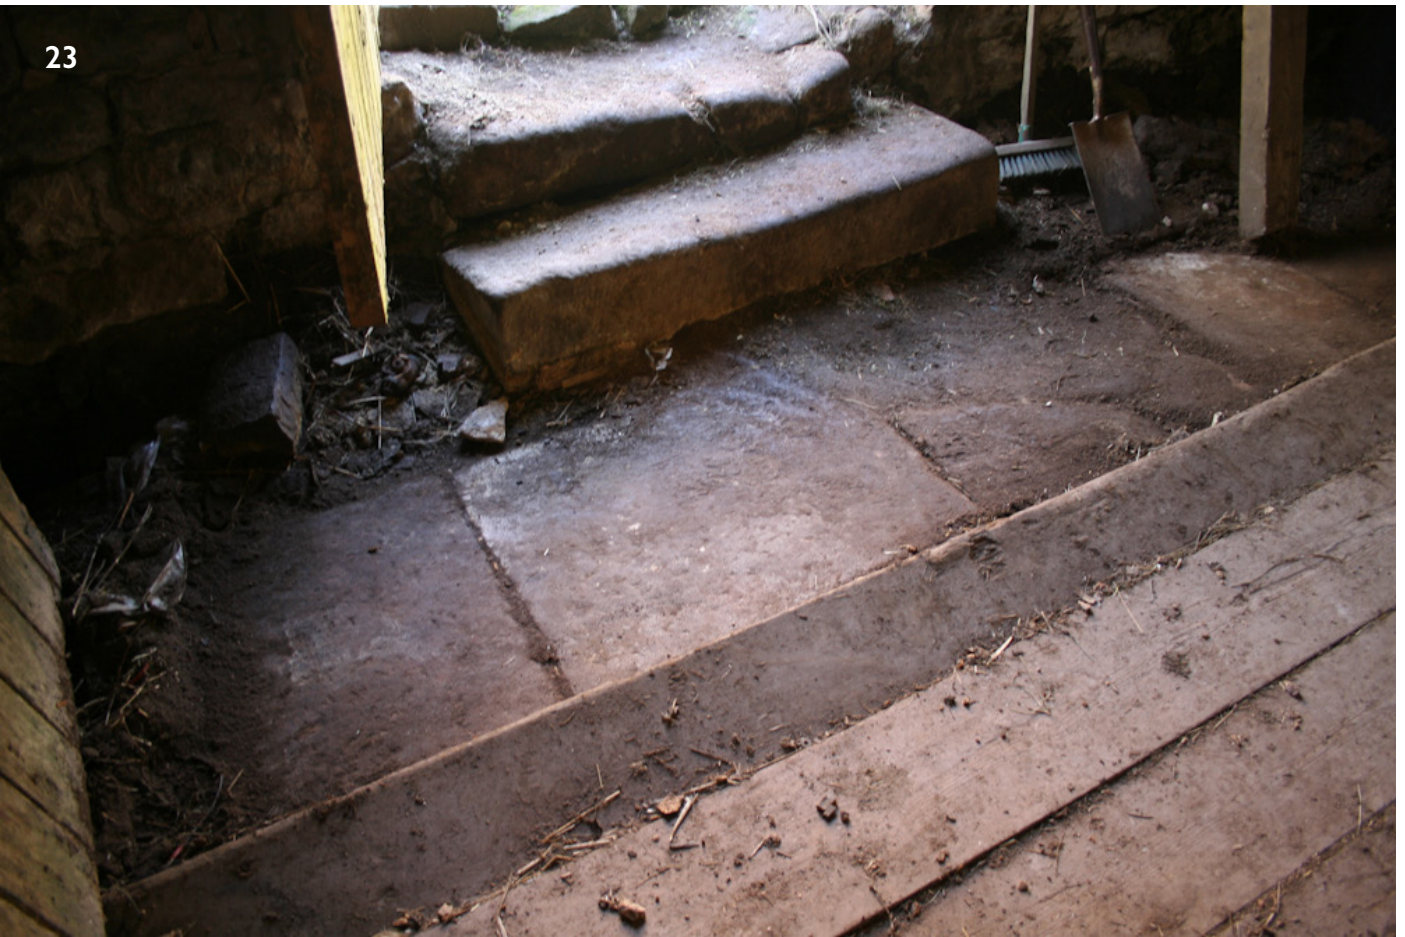
23 - Stone paving flags form the wide threshold in the threshing bay and may have continued across the whole bay. Timber planks are butted up across the former threshing floor and may have replaced an earlier timber floor
24 - brickwork to the dividing wall in English garden wall bond, of mid 18th century date; the wall was chopped back during the late 20th century

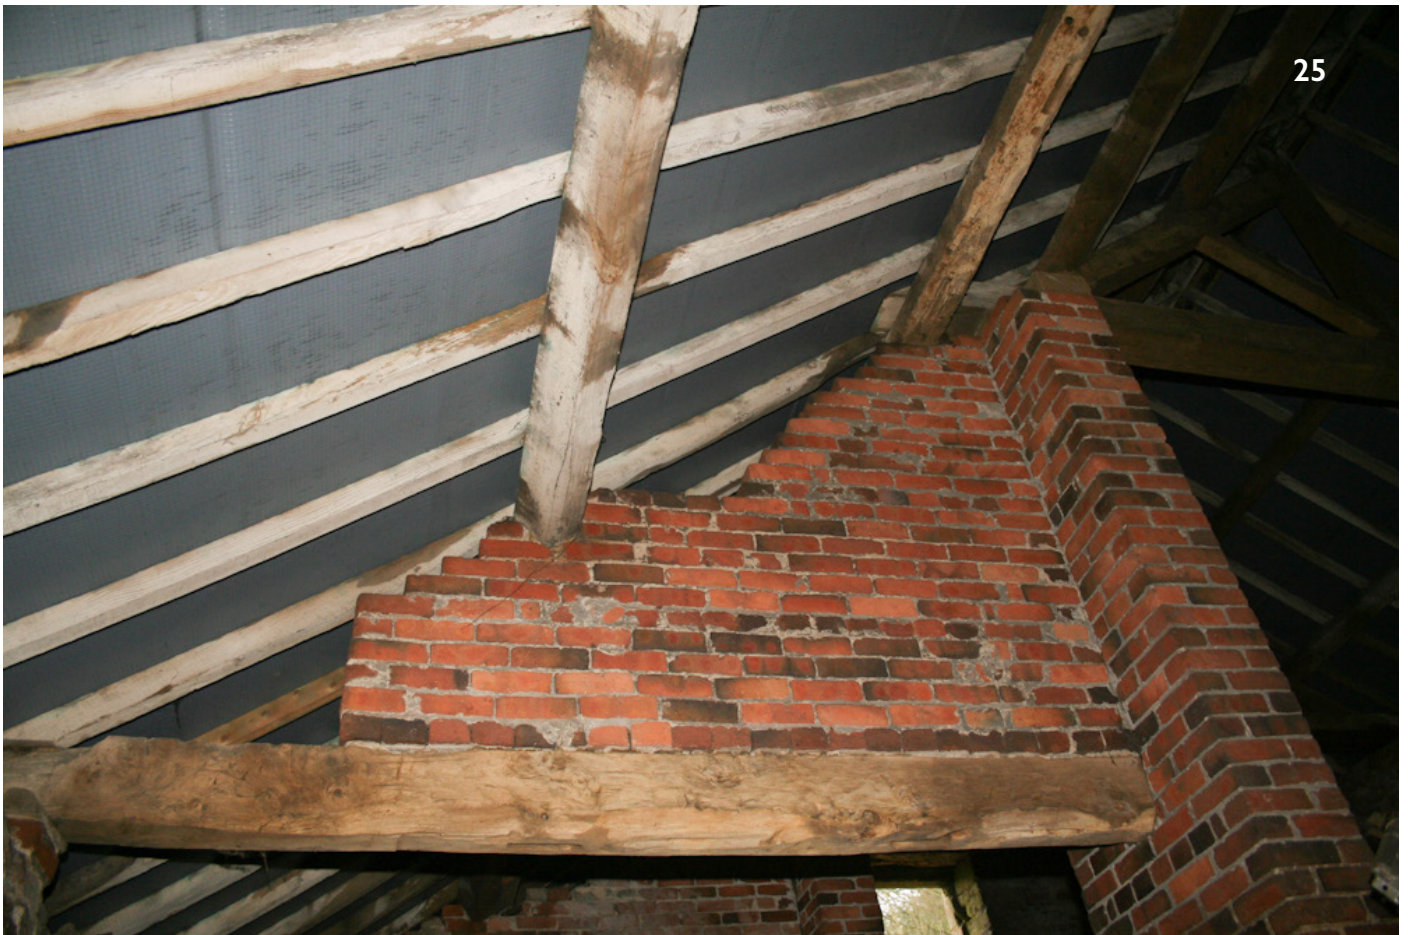
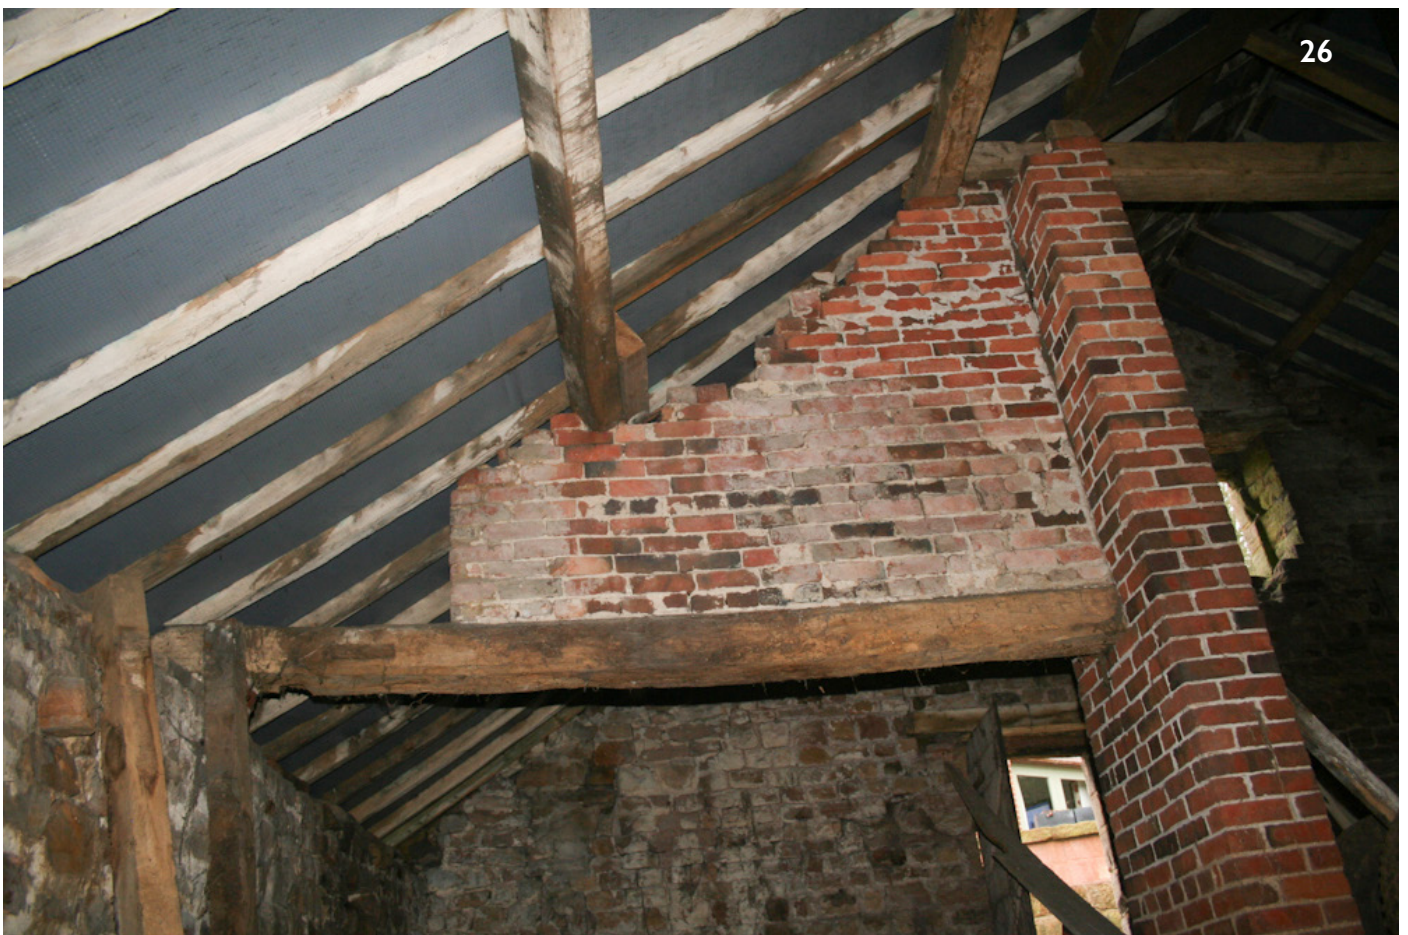
25 - re-used oak beam to the cowhouse, with inserted brickwork supporting the purlins, a 19th century alteration
26 - second re-used oak beam to the cowhouse, inserted 19th century brickwork

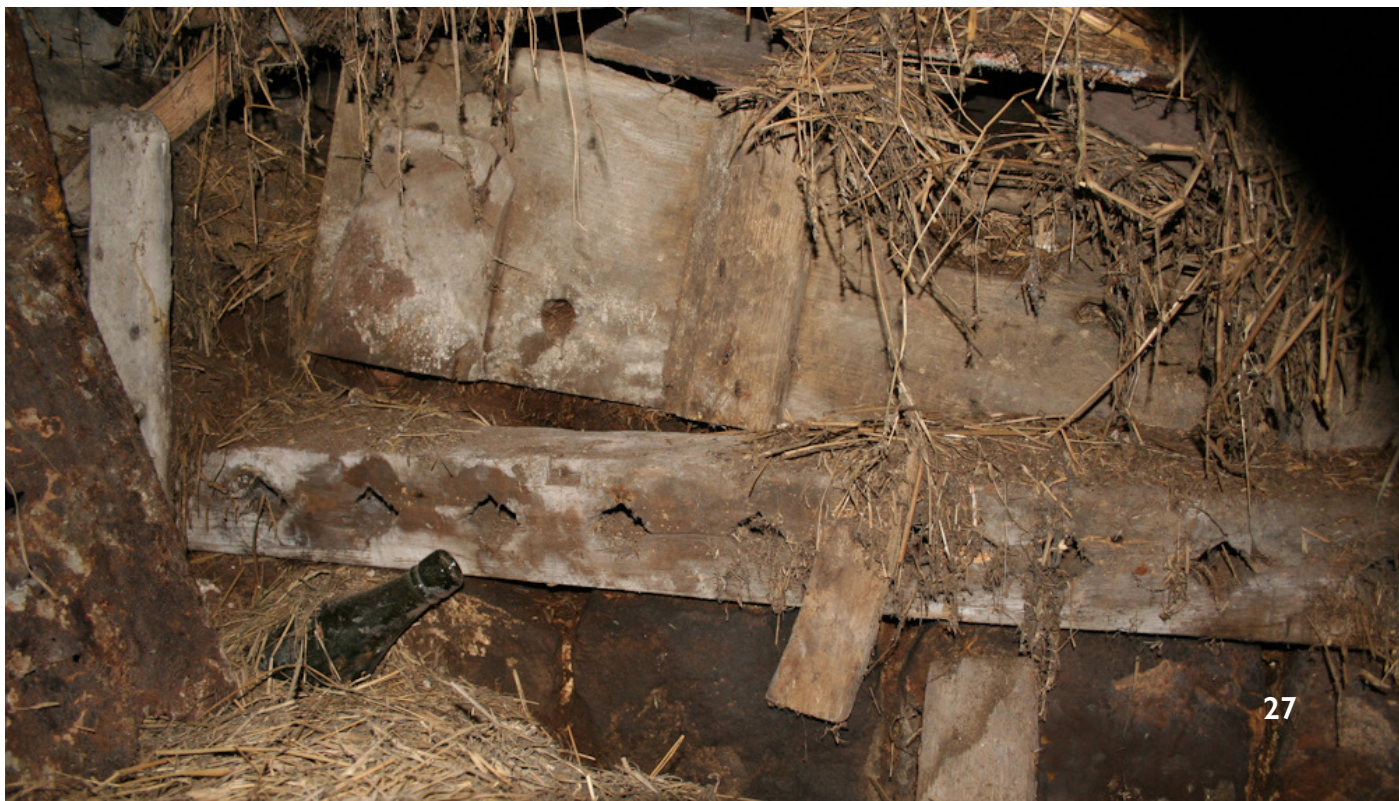
27 - fragments of oak manger, ex-situ, and lodged in the base of the cowhouse wall, with an old shutter or boarded door. The manger contained diamond-section slots for staves.

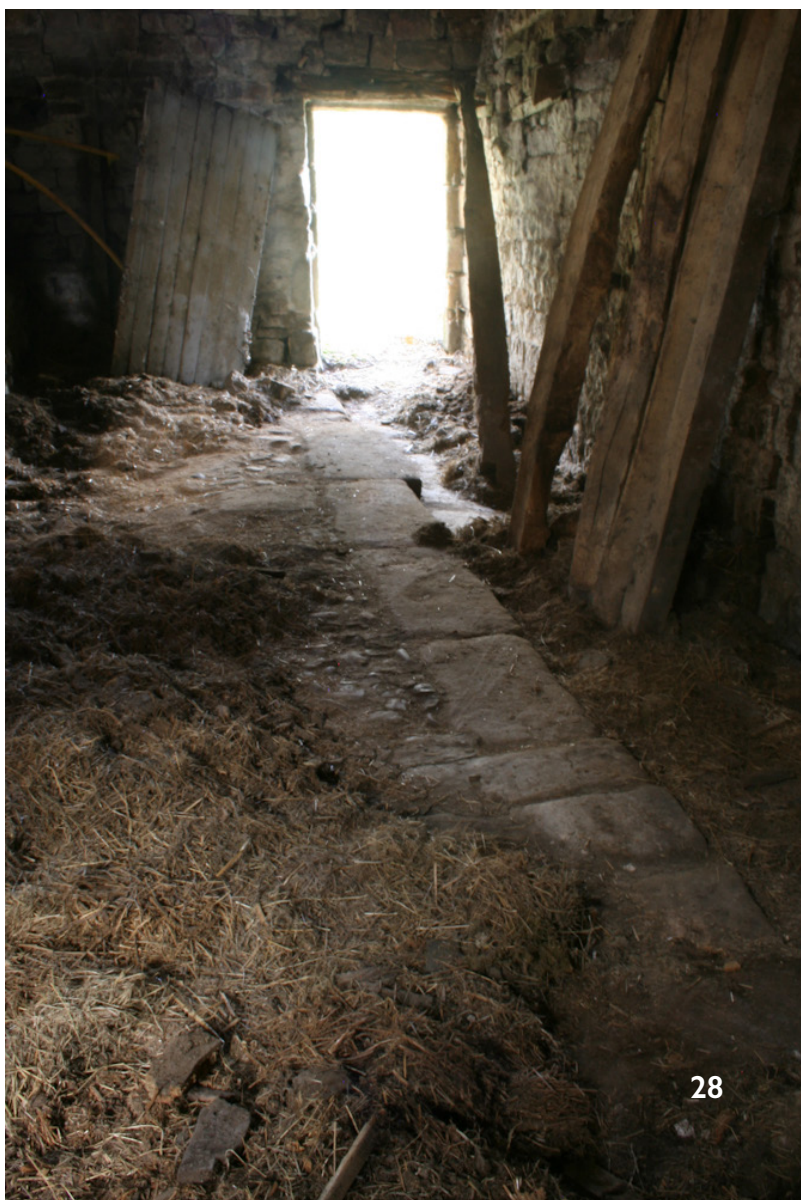
28 - Cowhouse with floor of stone flags, manuring passage, raised kerb and stone pitching to cow stalls, in-situ.

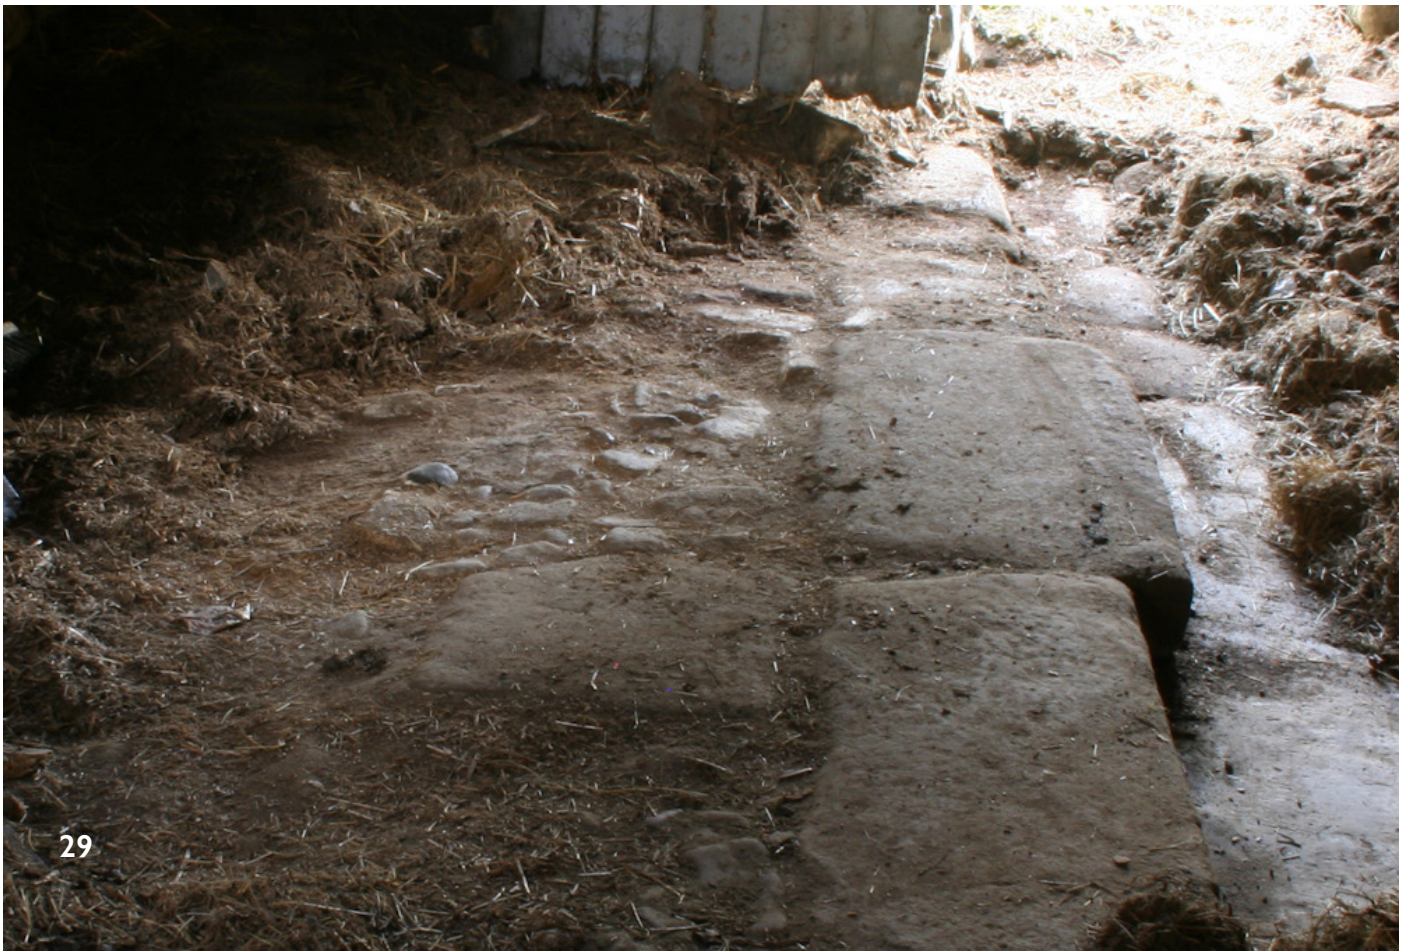
29 - Detail of stone paving flags, kerbs and pitching to cowhouse floor

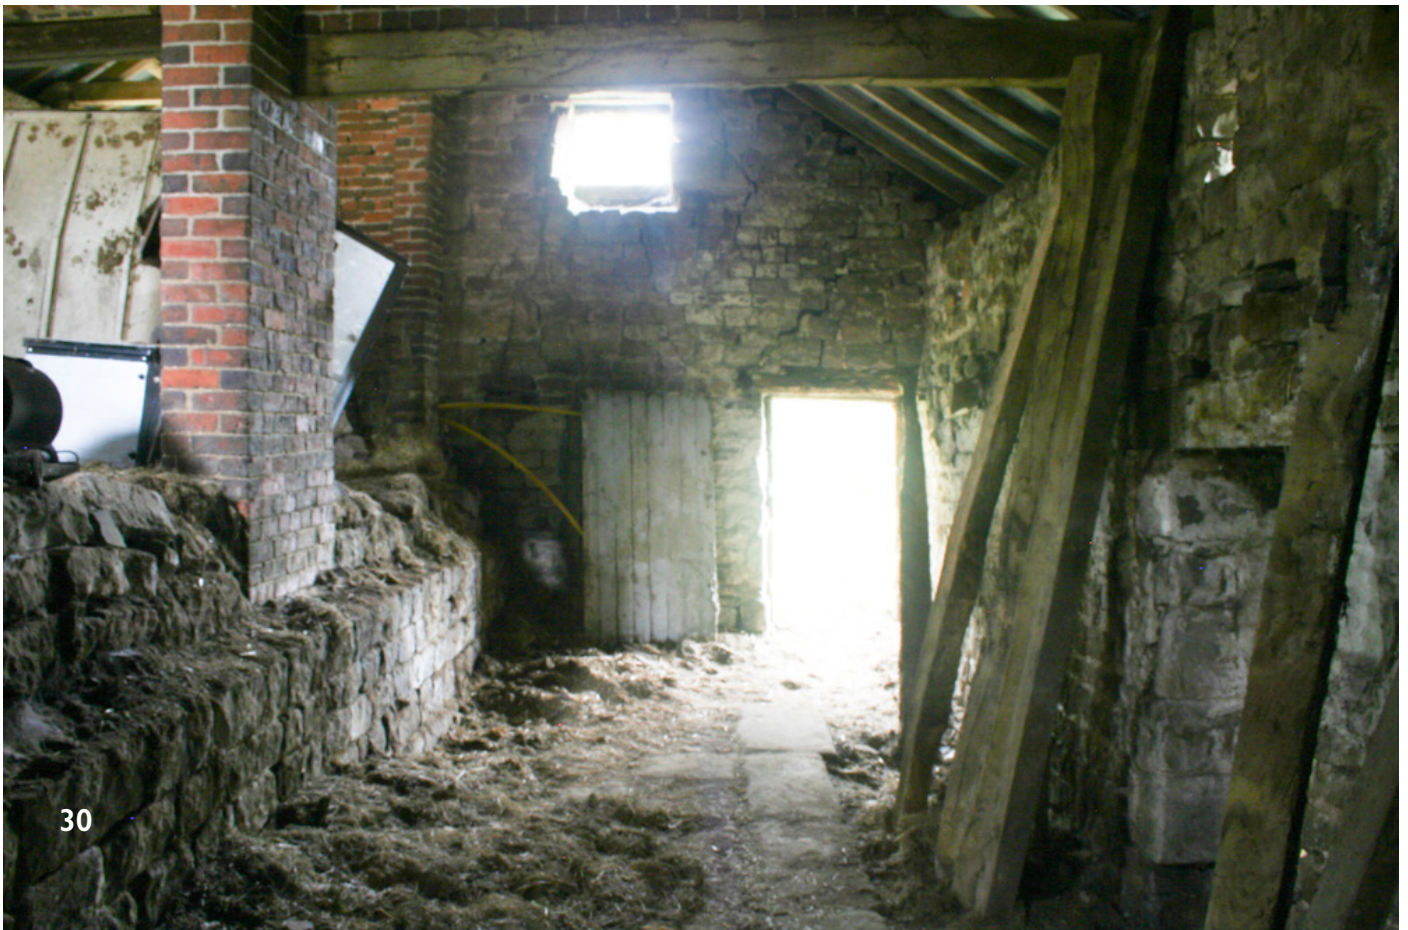
30 - view looking north through the cowhouse; manuring passage door and former mullioned window, and stone plinth, brick piers inserted to replace timber posts.

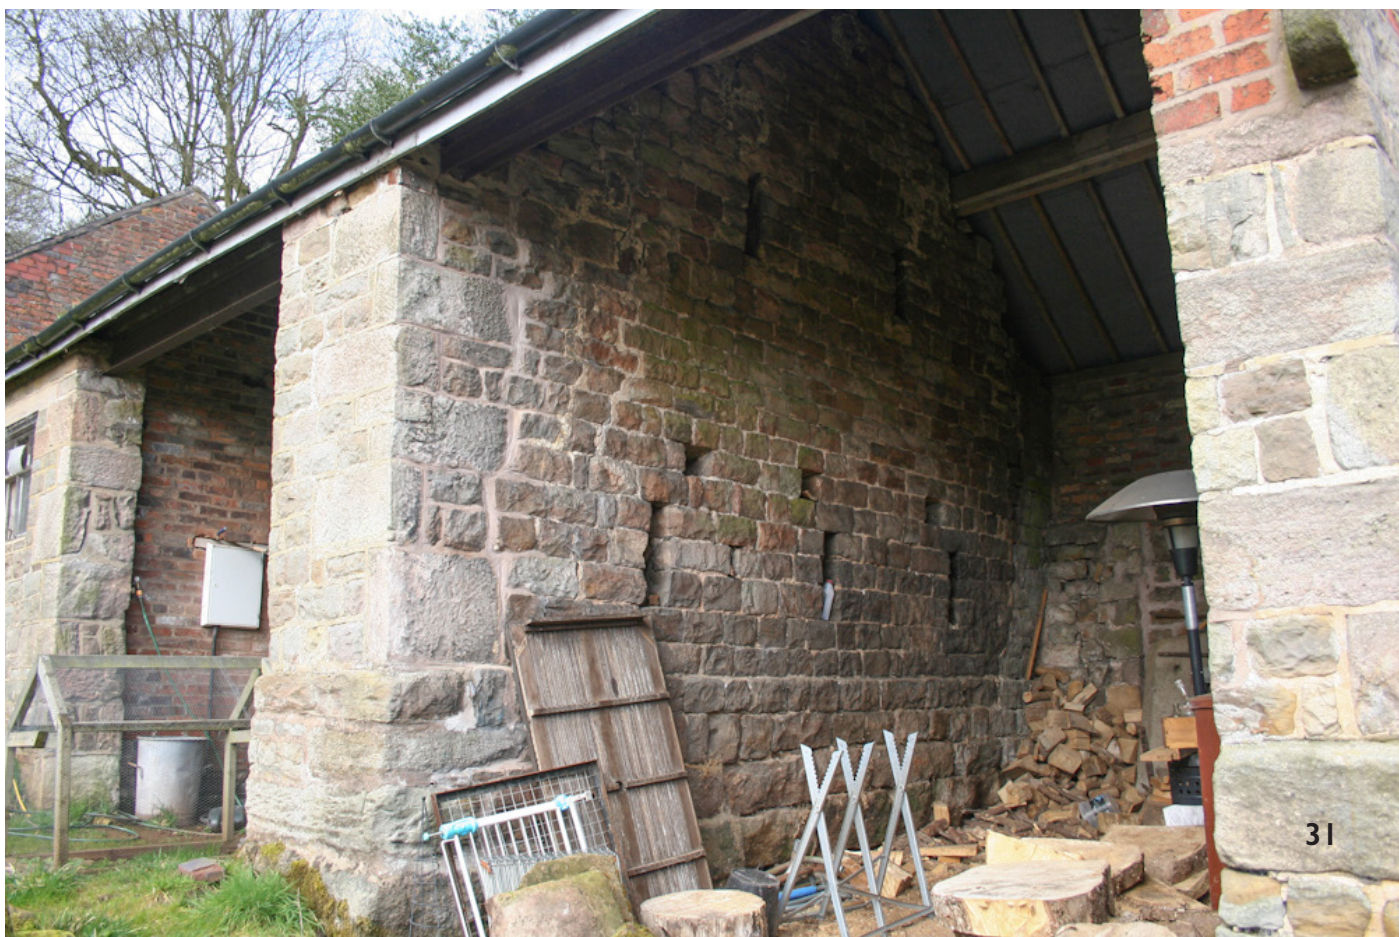
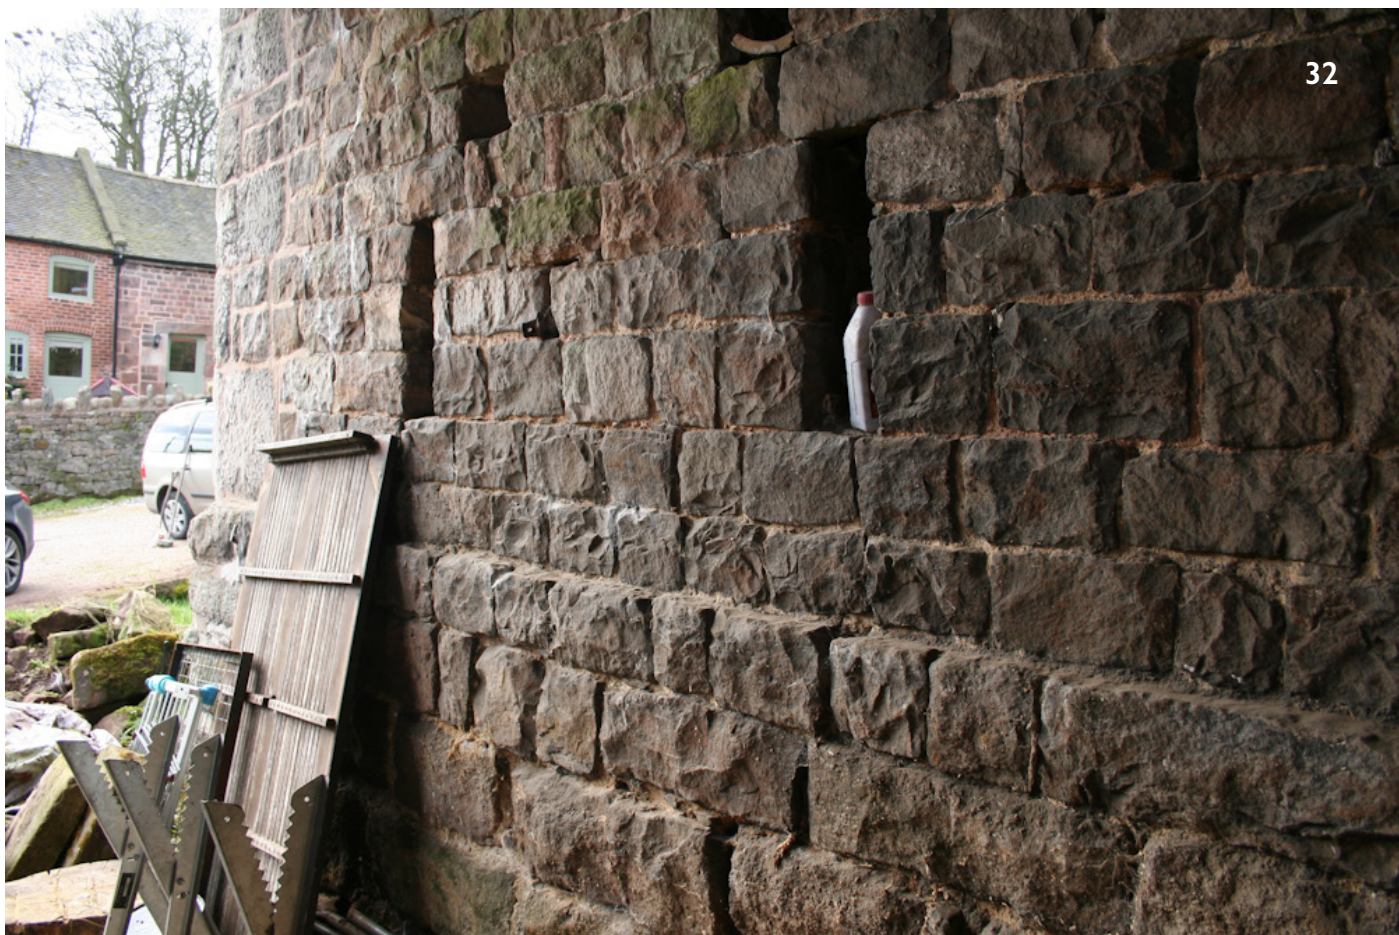
31 - Stable Range. View through cart entrance to former gable end of stone hay barn, with tiered ventilation slits, large masonry plinth, massive stone quoins.

32 - Detail of stone plinth, squared rubble masonry with large courses to plinth, ventilation slits, and sockets for a former inserted floor

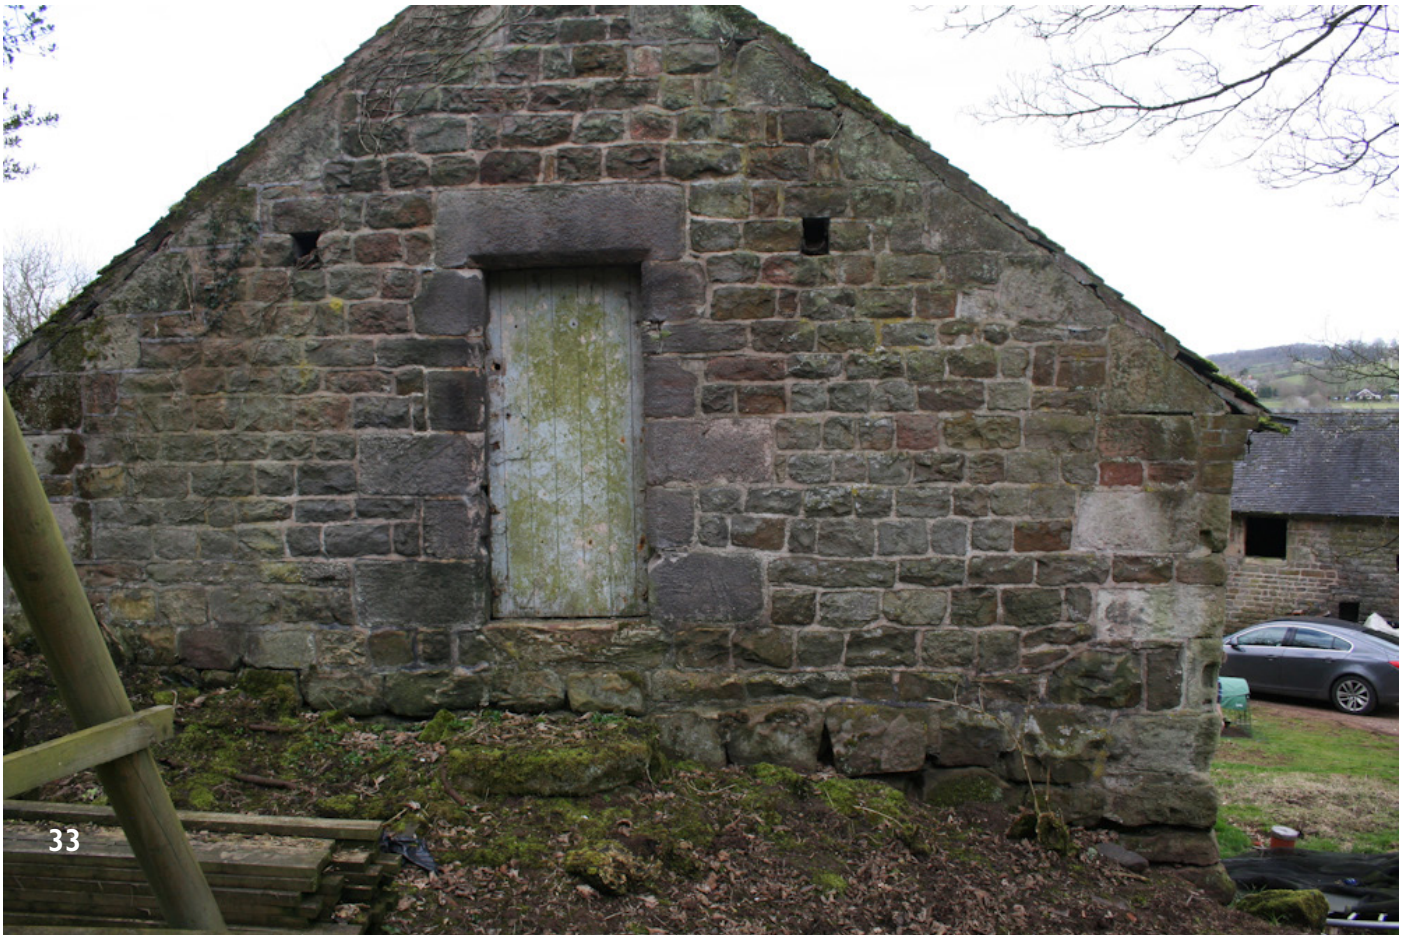
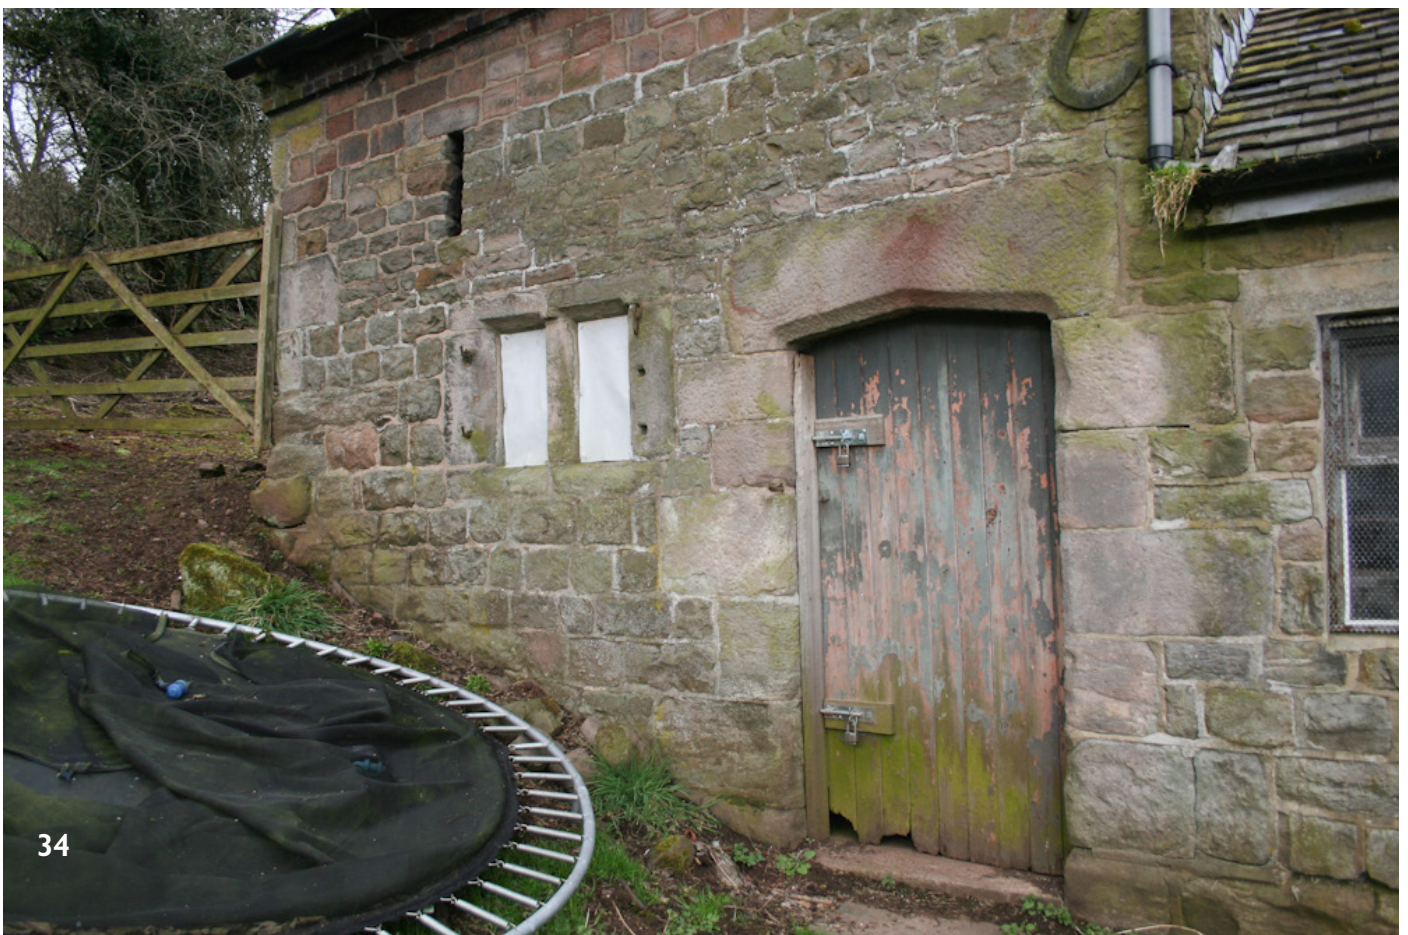
33 - Stable range. Gable end to the west with chamfered door surround and large verge stones; coping to gable removed. The gable was probably heightened when the eaves of the Stable was raised.

34 - Stable door with Tudor-arched doorway and small chamfered mullioned window. External shutters removed. The eaves were raised in three courses of pink coloured sandstone, with a corbelled brick eaves.

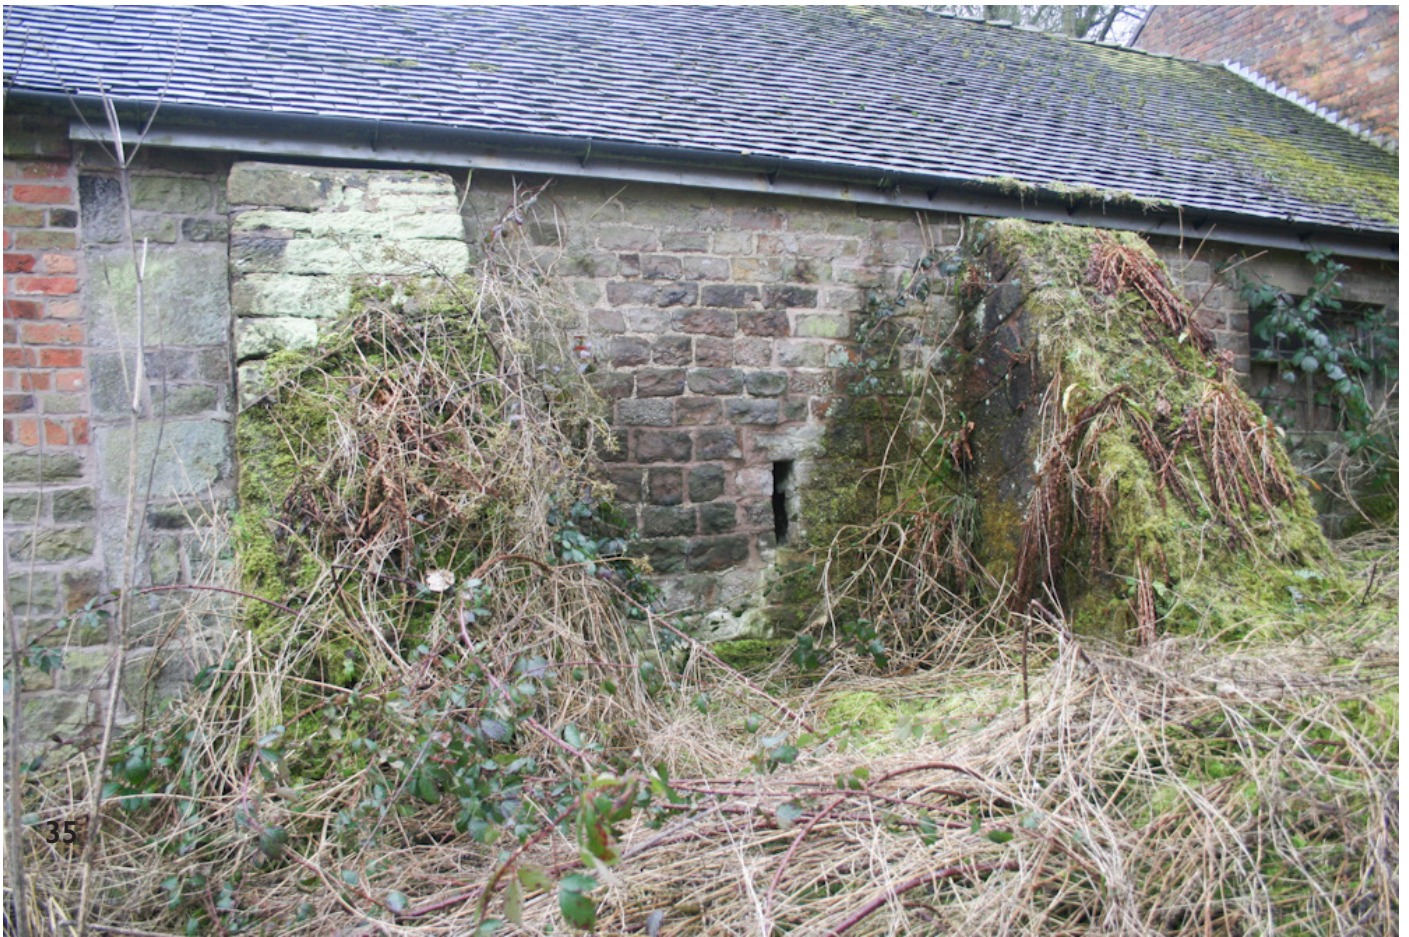
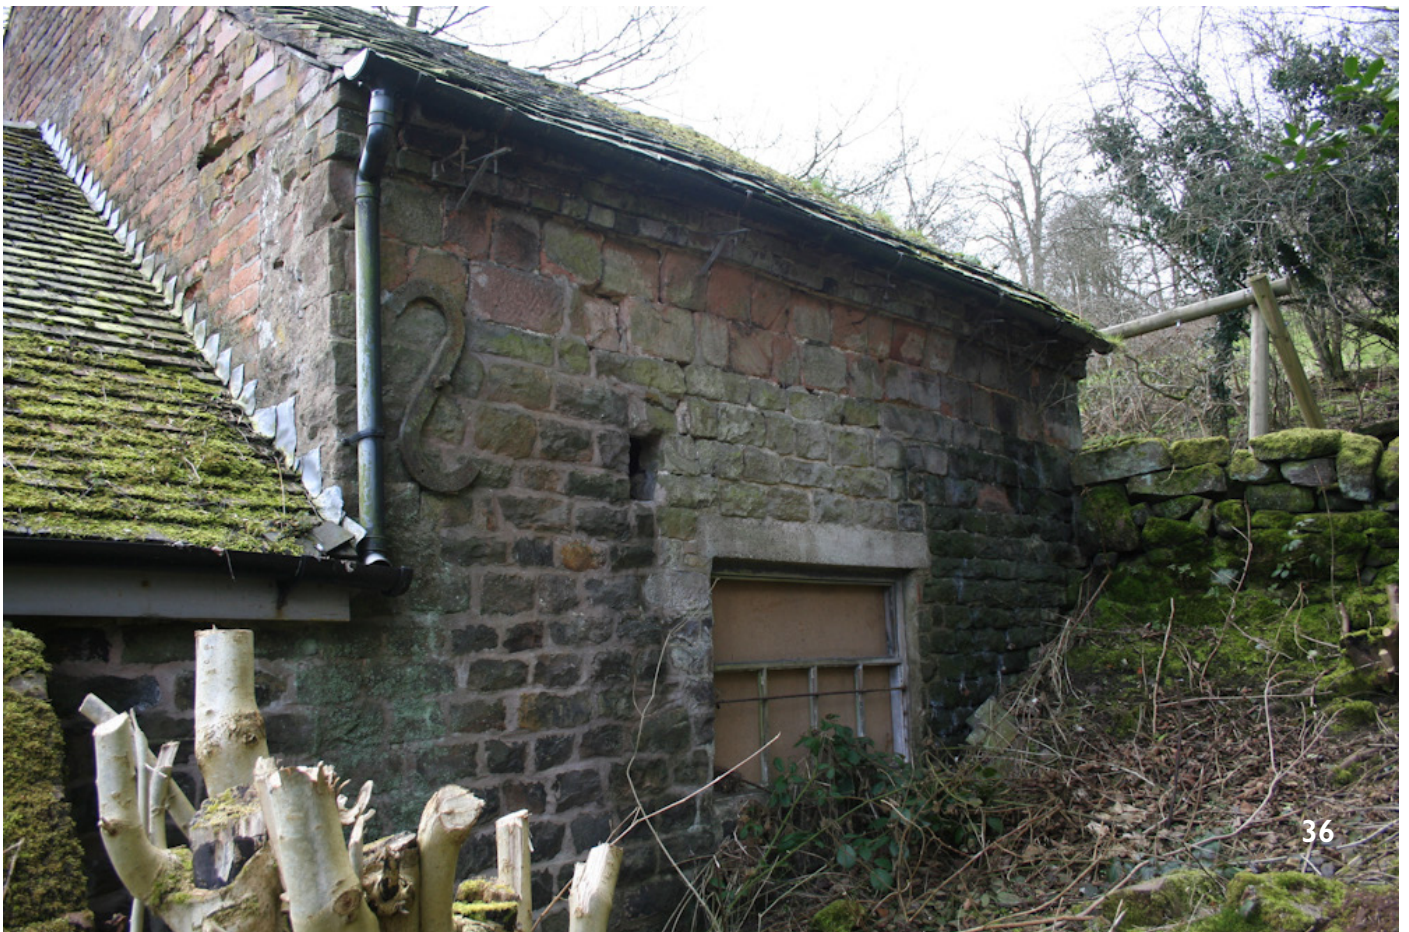
35 - North (rear) wall of barn to Stable Range. Ventilation slits, coursed sandstone with large irregular quoins, and later stone buttresses

36 - Rear elevation of Stable, altered in the 19th century with coursed stone raised in two courses of pink sandstone, with corbelled brick eaves.
