APPENDIX 2 - PHOTOGRAPHS

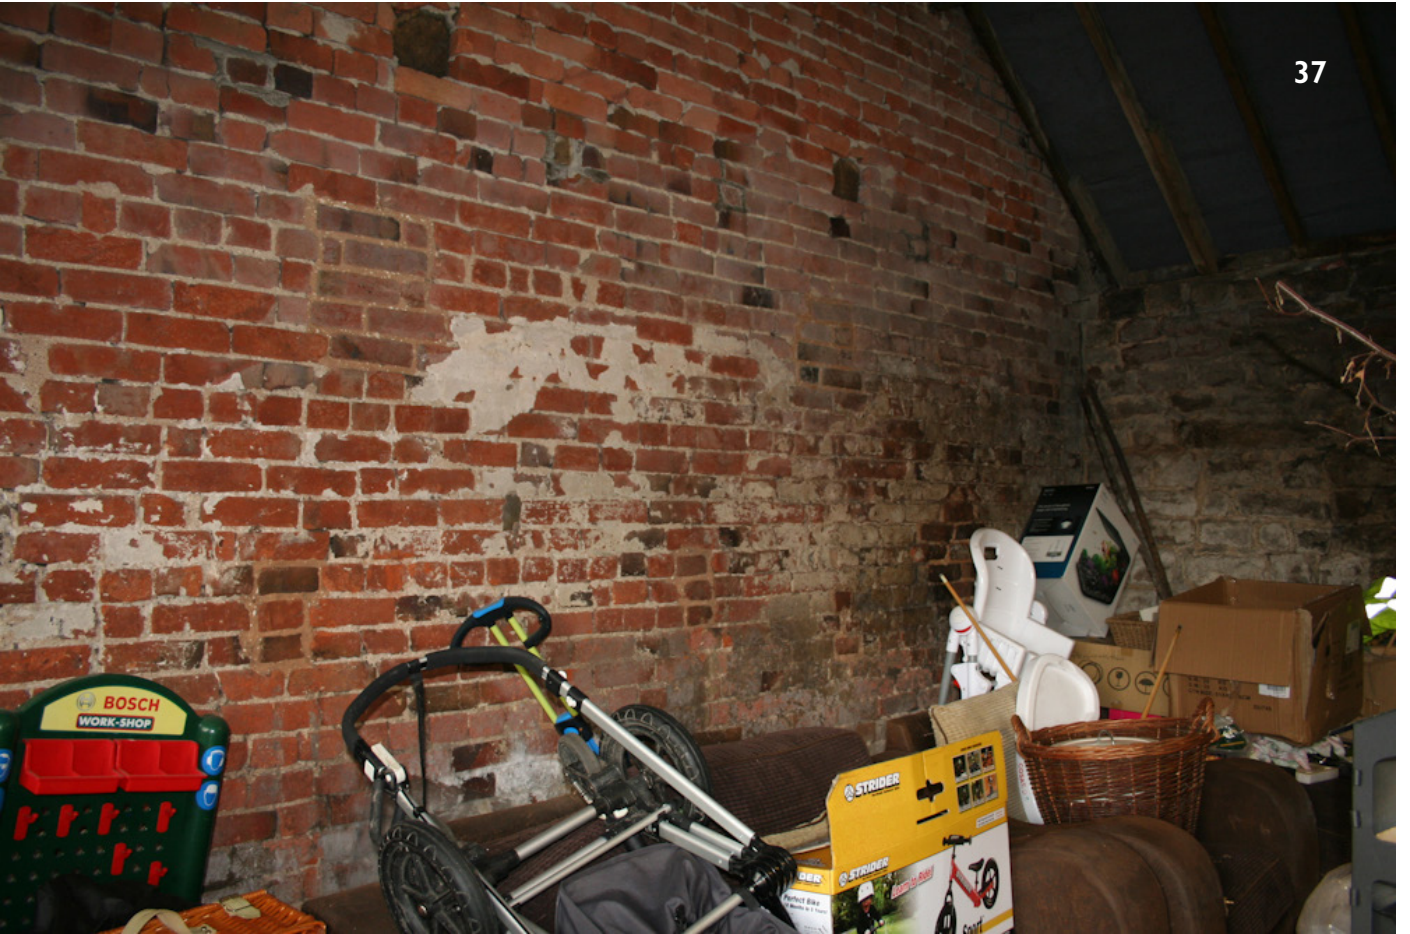
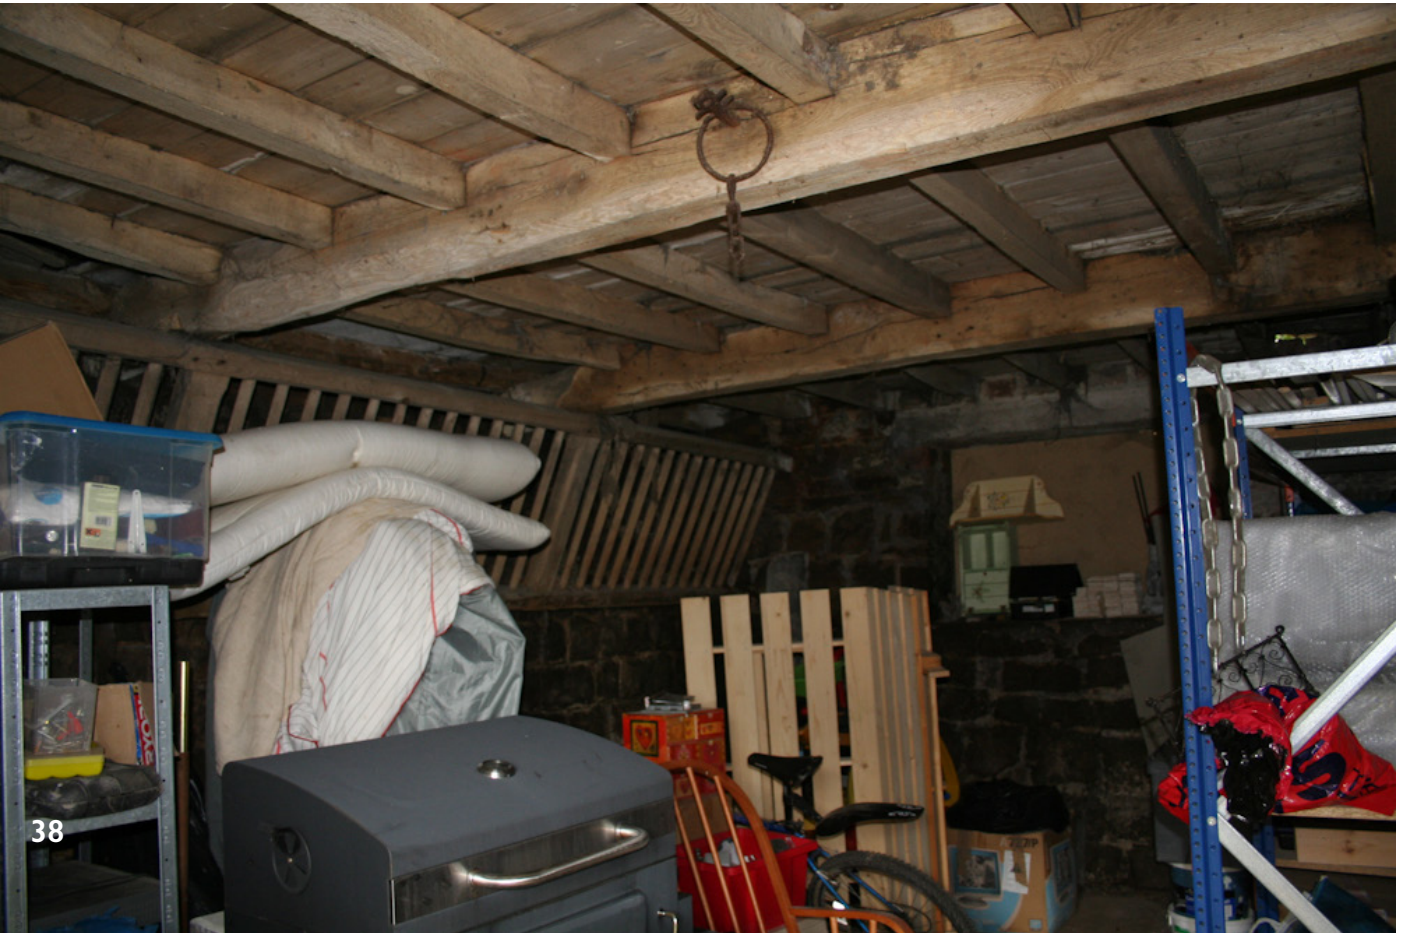
37 - 18th century brick wall dividing upper two bays from lower third bay to former 17th century combination building
38 - Stable with 19th century oak beams, joists and boarded floor to hayloft

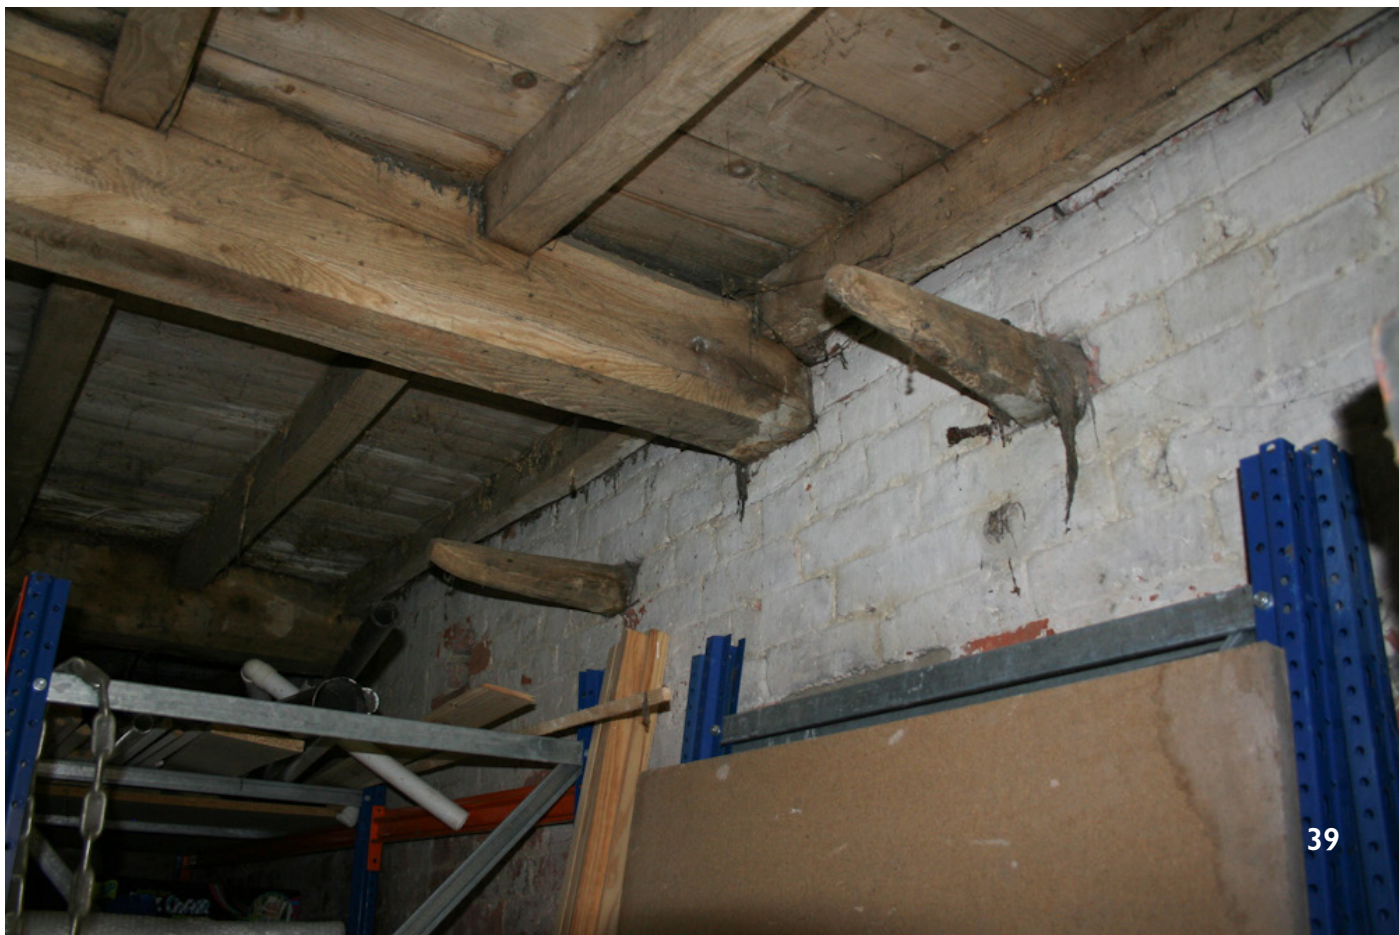
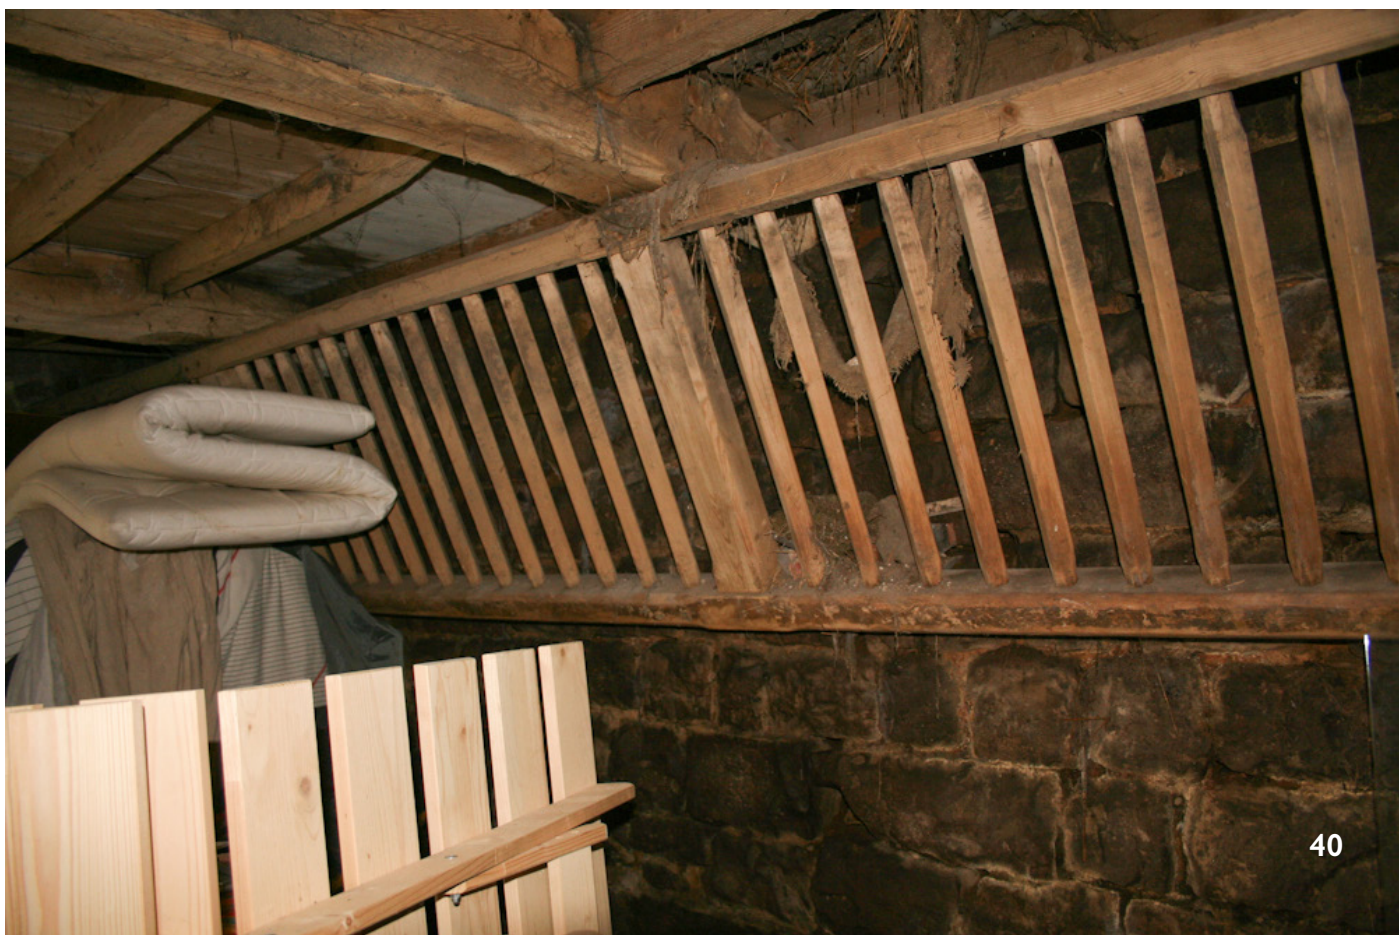
39 - 19th century inserted brick wall to Stable with oak brackets for saddles and tack
40 - horse hay manger to loose-box type stable, Stable Range

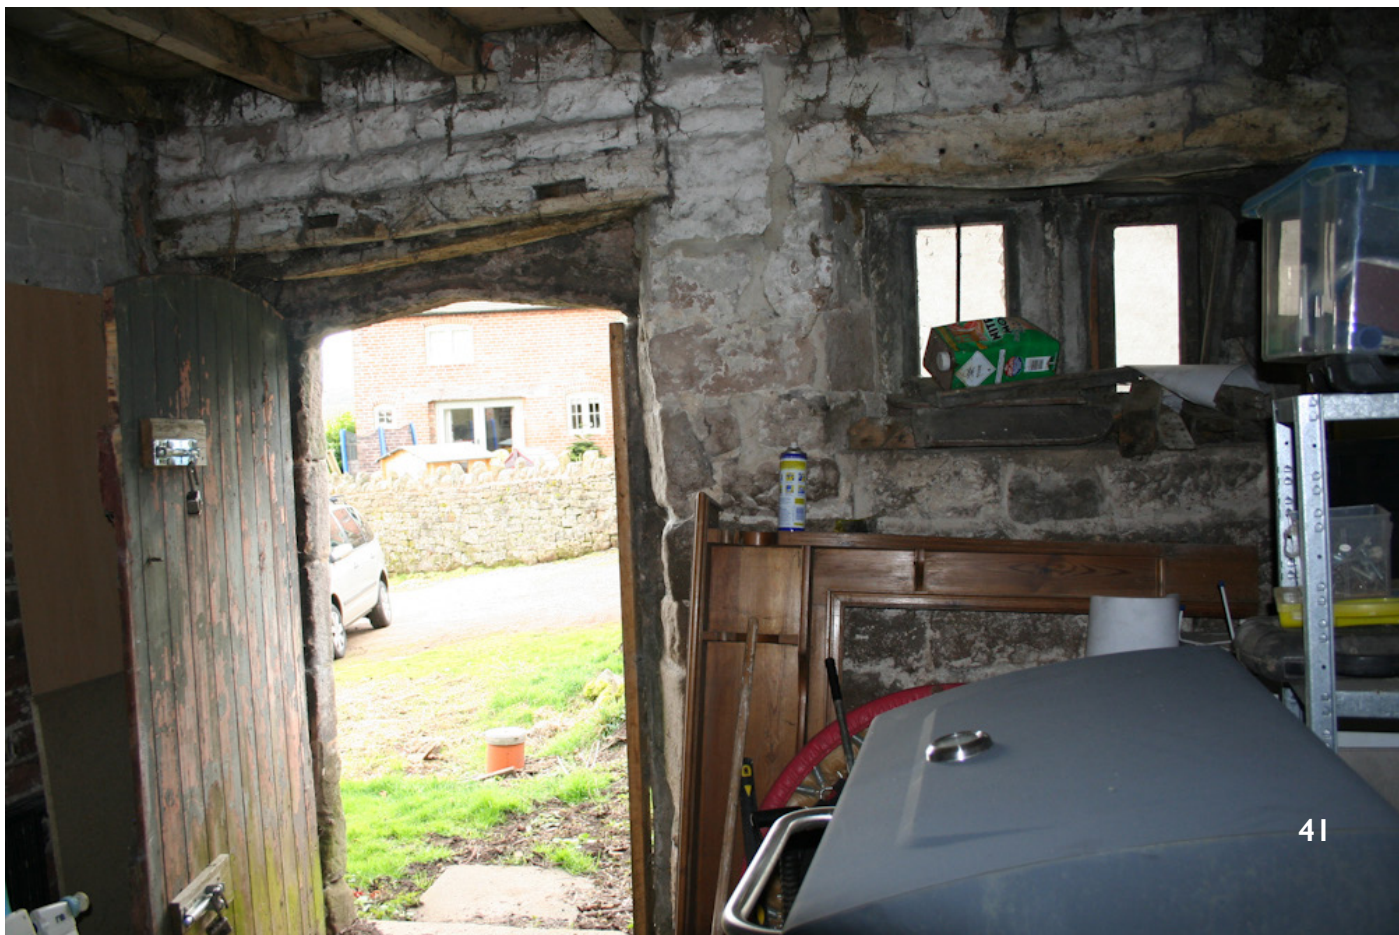
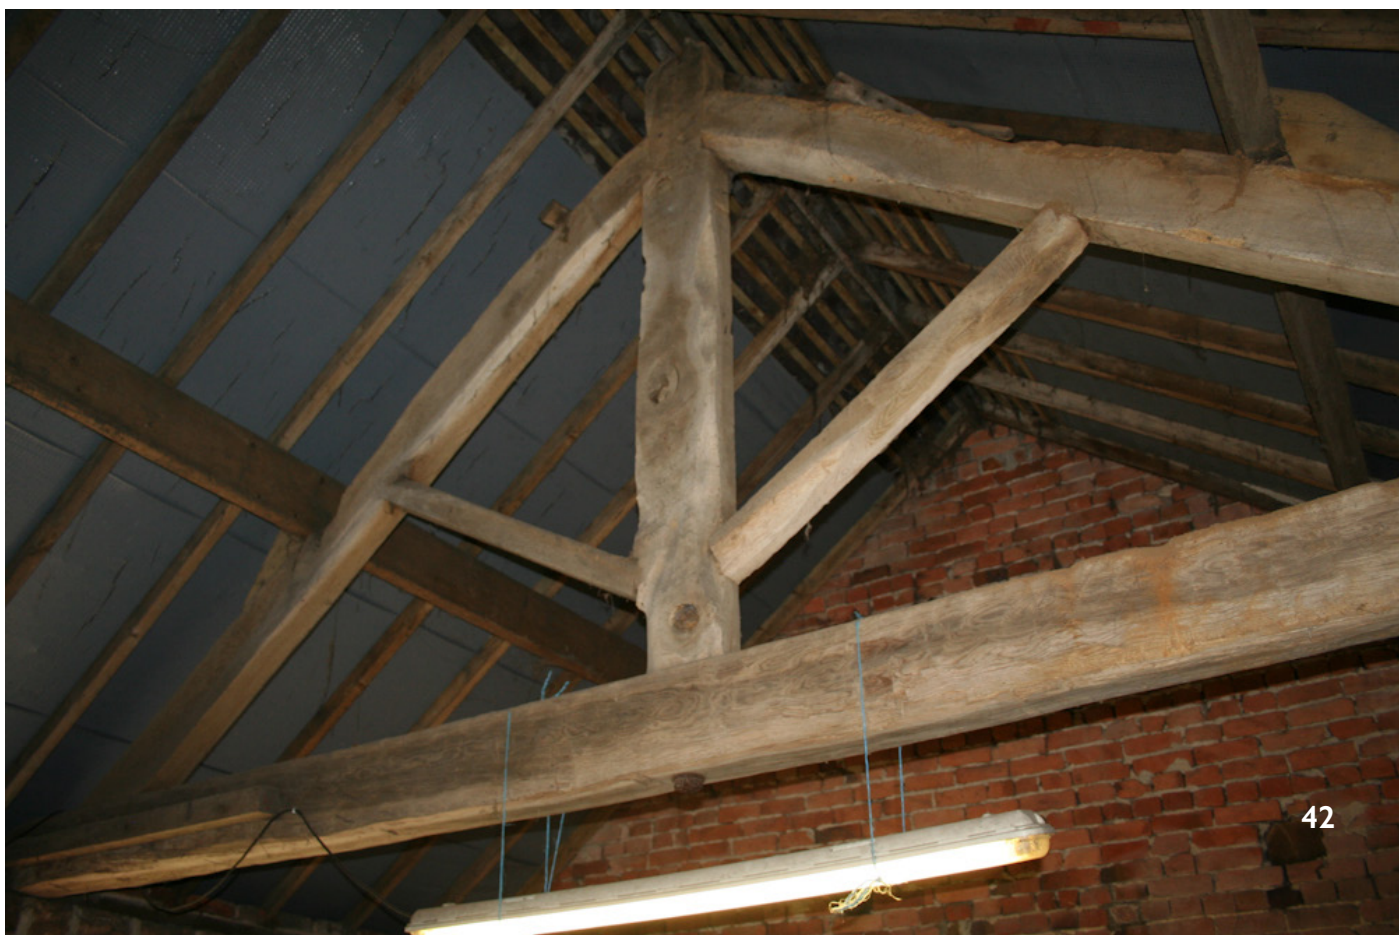
41 - View of front Stable door and chamfered stone mulioned window with oak lintels, 17th century stable
42 - 19th century king post truss with coach bolt threaded between tie beam and main post, and struts to the principal rafters. This is one of two inserted trusses in the Stable Range
