Photographs - Mezzanine

f14_003_14.05.20
Ashcombe Park - Historic Building Record

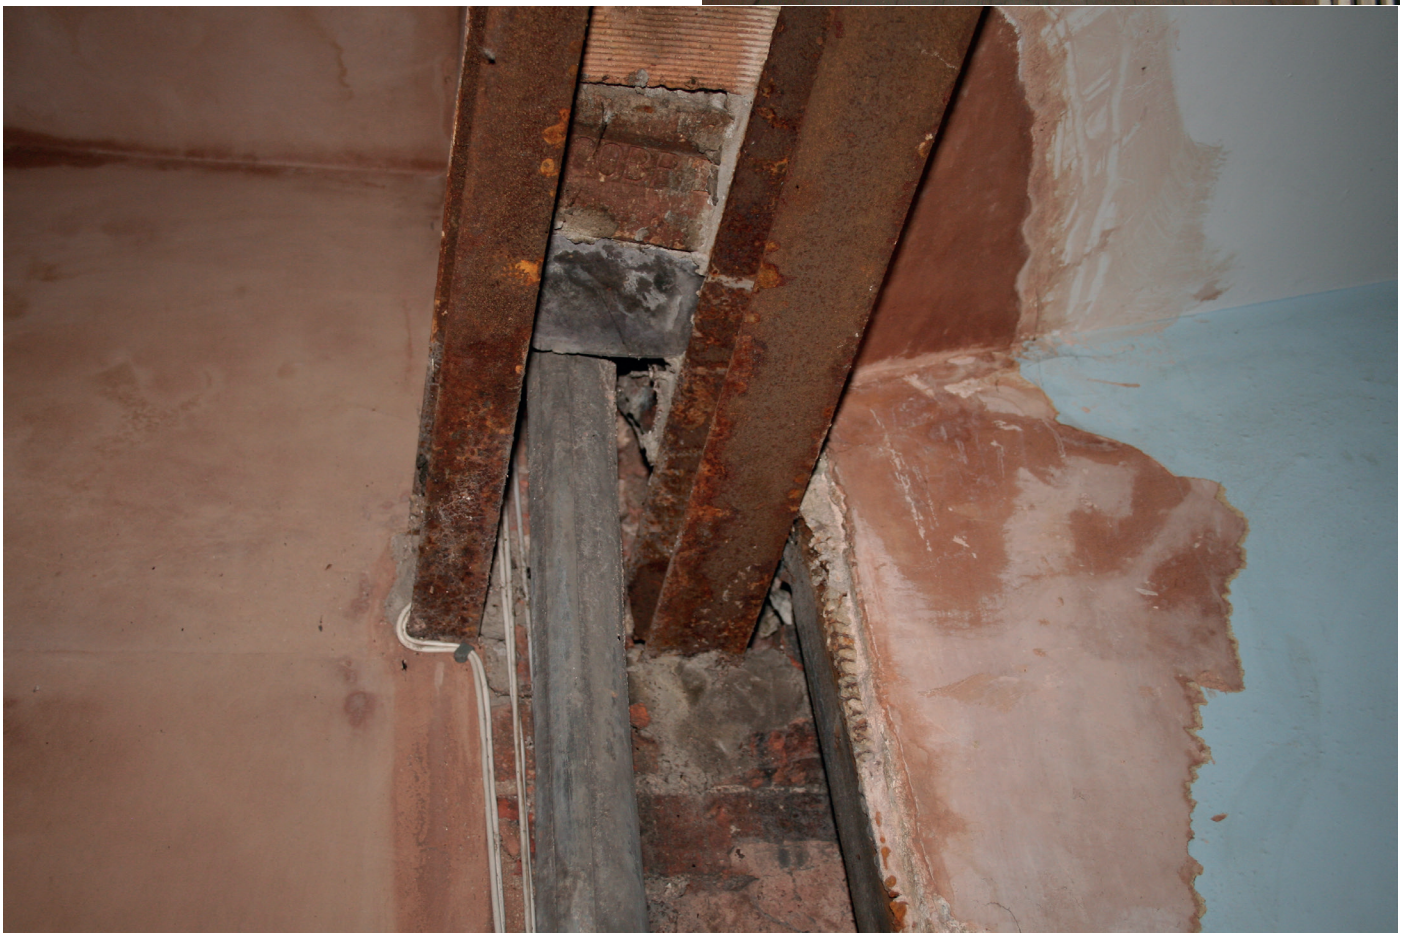
il_002_22.12.15

underside of lintel - steel joists & gypsum plaster repair
- C20

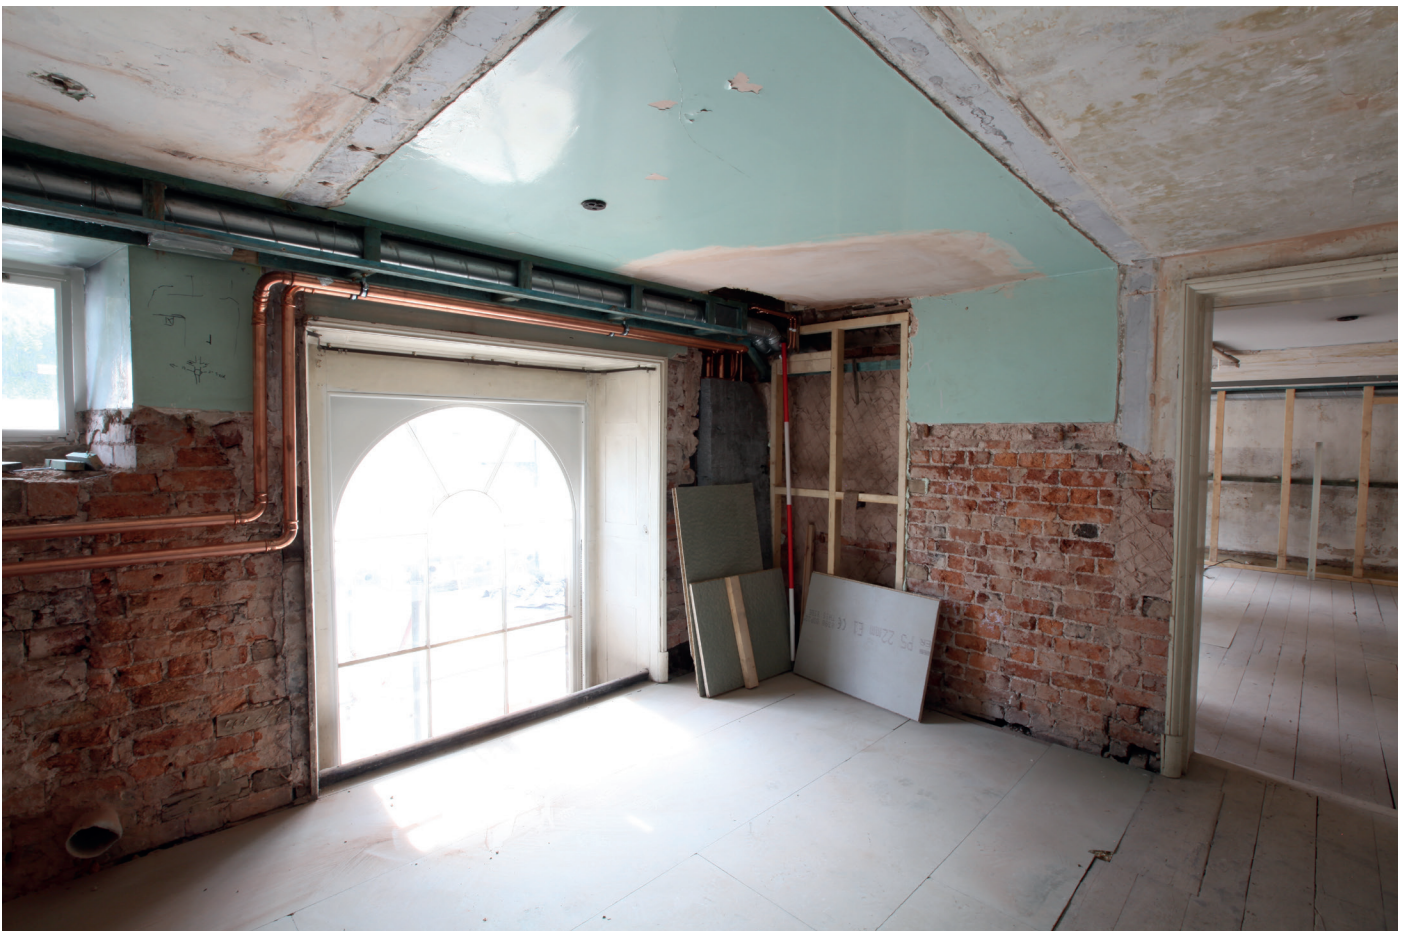
i6_003_14.06.21 - note straight joint, brick repair and lathe-and-plaster ceiling, with part gypsum skim.

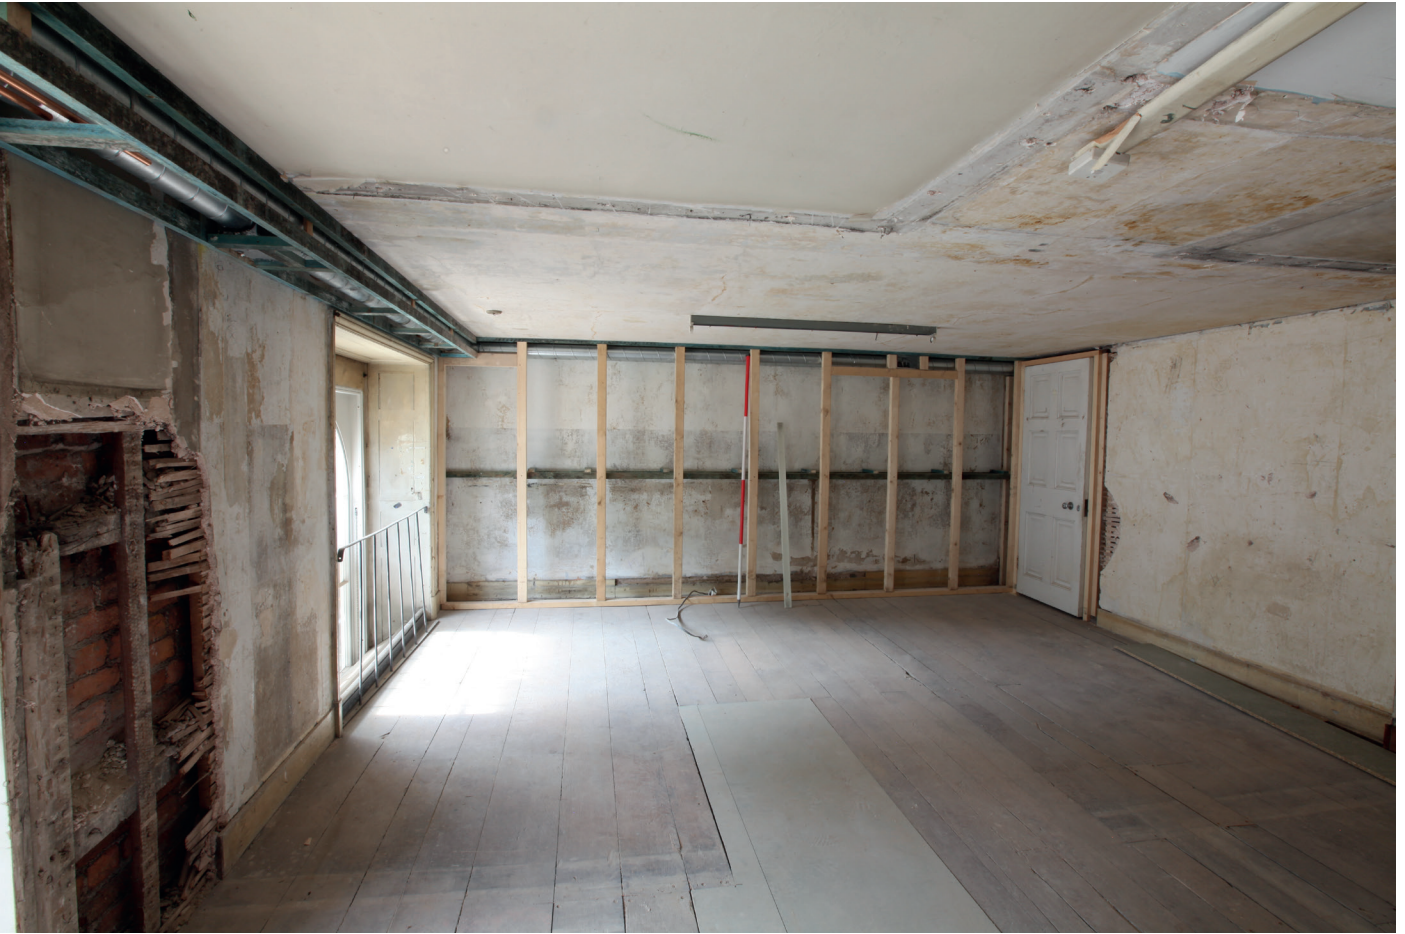
i8_004_14.06.21
new partition to replace linen cupboard to left.
Outer wall lined with studwork and lathe-and-plaster.

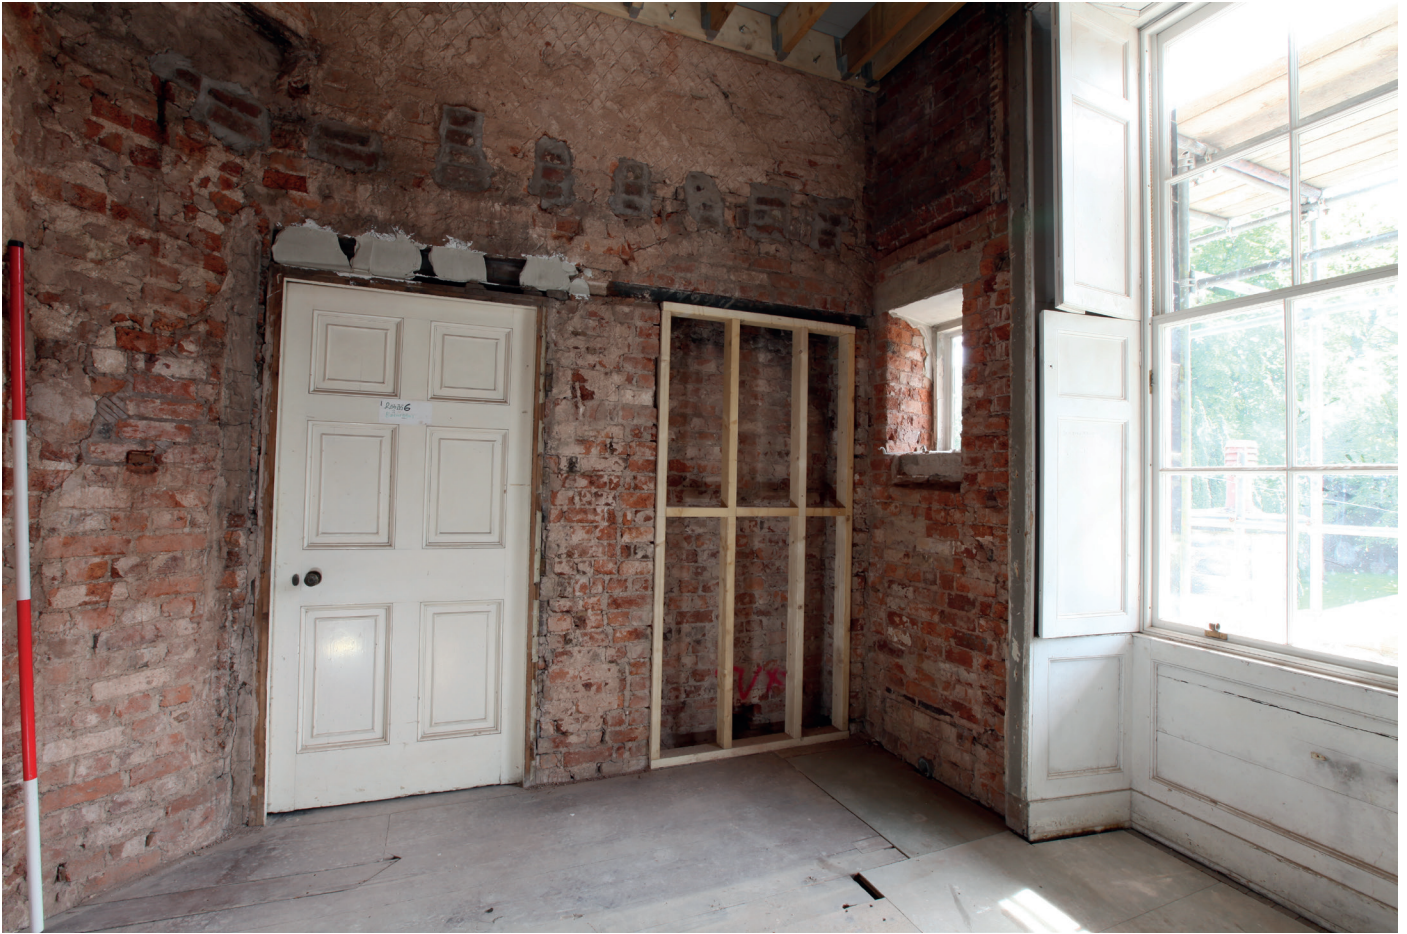
f7_003_14.06.21

Note arch to niche to right of current doorway,
indicates previous 1806 doorway position.
Inserted ceiling removed and raised to original height.

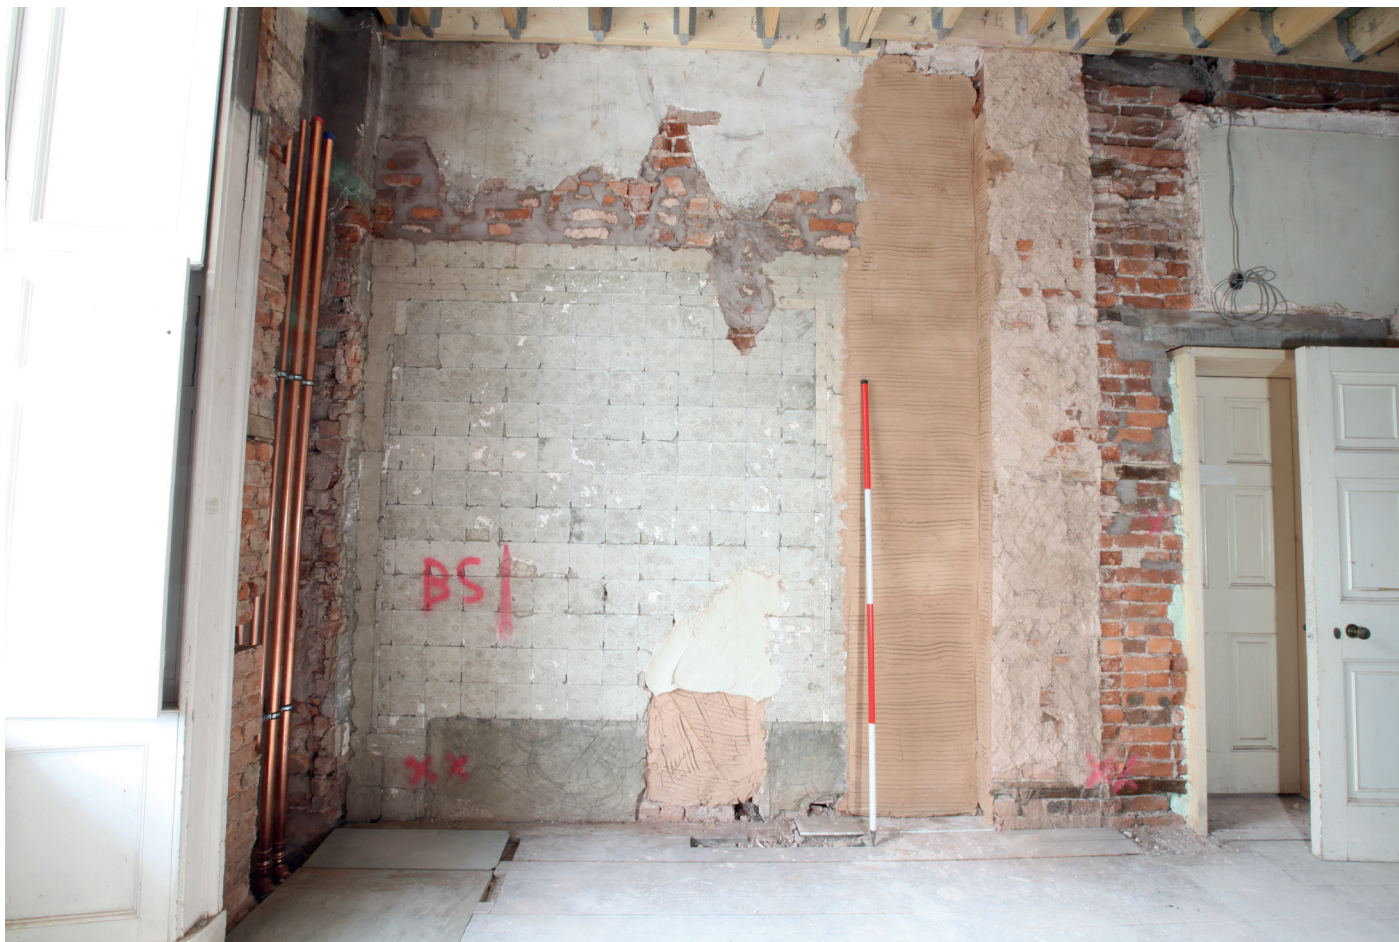
f8_004_14.06.21 - note bricked-up corner flue to this space.

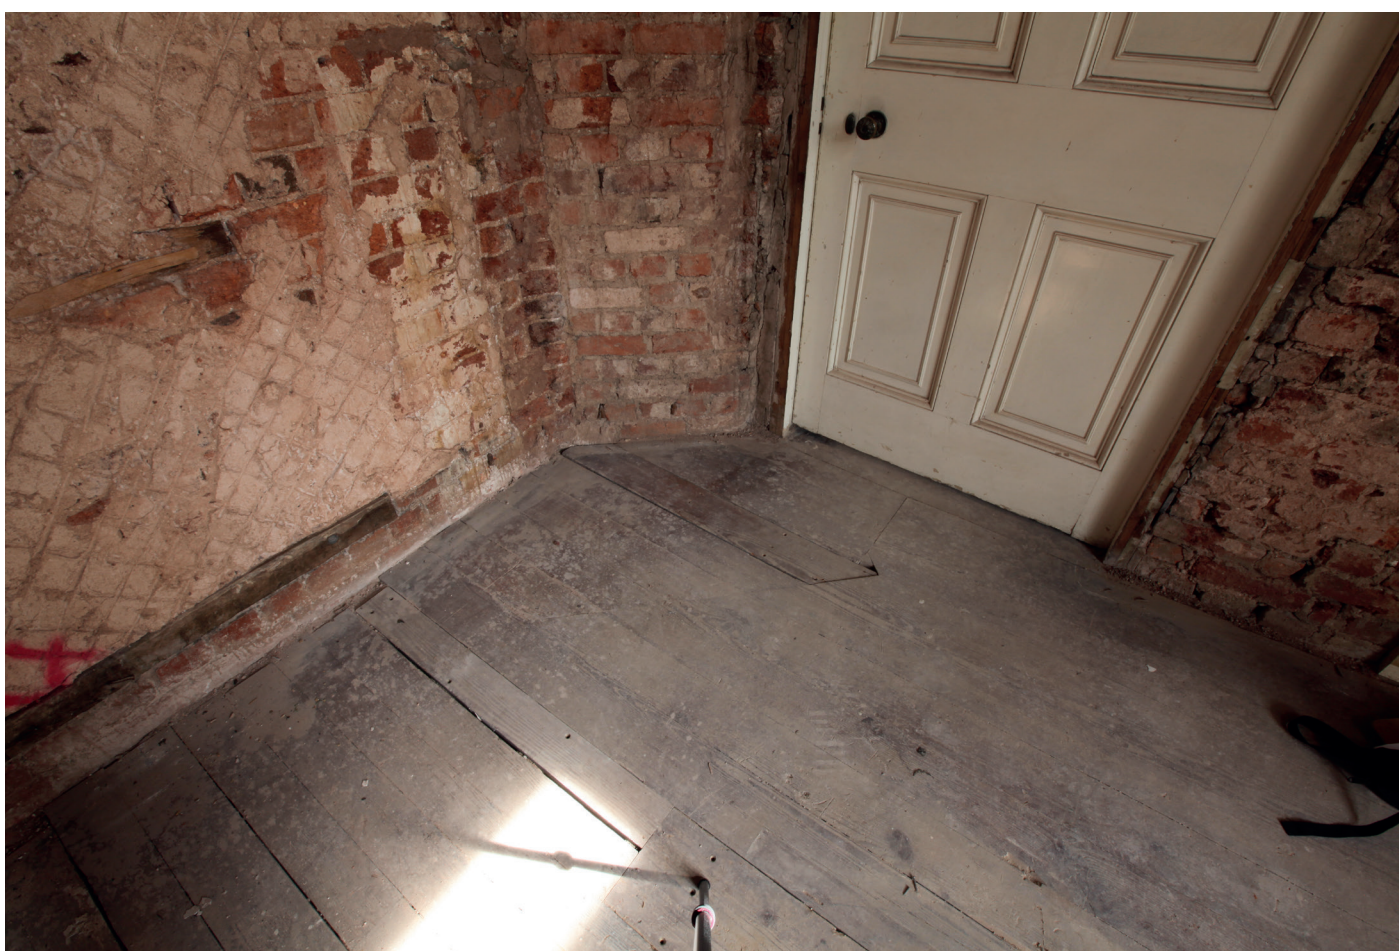
f8_006_14.06.21 - former location of hearth visible in floor by made-up boards replacing stone hearth

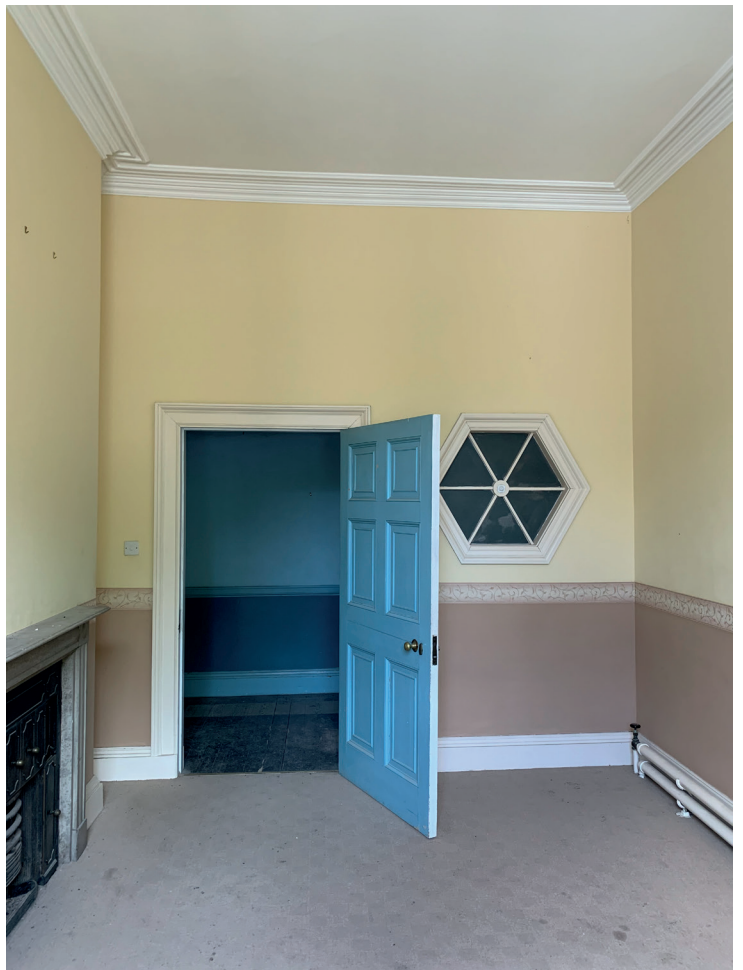
f12_002_14.05.20
Bedroom with small internal window and new partition,
probably added in 1851 to light the corridor

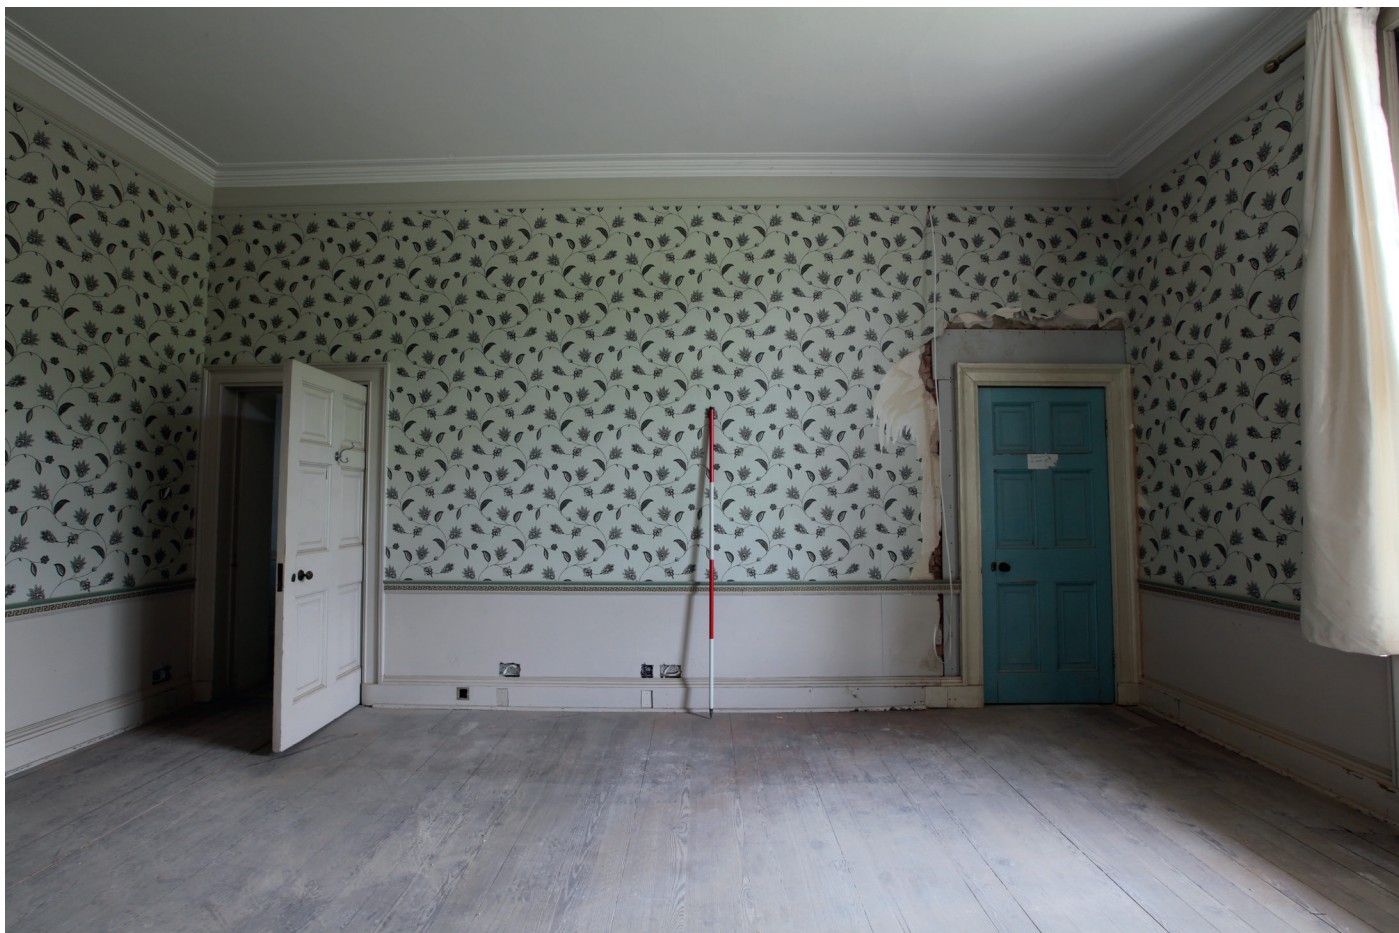
f17_001_14.06.21 - relocated door to right
