PRIORY CRESCENT SOUTHEND-ON-SEA

Condition Survey

06 November 2009

Site condition report following the dismantling of Camp Bling

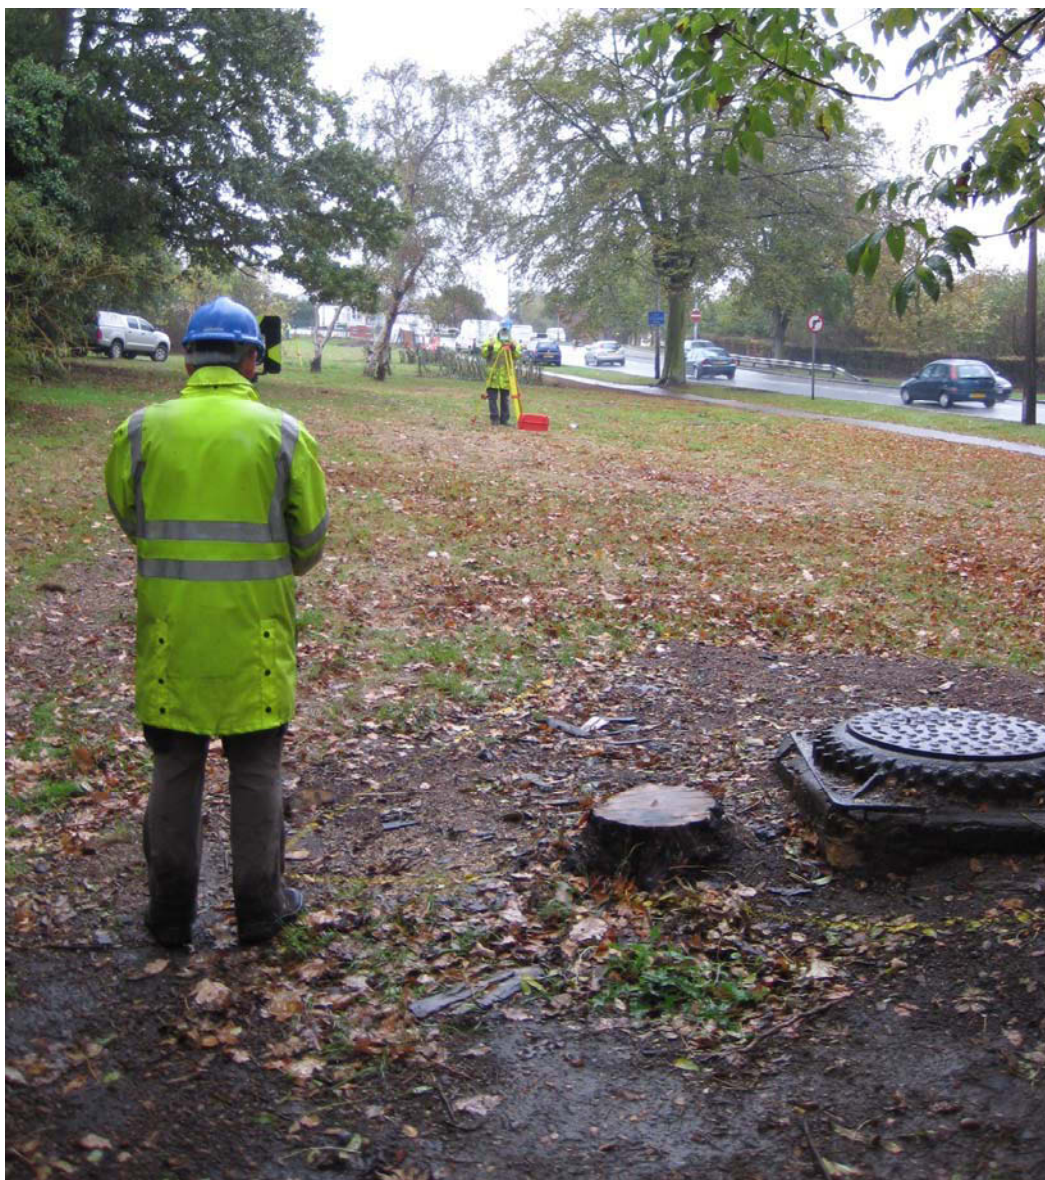
Cover: Site condition survey in progress – surveying the footprint of a Camp Bling structure erected to enclose a pre-existing manhole and likely entrance to the reported tunnel system

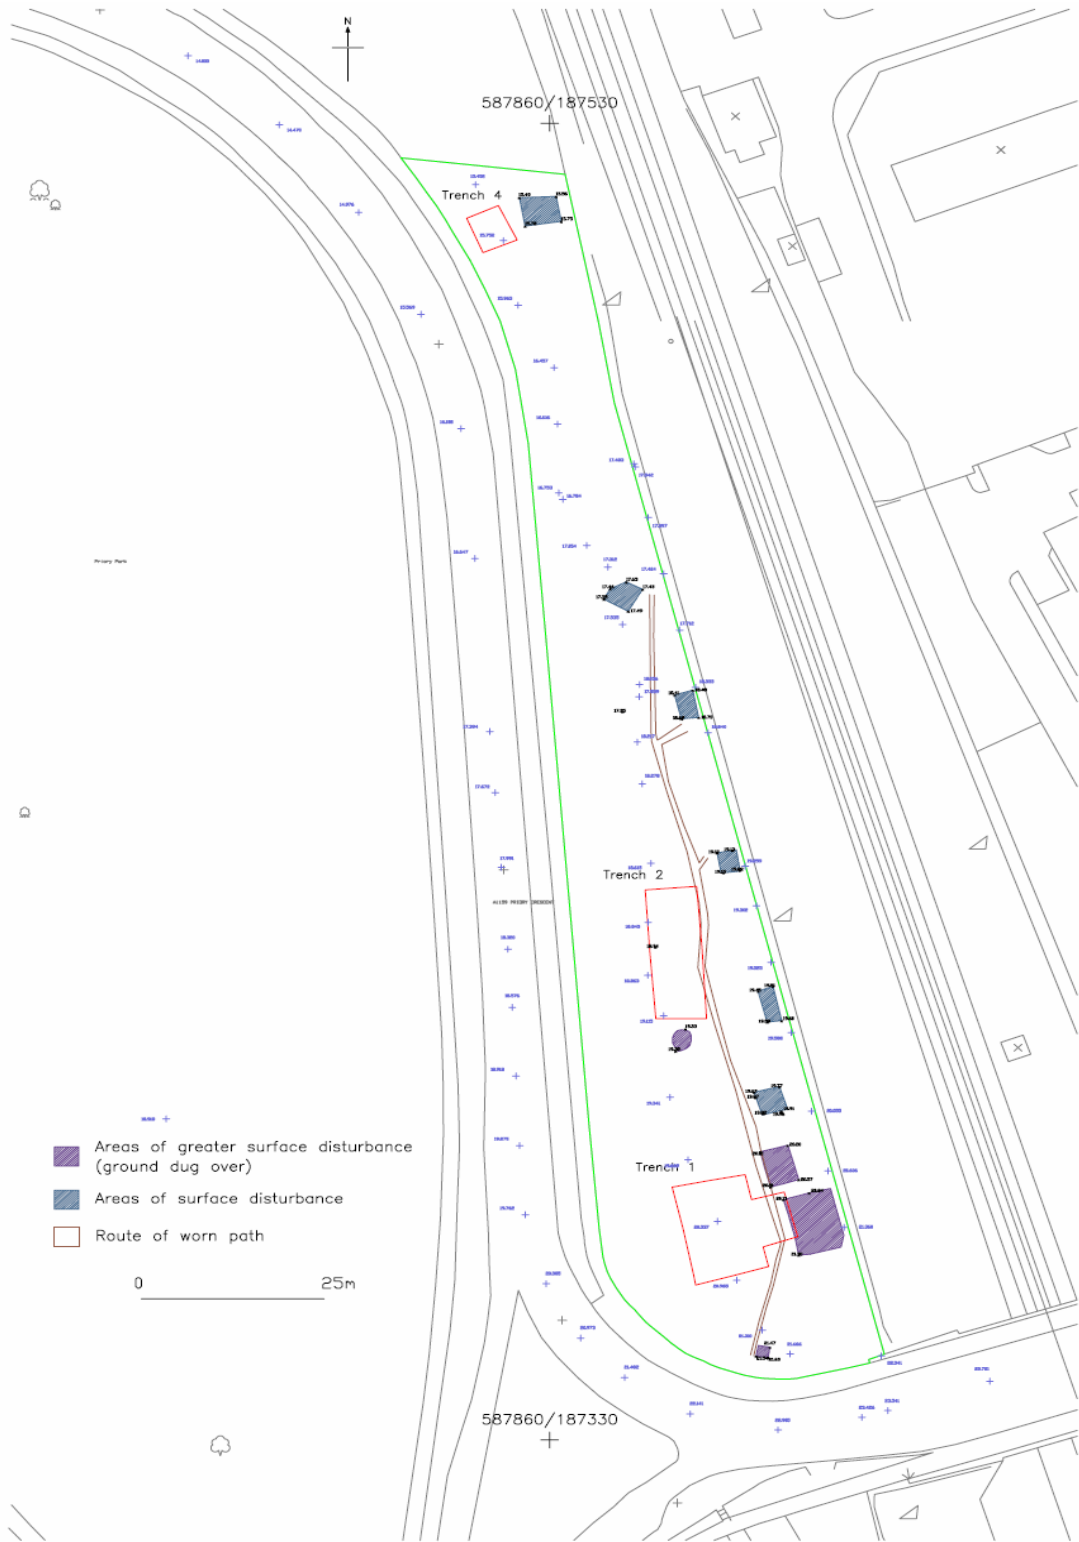
A total of ten areas which met with the above criteria were defined and these targets located using a combination of handheld Global Positioning System (GPS) and EDM total station (see Fig 1 and cover) likely to reflect the positions of the more robust structures and buildings of Camp Bling (see Fig 2 and Fig 3).

Fig 1 Condition survey plan of site showing areas of 'Camp Bling' surface disturbance in relation to the 2003 evaluation trenches

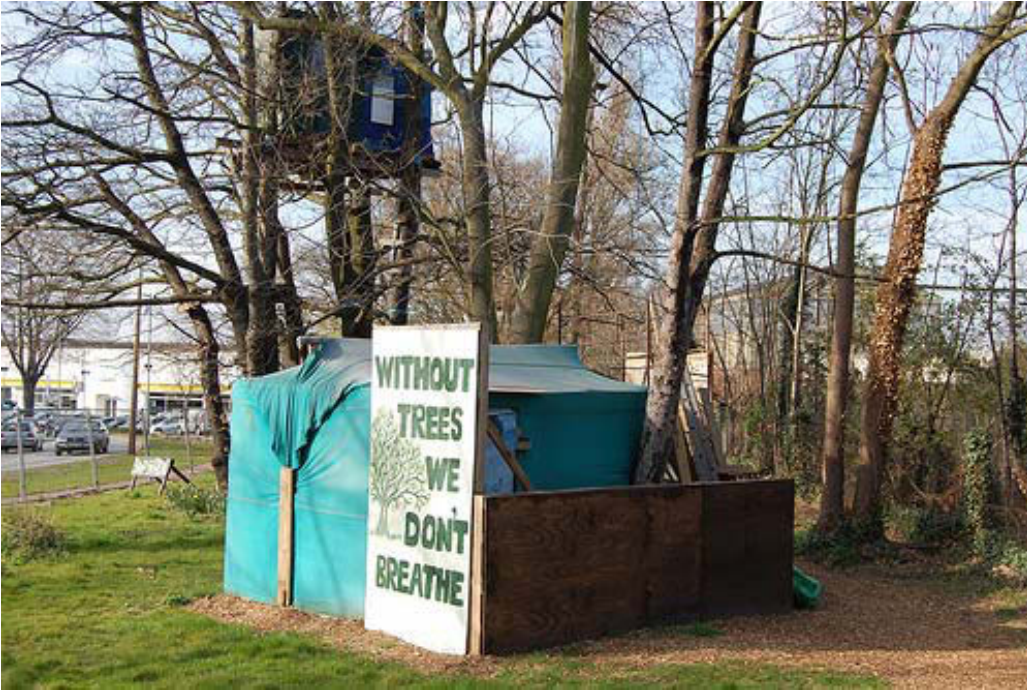
Although a question about the reported '*non-invasive tunnel system*' remained unanswered, my view was that a picture of a deep shaft purporting to be an entry point into the tunnels was part of a pre-existing lined shaft and part of an existing drainage system on site. There is a substantial raised manhole over a deep drop-shaft in the centre of the site which it is assumed to have been opened and photographed. This theory is borne out by the fact that one of the Camp Bling structures had been erected around and completely enclosed the manhole (Fig 4 and Fig 5). In relation to tunnels, it may be prudent to inspect the side of the railway embankment along the east side of the site (which lies outside of the footprint of the survey area) to ascertain if any headings had been tunnelled beneath the site from this point, but this is thought to be unlikely.

Fig 4 Structure erected around existing manhole over deep drainage drop shaft: thought to be the entrance into the reported Camp Bling tunnel system (looking N)

- *The reported tunnel system beneath Camp Bling:* inspect the side of the railway embankment cutting along the east side of the site to ascertain if any tunnelled headings have been made beneath the site from this point.
- *The condition and geophysical surveys:* compare and integrate the results of the condition survey with those of the forthcoming geophysical investigation to see if there is any evidence of deeper ground disturbance allied to Camp Bling.

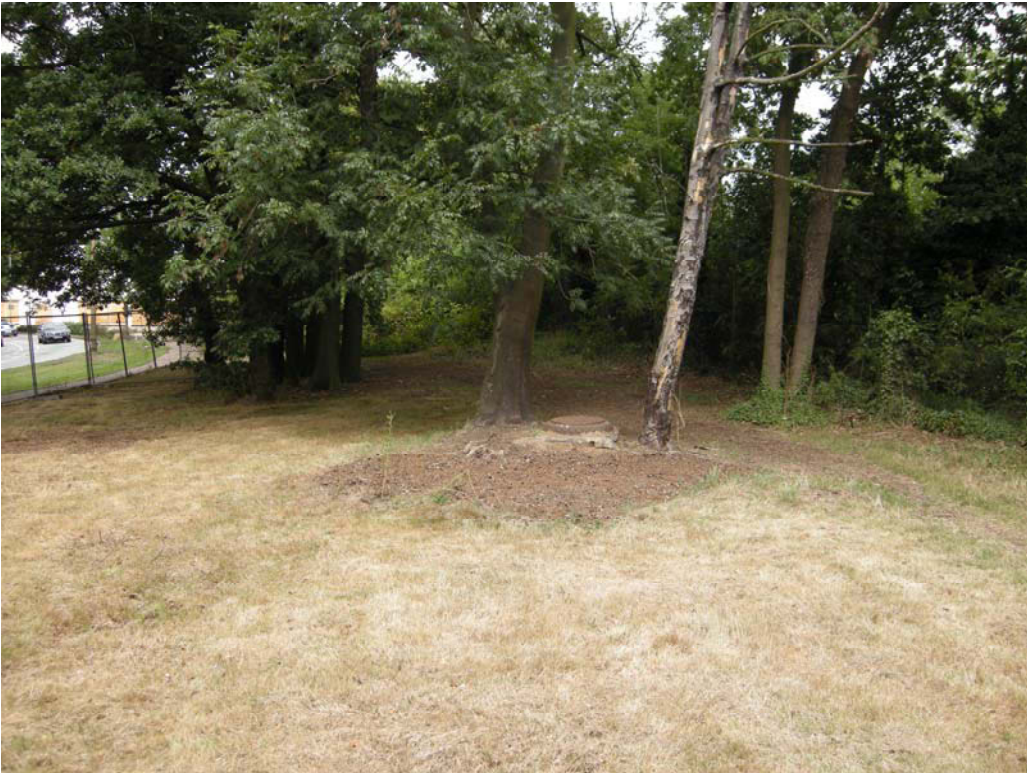
Fig 5 Disturbed surface scar following the removal of the Camp Bling structure shown above which originally enclosed the manhole (looking N)

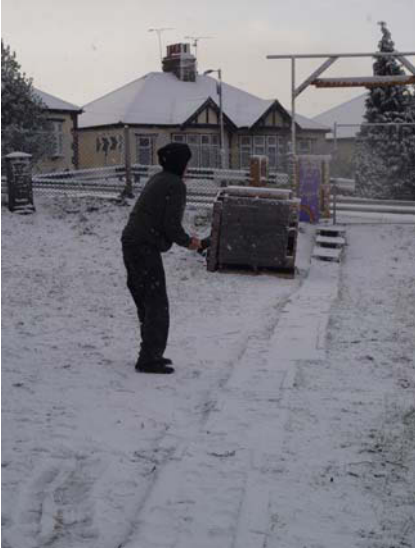
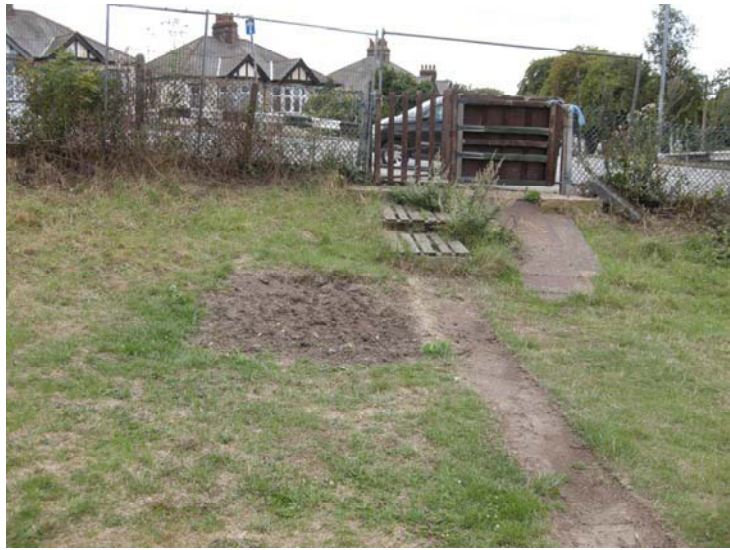
'We are doing it (the dismantling of the camp) as sympathetically as possible to minimise the impact. All that can be seen from the huts we have taken down is a patch of soil, which we dig over. Grass is already growing back' (see Fig 6 and Fig 7).

Fig 6 Small wooden structure at the entrance of Camp Bling and the resultant surface scar following its removal in July 2009 (looking S/W)

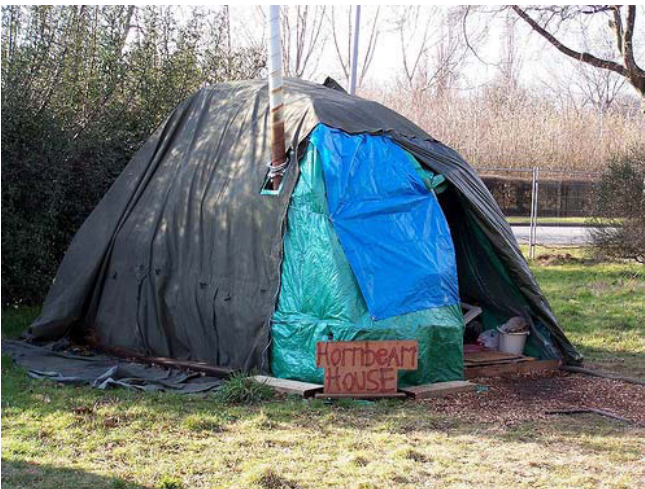
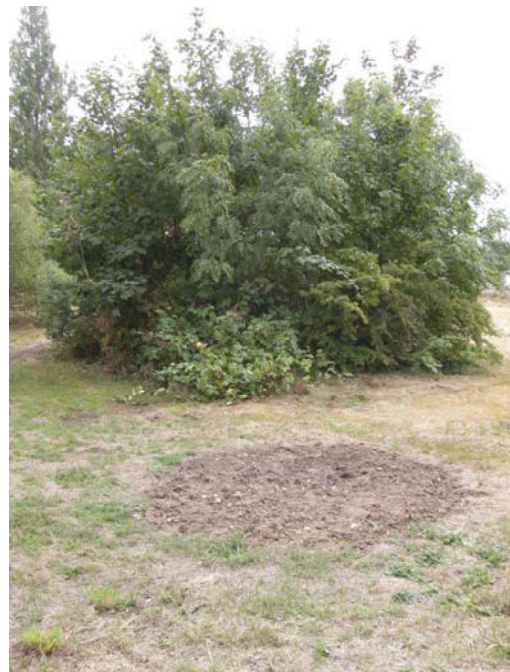
Fig 7 Temporary Camp Bling 'bender' structure and resultant surface scar following its removal (looking S/W & S)
