The Orchard 3rd Auxiliary Military Hospital, Dartford

Archaeological Survey

Report Date: July 2018

Report Number: 001

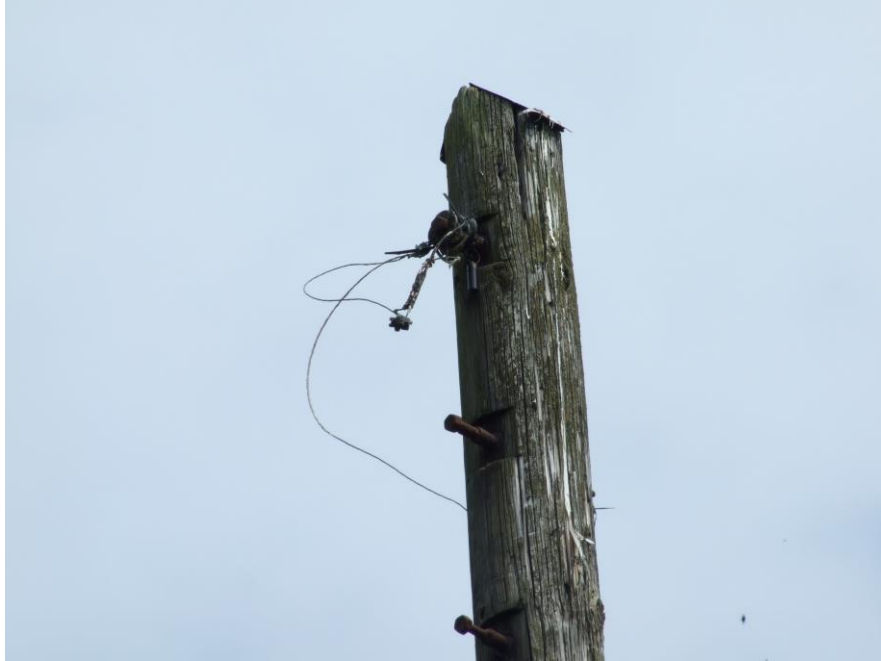
3.2.1 Rectangular building to the east of Buildings B and E, just within the perimeter of the site. The floor of this building is largely composed square, red tiles. The building measures 4.26m N-S and 9.84m E-W. In the southeastern corner of the building is a 2m² concrete floored area with exposed pipework. No walls remain. An original telegraph or telephone pole stands to the south of this building (GPS Lat: 51.46524 Long: 0.22534).

Figure 3 - Telephone/Telegraph Pole from Building A

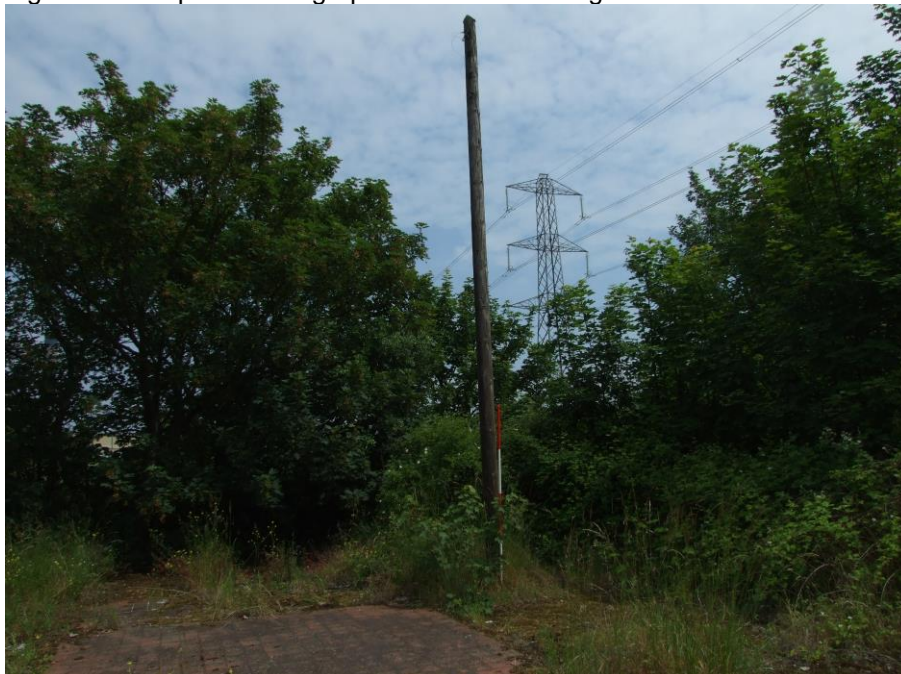
Figure 4 - Tiled floor and Telephone/Telegraph Pole to the south of the floor remains of Building A.

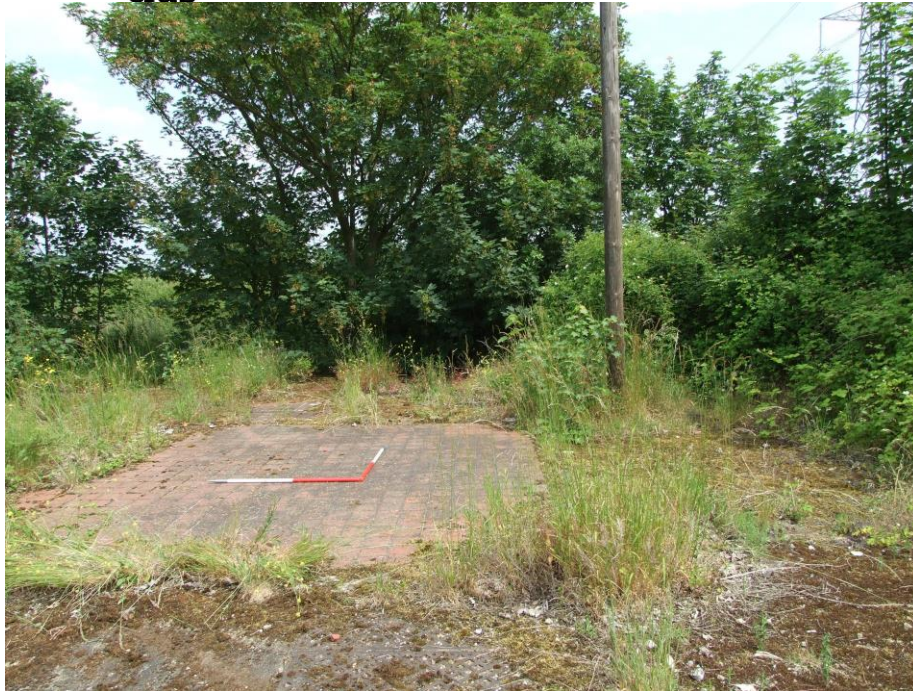
3.2.1 This building lies on the eastern most limit of the hospital site and on the line of the hospital tramway (Feature J). It is not marked on any of the maps of this site, though due to the presence of the telephone/telegraph pole it is possible that this building was a guard house on the eastern gate of the site. It is known that the Australian Military built new buildings and upgraded existing buildings throughout the length of their occupation in the First World War, so it is possible that this building may have been constructed then. The concrete area of this building may have been either a small kitchenette or bathroom, but it is impossible to say for certain.

Figure 5 - Tiled floor of Building A (looking east).

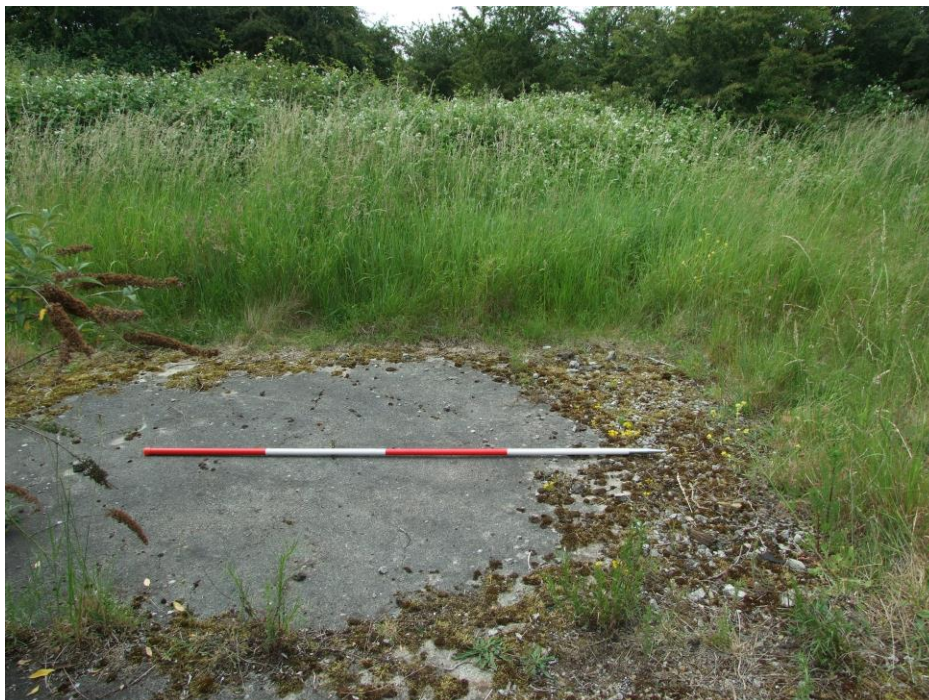
3.3.1 The size of this building is undetermined as the area was too overgrown to find the edges, it sits directly to the south of Building E. The building appears to be reasonably large, with a compact metalled floor with the remains of wooden posts, now collapsed. No walls remain.

3.3.1 The edges of this building are unclear, though some pieces of timber survive, suggesting that it may once have been a timber structure over a metal base. This building is also not marked on the surviving maps of the site. It is possible that it may have been a barn or shed-type building used for the storage of farm equipment after the site's destruction at the end of the Second World War to be used for farming for Joyce Green Hospital next door.

Figure 6 - Base of Building B, possible farm store.

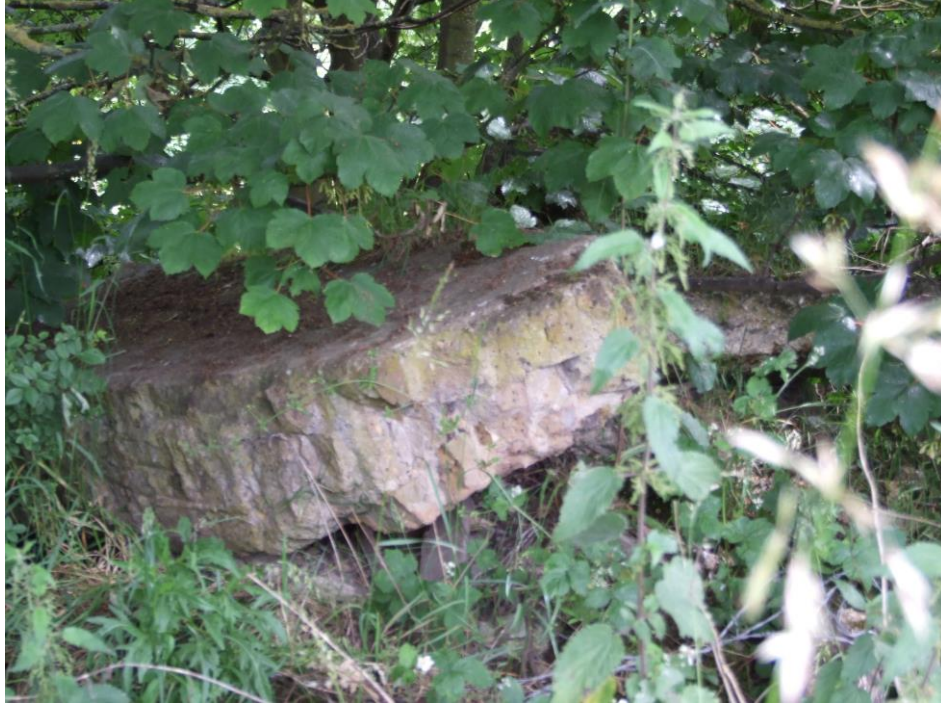
Figure 7 - Building rubble from next to Building C

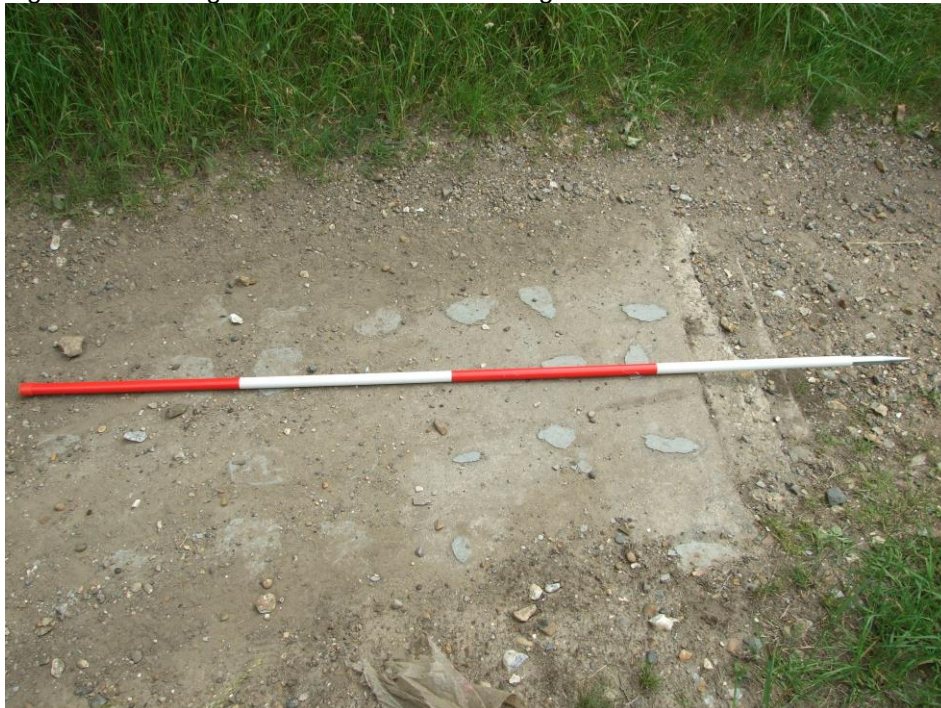
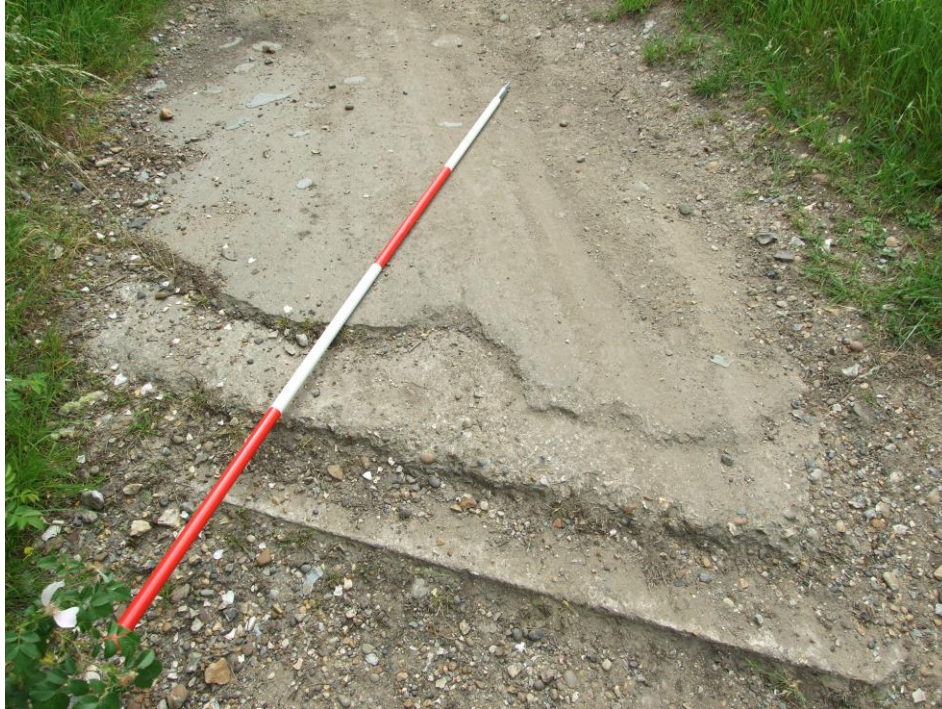
3.4.1 This building sits to the west of Buildings B and E. It measured 10.87m N-S, though it was impossible to determine its length E-W as these ends were too overgrown. No standing walls for this building remain. The floor was possibly Linoleum originally, building rubble around the building shows it was a brick structure, and white tiles and sanitary ware are also visible.

3.4.1 This building is not clearly visible on the existing maps of the site. It is possible that one of the buildings marked may match up to it, but its purpose is not listed. All the mess halls and staff/officers' accommodations are marked at the western end of the site on the existing maps. It is possible that it may have been a mortuary. An Australian military report of the site states that the mortuary, workshops and destructor are all in the southeastern part of the site.

Figure 8 - Base of Building C

Figure 9 - Base of Building C.

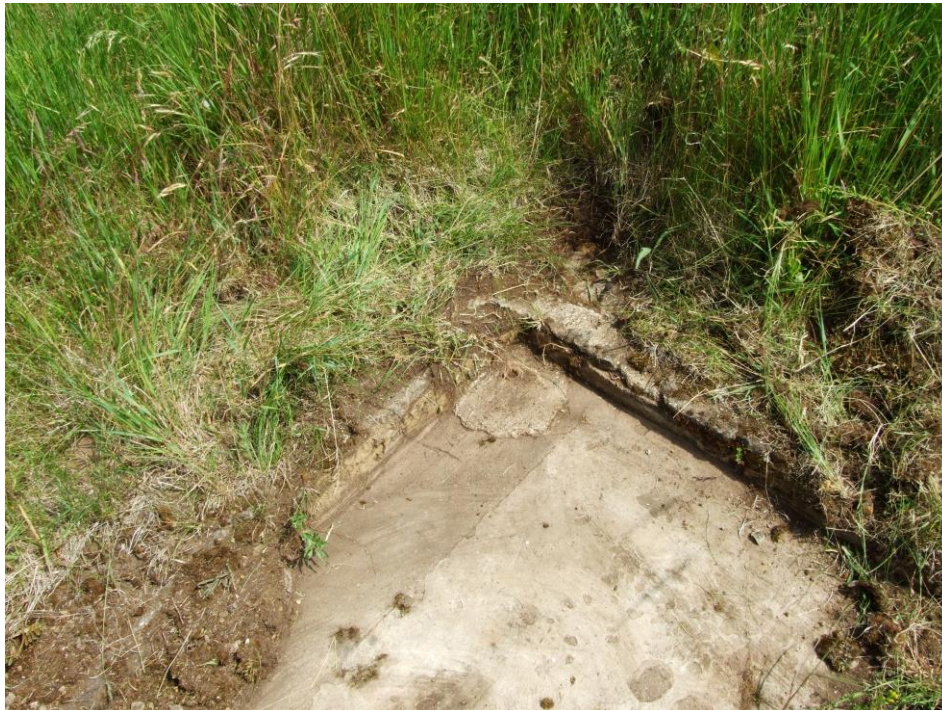
3.5.1 This building sits to the south of Building H. It measures 4.64m N-S and 13.11m E-W. The floor of this building is concrete and has a small wall (23cm wide) running around its perimeter. Pieces of metal and nails, broken window glass and broken mirror glass are all visible within the footings of this building.

3.5.1 This building appears on the existing maps of the site and is marked as a workshop, though it may also have doubled as a store building. The presence of mirror glass and nails would help corroborate its existence as a workshop.

Figure 10 - Base of Building D.

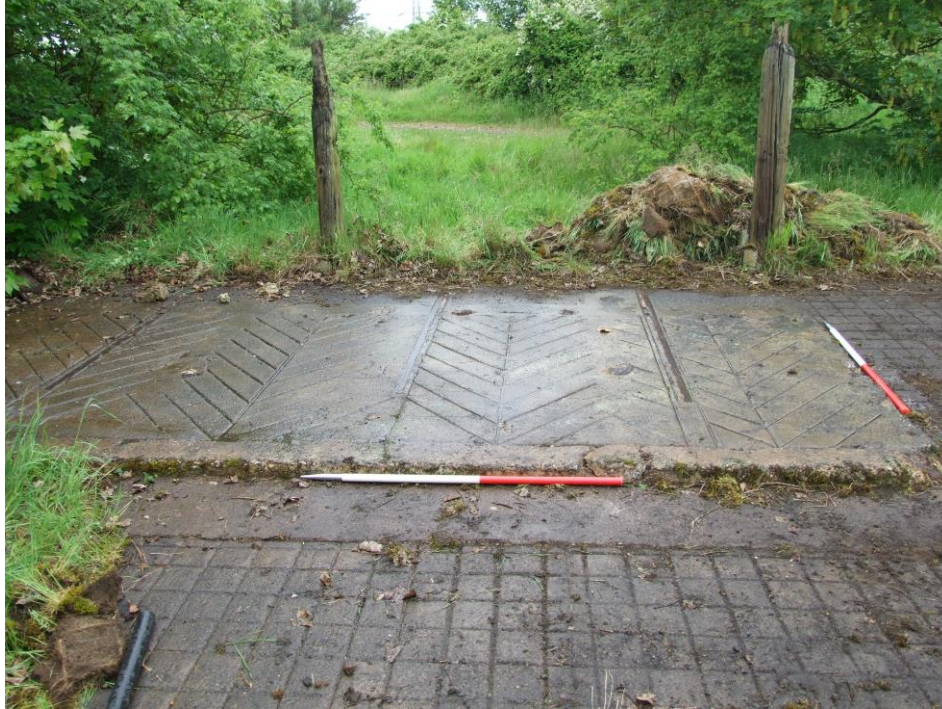
entrance slope. On the eastern platform metal post holes are set into the concrete, running N-S approximately 110cm apart. On the western platform, pairs of metal rails are set into the concrete between each pair of posts. Only three sets of these were fully exposed and the pairs were all set 4ft apart. Lots of broken window glass survives in this building. Unfortunately after our visit to record this building a fire was set on the north-western edge and the wooden posts are now largely lost and the concrete bases smashed up or otherwise moved.

Figure 11 - Tram Car bays on southern side of entrance slope on western side of the shed. (looking west).

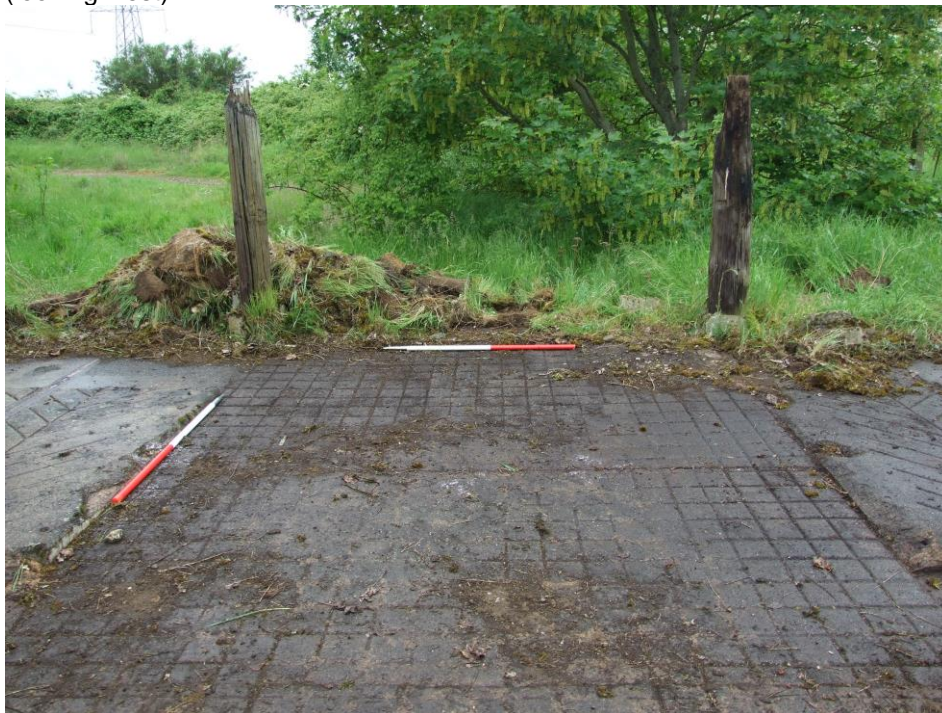
3.6.2 The floor of the building is made of moulded concrete (scored to look like tiles), with a central walkway running north to south and an access slope in the centre of the western side. The eastern and western sides of the building are raised above this central walkway, with a gully running in front of both. The gully on the western side of the walkway to the south of the entrance slope appears to have been filled in with concrete at a later date. Metal post holes are set into the western platform to the north and south side of the

Figure 12 - Entrance slopeway on western side of the tram shed. (looking west).

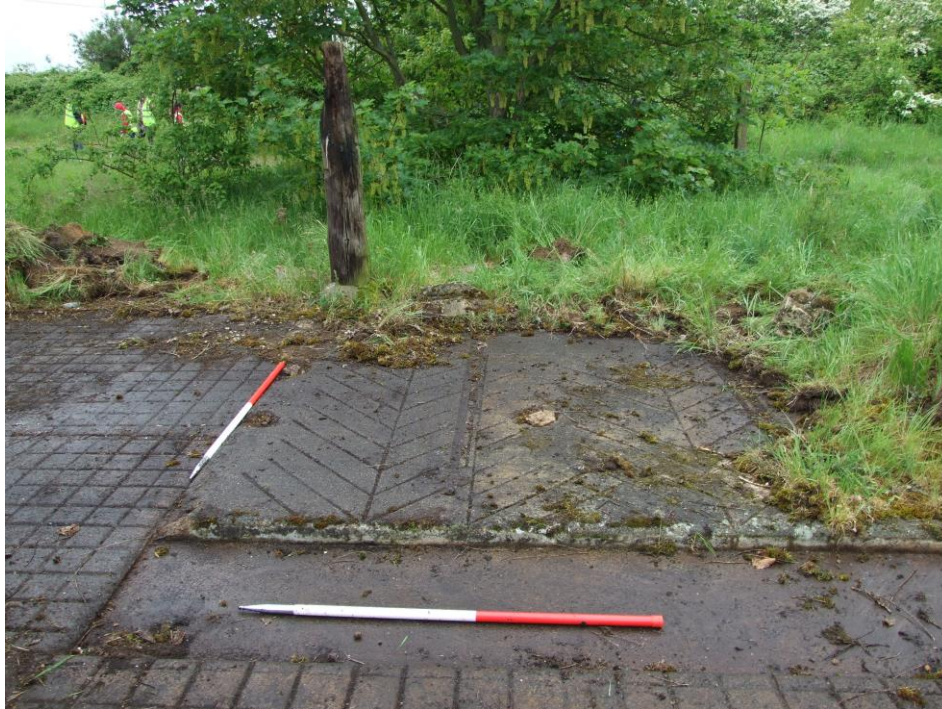
Figure 13 - Tram Car bays on northern side of entrance way on western side of the shed. (looking west).

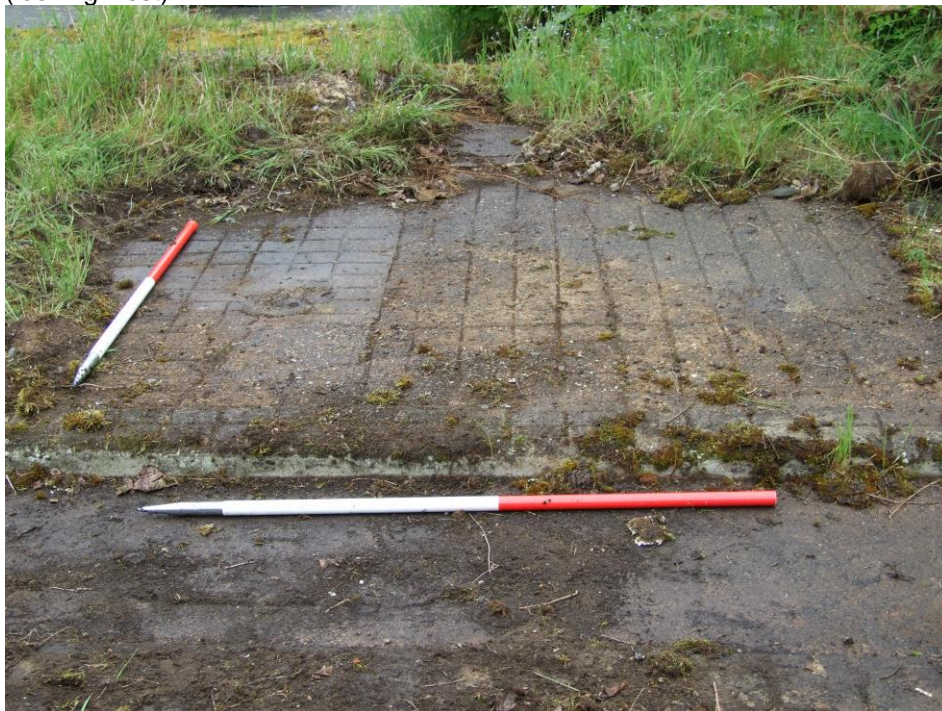
Figure 14 - Eastern platform opposite the entrance way with gully in front. (looking east)

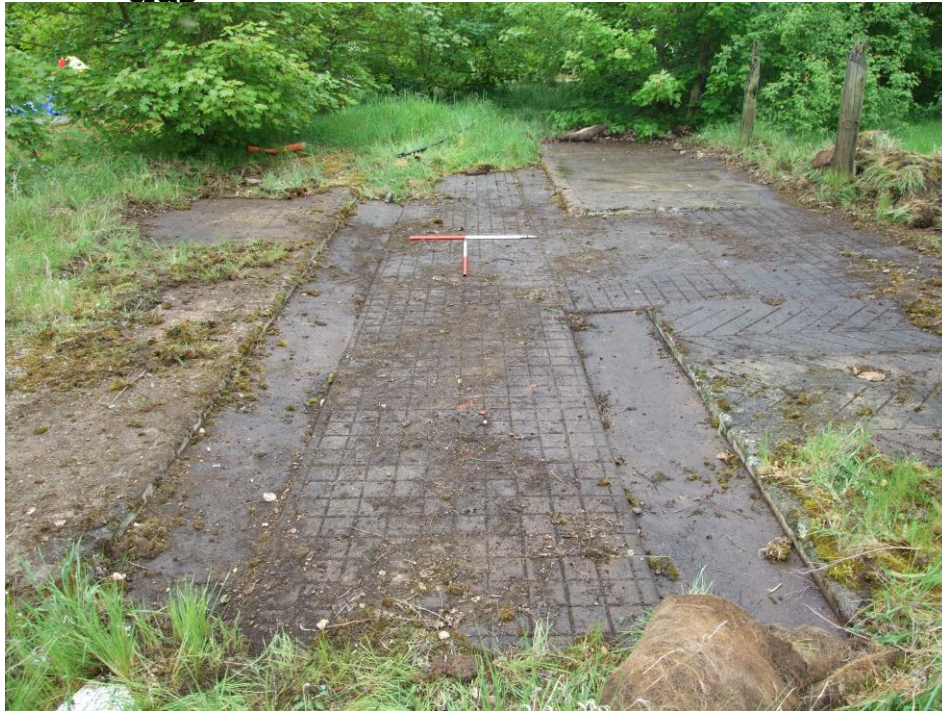
3.6.1 This building is present on the existing maps of the site and is marked as the car shed. The three hospitals in the area were all served by a tramway that started at the river and led south, branching off into each of the hospitals (see Feature J and Appendix...). The western side of the building is open to allow the tram cars to be parked in the bays between the wooden posts. This tramway is known to be unique as the cars were specially designed and patented by the Metropolitan Asylums Board and the gauge is 4m wide. The slope on the western side of the building allowed access to the central walkway and the eastern side of the building for men and presumably also for horses. The tramway was horse-drawn for the whole of its use between c.1902 and the 1930s. The metal post holes to either side of the entrance slope are assumed to have once held a safety rail to separate the tram car bays from the entrance way. It is assumed that the gullies to either side of the walkway were present for drainage and cleaning, though it is unknown as to why part of one has later been filled with concrete. The concrete of the eastern platform is well worn and the scored faux-tile surface is largely worn away in places. It is suggested that this side of the building may have housed stalls for the horses pulling the trams, with the metal post holes being part of partitions between each of the stalls.

Figure 15 - Tram Shed looking south. Eastern platform visible on the left, with the central walkway with gullies on either side, and the tram car bays visible on the right.

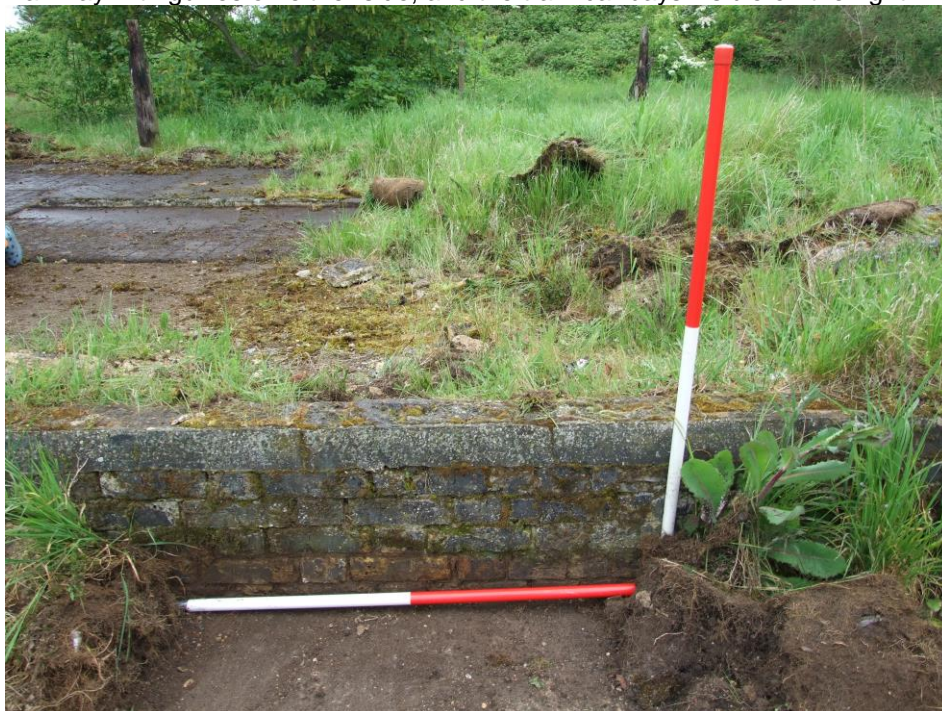
3.6.1 Rectangular building aligned N-S at eastern end of the site. The east wall measured approximately 29.4m N-S but was very overgrown and fragmentary at the southern end and as such may have extended further. The eastern wall is brick built, only 45cm of the height remains (4.5 courses) and it is capped with concrete. The north wall of the building measured 8m E-W. The western side of the building was open, with wooden posts set into concrete bases approximately every 2.5m. At the southern end of the building the posts and bases are completely missing, and the length of that side of the building is extrapolated from the length of the eastern wall. At the northern end of the western side some of the posts are missing, but the concrete bases survive. There are five posts that survive in their bases, all are badly damaged and missing approximately half to two thirds of their original height. The southern wall is completely missing.

Figure 16 - Outside face of the eastern wall of the tram shed. (looking west)

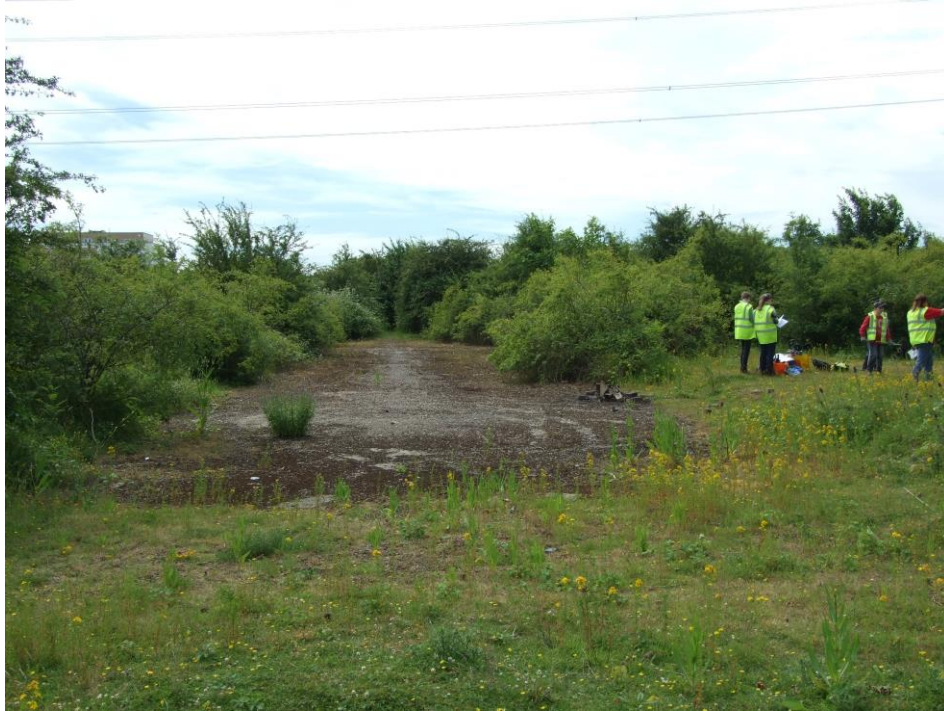
3.7.1 The footings of this building are one of many similar footings visible across the site. This one was recorded as it was the clearest and most easily accessible. It sits to the south of Feature J in the western part of the centre of the site. It measured c.433m N-S and c.8.4m E-W. It had a small spur on the southern end but this was not clearly visible and wasn't measured. Building rubble around the metallised footings suggest that there were some brick courses originally. Fragments of corrugated metal are also visible on the footings.

3.7.1 This building is one of many Ward Block footings still visible across the site. This building can be matched up to the existing maps of the site and is Ward Block 21. Photographic and documentary evidence shows that these ward blocks were wooden weatherboard huts built on small brick retaining walls and supported underneath by iron beams. The base beneath was compacted and metalled. The site is low-lying and was prone to flooding due to its proximity to the marshes and the Rivers Darent and Thames, which is why all of the blocks were raised off the ground on supports. Documentary evidence from the Australian occupation of the site in the First World War shows that each of these blocks housed 46 beds and that there were 32 blocks all together, though some of them were used as mess halls and recreational facilities. Each of the ward blocks had a toilet spur at the far end of the building, and a kitchen and bathroom by the entrance.

Figure 17 - Metalled base for Ward Block 21 (looking south).

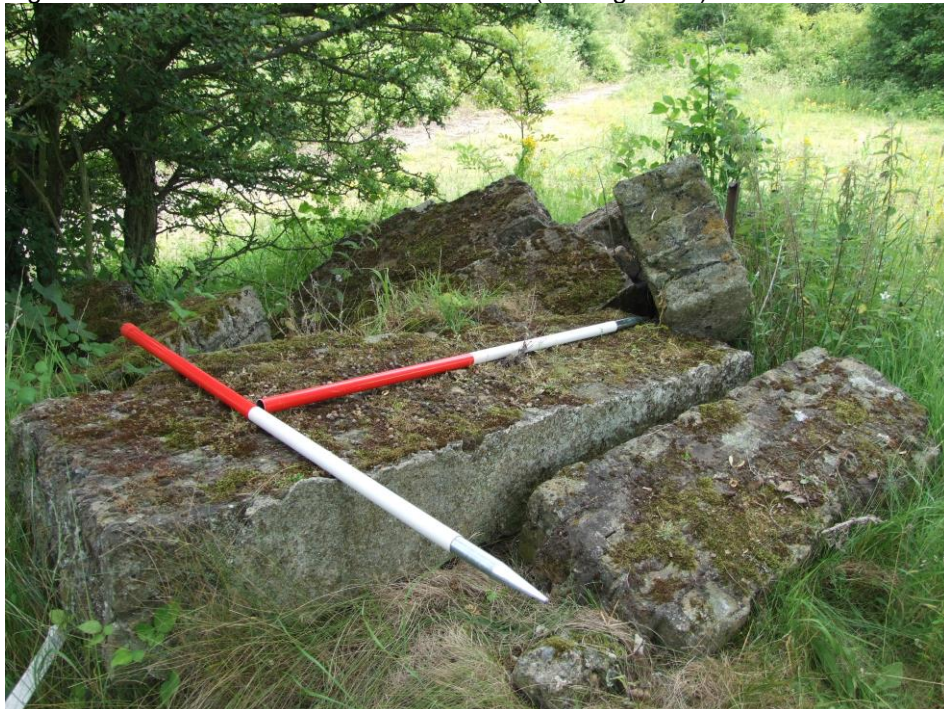
Figure 18 - Wall courses from Ward Block 21 dumped beside the base footings.

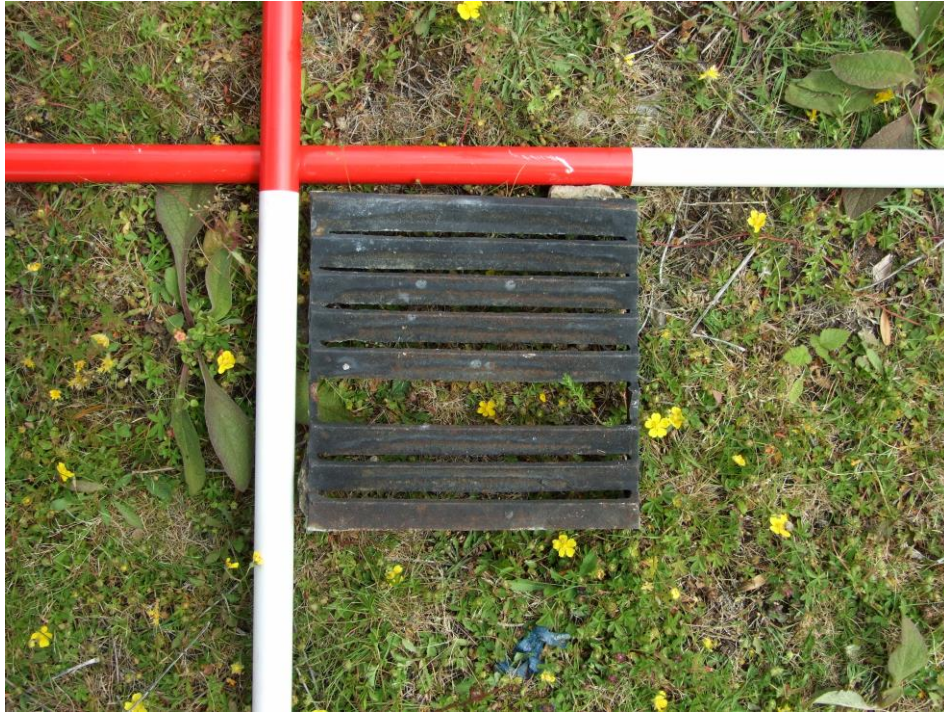
Figure 19 - Metal grill from the wall of Building G.

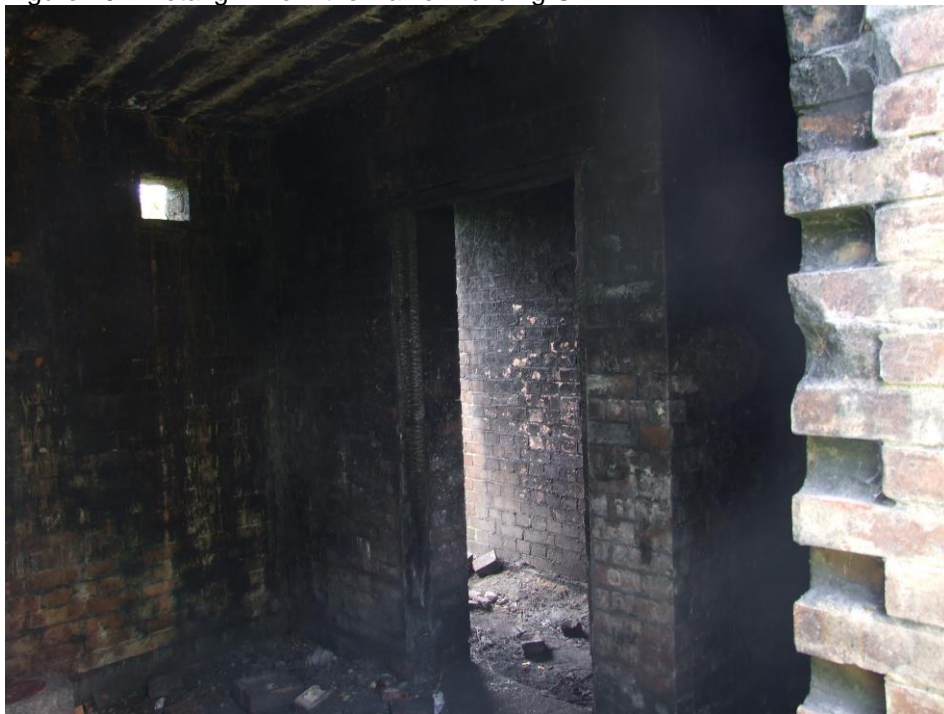
Figure 20 - The interior of Building G (with hole in the wall for the metal grill).

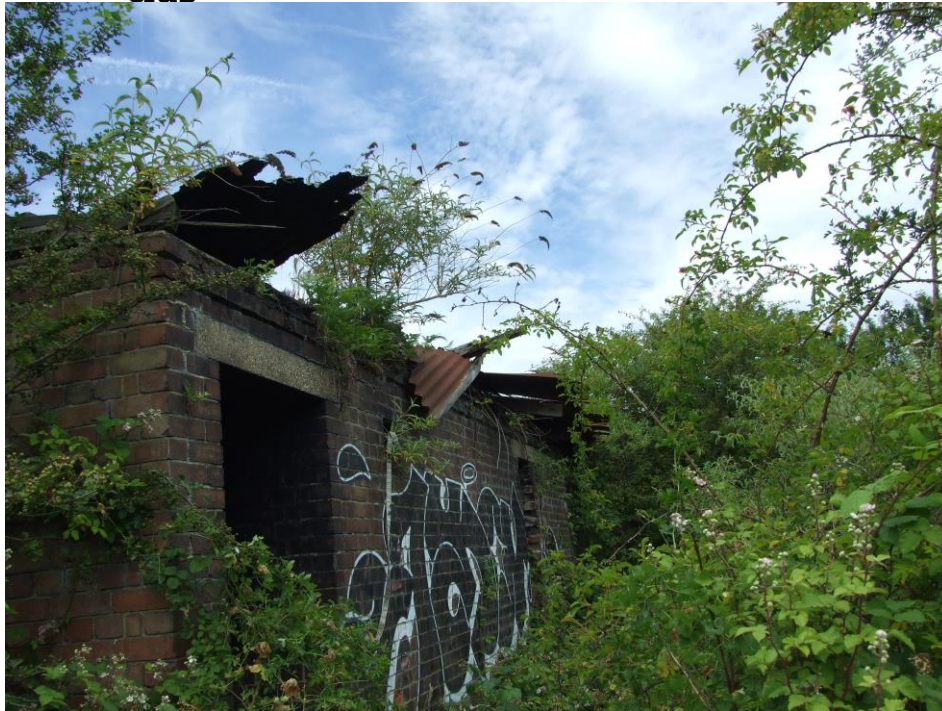
3.8.1 This is one of several of this type of building. These are the only structures still standing on the site. This example was chosen as it was the most accessible. It stands directly to the east of Building F, approximately 3.86m away. It measured 9.34m N-S and 3.74m E-W. It is a brick structure with a reinforced concrete roof, above which some timber roof beams survive. Some fragments of corrugated metal are also visible. There are two openings with concrete lintels in the eastern wall, the northern opening measuring 1.23m across and the southern opening measuring 93cm across. In the western wall is one opening with a concrete lintel at the northern end, measuring 93cm. The walls measure 2.66m from the ground to the base of the roof.

3.8.1 The purpose of these buildings is unknown, though there is one present every third ward block. The example recorded lies between Ward Block 21 and Ward Block 22, though all of the similar buildings along the central tramway are still standing. There are nine of them in total. It is possible that they may have been air raid shelters for the ward blocks, as they had reinforced concrete ceilings and door lintels, though as each ward housed up to 46 men and each of these building seemed to serve up to three wards, it is unlikely that they were constructed for this purpose. There are metal ventilation grills in each building and the remains of what appears to have been plumbing, suggesting that these may have been additional toilet blocks as each ward only had three toilets for 46 men and staff. The wooden roof timbers appear to have been added at a later date. These buildings are not marked or labelled on any existing map and are not referenced in the Australian military report from the First World War.

Figure 21 - Exterior of Building G (looking south).

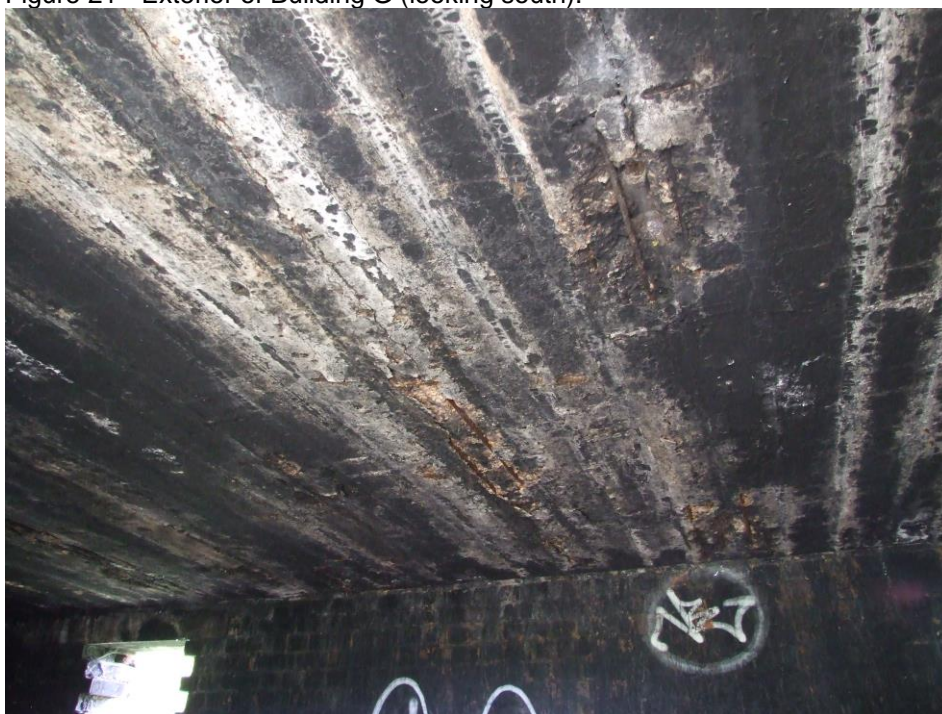
Figure 22 - Interior ceiling of Building G made of reinforced concrete.

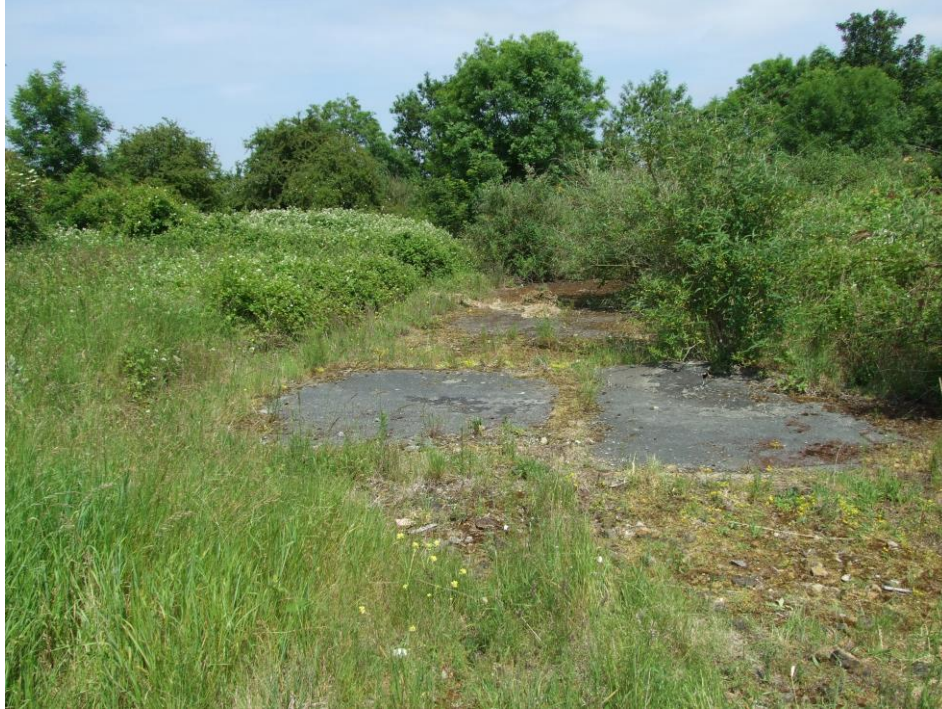
3.9.1 This building stands to the north of Building D. Accurate measurements were unable to be taken as the footings are very overgrown and the edges indiscernible. The building is largely rectangular and is aligned N-S. A substantial amount of building rubble surrounds these footings and these remains suggest that the walls were constructed from brick. The floor is made of reinforced concrete, with drains and water gullies still in situ. Fragments of corrugated metal are also visible.

3.9.1 This building is marked on existing maps as the Boiler House. It is likely that it also held an incinerator for the destruction of waste materials. It powered the Laundry building to the north of it, though no trace of the Laundry survives due to undergrowth and dumps of building rubble.

Figure 23 - Base of Building H (Boiler House). (looking north)

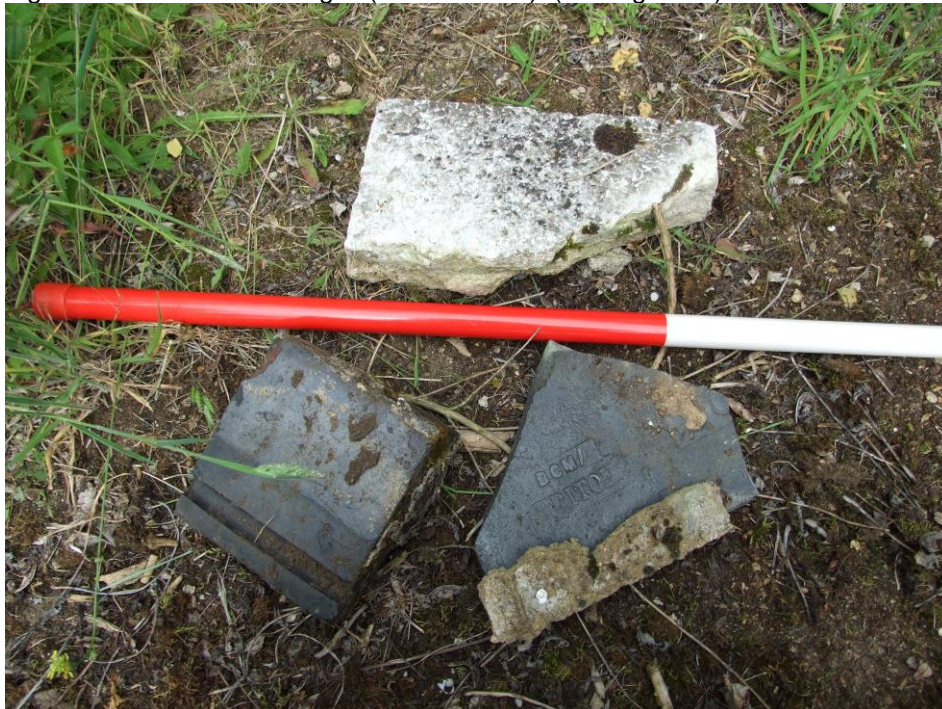
Figure 24 - Building rubble from Boiler House (building H).

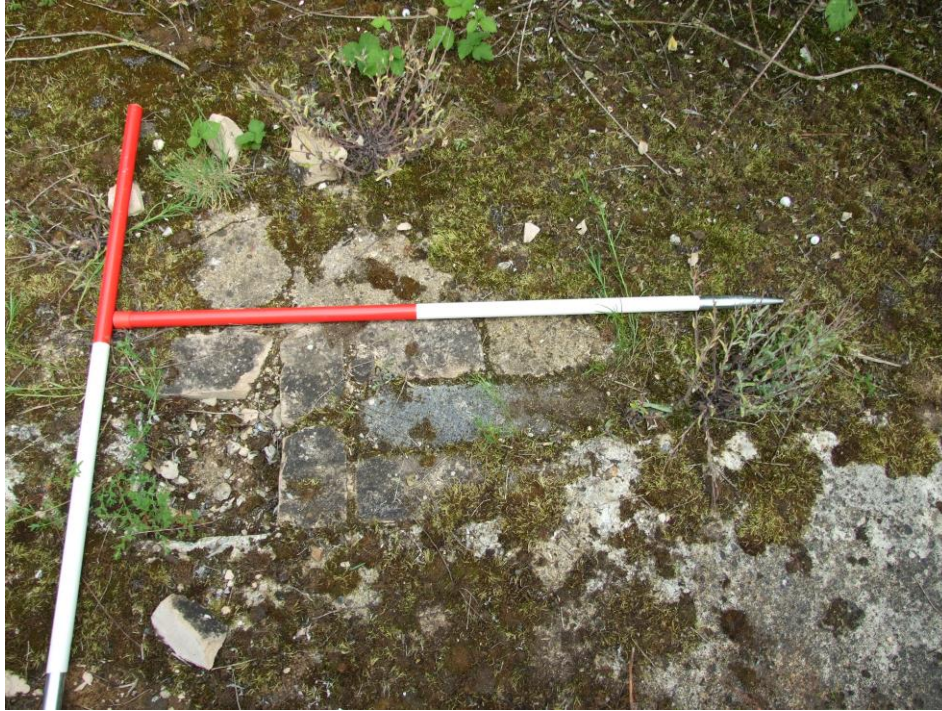
Figure 25 - Brick edge of drain from Boiler House (building H)

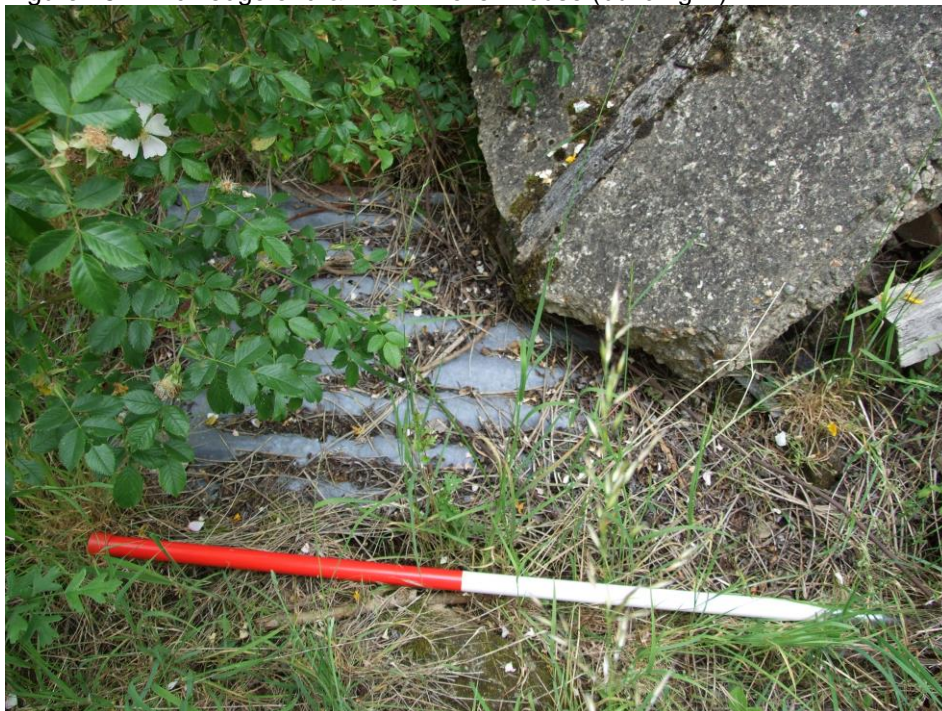
Figure 26 - Building material from Boiler House (building H)

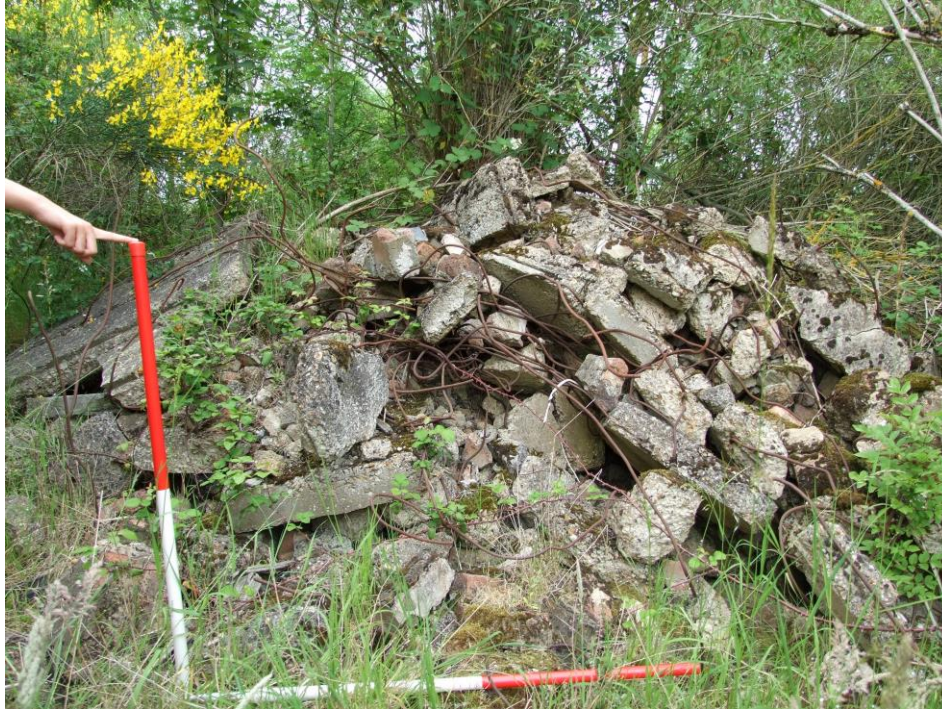
Figure 27 - Building rubble from Boiler House (building H)

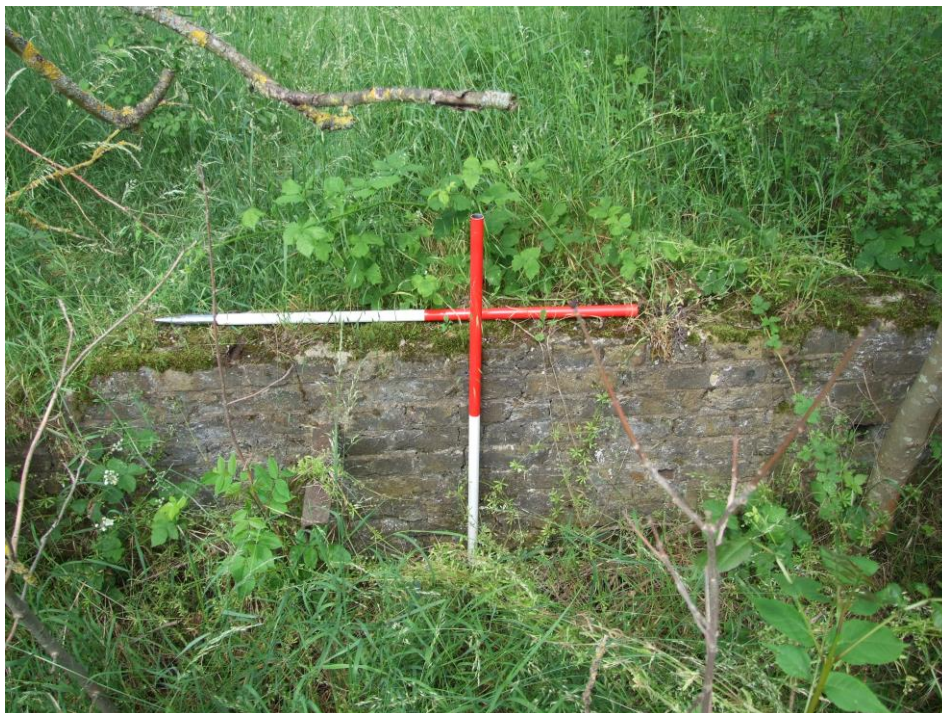
3.10.1 This feature is on the northern side of the hospital site. It is a brick lined gully between 76cm and 80cm deep. It measures 186cm wide and runs E-W. The retaining walls are two courses wide, measuring approximately 23cm.

3.10.1 This gully runs along the south edge of the staff accommodation blocks on the northern side of the site. This part of the site is the lowest lying and the closest to the Dartford Marshes. As such it must have been prone to flooding and drainage issues. It is believed that this ditch was a drainage ditch and would have had boarding over the top with a roof to create a veranda for the staff accommodation as well as to hide and create a pathway over the ditch.

Figure 28 - North retaining wall for gully (Feature I)

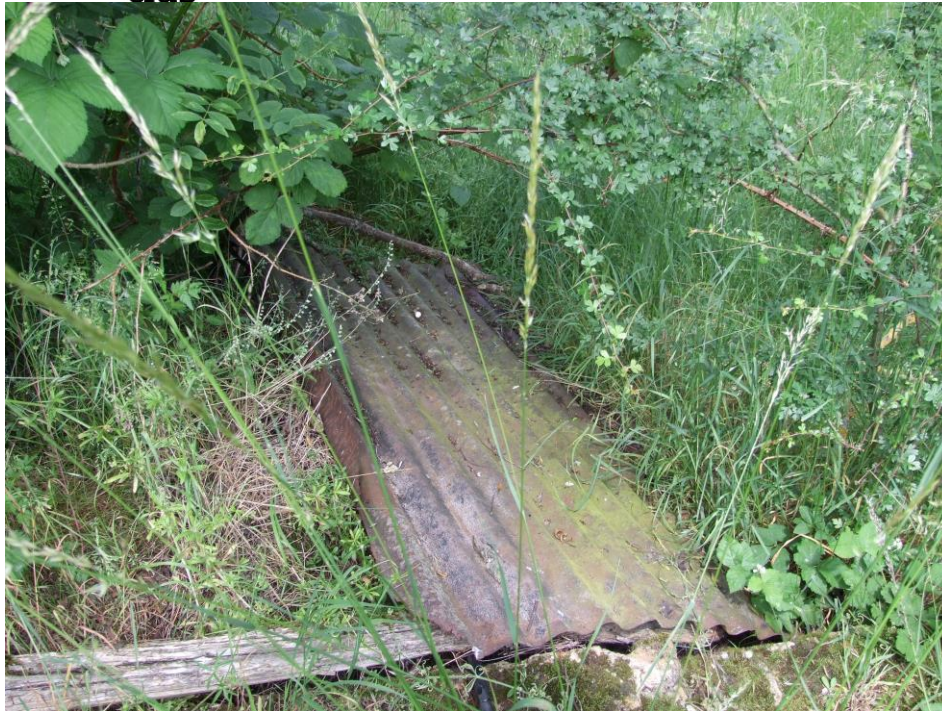
Figure 29 - Corrugated metal and timber posts - possibly from a roof over the covered drainage ditch (Feature I).

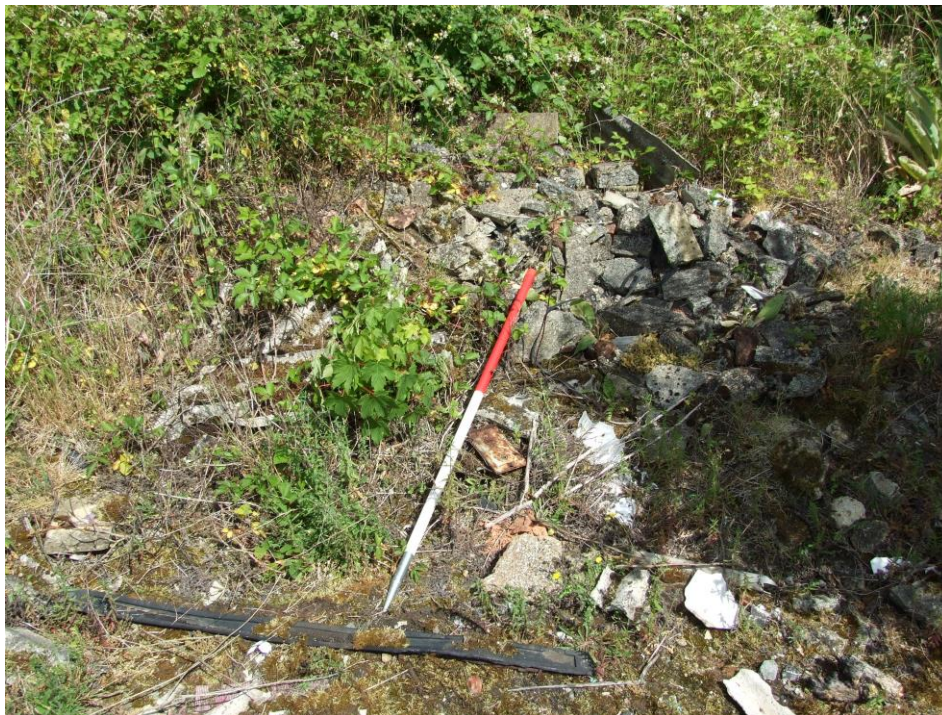
Figure 30 - Building rubble beside the turning circle at the western end of the hospital tramway.
