The Orchard 3rd Auxiliary Military Hospital, Dartford

Archaeological Survey

Report Date: July 2018

Report Number: 001

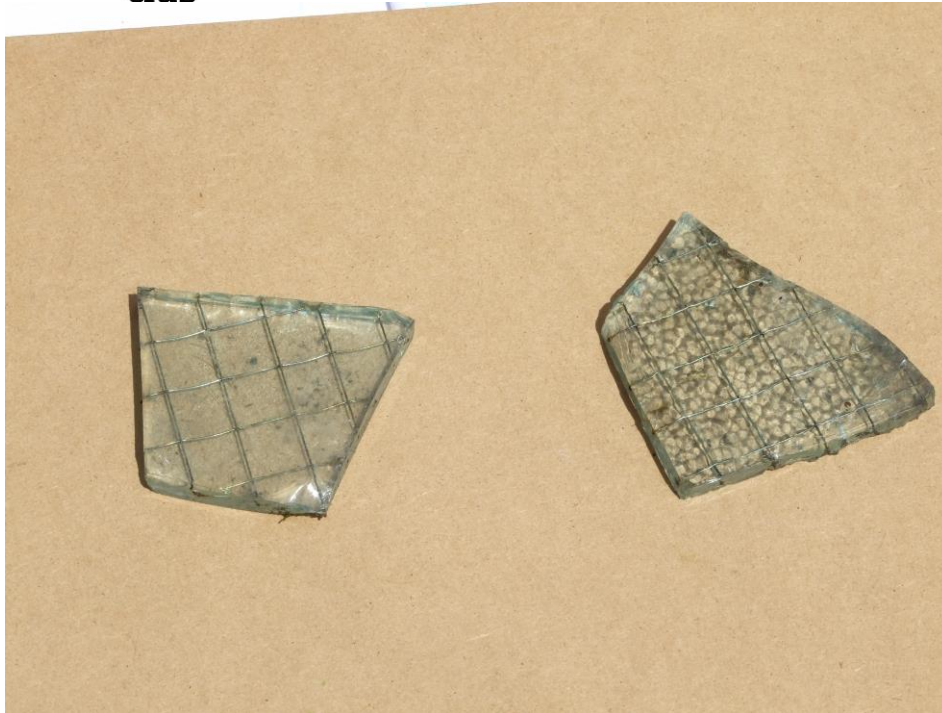
Figure 31 - Fragments of reinforced glass found beside the turning circle the western end of the hospital tramway (glass designed by Pilkingtons in 1898)

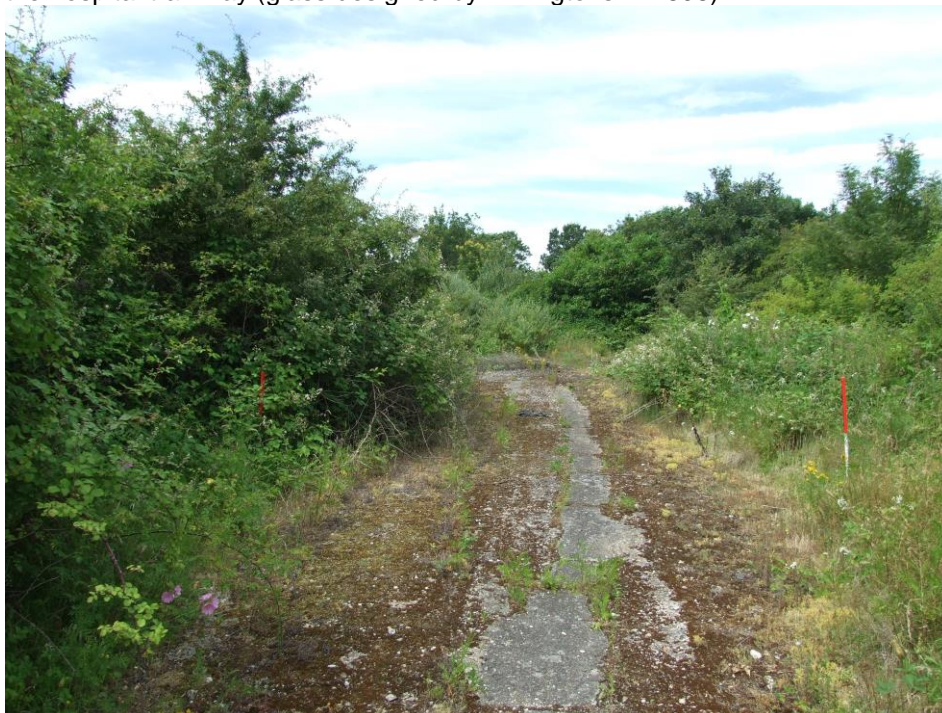
3.11.1 Feature J runs along the length of the site from E-W. Its length was not measured as in places it is overgrown. It is 3m N-S along most of the visible length. Approximately halfway along the site it widens to 4m, after 31m it narrows back to 3m (GPS Lat: 51.4657 Long: 0.22191). At the western most visible point the feature widens into a roughly circular shape approximately 14.3m N-S and 14.65m E-W (GPS Lat: 51.46572 Long: 0.21971). Building rubble lies to the western and northern sides of this circle, with reinforced glass, concrete slabs and bricks all visible. Just to the east of the circular shape is another wider portion of the feature, widening to approximately 4m, before returning to 3m (GPS Lat: 51.4657 Long: 0.21992).

Figure 32 - Passing point on the tramway approximately halfway along the hospital site.

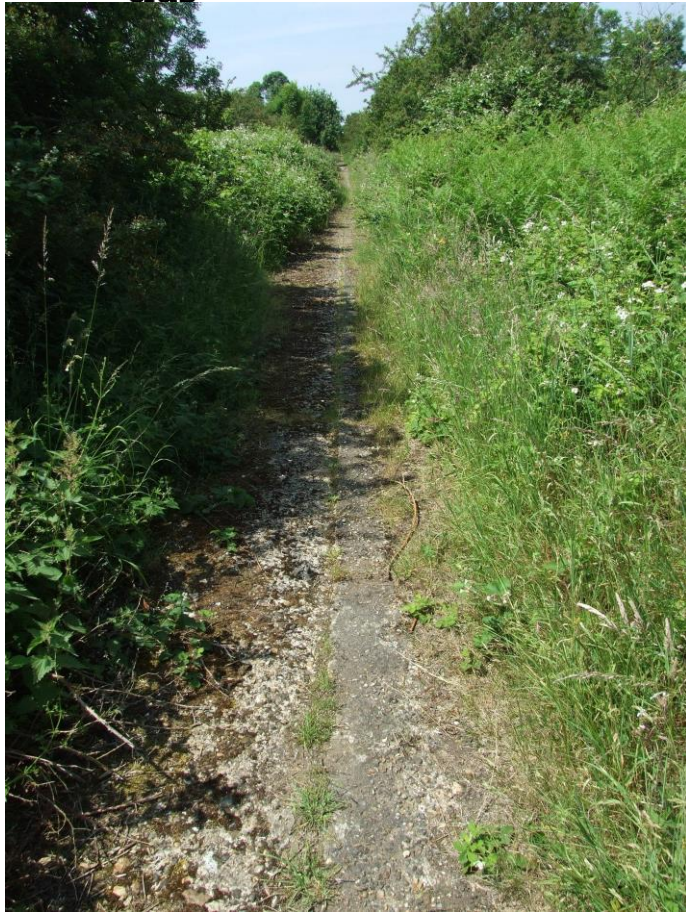
3.11.1 This feature is the remains of the hospital tramway, that branched off from the main tramway that ran between Long Reach Pier and Joyce Green Hospital. No rails survive in situ, but the line of the tramway is marked on the maps and the metalled base, into which the rails would have been set, is still visible. A passing place is visible approximately halfway along the length of the hospital tramway, with a turning circle at the western end. The tramway would have run between the Laundry and Boiler House buildings, past the gatehouse and out onto the main tramway, however the only visible section runs from the turning circle (at the western end) and ends just before the Boiler House and Laundry.

Figure 33 - Tramway running through centre of hospital site.

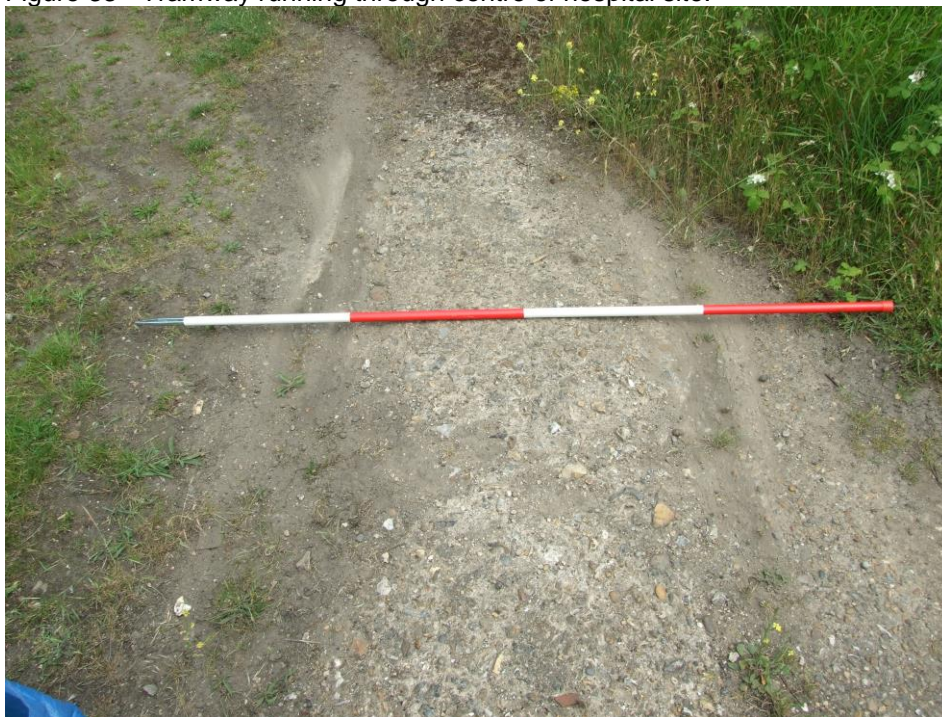
Figure 34 - Eastern most visible point of the hospital tramway.
