VI Aydon Castle Kitchen and its Roof

David Sherlock

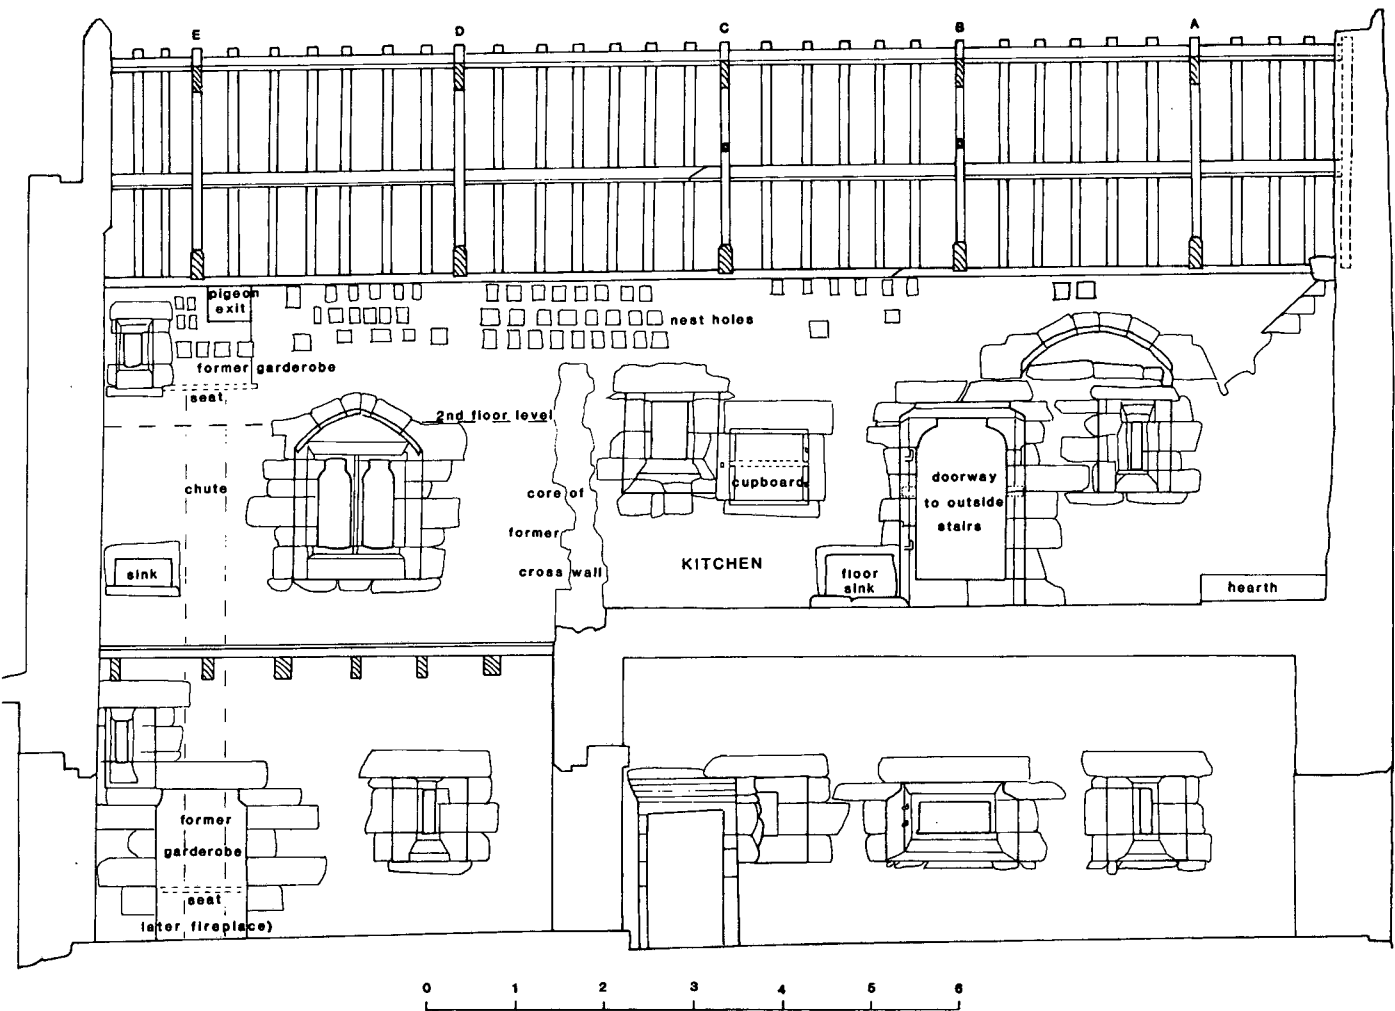
Fig. 6 Existing internal elevation of west wall of kitchen range and roof frame as originally built.

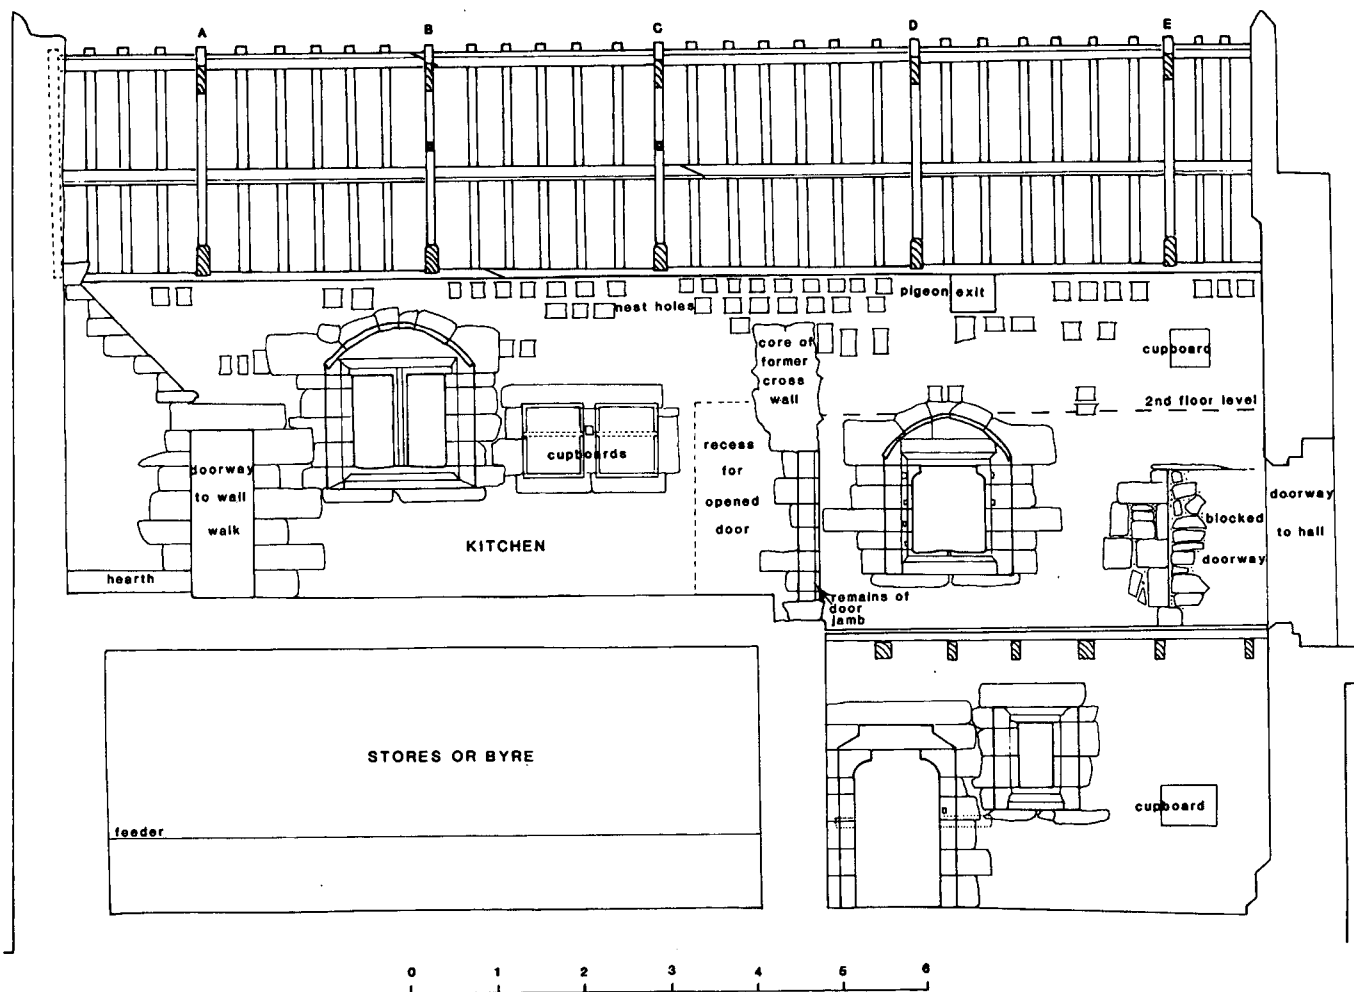
Fig. 7 Existing internal elevation of east wall of kitchen range and roof frame as originally built.

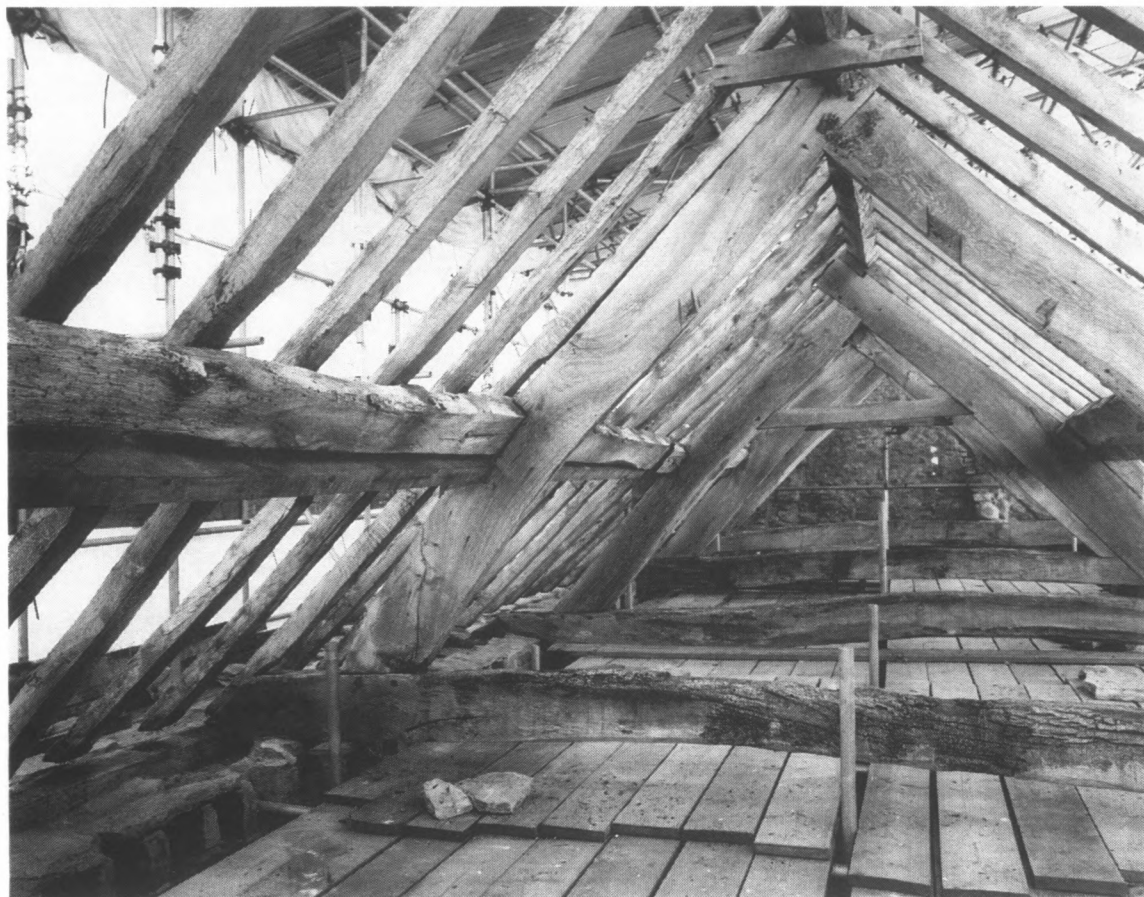
Fig. 9 West end of south face of truss D. Note curved end of principal, bark on the tie beam and thinner later purlin. Note also top row of nest holes in wall.

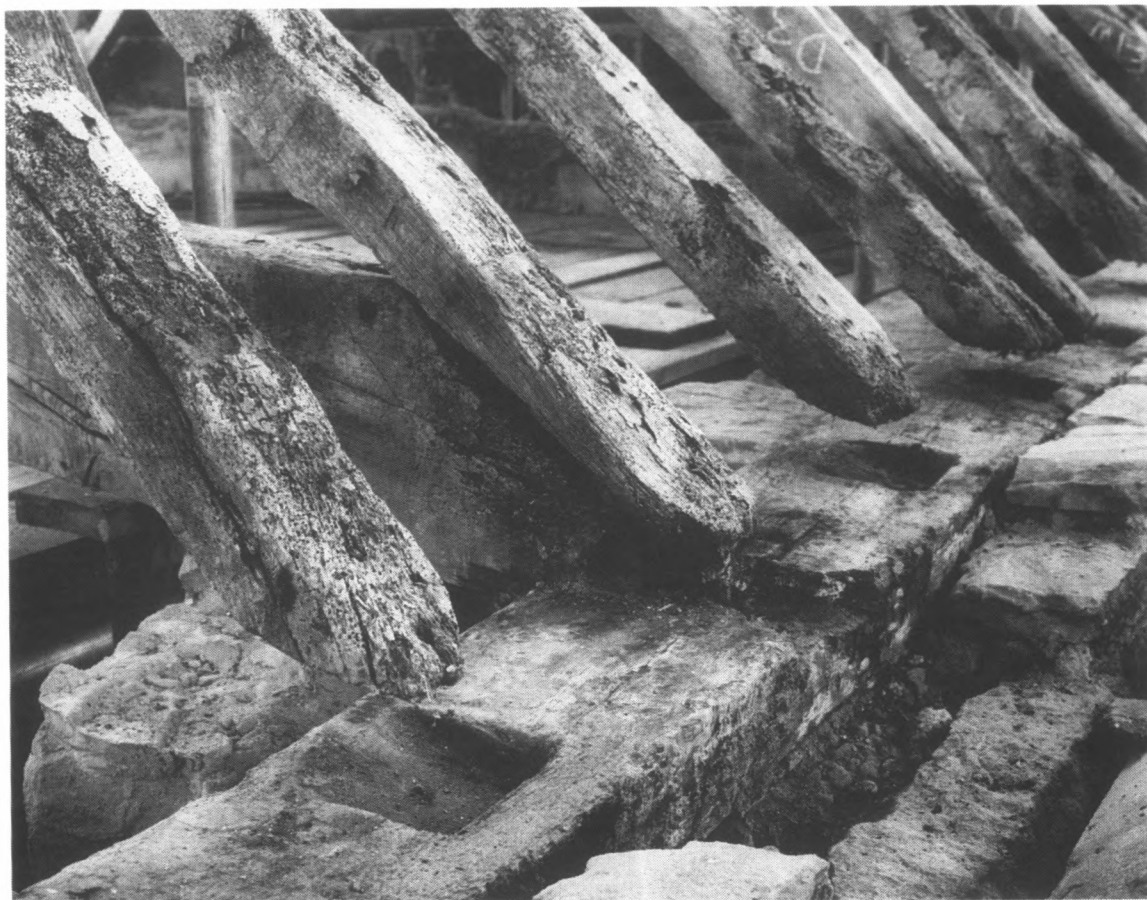
Fig. 10 Example of slots in wall plate for ends of original rafters near south end of west side. The ends were raised when deal boards were laid on the wall tops.

presumably not original. The slots in the wall plate are each approximately 130 mm or 5 inches wide which indicates the width of the actual rafters. The slots are roughly square and slope to a depth of 35 mm or 1½ inches. In the centre of each is a rust stain indicating that the rafters were held with a nail. The slots were made by drilling two wide holes in the two deepest corners and then chiselling the wood out. In most instances circles made by these drills remain visible at the bottom of the slots.

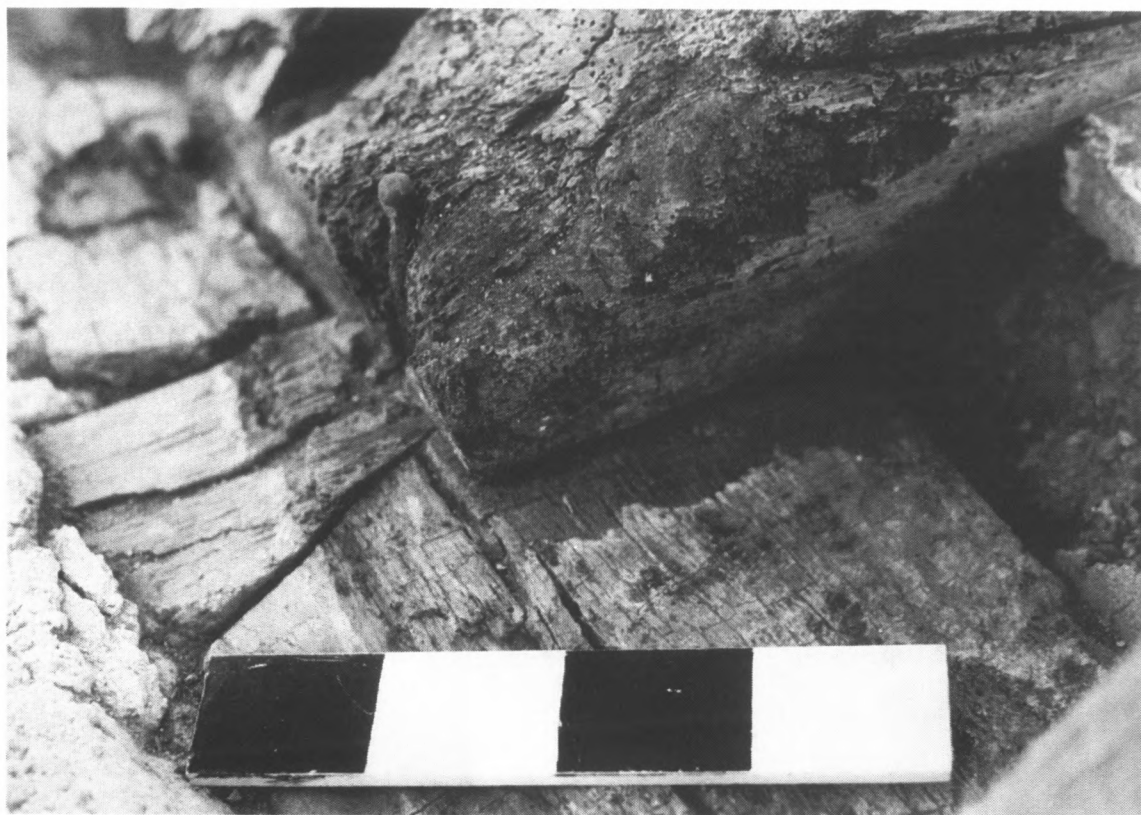
Fig. 14 Truss B, east end of tie beam cut off when boards were laid to raise ends of rafters, now showing remains of dovetail joint onto wall plate.
