# The Conservation and Study of the Eastern Arm of Tynemouth Priory Church

*Martin Leyland and David Sherlock*

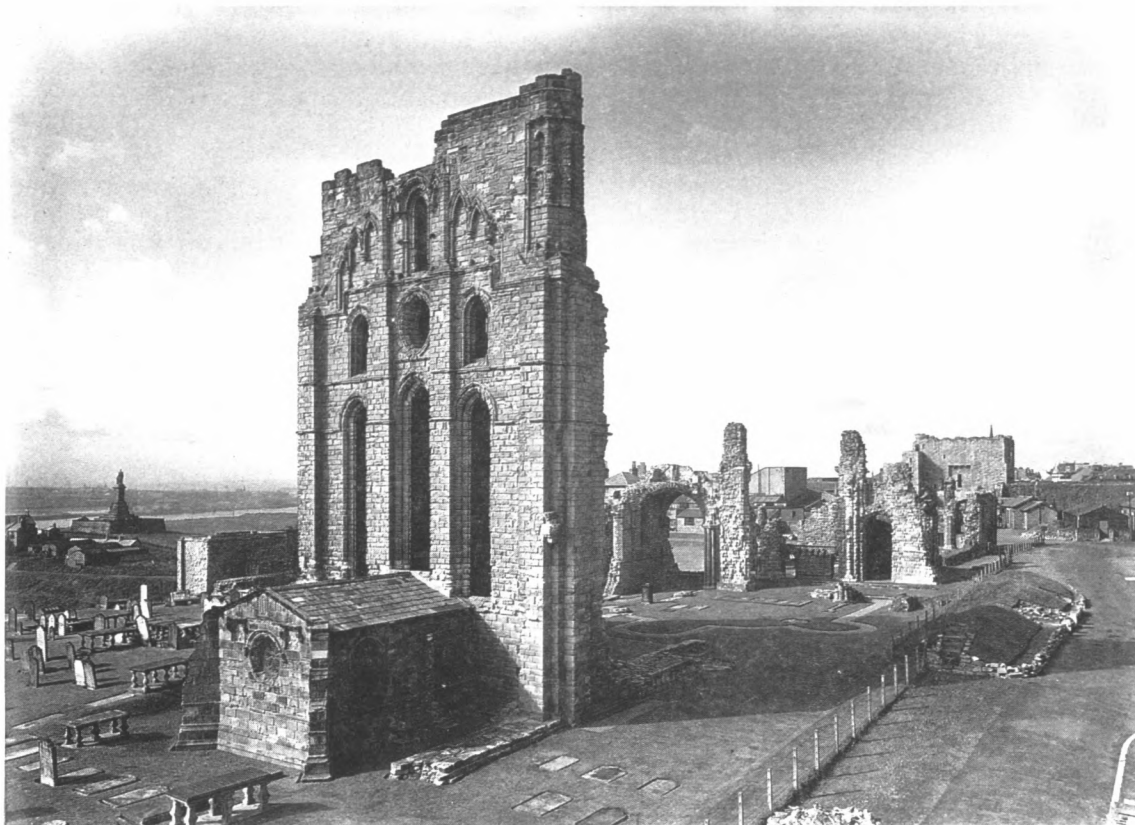
*Fig. 9 The presbytery from the north-east, 1950, fenced off while the military still occupied the headland.*  
© A. F. Kersting.

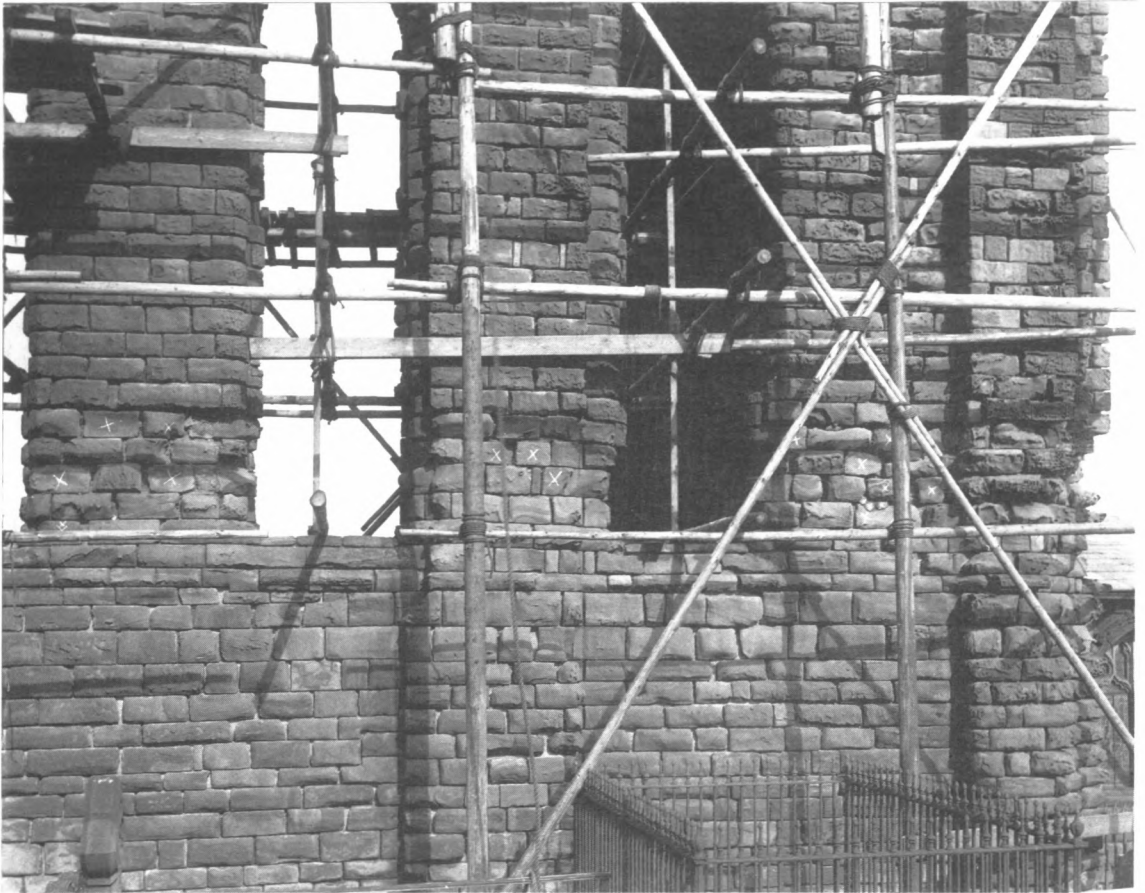
*Fig. 10 Old photograph of conservation works in 1914. "X" indicates stones to be replaced. © English Heritage.*

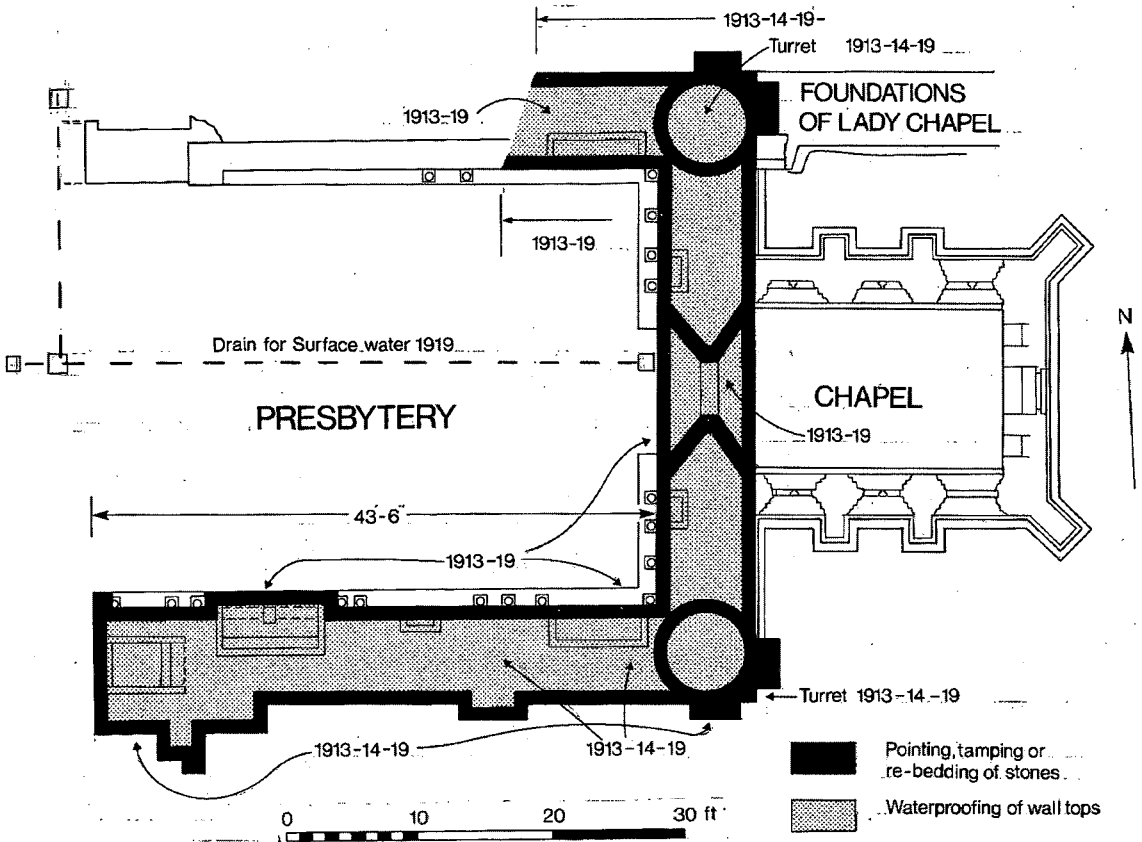
Fig. 11 Areas of repointing etc., 1913-1919, a re-drawing of Office of Works plans 88/8A1 and /8A3.

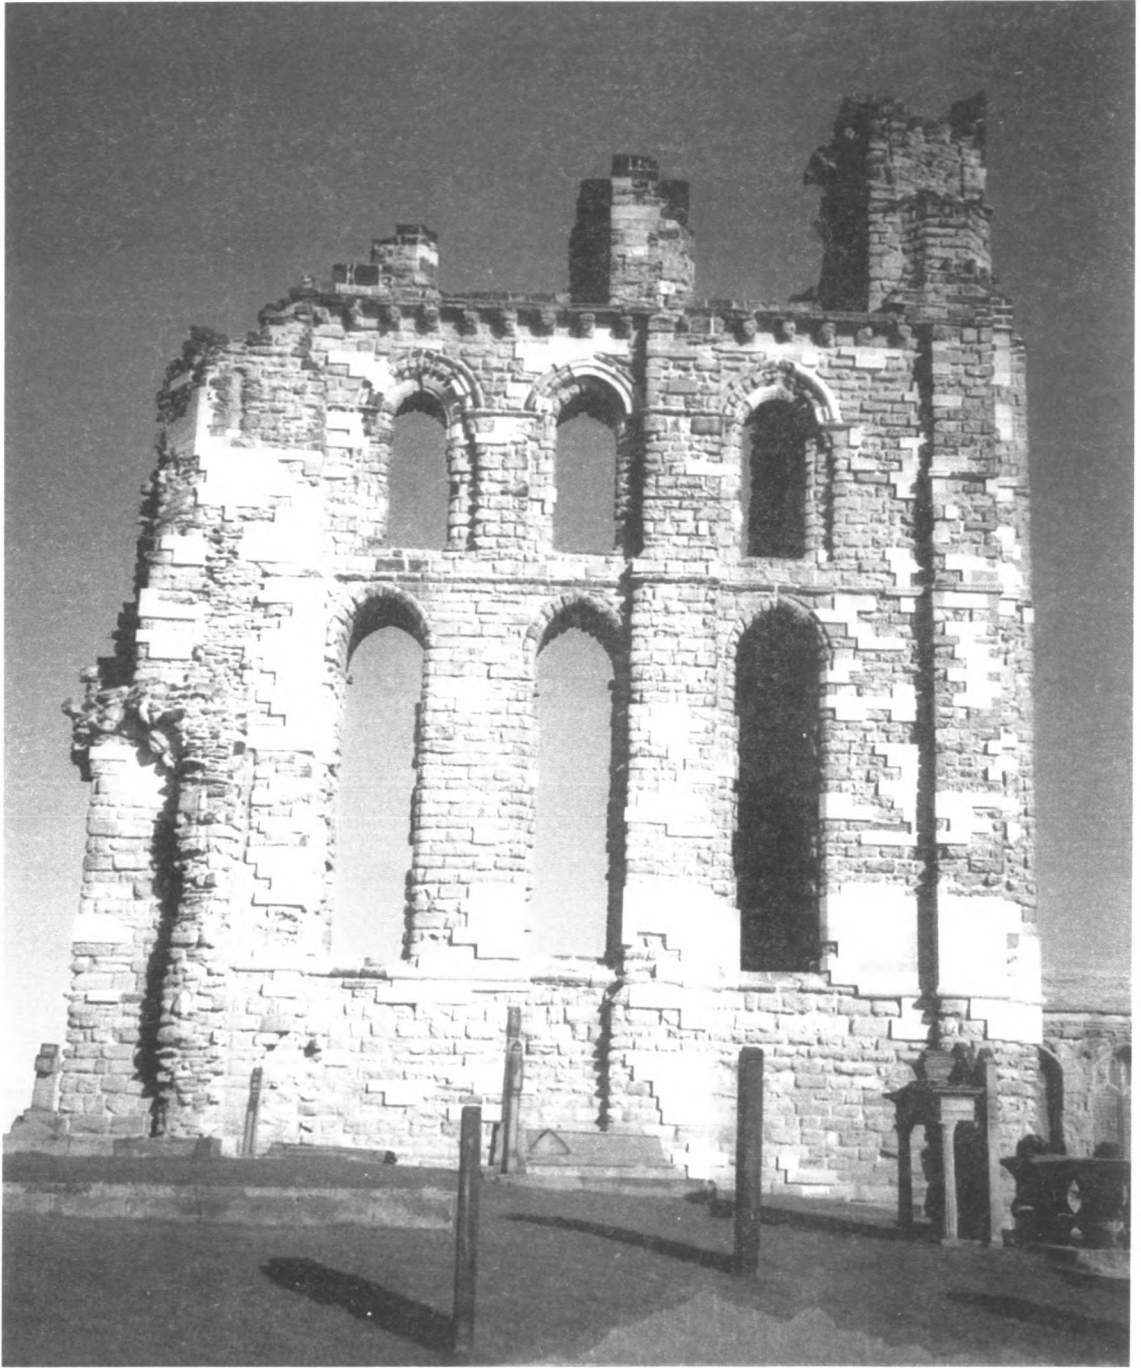
*Fig. 12* South elevation of south wall, showing stones replaced 1996–97. © English Heritage.

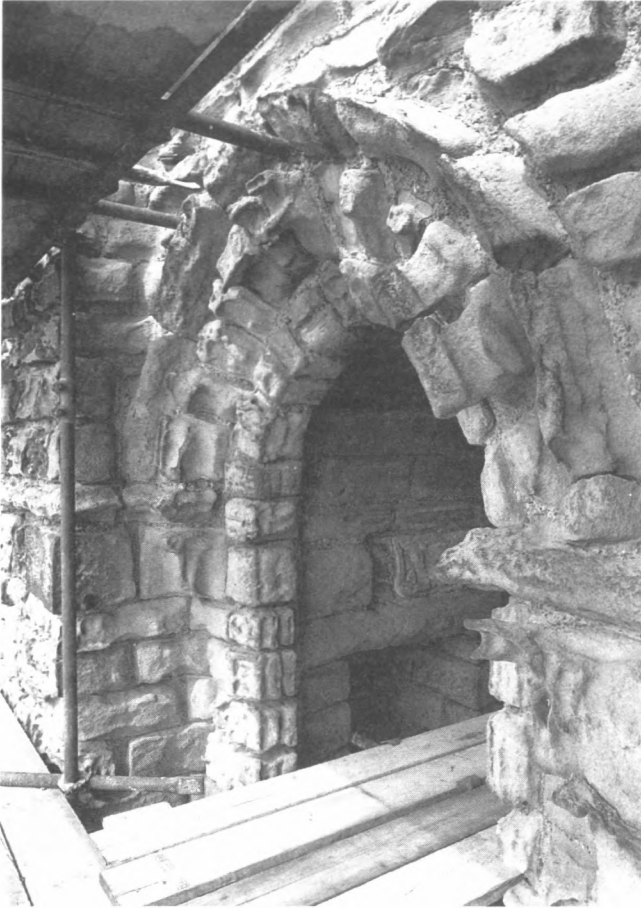
*Fig. 13 Head of a clerestory window on the south side, showing severe weathering, 1996.  
© English Heritage/Jonathan Bailey.*

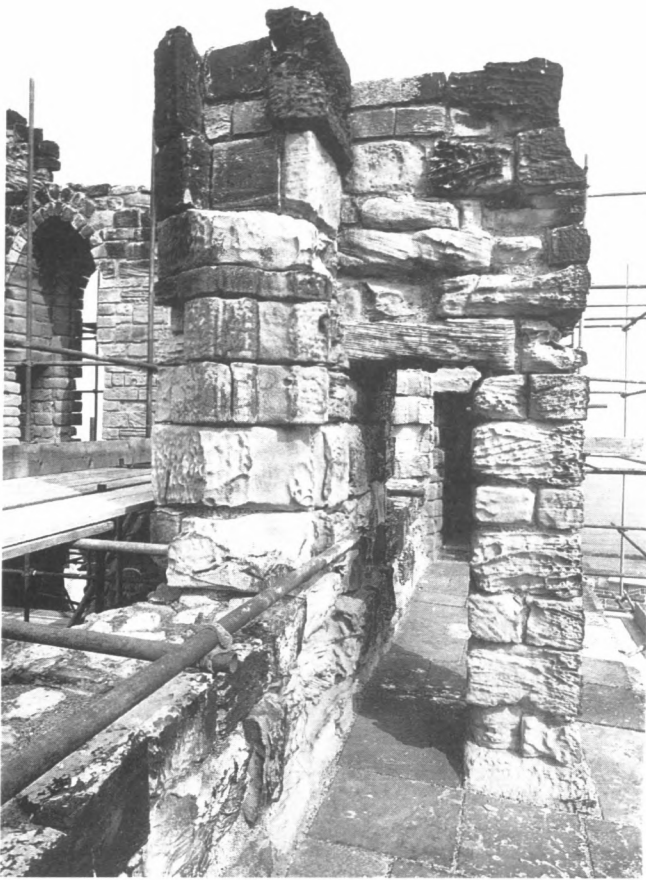
*Fig. 14 Top of south wall, 1996, showing severe weathering and the sloping pavings laid c. 1914 to shed water. The window reveal is for the great chamber which was added above the vaulting. © English Heritage/Jonathan Bailey.*

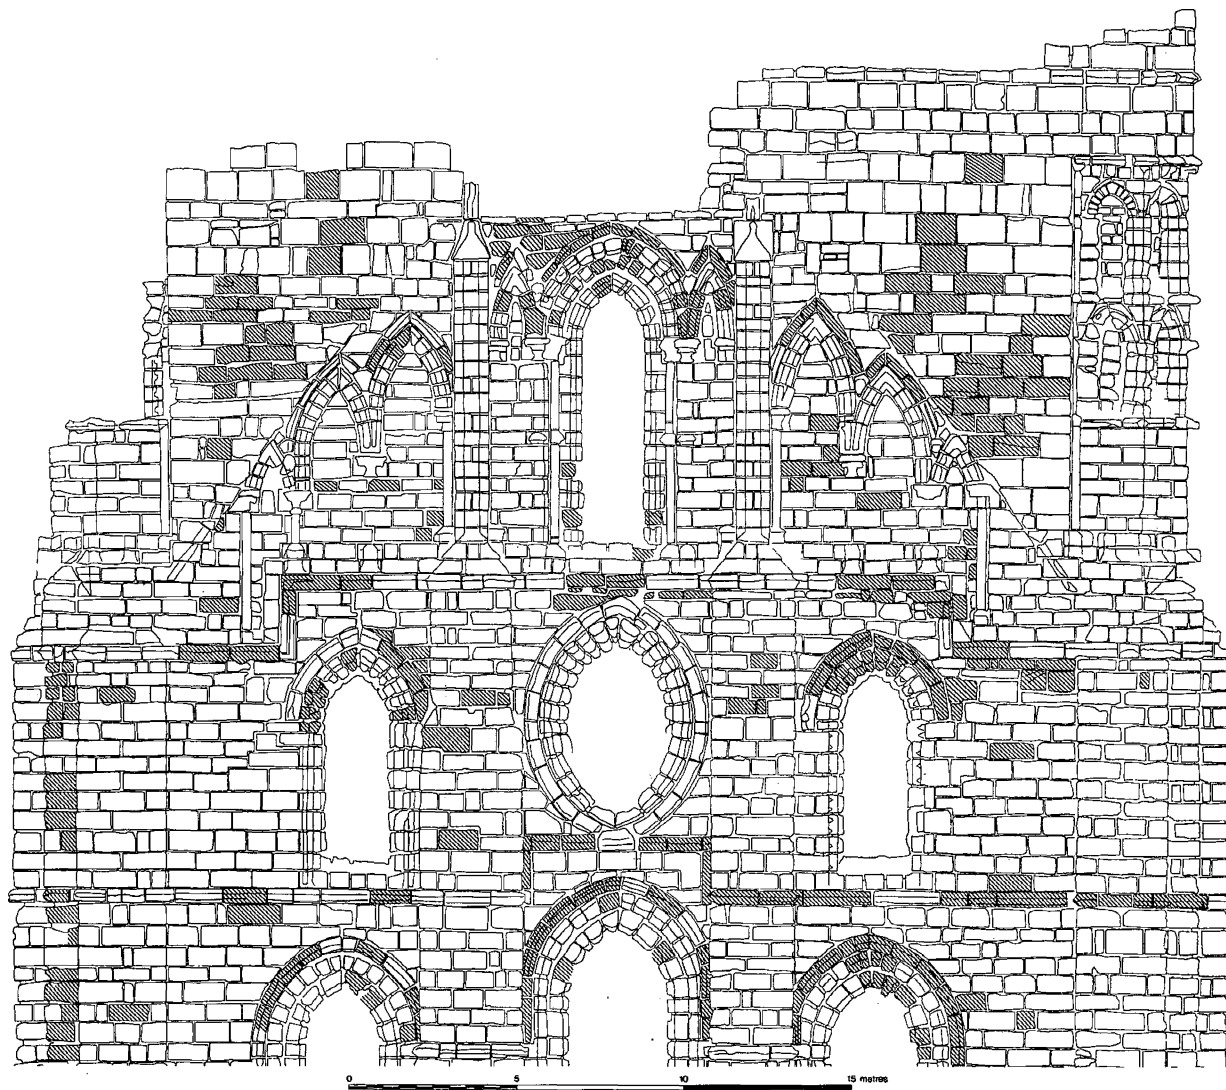
Fig. 15 Part of photogrammetric drawing of east elevation of east wall, showing stones replaced 1996–97 (hatched areas). It also shows the line of the gable before the heightening. © English Heritage.
