# The Black Barn at Tow House, Bardon Mill, Northumberland: a heather-thatched barn and its context

*Robin Dower and Peter Ryder*

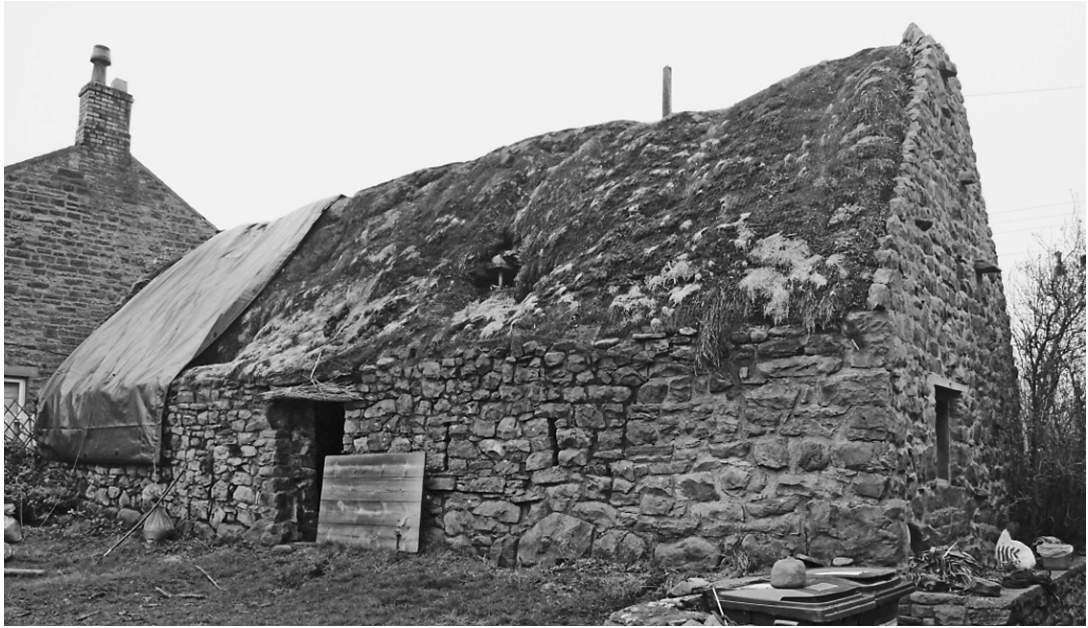
Fig. 3 South-west side of Black Barn 2010. The failure of the thatch is evident.

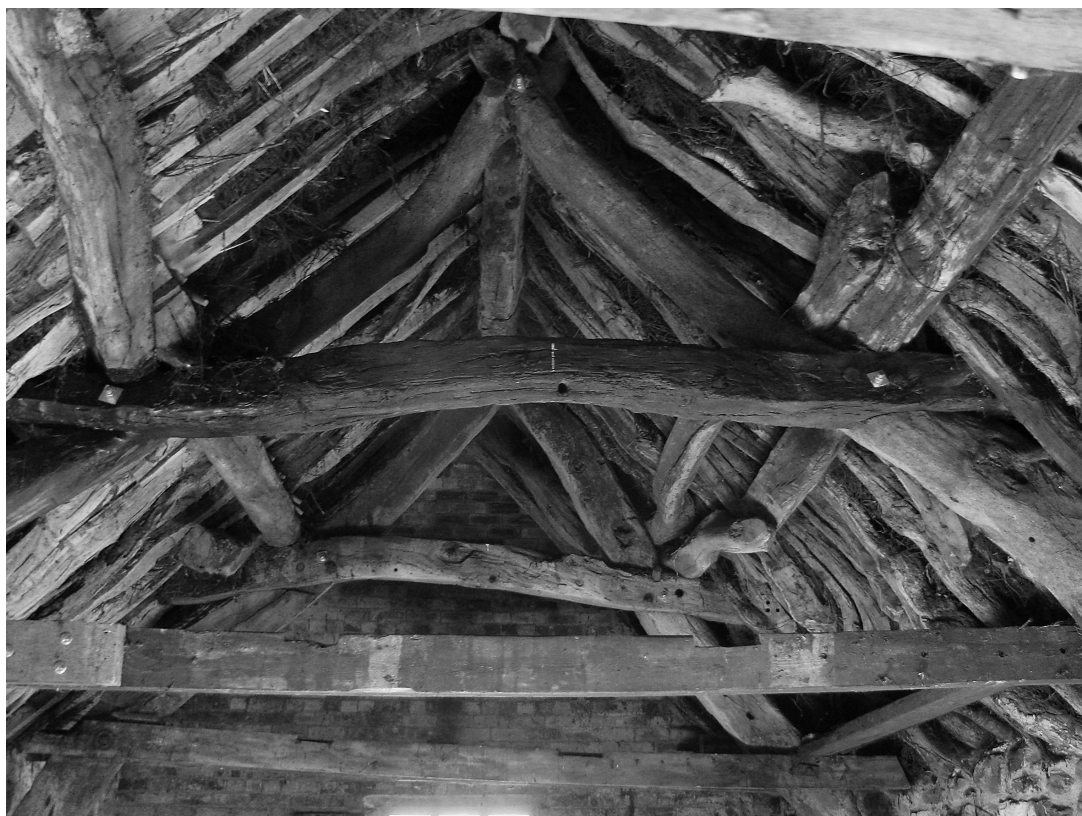
Fig. 5 Interior of barn roof looking north, December 2013. The sawn timbers have been added, perhaps in the late 19th century, to control spread of crucks.

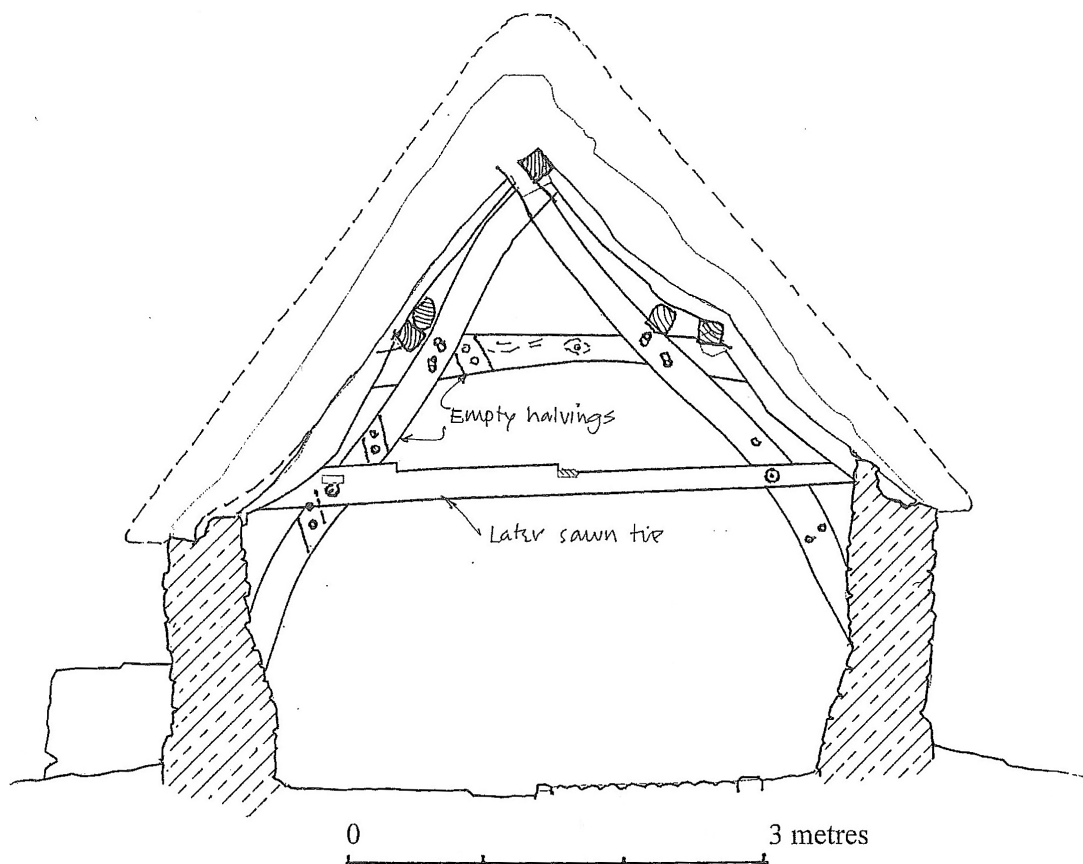
The cruck blades here do not match, and it is clear that the north-eastern is a re-used piece; it has a pair of empty halvings (each with two pegholes) set vertically, showing that it has been re-used upside down (fig. 6). There is also an empty diagonal halving on the collar, which

Fig. 6 Truss No. 1. North elevation showing empty halvings — evidence of re-use.

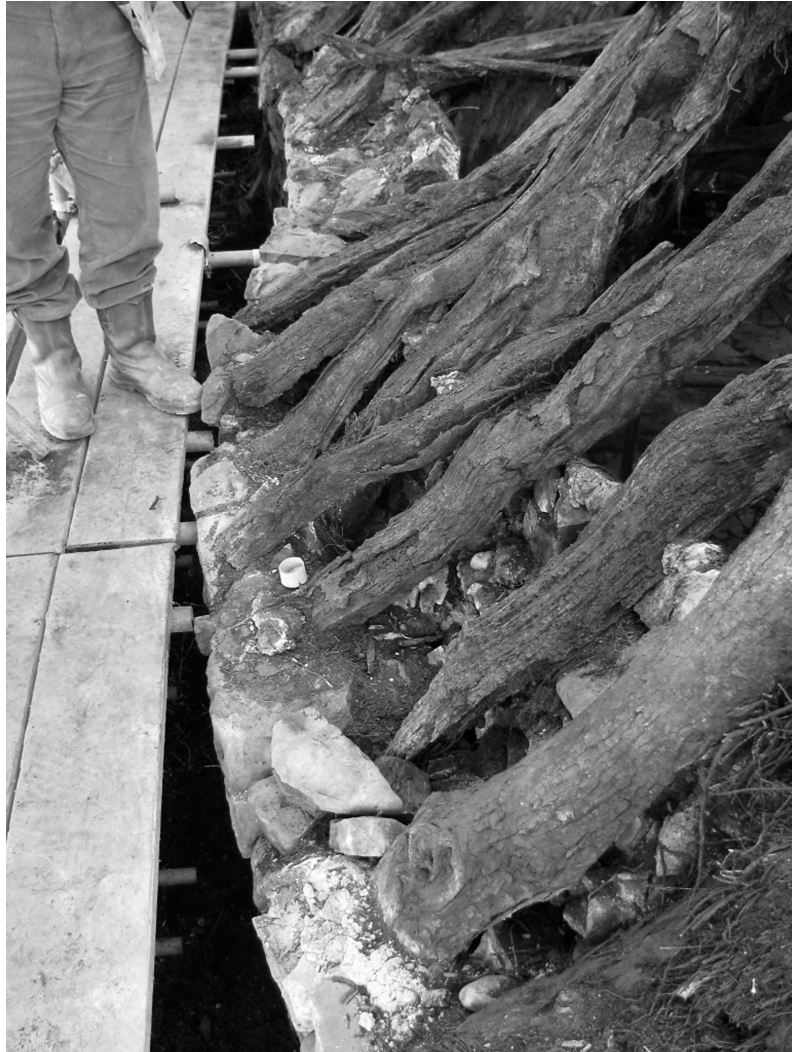
Fig. 7 The south-west eaves wall showing effect of spreading trusses and rafters.

The roughly-shaped oak purlins midway up each slope are overlapped on the backs of the cruck blades and supported on the extended ends of the truss collars. There are no wall-plates. It appears that a few of the original rafters were full length to the slope but that most were cut to span from ridge to purlin or purlin to wallhead. Rafters were generally cleft oak though ash was also used. There is no consistent evidence for the fixing of the rafters; some may have been pegged side by side across the ridge beam to hang them from the top but most seemed to rely on support on the wallhead and the loading at the purlin to hold them in place. The fact that the eaves wallhead had been deformed by outward pressure from the roof structure certainly appears to have had as much to do with slippage of the rafters as with spreading of the trusses (fig. 7).

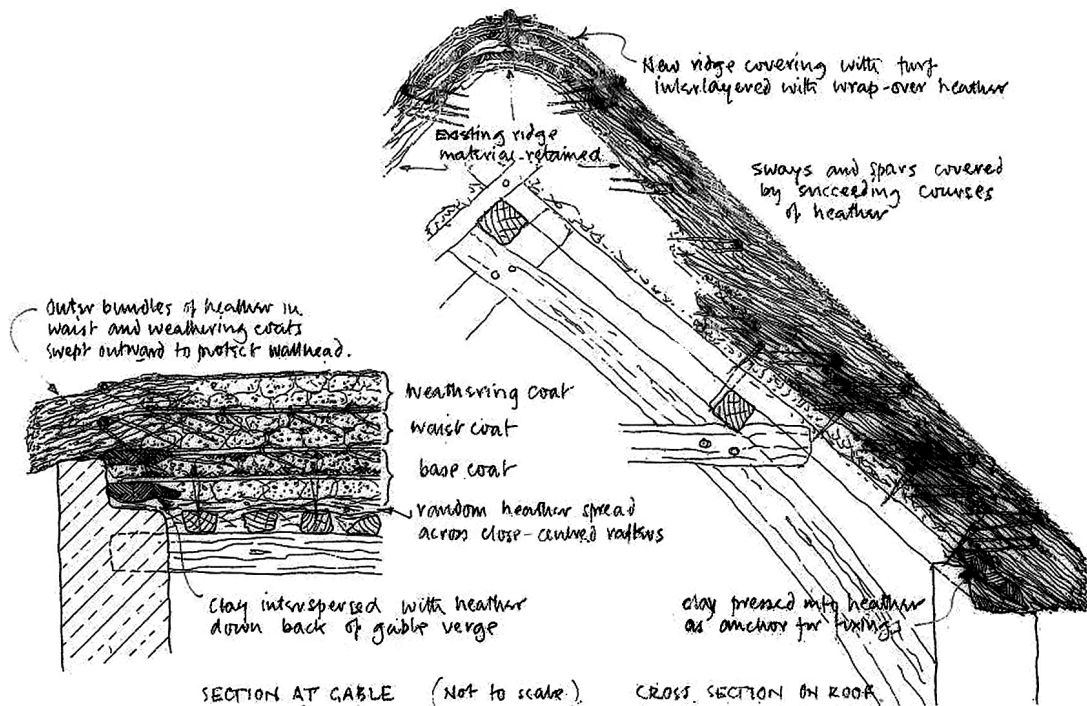
Fig. 8 Detailed section of gable verge, ridge and eaves with schematic layering of heather, clay, turf and fixings.

Heather is unique amongst thatching materials in being laid so that its roots or cut-stem lie up the slope and its head down the slope. As a bushy dividing growth with springy hard stems it is difficult to persuade the material to bed down into a dense compact surface. With wheat straw and water reed the long stems laid with the cut end down the slope do lie tightly together and form a dense surface down which water can run freely and drain off. With heather there is something of a competition between water running down the slope or percolating through the stems into the heart of the deep thatch cover. This race can be influenced by the steepness of the roof pitch. At the Black Barn this is relatively shallow, about 50° from horizontal, but much steeper pitches can be seen at other buildings (for instance the Whitehouse at Featherstone where the structural roof pitch must have been not less than 58° from horizontal and the finished thatch probably 60°). One possibility is that, with successive coats of thatch, the pitch might be increased by enhancing the thickness of the thatch towards the top and creating a very deep build-up over the ridge (fig. 8).

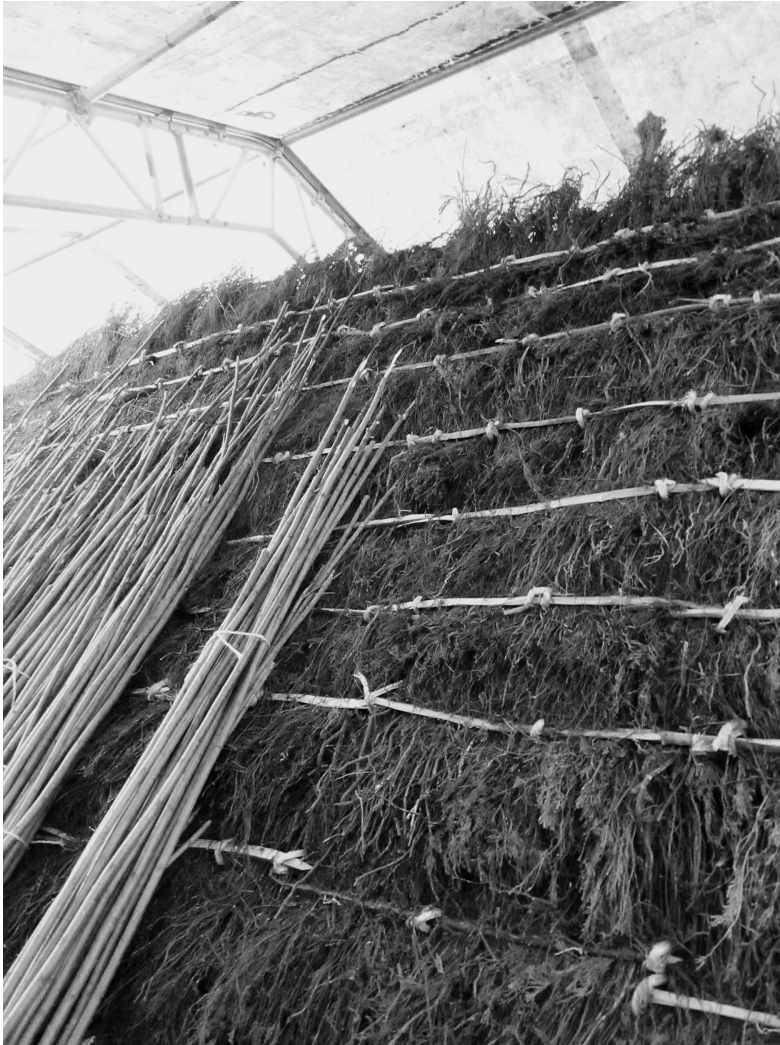
Fig. 9 The waist coat is fixed with hazel sways and spars (or staples).

The next coat, normally referred to as the waistcoat, starts at the bottom in much the same way but now the sways (willow or hazel rods of a man's thumb thickness) are fixed with twisted hazel spars (in the North East also called staples or stapples) about 0.40m long with sharpened points driven into the basecoat. Care is taken that these should not point downward and risk conducting water into the thatch, but are driven at least horizontally against the slope of the roof (fig. 9). Across the top of each course the dip above the stems of heather

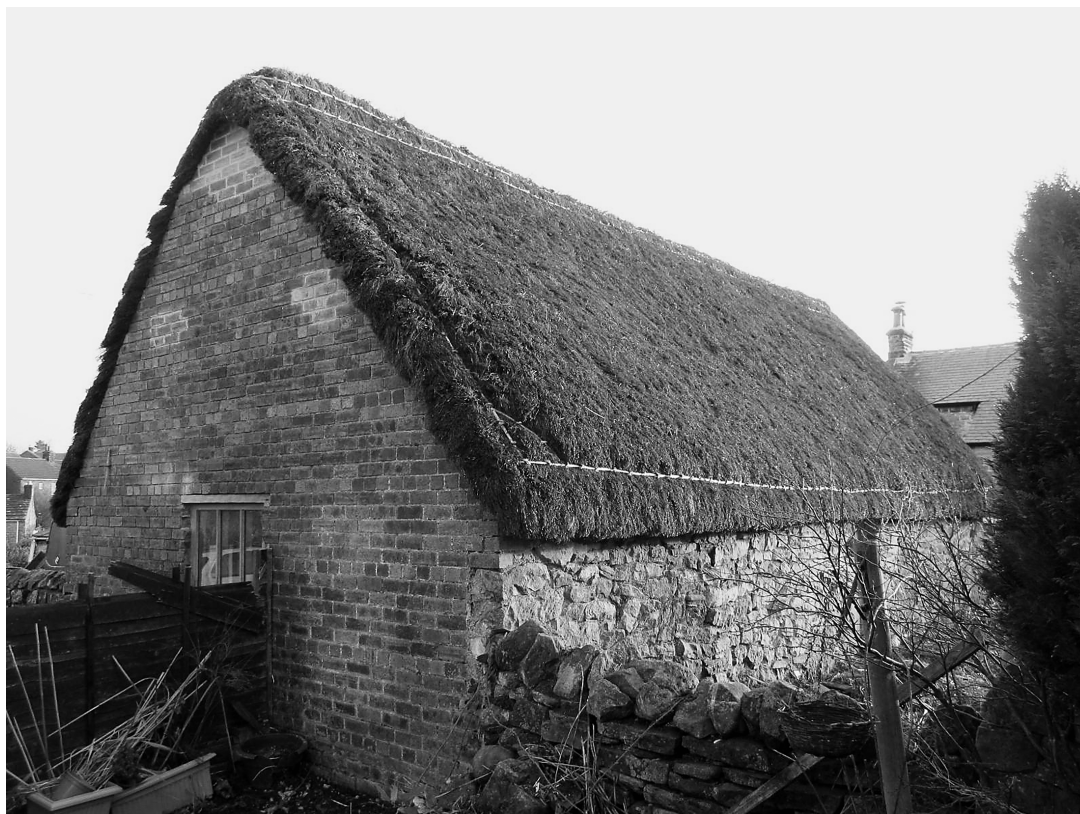
Fig. 10 The exposed ridge eaves and gables are reinforced against wind with liggers.

wind by fixing hazel liggers held with frequent spars hammered deep into the combined waist and base coats. At the bottom corners an extra short diagonal ligger is added to resist strong wind ruffling (fig. 10).

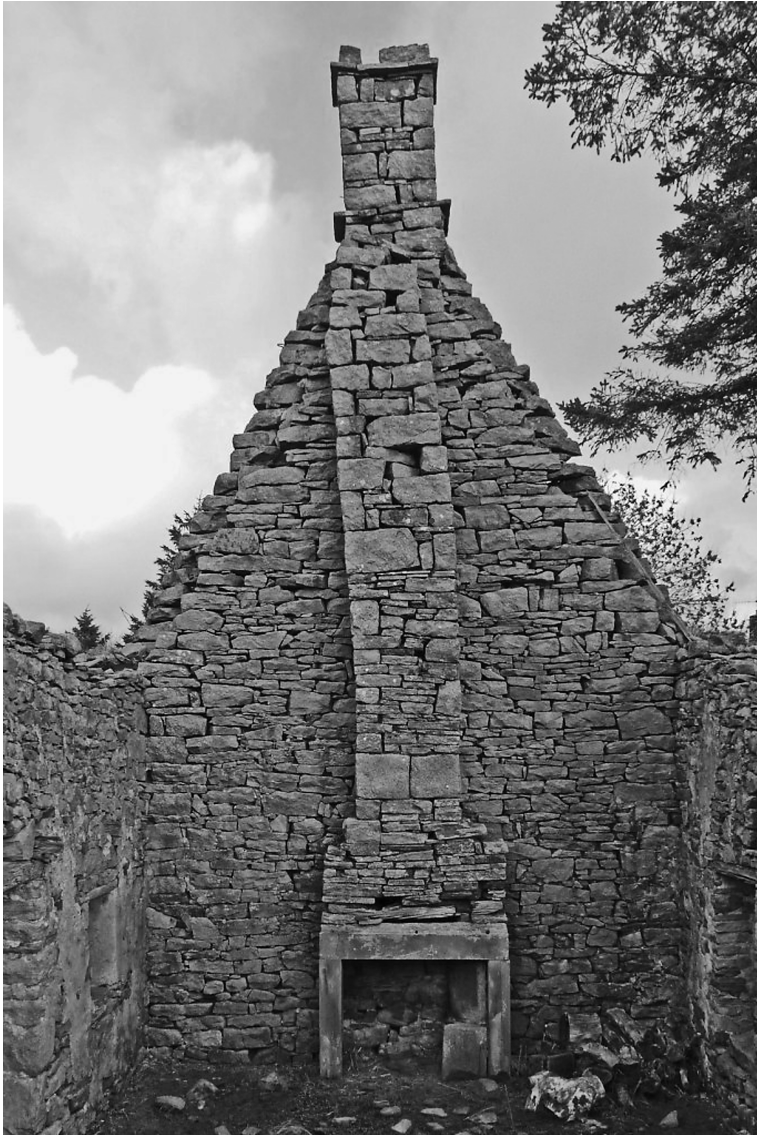
Fig. 17 The steep gable wall of ruin behind Whitehouse, Featherstone: now sadly a dangerous structure.
