**HISTORIC BUILDING RECORDING:
THE OLD MALTINGS
BEDFORD ROAD
MILTON ERNEST
BEDFORDSHIRE MK44 1RJ**

NGR: TL 01959 55942

on behalf of Reach Living

Ref: BHS/0092/MEM/2

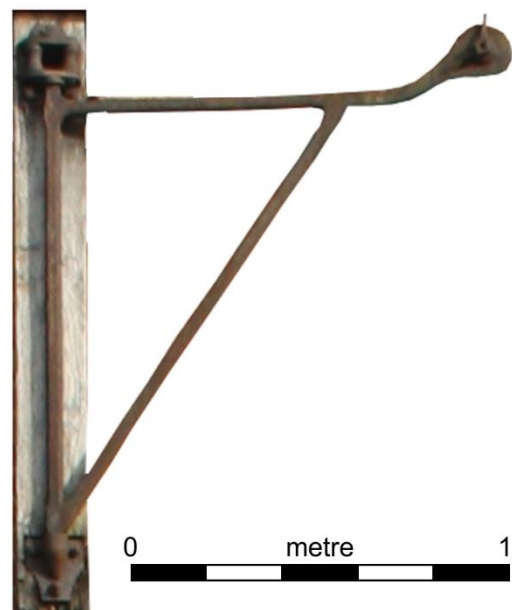
Figure 8: Surviving pulley hoist, west end of Building 1 (scale 1:20 approx.)

Alongside the upper taking-in door, the pivoting arm of a pulley hoist survived (Fig. 8).

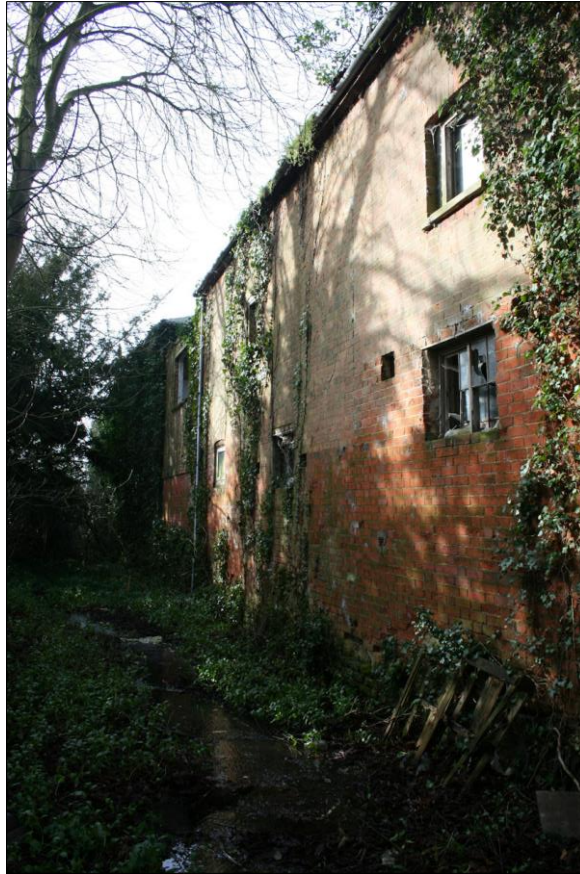
Plate 1: Buildings 1 & 2, south elevations from south-east

4.3 **South Elevation** (Figs 9, 10 & 13; Plate 1)

Building 1: As with the north elevation, the south elevation of Bldg 1 has string courses, three bricks deep, running the length of the building at first and second-floor levels with window and door openings, particularly on the upper floors, mostly aligned vertically in each bay. Windows on the first floor are mostly 6-pane casements with timber sills, set beneath flat brick arches. One first-floor window opening (Room G3) contains wooden louvres. On the second floor the windows are smaller, 4-pane hopper windows (see Plate 34), beneath timber lintels. The easternmost of these has been partly bricked up. Three additional window openings at first-floor level are set close to the lower string course, beneath brick-arched lintels. Two contain 6-pane casements: the easternmost is damaged and incomplete. At ground-floor level, the two western windows appear to be enlargements or later insertions, the next two have been bricked up and the easternmost has been boarded over.

Infill Structure: As with the north elevation, the lower string course of Bldg 1 extends across the lower part of the infill structure: about 3 courses above it, the character of the brickwork changes. The upper brickwork is not of the same quality as that in Bldgs 1 and 2, into which it is roughly bonded. There appears to be a single large modern window in the upper part of this section, but it could not be examined closely or measured accurately.

Building 2: Because of the dense ivy growth it was not possible to determine whether the south elevation of Bldg 2 showed evidence of rebuilding, as with the north. The only features noted in this elevation were five windows, two at first-floor level and three set high up in the ground floor. These were mostly boarded up, making details difficult to ascertain.

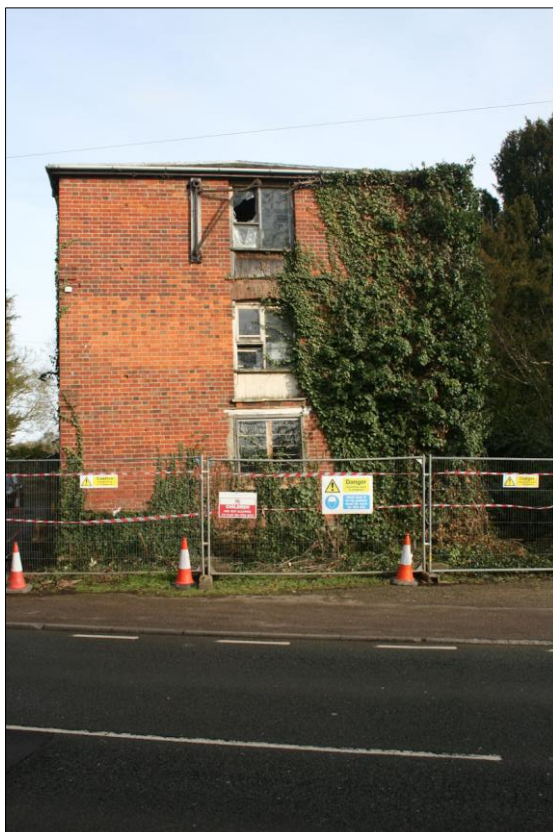
Plate 2: Building 1, west elevation from west

4.4 **West Elevation** (Fig. 11, Plate 2)

Building 1: The string courses noted on the north and south elevations did not extend across this elevation, terminating $1\frac{1}{2}$ bricks (c.33cm) from the corners. Located centrally on the ground floor was a fixed single-pane window beneath a timber lintel. This was evidently a modern insertion, as the opening had been rather crudely modified to accept it. Above the window at first- and second-floor levels were openings for taking-in doors, the first-floor opening having a flat brick-arched lintel. Both openings had been converted subsequently to windows, by boarding up the lower part and inserting glazed panels above.

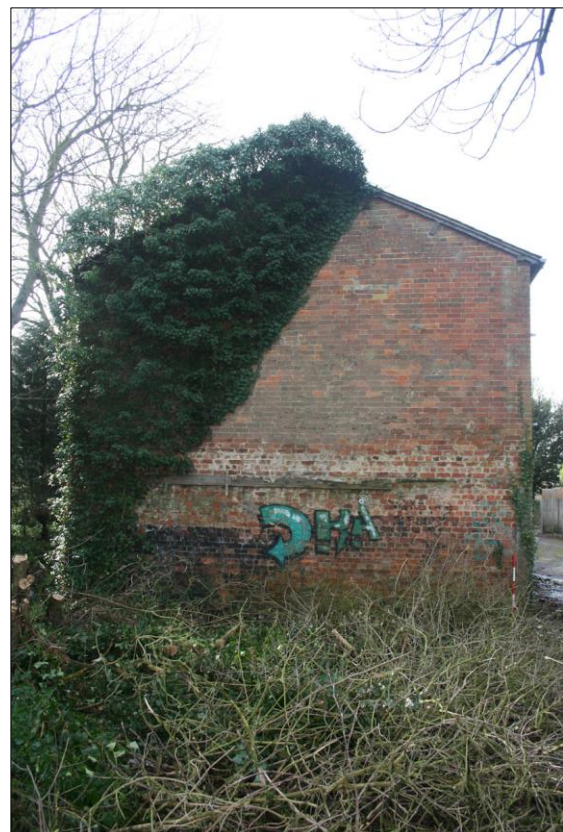
Plate 3: Building 2, east elevation from east

4.5 **East Elevation** (Fig. 13, Plate 3)

Building 2: Partly covered with ivy, this elevation was featureless, apart from exposed purlin ends. A horizontal timber, fastened to the wall c.2m above ground level, may be the surviving roof support for a possible lean-to structure at this end of the range, shown on the 1979 Ordnance Survey sheet (Fig. 7).

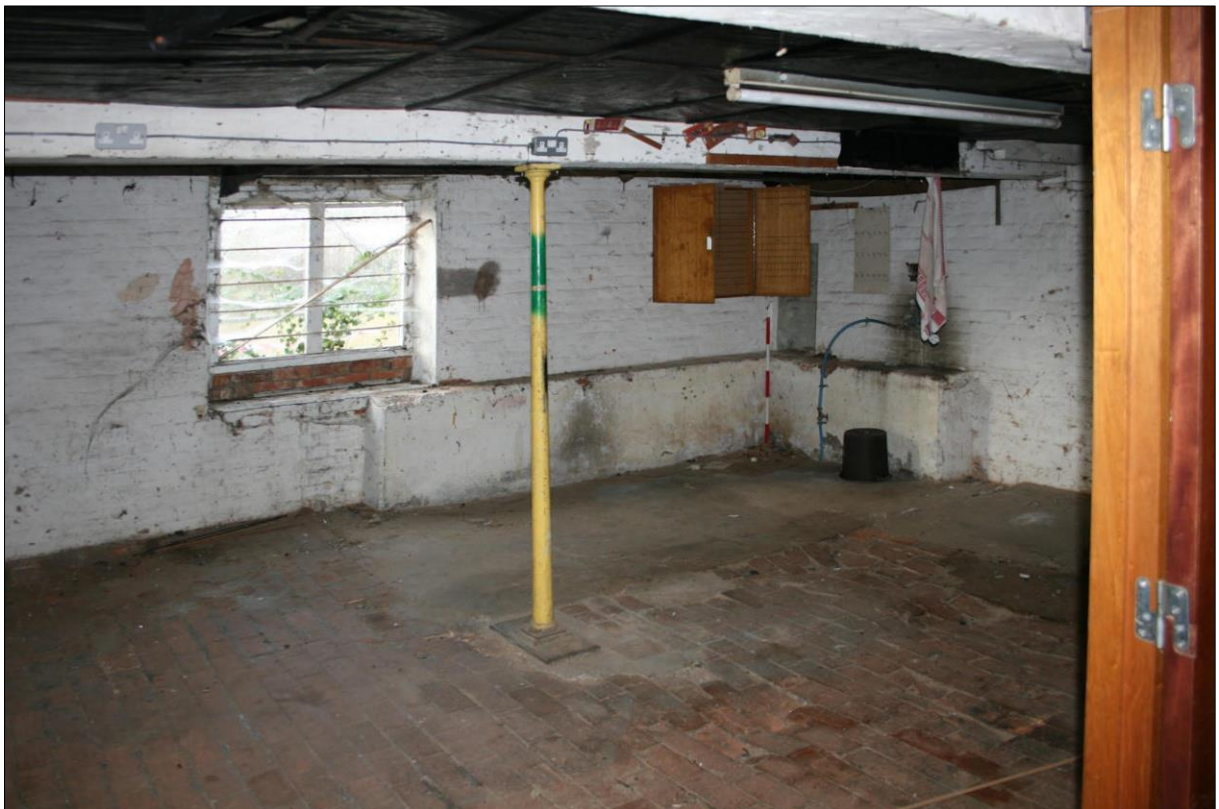
Plate 5: G1, looking north-west

Description: Brick floor with concrete repairs. External door to north: windows, both probably modern insertions/enlargements of originals, to west and south. Brick 'benches', c.1m high, along part of the south wall and in the north-west corner: possibly former supports for a vat or tank? In the centre of the room, the principal floor joist is supported by a cast iron column.

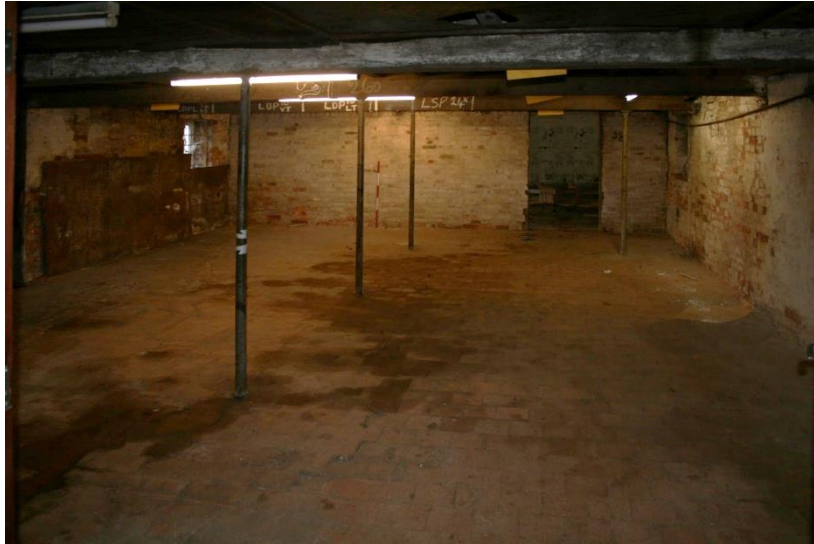
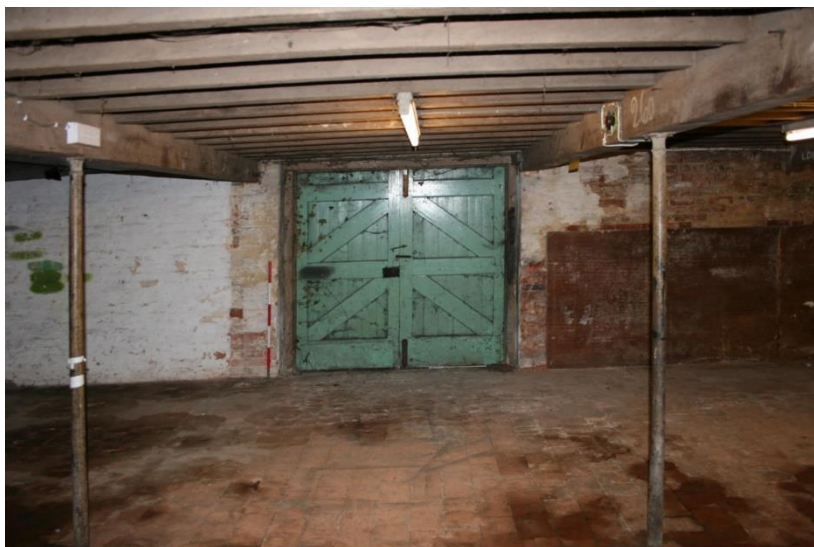
Description: Quarry tiled floor, largely complete. Double external door to north, doorway to G3 to east. Three windows to south: one a later insertion, the other two are original openings, bricked up. The three principal floor joists are supported by cast iron columns, in a line down the centre of the room: the easternmost joist has a second column inserted, towards the south wall.

Plate 6: G2, looking east

Plate 7: G2, detail of double doors to north

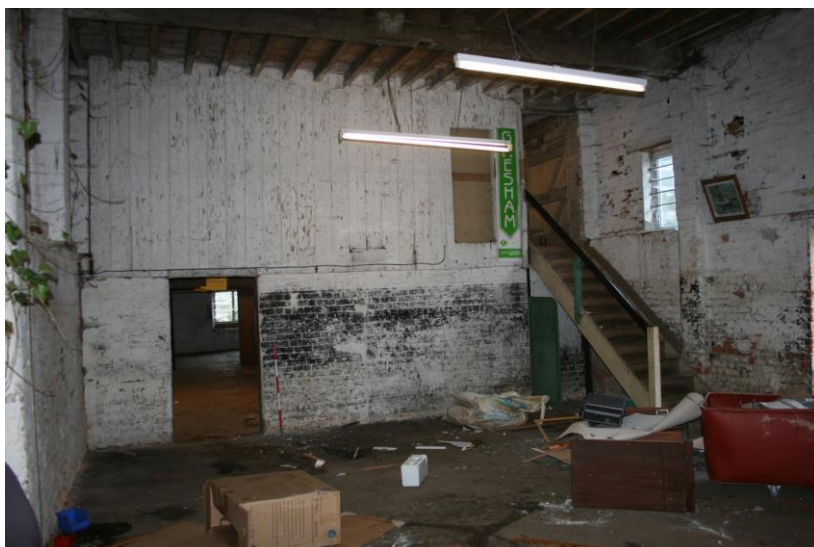
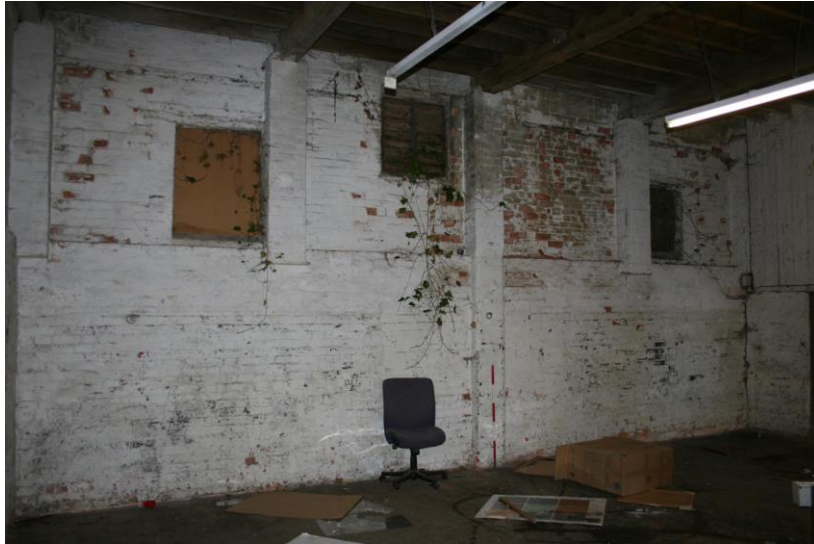
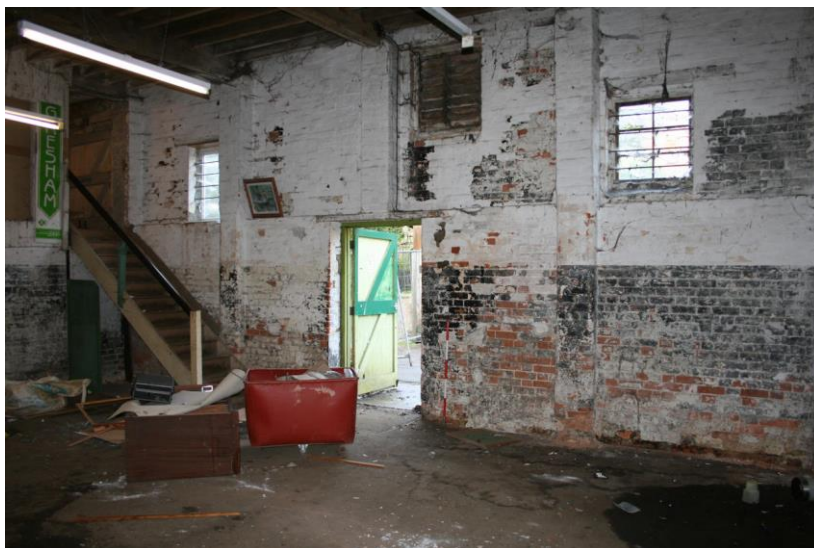
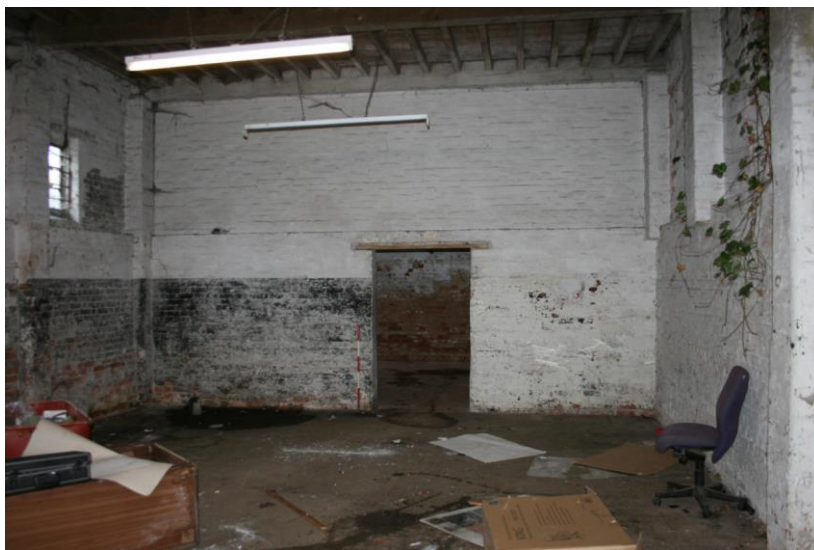
Description: Quarry tiled floor. External door to north, internal doorways to G2 and G4. No ground-floor windows: three window openings at first-floor level to north and south, the central one on both sides having wooden louvres rather than a window. Wall thickness reduces at first-floor height on north, south and east walls, with buttresses to the principal joists. The west wall above first-floor height is constructed in timber, clad in vertical planks c.20cm width. In the north-west corner, a modern timber staircase gives access to the first floor. Beneath this, there appears to have been a cupboard. All four walls appear to have originally been painted black to c.1.6m above floor level.

Plate 8: G3, looking north-west

Plate 9: G3, looking south-west

Plate 10: G3, looking north

Plate 11: G3, looking east

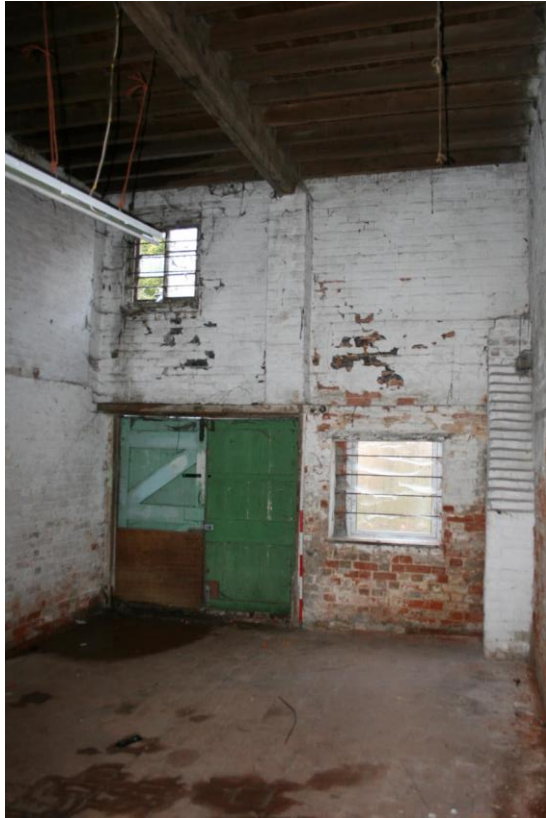
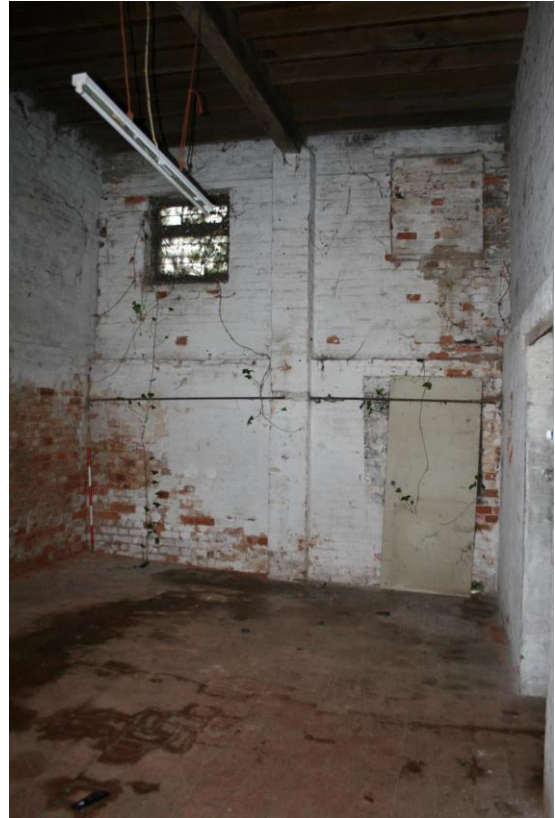
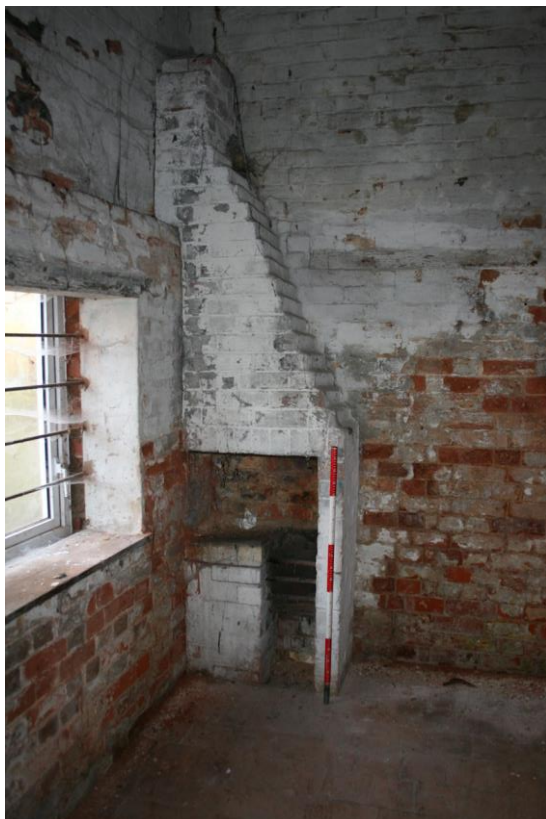
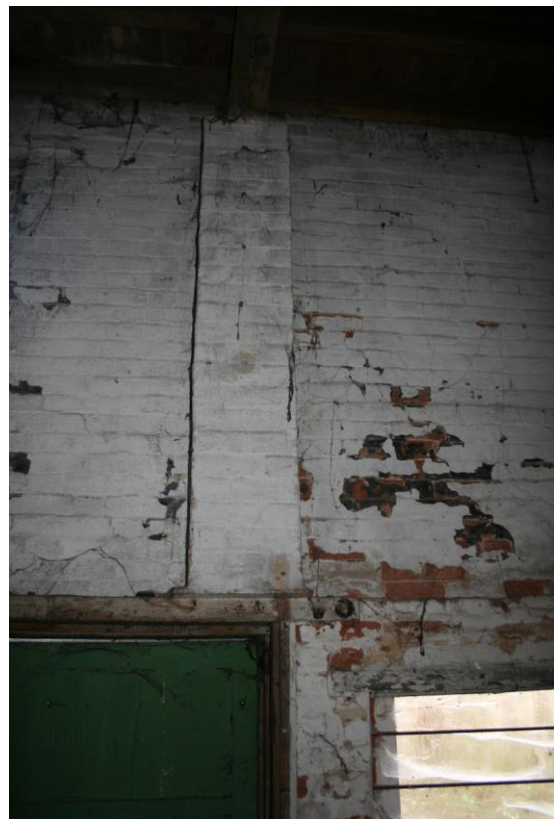
Description: Quarry tiled floor, sloping down to west. External double door to north, internal doorway to G3. Ground and first-floor window openings to north and south. In the east wall, traces of a blocked doorway at first-floor level. Wall thickness reduces at first-floor height on all four walls, with buttresses to the principal joist. In the north-east corner is a brick-built hearth, 0.6 x 0.4m and 1.0m high, with a corbelled brick flue above rising towards the north wall. Examination of the exterior revealed repairs to the brickwork in the area where the flue would be expected to emerge. The function of this hearth remains unknown.

Plate 12: G4, looking north

Plate 13: G4, looking south

Plate 14: G4, detail of hearth in north-east corner

Plate 15: G4, detail of buttress above north door

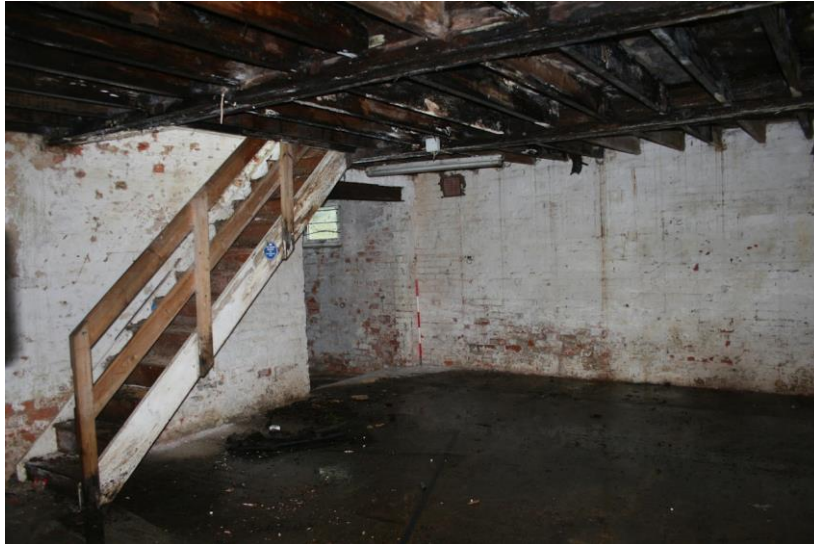
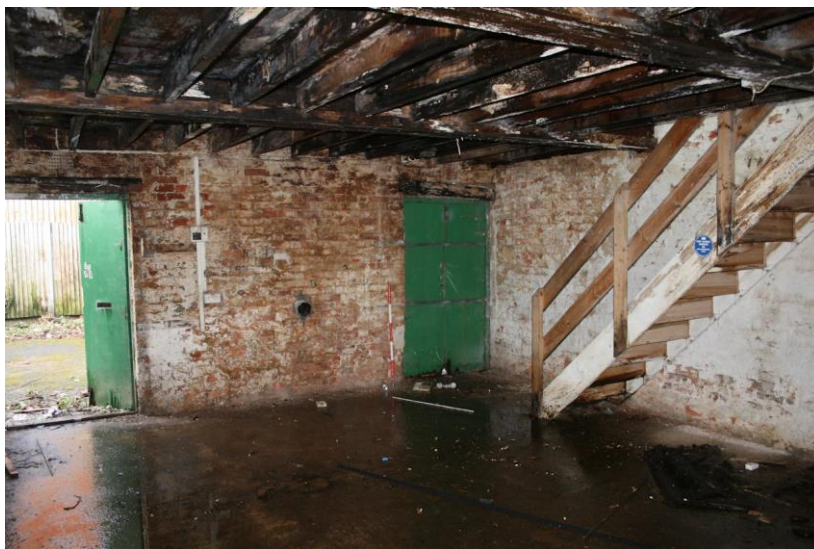
Description: Concrete floor. Two doorways to north, each fitted with modern flush double doors. Inserted doorway (iron lintel) with step down into G6 in south-east corner. Modern staircase on south side, giving access to F2. It is worth noting that in this part of the building, the principal floor joists are aligned east-west rather than north-south, as they are in Buildings 1 & 2.

Plate 16: G5, looking south-east

Plate 17: G5, looking north-east

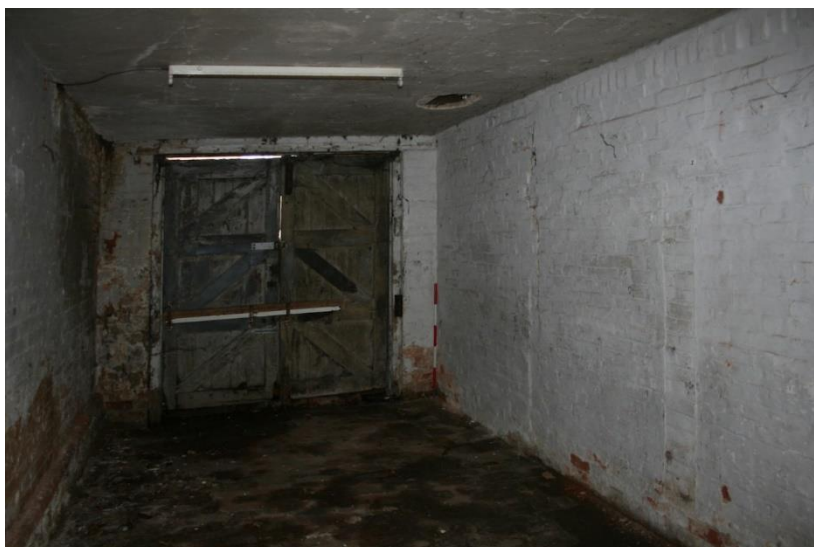
Plate 18: G6, looking north

Description: Brick floor. Brick walls, whitewashed. Wide double door to north, high-level window to south, inserted doorway to G5. Lath & plaster ceiling.

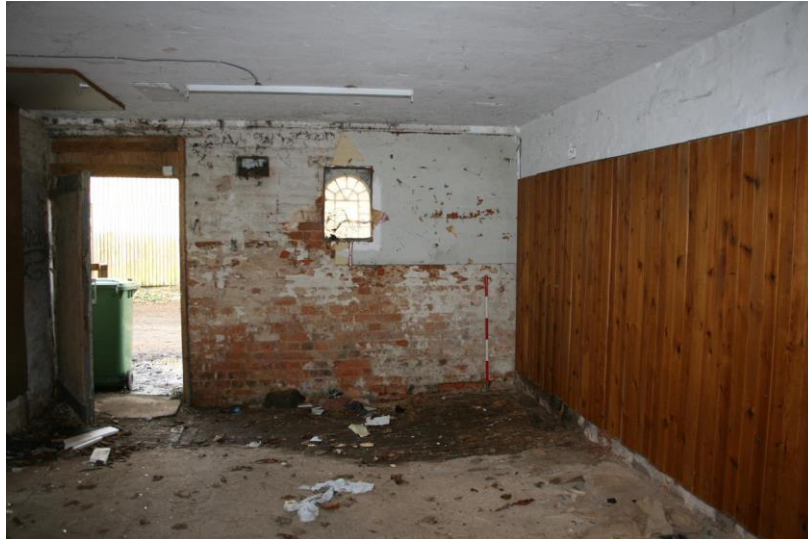
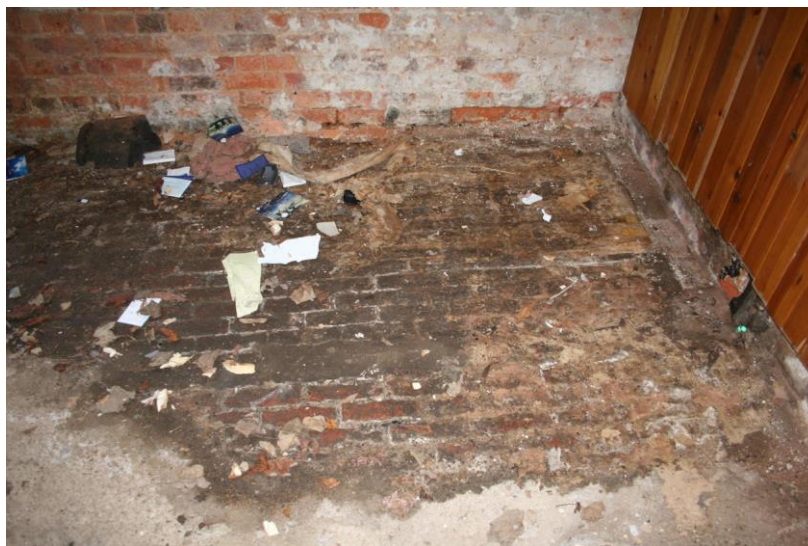
Description: Brick floor, partly covered in concrete. Brick west wall, whitewashed: east wall clad in modern matchboarding, south wall in hardboard and fabric. Door and small window to north, high-level window to south, inserted (?) doorway to G8. Lath & plaster ceiling. Modern fabric-covered display bench across south end.

Plate 19: G7, looking north

Plate 20: G7, surviving brick flooring in north-east corner

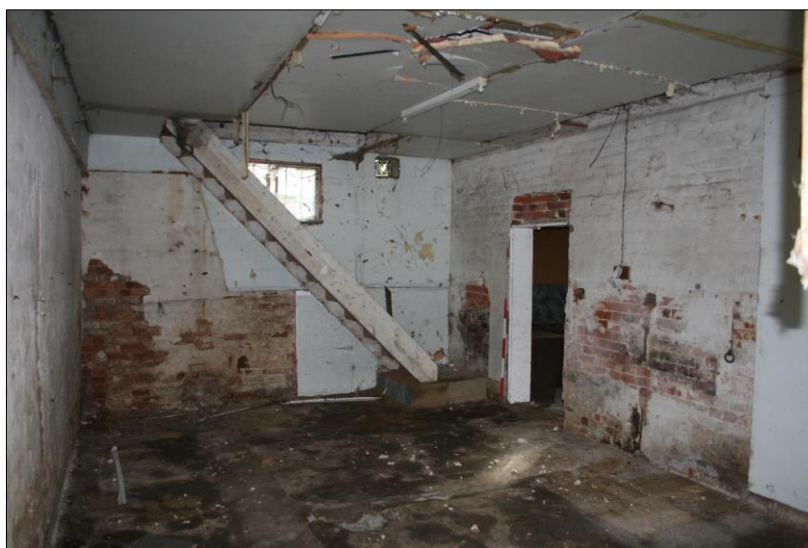
Plate 21: G8, looking south

Description: Concrete floor, probably over brick. Brick east wall, whitewashed, with stone footings: west and north walls partly clad in modern board. Door and small window to north, high-level window to south, inserted (?) doorway to G7. Modern timber stairs with concrete base at south end of room, leading to F4. Lath & plaster ceiling.

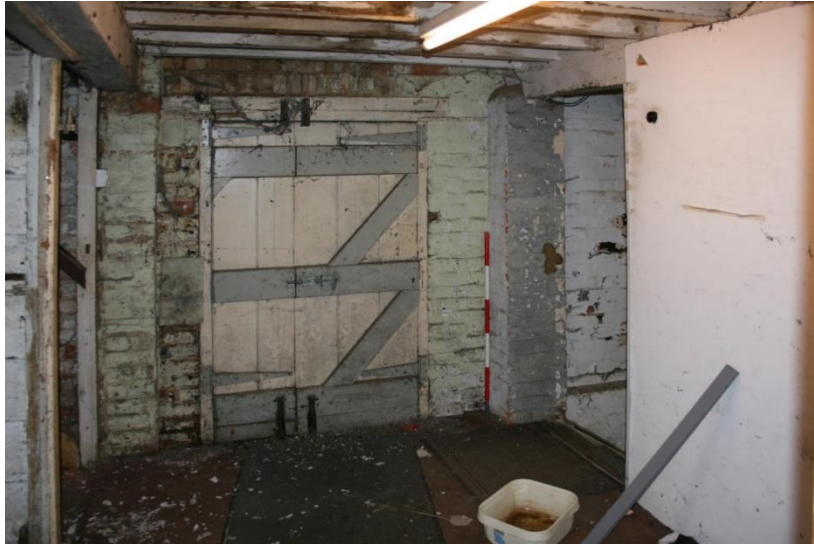
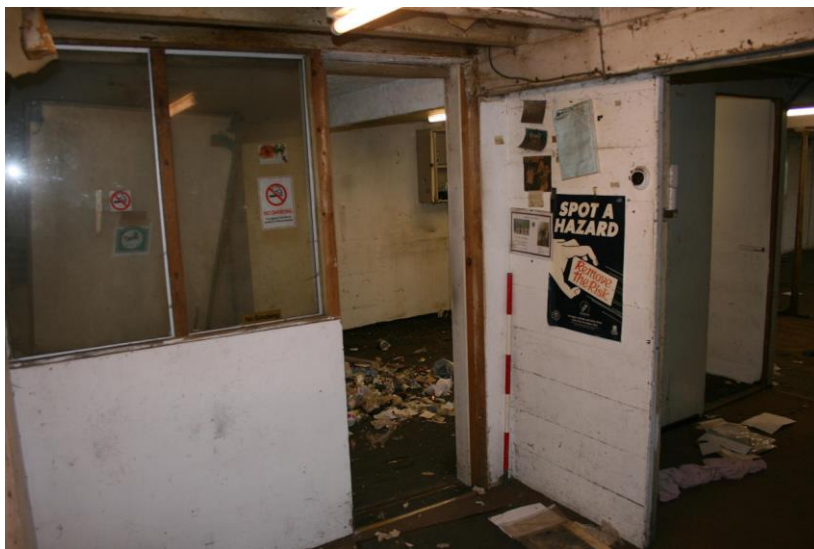
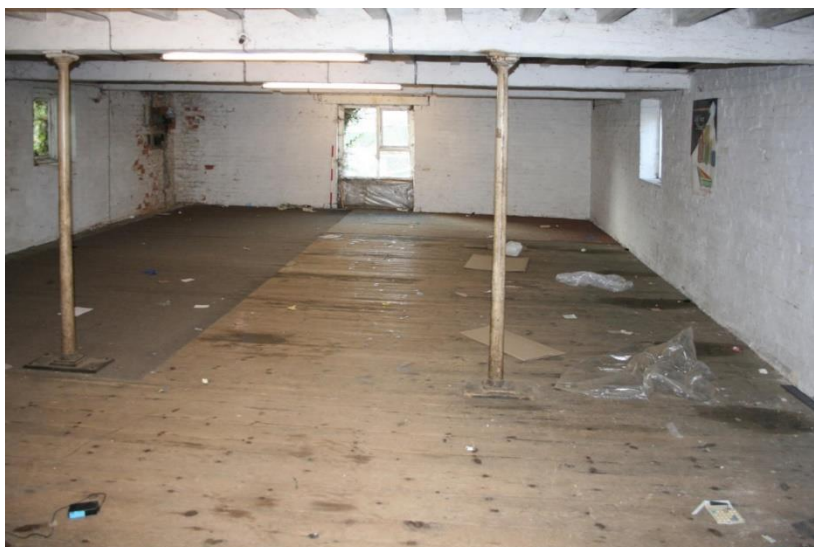
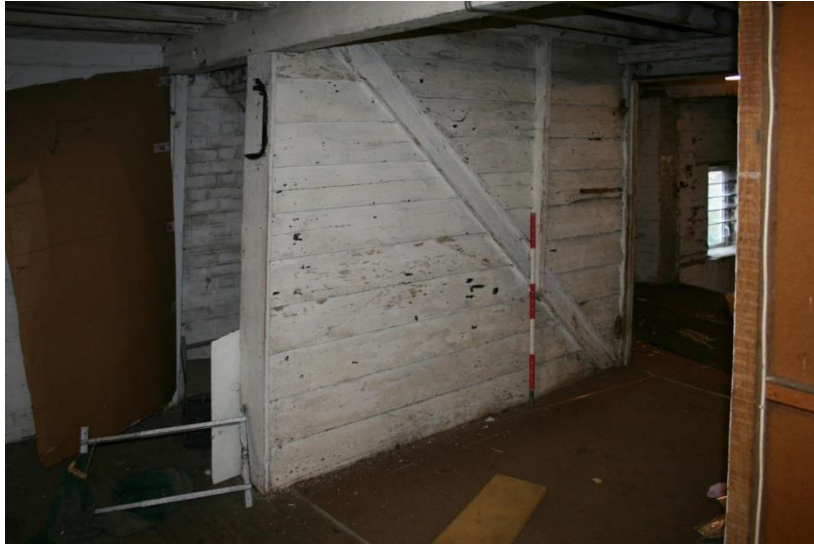
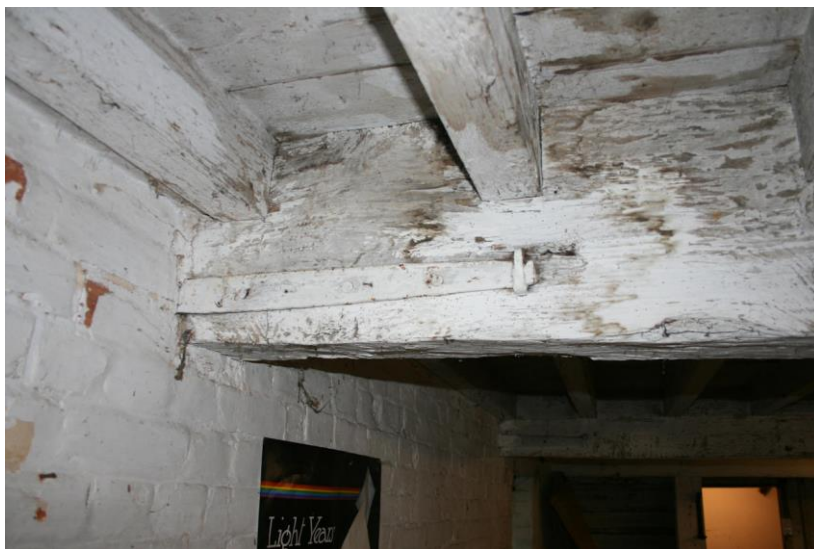
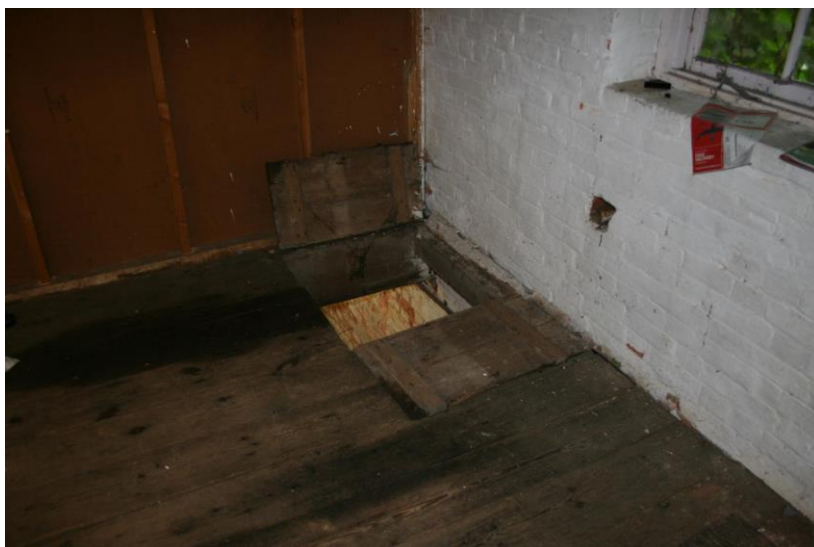
Description: Originally a single space, an office has been partitioned off in its south-east corner, with modern studding partitioning. It has a single south-facing window. At the top of the stairs from G3 is a landing area with a taking-in door to the north, stairs to the second floor and a doorway into the main part of F1 to the west, and a part-glazed partition and doorway into the office to the south. The area beneath the stairs is partitioned off for storage: the partition here is constructed with much rougher timber than the office partitions and is almost certainly earlier. The main part of F1 has two windows to the north and south and a former taking-in door (now a window) to the east. Two cast iron columns, similar to those on the ground floor, support the third principal joist from the west end. The principal joists all have substantial iron strapping where they meet the walls. Against the office partition, in the south-east corner, a small 2-leaf trapdoor has been inserted in the floor: its function is uncertain.

Plate 22: F1 landing, looking north

Plate 23: F1 landing, looking south-west to office

Plate 24: F1, looking west

Plate 25: F1, detail of timber partition enclosing stairs

Plate 26: F1, detail of strapping on principal joist

Plate 27: F1, detail of trapdoor in floor in south-east corner

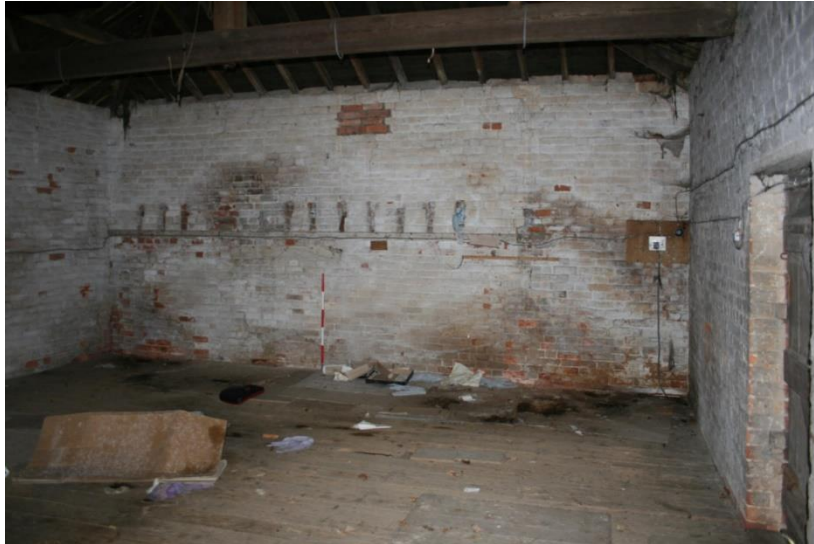
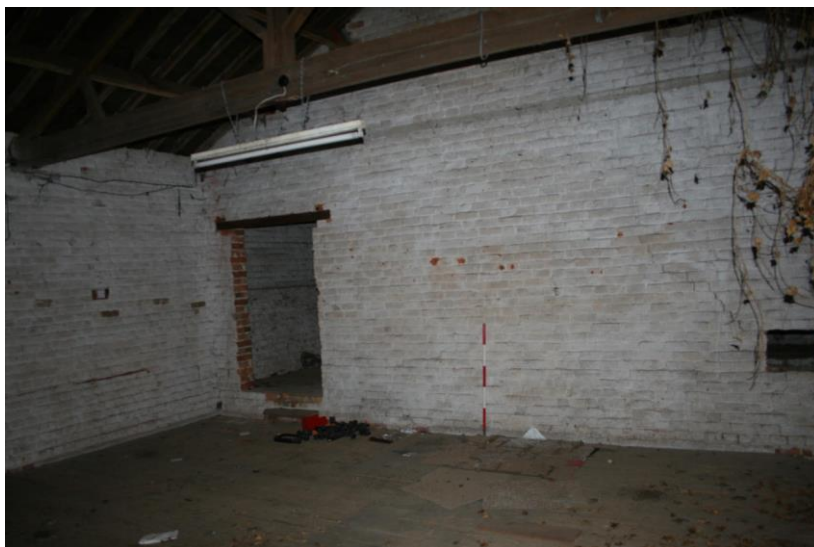
Description: Timber floor, boards on north-south alignment. Loading door to north, single window to south, inserted door to F4 to east. Brick walls, whitewashed. In the west wall is a row of timber sockets, each c.300 × 75mm, at c.1.4m above floor level. Their function is unknown. The room is open to the roof.

Plate 28: F3, looking west

Plate 29: F3, looking north-east

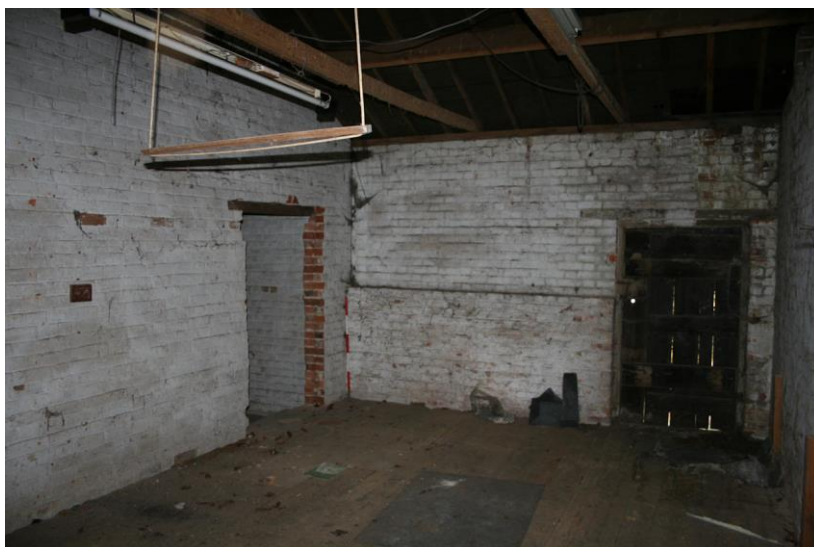
Plate 30: F4, looking north

Description: Timber floor, boards on north-south alignment. The floor in this room is c.200mm above that in F3. Brick walls, whitewashed. Loading door to north, single window to south, inserted door to F3 to west. The room is open to the roof. Opening to south, with modern staircase to G8.

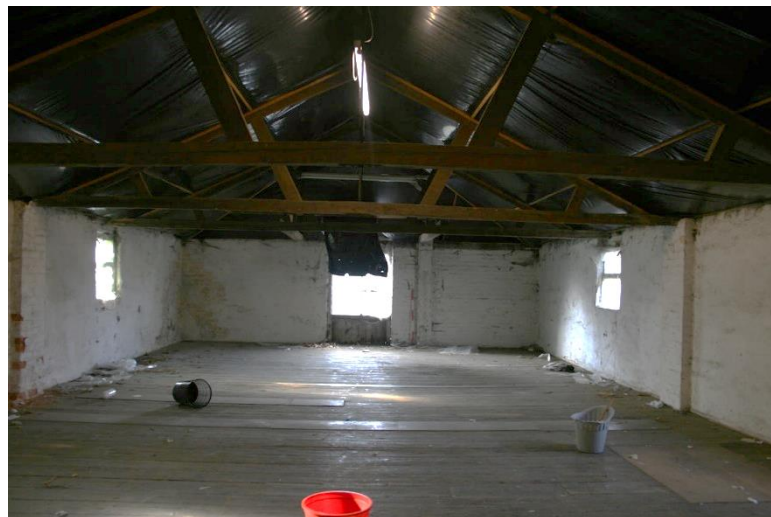
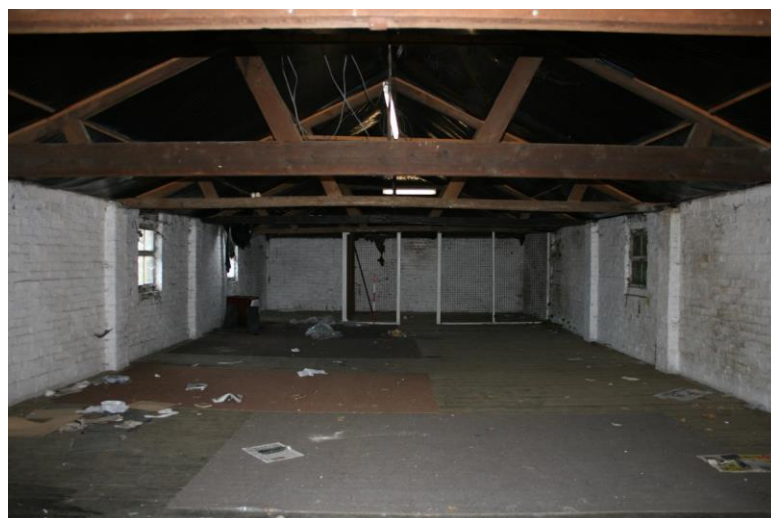
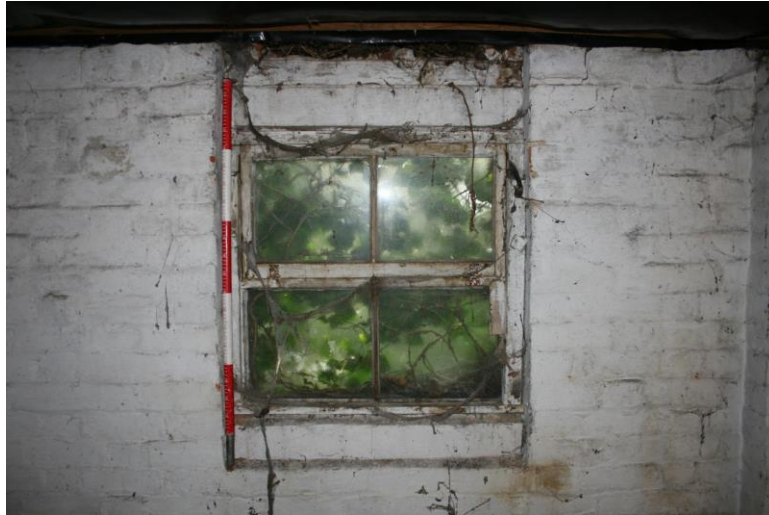
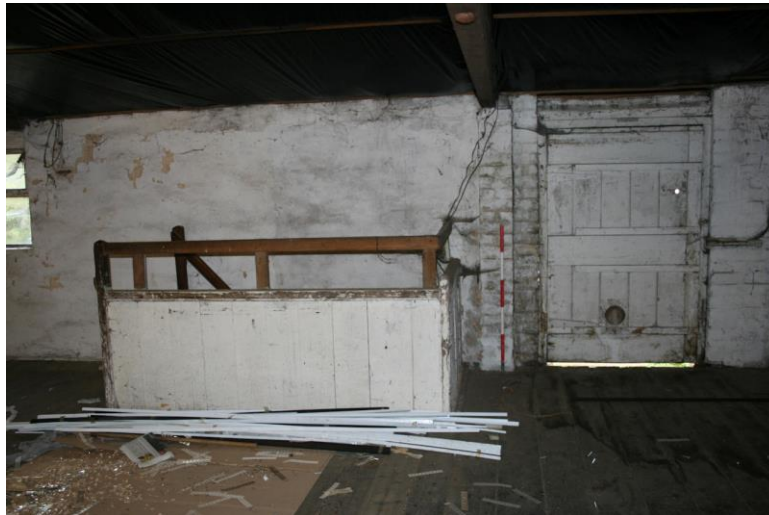
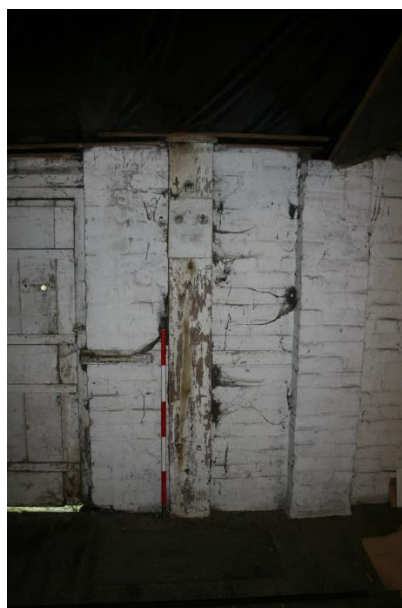
Description: Timber floor, boards aligned north-south. Taking-in doors to west (now a window) and north. To the right of each taking-in door, a substantial upright timber is bolted to the wall as the inner support of the external pulley hoist. Apart from the taking-in doors, there are four north-facing windows and five south-facing. There are narrow brick buttresses beneath some but not all of the roof trusses. There is no ceiling, the room being open to the roof, which has been clad internally with black polythene, obscuring some structural detail.

Plate 32: S1, looking west

Plate 33: S1, looking east

Plate 34: S1, detail of hopper window on south side

Plate 35: S1, top of stairs and taking-in door on north side

Plate 36: S1, inner part of crane mounting by north taking-in door
