# **Crake Trees**

Crosby Ravensworth, District of Eden, Cumbria

## **THE EARTHWORKS**

June 2012

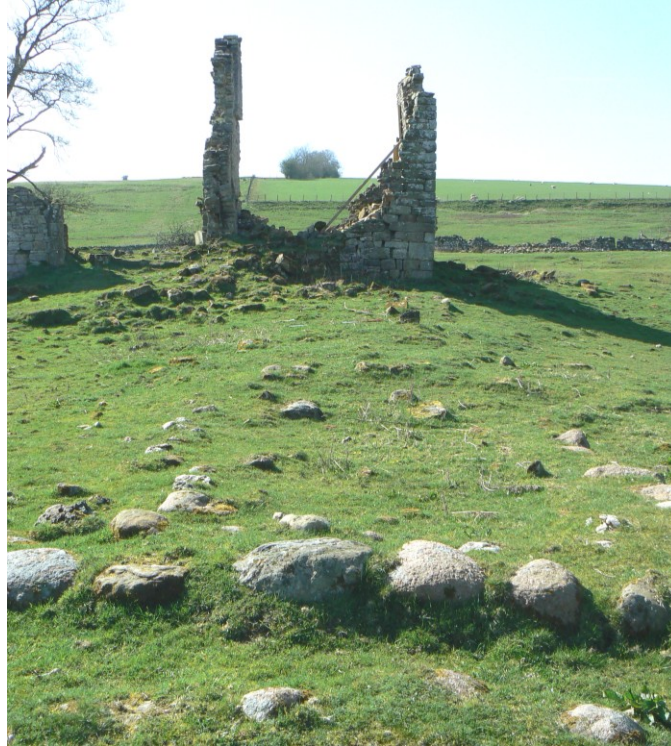
*Plate 2: Looking west across the north end of Crake Trees with boundary wall B16 in the foreground (CT 2).*

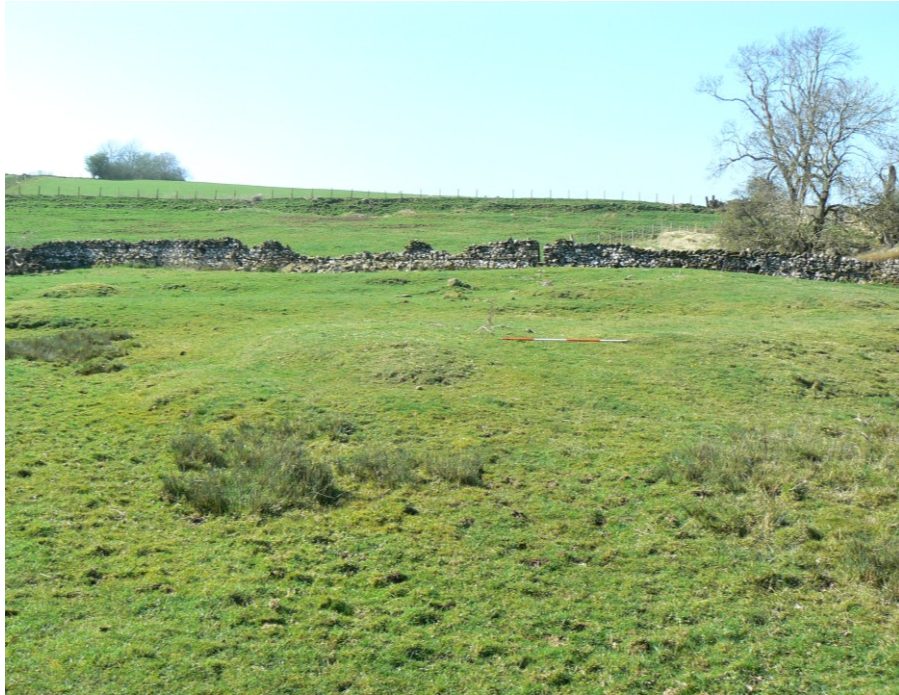
More widely, a substantial fish pond (W1), now dry, was also identified. This lay to the north of the house and was, at least in part, quarried out probably as a source of stone for the construction of the house. It was supplied with water from a stream and impounded by an earth dam on its eastern flank. Terraces on the western edge of the pond (P2 and P3) may represent a contemporary garden.

**Plate 6:** Looking west across the former fish pond (W1) to boundary wall B15 (CT 17).

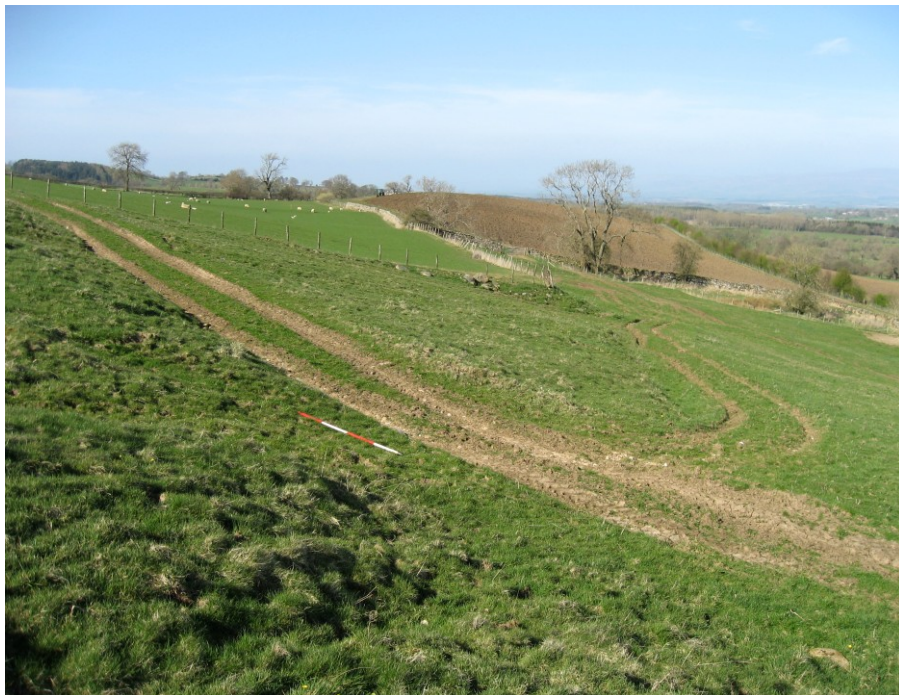
**Plate 7:** Looking north-east towards boundary B1 along line of rutting east of track T4 (CT 21).

Any plant used on the site should be equipped with appropriate tyres to prevent rutting and damage to surfaces. Movement of plant (if required) and materials from the compound to the tower house should be along the track identified during the 2000 EH survey (T7, figure 23). No movement of plant should be carried out across earthworks. If any movement of plant beyond route ways is deemed necessary, a suitable strategy in consultation with the managing architect and English Heritage should be implemented to protect these areas. Movement of materials over the remains of the former yard wall B16 up to the tower house should ideally be manual only, or if not possible, carried out with appropriate protection over the exposed feature.

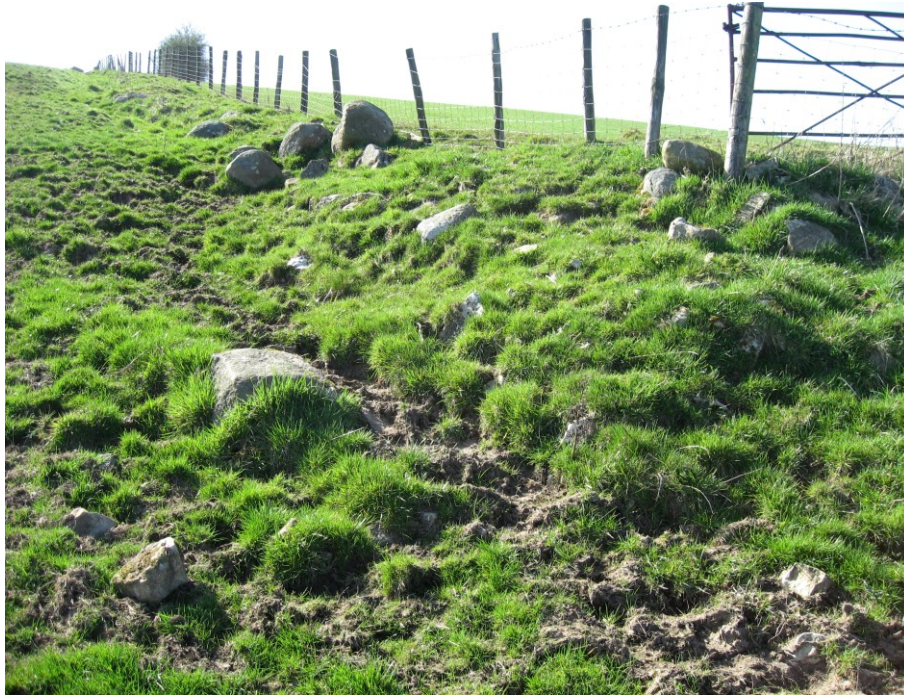
- No evidence was noted during the site walkover in March 2012 for ongoing erosion or damage to earthworks in Area B which includes the scheduled area and the field beyond (see figure 2). At a number of points there is limited tumble of dry-stone walls but this is considered beyond the scope of the current survey.
- In Area A, upslope from B, there is some evidence for minor rutting by farm vehicles (none occurring across earthwork boundaries) and limited poaching by livestock. This is in the context of a working agricultural landscape and has not had a major impact on the earthworks. Catalogue photographs 20 and 21 and 25 show limited rutting along parts of T1 and T5; Photographs 28, 32 and 35 show vehicle disturbance at the gateway along south side of wall B15; 36 shows some animal poaching or tracking adjacent to the south corner of B1.

**Plate 10:** Looking west at corner of boundary B1 showing limited livestock poaching and disturbance (CT 36).
