THE VAULTED BUILDING AT CASTLE HEATON

CORNHILL-ON-TWEED, NORTHUMBERLAND

ARCHAEOLOGICAL MONITORING
DURING GROUNDWORK FOR
INSTALLATION OF BUTTRESSES

July 2015

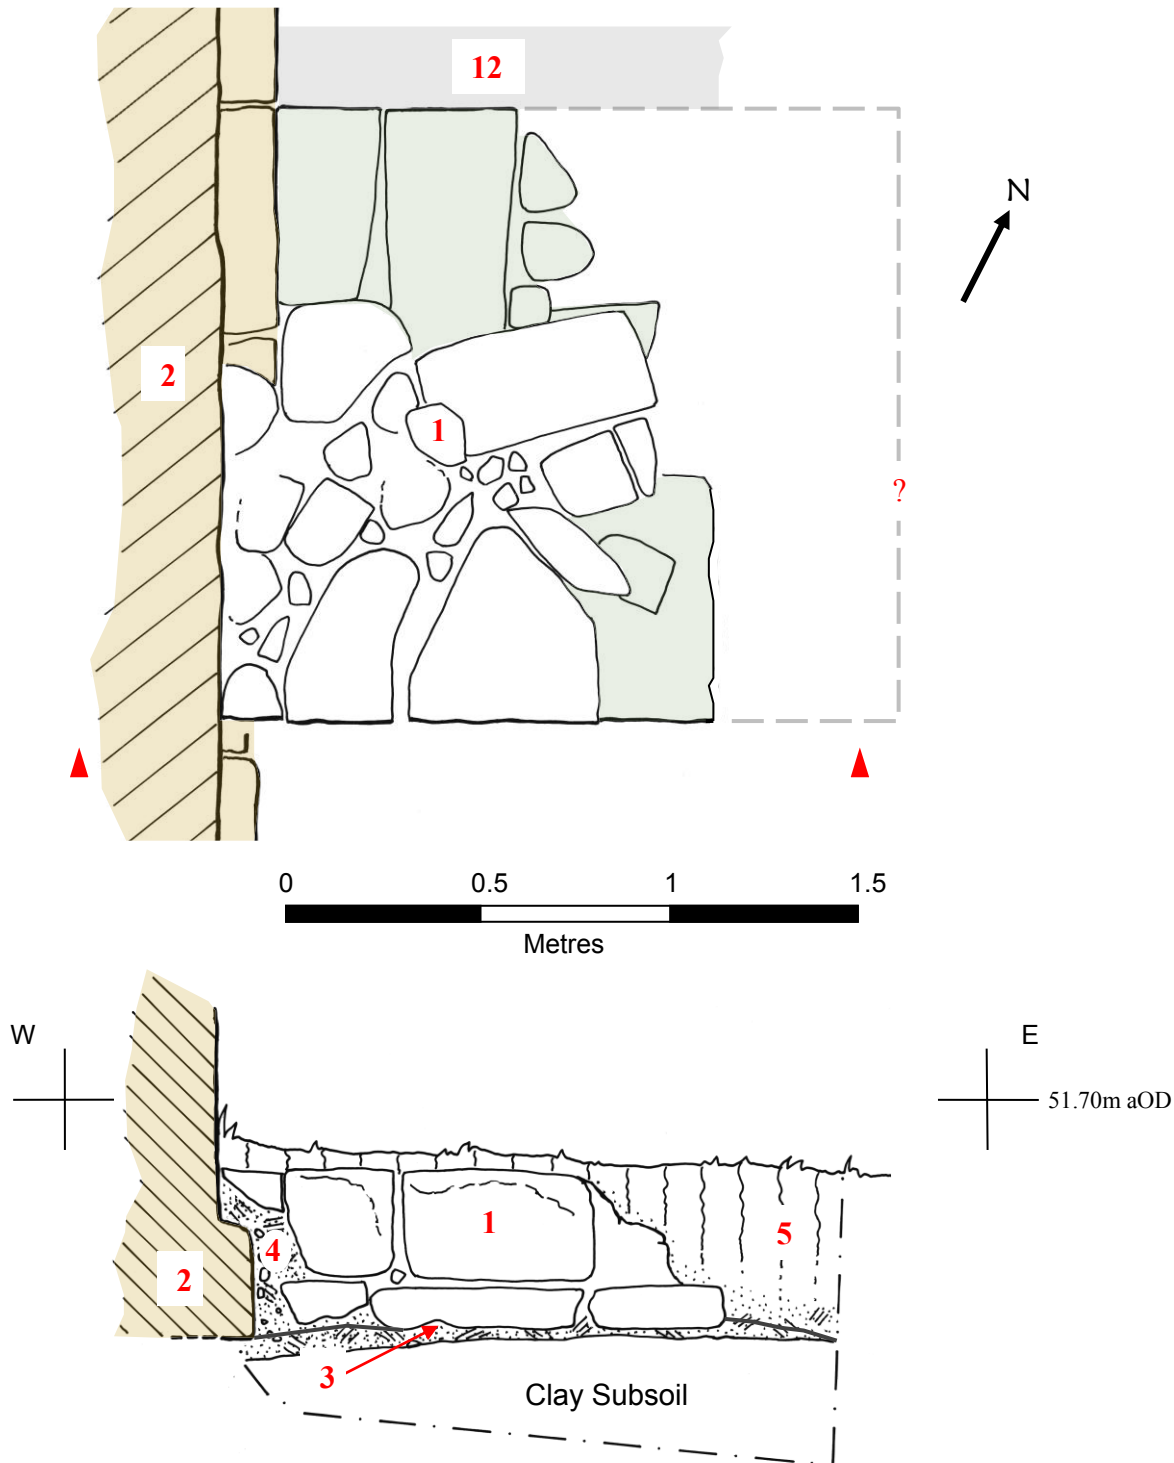
Figure 3 and plates 1 to 3 show the exposed remains of the buttress located 5.5m from the north end of the building. The foundation butted wall [2] but was not bonded to it. It extended 1.6m along the face of the building and projected 1.3m from it, surviving to a maximum depth of 0.5m below ground surface. The maximum surviving depth of the structure was 0.45m. It sat over a thin layer of dense clay-loam [3] above clay subsoil. The lowest course of the buttress was of large, fairly regular and thin blocks of sandstone with only little core. The partially surviving second course was of large facing stones to the south with a considerable core. It is likely that the east face of the buttress had been lost. Both courses were bonded with a pale whitish-cream mortar.

Figure 3: Plan (top) and south elevation of the remains of an buttress [1] in Foundation Trench A. Pale green tone indicates the lower course on the plan. 1: 40 scale.

It was decided to incorporate the remains of the early buttress into the new structure. This entailed the temporary removal and re-installation of the feature. Following recording of the buttress and associated deposits, each stone of the buttress was numbered (see plate 8) and removed by the conservation builders. Once the piles and concrete slab for the new

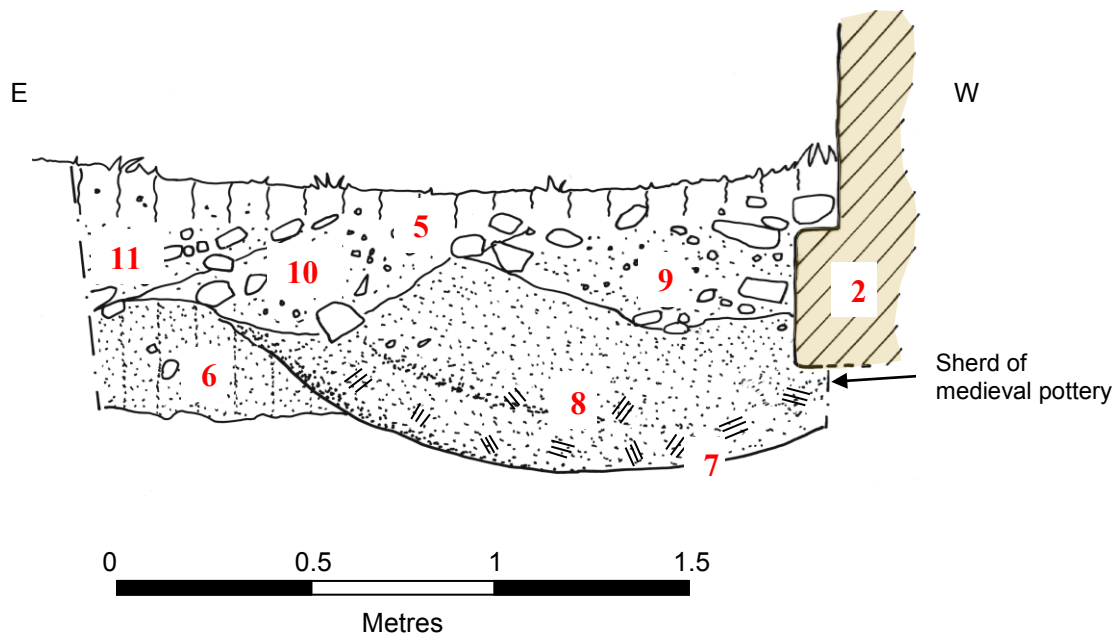
Stratigraphy varied across the trench. Deposits seen at the south end are shown on figure 4. Here, what may have been an early developed soil [6] was cut away to the west by a negative feature - a shallow pit or hollow – [7] with a broad bowl-shaped profile, filled with a fine silty-clay loam [8], becoming increasingly compacted and tenacious towards the base. Both cut and fill pre-dated the east wall of the east wall [2] of the vaulted building and ran below the structure: A sherd of oxidised pottery with an external green spatter-glaze, probably of thirteenth-century date, was recovered from below the foundation (see figure 3 for location). There was no evidence for feature [7] in Test Pit 2, excavated in 2014, although a thin clay loam (Layer [2F]) did run beneath the east wall of the building.

Figure 4: East-west section forming the south face of Foundation Trench A. 1: 40 scale. AOD as per figure 3.

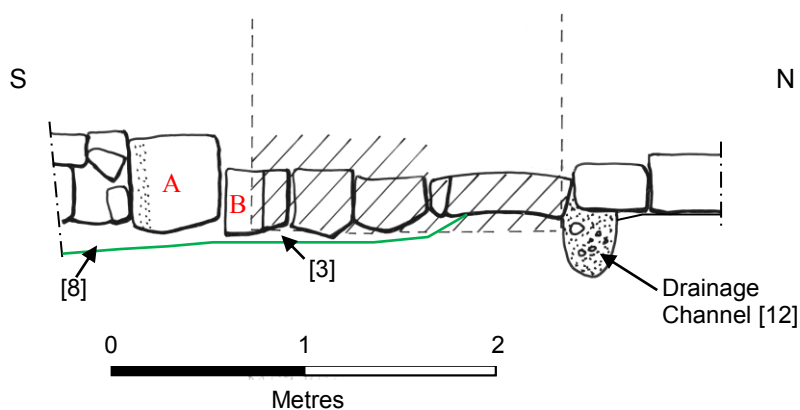
Removal of the buttress exposed a length of the foundation offset course of the vaulted building (Figure 4 and plate 7). The stones were irregular and a number re-used. Two of the stones (A and B on figure 4 and plate 8) were moulded. Stone A, a simple ogee; stone B, a square section. At some point, a drainage channel [12] had been cut through the wall, running out along the north face of the buttress.

Figure 5: Offset course of the east wall of the vaulted building exposed in Foundation Trench A. Hatching marks the location of the early buttress. All the stones are irregular and a number re-used. A and B have mouldings. The green line indicates the extent of deposits [3] and [8]. 1: 80 scale. AOD as per figure 3.

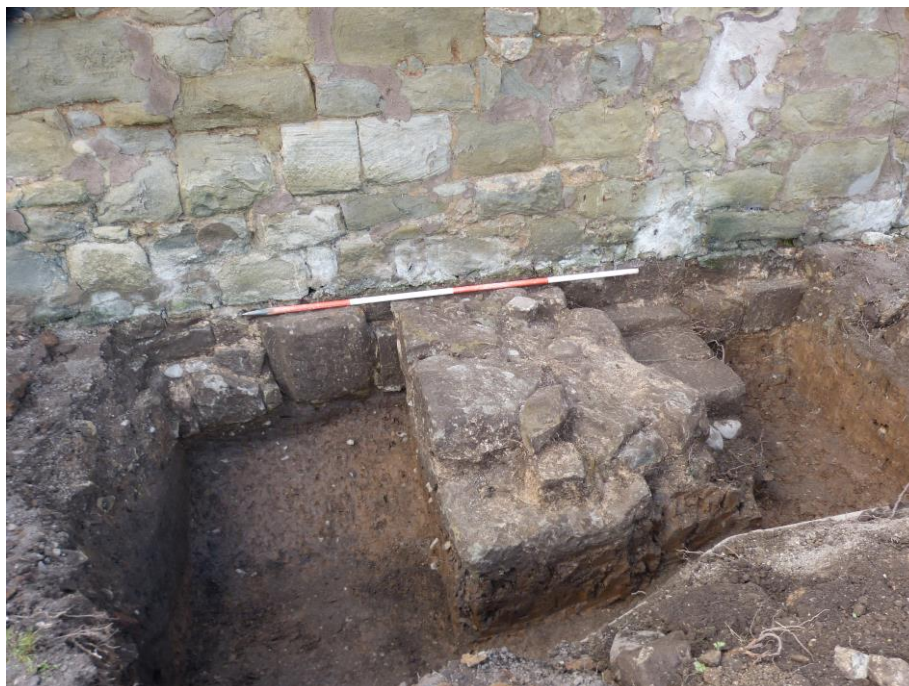
Plate 1: *Remains of buttress as exposed in Foundation Trench A.
Looking west. 2m scale.*

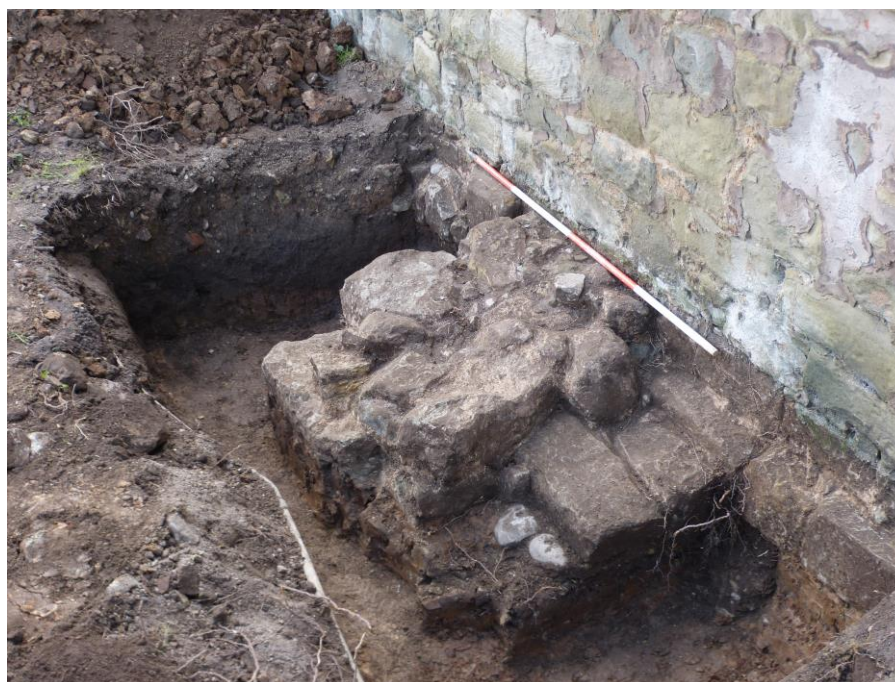
Plate 2: *The buttress. Looking south.*

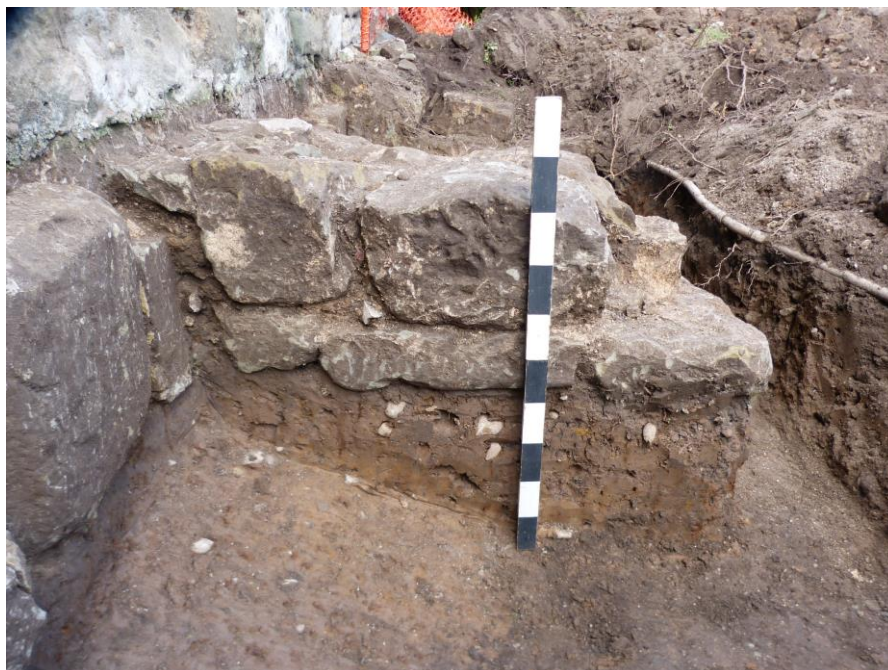
Plate 3: Looking north at the south face of the buttress. 1m scale.

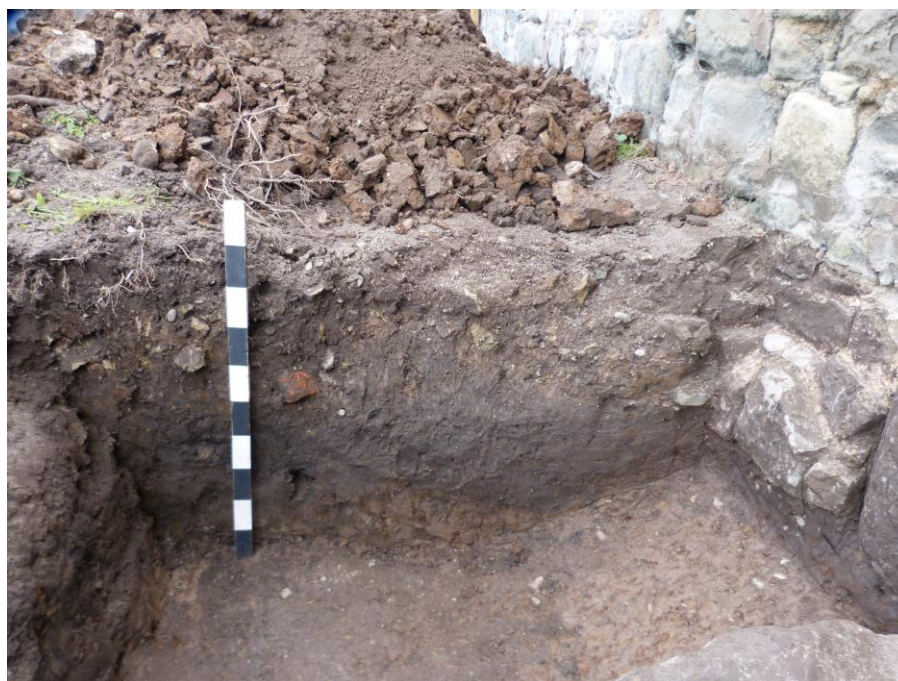
Plate 4: The south section of Foundation Trench A (see figure 4)

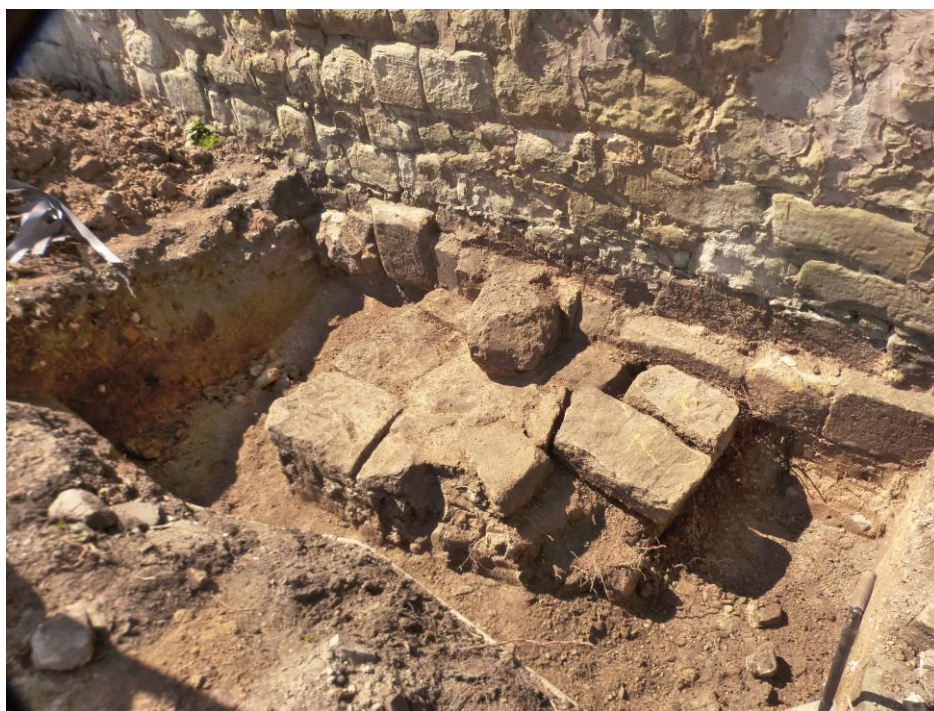
Plate 5: Most of the upper course of the buttress removed. Looking south-west.

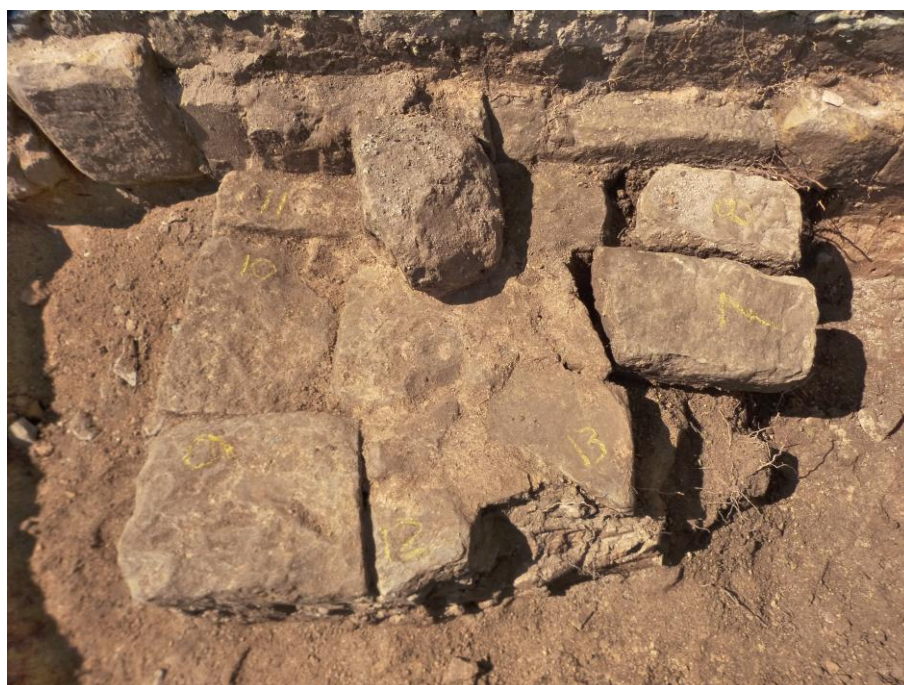
Plate 6: Stones numbered for removal.

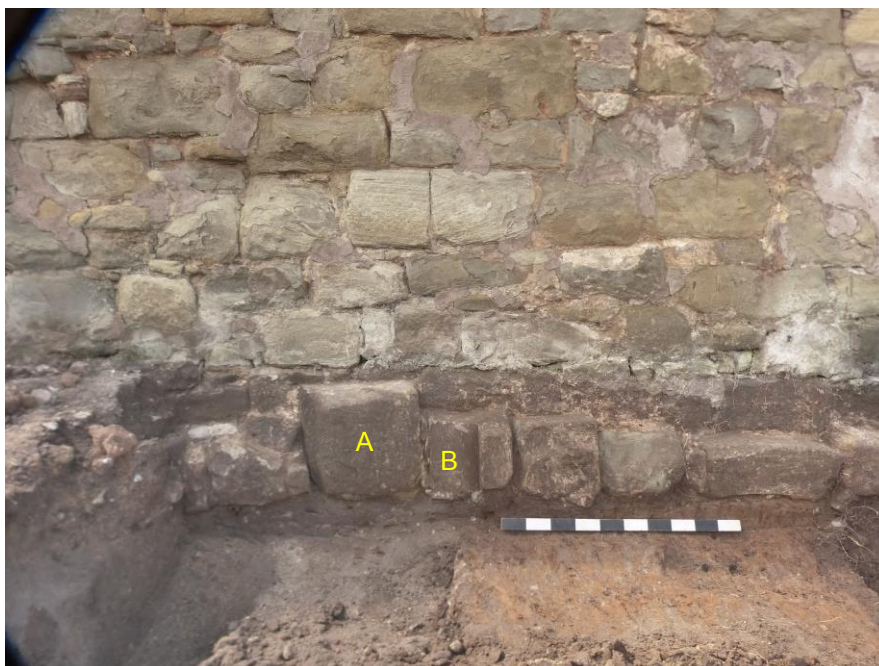
Plate 7: *The offset foundation course of the vaulted building exposed in Trench A following removal of the buttress (see figure 5). A and B mark re-used stones with mouldings.*

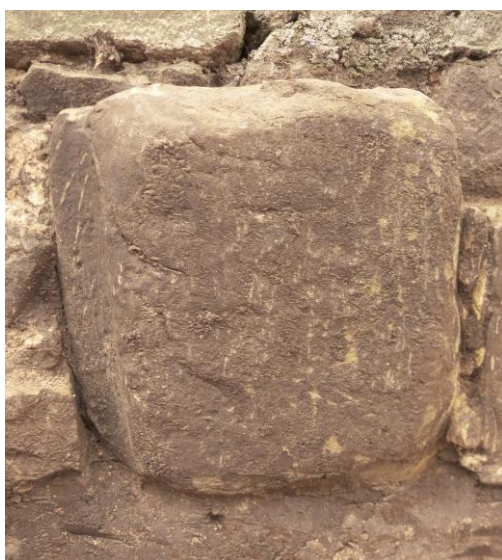
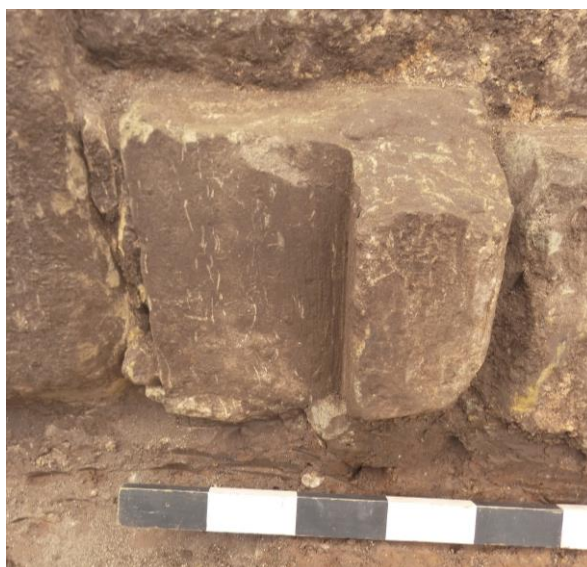
Plate 8: *Re-used stones A (left) with a simple ogee moulding and B (right) with square moulding.*

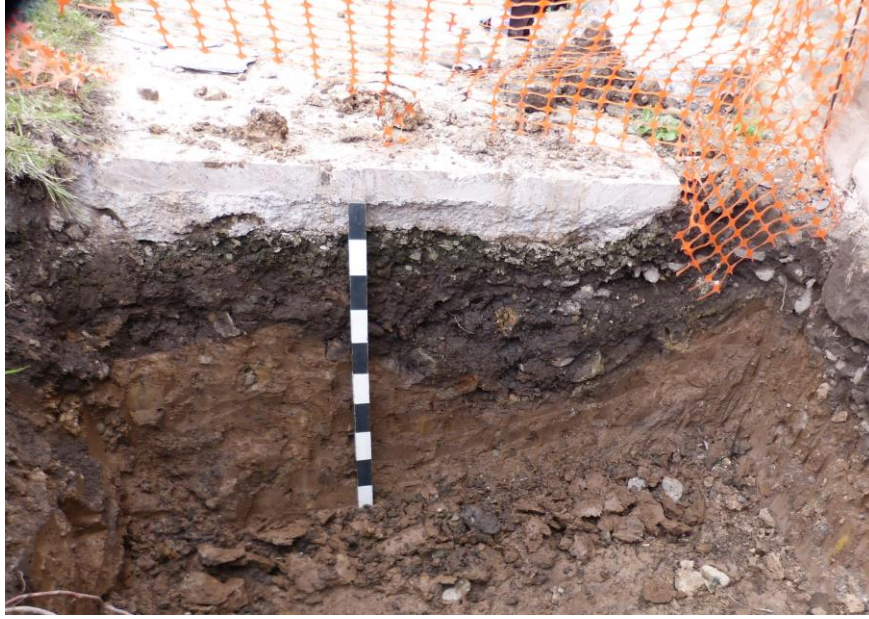
The excavation of this trench, for a second new buttress (see figure 2) was not monitored archaeologically, given the indication from previous test pitting that archaeological deposits had not survived in this area. However, the trench was inspected during recording of Foundation Trench A. Although no deposits other than topsoil had accumulated over subsoil, north and south sections showed the profile of a substantial negative feature [13] (plates 9 and 10). This was filled with amorphous and loose deposits, including some brick fragments, suggesting that it had been excavated in fairly recent times. The context of the feature is not known.

Plate 9: South section of Foundation Trench B showing feature [13] below concrete. Its fill was amorphous clay loam soil with some stone; probably a modern feature

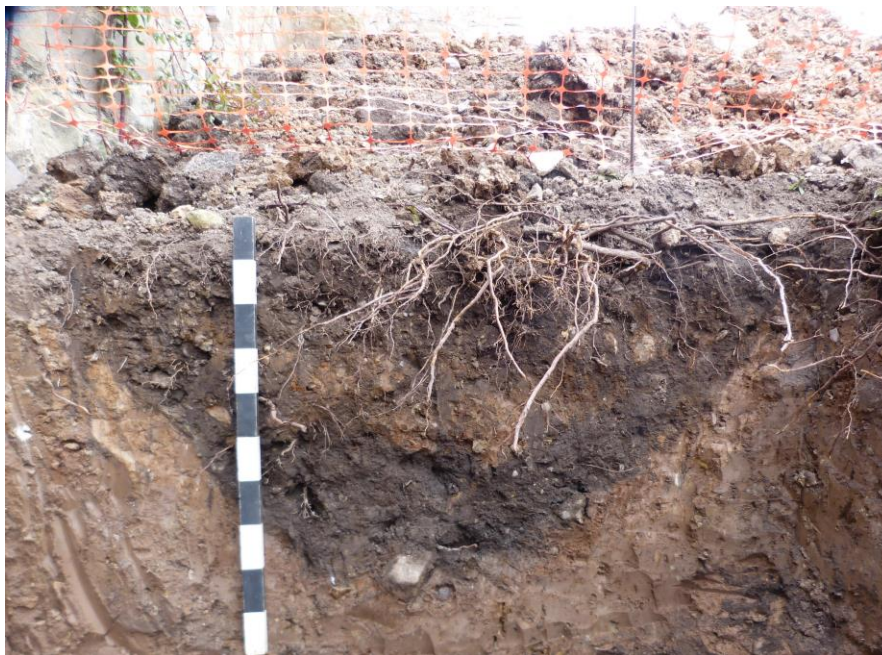
Plate 10: The north section of Foundation Trench B showing feature [13] with banded fill including a central area of sandy clay. The fill was loose and amorphous and probably fairly modern.
