CRAKE TREES TOWER HOUSE

CROSBY RAVENSWORTH, CUMBRIA

BUILDING RECORDING AND MONITORING

DURING CONSERVATION WORKS

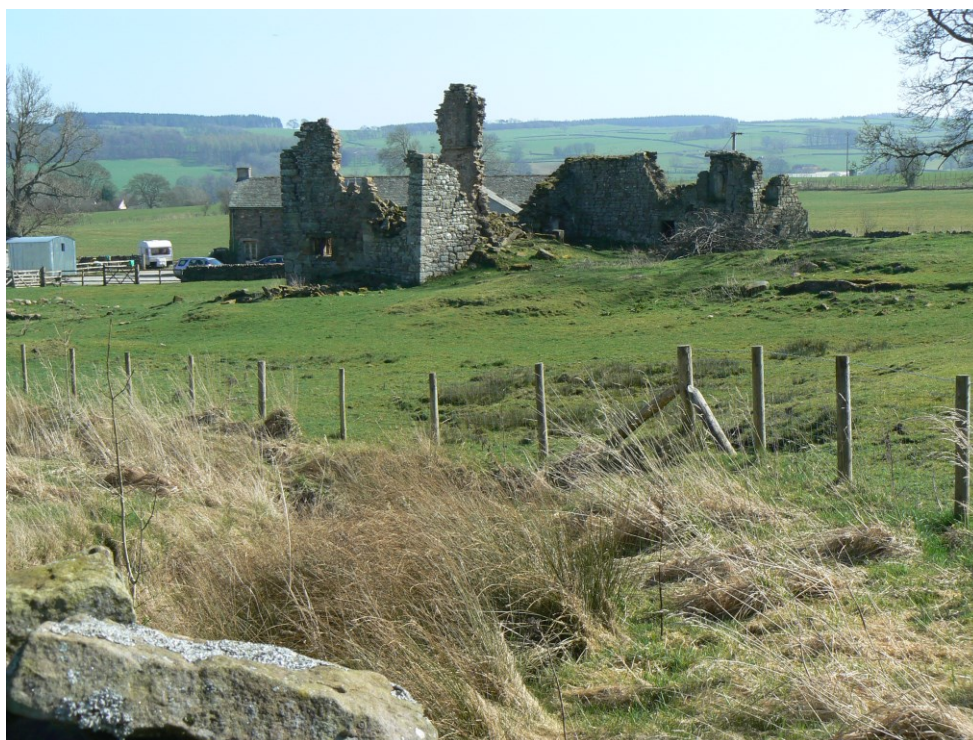
Structures north of the barrel-vaulted block were in extremely poor repair. The east and west walls had substantially fallen leaving the central cross wall and north-gable wall unsupported and in danger of collapse. These lateral walls had also lost much fabric.

Plate 3: Crake Trees from the north-west in 2012.

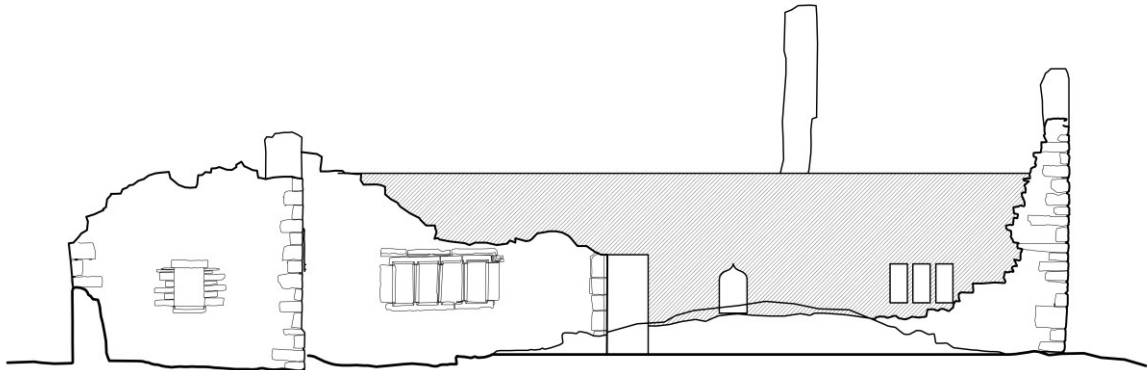
Figure 4: Survival of the east face of the tower house in 2012 with indicative extent of rebuild in grey tone (Drawing prepared by Kevin Doonan Architect).

2.2.3 Rebuilding of East Wall The extensively tumbled east (front) wall of the tower house to the north of the barrel-vaulted storerooms was rebuilt to a little under eaves level. This stabilized the largely unattached cross and gable walls without introducing new supporting structures. Standing components of the wall – its lower courses and parts of the jambs of the central front door - along with photographs of the wall from 1935, guided the rebuilding. Piles of rubble fallen subsequently to 1935 lay within and outside the east face of the building. This was re-used during the rebuilding. It contained window jambs, sills and lintels which were replaced in original locations. An heraldic panel, formerly set in the east wall at Crake Trees had been removed since 1935 and built into a farm building in the village of Maulds Meaburn. This was returned to site and re-mounted in its original position.

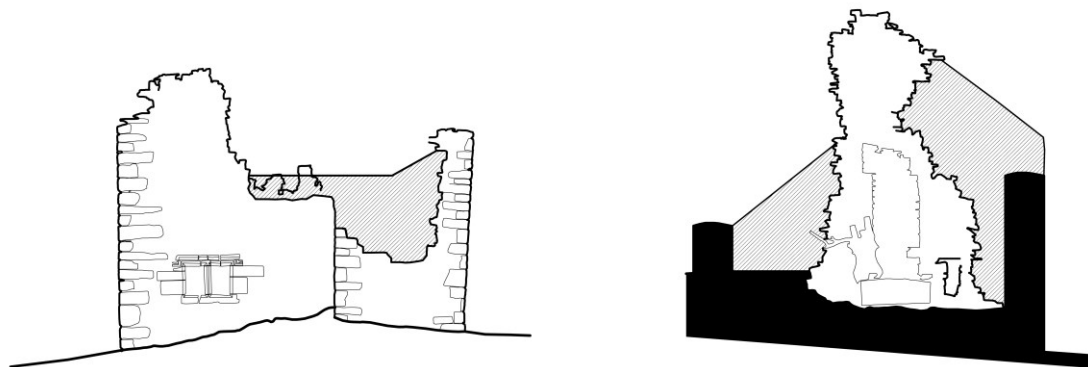
Figure 5: Survival of the north gable wall (left) and south elevation of the northern cross-wall in 2012 showing indicative areas of rebuilding in tone (Drawing prepared by Kevin Doonan Architect).

2.2.4 Rebuilding of Cross and Gable Walls Additional rebuilding was carried out at the western end of the north cross-wall to consolidate overhanging masonry and improve its stability. Rebuilding was also required at the stair tower on the north gable wall so that lateral support could be provided to the surviving portions of the outward-leaning west wall. The north cross-wall

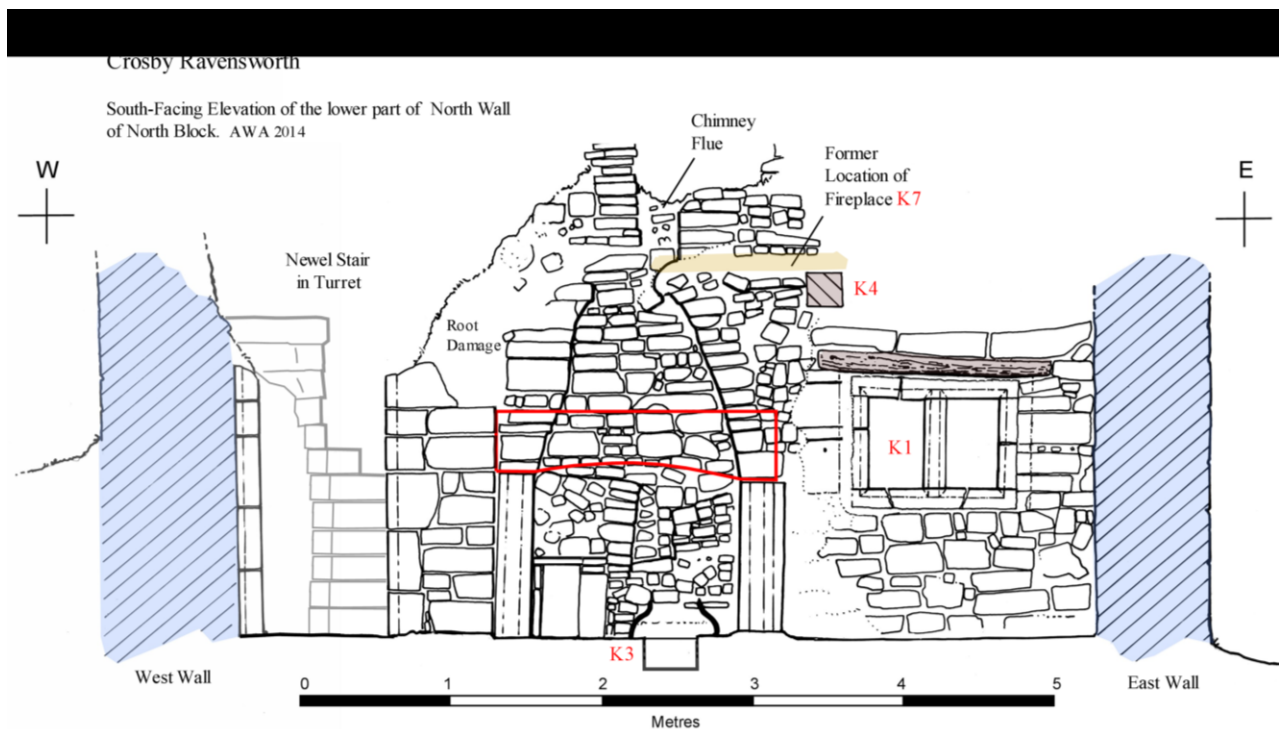
In 2012, the stair turret was filled with rubble and survived precariously, with a markedly leaning west wall, badly tumbled north wall and a substantial tree forcing apart the visible portion of the stair. Cleared and stabilized, the structure is impressive with 12 steps of the newel stair surviving - probably to the original full height (Figure 6 and plate 5). The jambs of a window (K2) in the north wall, which had fallen, were restored

Figure 8: South-facing elevation A (see figure 7) showing internal face of the north gable wall (K) and turret for newel stair. The flue for fireplace K3 was exposed during the clearance works. The position of the lintel, which had fallen, is indicated in red line. (1:50 scale).

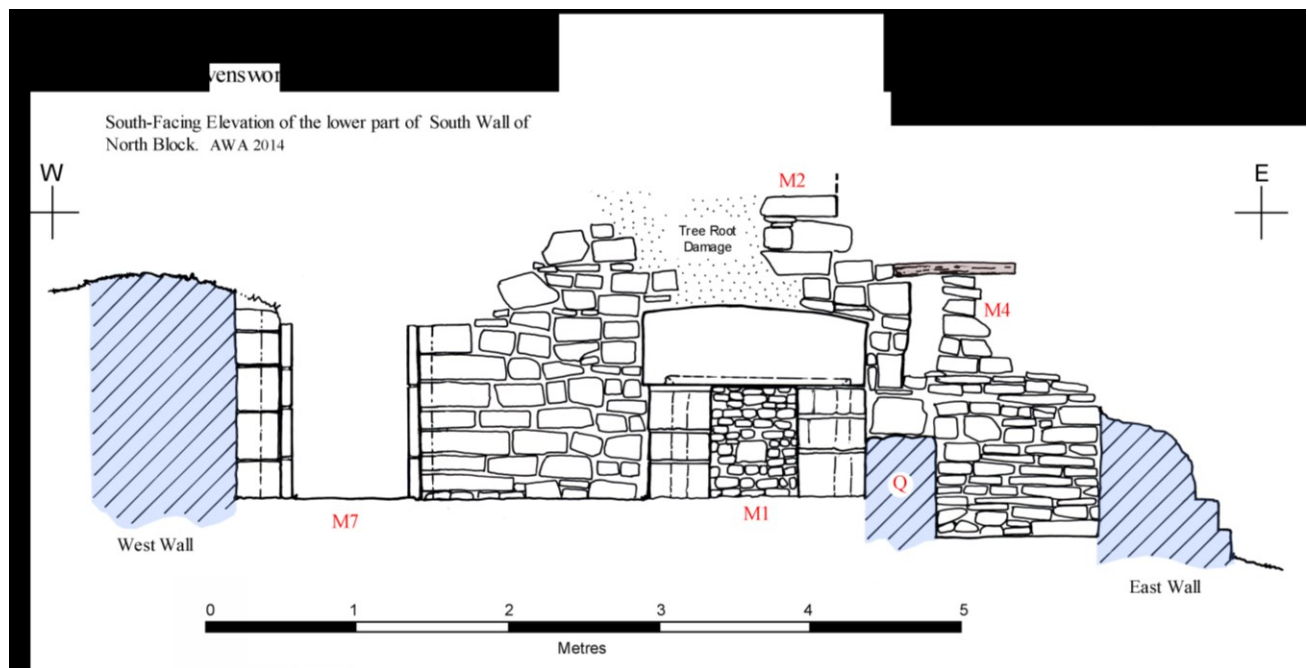
Figure 9: South-facing elevation C of cross wall (M) with fireplace (M1) chimney breast (M2), doorway M7 and feature M4 (1:50 scale).

In 2012, cross-wall M survived as an unattached leaf of masonry to near full height towards the ridge but only very partially to east and west where doors through the wall had compromised the structure. Fireplace M1 sits almost centrally in the south face of the wall, with a projecting chimney breast above which merges with the wall face at c3m above the fireplace lintel. A narrow strip of ground c1m wide was to be cleared of rubble and late deposits to the south of the cross wall to allow consolidation of the wall fabric. This was eventually extended to encompass the room defined by dwarf wall Q and as far as the south wall of the cross passage (P). A sandstone slab floor was uncovered in the cross passage extending from wall Q to the west door through wall H. This floor rose slowly to the west across the building and finally stepped up at the entrance through the west wall. The floor respected wall Q. A cobble floor was uncovered within Q. This maintained a level and at the east face of Q was c0.3m higher than the adjacent slab floor in the cross passage. Rubble was cleared from around fireplace (M1) against the south face of the wall. Removal of a tree which had forced the substantial stone lintel out from the wall allowed the full conservation of the feature. There was no evidence to suggest that its jambs (splayed and chamfered) extended below the cobble floor in the room. A much reworked door (M4) to the right of the fireplace was exposed and consolidated although interpretation remains problematic. To stabilize the western end of wall M, new jambs and a lintel were set above the surviving jambs of door M7.

One lofty crag of the central section of the wall still stands. This was in a very precarious condition, and during the 2012/13 works some additional masonry was built to either side – and the head of doorway M7 reconstructed – to provide structural stability.

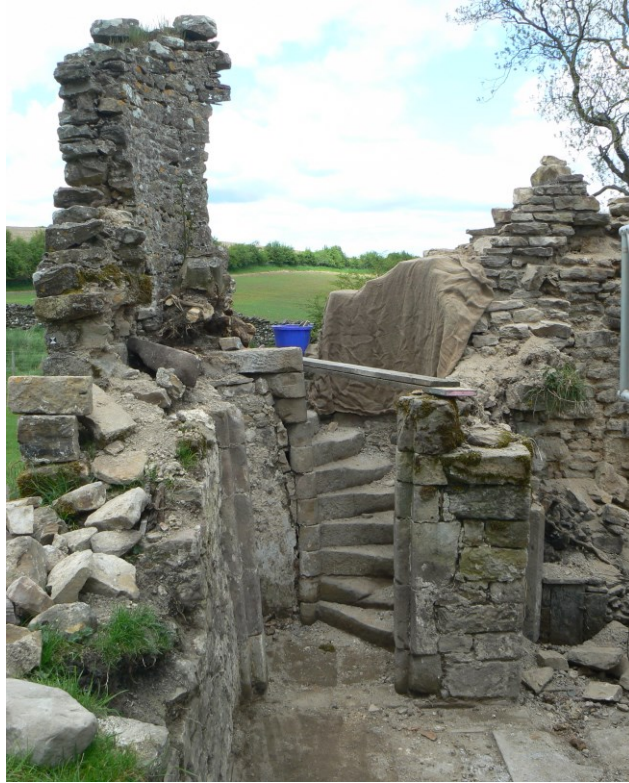
Plate 5: *The newel stair during consolidation in 2013.*

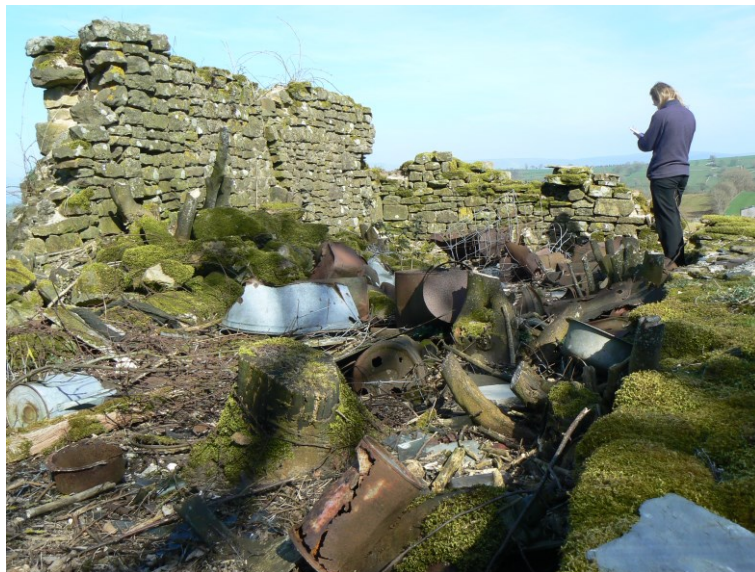
The area above the vault was cleared of rubbish and stripped back. No flooring was seen, presumably it had been removed subsequent to 1935 when the building was still roofed.

Plate 6: *Above the vaulted storerooms in 2012. Looking east.*

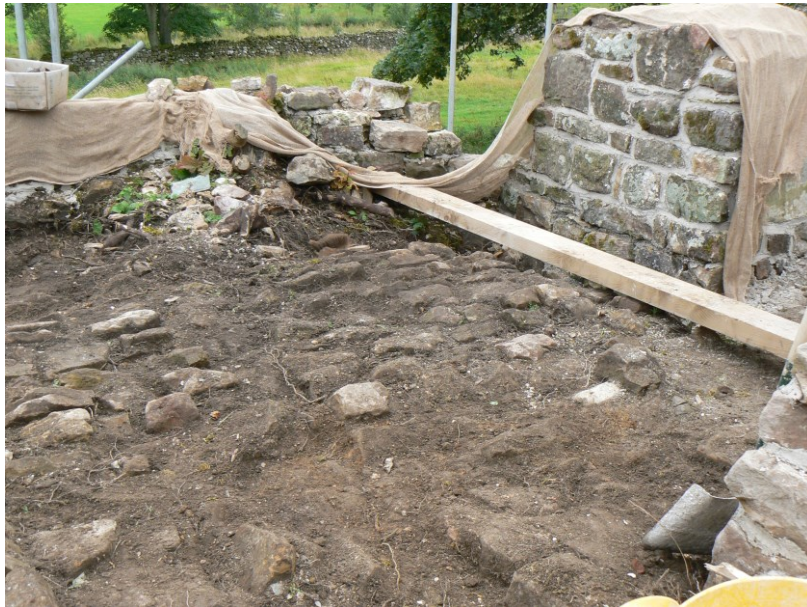
place. The north-west corner of the first floor wall over the vault collapsed during works. This was rebuilt from the fallen material using the Photarc elevation drawings to match the fabric.

Plate 7: The vault cleared. Looking south-west.

Deposits over the vault were then stripped back, the vault covered, and a concrete floor set in

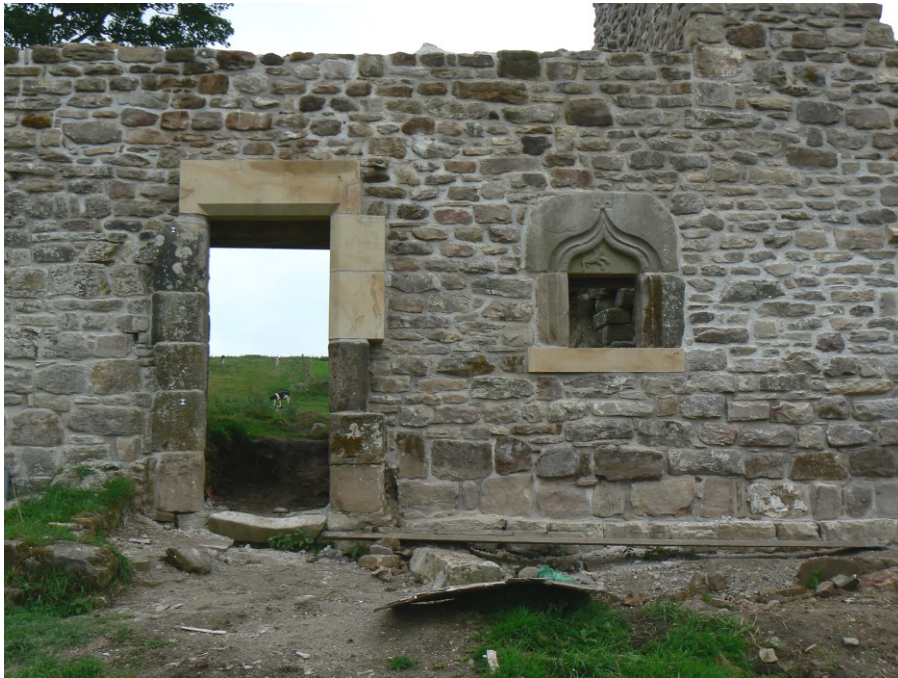
The carved lintel, considering its ill-treatment in the mid-20th century, survived in remarkably good condition; the jambs on which it was re-set do not appear original;

Plate 9: The extensively rebuilt east wall at Crake Trees with door E3 and window E8 towards the right.

each seems to be the sill or head of a single-light window with a hollow-chamfered surround. The original jambs, each a single large block continuing the roll-and-hollow mouldings of the lintel, were retrieved when debris was cleared in 2012. The window, with a new sill, has been reinstated as nearly as possible in its correct position in the rebuilt wall.

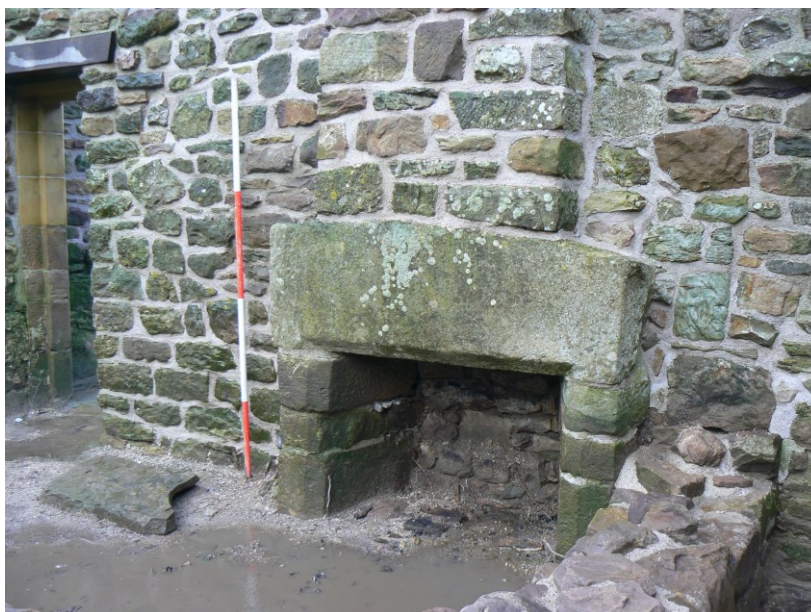
Plate 11: Fireplace M1, cleared in 2013. 2m ranging rod.

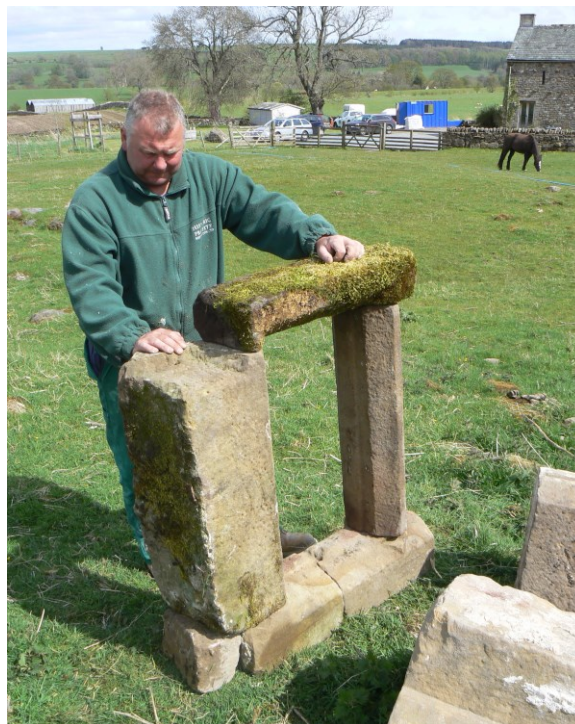
Plate 12: *Stones from a mullion window found in rubble during consolidation at Crake Trees and re-used in the rebuild of the east wall.*
