**Archaeological
Building Survey:**

Woods Mill, The
Narrow Spinning
Mill, Glossop

Report No:
2015/25

Document Type: Archaeological Building Survey

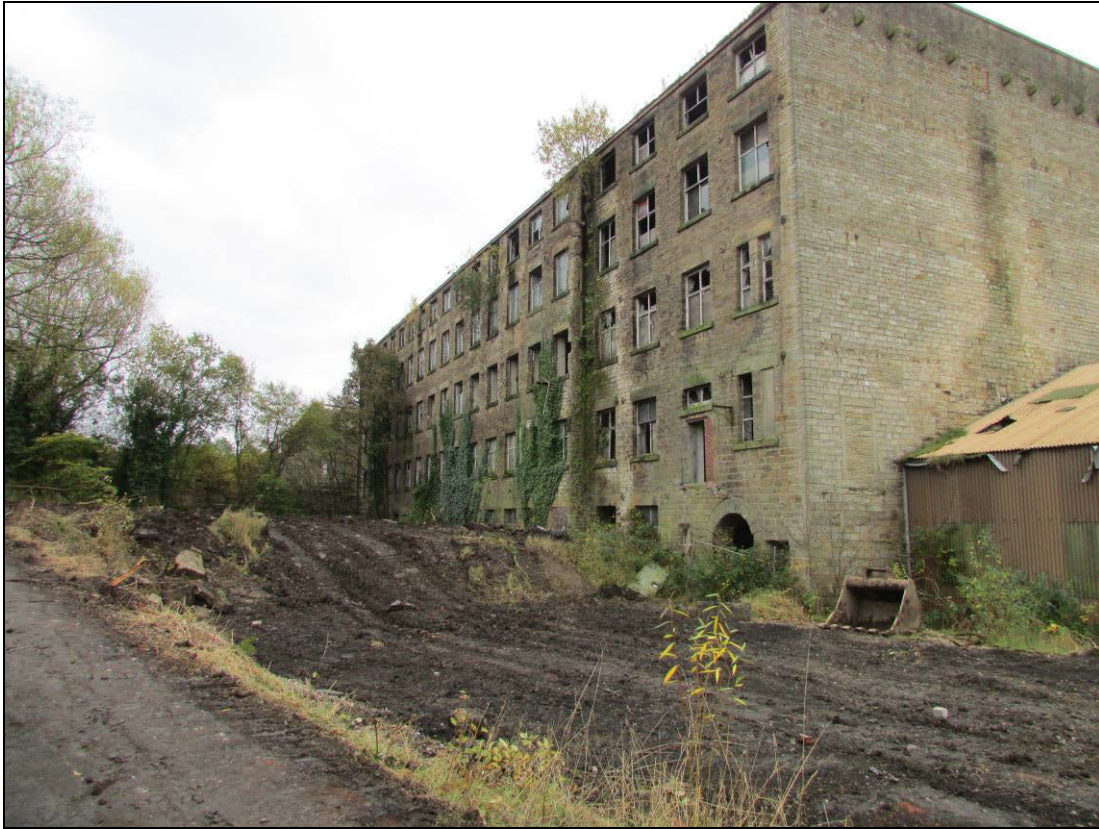
Plate 1 Oblique shot of the northern elevation

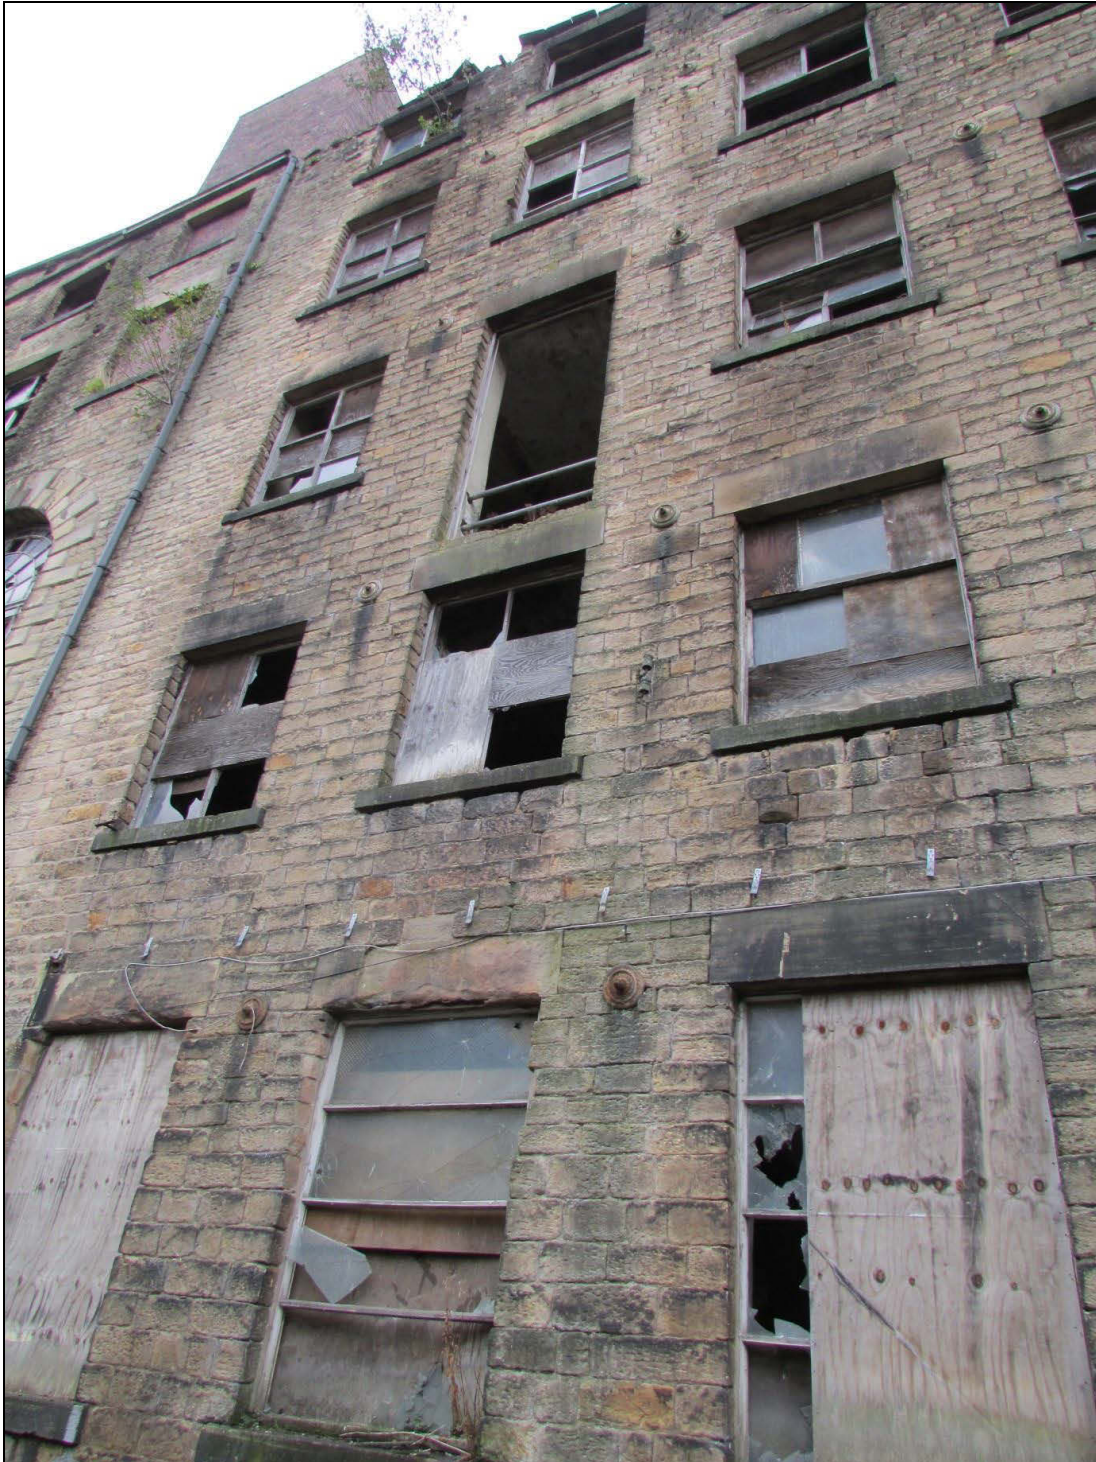
Plate 2 The modified second-floor window (in the middle)

and metal lining and located immediately west of the westernmost ground-floor window. The second window from the west on the second-floor appears to have been modified into a possible taking-in door (Plate 2). The change in mortar around where the sill should be indicates this modification. The third window from the east on the ground-floor has also been modified into an entrance (Plate 3). The original entrance to the building is located within the covered archway at the eastern end of the building (described below as part of the office block) and consists of a chamfered stone surround with a step up (Plate 4). Overall, the entrance measures 2.60 x 2.00m (including chamfering) and the door frame was wooden. This also appears to have been modified with the addition of a possible sliding door, although only part of a wooden frame was evident.

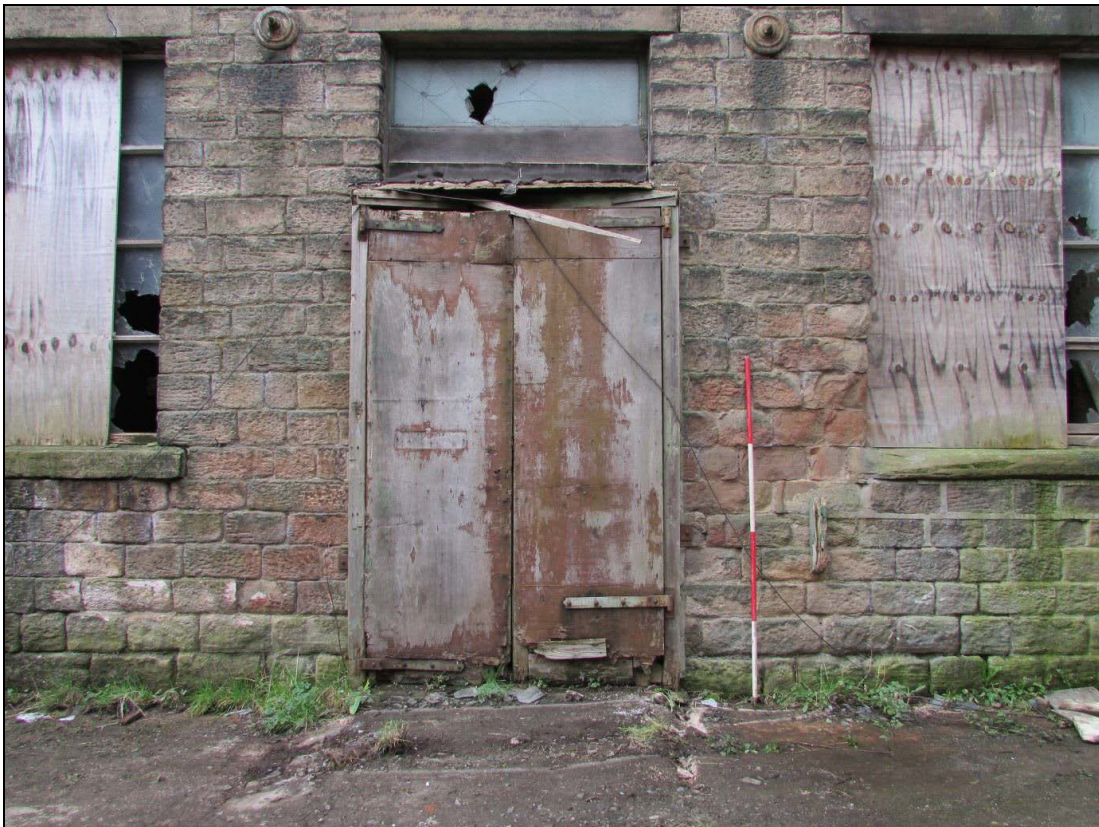
Plate 3 Window on the ground-floor of the mill, later modified into a door

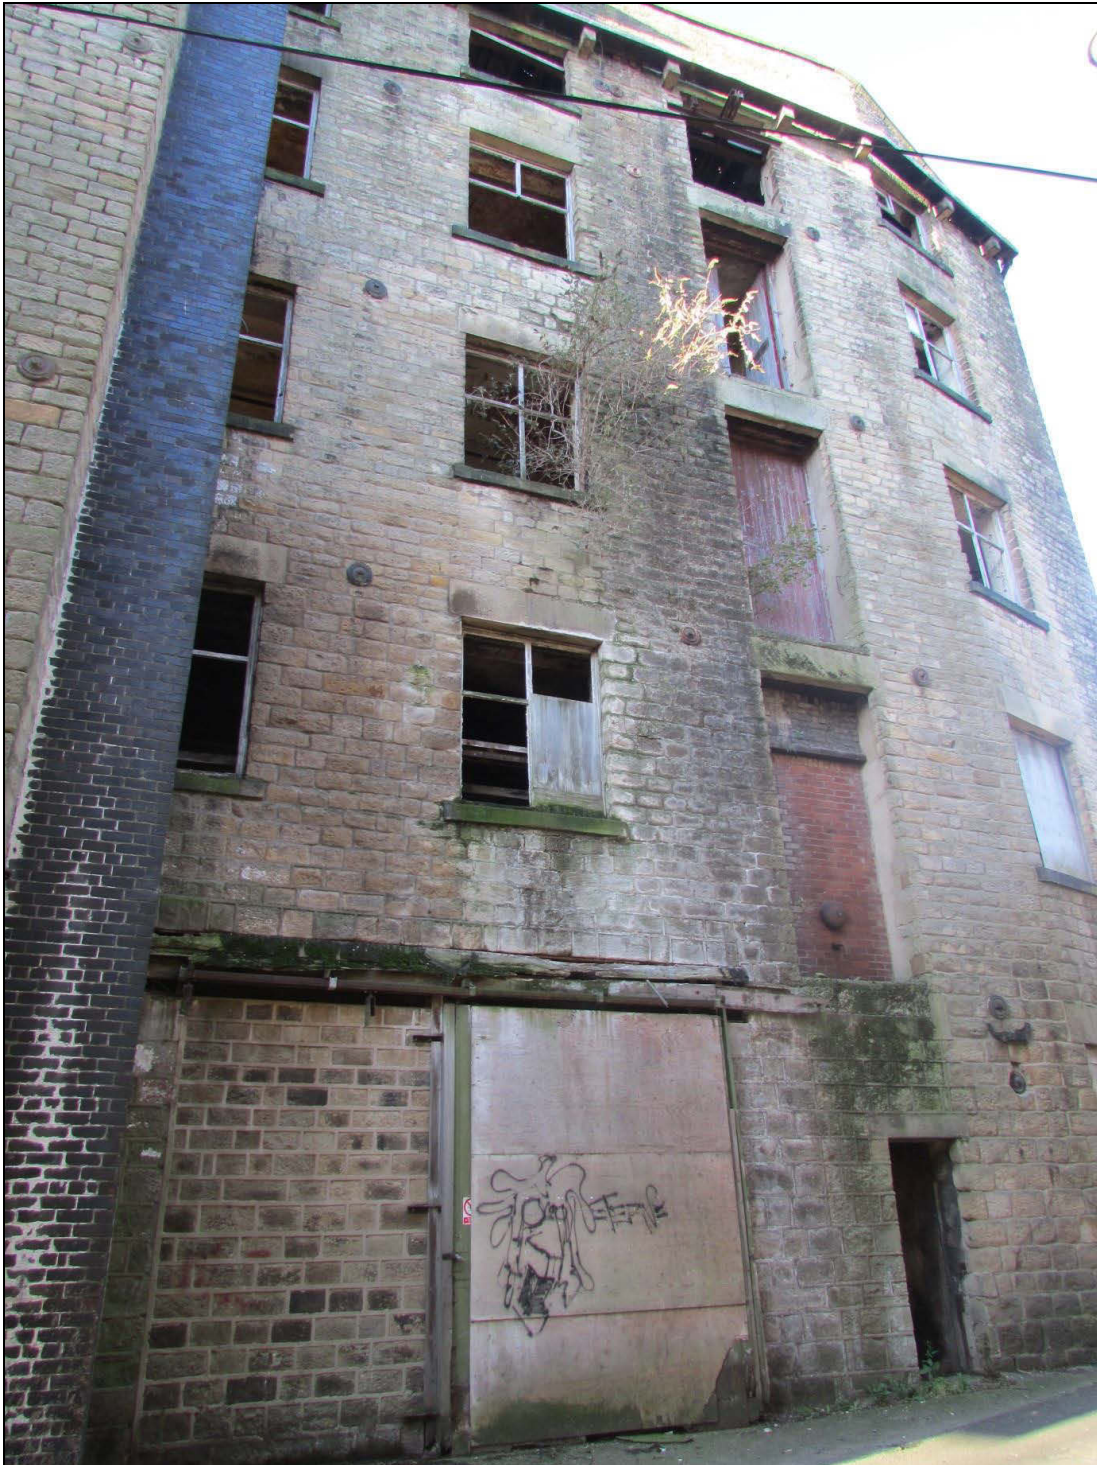
Plate 5 Eastern elevation with taking-in doors and modified ground-floor entrance

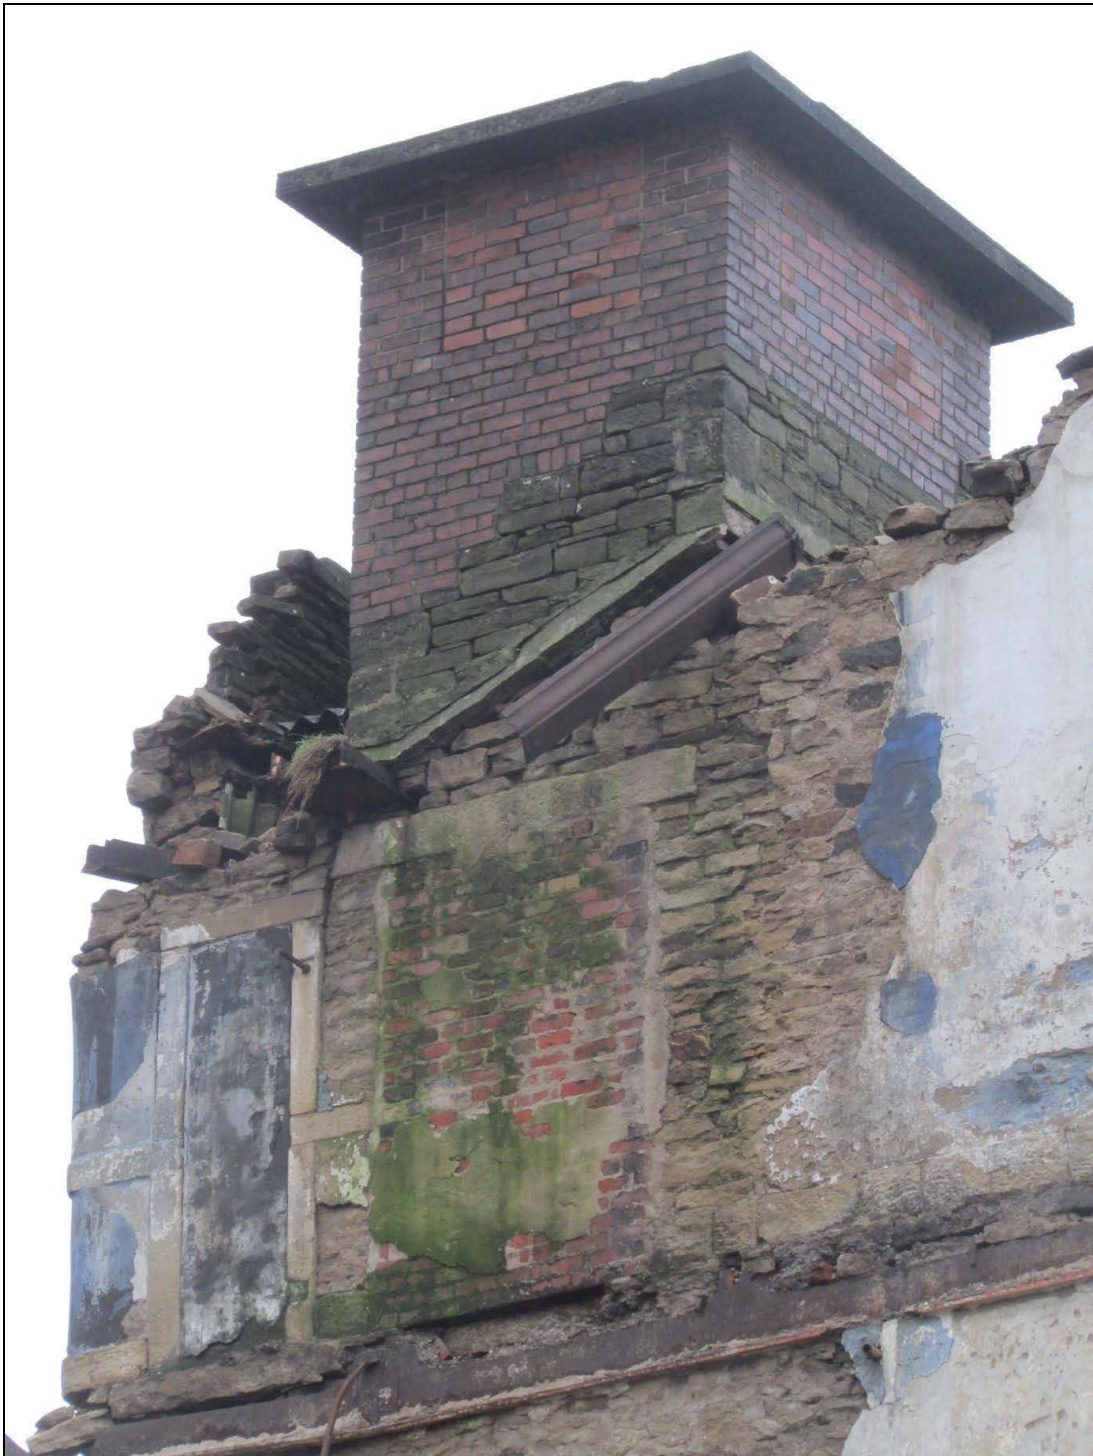
brick, with blocked apertures (Plate 6). The southernmost bay in the east elevation consists of ten windows (measuring 1.20 x 1.00m) in two parallel lengths, offset from each other.

Plate 6 Close-up of the eastern lift shaft headgear shows the partial reconstruction in brick, as well as subsequent blocking of apertures

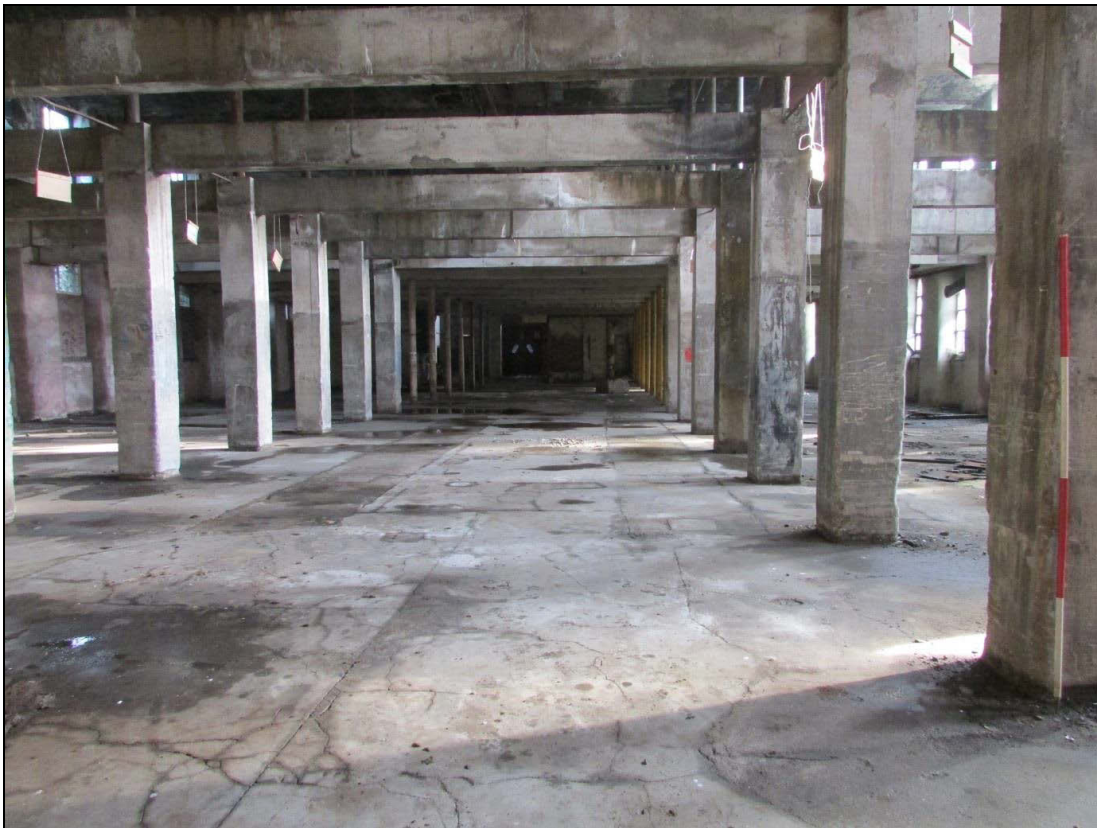
Plate 7 The iron columns at the western end of the mill were encased in concrete

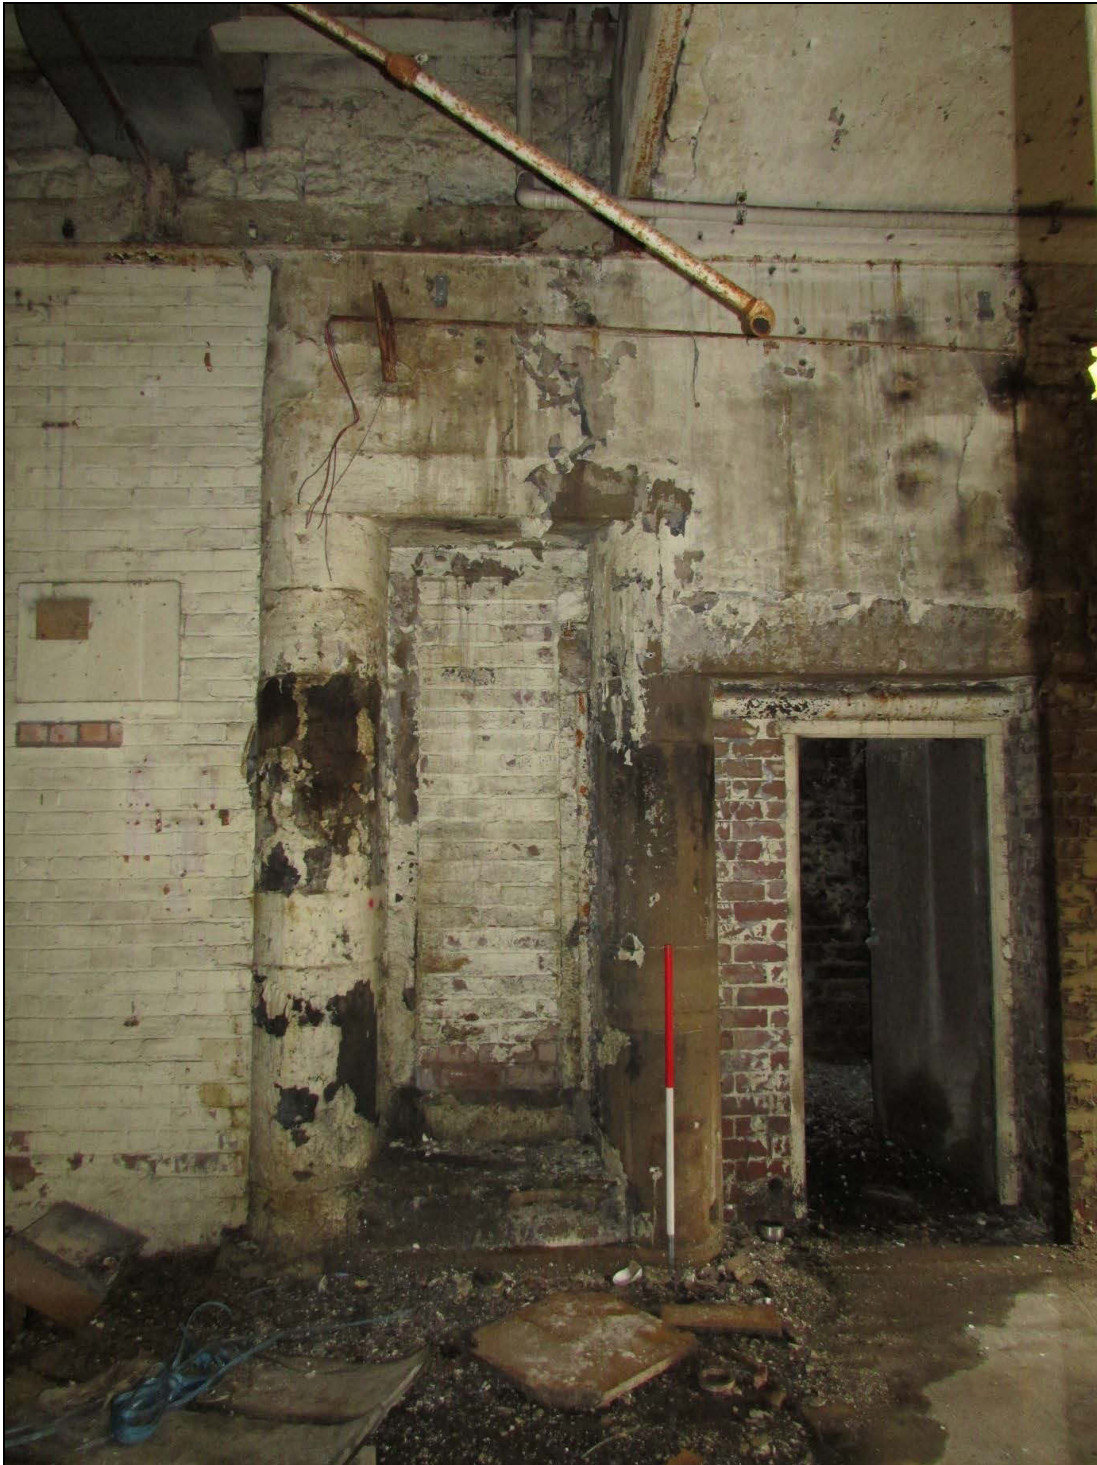
Where the eastern elevation steps out, this is evidenced by a blocked entrance into what was the privy tower (Plate 10) The entrance frame was almost column-like with two steps visible before the machine-made brick blocking is evident. Immediately south of this entrance was the entrance to another small room (which was not accessed due to health and safety issues). A stone lintel had been inserted and truncated the southern privy entrance column. This entrance was modified later still using machine-made brick, supporting a wooden frame.

Plate 10 Blocked entrance into the former privy tower, with the later entrance to the lift shaft on the right, subsequently made smaller

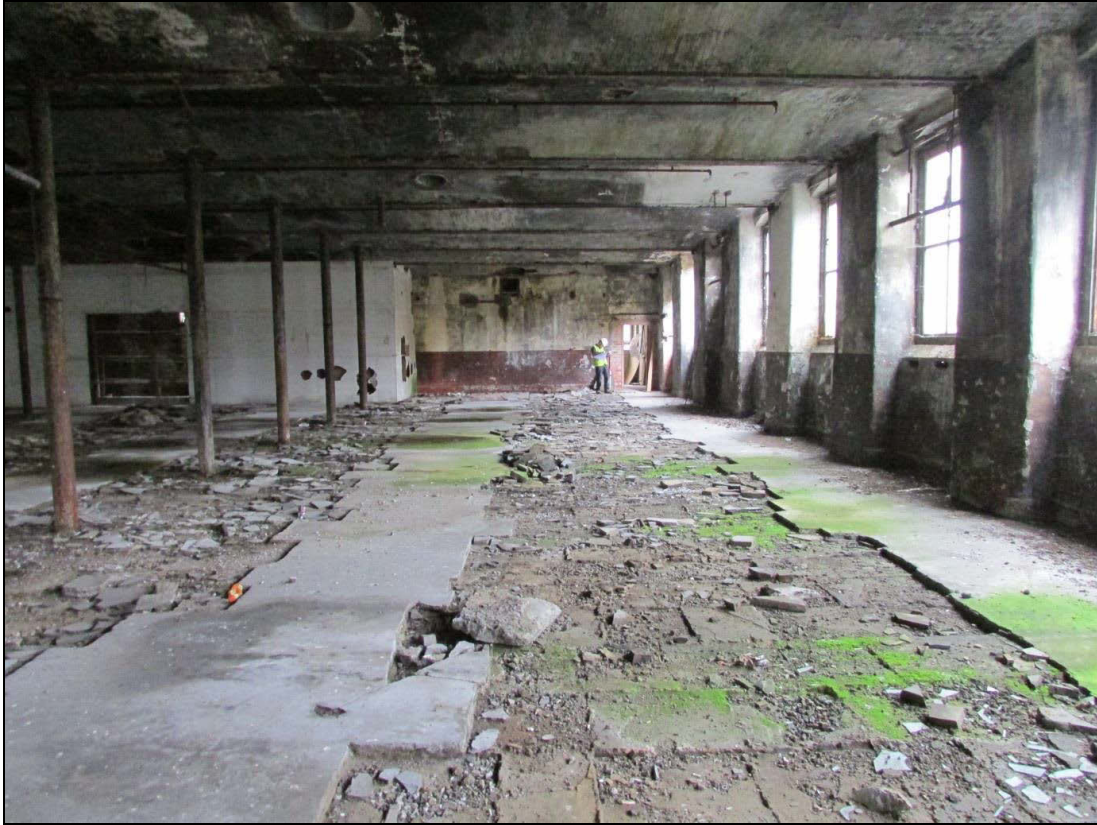
Plate 13 Robbed out flagged flooring on the first-floor

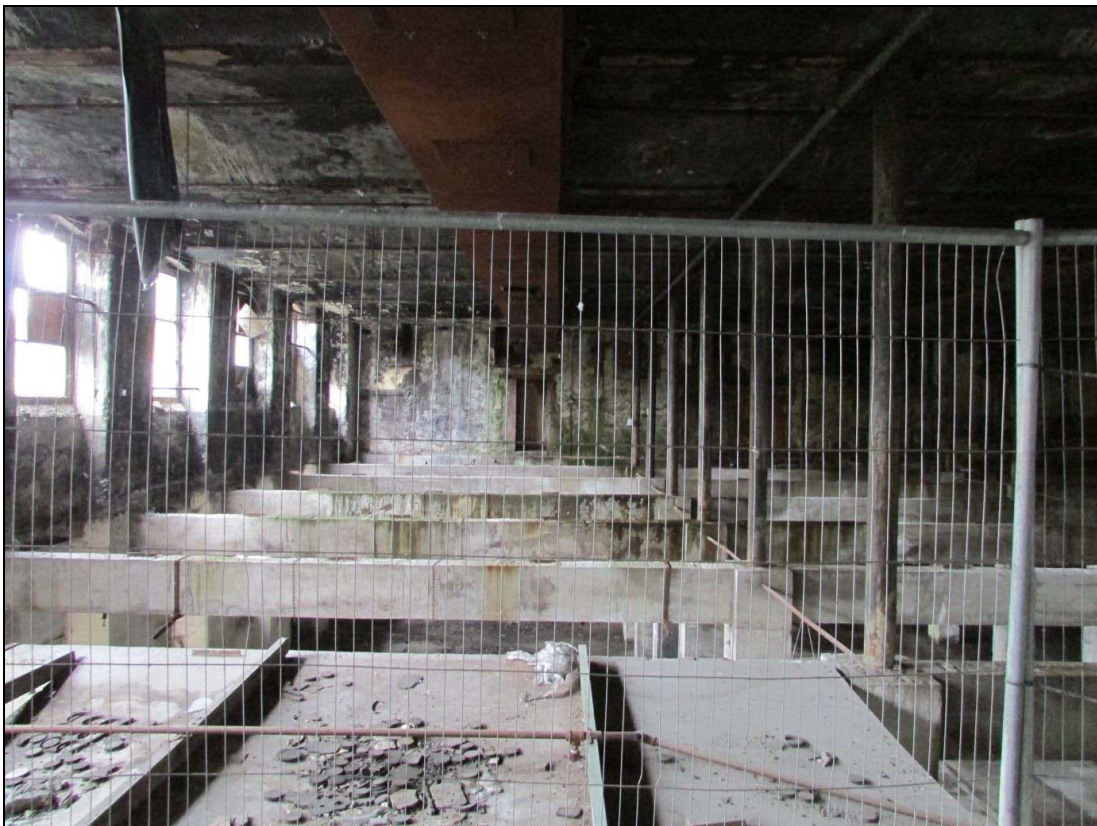
Plate 14 The first-floor in the western half of the mill was removed at a later stage

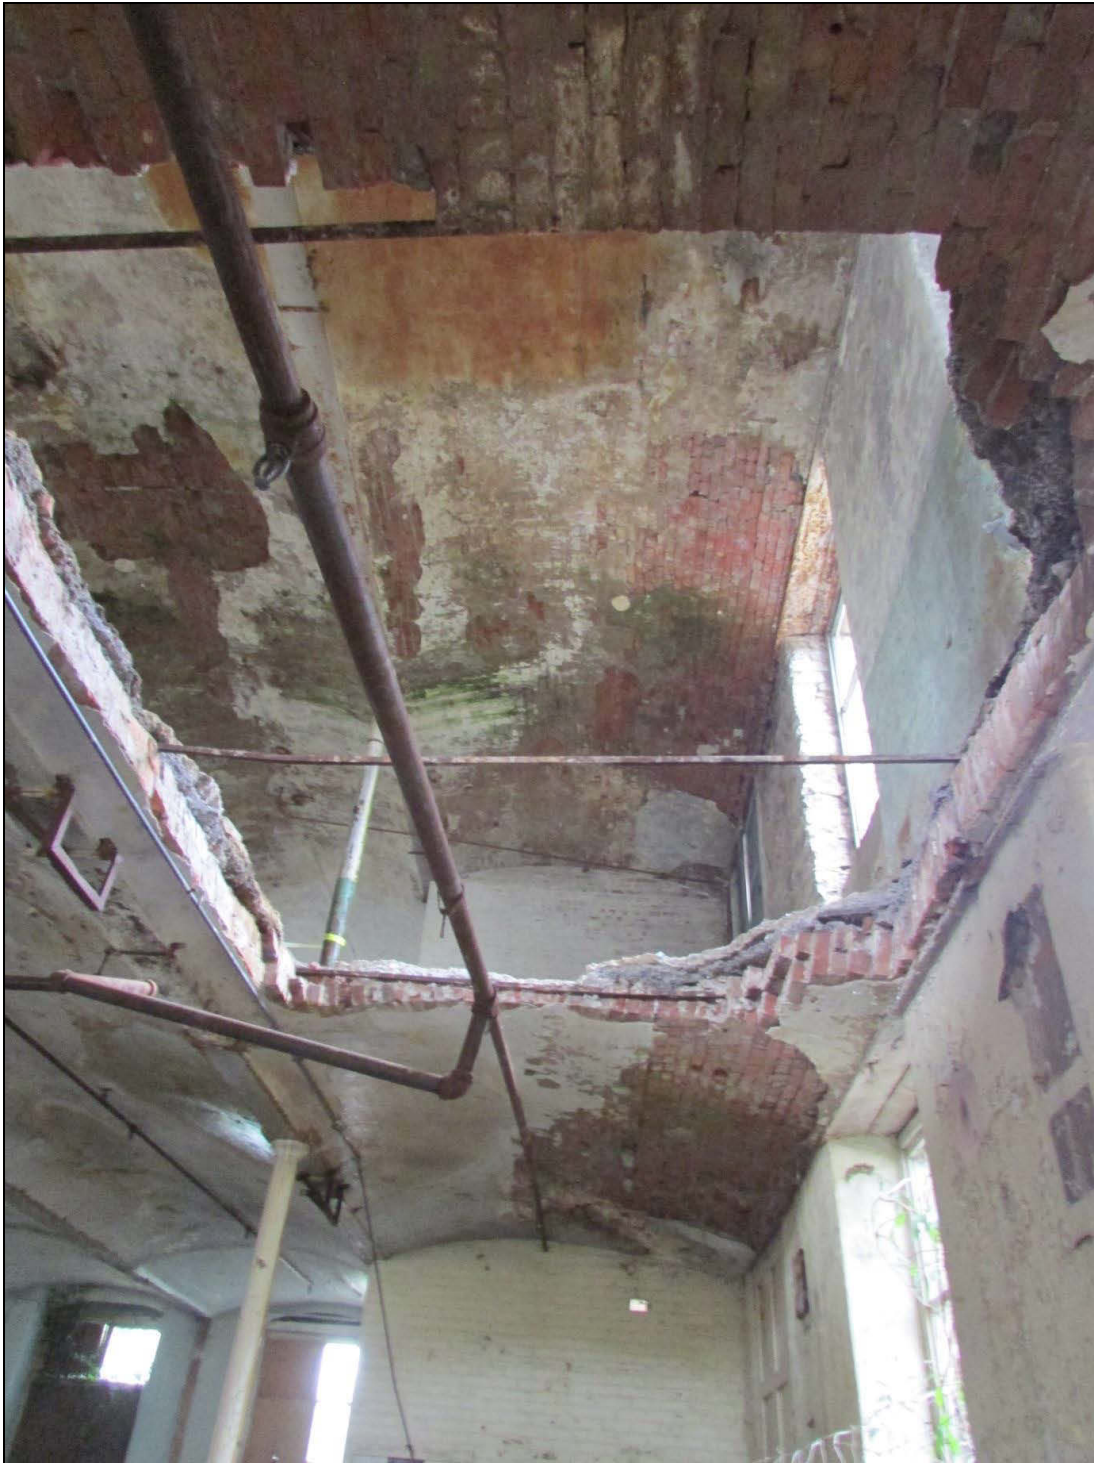
Plate 17 A small part of the second-floor ceiling had collapsed within the eastern part of the mill, exposing the metal tie-beams integral to the fireproof arches' structure

(Plate 17). The columns continued in the same pattern as seen on other floors (30 in two rows of 15) and the fireproof ceiling was the same as seen on other floors. There was plaster on the ceiling, which was generally in good condition although there was blackening along the north line of columns.

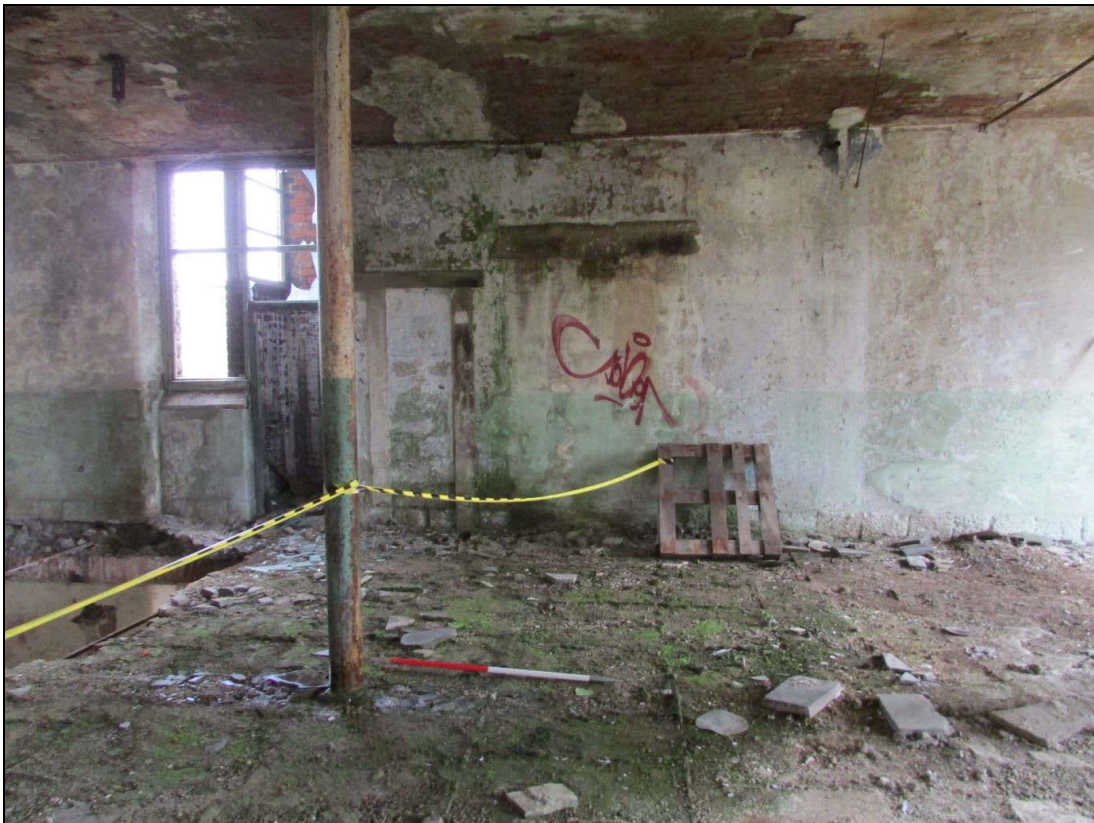
A small toilet block, constructed from machine-made brick was located at the north-eastern corner. A wooden taking-in door was located within the eastern elevation immediately south of the toilet block. As seen on the second-floor, there was a later entrance into the privy tower extension which had truncated a window and its sill. Immediately south were two blocked entrances, with the southerly most one wider although due to the floor collapse (Plate 25).

Plate 25 The later entrance to the privy tower extension is evident to the left, with two former entrances blocked to the right

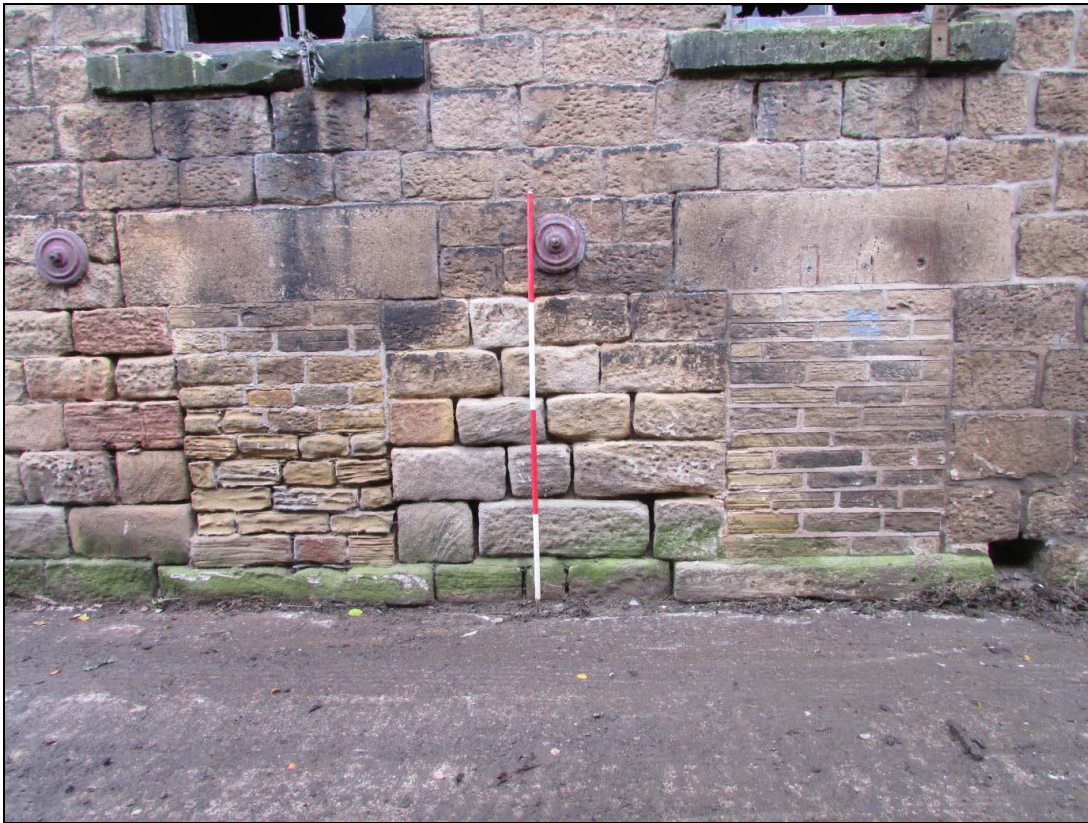
The two ground-floor bays in the western side contain four windows with plain flat stone lintels and slightly projecting sills. The two lower windows have been blocked with undressed regularly coursed sandstone (Plate 36). The two windows on the first-floor are the same as observed on the southern elevation of the mill. On the second-floor, the bay immediately west of the fanlight is taller and has a projecting I-section RSJ cat head retaining an *in situ* block. The westernmost bay differs again, with a smaller four-light bay below an aperture 0.30m wide with a dressed stone surround, possibly for an earlier hoist. This has a wooden taking-in door with an iron

Plate 36 Two former windows blocked up on the ground-floor of the engine house

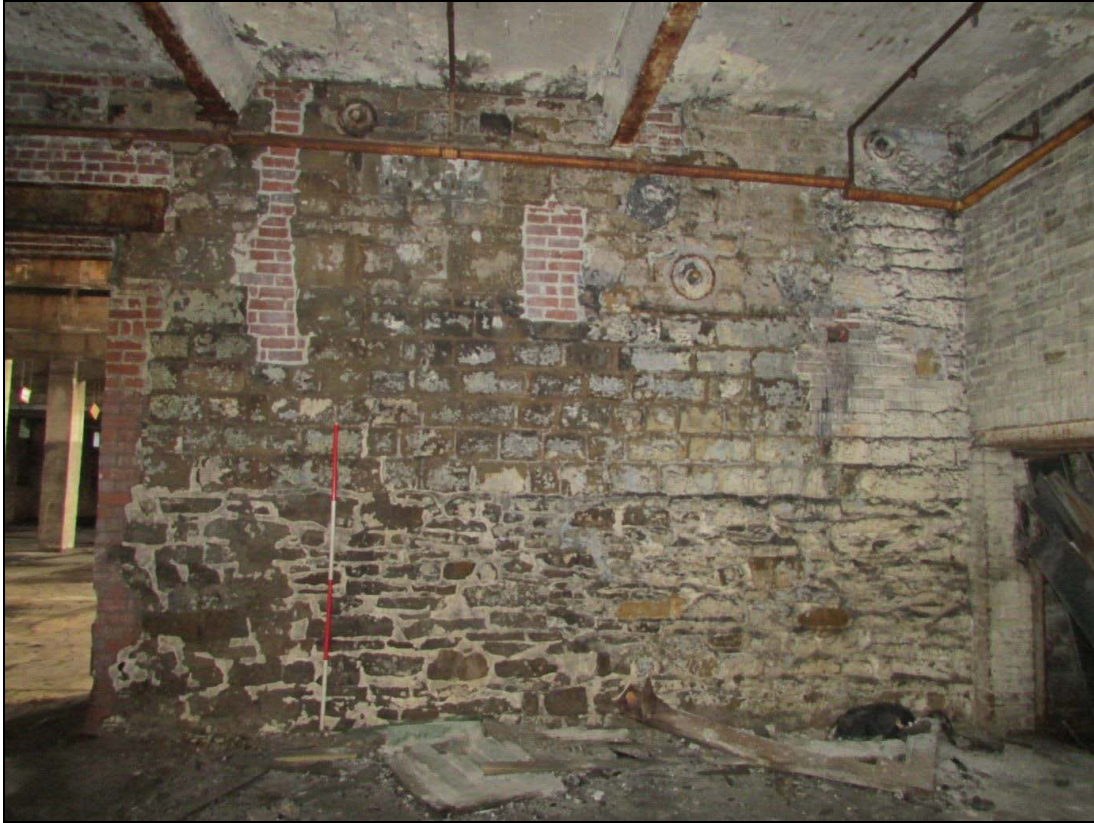
The gearing wall located between the engine house and the mill is a mix of coursed rough ashlar stones and uncoursed random rubble. There are several possible repairs using machine-made brick (Plate 40). The south-east room had a flat roof, possibly constructed of timber although this was obscured by white plaster, with iron beams running east/west (Plate 41). A machine-made brick lift shaft was inserted in the south-east corner which crosses all floors (Plate 42). Built into the gearing wall are very large rough ashlar blocks with a machine-made brick blocking a bearing box. There appears to be two phases as the mortar used between the upper and lower parts are different (Plate 43). Opposite this in the dividing wall was another blocked bearing box (Plate 38).

Plate 40 Examples of later brick repairs within the gearing wall, possibly after removal of the engine

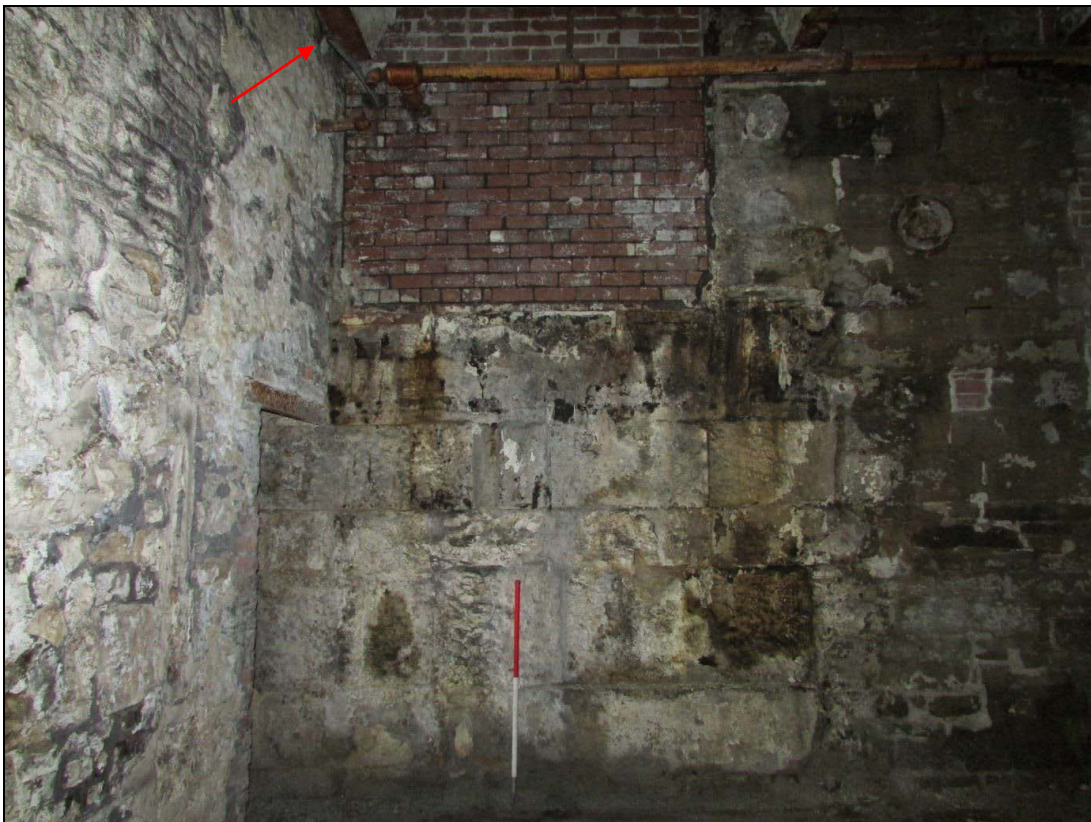
Plate 43 Blocked footstep bearing, with part of the later ceiling visible (the beam (arrowed) abuts the brick blocking)

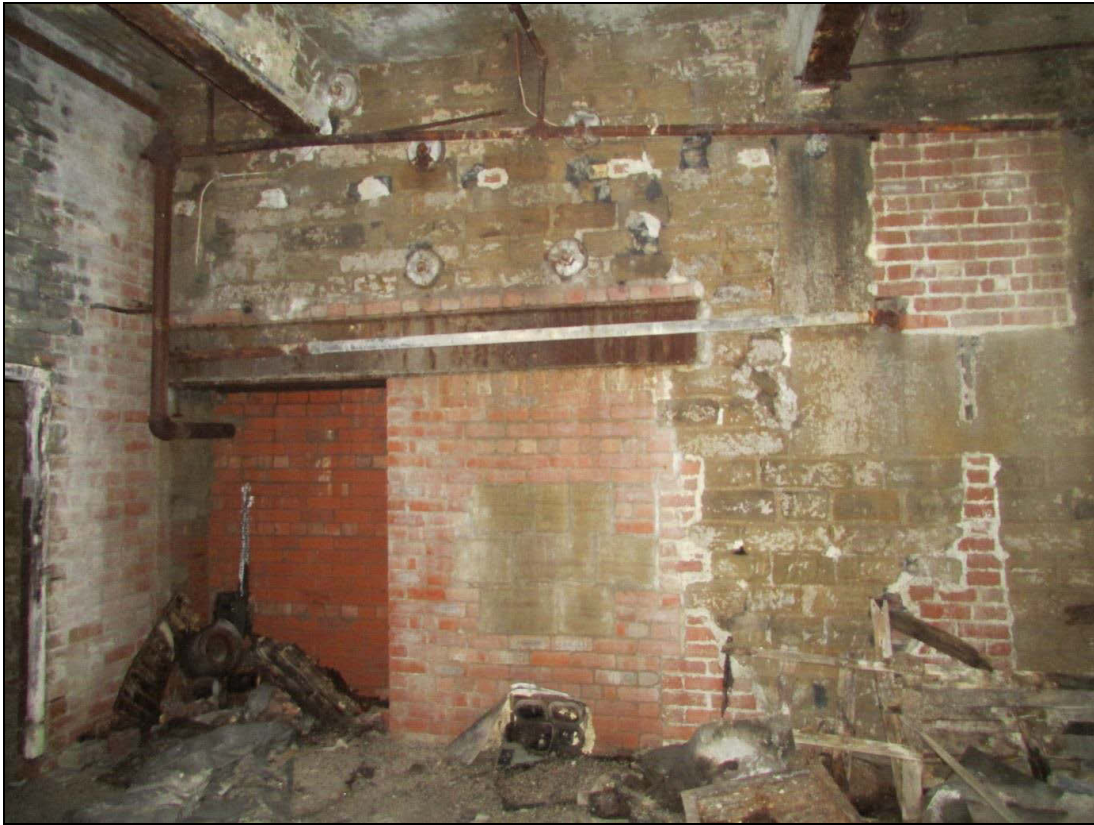
The south-east room had a flat ceiling with east/west metal beams supporting it, but due to the plastering, the material used for construction could not be ascertained. The room had also been subdivided with a machine-made brick division and a number of alterations were noted within the gearing wall. A number of localised infilling of stonework using machine-made brick were noted, including a large square aperture with dressed sandstone surround which was blocked with machine-made brick at a later stage. Immediately north of this was an entrance which was punched through the stonework and an RSJ lintel inserted above. Machine-made brick was then used to square off the entrance, which was then narrowed utilising a mix of machine-made brick and undressed coursed ashlar stones. The resulting entrance was blocked off at an even later stage, and metal piping inserted through it (Plate 48).

Plate 48 Later inserted doorway, which was then blocked and a blocked footstep bearing for another upright shaft (see also Plate 16 for the bracket on the other side of the gearing wall)

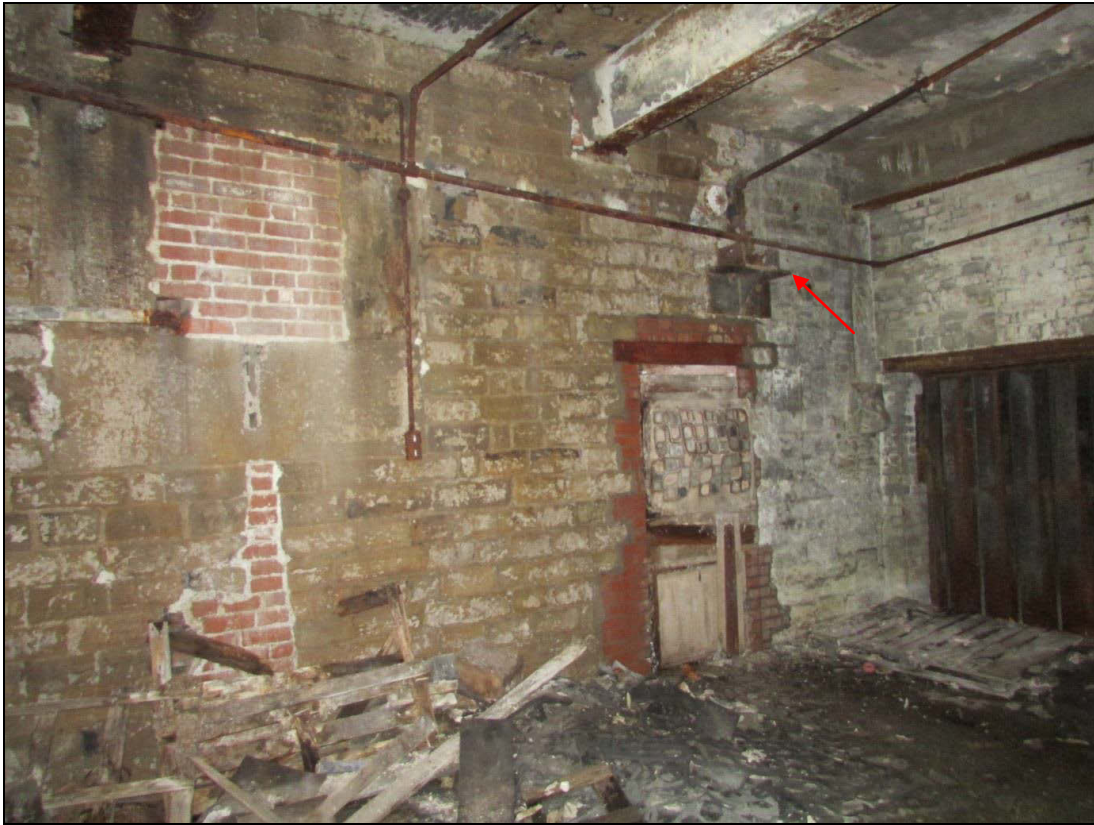
Plate 49 Another inserted doorway had been blocked subsequently with a mixture of unknown materials. An original engine fitting is visible above (arrowed)

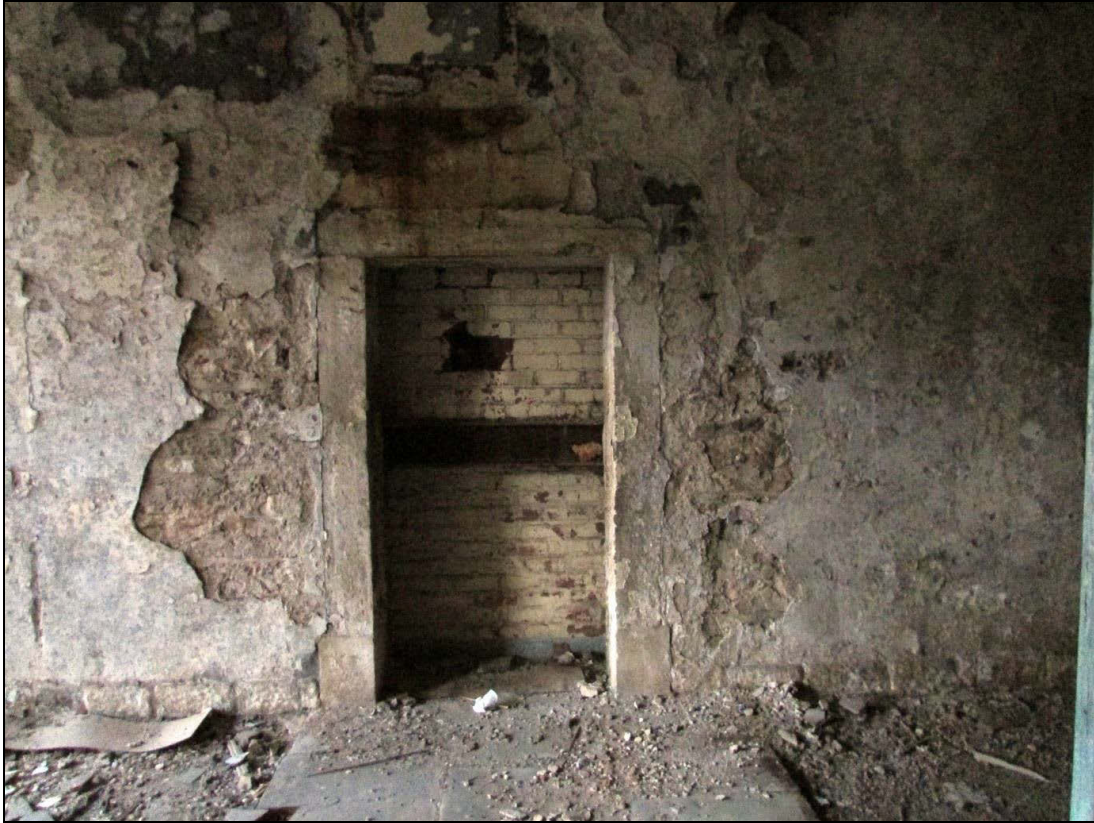
Plate 50 Blocked entrance which would have connected the engine house with the other spinning mill

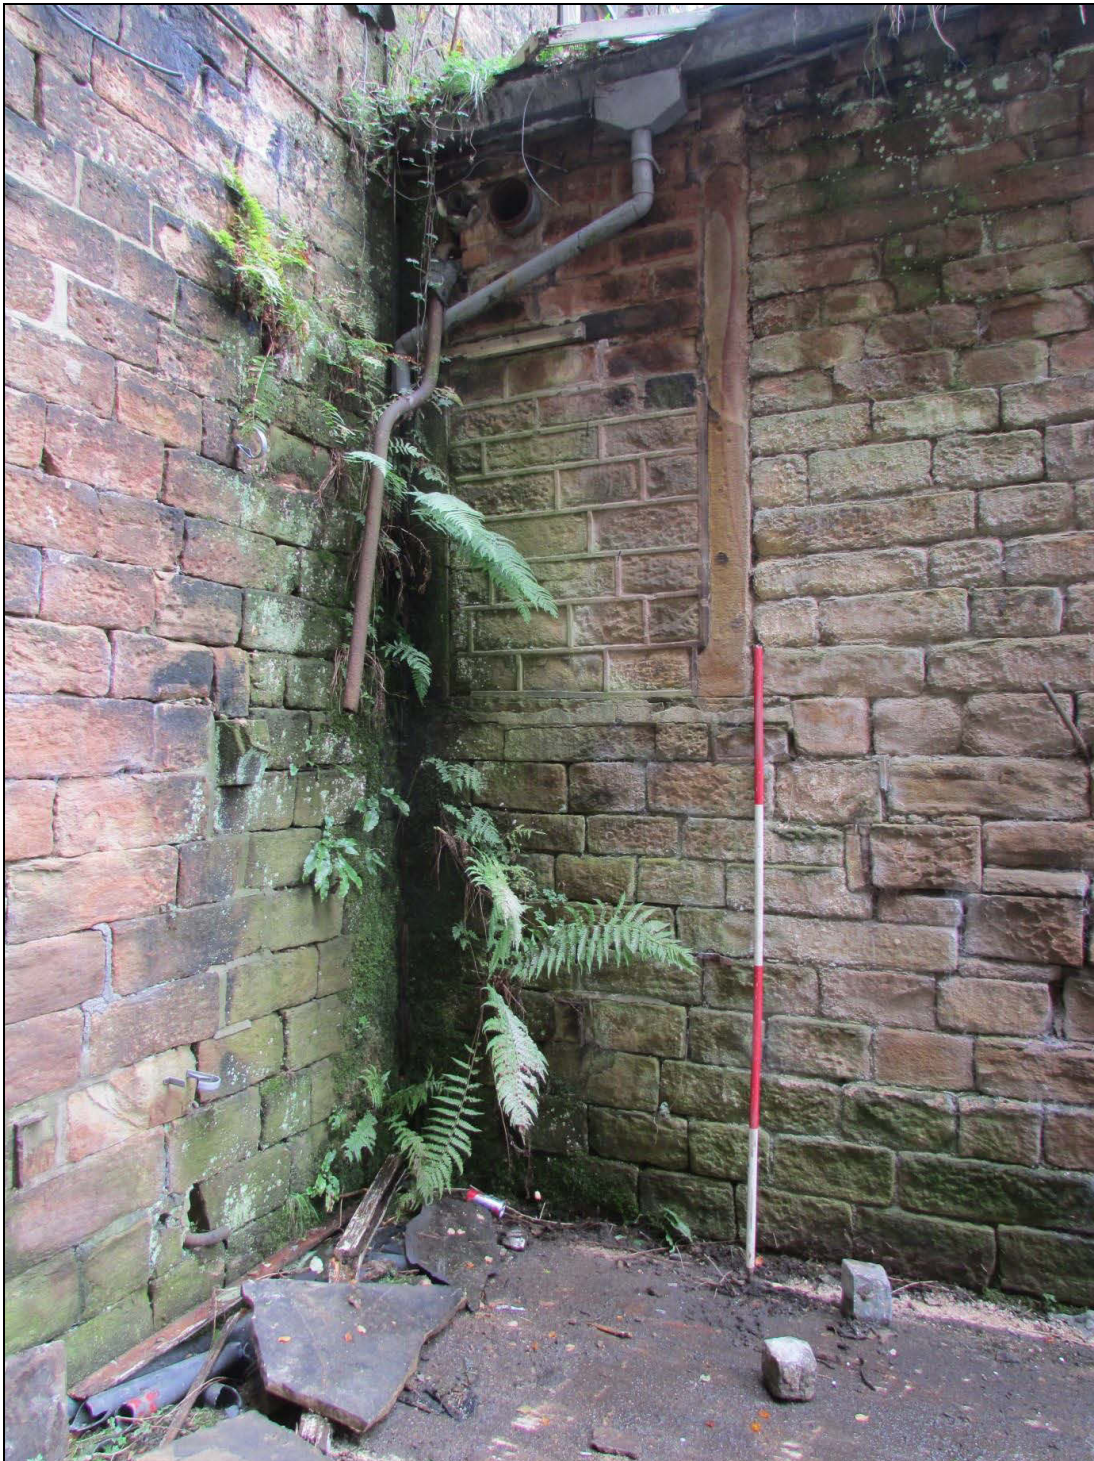
Plate 76 Blocked window within the northern elevation of the east shed

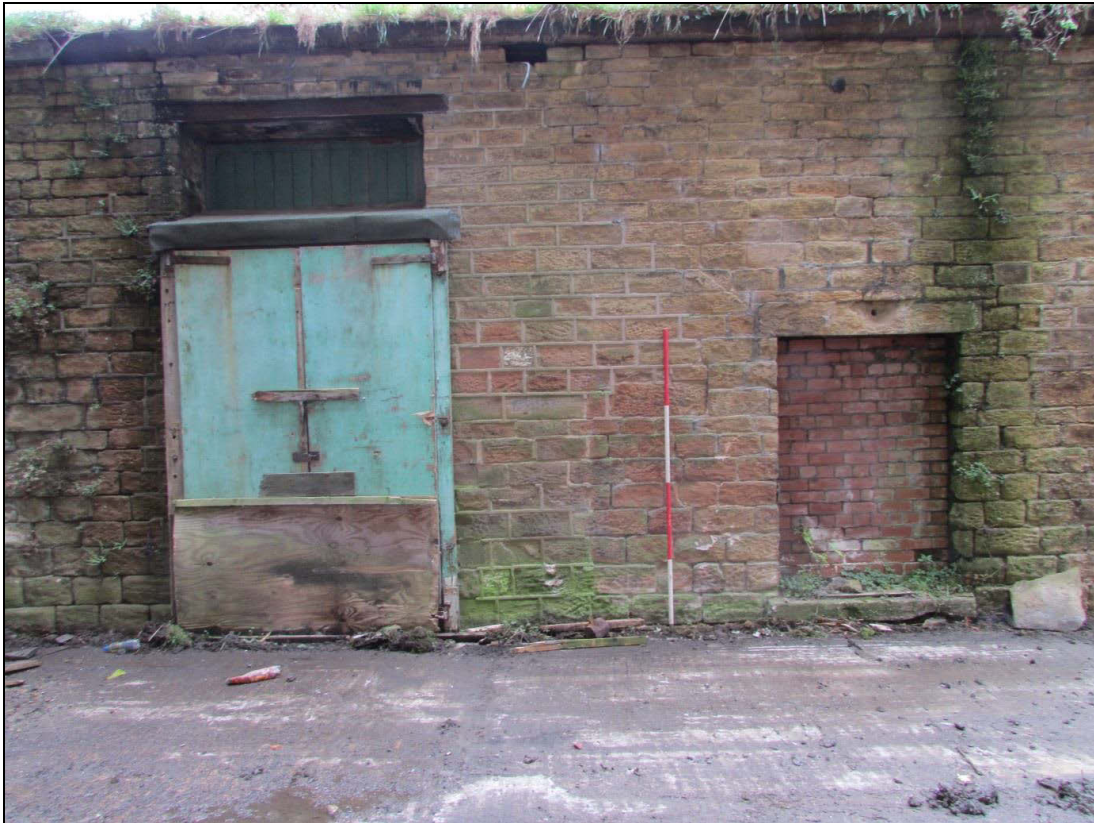
Plate 77 A door was inserted into the northern elevation of the east shed (left) and a window was also blocked at a later stage
