**Archaeological
Building Survey:**

Woods Mill, The
Narrow Spinning
Mill, Glossop

Report No:
2015/25

Document Type: Archaeological Building Survey

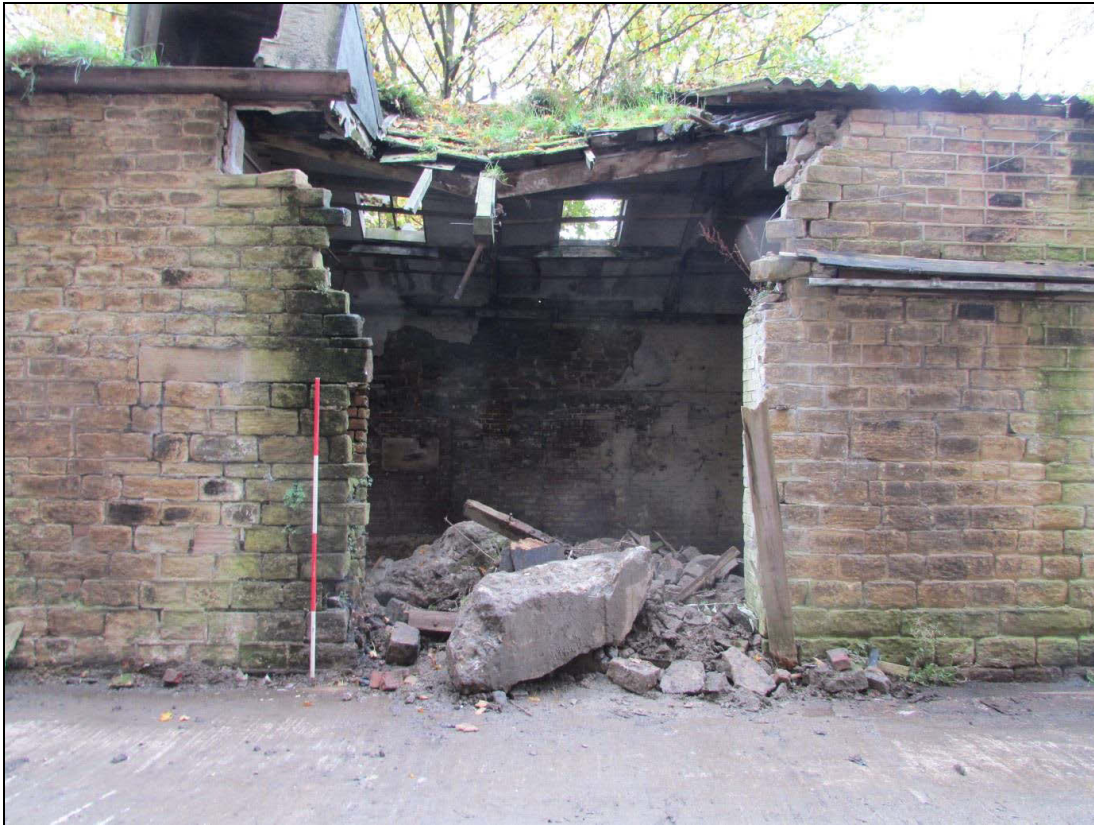
To the west of this was a gap which appeared to have been the position of a former sliding door. Part of a wooden frame and canopy was partially preserved which indicated this however the area had been damaged by partial collapse of the roof (Plate 78). It is probably an inserted entrance, as further to the west was a former entrance with a dressed stone surround, blocked subsequently with coursed stone. Just below the roof level there were also a series of small square apertures and containing windows (Plate 79). Just below this level, and west of the inserted doorway, was a small circular aperture which had been blocked subsequently with coursed stone.

Plate 78 There appears to have been an entrance located here into the east shed, however roof collapse has damaged this area

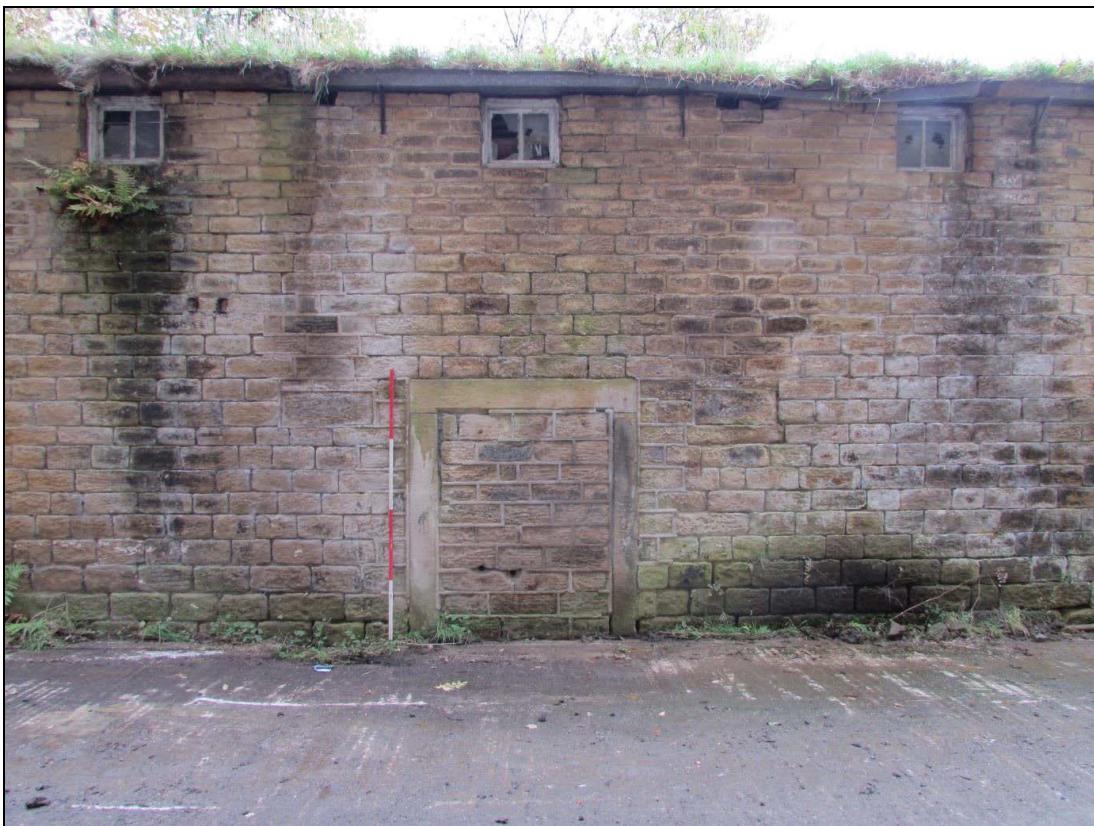
Plate 79 Blocked entrance in East Shed

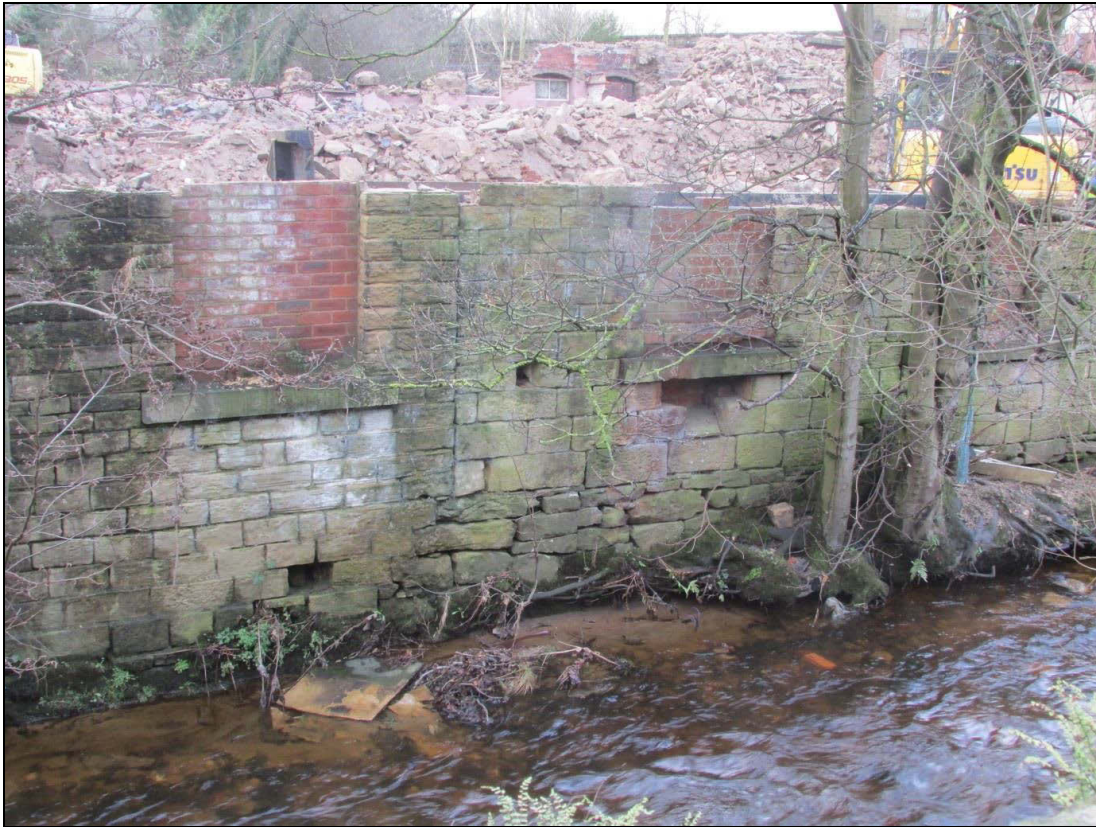
Plate 82 The butt joint between the earlier shed (east) and the later shed (west) is clearly visible, as well as where the later shed partly used the drystone foundations of the earlier building
