SURVEY OF THE 18TH CENTURY MILITARY ROAD NETWORK ON NATIONAL FOREST ESTATE, WEST ARGYLL

Inverawe to Bridge of Orchy

Biddy Simpson December 2012

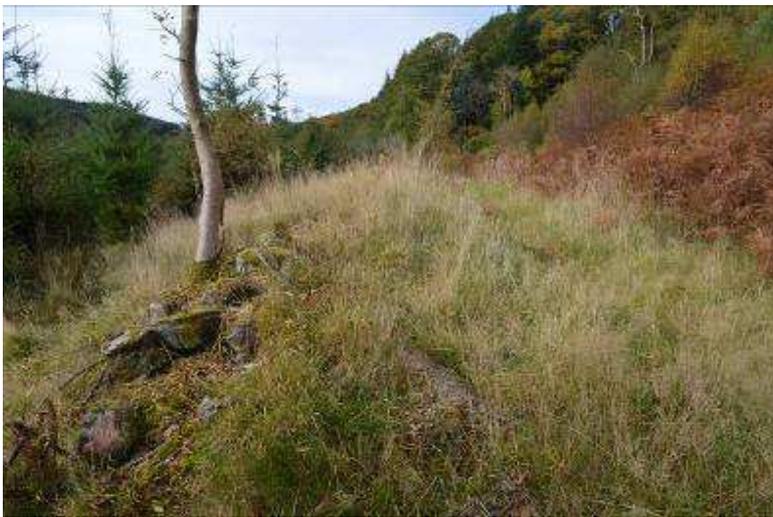
Photo 1: General view from E.

The military road is approximately 4.5 metres wide and terraced into the hillside. No bank is present on its south side. Instead there is a steep drop down towards the drystone dyke. The road is very overgrown with long grasses and regenerated trees along the western half and dense bracken along the eastern half. Piles of rotting, cut branches pepper the length of the section. A number of trees are also growing out of the wall head of the dyke to the south.

A small, unroofed stone-built structure [01] was identified at the west end of the road. It appears to post-date the road and is filled with wood, stone and general rubbish.

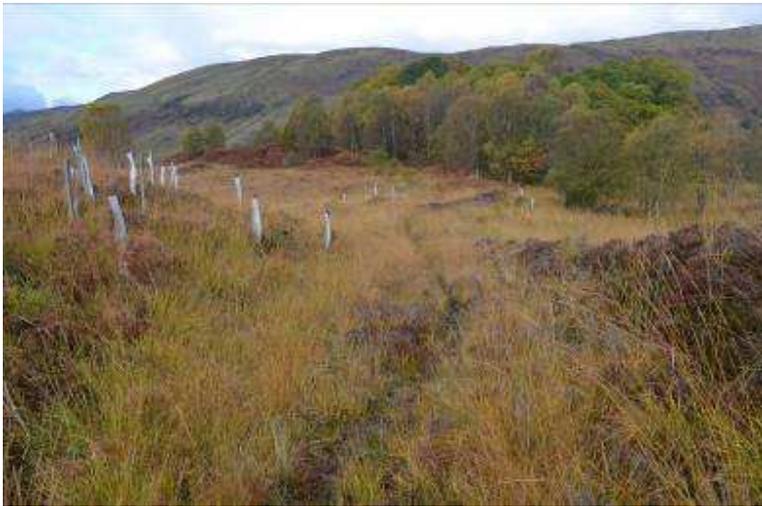
Photo 10: Section 2 from E

A degraded, curvilinear 450m length of the military way survives on the north side of the A85 (Fig. 3). Although overgrown with grass and bracken, the carriageway is approx five metres in width and clear along its entire length. It appears not to have been disturbed by any later developments, however, a number of young trees have been planted into its banks, which are visible intermittently on either side of the road. A number of quarries have been identified on either side of the road but no further features. The carriageway is particularly boggy at its immediate western and towards its eastern end.

This short section is overgrown and boggy in places. Young trees have been planted on the banks of the road. It is recommended that the young trees are removed to prevent long term damage to the road.

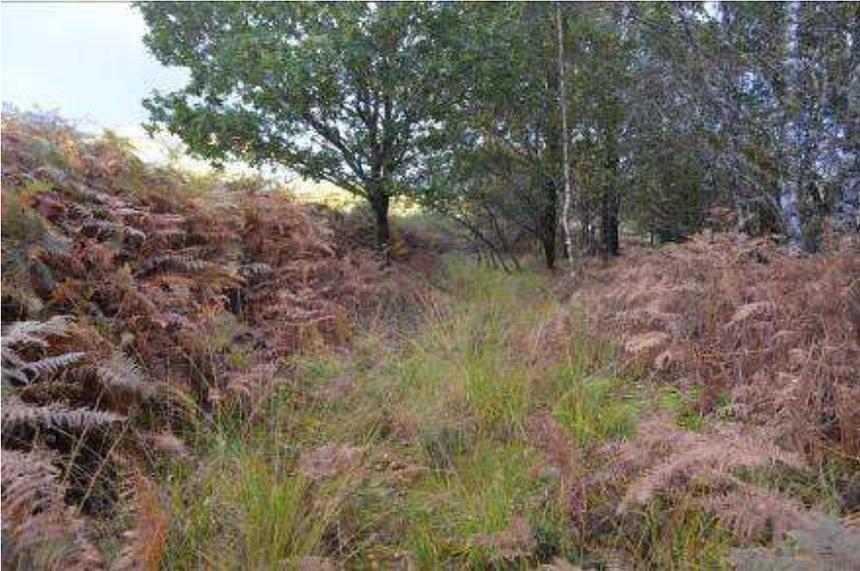
Photo 13: General view from W

A degraded, short 200m section of the military road survives south of, and approximately three metres below, the existing road level of the A85, just to southeast of Strone (Fig. 3). This section is very overgrown and is almost impassable in places. The carriageway is generally five metres in width with two metre wide banks to either side which are up to one metre high. The entire road is covered in bracken (two metres high in places) and heather. The western end of the section is quite boggy and totally overgrown with scrubby trees. Towards the western end, a drainage ditch and a section of walling lie on the south side of the road, whilst a further drainage ditch appears to have been cut through the carriageway close to the northern bank. Towards the centre of this section an oak and a birch are growing out of the carriageway. Further to the east, material appears to have been dumped onto the carriageway across an area of approximately 20 metres in length and a number of trees have now established themselves in this material.

This short section of the Military Road is particularly overgrown with vegetation and scrubby trees. The FCS may wish to consider removing the scrubby trees to prevent further long term damage to the road.

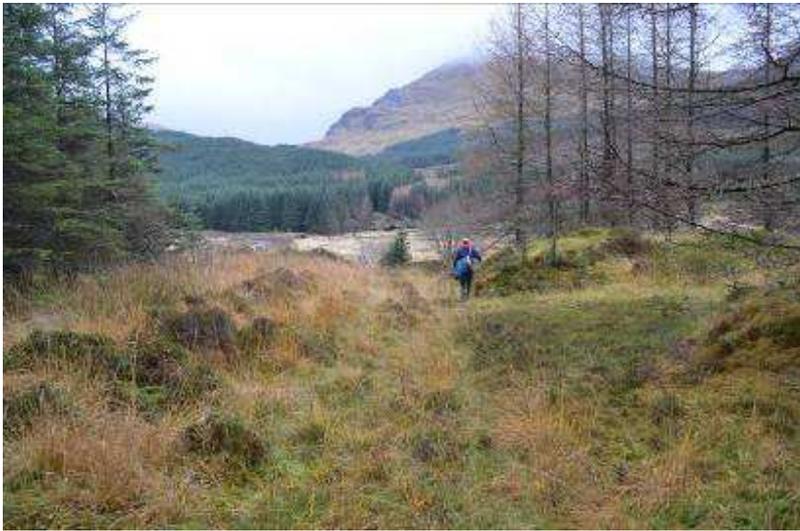
Photo 60: Section 15 from W

A three kilometre, predominantly well-preserved section of the military way, survives north of the A85 between Strone and Airigh nan Cioch, starting and ending on the north side of the A85 (Figs. 4-5). The road has been bisected by a substantial forestry extraction road which extends from the north side of the A85 up to meet the military road between sections 09 and 010. This three kilometre stretch passes through mature forest, climbing steadily for the first 1.5km until it reaches a plateau and starts to descend again to meet the A85. The carriageway is on average five metres in width with intermittent banks on either side. It is clearly defined for the entire length but covered in grass, moss, patches of heather and the occasional windblown tree. A number of wet areas along the route showed signs of being used by rutting stags. A number of areas (particularly in the eastern half) have serious drainage issues as a consequence of blocked drains and collapsed culverts (see Sections 2, 5, 9, 11, 12, 14 and 15). The following drainage features have serious issues which need addressing (13, 14, 26, 27, 34, 40, 42, 44, 46, 49, 50, 52 and 55).

The features identified along this stretch of the military road were predominantly quarries (18) and culverts (20) but a number of unclassified drainage features were noted in addition to possible sidings and track ways. All the culverts were drystone built and at least three distinctive types were represented. Culverts [02], [020] and [039] represented a relatively squat, square type with no or very little apron; culverts [010], [032] and [044] represented large types with quite large drystone built aprons spanning the banks of the burn; whilst culvert [014] showed signs of having been extended.

This lovely long section of predominantly well-preserved Military Road should to be actively conserved and managed. The main issues are drainage and culvert repairs, removal of windblown trees and removal of intrusive vegetation and regenerated trees on the carriageway and banks. The culverts and drainage features represent a range of types from different periods of the Military Road's history. It is recommended that prior to and during any work to repair any culverts or drainage features, a professional archaeologist records the remains. Not only will this enable the construction of the culverts to be recorded, but also any different phases of construction and their possible date.

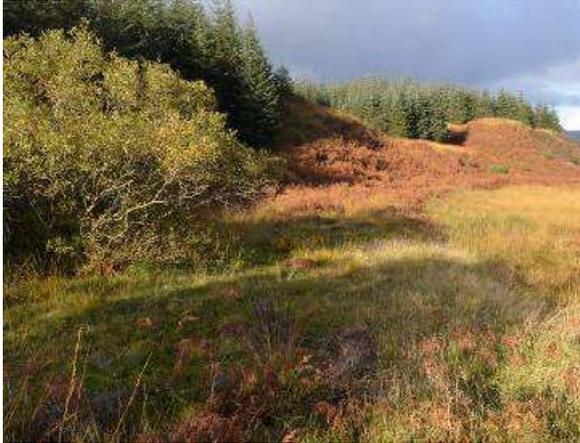
Photo 62: General view from SW

A short, curvilinear 200 metre section of degraded military road survives to the north side of the A85, separated from the road by a fence, within an area dense with bracken (Fig. 6). The road is clearly visible as a raised terrace (approximately one metre in height and four metres in width) hugging the foot of the hill with a ditch on its northern side. Towards the eastern end of this section a number of large boulders are apparent to either side of the road. A burn cuts through the road approximately halfway along its length but there is no evidence for any drainage feature, such as a culvert.

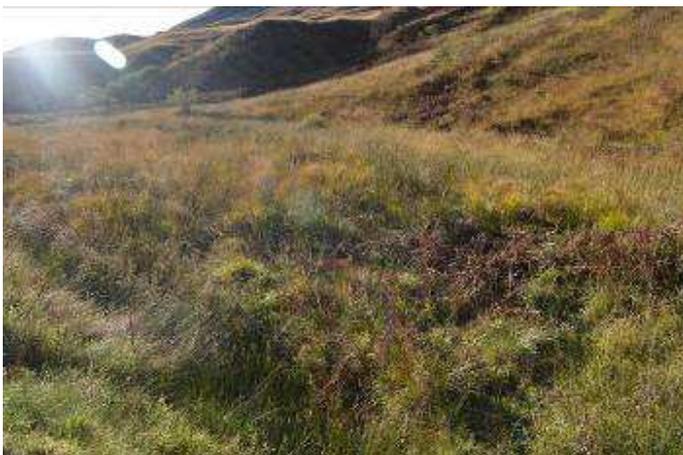
Photo 64: NE end of section from E

A short, curvilinear 200 metre degraded section of military road survives to the north side of the A85 (Fig. 6). The military road is separated from the road by a fence and a massive drainage ditch. Within the fenced area, the area is overgrown with grasses, rushes and bracken making it very difficult to establish the presence of the military road. However, the military road can be seen surviving as a slight raised terrace, hugging the foot of the hill.

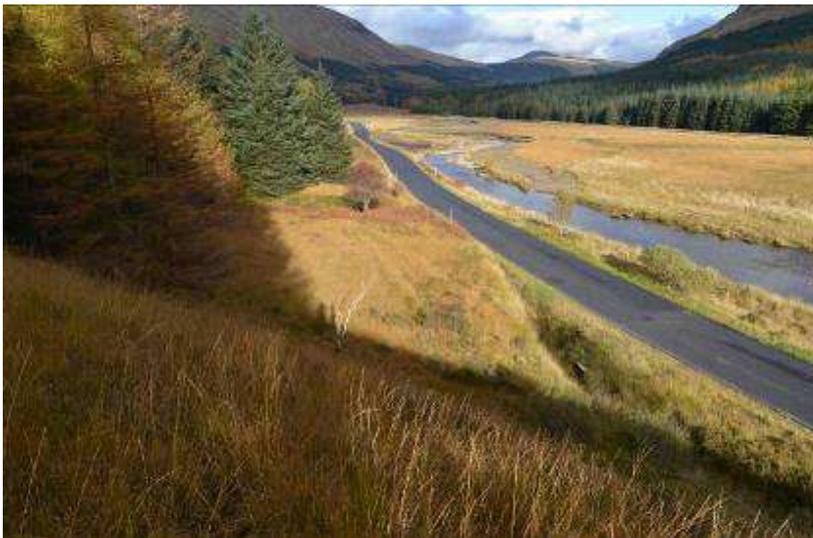
Photo 67: View from vantage point down onto faint remains of military road

A short length of degraded track, which may be the surviving remains of the military road, is faintly visible stretching from the north side of the A85 through boggy, tall grass to meet the junction (NN 25326 29594) between a part tarmac siding off the main A85 and a gravelly/stony hill track, which ascends up into the tree belt. A rowan tree is growing in the middle of the carriageway at the northern end of this surviving section.

The military road then disappears but from a vantage point (NN 25373 29662) next to the hill track (mentioned above) it is possible to see the faint remains of a carriageway defined by two banks at approximately NN 2541 2971 extending over a length of about 20m. The feature, however, disappears before it reaches a burn further to the north. Improvements to the A85, particularly the deep drain on its west side, in addition to the tarmac siding may well have destroyed the part of the military road which extended from NN 25326 29594 to NN 2541

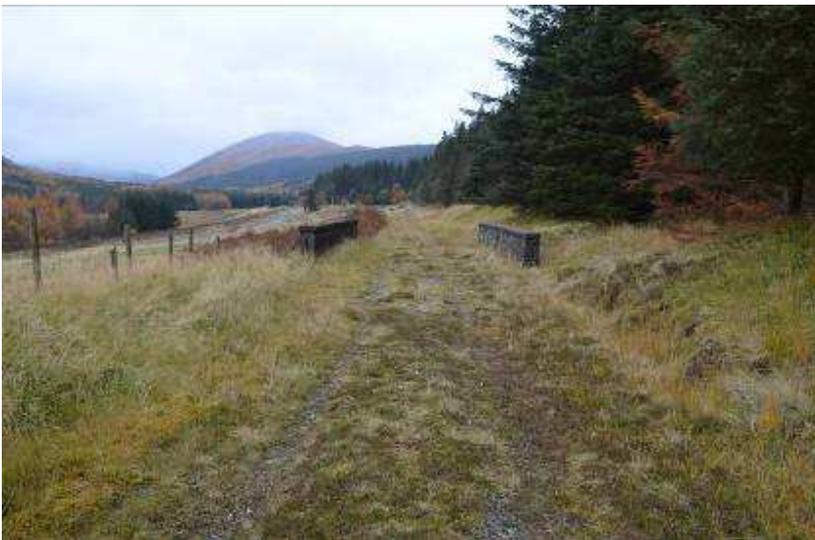
Photo 76: Section 4 general photograph.

A number of areas have serious drainage issues as a consequence of blocked drains and collapsed culverts (see Sections 4, 5, 6, 7, 10, 15 and 16). The following drainage features have particular serious issues which need addressing (10, 17, 22, 23, 27, 36, 38, 43, 44 and 46).

Although this stretch of the Military Road has been classified as ‘Degraded’ because it has been slightly compromised by the addition of a layer of surface concrete, it is presumed that the Military Road survives completely intact below. This is a lovely long stretch of Military Road which is in excellent condition and deserves to be conserved and managed. The main issues are drainage and culvert repairs and the removal of intrusive vegetation and regenerated trees on the carriageway and banks.

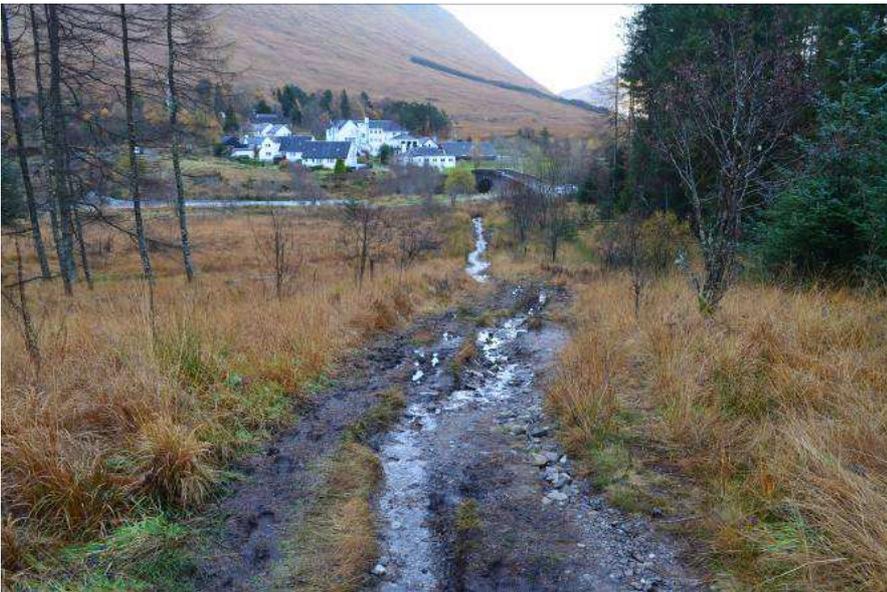
Photo 96: Severely eroded section 1 from NW

As also outlined in the Atkinson (1994) report, this stretch of the Military Road has been severely compromised by both serious visitor erosion and poor drainage. In fact, the East Strone and Arrivain stretches are in much better condition than the Bridge of Orchy section.

In addition, visitor pressure on the path which leads along the Military Road has meant that the surface of the Road has been severely eroded, exposing the upper levels of gravel and underlying larger stone material. Along Section 1, the situation has been greatly exasperated by water running down the path and Military Road and the visitor erosion is over a wider area of the Road. Where the Road has been eroded, it needs to be urgently repaired. The worst affected area is from the start of Section 1 at the car park (on the west side of the Bridge of Orchy bridge) up to the re-diverted section of path at features [01] and [02]. This area requires serious repairs and either the path re-routed away from the Military Road (to join up with it again in Section 2 or 3) or extensive board walks erected. Any work on this section of the Military Road would require consent from Historic Scotland.

It is strongly recommended that the drainage along the entire stretch (but particularly Sections 1 and 2) is re-designed to carry water away from the Military Road as soon as possible.

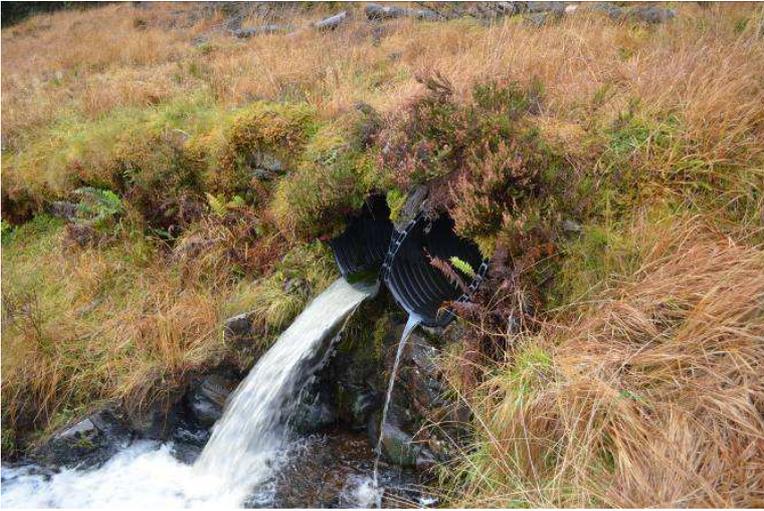
Photo 107: Culvert/Bridge [09] with modern pipes inserted.

The remains of an original and substantial drystone built culvert with two plastic pipes inserted and visibly protruding through the path surface. The culvert, itself, measures approximately 1m by 1m with a basal stone and two side walls still visible. There is a 1m height drystone built face below the basal stone. The culvert sits within a massive drystone built ramped apron (14m in length and 5m in width) which acts a ford or bridge across the burn.

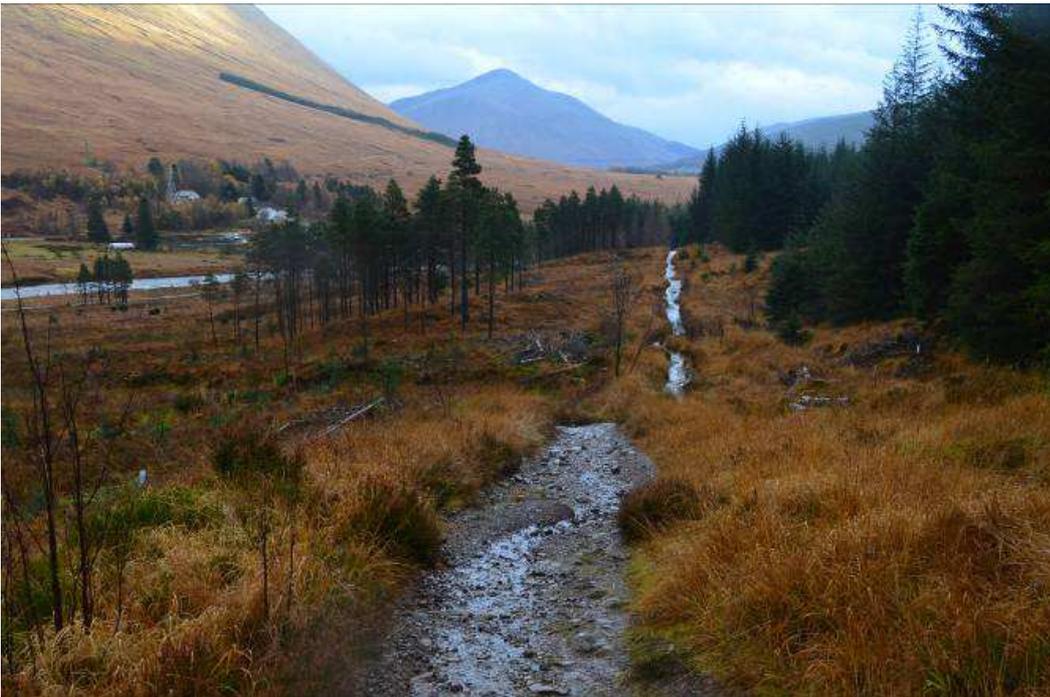
Photo 109: Section 3 from NW

Bridge of Orchy		3	NN 25363 30994 - NN 25297 40183	Double banks; raised road; regen; erosion	Degraded						105,110
