Outbuilding at Rams Farm, Fordham, Essex

Historic Building Record

Leigh Alston MA (Oxon), Architectural Historian

April 2019

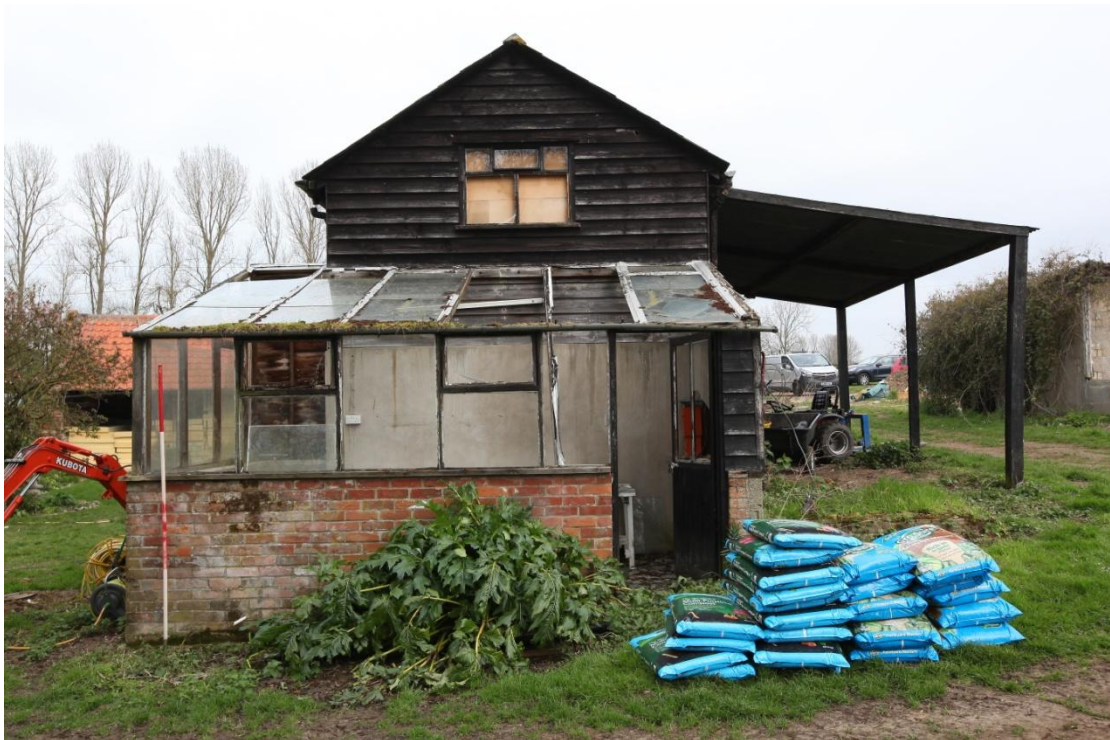
Illus. 4. The granary (1) from the south showing the 20th century lean-to greenhouse against its gable and the 20th century tractor and implement shelter projecting from the rear (eastern) wall to the right.

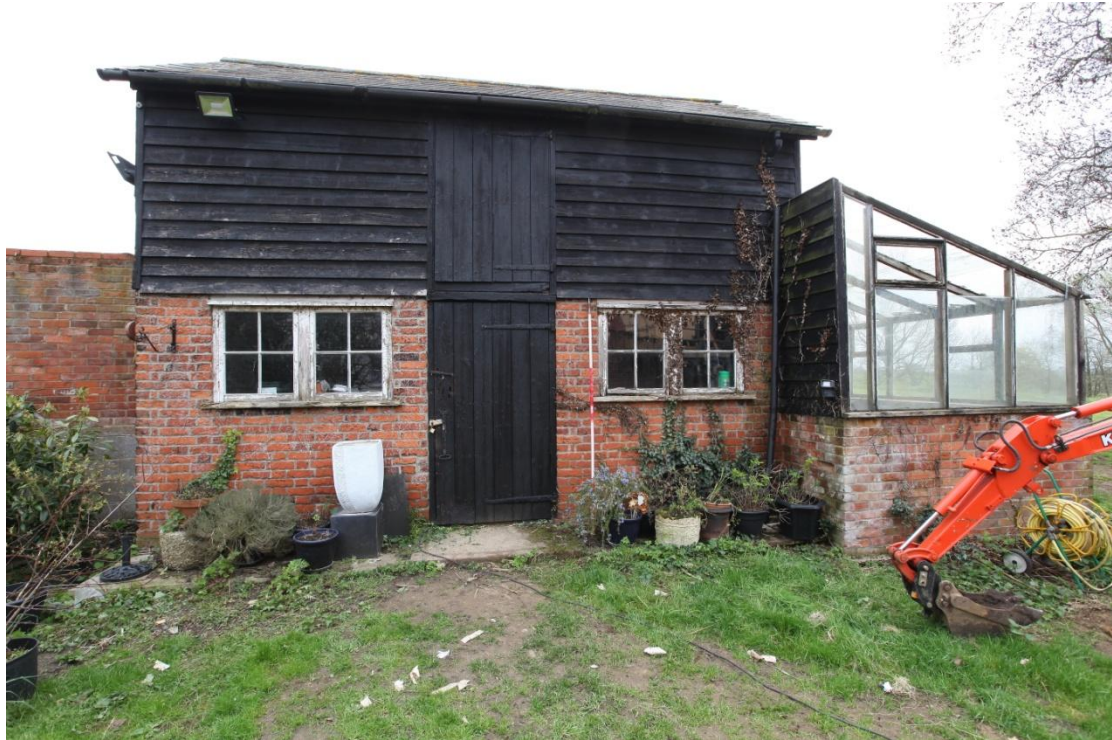
The building forms a typical 19th century granary with a central entrance in its western facade (facing the house) and a loading door to the grain loft immediately above. The ground-floor doorway is respected by closers but its left-hand (northern) jamb appears to cut the brickwork in a manner that would normally indicate secondary widening, although there is no other evidence of this and both doors are of equal width (at 1 m or 40 ins). The ground-floor windows flanking the door interrupt the brickwork in a similar manner but these are clearly 20th century insertions – but may have replaced smaller predecessors. A wooden ladder opens onto the loft via a hinged trap door immediately inside the entrance. This represents an unusual arrangement but appears to be original as the trap is fully framed with a tenoned trimmer secured by a peg. The gables and rear wall are blind on the ground floor and the loft walls are lined by horizontal deal boarding. A series of secondary vertical fillets nailed to these boards formed grooves to secure a pair of missing partitions that divided the storage compartments on each side from the narrow area opposite the loading door. There is no evidence of bins in the normal sense and both compartments were probably designed for grain in sacks. The original purpose of the loft is confirmed by a number of chalk tally marks as shown in illustrations A2. 15 & 16, with rodent damage repaired by nailed sheets of tin (A2. 14). The roof retains an original boarded ceiling between the slate and rafters, and 20th century windows in both loft gables probably replaced original predecessors.

Illus. 5. The granary's western facade showing its red-brick lower storey and the central loading door of the weatherboarded loft. The ground-floor doorway is respected by closers (quarter bricks) to the right but its left-hand jamb cuts the brickwork suggesting it has been widened. The present windows date from the 20th century and also interrupt the brickwork.

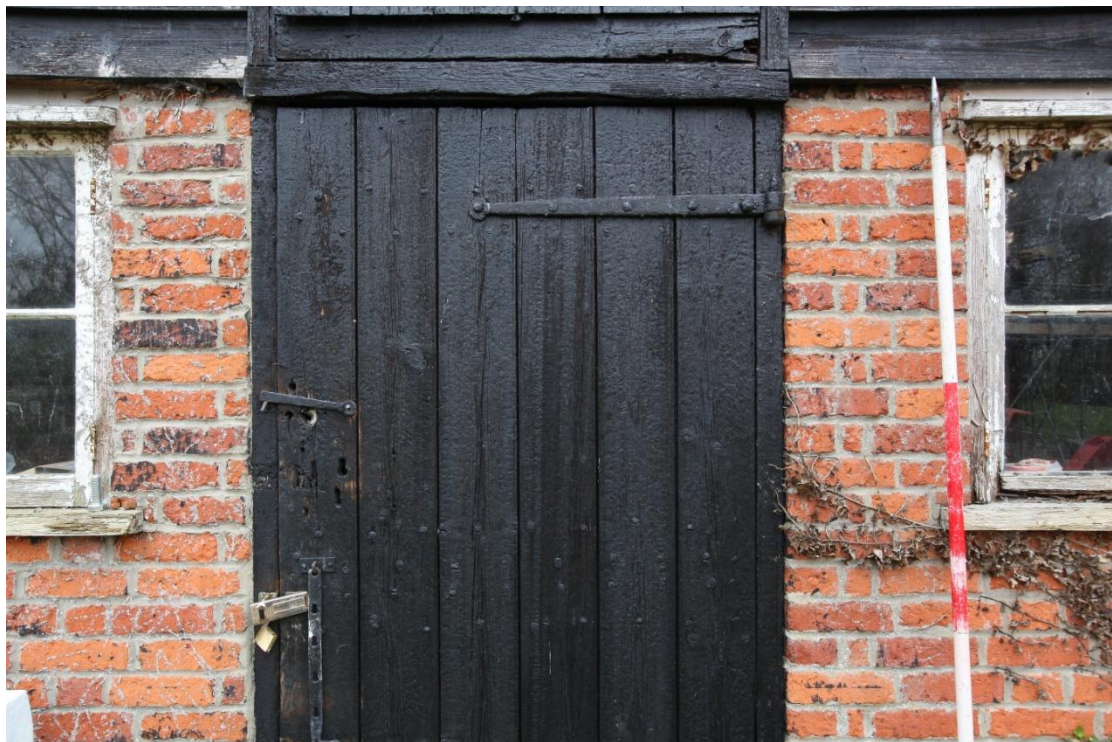
Illus. 6. A detail of the heavily tarred western entrance door with closers to the right and cut bricks to the left.

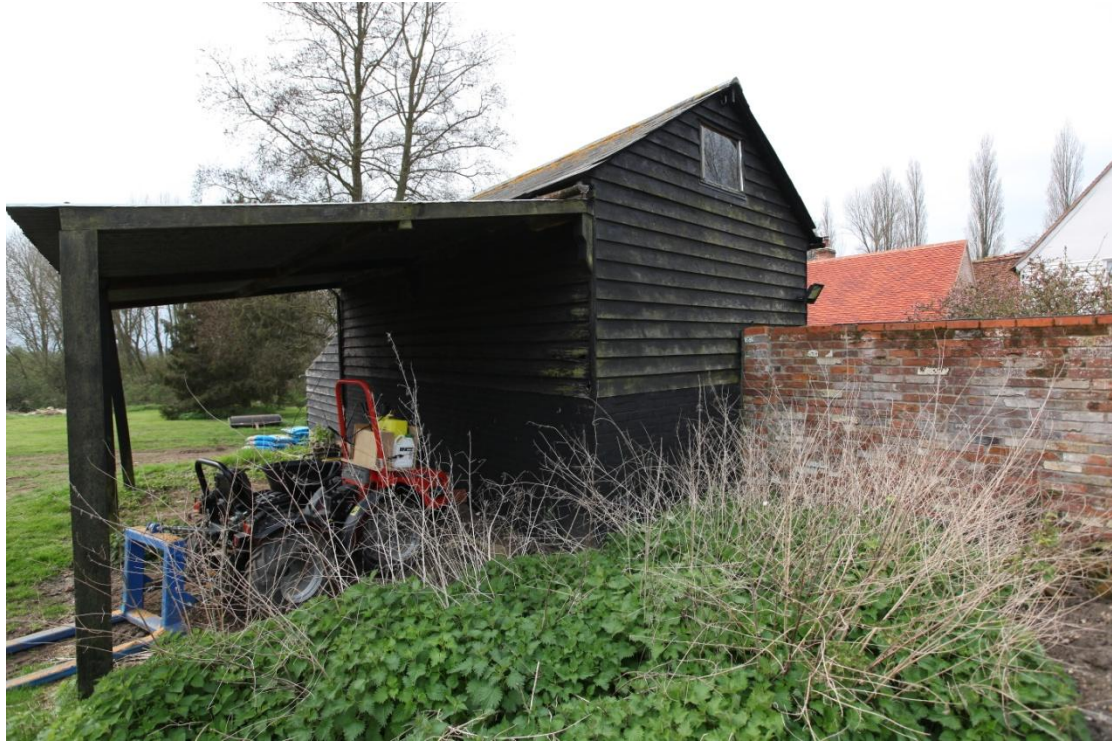
Illus. 7. The granary from the north-east showing its tarred northern gable and the 20th century lean-to implement shelter against its rear wall.

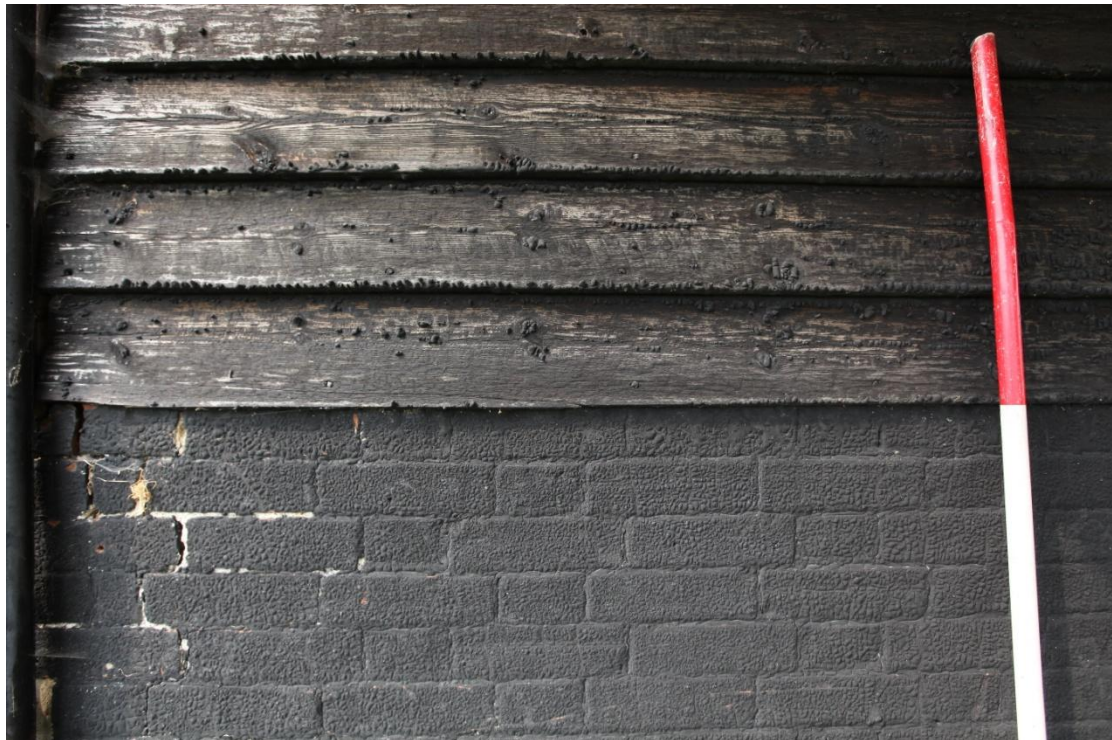
Illus. 8. A detail of the granary's heavily tarred eastern external brickwork and weatherboarding protected by the later implement shelter. There is some evidence of earlier red-ochre pigment beneath the tar.

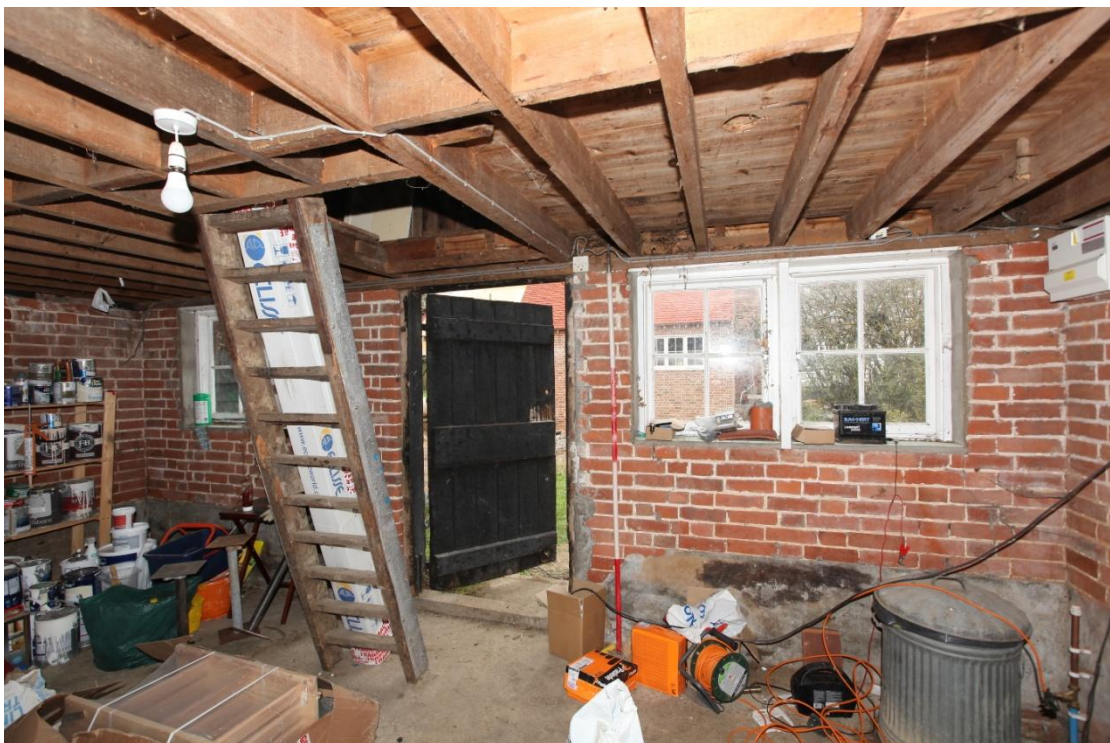
Illus. 10. The interior of the western ground-floor facade showing cement repairs to the cut brickwork on the right of the door. The windows also appear to cut the brickwork on the left and may have replaced smaller originals.

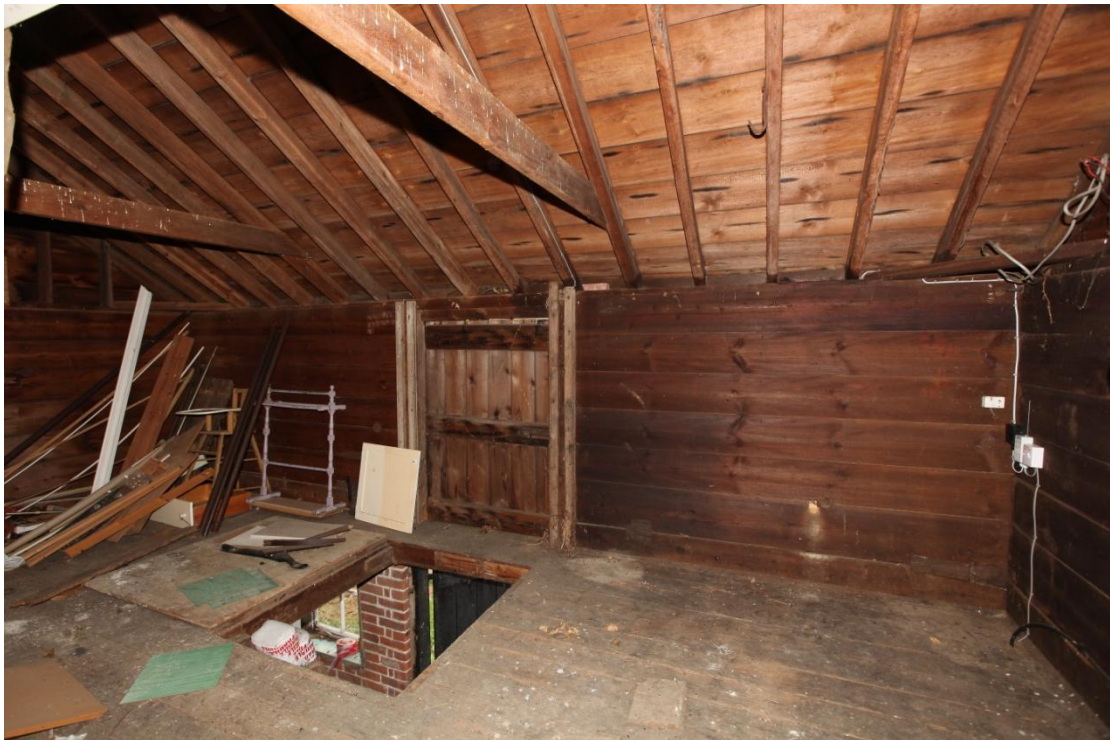
Illus. 12. The western interior of the grain loft showing the vertical grooves for missing bin partitions flanking the loading door. The interior is clad in deal boards with later staining and the original softwood roof structure consists only of coupled rafters with a ridge board and two nailed collars.

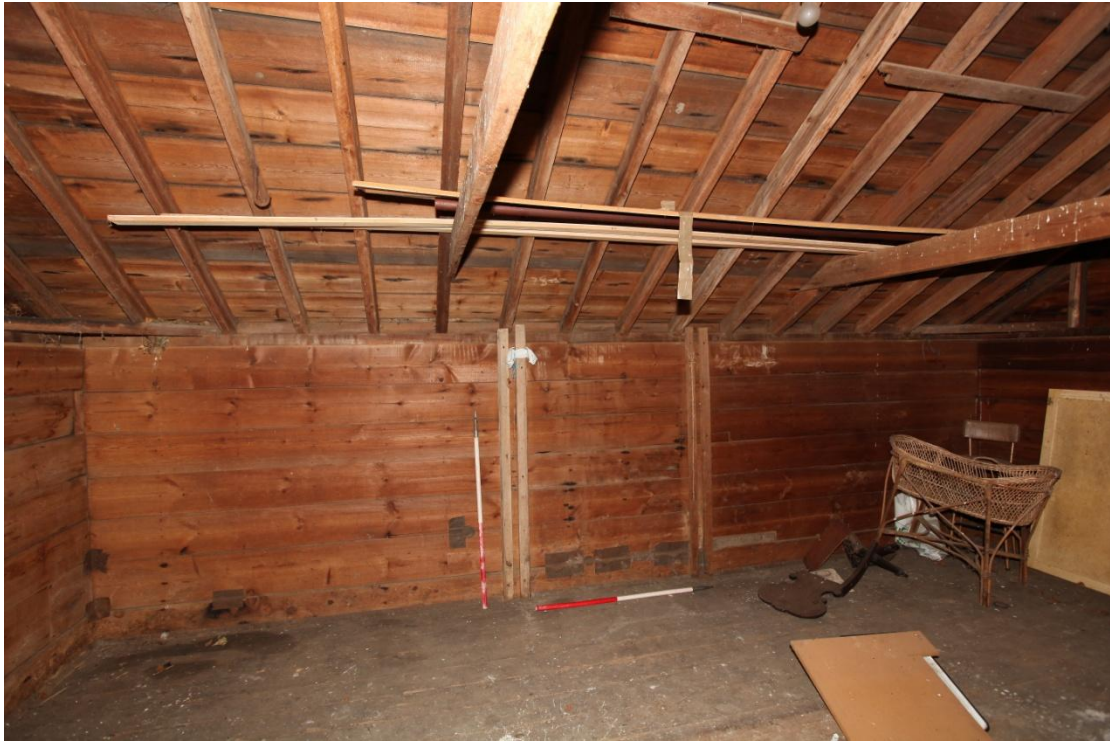
Illus. 13. The eastern interior of the grain loft showing the vertical grooves for missing bin partitions opposite the loading door.

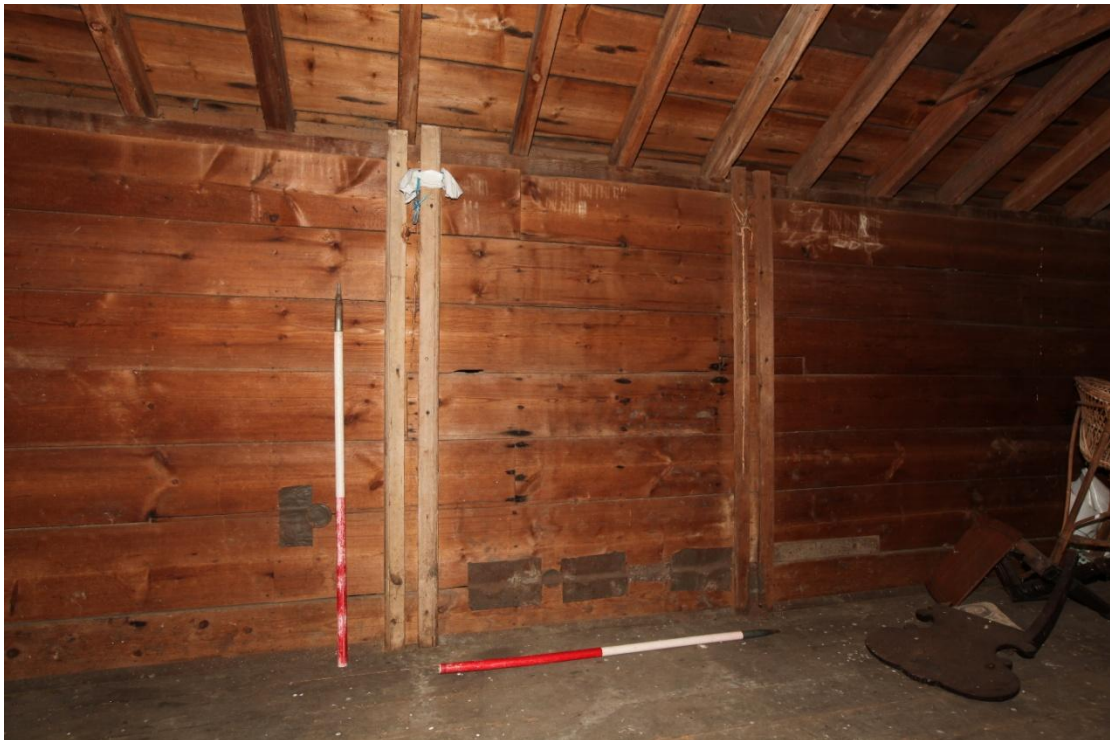
Illus. 14. A detail of the eastern loft interior showing the nailed patches of sheet tin to the deal boarding. The circular patch on the left appears to be the base of a tin can. A series of chalk tally marks are visible on the top board (see detail in illus. A2. 16).
