# **Historic Building Assessment**

## **5 Carlton Crescent Southampton**

June 2016  
Reference: 16307  
Site Code: SOU 1730

**Oakdene Construction UK Limited  
2 Kings Copse Avenue  
Hedge End  
Southampton  
SO30 0FW**

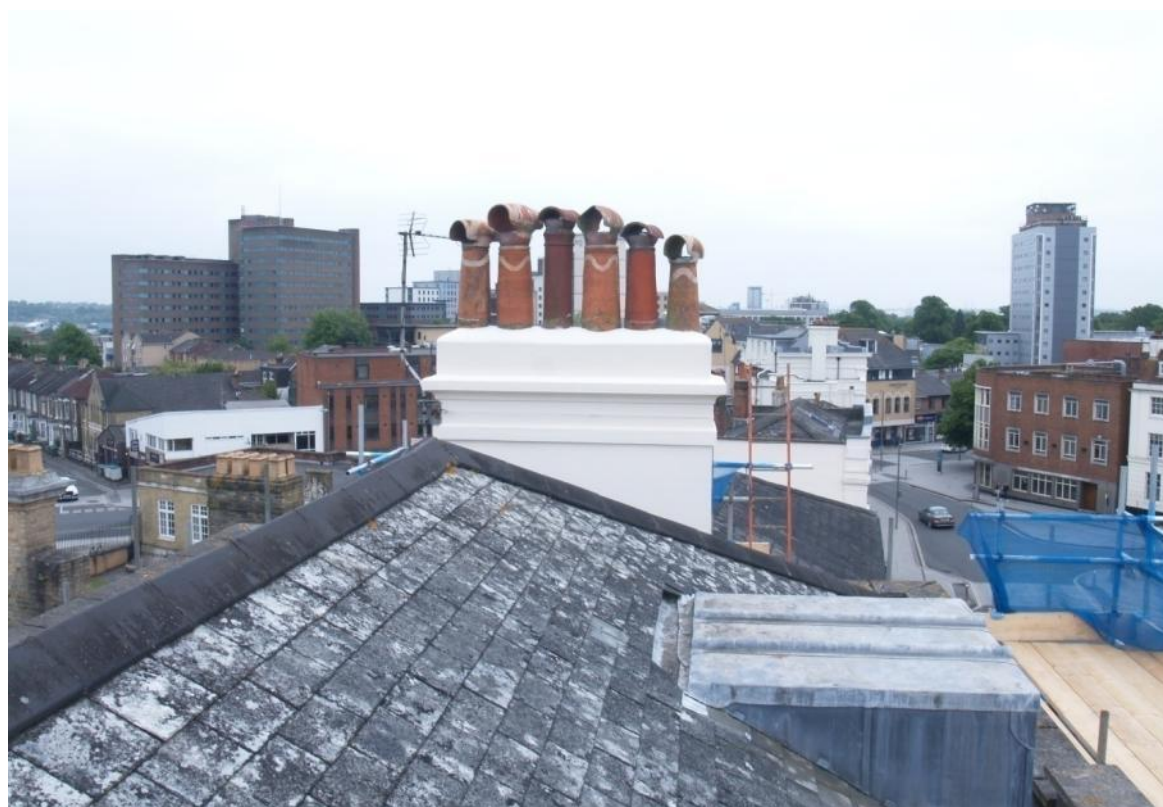
- 3.1.3 The roof slopes are covered with a pale grey slate of a heavy surface texture type with riven edges. This is of a type that could either be a Cornish Delabole or Cumbrian Fell type. The hips and ridges are capped with modern machine made angular clayware ridge tiles these have been mortared together with a heavy cement type mortar and these are supported by modern galvanised hip irons at the bottom of the hips.

Fig 3.1; Main roof and south chimney

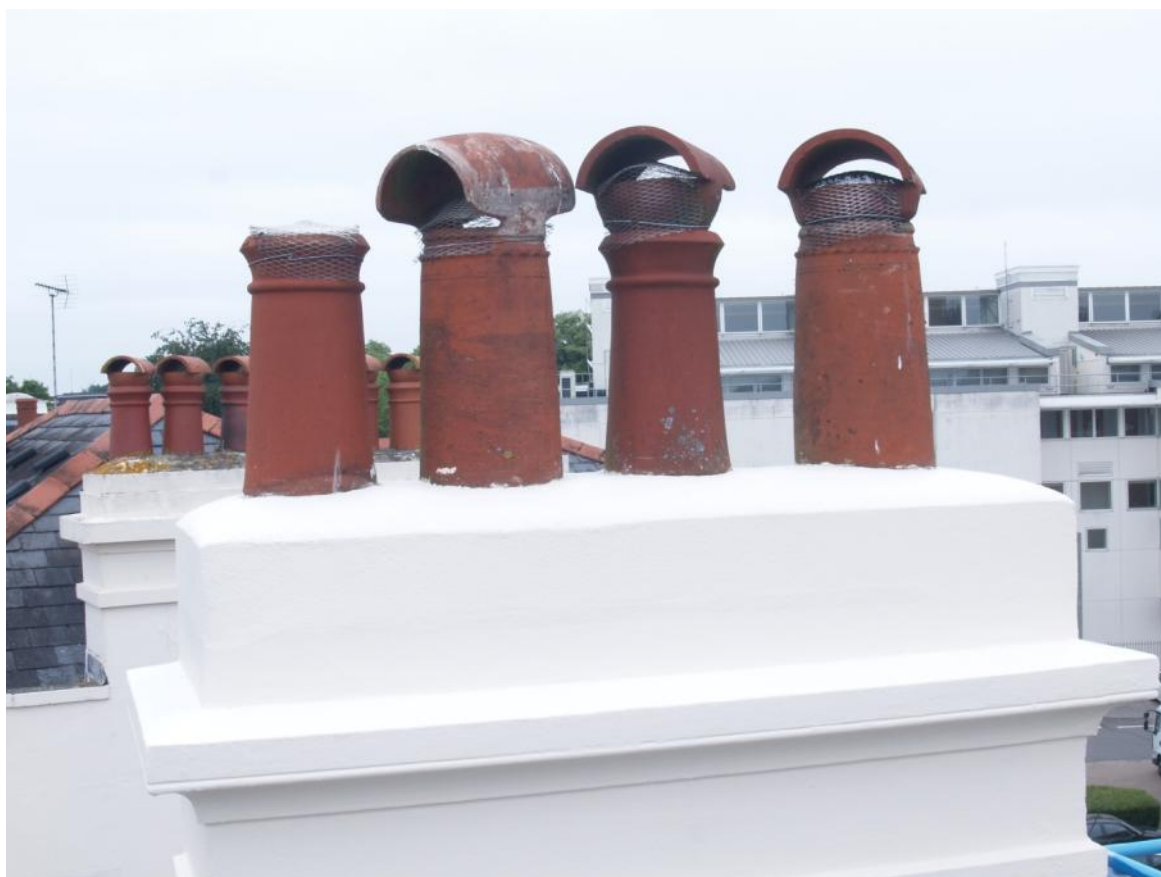
- 3.3.1 Projecting up through the north wall to the parapet there is a chimney stack and this contains four flues and each of which is capped with a clay flue terminal. Two of these are of a traditional Hampshire pattern and two of which are modern Staffordshire type pots. Two of these pots are fitted with bird nests preventers and one pot is fitted with a cowl of a Fareham type. The two traditional pots are of a semi barrelled type with thumb or cable decoration band to the top over a double scribed line.
- 3.3.2 The chimney stack at the south end of the building contains six flues with flue terminals to the tops of them all. Apart from one these are all of a traditional Hampshire and particularly of a Fareham type pot and all have cowls over them of which three are Fareham type decorated terminals with white clayware slip decoration.

Fig 3.3; Chimney pots, north chimney

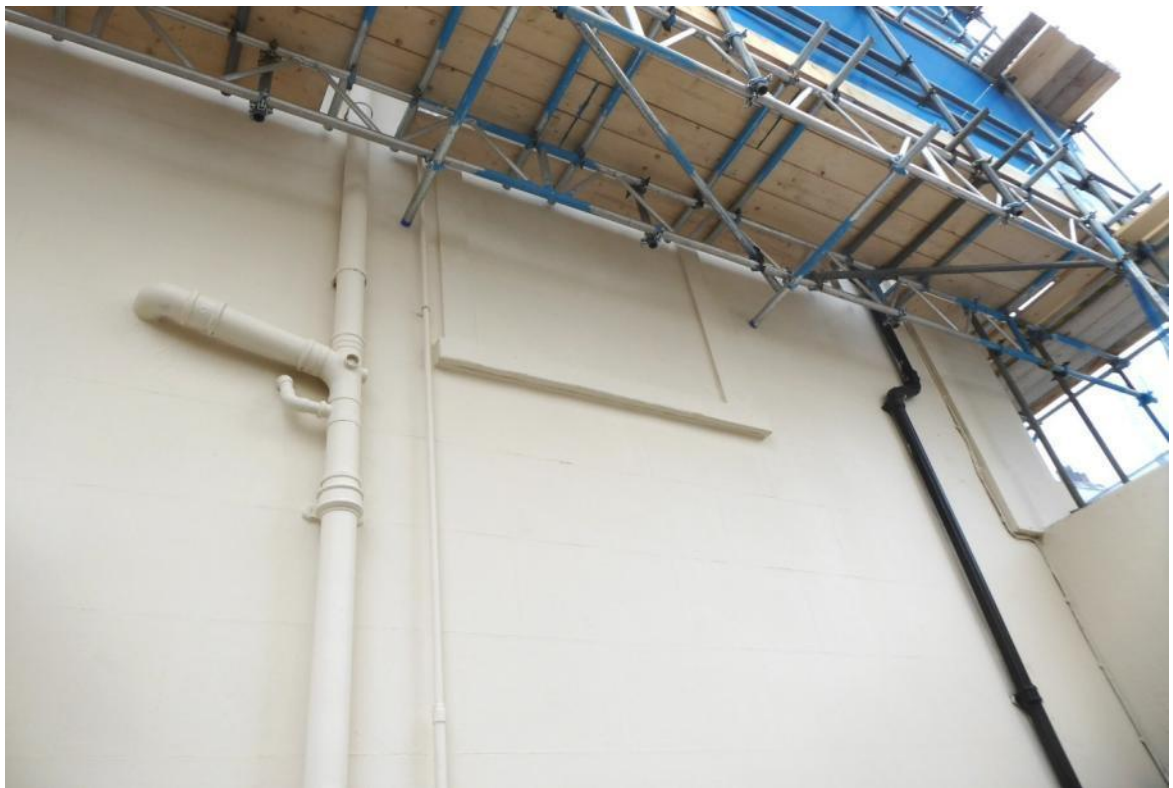
Fig 3.5.4; North flank wall

- 3.5.4 The north flank wall to the main part of the building is in plain render for the full height with an applied pilaster on the front face return, but not to the rear. This area has been scribed out to resemble ashlar stonework, but shows many signs of patch repair to the render behind the decorations. Running up this face are blind windows at approximately each major floor level.

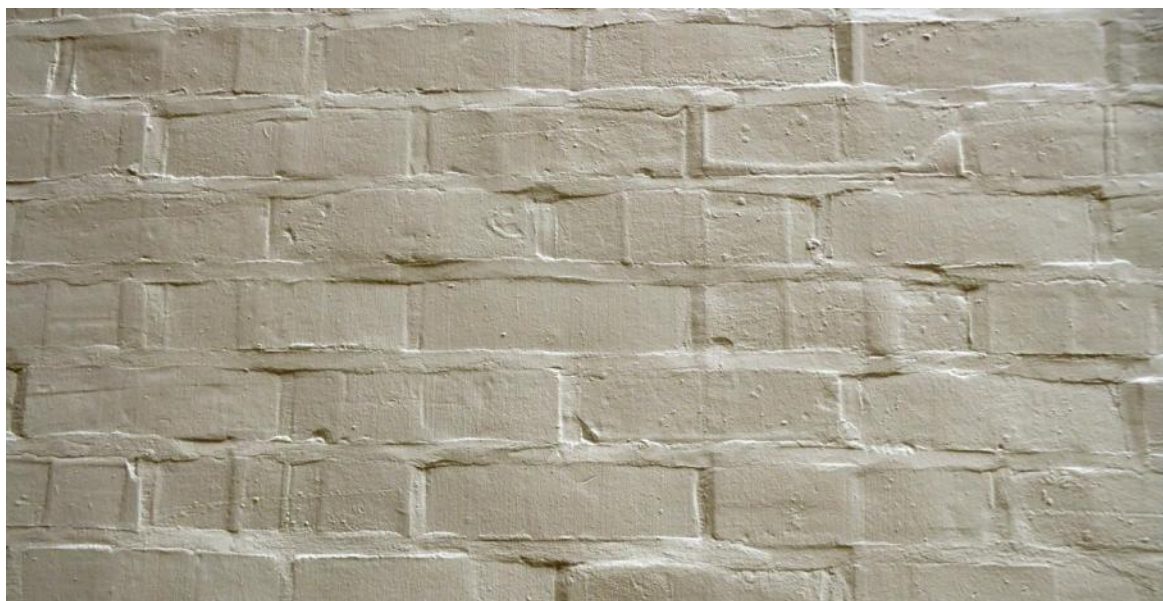
- 3.5.10 Extending off the rear elevation on the northeast corner is an extension that contains the ground floor toilets. The external walls have been rendered and painted on the street and north side and on the rear (east) side there is painted brickwork.

Fig 3.5.10; Brickwork to ground floor northeast extension, east external wall

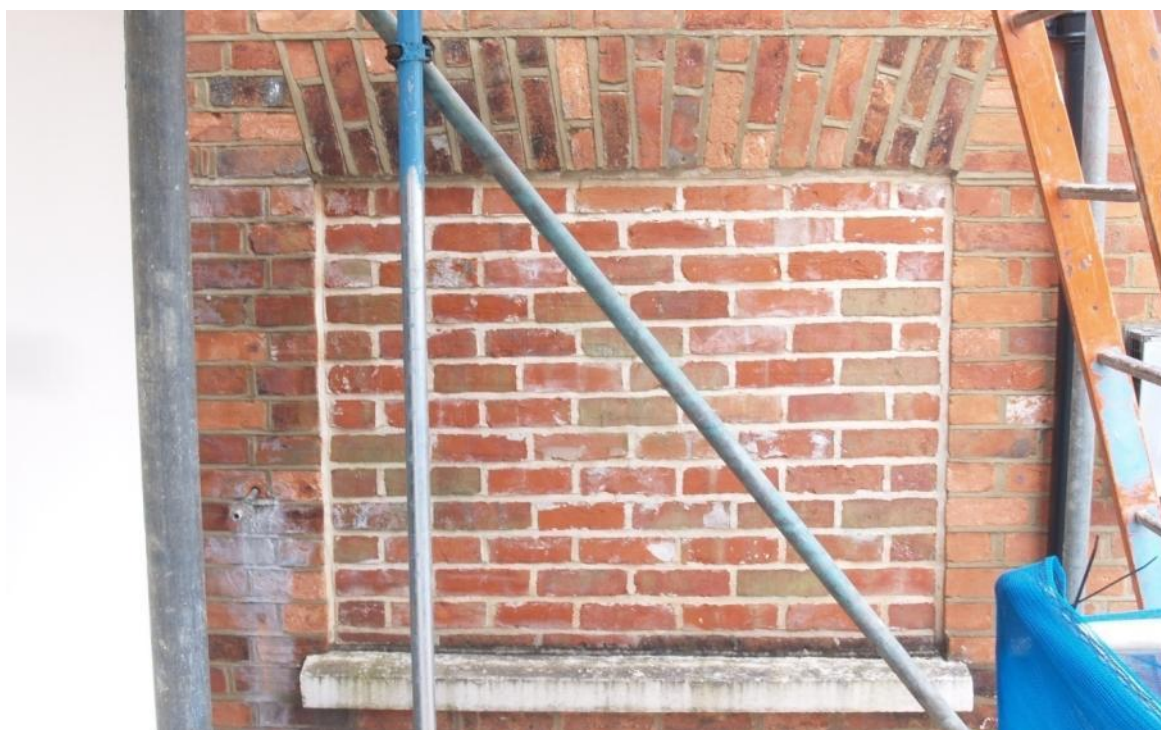
Fig 3.6.20; blocked window in east elevation, north side of lift shaft, third floor

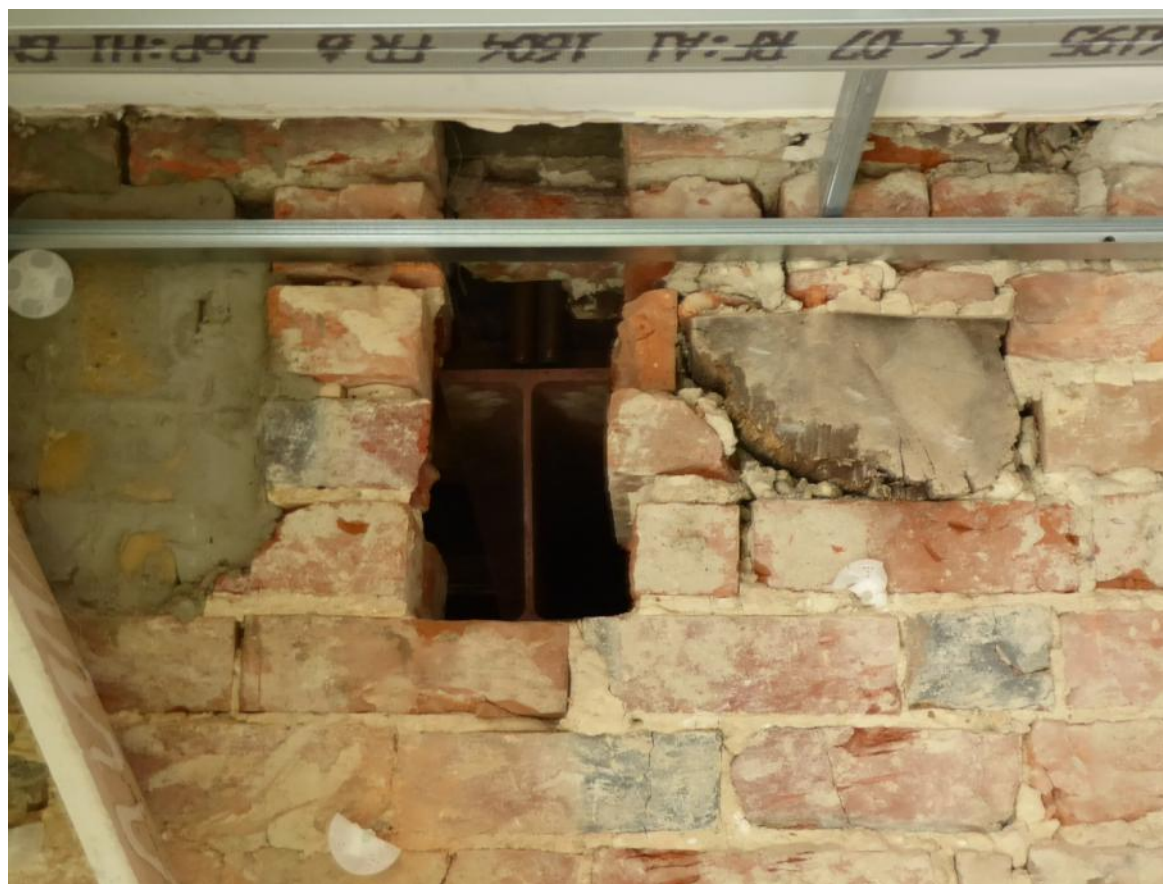
Fig 4.1.4; end of steel beam within north wall

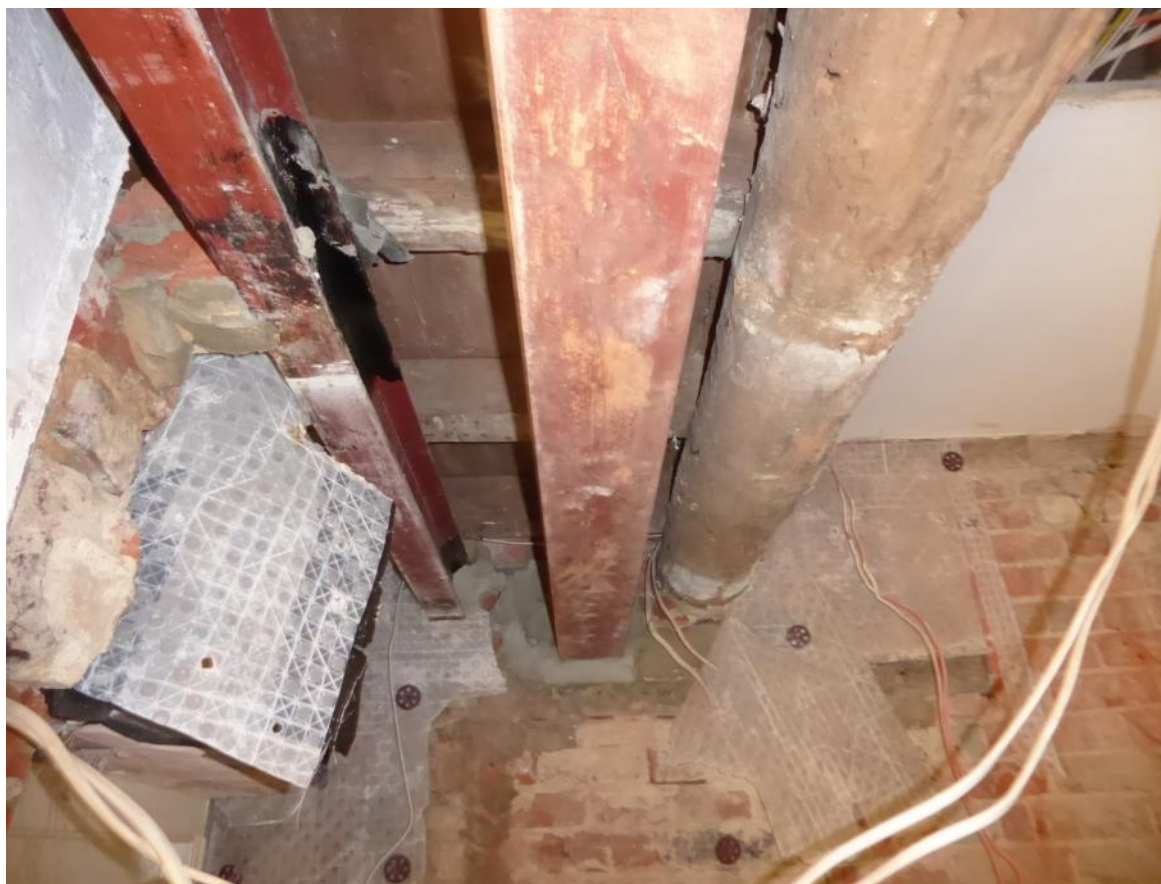
- 4.2.6 The first floor is carried onto an original timber beam (RHS of Fig 4.2.6) towards the street side of the room. This is in a rough section with timber packings over this to the underside of the floor joists. A new steel RSJ is inserted alongside it with a secondary steel beam from an earlier insertion at approximately the core of wall.

Fig 4.2.6; beam arrangement in ceiling of room 4.2

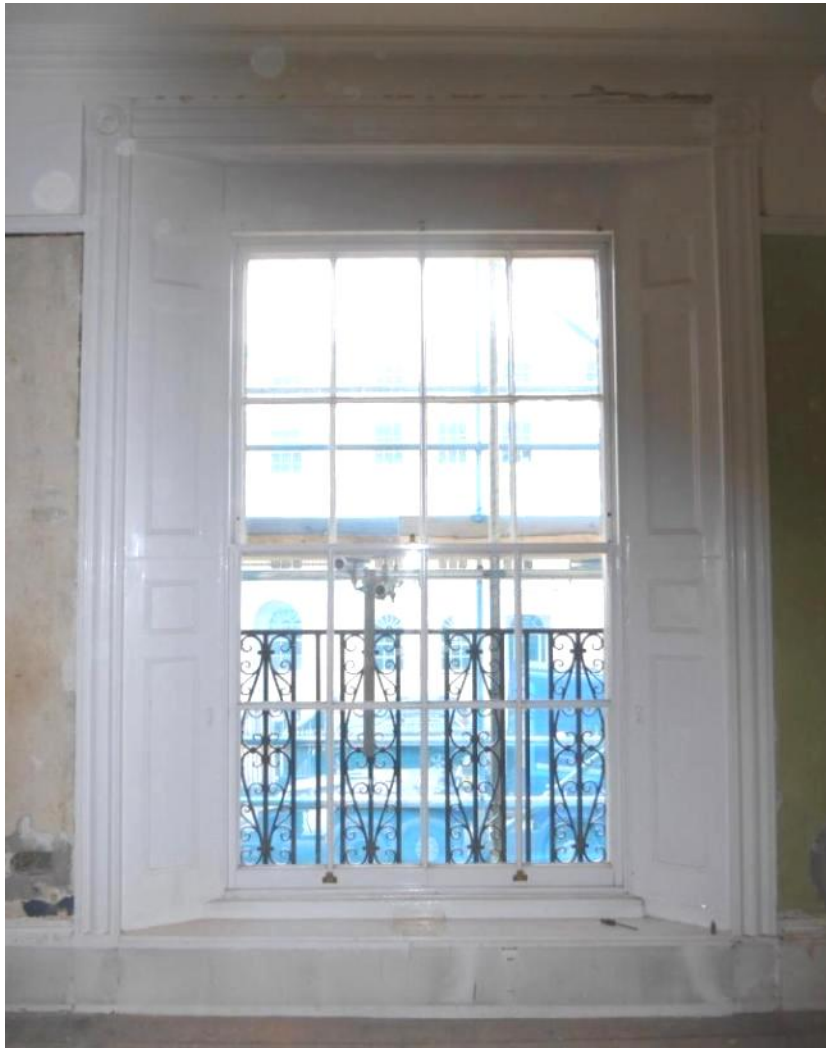
Fig 4.16.6; window to the front of the south front first floor room

- 4.16.6 The window to the front possibly has the original linings to the side as well as blind shutter boxes on either side. Adaptations to base have been made where some of low level entablature has been removed and replaced with modern skirting boards.

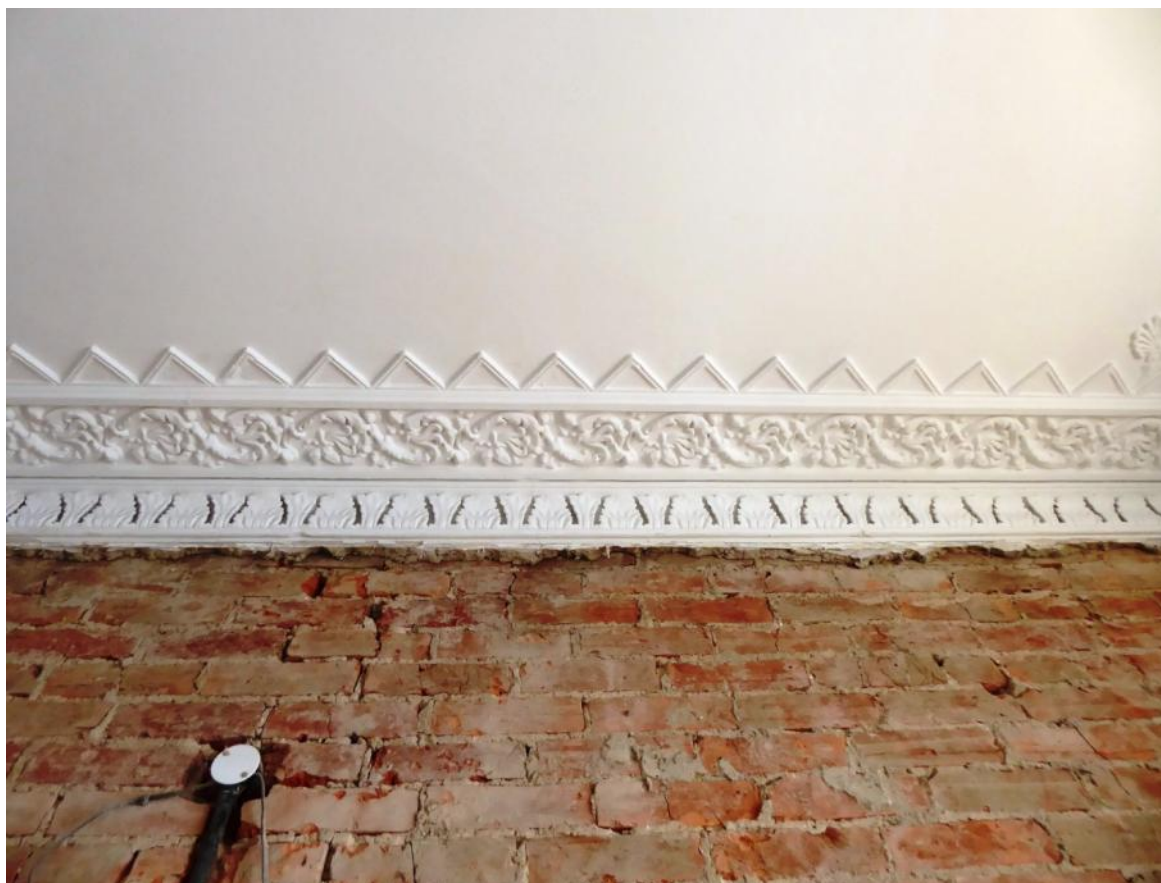
- 4.17.3 The ceiling is a flat soffit of plasterboard with hairline cracks on board joints. Around the ceiling is a decorative plaster frieze and cornice that appears to be of

modern construction with straight joints seen across joints within it on regular intervals of approximately 1.0 m.

Fig 4.17.3; Decorative plaster frieze and cornice

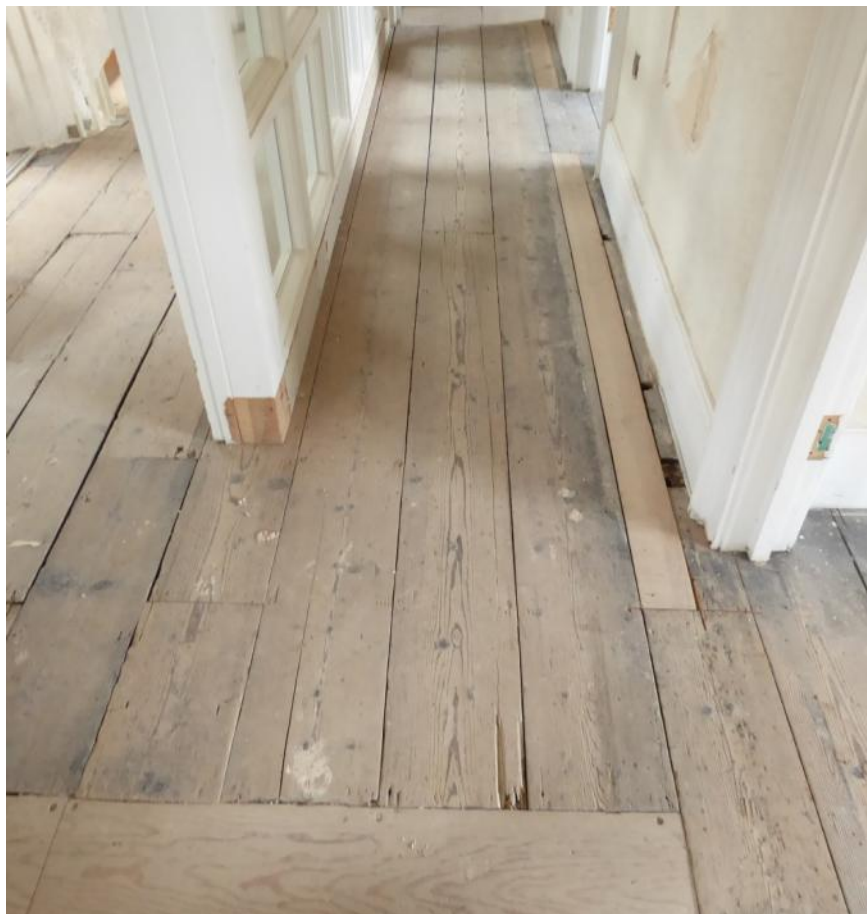
- 4.22.1 This was originally part of the greater landing, but shows where the original wall has been moved towards the front by approximately 170 mm all the way along across the central front room.

Fig 4.22; light floor boards showing where original wall would have been

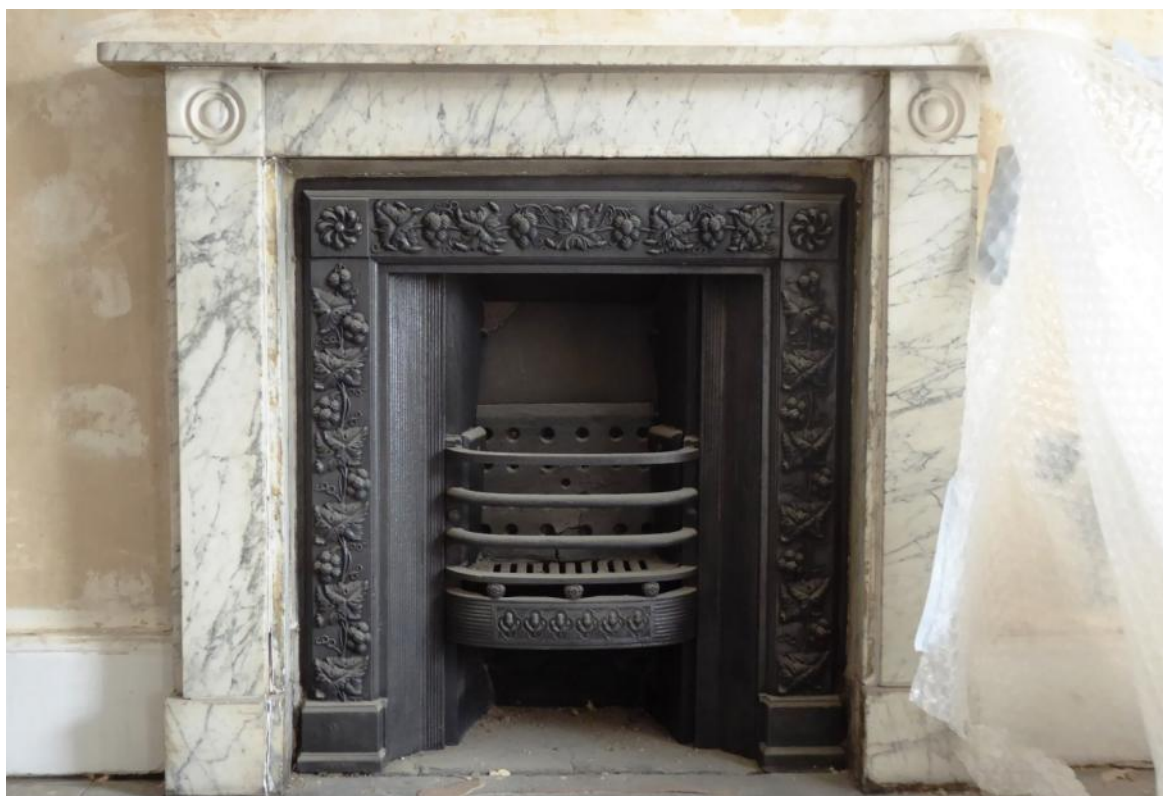
- 4.23.3 In the south wall is a rebuilt marble surround fireplace with apparently modern reproduction cast iron fire surround and hearth. Rebuilding is indicated by the side and cheek panels not being in their original position and showing much signs of mortar and adhesive staining on the surface. This sits over original stone or concrete hearth set within the floor surface.

Fig 4.23.3; rebuilt marble fireplace

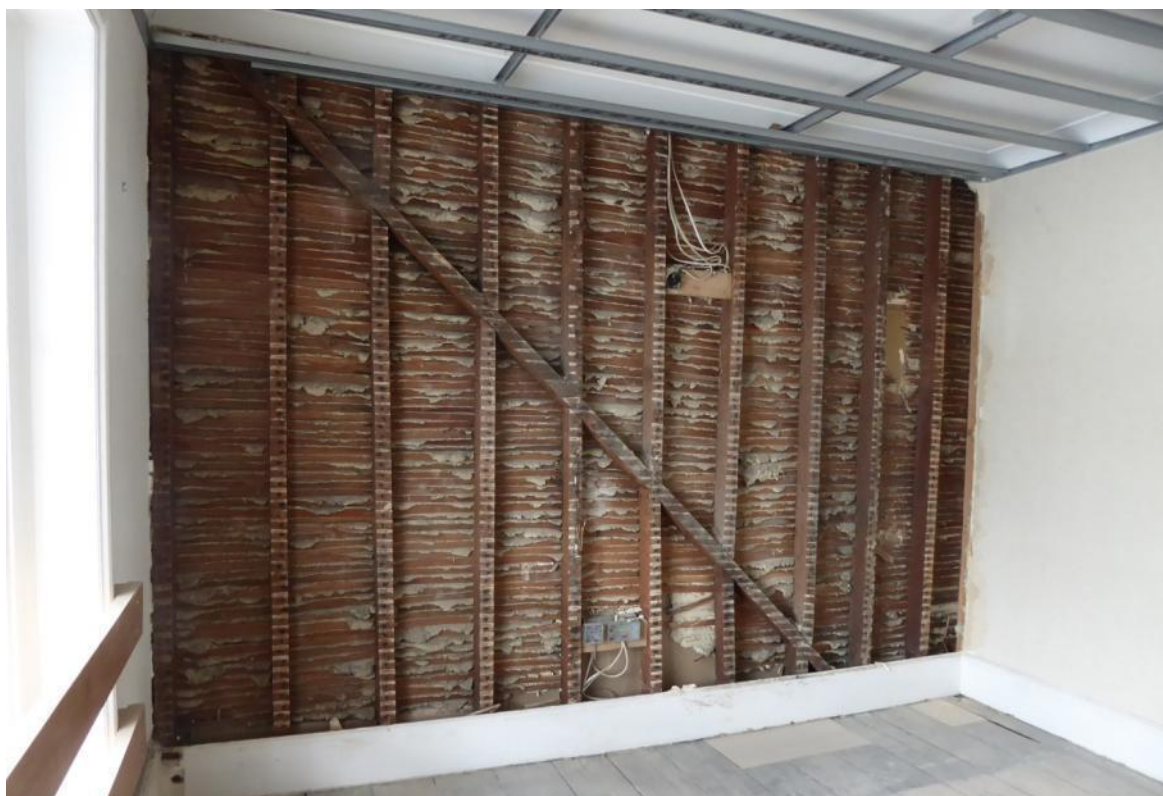
- 4.24.1 The walls apart from the front wall are all of hollow construction of traditional lath and plaster and both where they are exposed are double braced wall to the east room and a single braced wall to the north room. The wall having the lath and plaster still remaining is severely damaged towards the base and the upper section. In locations there is possibly the original skirting board still fixed to the base. The wall to the inner corridor is of modern stud partitioning with plasterboard on modern framing. To the front wall is of solid construction with a painted plaster finish.
- 4.24.2 The ceiling is as is that to the second floor east room.

Fig 4.24.1; exposed lath and plaster walls

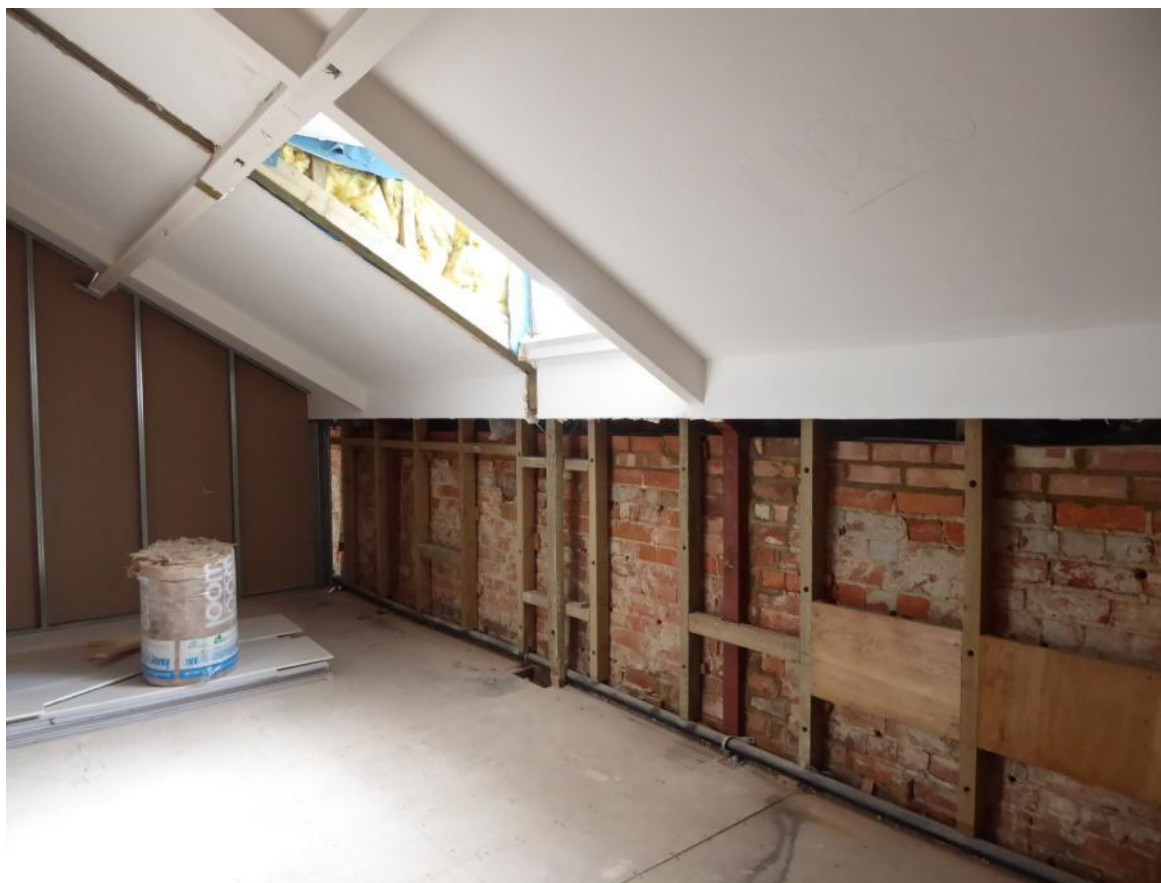
Fig 4.28.3; metal framing and raising of brick courses

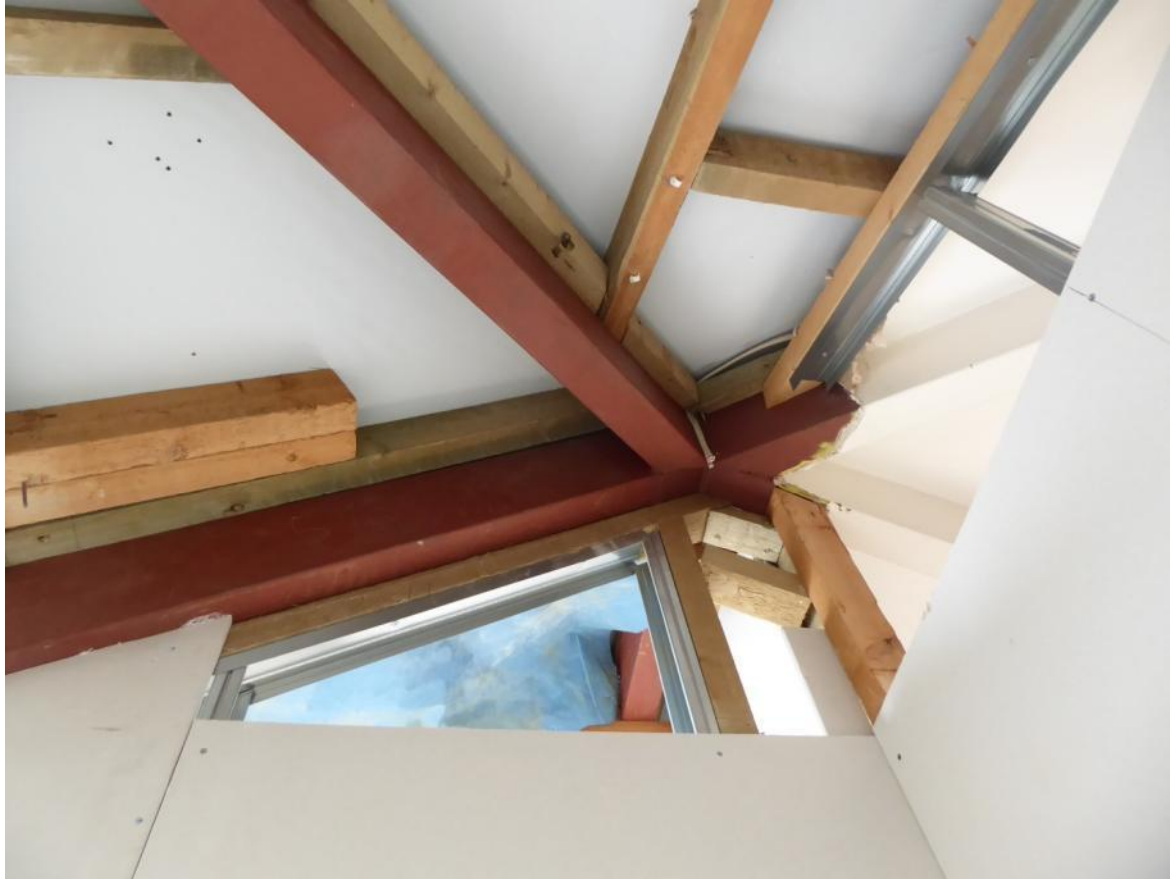
- 4.28.8 The whole roof structure is based on box section steel frames that run from the head of the raised wall over this floor and carry modern softwood purlins between them all the way around.

Fig 4.28.8; roof structure over third floor
