Whitelee Farm, Wincle, Cheshire, SK11 0QF
Level 1-2 Historic Building Recording of Farm Buildings
Planning Ref. NP/CEC/0420/0338

for Jonathan and Jenny Marsh of Whitelee Farm

November 2020

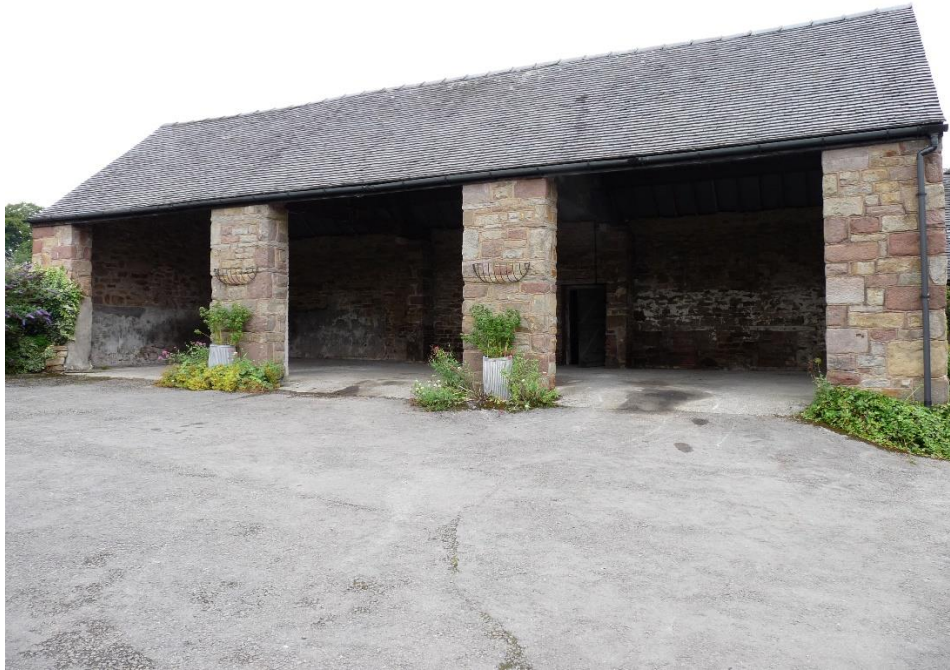
Building 1 has roughly coursed sandstone walls with lime mortar to the lower portions of the walls; above this, the walls were rebuilt in 1987 using a cement-rich mortar and salvaged stone. On the west gable-end historic masonry has been retained to approximately the present eaves height, to the east gable-end only the

lower 2 metres are historic and on the north wall, the upper metre of masonry has been rebuilt. Both gable-ends are blind. The rebuilding reduced the integrity of the historic building, but some features have survived in situ in the lower parts of the structure. The south elevation now consists of three open bays and two stone-faced piers that carry the wall plate; these date from 1987.

Fig.7: Building 1, rebuilt in 1987, from the south

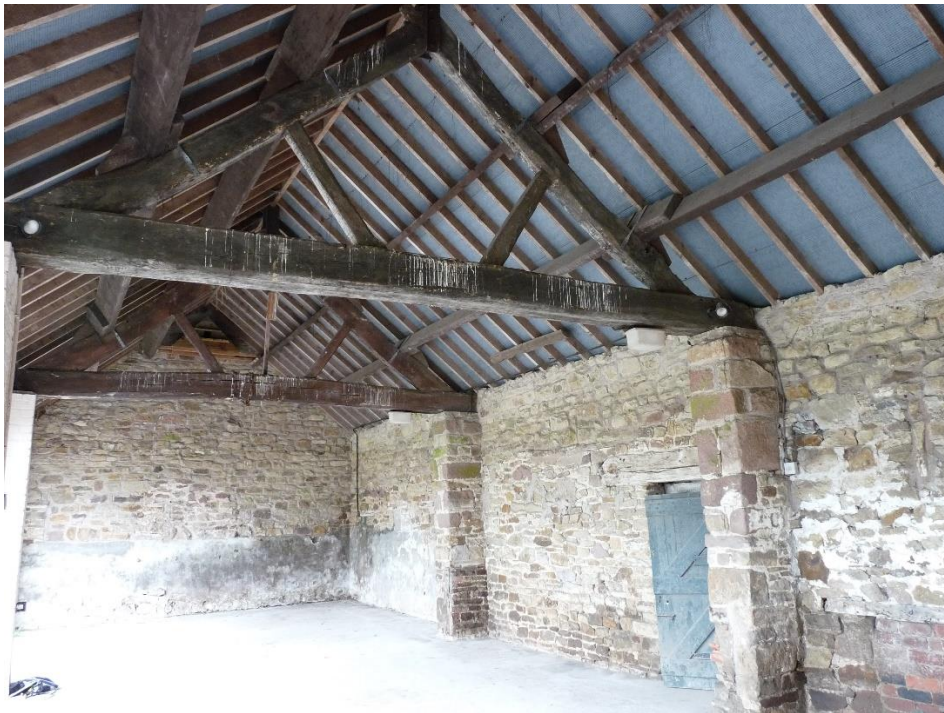
The single-volume barn has no partitions or divisions, and is open to the roof structure. The concrete floor was laid in 1987; the underlying floor structure is not known. The 3-bay roof consists of two re-set tie-beam trusses, each with a heavy chamfered tie-beam and raking struts. The two tiers of softwood purlins are carried on the backs of the trusses with wedge-shaped brackets, rather than utilising the earlier mortices for the original purlins. The softwood rafters and sarking felt are modern (1987).

Two projecting stone piers are built into the north wall, part of the earlier 2-storey building, designed to carry the roof trusses. The upper half metre of these piers was rebuilt with masonry using a cement mortar in 1987. Horizontal timbers are embedded in the inner returns (ie. west face of east pier and east face of west pier) of each pier, approximately 1m above floor level; their purpose is not known but they may relate to removed timber fittings. Visible in the west bay of the north wall are three blocked breathers or vents, filled with rubblestone; only the western of these is visible externally, on the north face of the wall. The lower 1 metre of the wall is rendered with grey cement. Visible in the east bay of the north wall are two

feed holes and part of a third, located with their timber sills at floor level, the two western holes are infilled flush to the face of the wall with red brick and the eastern hole is infilled with rubblestone. The eastern feed hole is partly hidden by the gable wall that abuts it, suggesting that the gable wall has been rebuilt further to the west than its original position. Each feedhole has a timber lintel and sill, visible on both sides of the wall. The lower part of the east bay on the north wall is partly lime-washed.

Fig.8: interior of Building 1 from the east

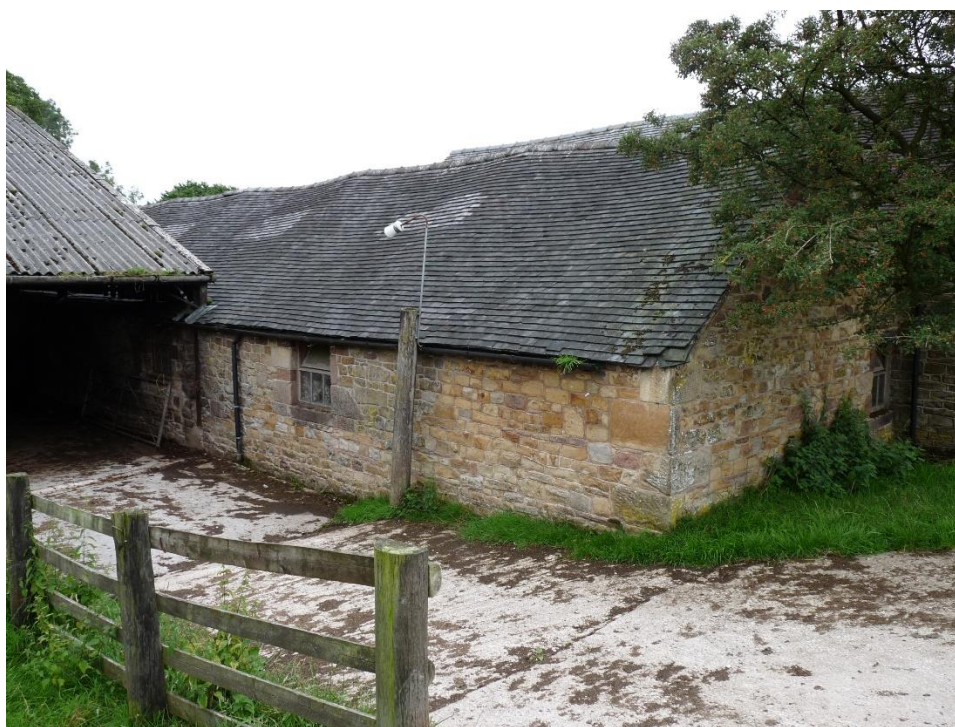
The north wall of Building 1 forms the south wall of this single-storey cow house. The roof is laid with plain Staffordshire blue tiles, with ceramic ridges and plain verges (no copings); the ridge has a noticeably undulating profile. Areas of colour variation in the roof tiles of the north pitch may relate to patching of the roof after the removal of roof-lights (Fig.9). Rainwater goods are plastic.

The three windows are timber hoppers, all of matching pattern and plainly detailed; each has square-section glazing bars and frames, timber lintels and stone sills. The hopper lights are not fitted with hinges and can be lifted out. There is one window to the west gable-end set close to the north wall of the south barn, and two to the north elevation. There are no external doorways into the building from the west or north; access is via the doorway from Building 1 or via external doorways in the east range (north) or from the south side of the east bay (outside the area of the recording). Two steel stanchions have been cut into the face of the north wall, part of the portal frame shed erected in the late 20th century. The west gable end has a high level owl hole, filled with glass (not visible in photographs due to a tree).

Fig.9: Building 2 from the north-west

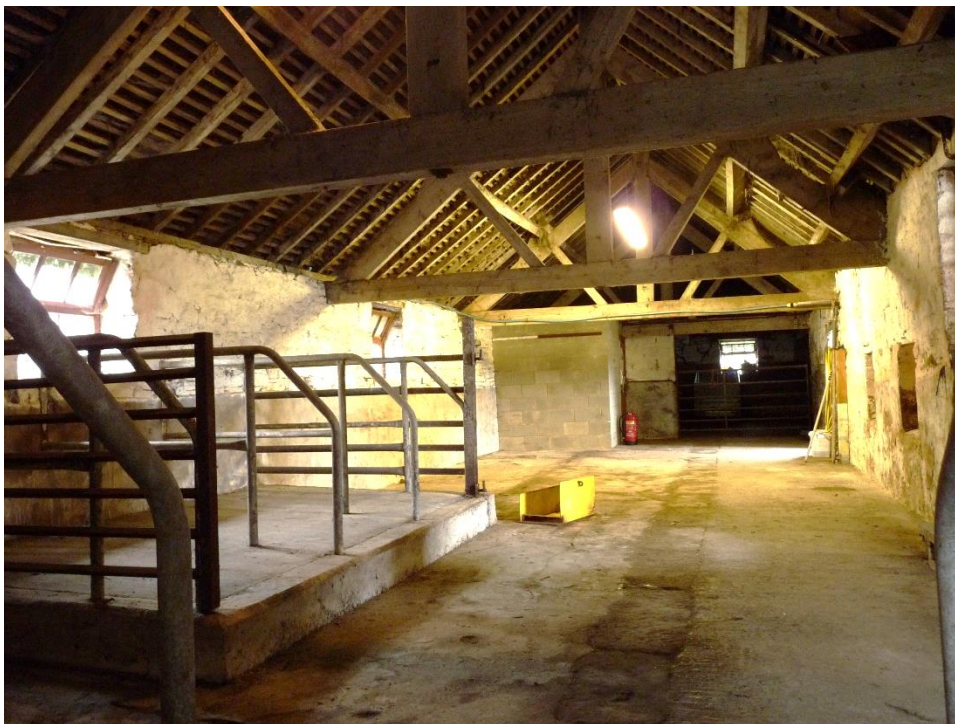
The 4-bay building is a single volume, open to the roof, without partitions or divisions, apart from a concrete block store against the north wall, towards the east end. The linear space is accessed from the doorway in the north wall of Building 1, described in section 5.4. It is lit from the west by one hopper window and from the north by two hopper windows, of matching pattern and detail. The walls are lined with cement up to approximately 1.5 metres above the floor level, a finish required to comply with mid 20th century dairy hygiene standards. All walls are lime-washed above the cement render. The floor is laid with concrete on one level, but there is an in situ stone kerb that runs longitudinally from east to west, towards the south side of the floor. This marks the south edge of a former raised stone floor for the cows, which would have been in stalls facing north. The raised concrete platforms to the west and part of the north side of the space are modern; these have galvanised steel stall divisions. There is no evidence for historic boskins or other fittings.

Fig.10: interior of Building 2 from the west

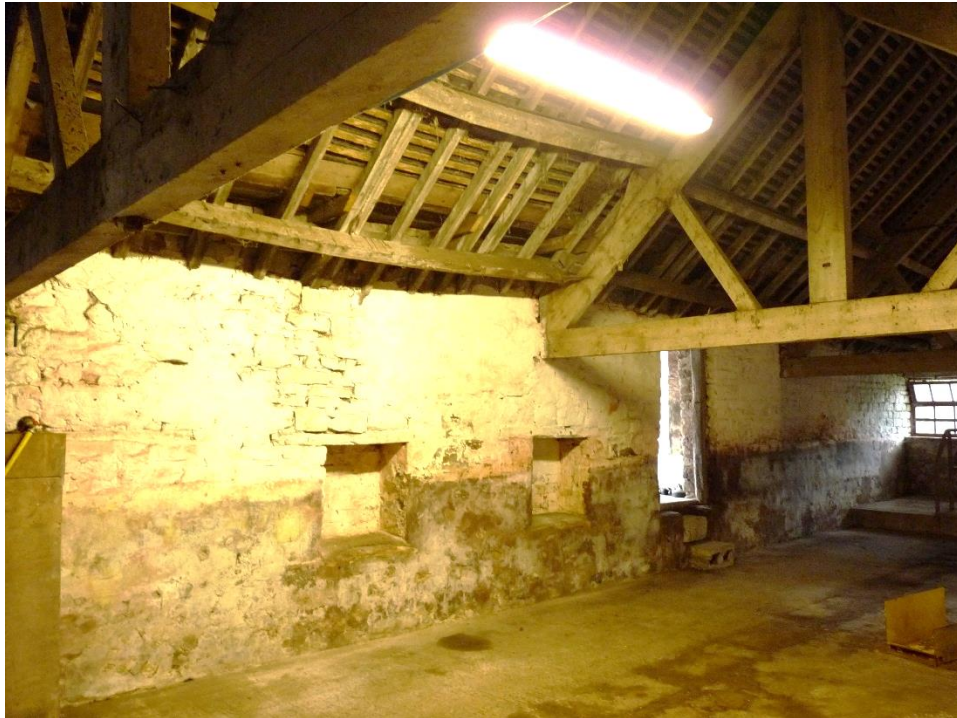
The south wall of the interior has three blocked feed-holes towards the east end of the wall; the eastern of these is blocked flush to the inner wall face and only visible the lintel is visible. The two to the west are blocked with brick to form recesses, each with a timber sill and lintel, with lime-washed surfaces. These features are also visible in Building 1.

Fig.11: blocked feed-holes and doorway on the south wall of Building 2, from the south-east

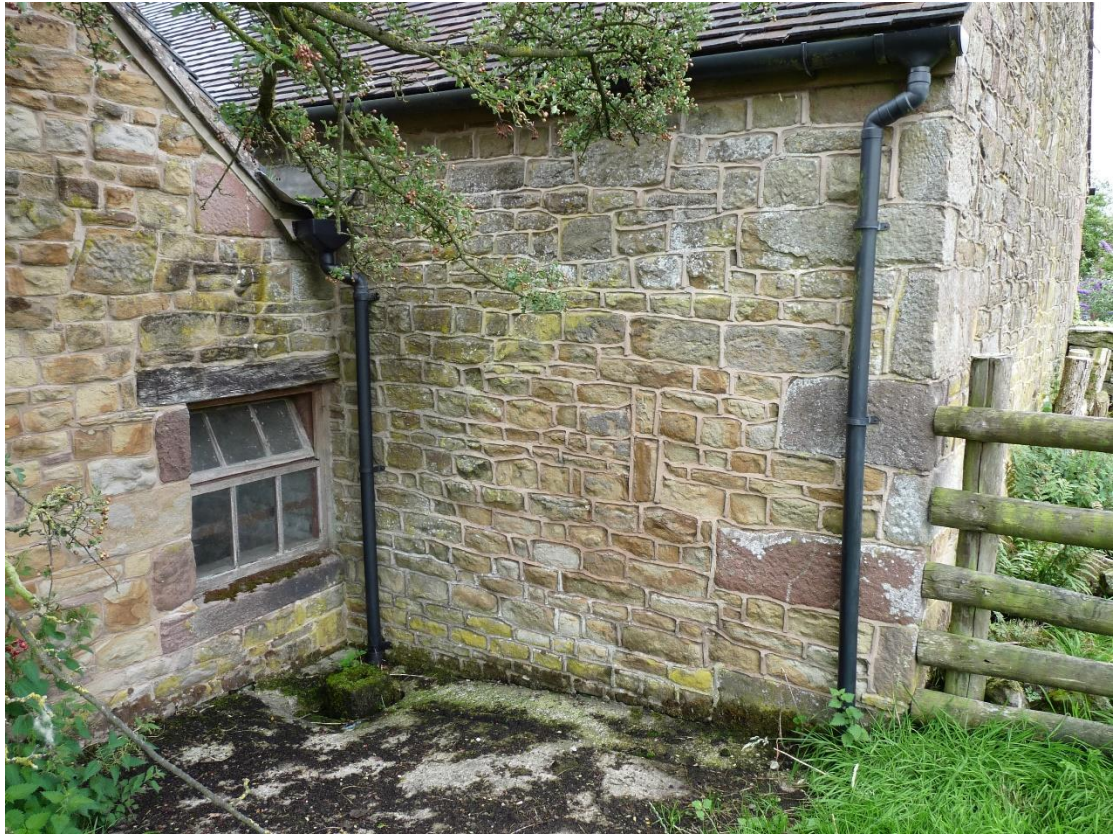
Plate 5: external junction between Buildings 1 and 2, from the north-west, with blocked breather on north wall of Building 1

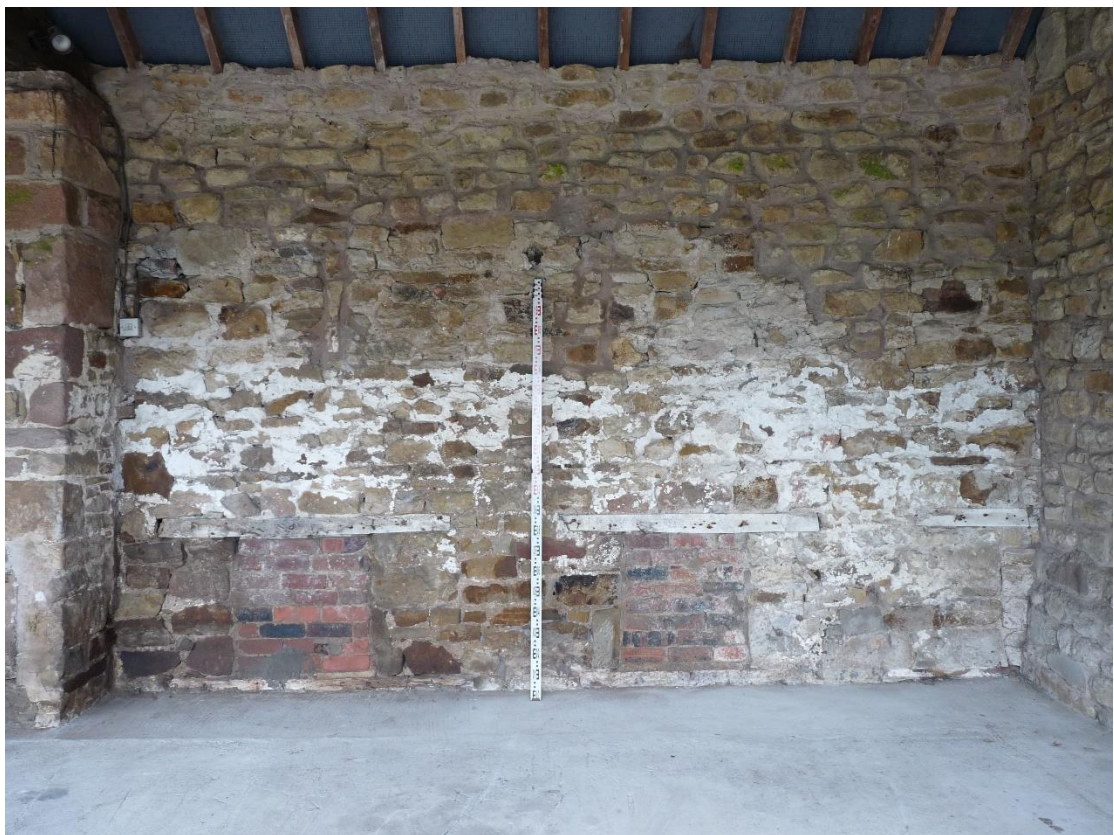
The three feed holes to the west bay of Building 1 indicate that the earlier range on the site of Building 2 was used as a cow house; this abutted the eastern end of Building 1 building on its north side. Feed holes were used to deliver fodder from the area where hay or fodder was stored (or from a feed passage) into a cow house, to reduce manual handling. In some examples of Peak District cow houses, each feedhole directly relates to a cow stall and its manger or hayrack, but there is no evidence of this here. The eastern feedhole appears to be abutted by the east gable wall of the south barn; it is blocked with rubblestone that is filled flush to both faces of the wall, with no recess on the north face of the wall, in contrast to the other two. As the east gable wall of Building 1 was rebuilt up from ground level at its north end in 1987, the historic relationship between the gable wall and this feed-hole has been obscured.

Plate 12: blocked feed-holes on north wall (east bay) of Building 1

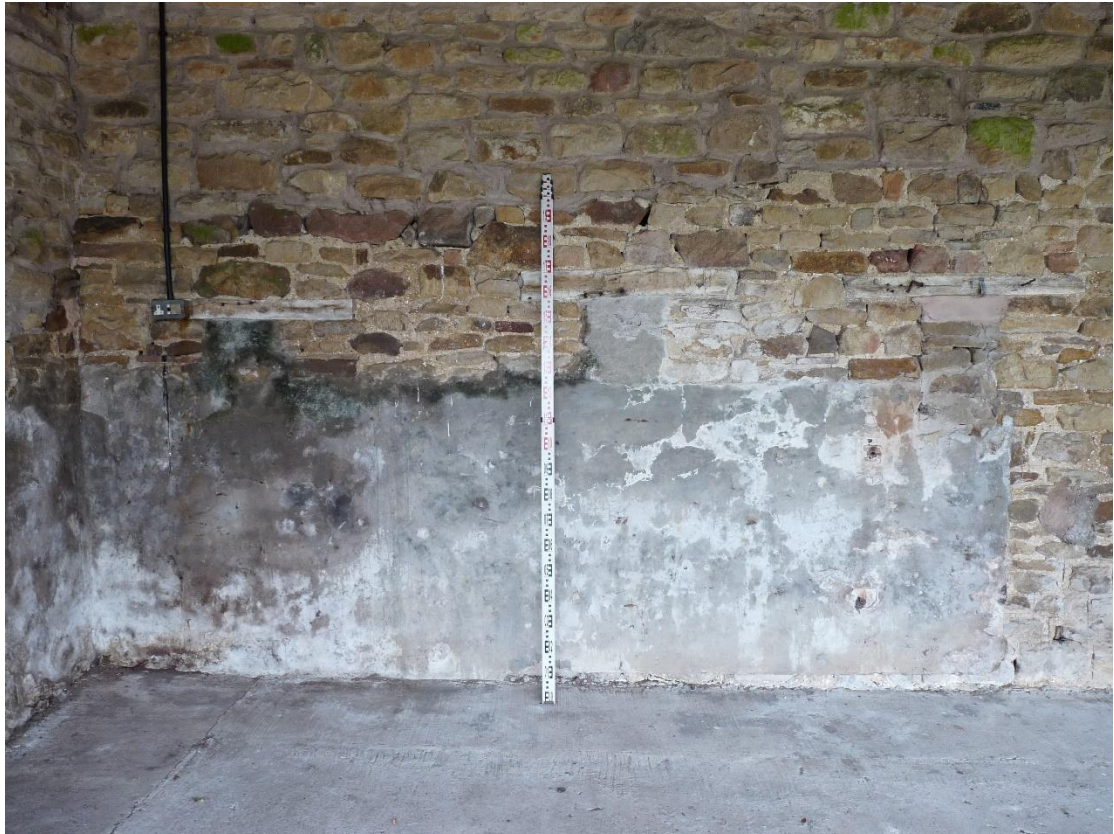
Plate 13: blocked vents on the north wall (west bay) of Building 1

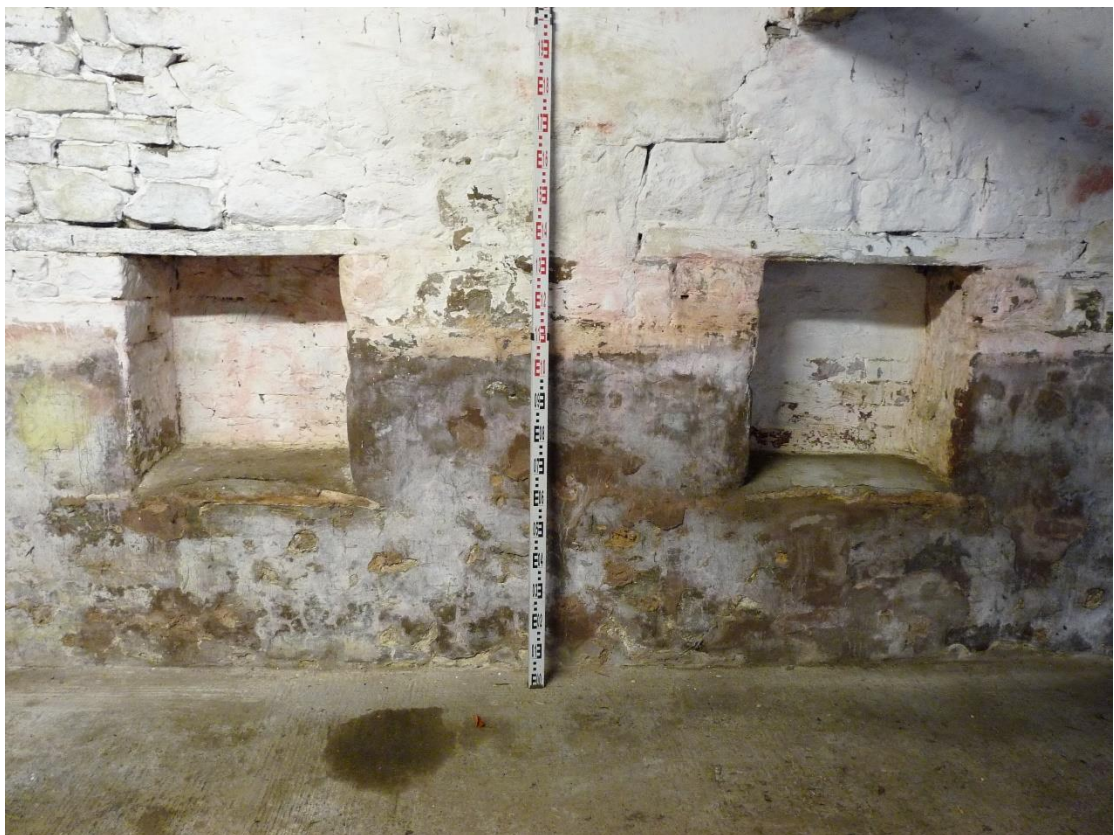
Plate 16: blocked feedholes on north wall (east end) of Building 2 from the north

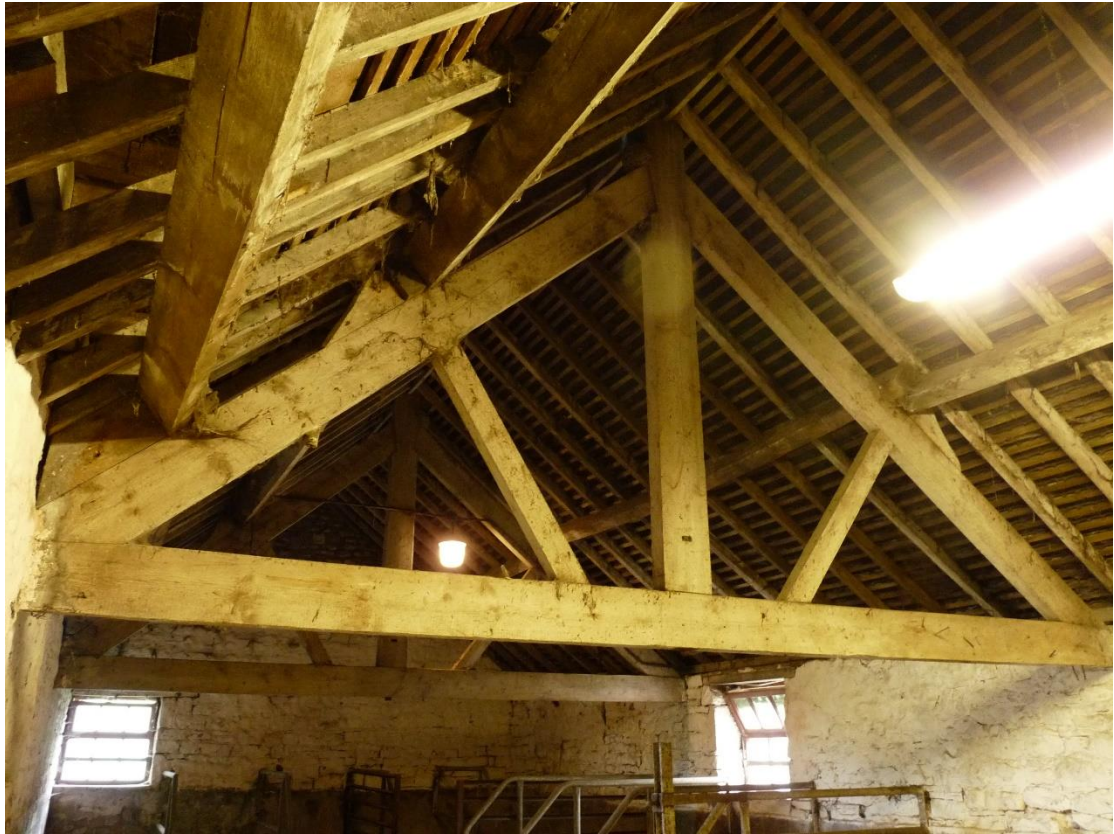
The 4-bay roof structure comprises matching machine-sawn softwood king-post trusses with raking struts and through purlins; two tiers to the south pitch and one to the north, supported on wedge-shaped brackets. Iron bolts are used to connect the tie-beams to the king posts, a late 19th or early 20th century detail. The roof has

Plate 17: roof truss in Building 2 from the east
